BIOLOGICAL CONDITIONS ENVIRONMENTAL AUDITOR REPORT

Resource ID: S-D17

Milepost: 248.83

Station: 13138+50

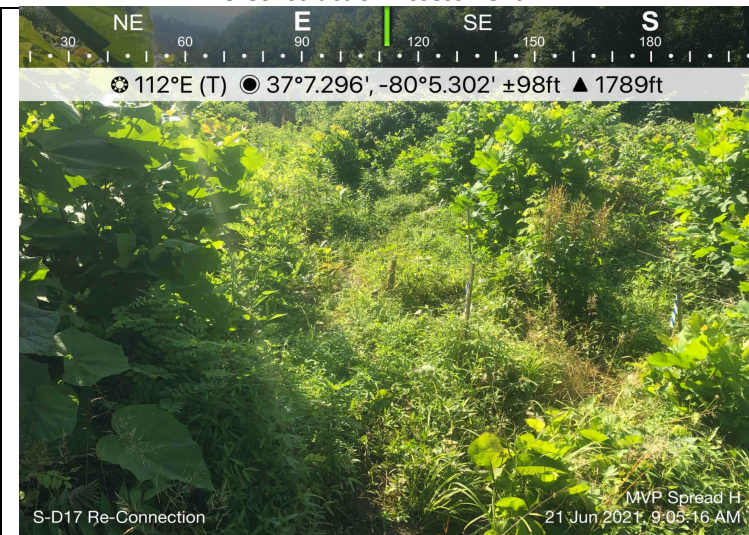
Pre-Construction Assessment

Overview of work area during pre-construction conditions. Wetland habitat log is to be installed across stream channel and re-connect the channel through the berm, depicted near the blue and white striped flagging. No aquatic macroinvertebrates or fish were observed in the channel prior to the work activity.

The in-stream activity re-connected MVP stream S-D17 (UNT to North Fork Blackwater River) to its historical channel, MVP stream S-D14, that was diverted by historic logging activities. This activity was permitted and approved through the Norfolk District Army Corps of Engineers (NAO-2015-00898). The stream substrate generally consisted of mud and/or silt material prior to the Wetland Habitat Log (WHL) installation, and the substrate was consistent with pre-construction conditions after the installation. Areas permitted to be temporarily impacted for this work activity were restored to pre-construction contours. The WHL was installed and secured with duck-bill anchors, and backfilled with the material excavated for the installation. The areas were seeded with the appropriate wetland seed mix, and stabilized with erosion control matting. Upon completion of the work, the stream flow was re-established to the completed work area, and verified that the stream flow was re-connected successfully. This re-connection work will reduce erosion and sedimentation by allowing the stream to follow its original stream course, instead of the historic logging road.

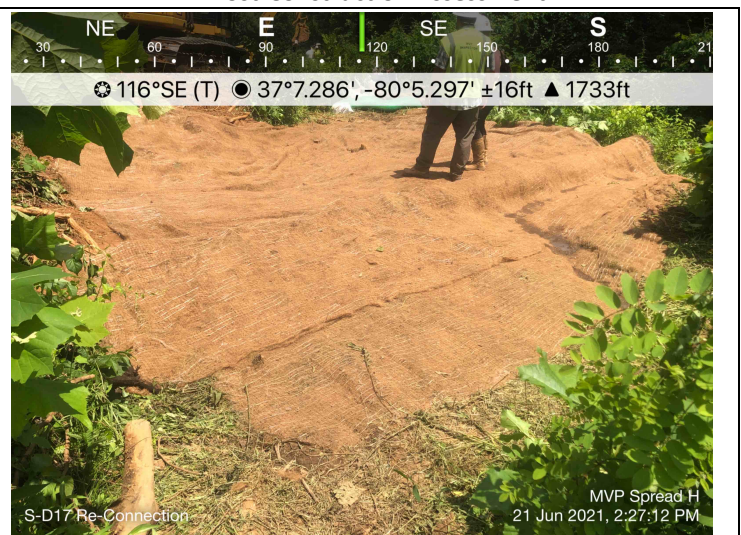
Post-Construction Assessment

Post-construction stream flow at the re-connection point of S-D17 to S-D14. The WHL was installed across the stream and the re-connection has prevented the continued erosion of the hillside. The disturbed area was seeded and stabilized with matting, and the stream flow was clear after flowing through the work area.
