Baseline Assessment – Stream Attributes

**Reach S-C39 (Pipeline ROW)
Perennial
Spread F
Monroe County, West Virginia**

Title:
 PROFILE AND CROSS-SECTIONS
 BASELINE SURVEY
 CROSSING S-C39
 PAINTER RUN, (MP 194.57)
 MONROE COUNTY, WV

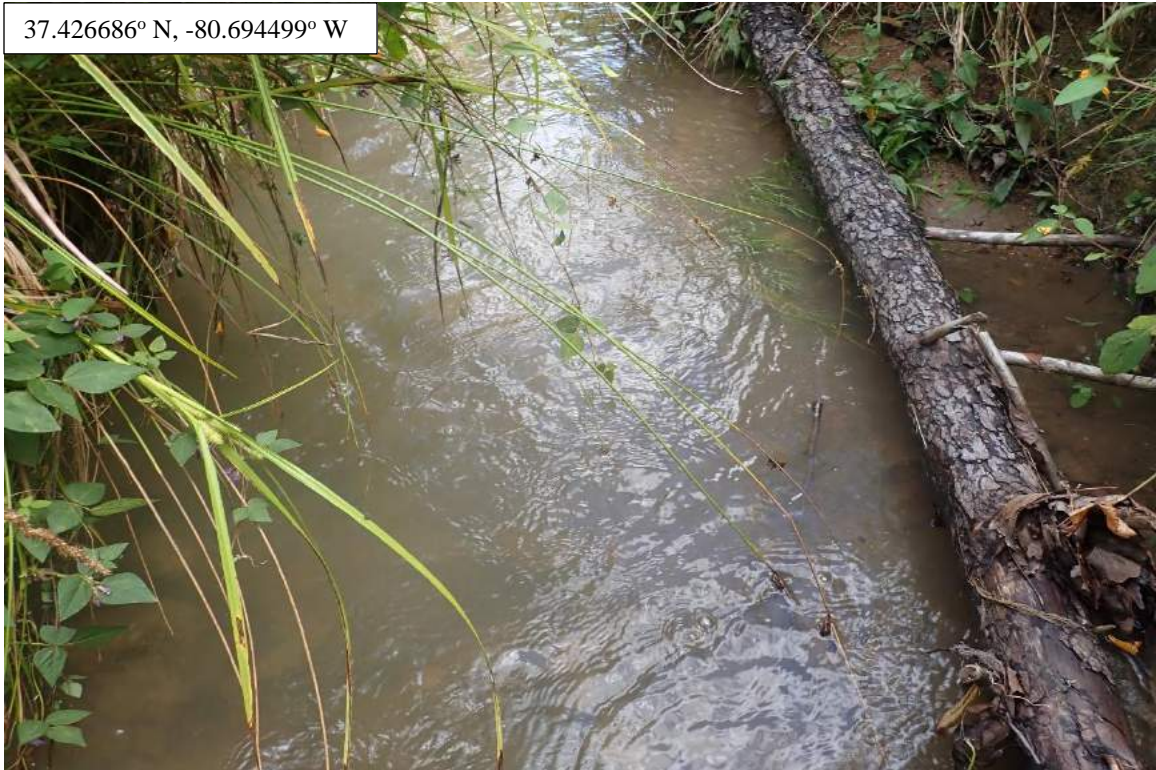
Photo Type: DS, US View

Location, Orientation, Photographer Initials: Downstream Edge of ROW, Upstream View, AK/TF/TA/WP

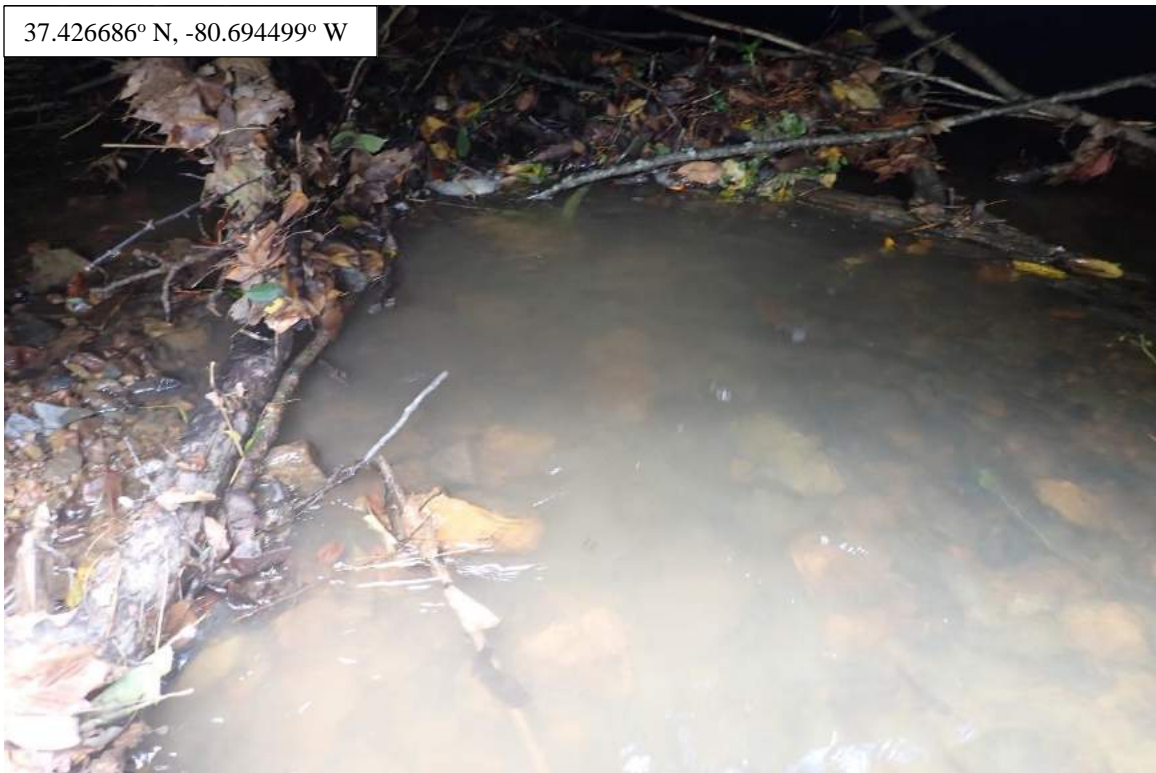
Photo Type: DS, DS View

Location, Orientation, Photographer Initials: Downstream Edge of ROW, Downstream View, AK/TF/TA/WP

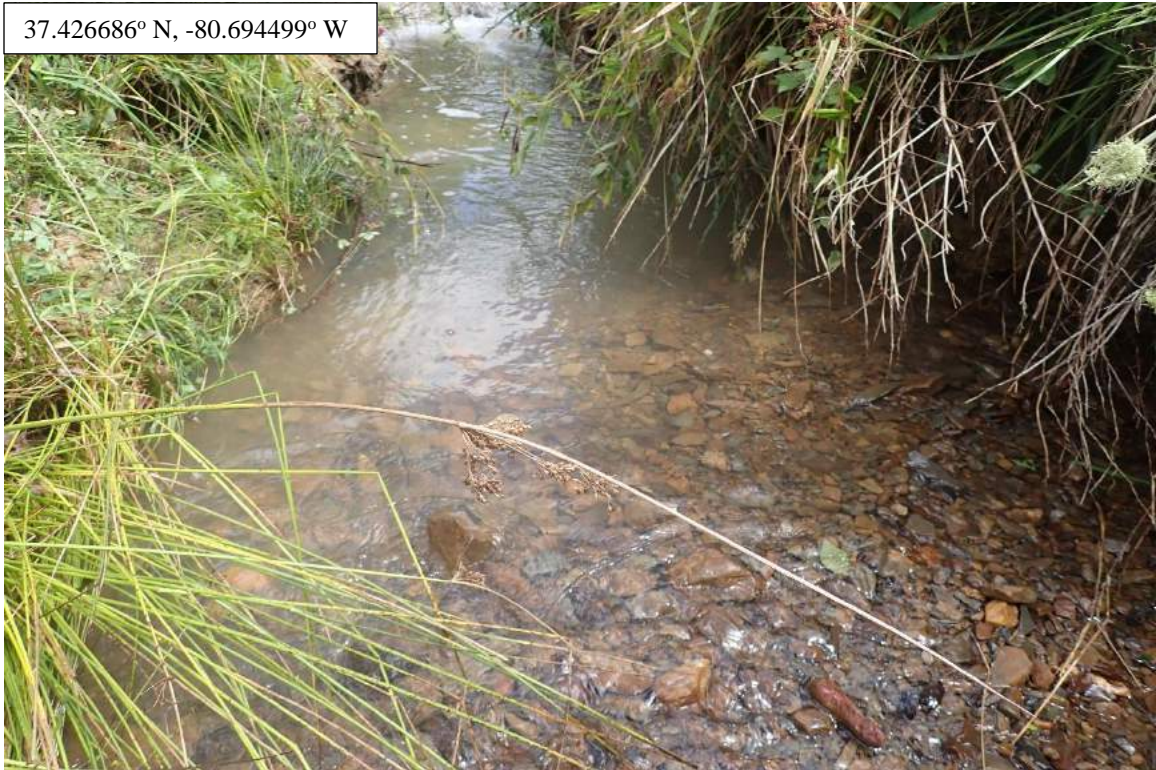
Photo Type: CP, US View
Location, Orientation, Photographer Initials: Center ROW, Upstream View, AK/TF/TA/WP

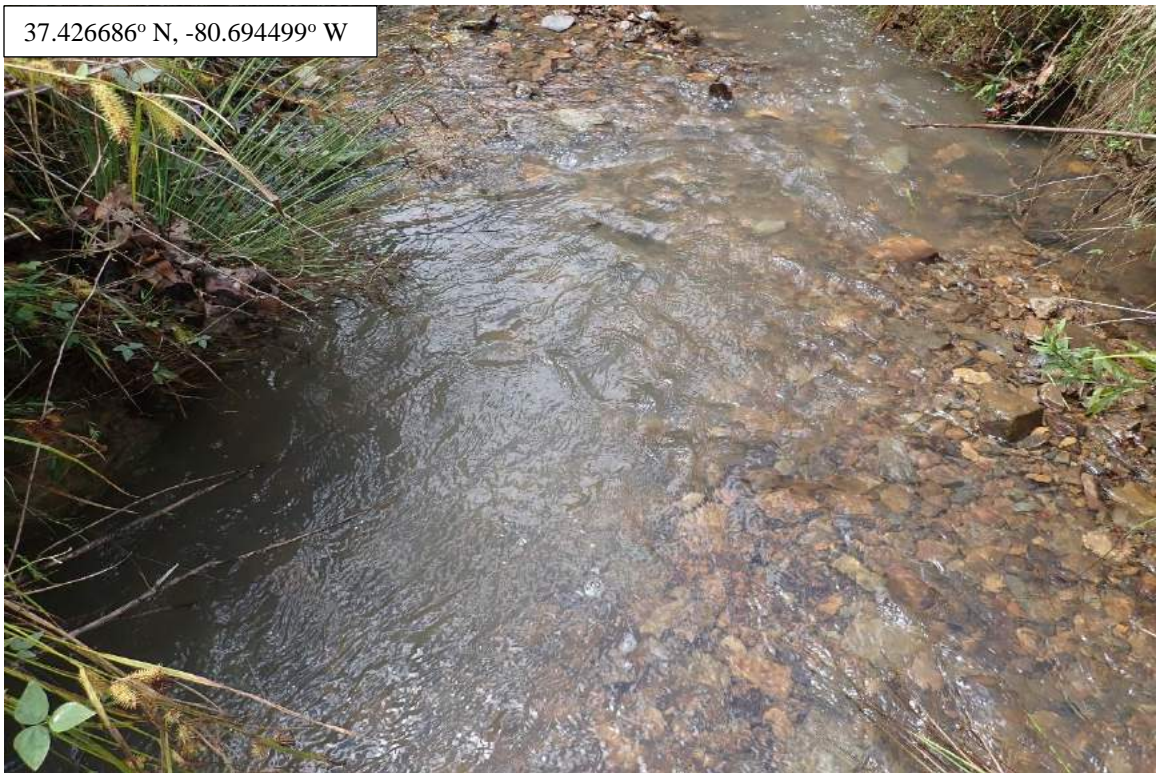
Photo Type: CP, DS View
Location, Orientation, Photographer Initials: ROW Center, Downstream View, AK/TF/TA/WP

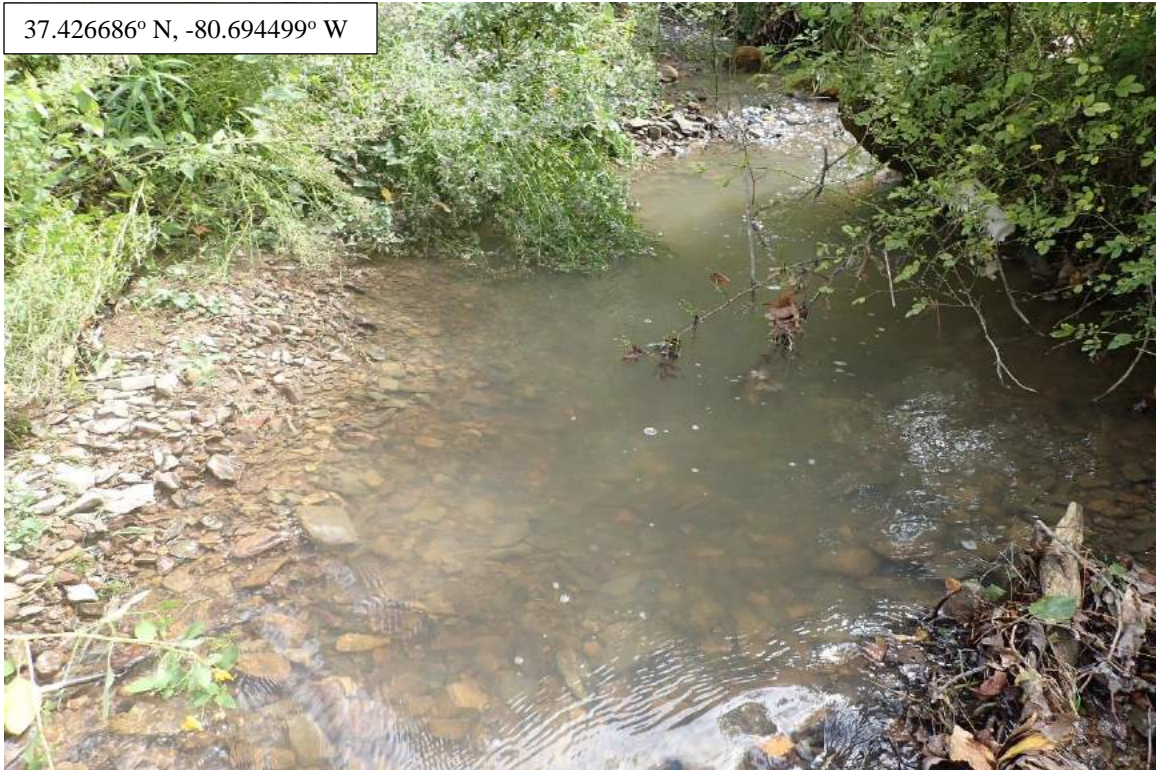
Photo Type: US, US View, US Riffle Cross-Section, US View
Location, Orientation, Photographer Initials: Upstream Edge of ROW, Upstream View, Upstream Riffle Cross-Section, Upstream View, AK/TF/TA/WP

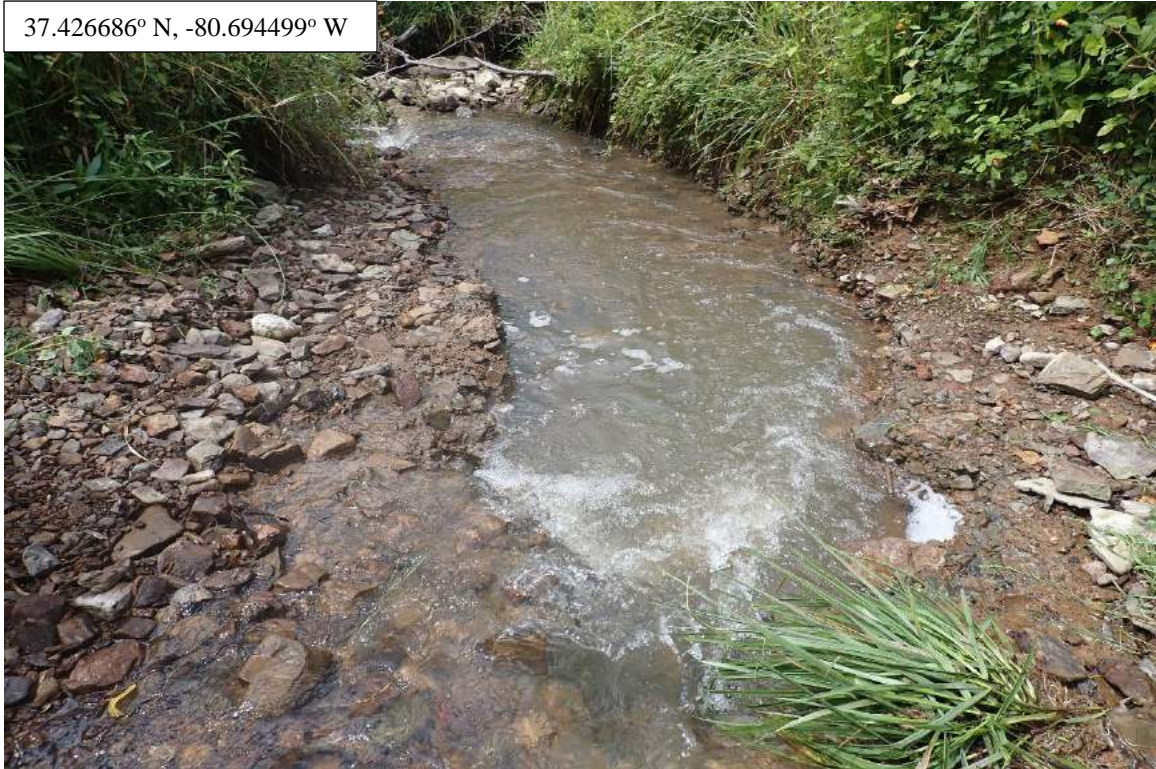
Photo Type: US, DS View, US Riffle Cross-Section, DS View
Location, Orientation, Photographer Initials: Upstream Edge of ROW, Downstream View, Upstream Riffle Cross-Section, Downstream View, AK/TF/TA/WP

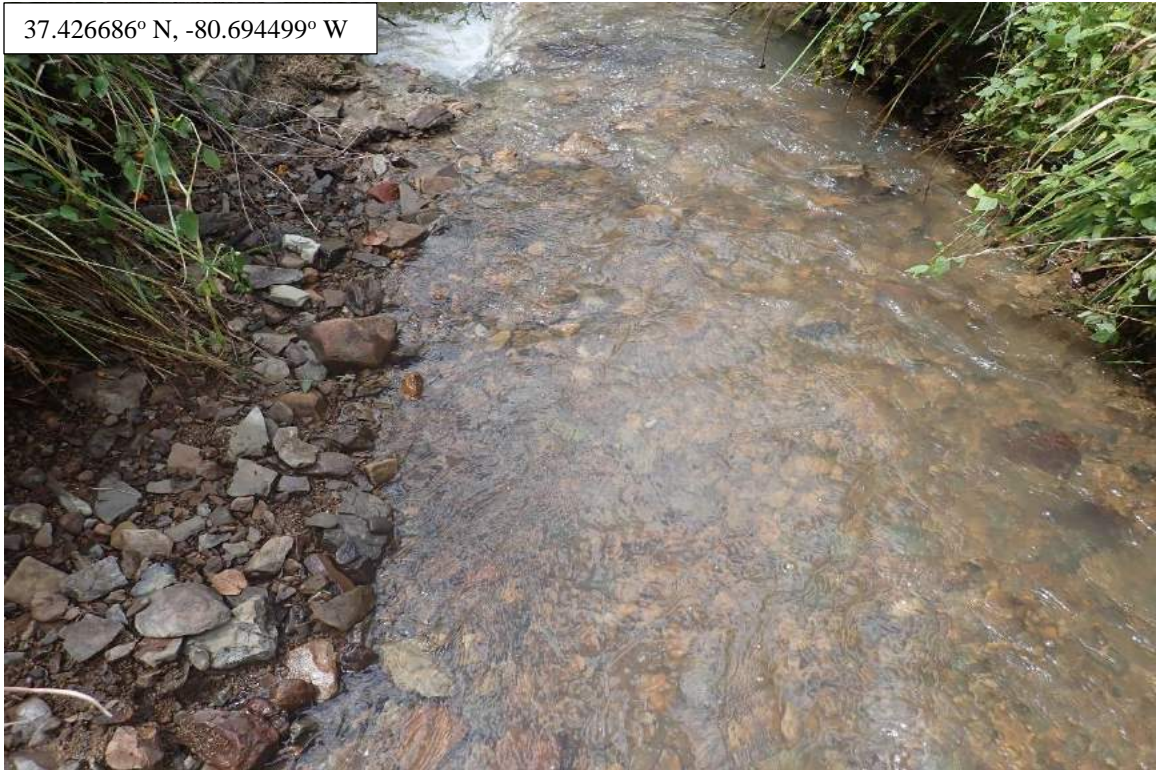
Photo Type: US Pool Cross Section, US View

Location, Orientation, Photographer Initials: Upstream Pool Cross Section, Upstream View, AK/TF/TA/WP

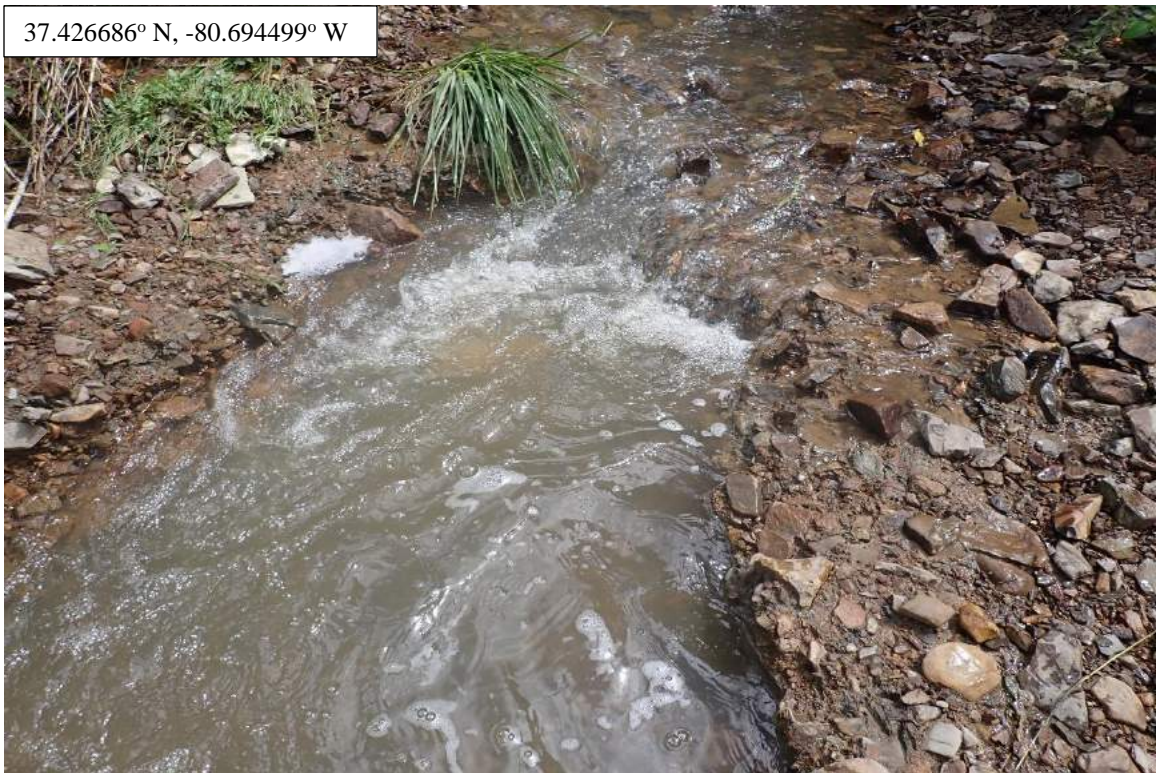
Photo Type: US Pool Cross Section, Downstream View

Location, Orientation, Photographer Initials: Upstream Pool Cross Section, Downstream View, AK/TF/TA/WP

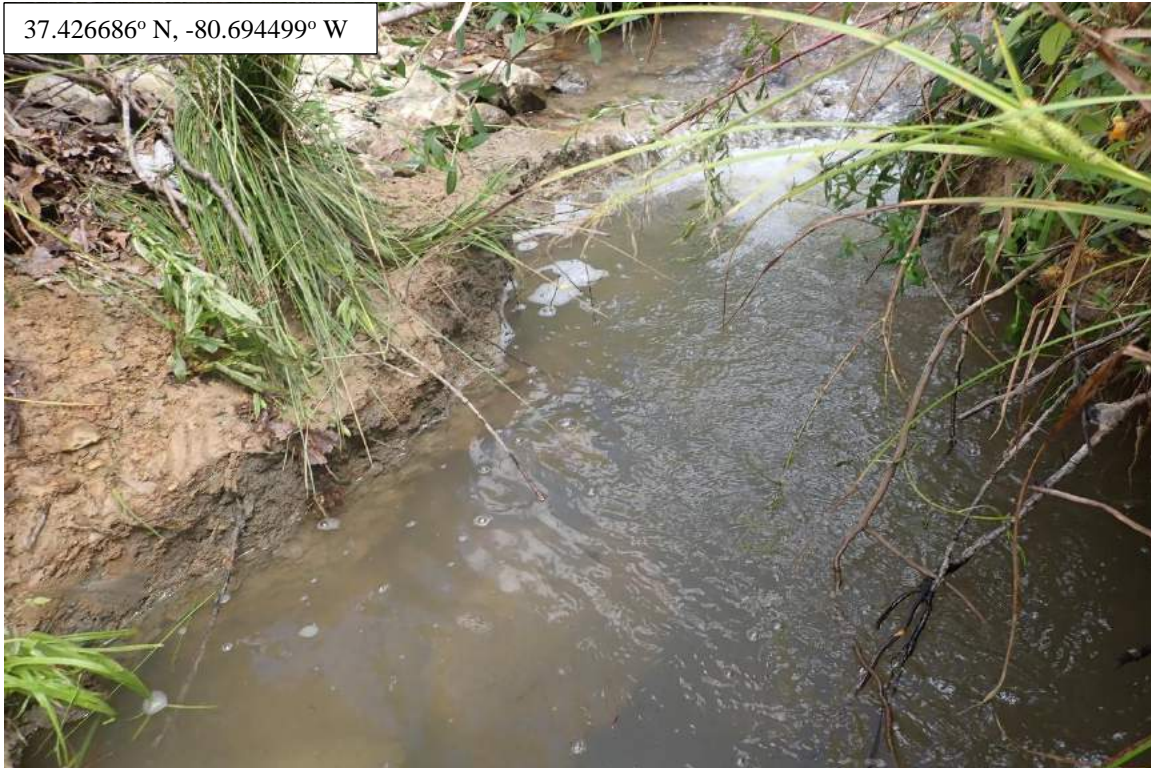
Photo Type: DS Pool Cross Section, US View

Location, Orientation, Photographer Initials: Downstream Pool Cross Section, Upstream View, AK/TF/TA/WP

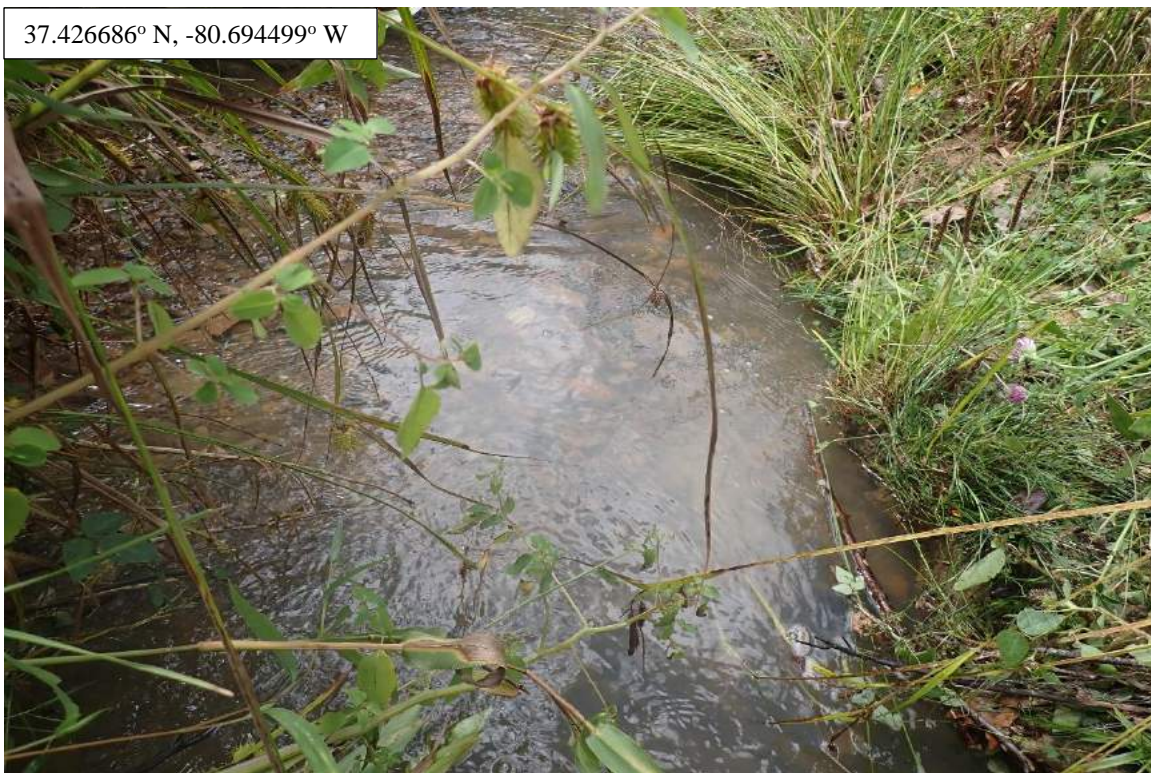
Photo Type: DS Pool Cross Section, DS View

Location, Orientation, Photographer Initials: Downstream Pool Cross Section, Downstream View, AK/TF/TA/WP

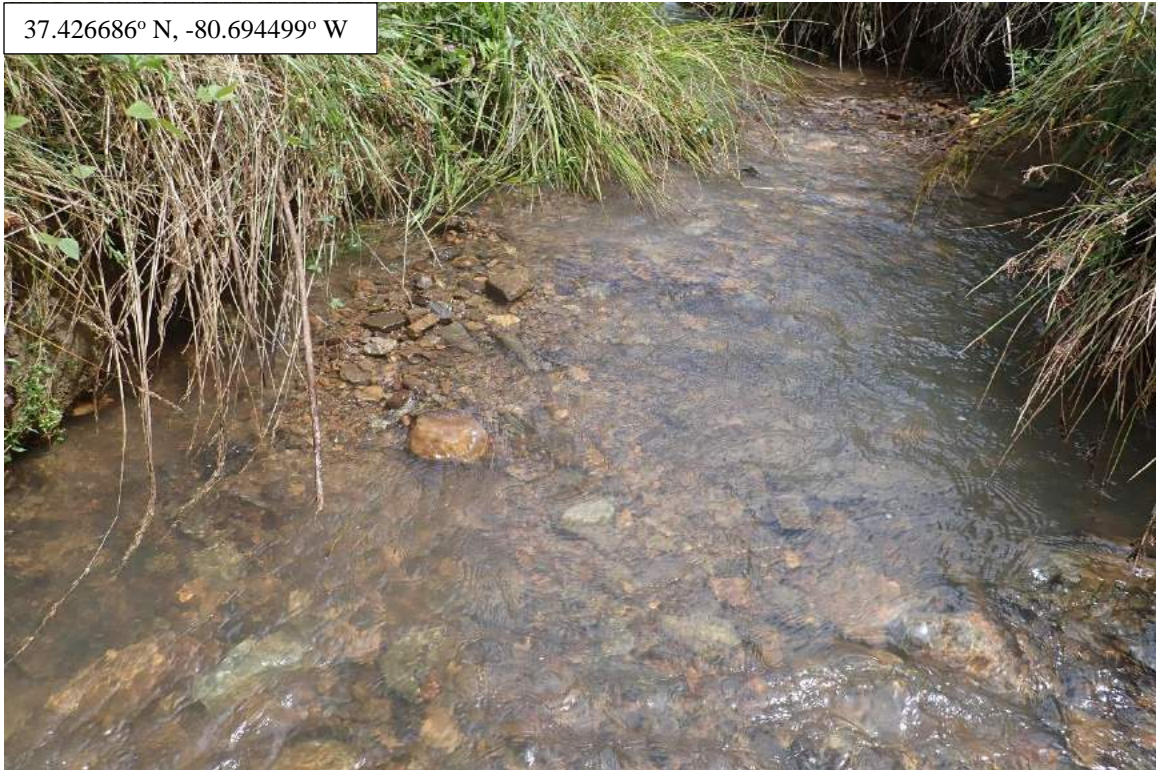
Photo Type: DS Riffle Cross Section, US View

Location, Orientation, Photographer Initials: Downstream Riffle Cross Section, Upstream View, AK/TF/TA/WP

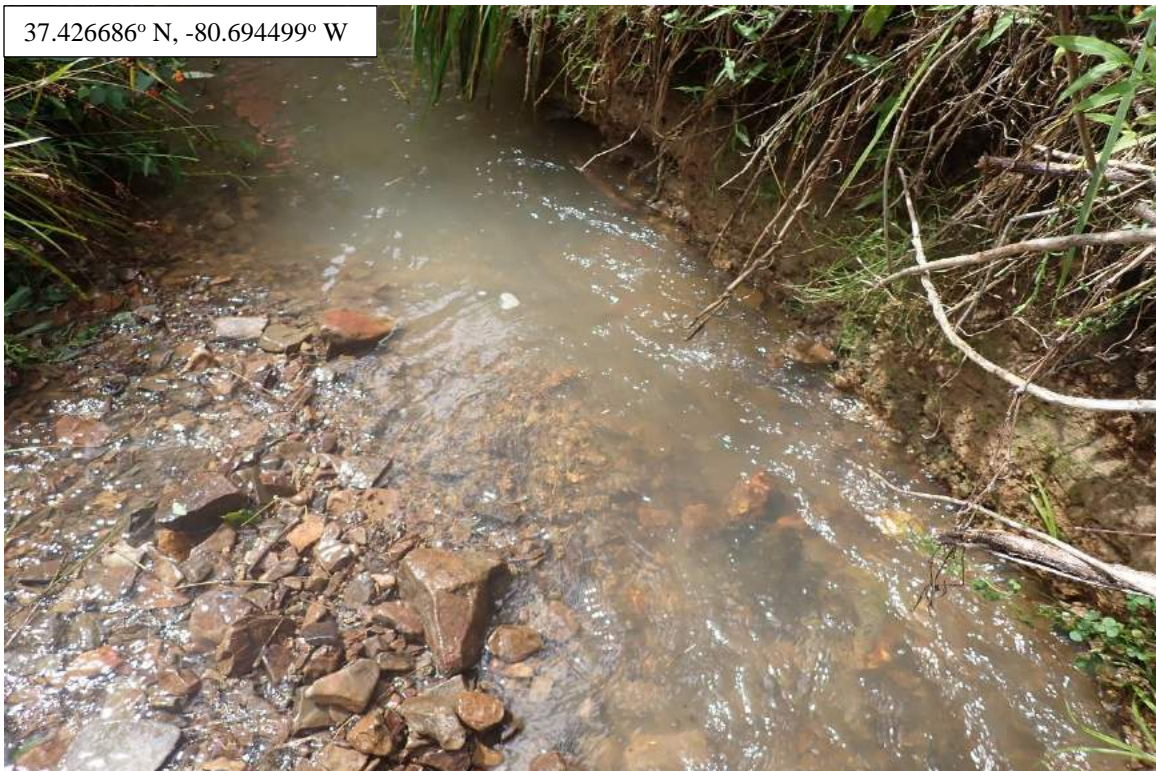
Photo Type: DS Riffle Cross Section, DS View

Location, Orientation, Photographer Initials: Downstream Riffle Cross Section, Downstream View, AK/TF/TA/WP

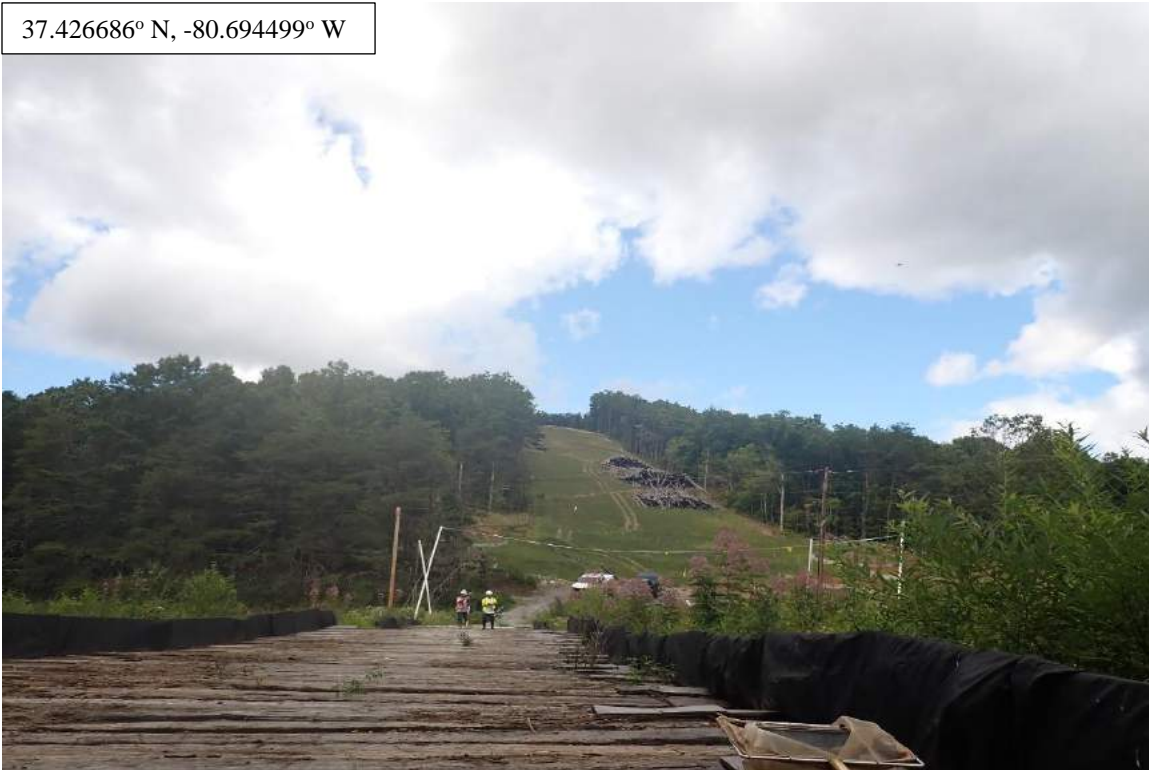
Photo Type: ROW N

Location, Orientation, Photographer Initials: ROW, Facing North, AK/TF/TA/WP

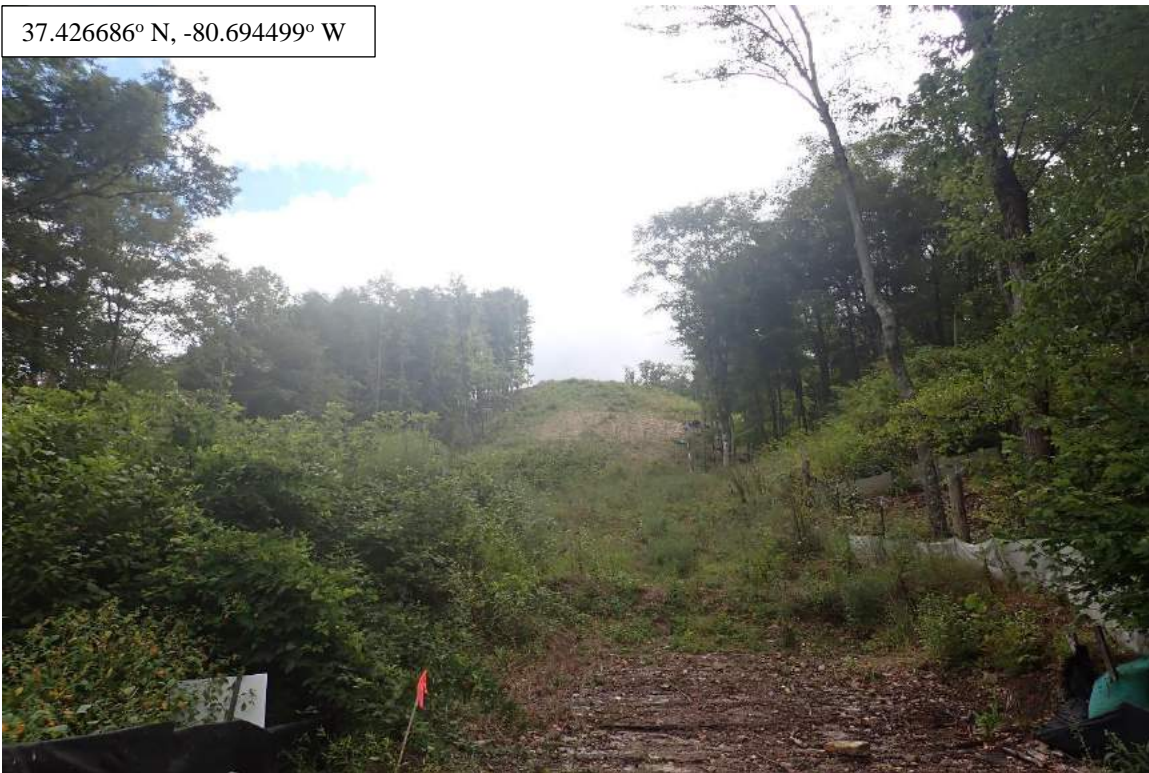
Photo Type: ROW S

Location, Orientation, Photographer Initials: ROW, Facing South, AK/TF/TA/WP

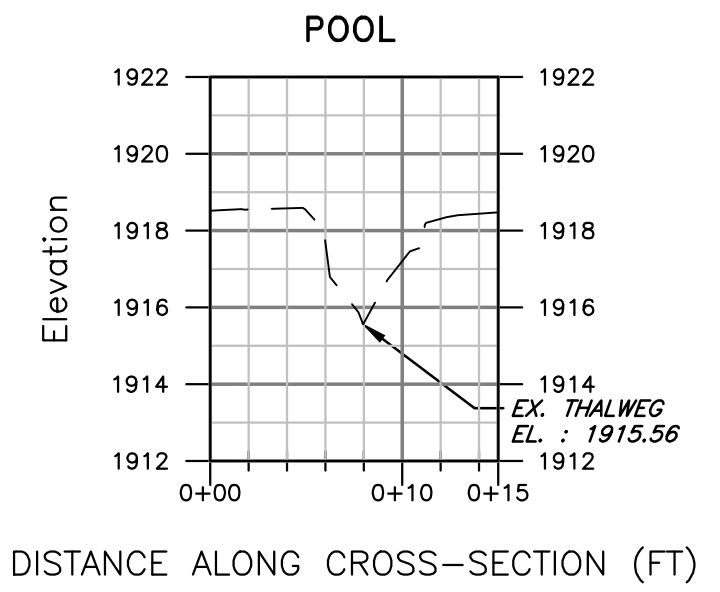
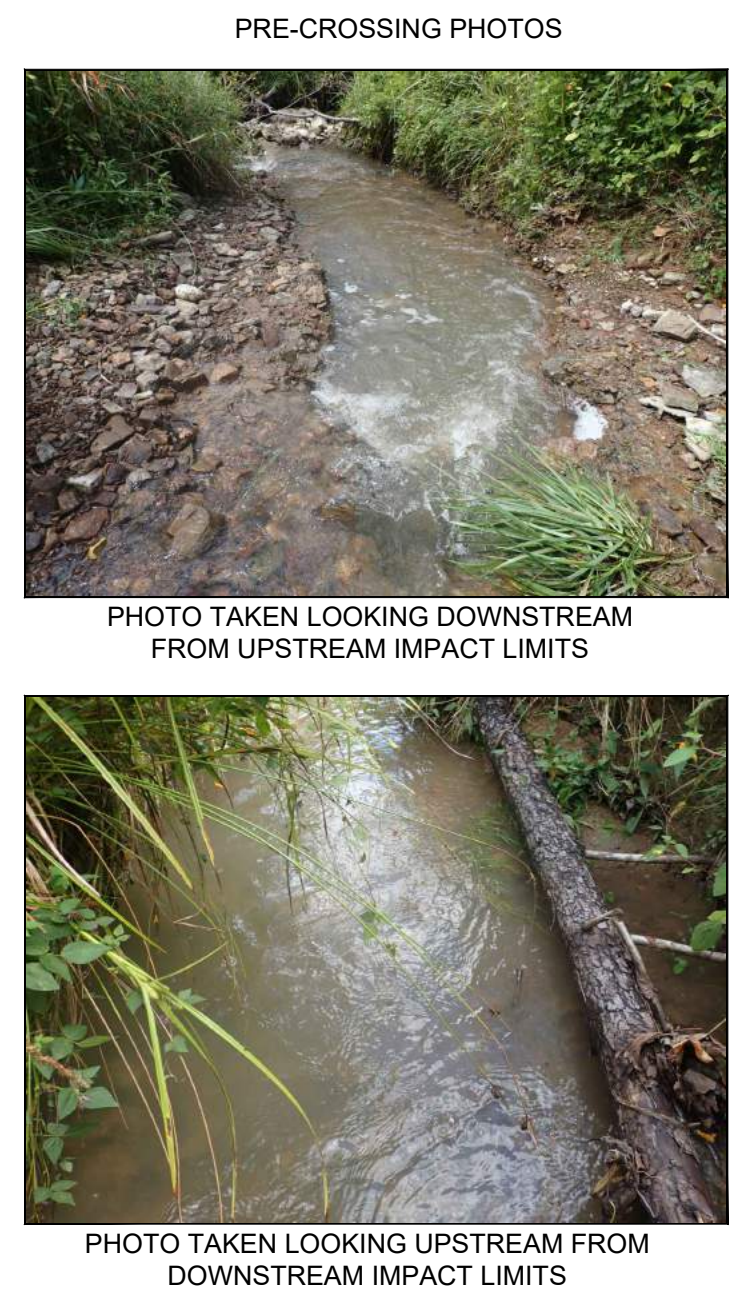
S-C39 BASELINE CROSS-SECTION A

- ALL SECTION VIEWS SHOWN LEFT TO RIGHT FACING DOWNSTREAM.
 - POST-CROSSING SURVEY INFORMATION SHOWN IN RED. DATA PENDING.
 - POST-CROSSING SURVEY POINTS FOR CROSS SECTIONS AND THALWEG ARE PROJECTED ONTO PRE-CROSSING SECTION AND PROFILE VIEWS FOR COMPARISON.

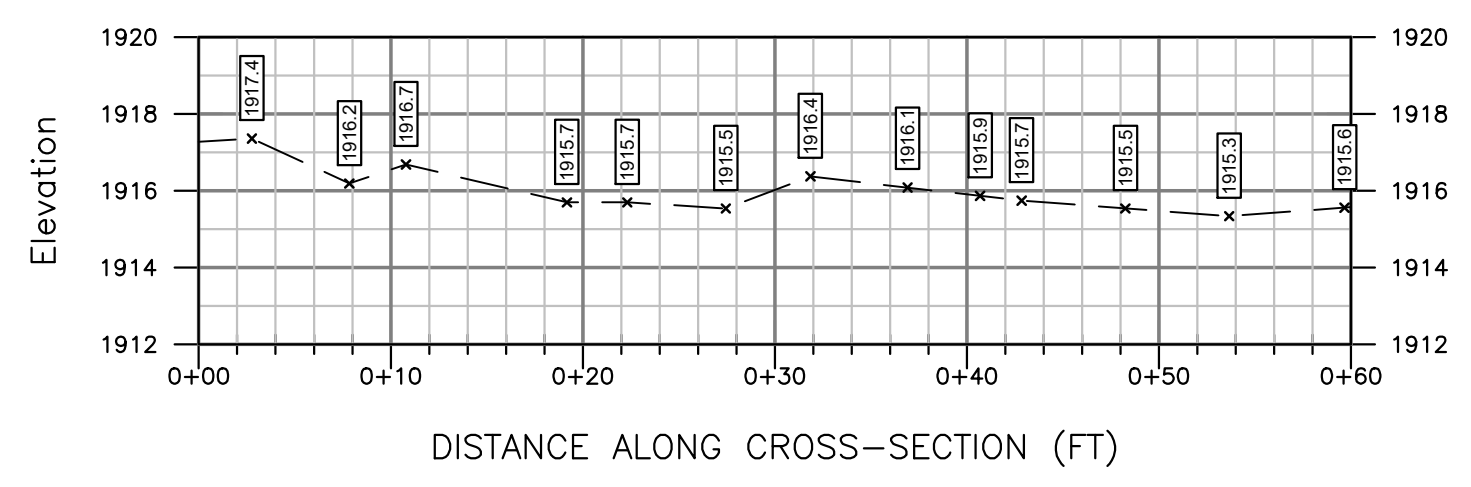
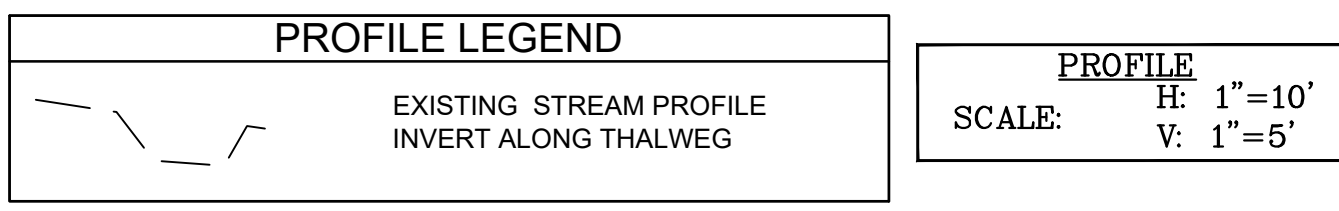
S-C39 BASELINE THALWEG PROFILE

- EASEMENT LINES SHOWN ON PLAN VIEW WERE PROVIDED BY MOUNTAIN VALLEY PIPELINE.
 - SURVEY POINTS FOR CROSS SECTIONS AND THALWEG PROFILES COLLECTED IN 2021 HAVE BEEN USED IN COMBINATION WITH SURVEY POINTS AND COLLECTED PREVIOUSLY IN 2020 IN ORDER TO GENERATE THE PRE-CROSSING SURFACE SHOWN IN PLAN. DUE TO NATURAL EROSIONAL STREAM PROCESSES THAT OCCUR OVER TIME, MINOR ADJUSTMENTS TO THE PROFILE ALIGNMENTS MAY HAVE BEEN REQUIRED IN ORDER TO GENERATE A CLEAN PRE-CROSSING SURFACE.

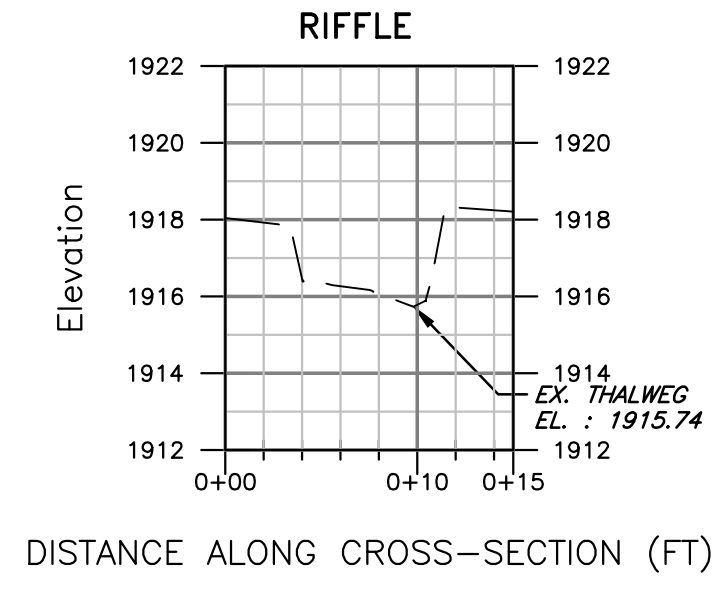
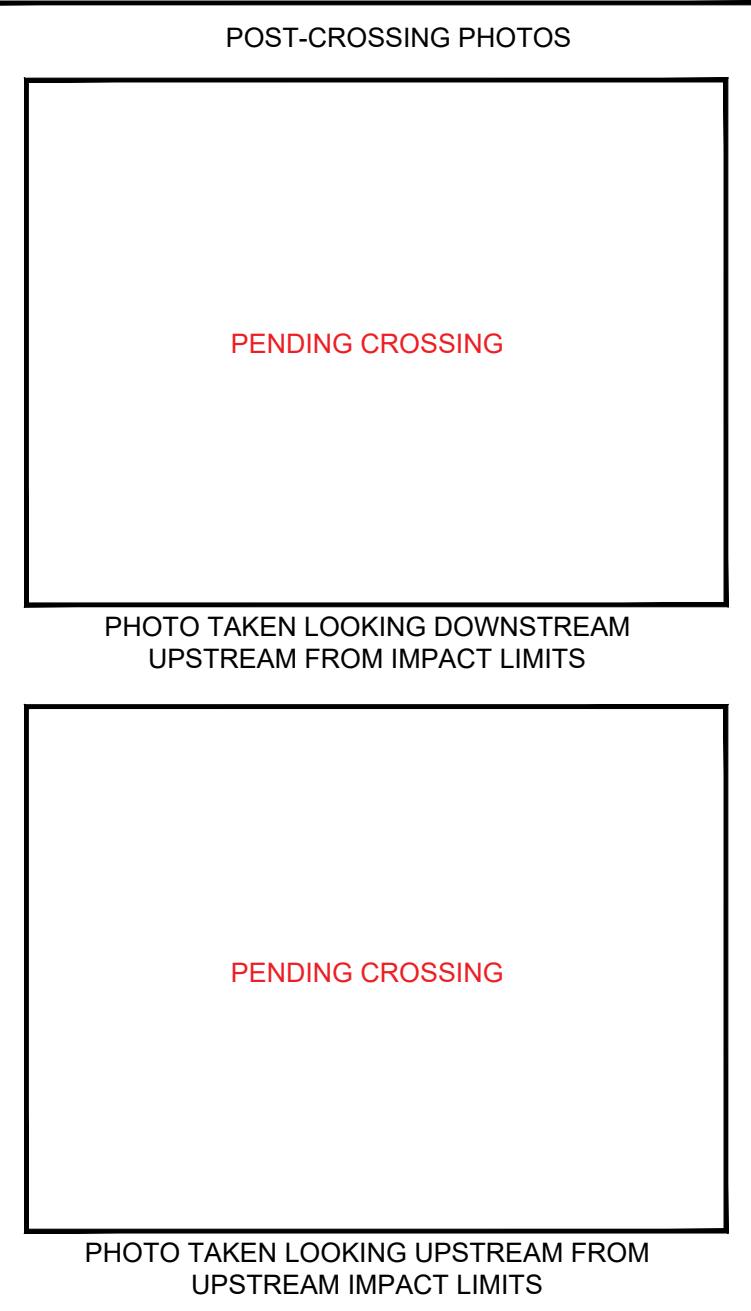
S-C39 BASELINE CROSS-SECTION B

NOTE: ALL SECTION VIEWS SHOWN LEFT TO RIGHT FACING DOWNSTREAM.
