Baseline Assessment – Stream Attributes

REVISIT

Reach S-C40 (Temporary Access Road) Perennial Spread F Monroe County, West Virginia

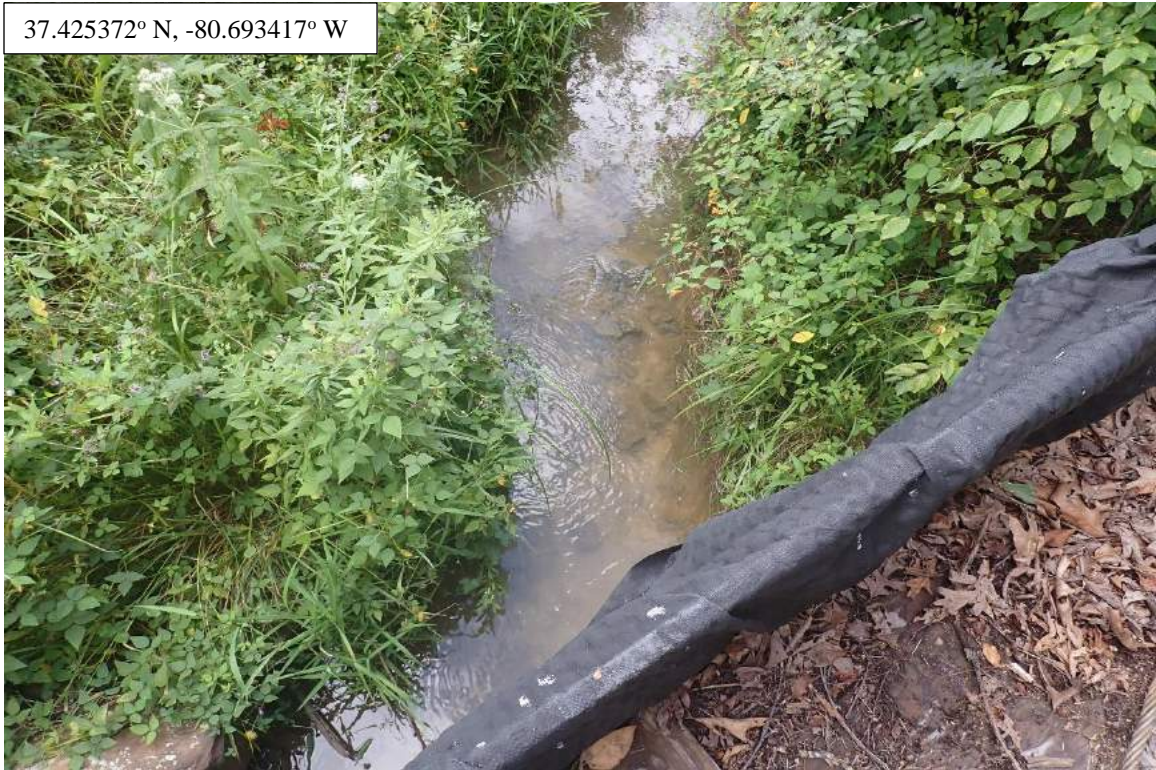
Photo Type: US Edge of TMB, Looking Down
Location, Orientation, Photographer Initials: Upstream Edge of Bridge, Looking Down View, AK/TF (8/18/2021)

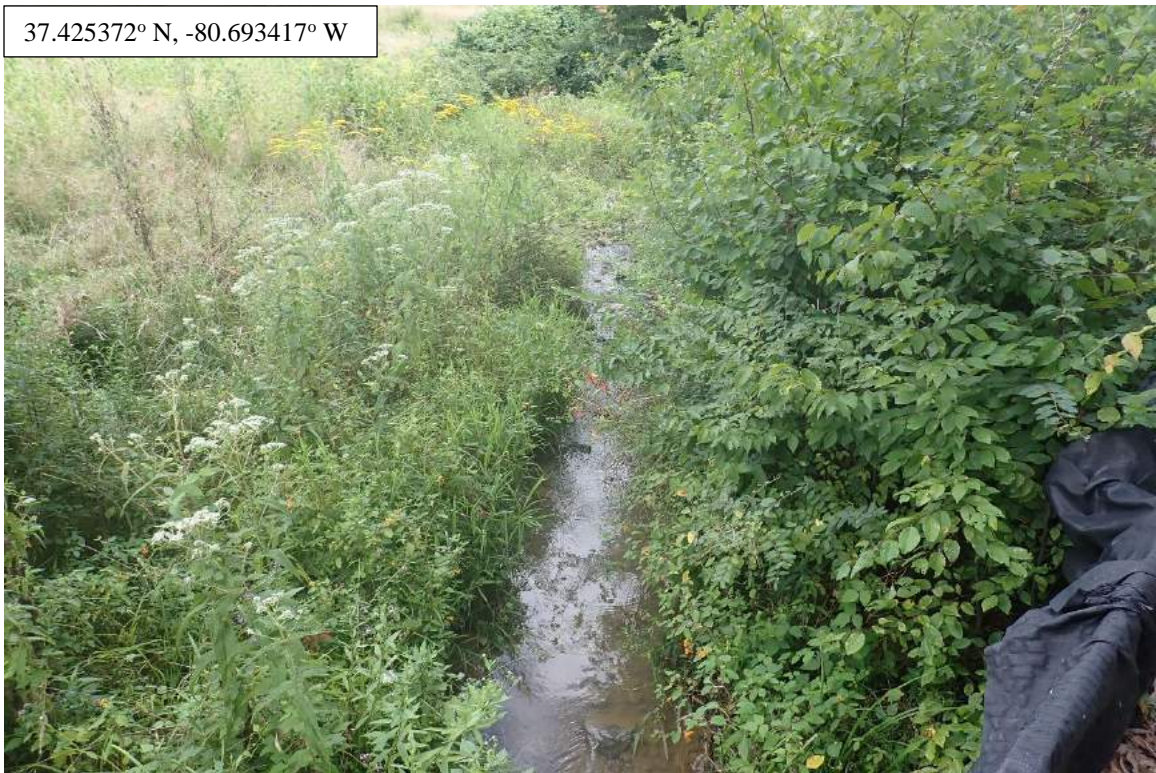
Photo Type: US Edge of TMB, US View
Location, Orientation, Photographer Initials: Upstream Edge of Bridge, Upstream View, AK/TF (8/18/2021)

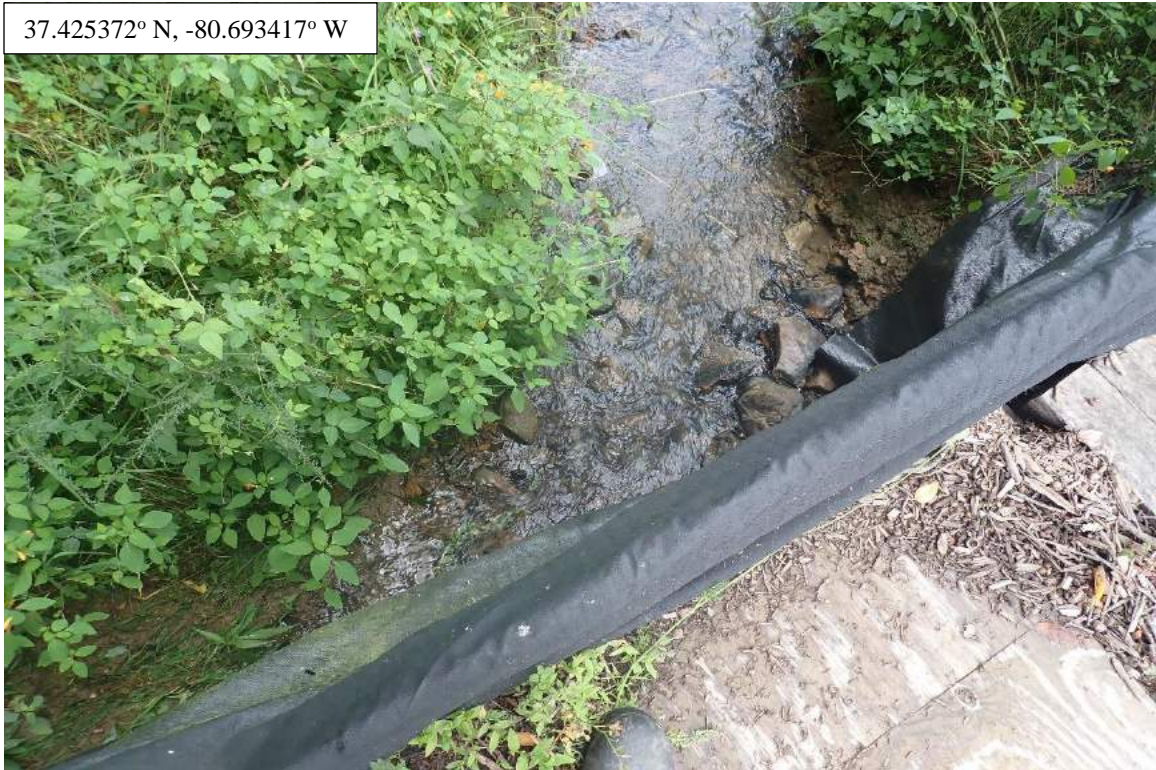
Photo Type: DS Edge of TMB, Looking Downstream
Location, Orientation, Photographer Initials: Downstream Edge of Bridge, Looking Downstream, AK/TF (8/18/2021)

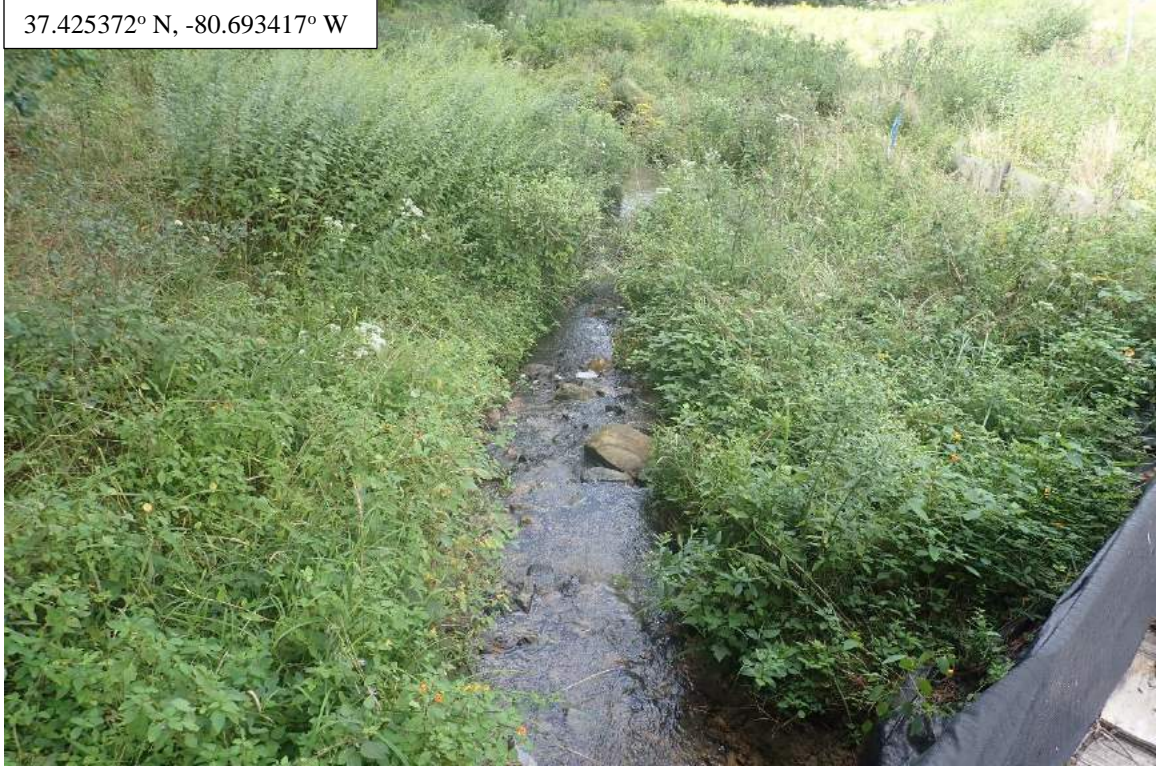
Photo Type: DS Edge of TMB, DS View
Location, Orientation, Photographer Initials: Downstream Edge of Bridge, Downstream View, AK/TF (8/18/2021)

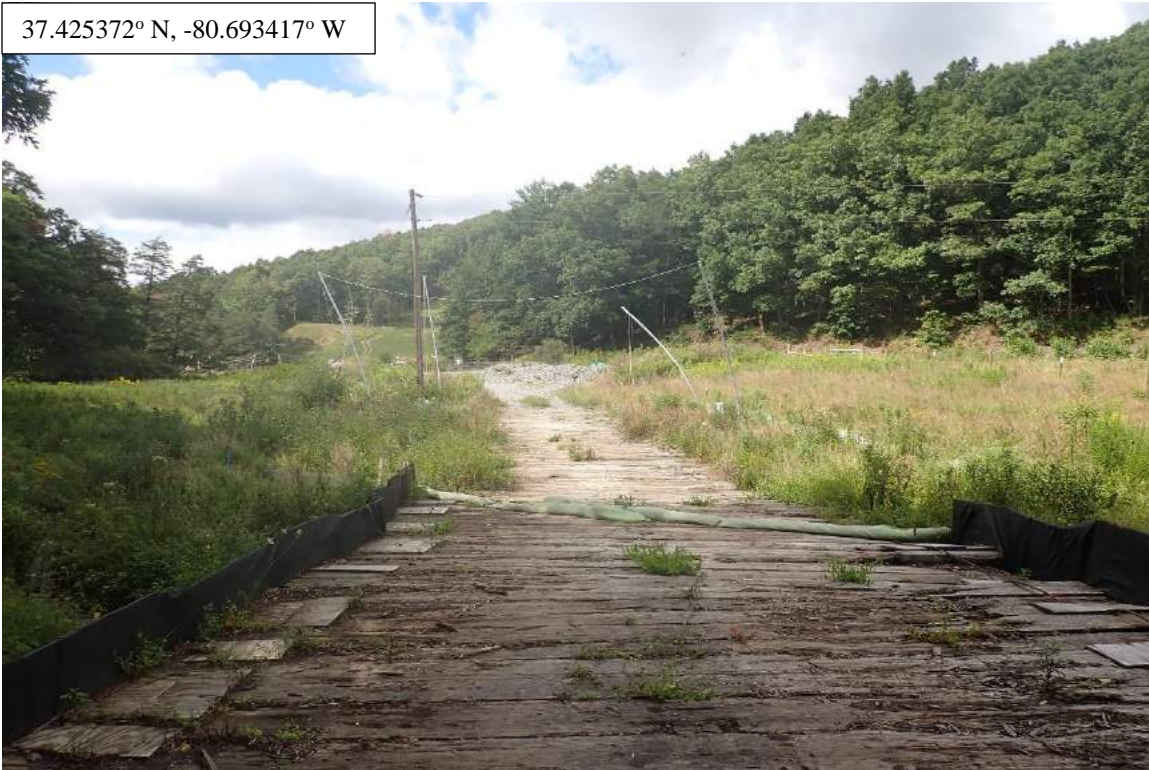
Photo Type: View Going Down AR, N

Location, Orientation, Photographer Initials: View Going Down Access Road, Facing North, AK/TF (8/18/2021)

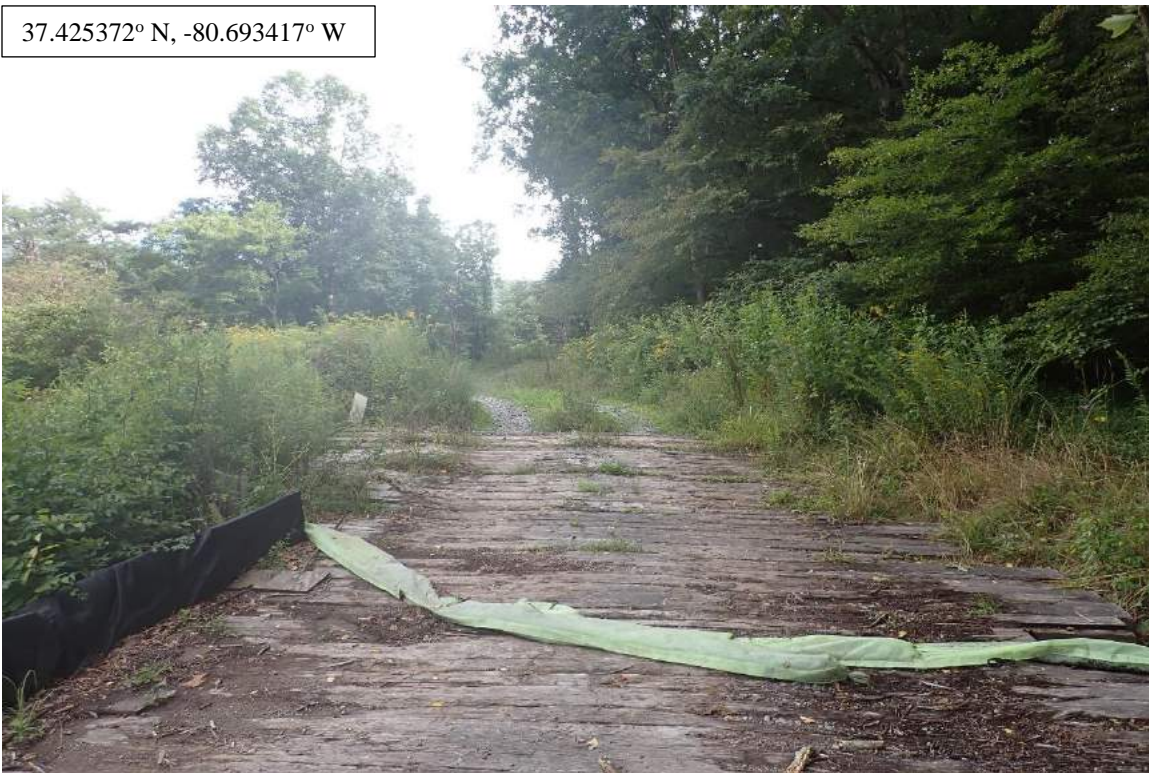
Photo Type: View Going Up AR, S

Location, Orientation, Photographer Initials: View Going Up Access Road, Facing South, AK/TF (8/18/2021)

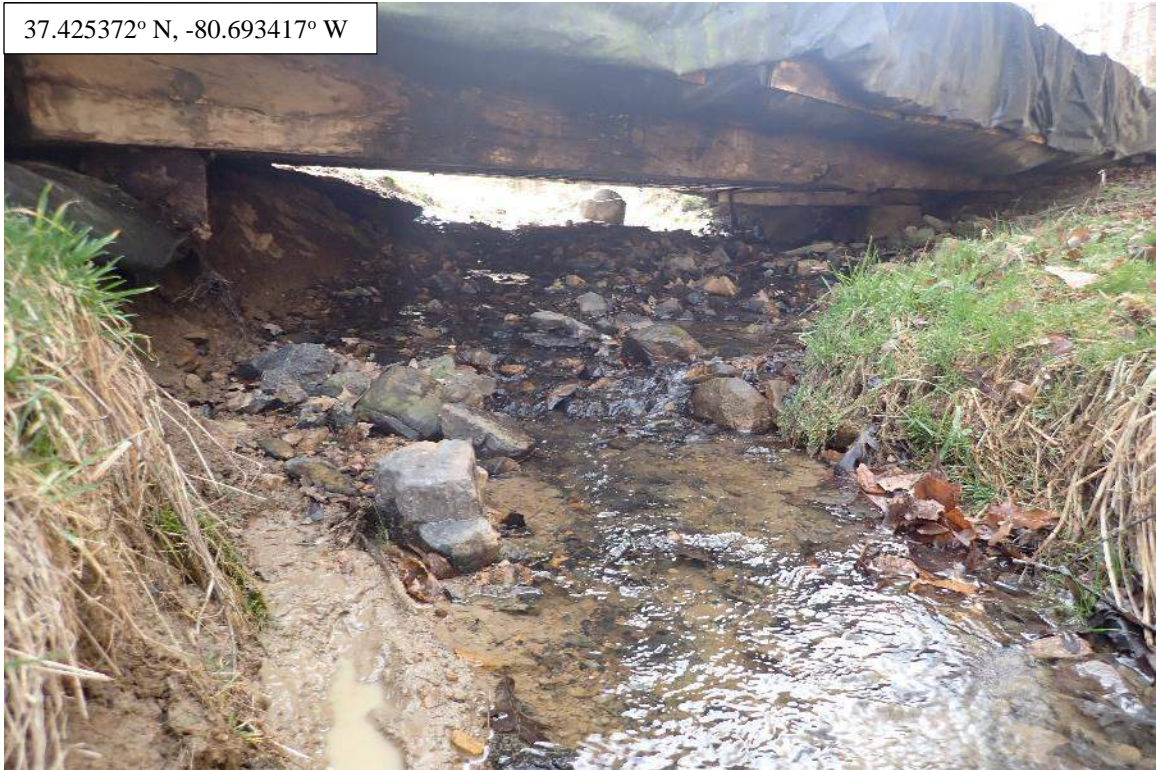
Photo Type: DS, US View
Location, Orientation, Photographer Initials: Downstream, Upstream View, BB/ABK (3/24/2022)

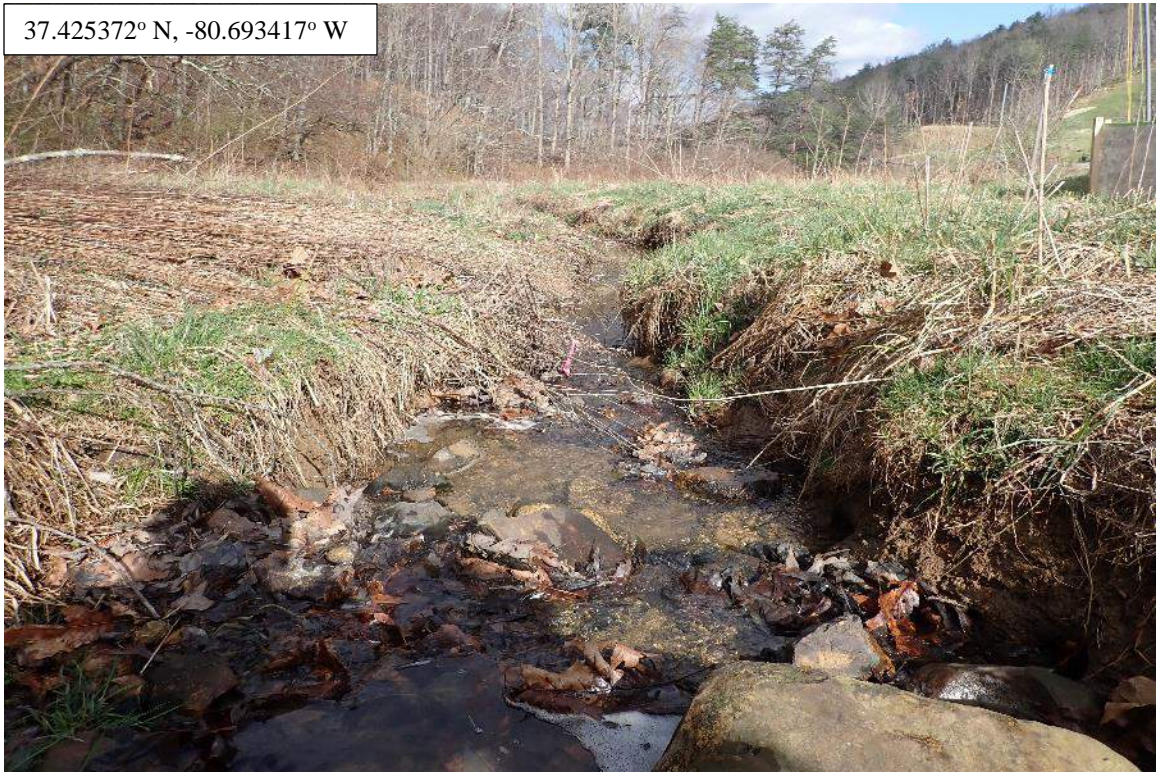
Photo Type: DS, DS View
Location, Orientation, Photographer Initials: Downstream, Downstream View, BB/ABK (3/24/2022)

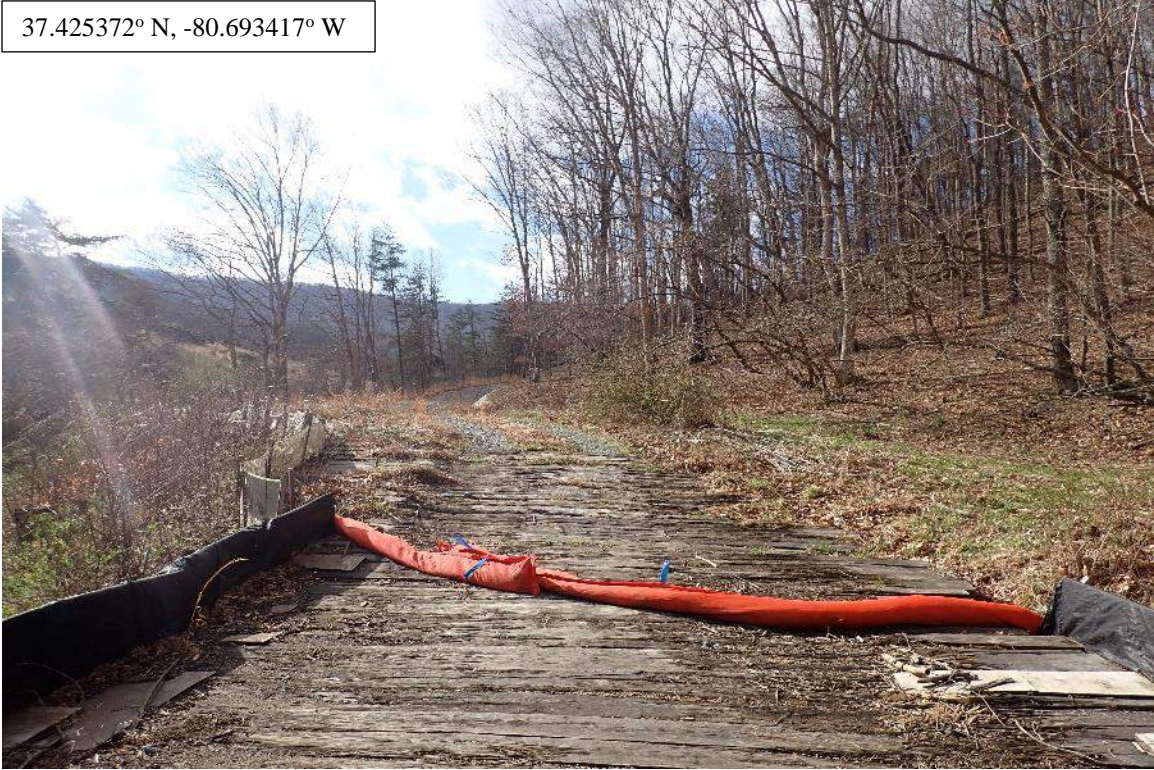
Photo Type: View Up AR, S
Location, Orientation, Photographer Initials: View Up Access Road, South, BB/ABK (3/24/2022)

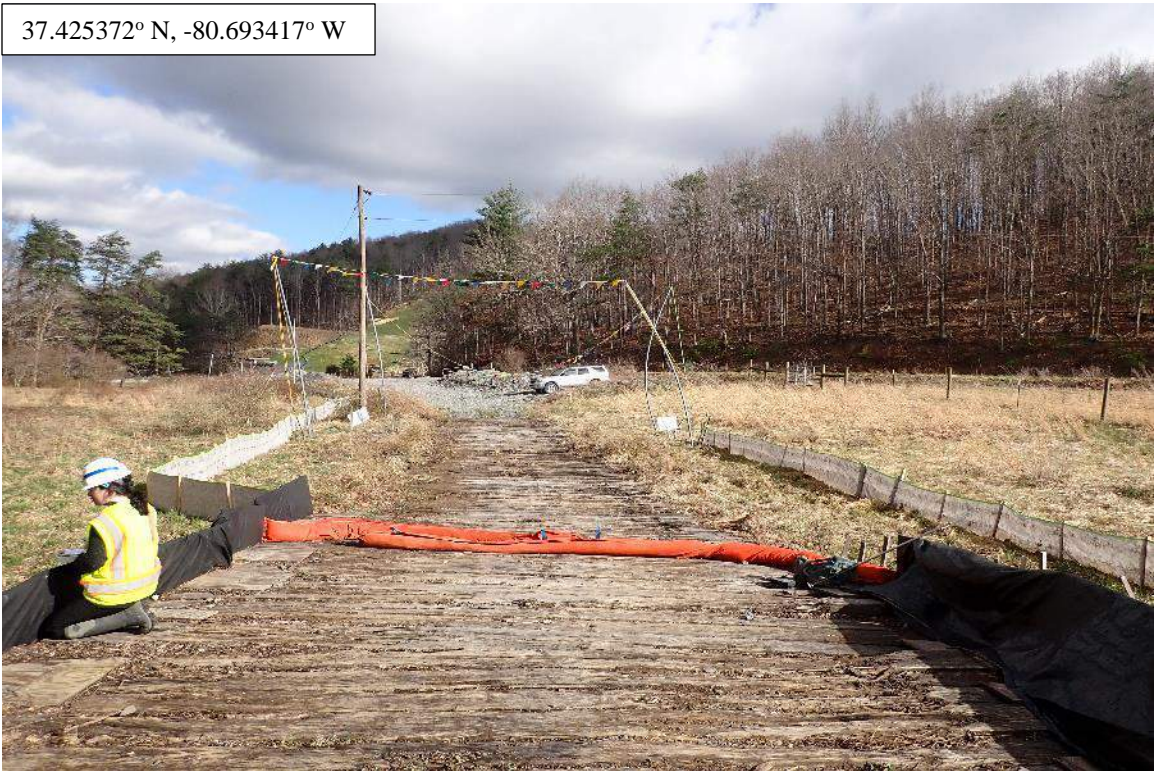
Photo Type: View Down AR, N
Location, Orientation, Photographer Initials: View Down Access Road, North, BB/ABK (3/24/2022)

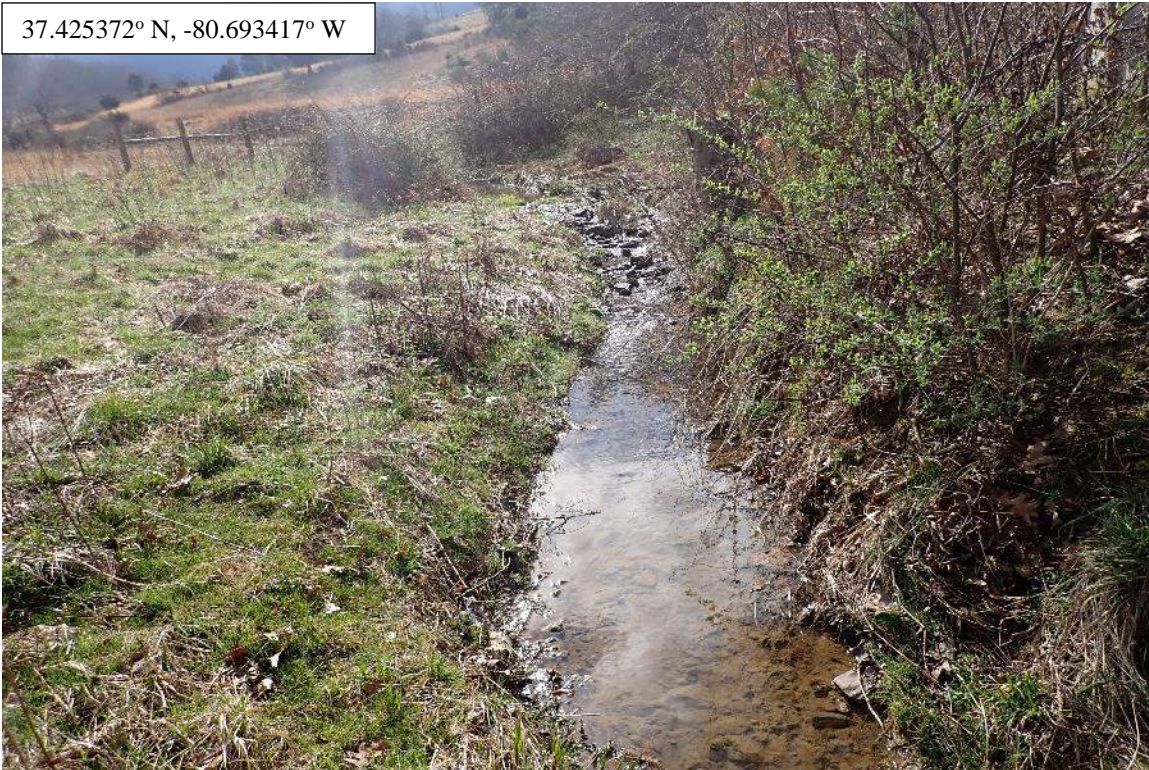
Photo Type: US, US View

Location, Orientation, Photographer Initials: Upstream, Upstream View, BB/ABK (3/24/2022)

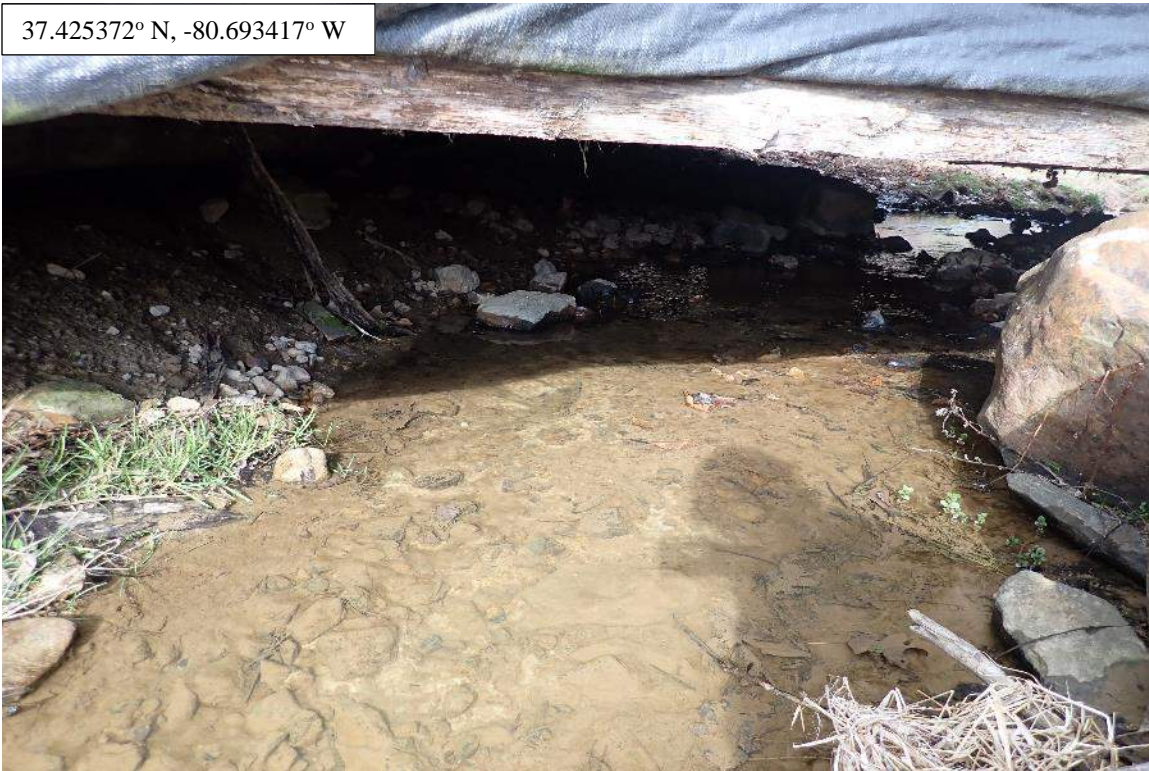
Photo Type: US, DS View

Location, Orientation, Photographer Initials: Upstream, Downstream View, BB/ABK (3/24/2022)

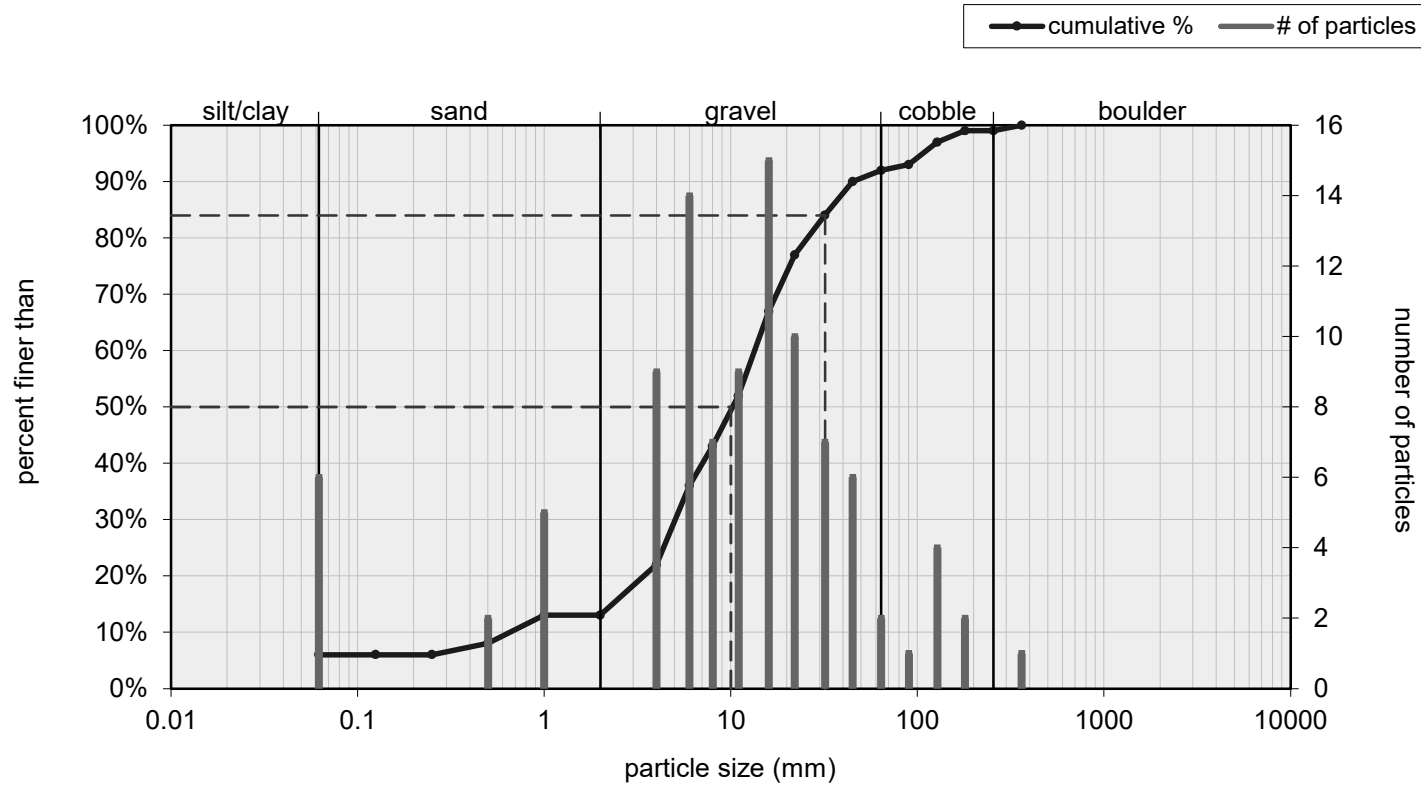
Bankfull Channel Pebble Count, UNT to Painter Run

Size (mm)		Size Distribution		Type	
D16	2.5	mean	8.9	silt/clay	6%
D35	5.8	dispersion	3.6	sand	7%
D50	10	skewness	-0.05	gravel	79%
D65	15			cobble	7%
D84	32			boulder	1%
D95	110
