Baseline Assessment – Stream Attributes

Reach S-H88 (Pipeline ROW) Perennial Spread E Nicholas County, West Virginia

Title: PROFILE AND CROSS-SECTIONS
BASELINE SURVEY
CROSSING S-H88 - SUGAR BRANCH
(MP 130.36)
NICHOLAS COUNTY, WV

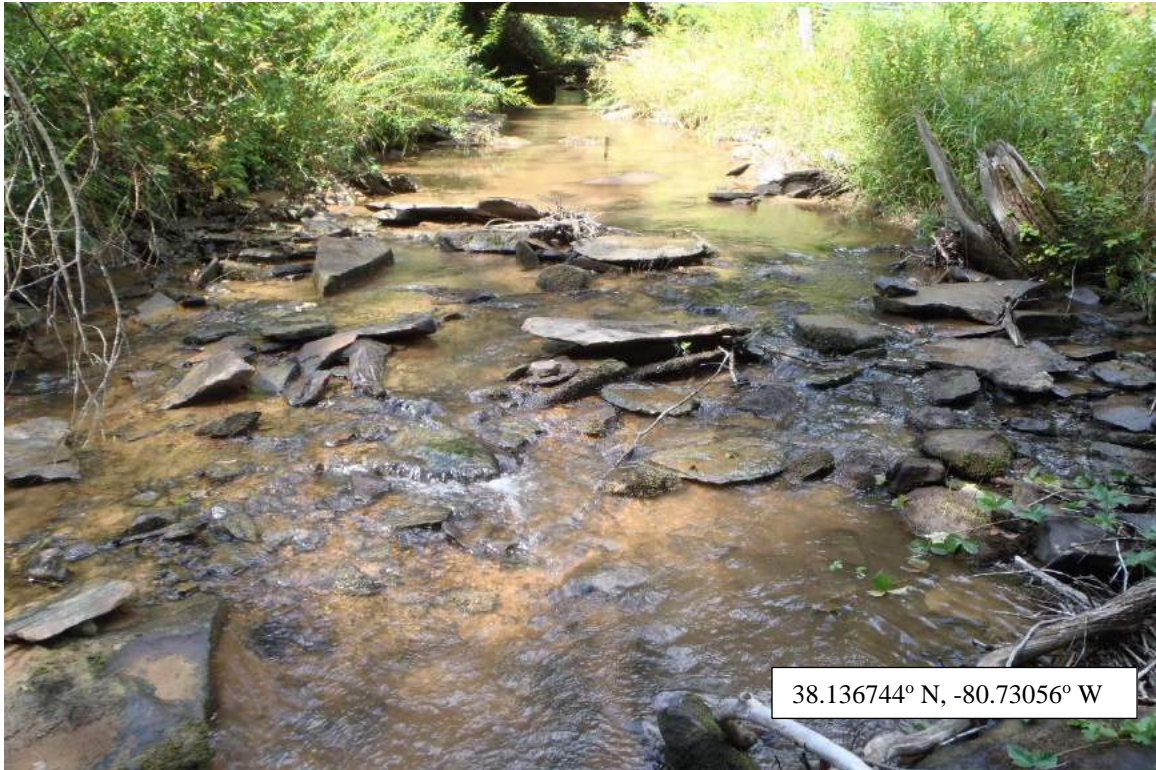
Photo Type: DS Edge ROW, US View

Location, Orientation, Photographer Initials: Downstream Edge of Right of Way, Upstream View, CH/AG/EW/WP

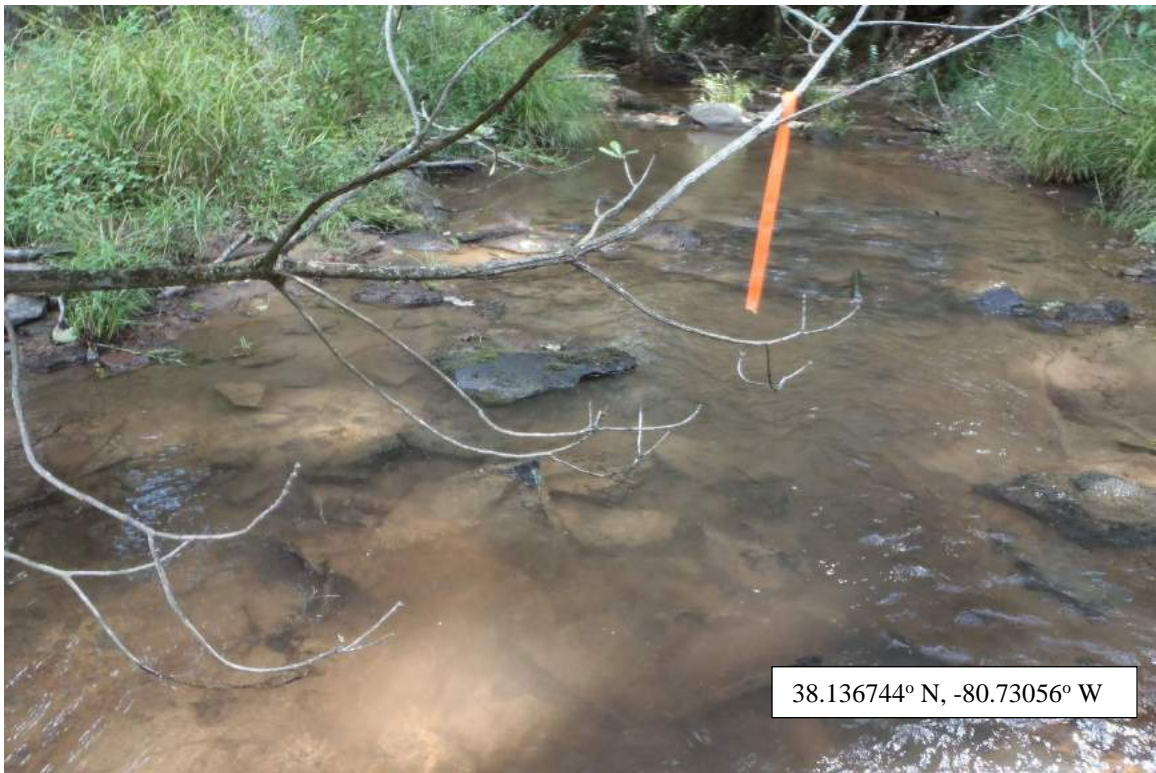
Photo Type: DS Edge ROW, DS View

Location, Orientation, Photographer Initials: Downstream Edge of ROW, Downstream View, CH/AG/EW/WP

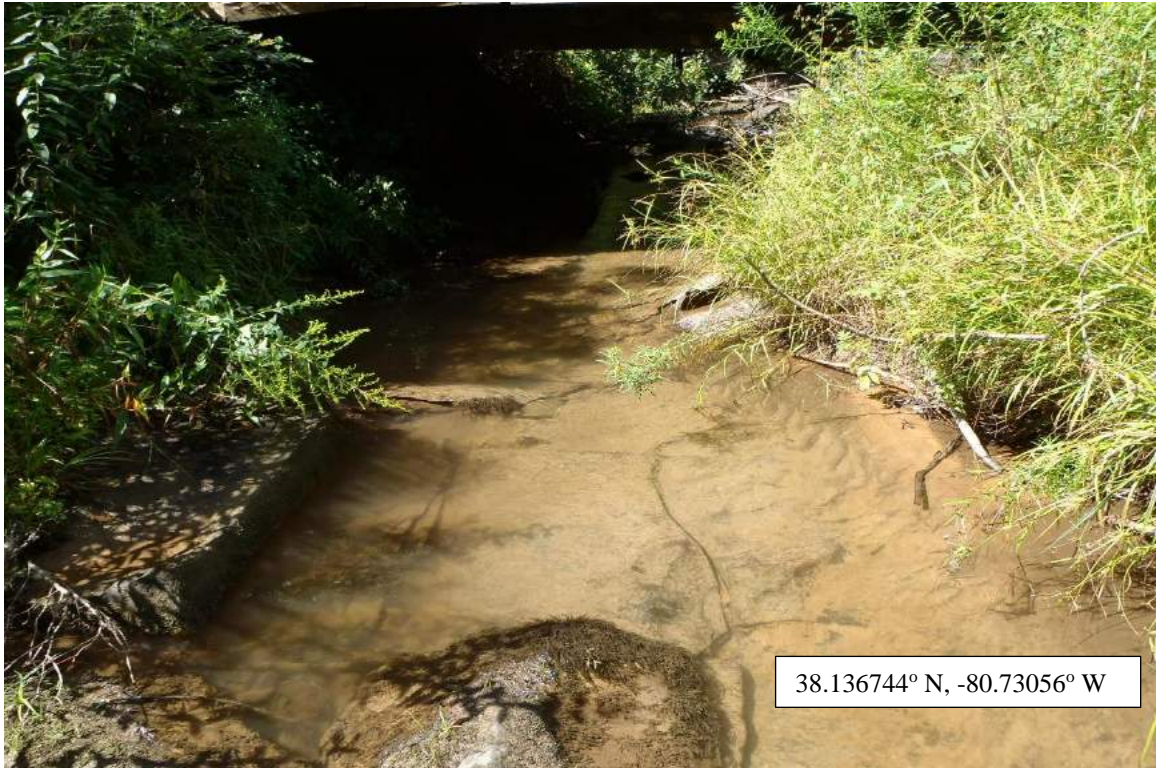
Photo Type: C ROW, US View
Location, Orientation, Photographer Initials: Center Right of Way, Upstream View, CH/AG/EW/WP

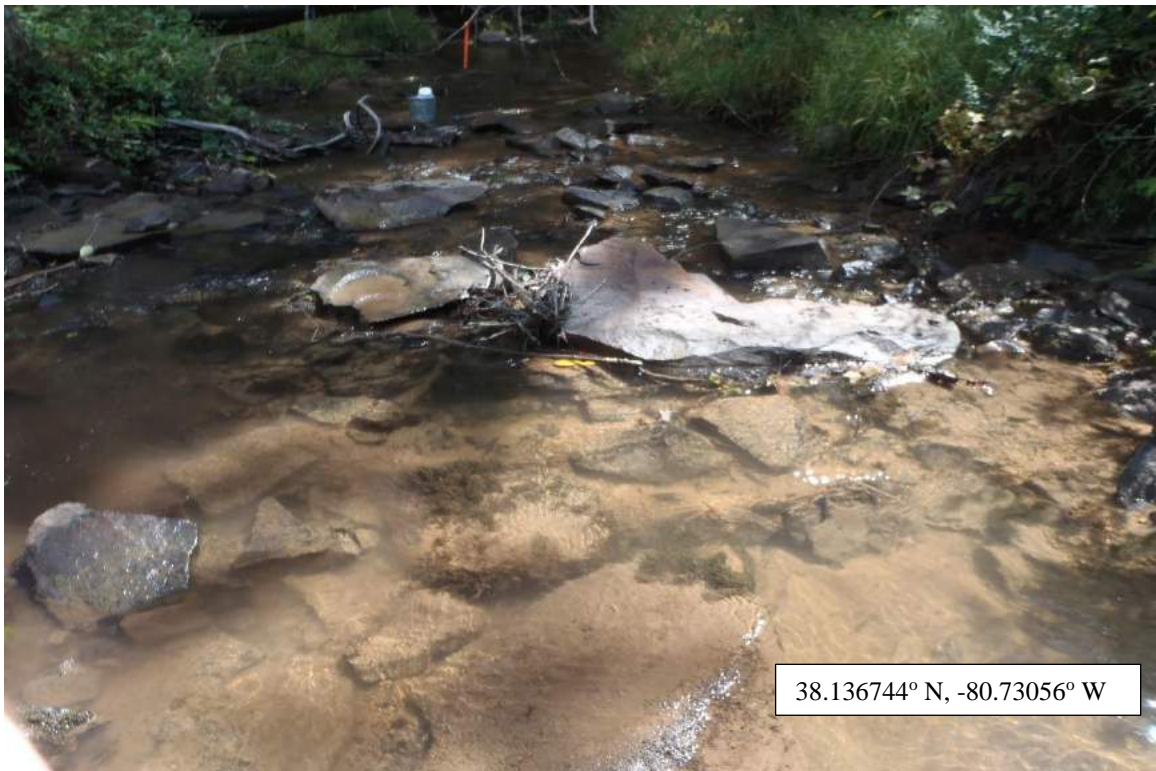
Photo Type: C ROW, DS View
Location, Orientation, Photographer Initials: Center of Right of Way, Downstream View, CH/AG/EW/WP

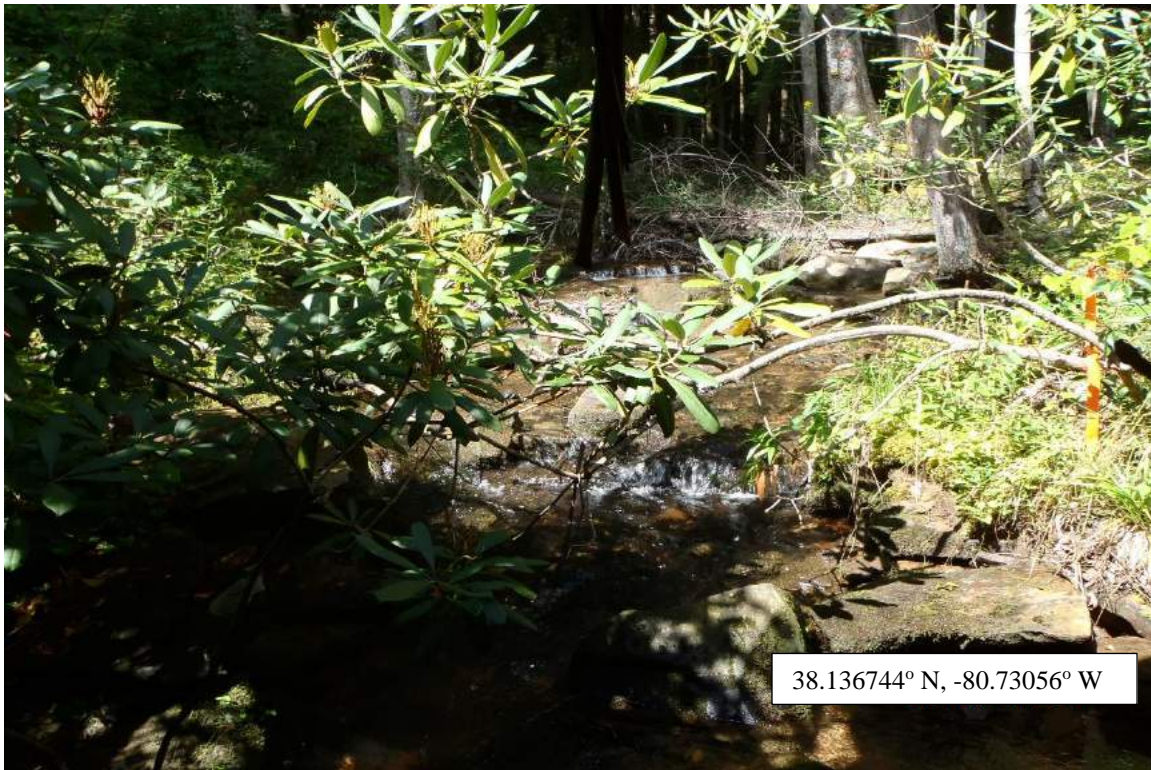
Photo Type: US Edge ROW, US View

Location, Orientation, Photographer Initials: Upstream Edge of Right of Way, Upstream View, CH/AG/EW/WP

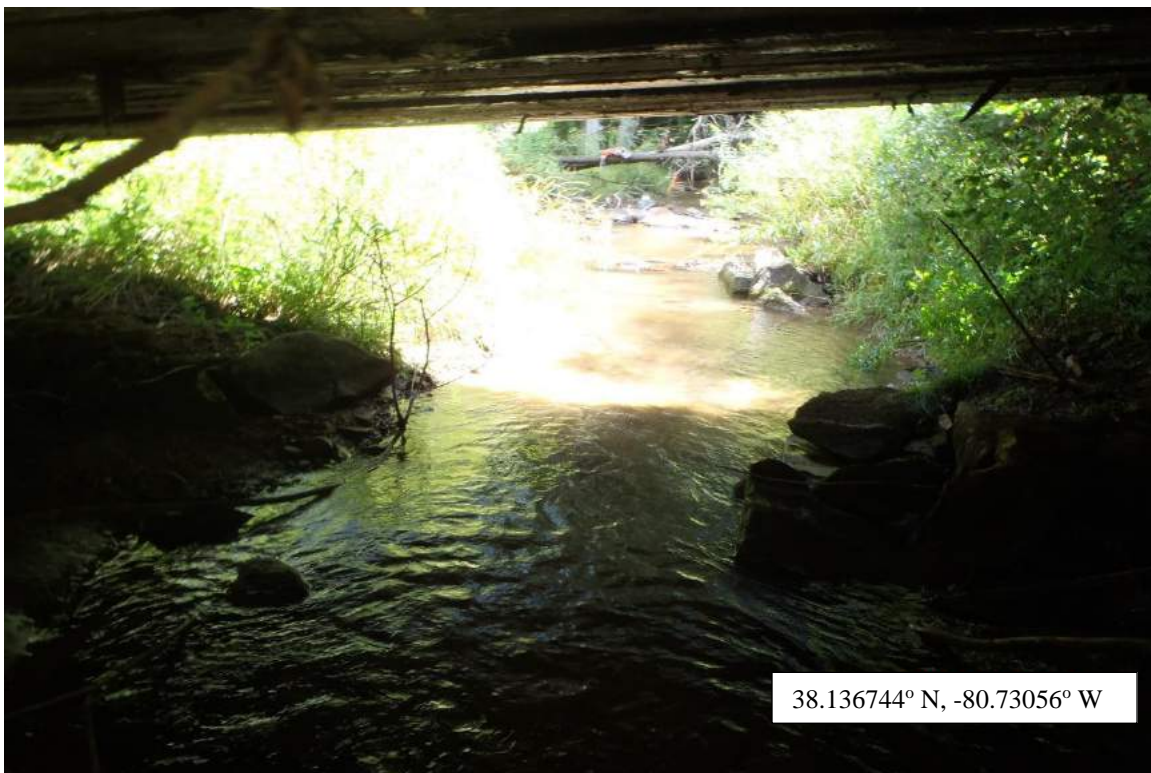
Photo Type: US Edge ROW, DS View

Location, Orientation, Photographer Initials: Upstream Edge Right of Way, Downstream View, CH/AG/EW/WP

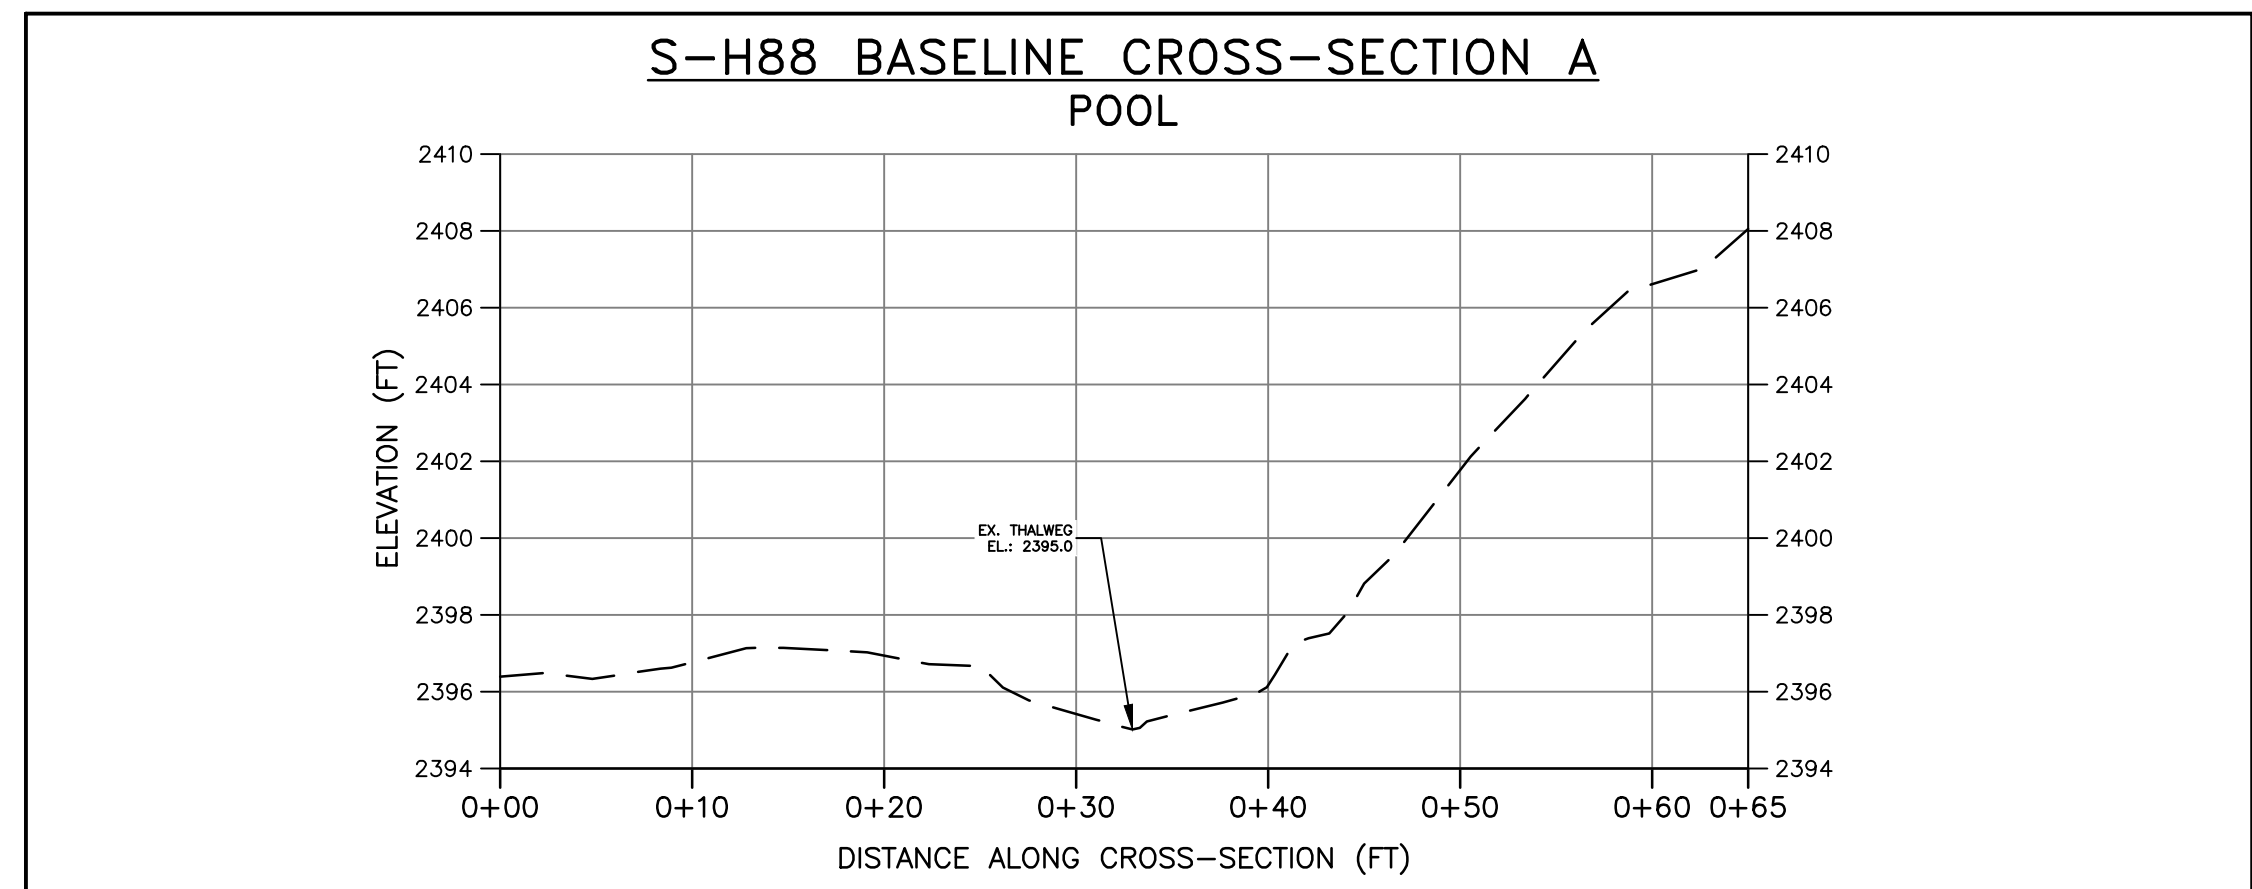
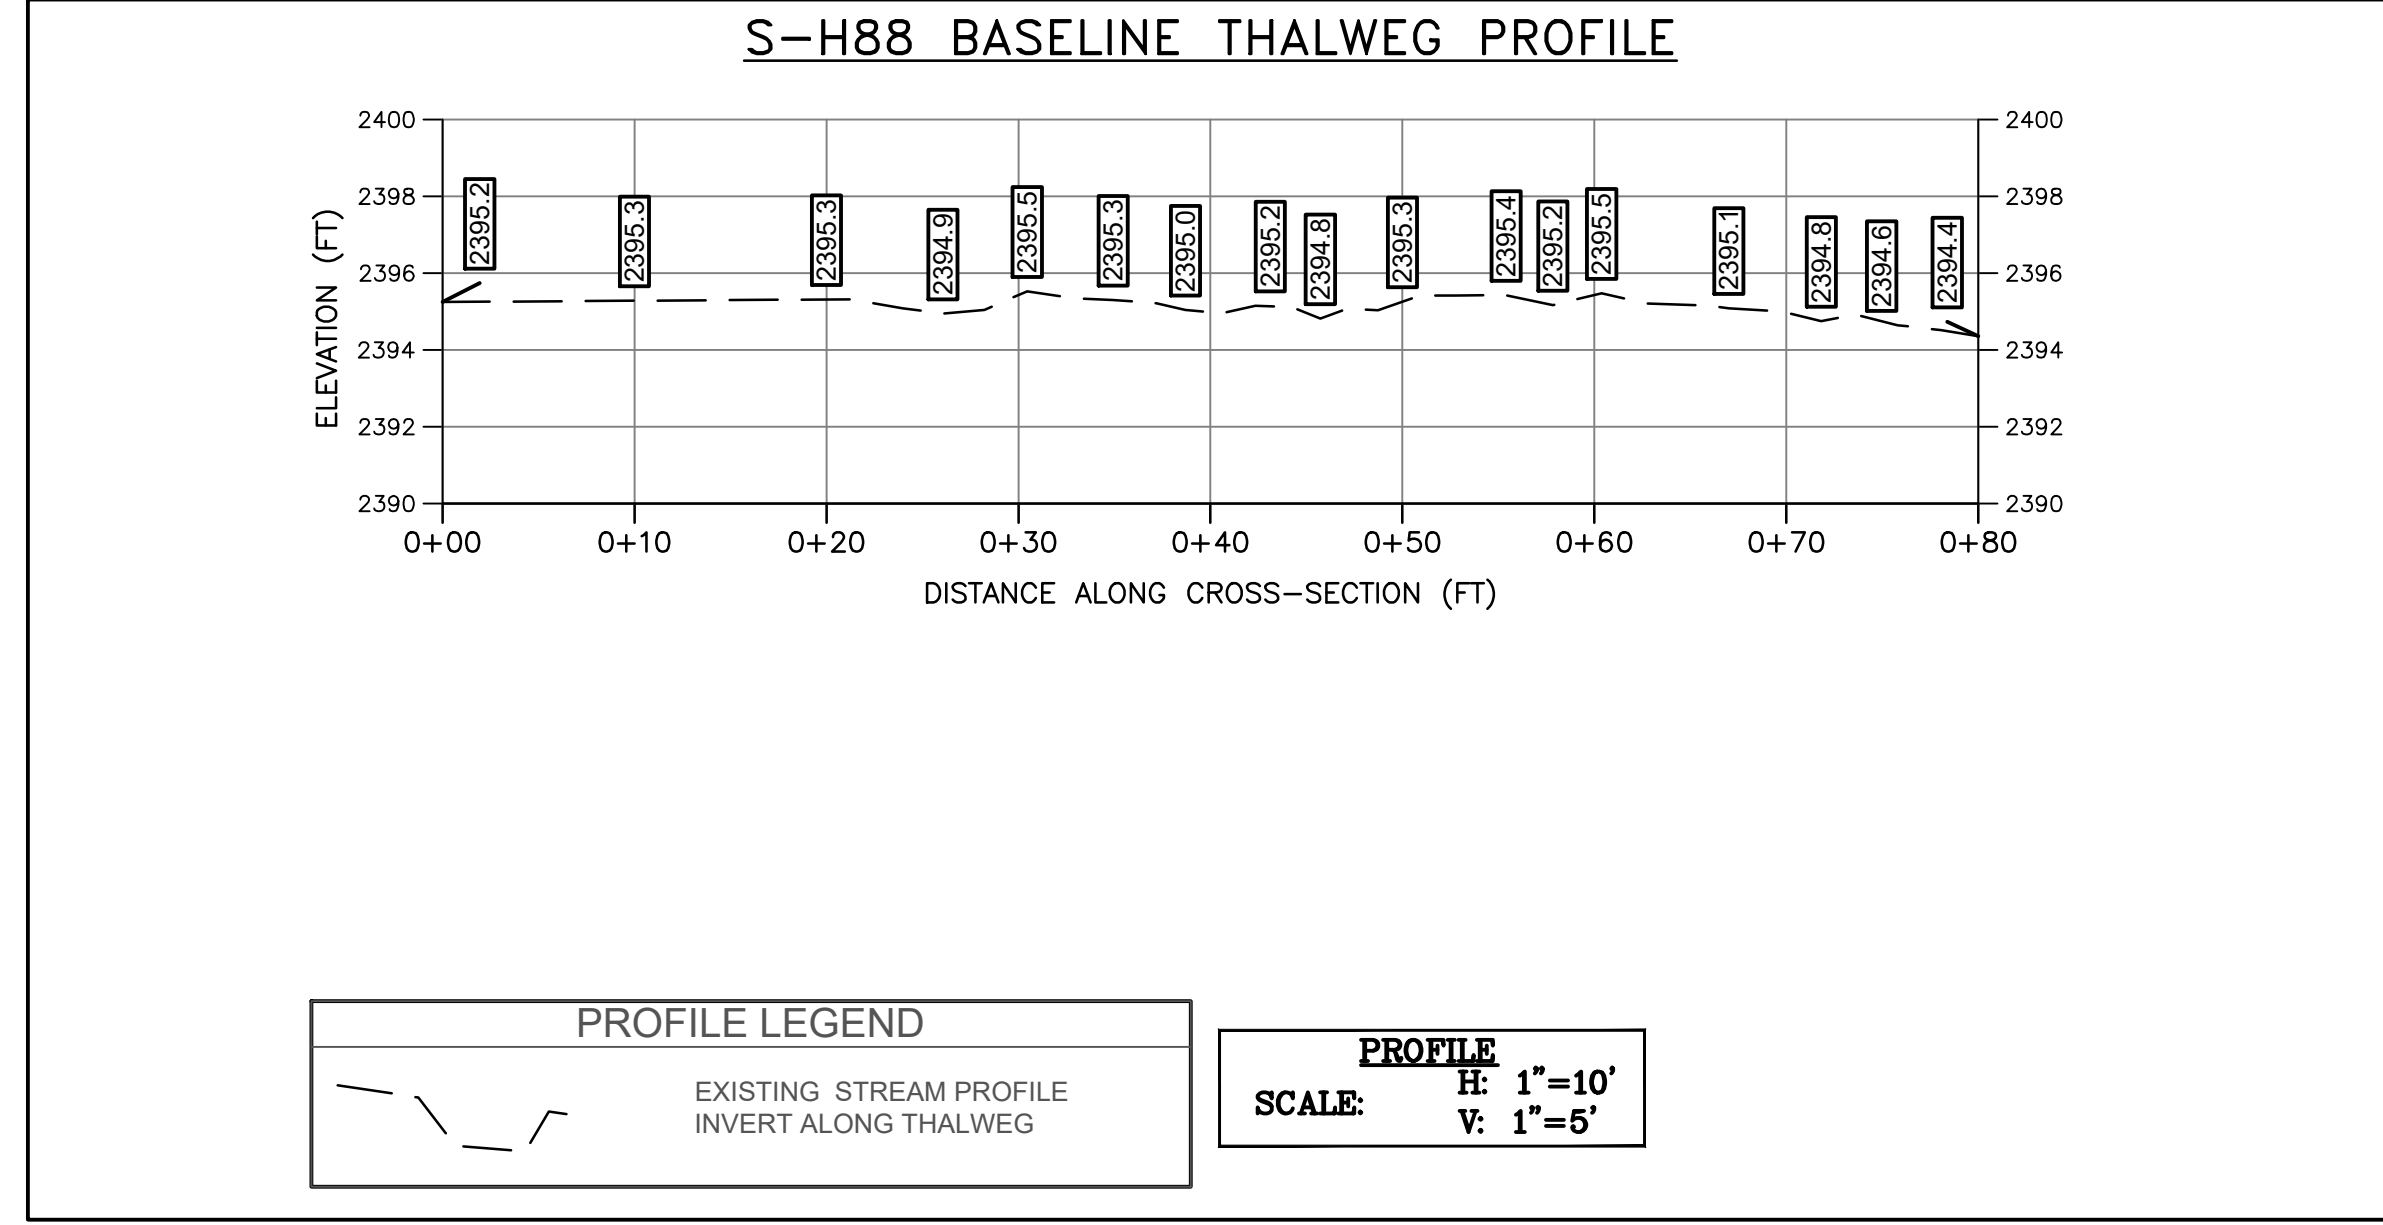
- ALL SECTION VIEWS SHOWN LEFT TO RIGHT FACING DOWNSTREAM.
 - POST-CROSSING SURVEY INFORMATION SHOWN IN RED. DATA PENDING.
 - POST-CROSSING SURVEY POINTS FOR CROSS SECTIONS AND THALWEG ARE PROJECTED ONTO PRE-CROSSING SECTION AND PROFILE VIEWS FOR COMPARISON.

NOTE: ALL SECTIONS VIEWS SHOWN LEFT TO RIGHT FACING DOWNSTREAM.

AS-BUILT TABLE: S-H88 CROSS SECTION A					
PT. LOC.	PRE-CROSSING			AS-BUILT	
	NORTHING	EASTING	ELEV.	VERT. DIFF.	HORZ. DIFF.
TS-L	13848460.1300	1717890.5770	2396.719'		
BS-L	13848459.0400	1717890.5150	2396.202'		
THW	13848451.8800	1717891.8190	2394.961'		
BS-R	13848445.5800	1717894.0950	2396.029'		
TS-R	13848444.3500	1717894.2300	2396.992'
