Baseline Assessment – Stream Attributes

Reach S-L35 (Temporary Access Road) Perennial Spread D Nicholas County, West Virginia

PROFILE AND CROSS-SECTIONS
BASELINE SURVEY
CROSSING S-L35 TEMP AR -
RILEY BRANCH (MP 124.70)
NICHOLAS COUNTY, WV

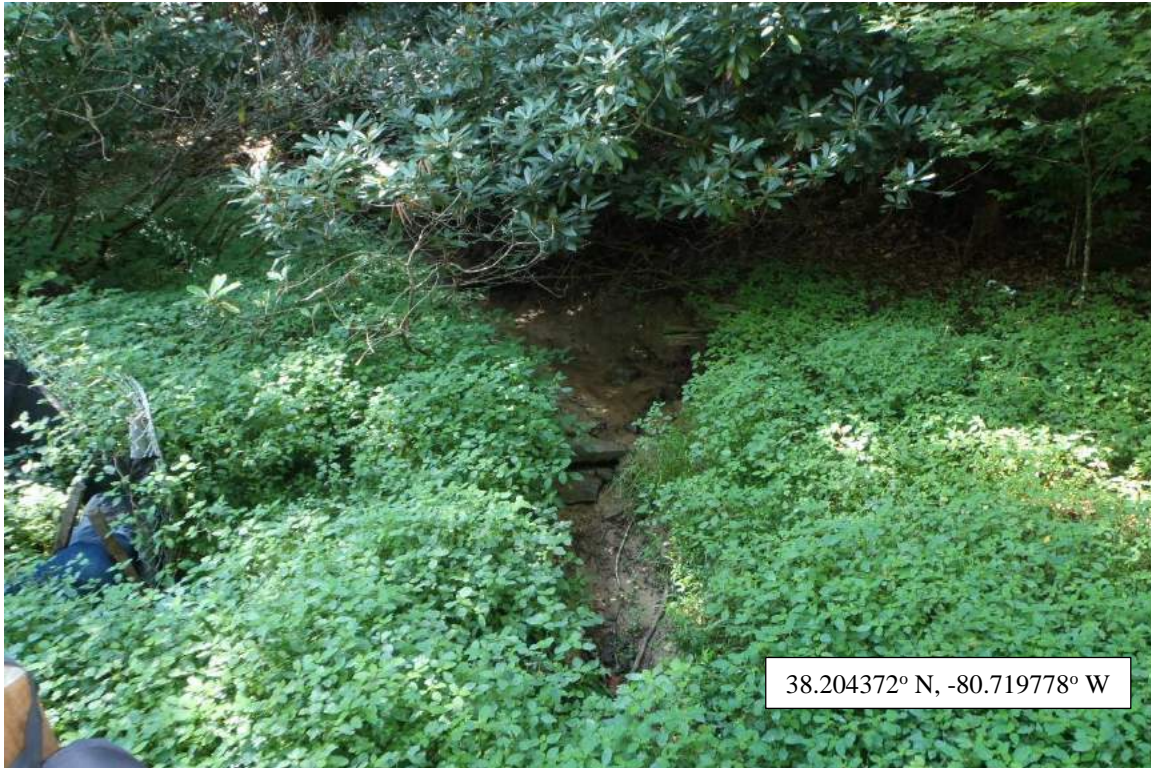
Photo Type: US View at US Side of Bridge
Location, Orientation, Photographer Initials: Upstream Side of Bridge, Upstream View, TF/AG/WP/EW

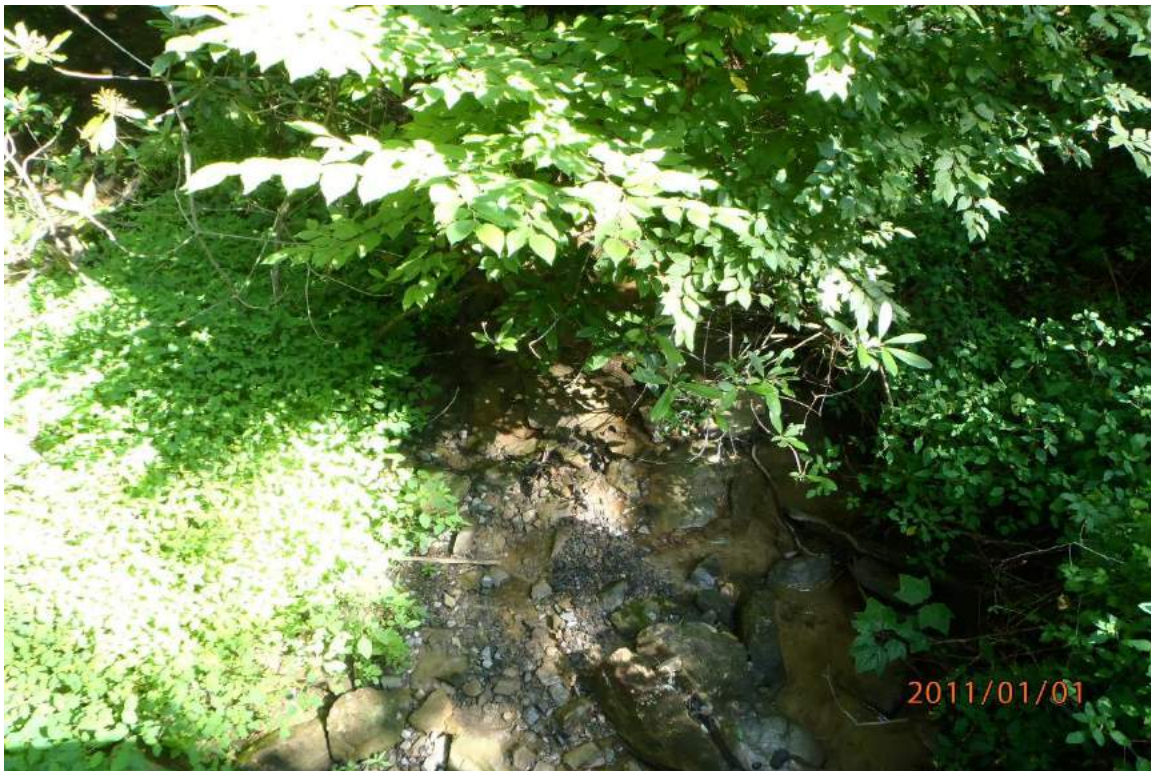
Photo Type: DS View at DS Side of Bridge
Location, Orientation, Photographer Initials: Downstream Side of Bridge, Downstream View, TF/AG/WP/EW

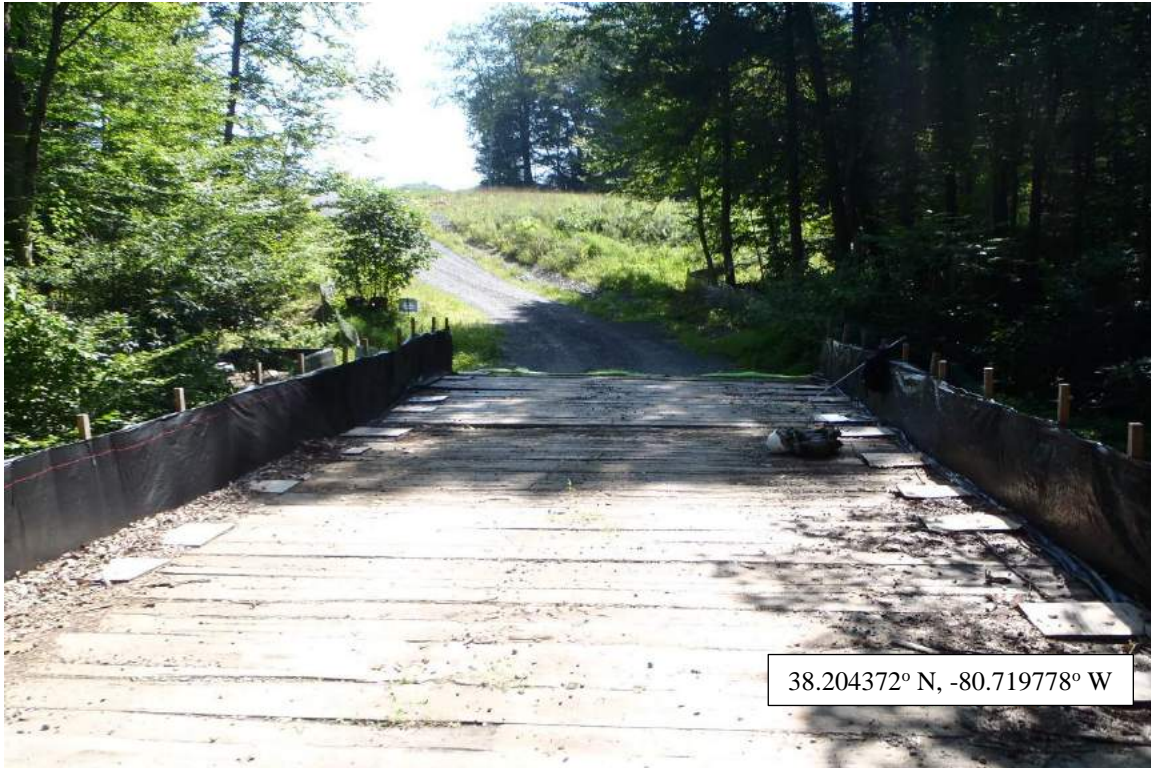
Photo Type: Facing W Across Bridge
Location, Orientation, Photographer Initials: Facing West Across Bridge, TF/AG/WP/EW

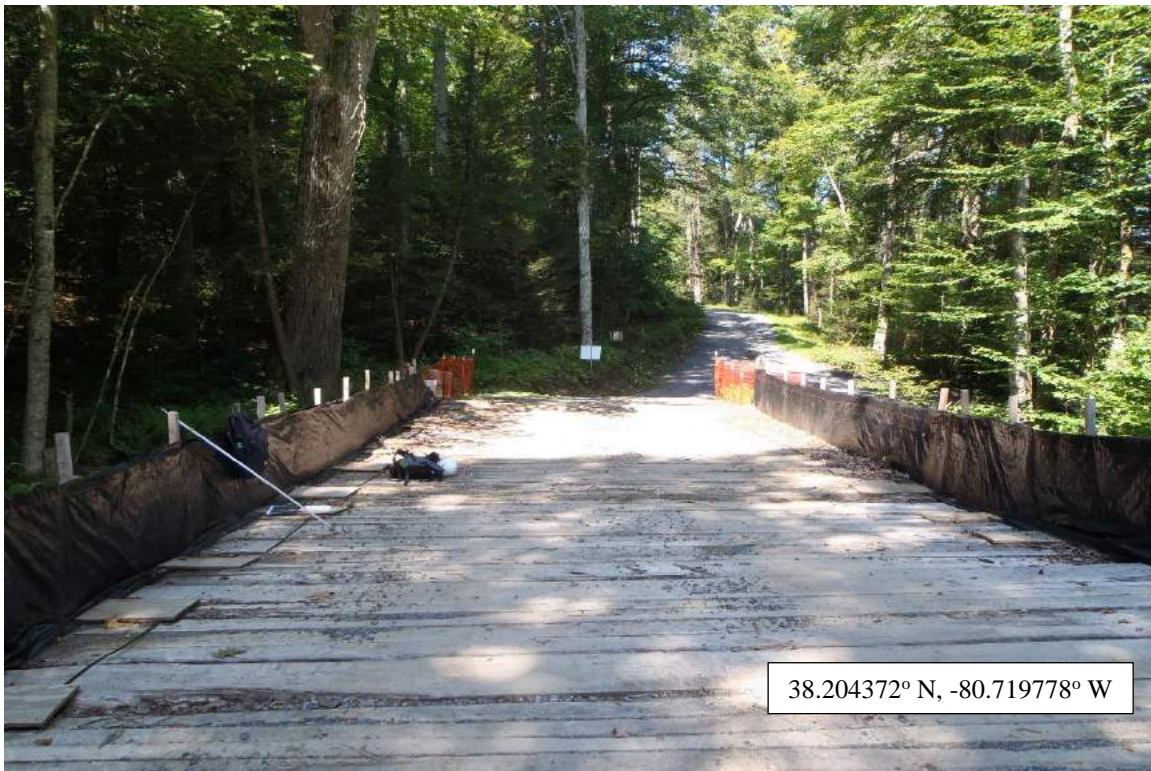
Photo Type: Facing N Across Bridge
Location, Orientation, Photographer Initials: Facing North Across Bridge, TF/AG/WP/EW

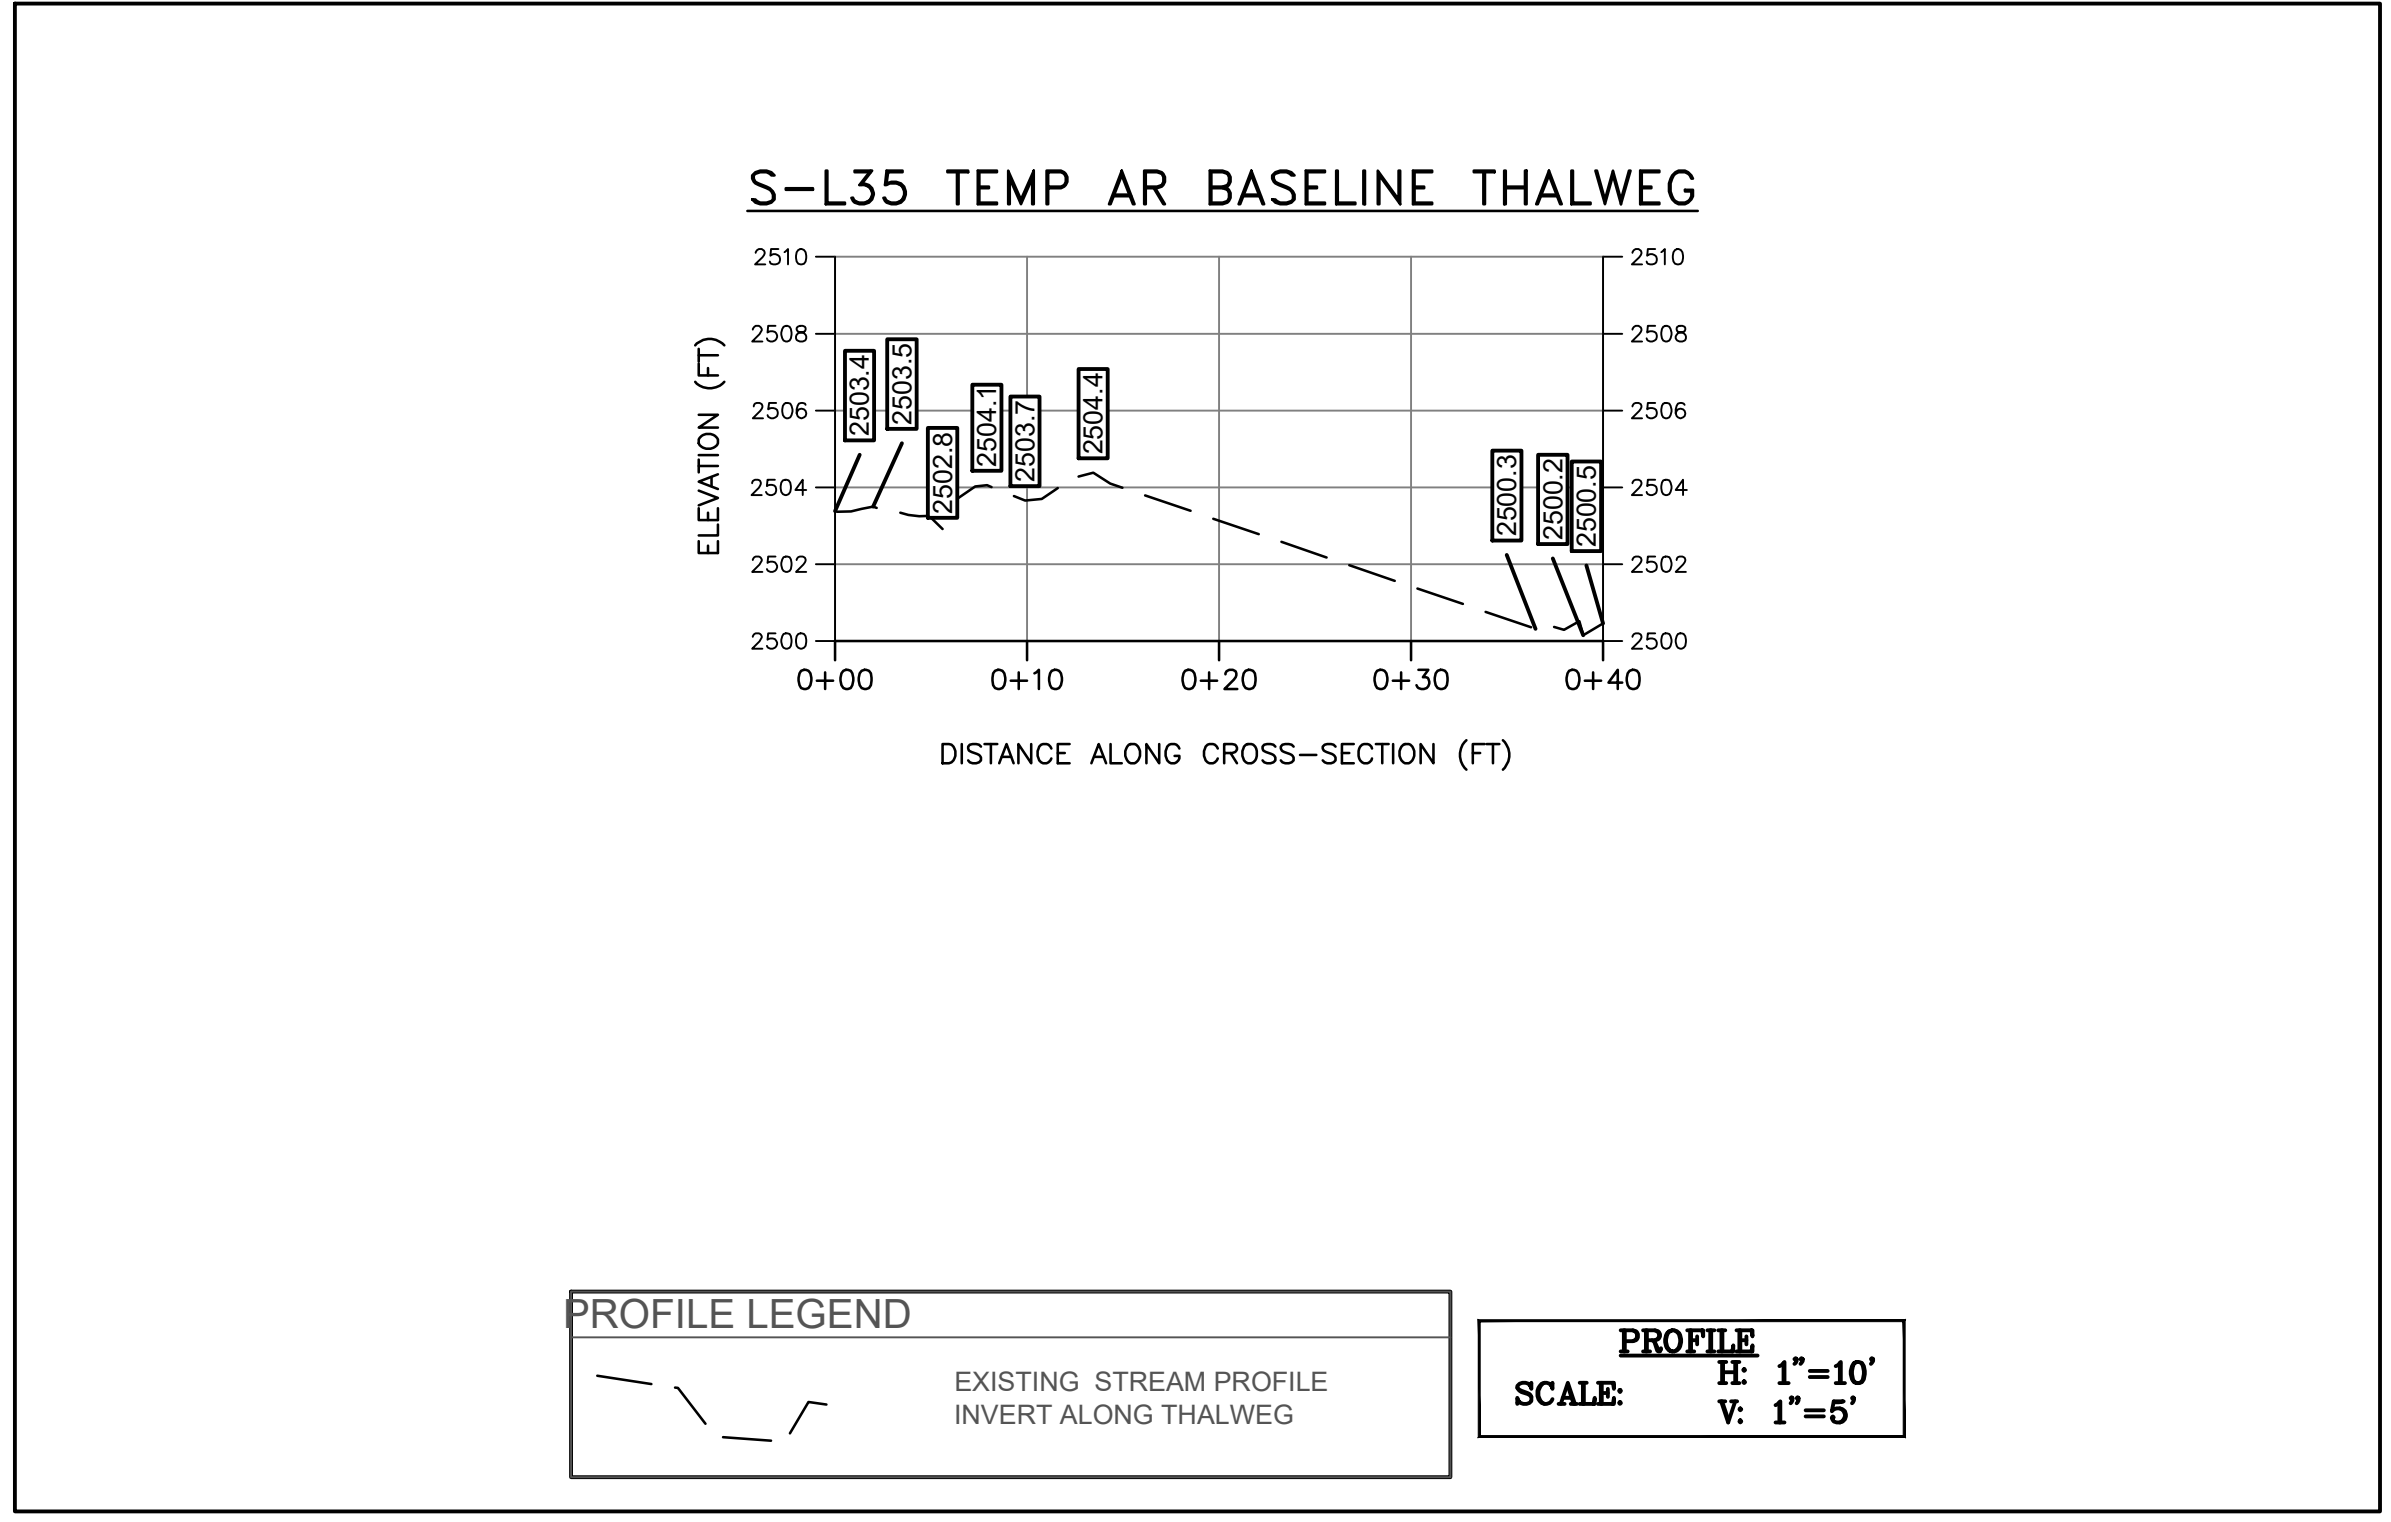
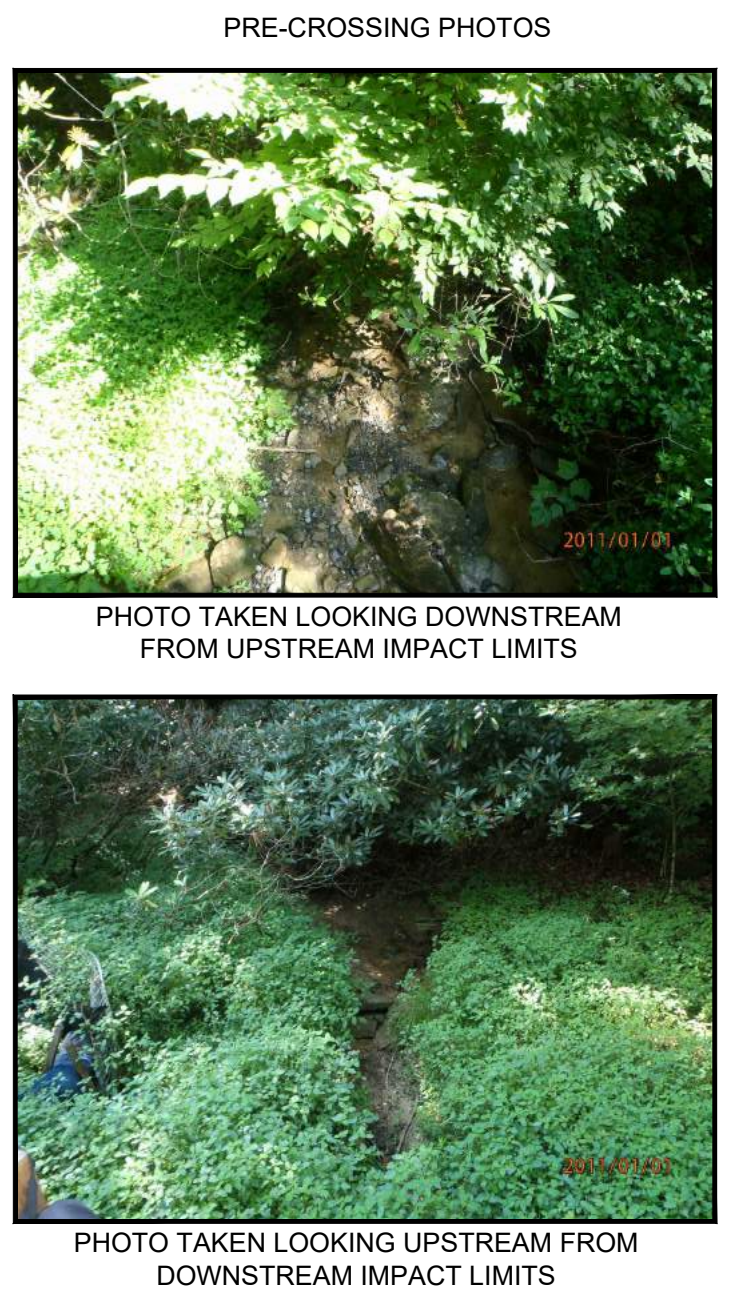
- ALL SECTION VIEWS SHOWN LEFT TO RIGHT FACING DOWNSTREAM.
 - POST-CROSSING SURVEY INFORMATION SHOWN IN RED. DATA PENDING.
 - POST-CROSSING SURVEY POINTS FOR CROSS SECTIONS AND THALWEG ARE PROJECTED ONTO PRE-CROSSING SECTION AND PROFILE VIEWS FOR COMPARISON.

| AS-BUILT TABLE: S-L35 TEMP AR CROSS SECTION A | | | | | |
