Baseline Assessment – Stream Attributes

Reach S-L38 (Pipeline ROW) Perennial Spread D Nicholas County, West Virginia

Title
 PROFILE AND CROSS-SECTIONS
 BASELINE SURVEY
 CROSSING S-L38 - UNNAMED TRIB.
 RILEY BRANCH (MP 124.55)
 NICHOLAS COUNTY, WV

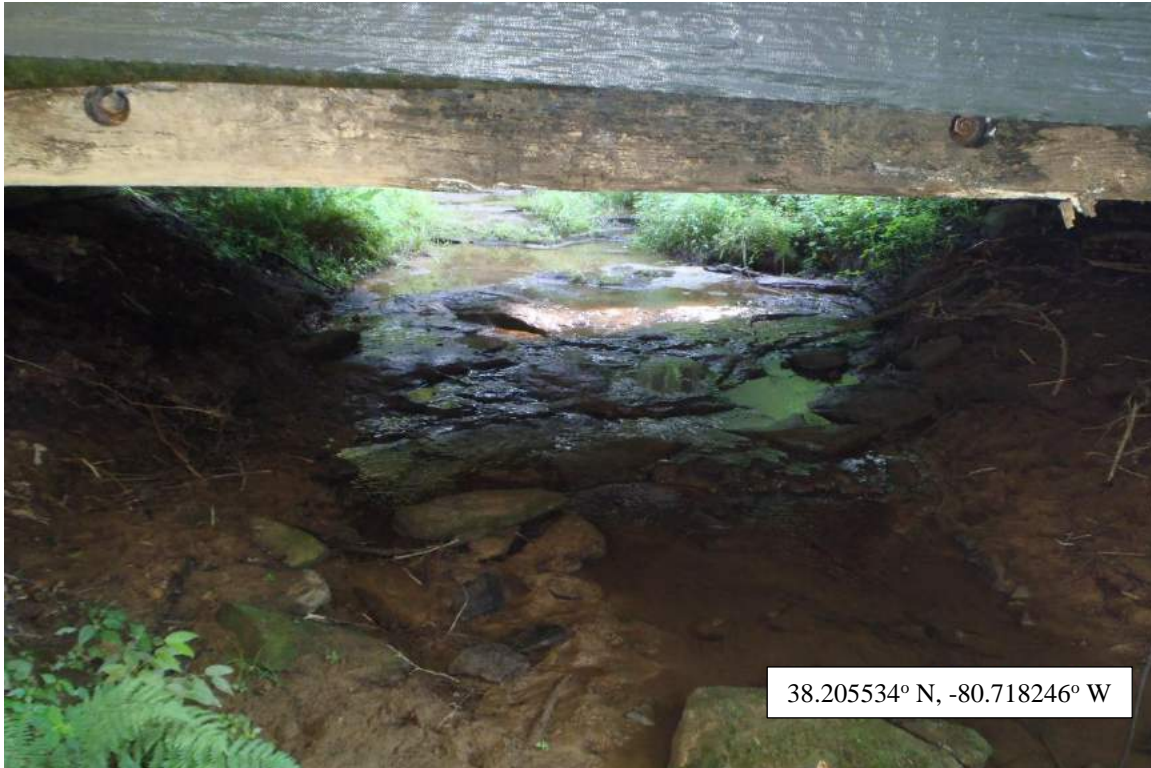
Photo Type: US at DS Edge of ROW

Location, Orientation, Photographer Initials: Downstream Edge of Right of Way, Upstream View, TF/AG/WP/EW

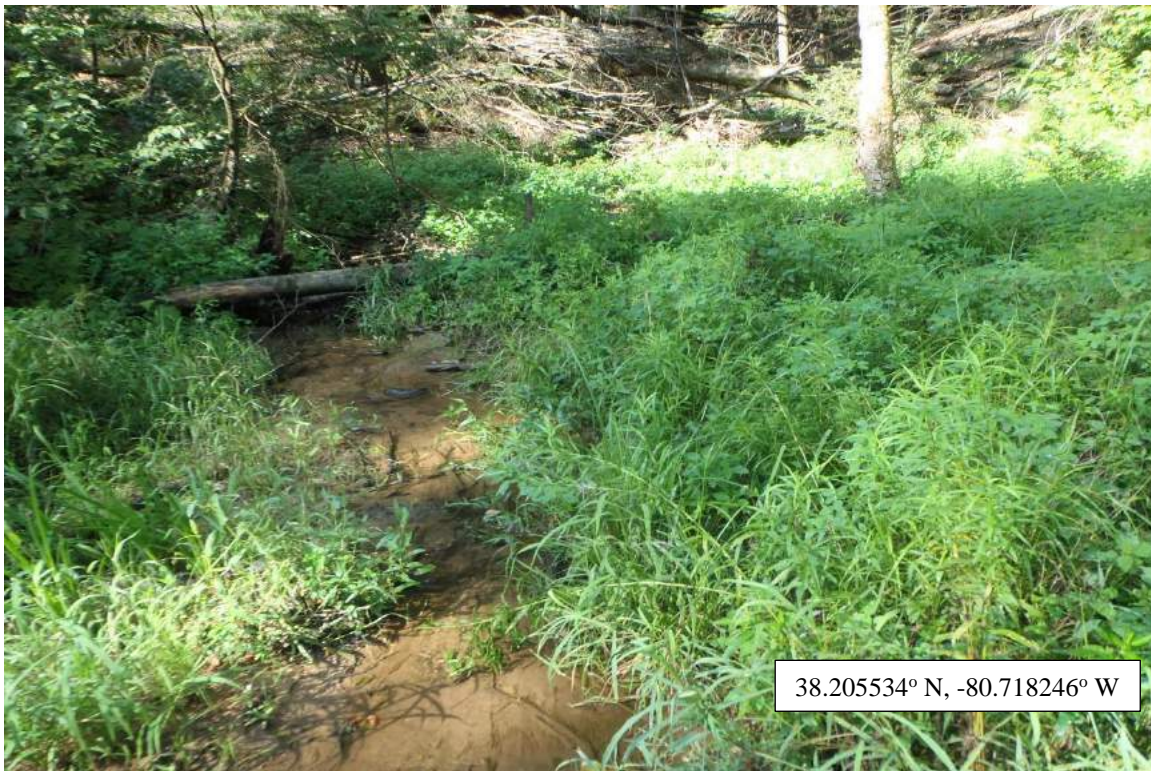
Photo Type: DS at DS Edge of ROW

Location, Orientation, Photographer Initials: Downstream Edge of Right of Way, Downstream View, TF/AG/WP/EW

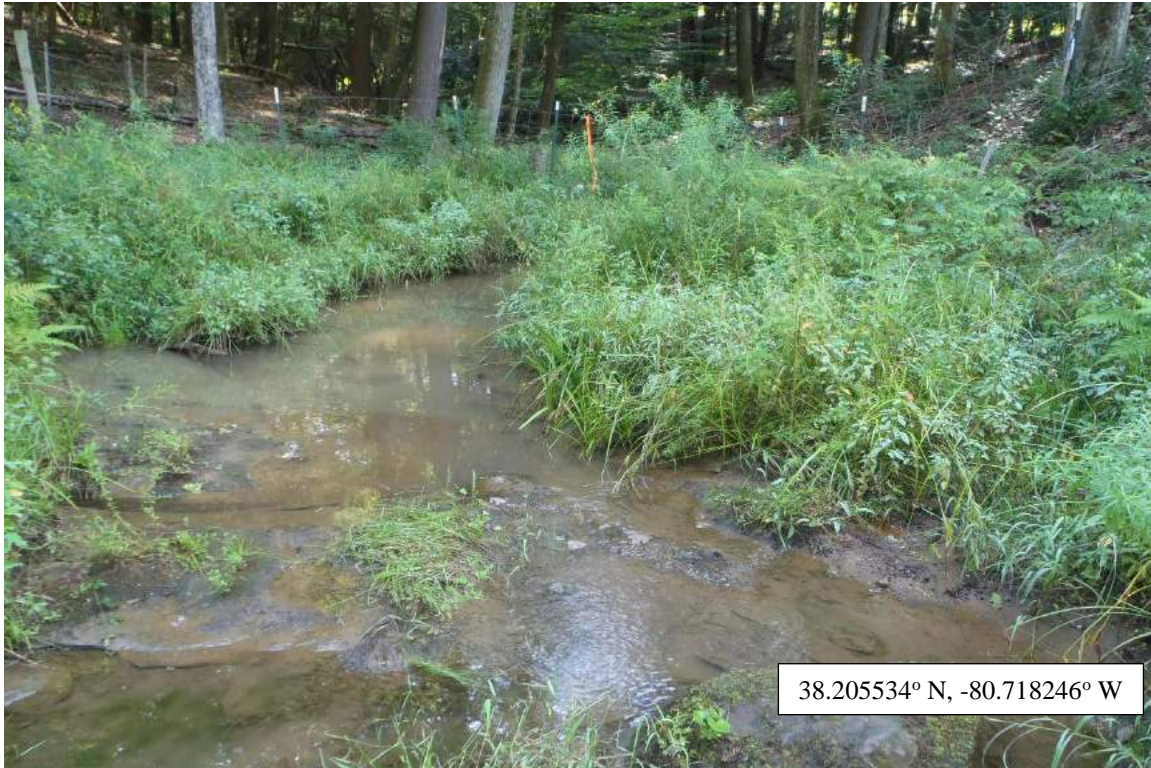
Photo Type: US at Center of ROW
Location, Orientation, Photographer Initials: Center of Right of Way, Upstream View, TF/AG/WP/EW

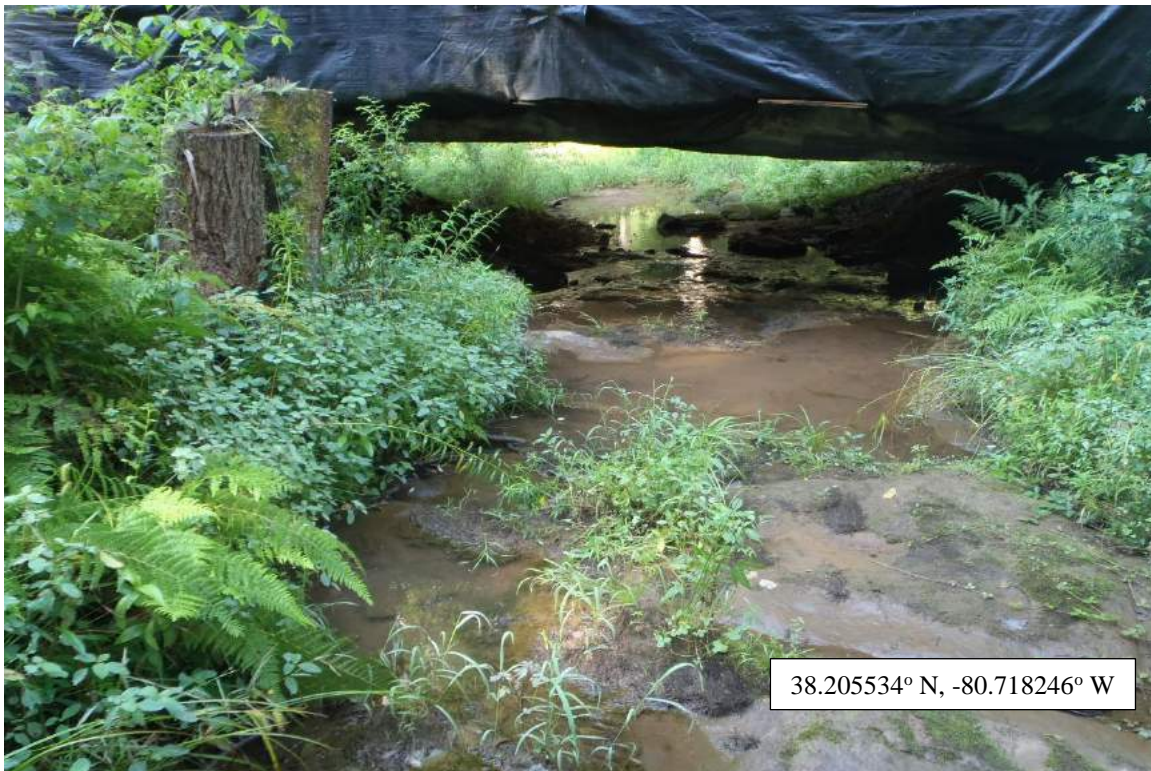
Photo Type: DS at Center of ROW
Location, Orientation, Photographer Initials: Center of Right of Way, Downstream View, TF/AG/WP/EW

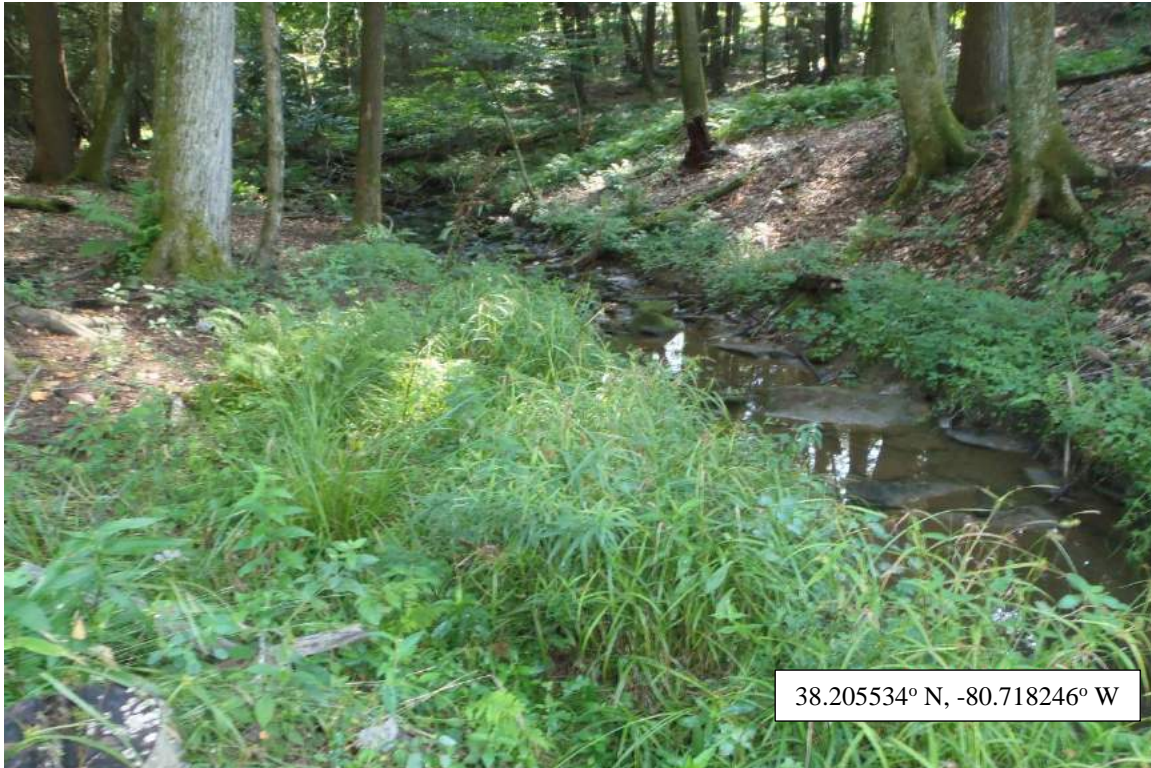
Photo Type: US at US Edge of ROW

Location, Orientation, Photographer Initials: Upstream Edge of Right of Way, Upstream View, TF/AG/WP/EW

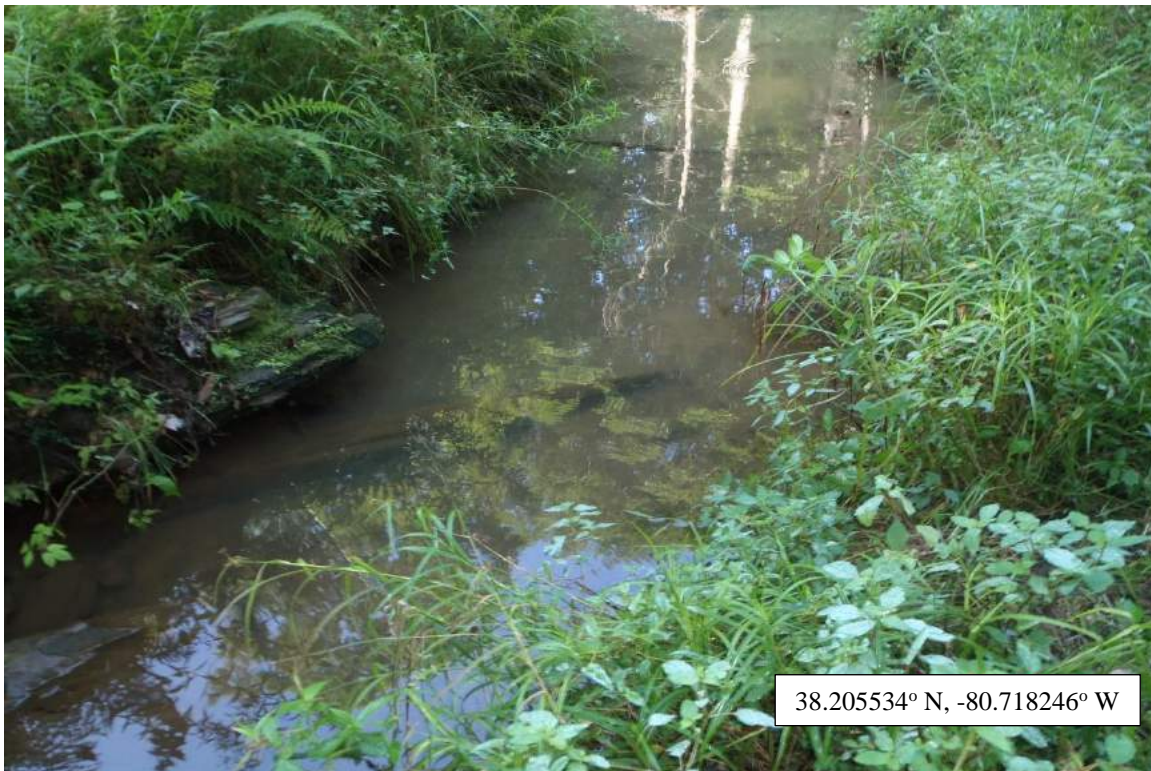
Photo Type: DS at US Edge of ROW

Location, Orientation, Photographer Initials: Upstream Edge of Right of Way, Downstream View, TF/AG/WP/EW

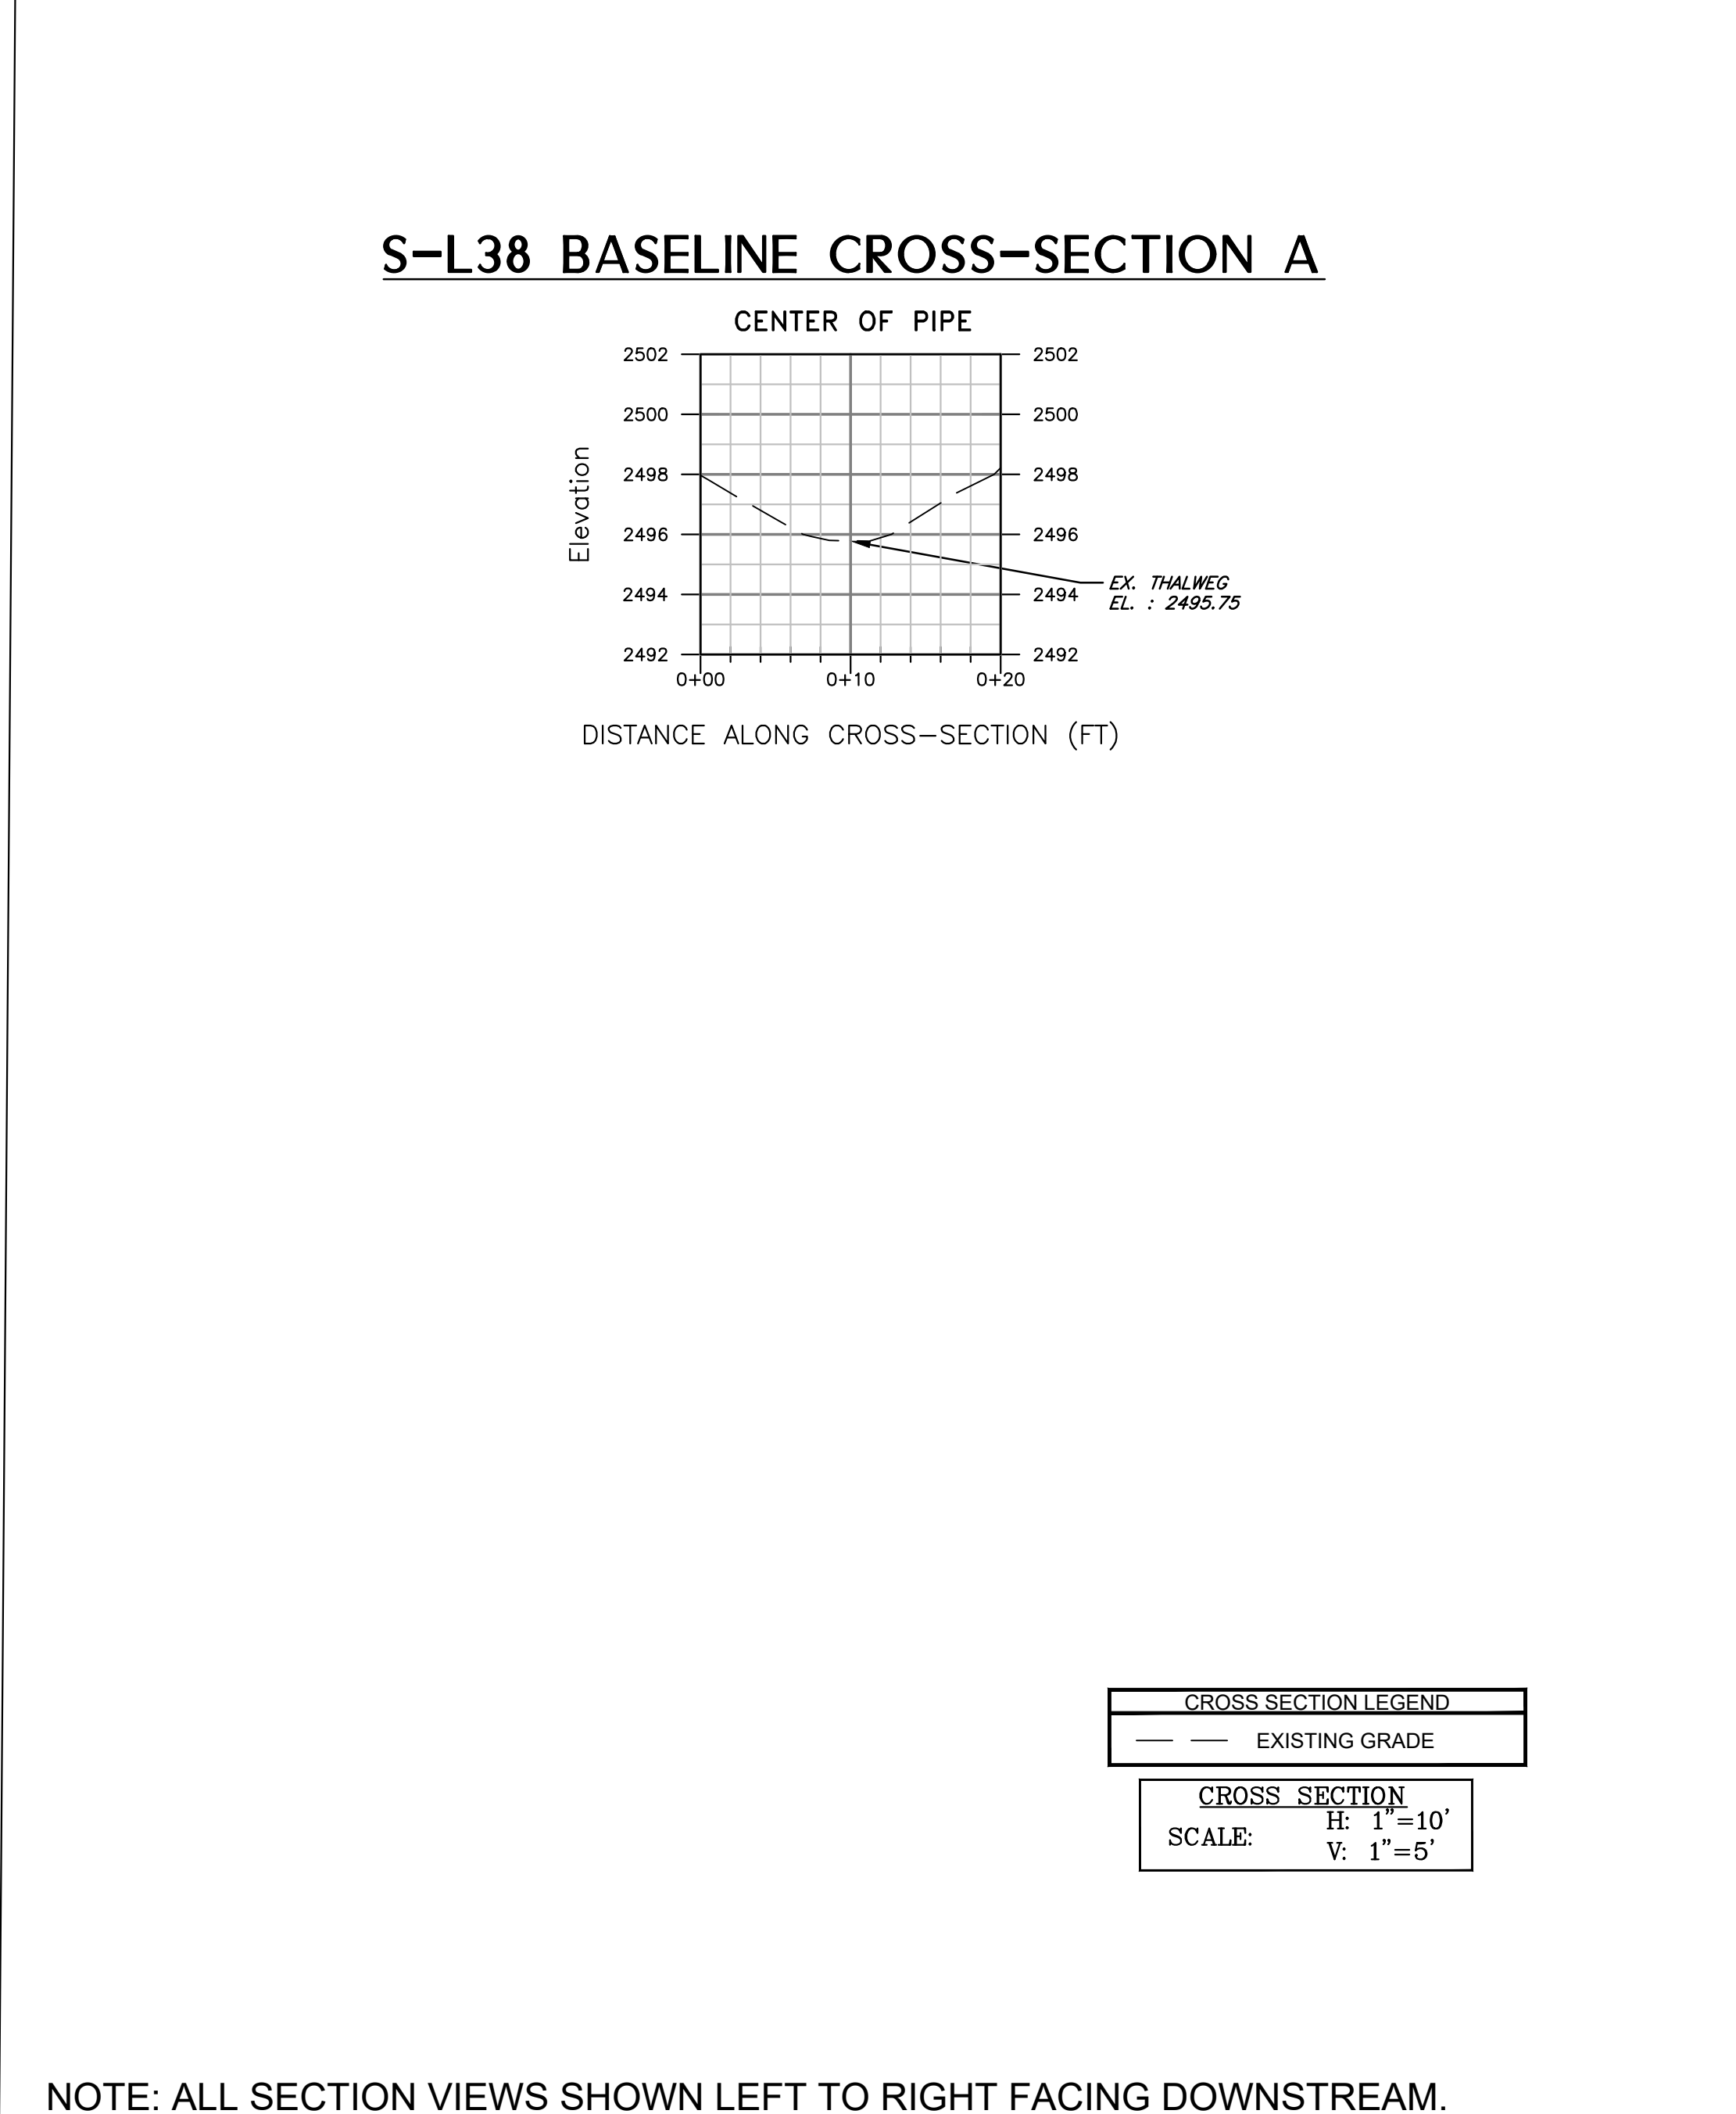
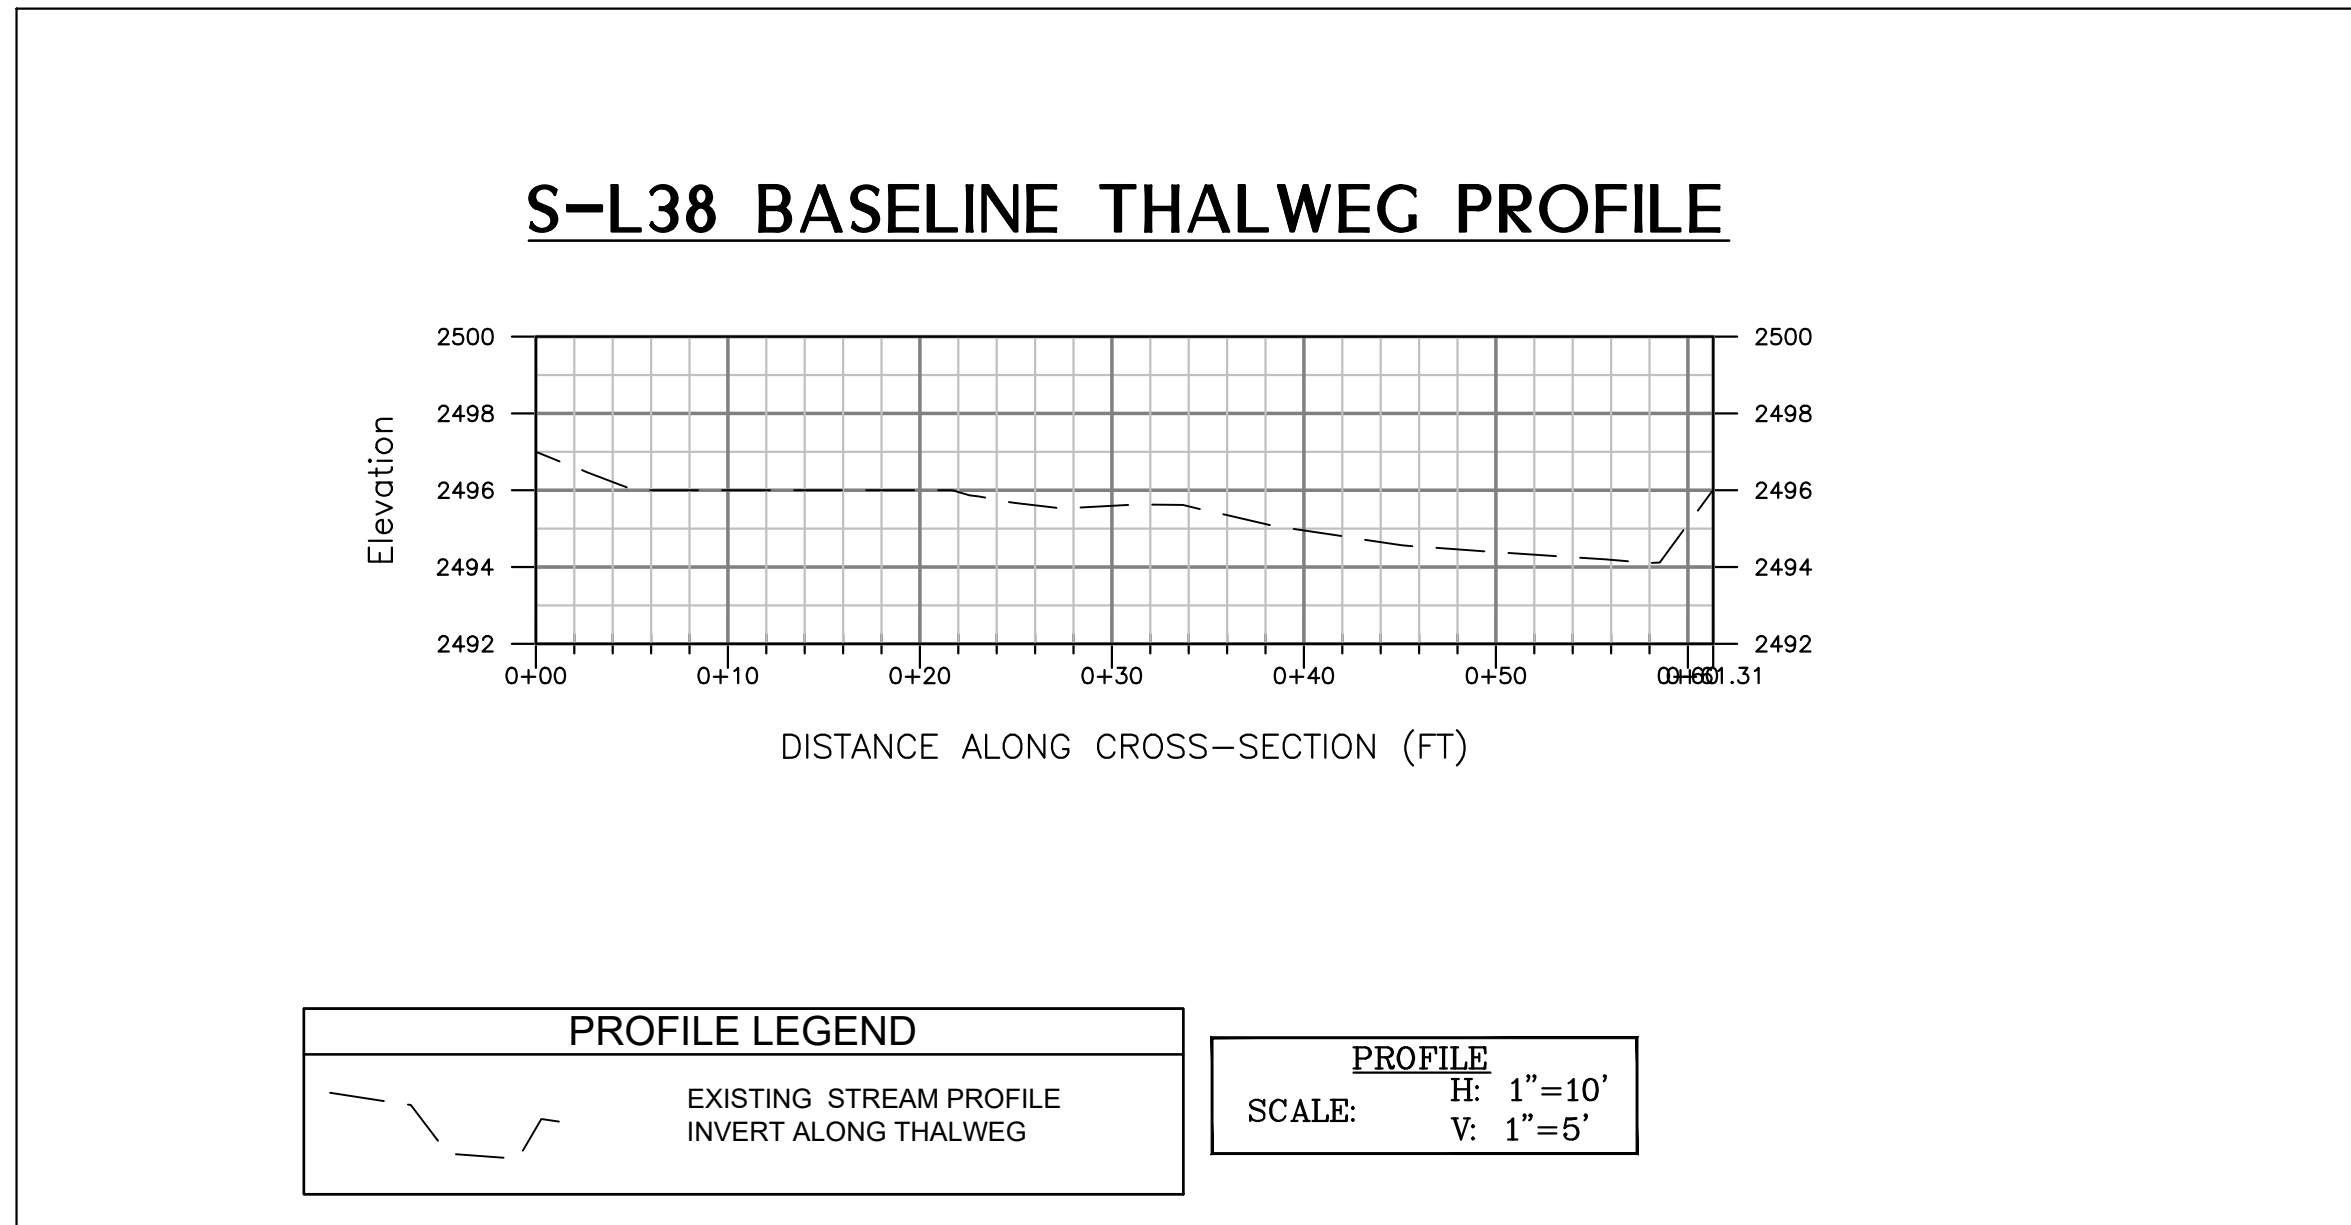
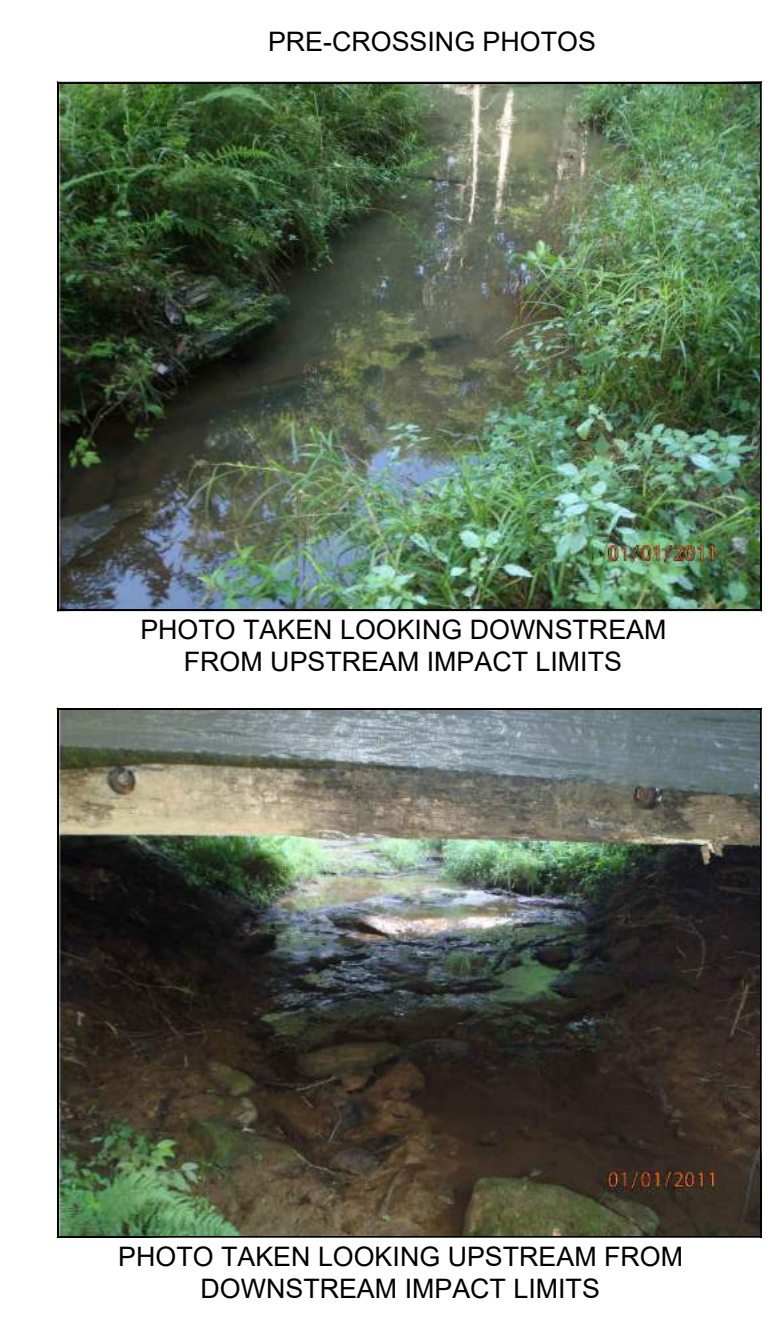
- SURVEY NOTES:**
- THIS MAP HAS BEEN ORIENTED TO NAD 1983 UTM ZONE 17N, AND VERTICALLY TO THE NORTH AMERICAN VERTICAL DATUM OF 1988 (NAVD 88), USING REAL TIME DGPS. FIELD LOCATIONS WERE COMPLETED ON 8-25-2021.

- EASEMENT LINES SHOWN ON PLAN VIEW WERE PROVIDED BY MOUNTAIN VALLEY PIPELINE.
 - SURVEY POINTS FOR CROSS SECTIONS AND THALWEG PROFILES COLLECTED IN 2021 HAVE BEEN USED IN COMBINATION WITH SURVEY POINTS AND COLLECTED PREVIOUSLY IN 2020 IN ORDER TO GENERATE THE PRE-CROSSING SURFACE SHOWN IN PLAN. DUE TO NATURAL EROSIONAL STREAM PROCESSES THAT OCCUR OVER TIME, MINOR ADJUSTMENTS TO THE PROFILE ALIGNMENTS MAY HAVE BEEN REQUIRED IN ORDER TO GENERATE A CLEAN PRE-CROSSING SURFACE.

- ALL SECTION VIEWS SHOWN LEFT TO RIGHT FACING DOWNSTREAM.
 - POST-CROSSING SURVEY INFORMATION SHOWN IN RED. DATA PENDING.
 - POST-CROSSING SURVEY POINTS FOR CROSS SECTIONS AND THALWEG ARE PROJECTED ONTO PRE-CROSSING SECTION AND PROFILE VIEWS FOR COMPARISON.

AS-BUILT TABLE: S-L38 CROSS SECTION A					
PT. LOC.	PRE-CROSSING			AS-BUILT	
	NORTHING	EASTING	ELEV.	VERT. DIFF.	HORZ. DIFF.
TS-L	13873510.18	1721350.16	2497.95		
BS-L	13873516.91	1721349.00	2495.98		
THW	13873521.21	1721348.25	2495.79		
BS-R	13873525.63	1721347.39	2497.01		
TS-R	13873529.90	1721346.73	2497.95
