Baseline Assessment – Stream Attributes

Reach S-A119 (Timber Mat Crossing) Intermittent Spread A Wetzel County, West Virginia

Title: PROFILE AND CROSS-SECTIONS
 BASELINE SURVEY
 CROSSING S-A119 - UNNAMED TRIB. TO
 STOUT RUN (MP 6.56)
 WETZEL COUNTY, WV

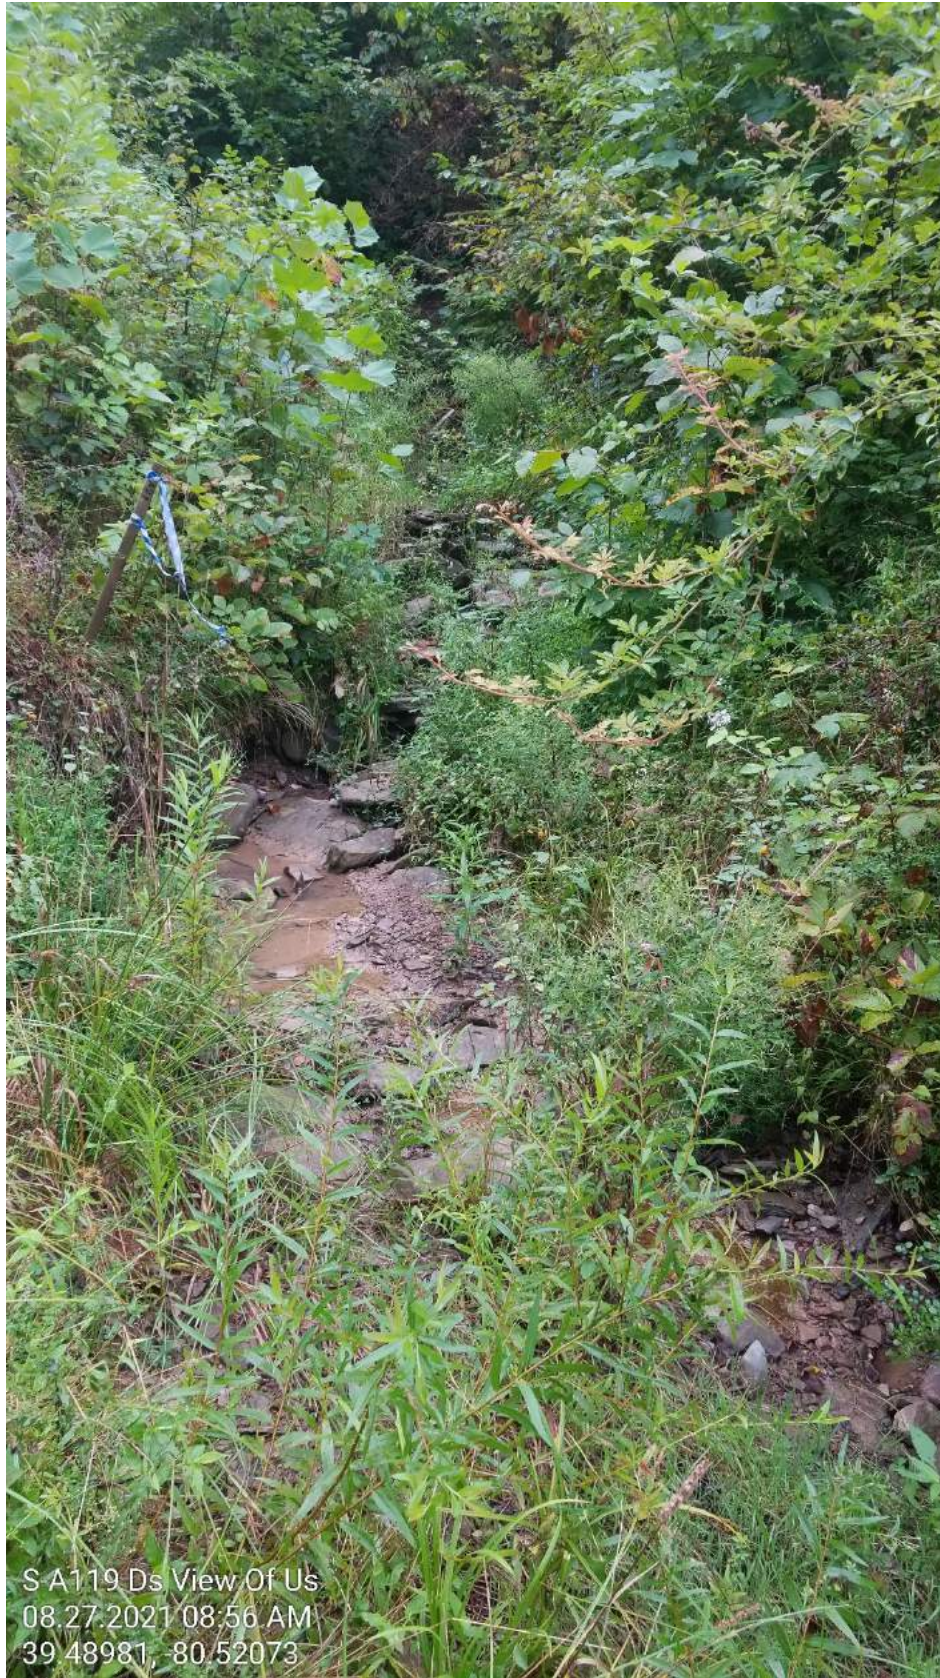
Spread A Stream S-A119 (Timber Mat Crossing) Wetzel County

Photo Type: DS, US View

Location, Orientation, Photographer Initials: Downstream Edge of ROW, Upstream View, JR/MB

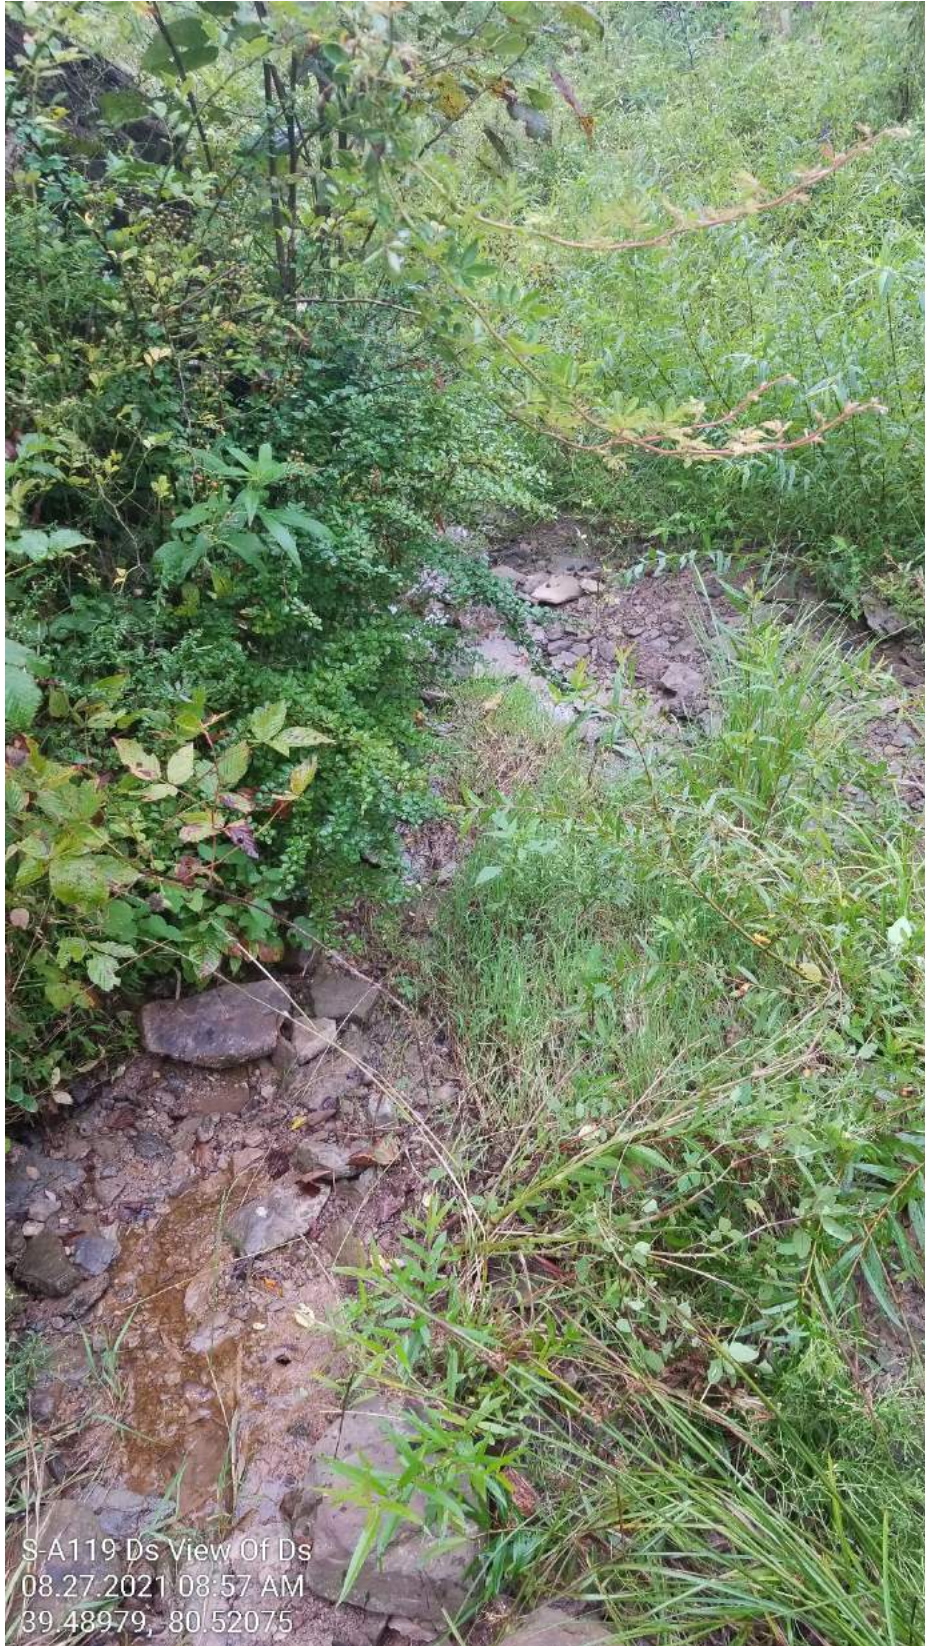
Spread A Stream S-A119 (Timber Mat Crossing) Wetzel County

Photo Type: DS, DS View

Location, Orientation, Photographer Initials: Downstream Edge of ROW, Downstream View, JR/MB

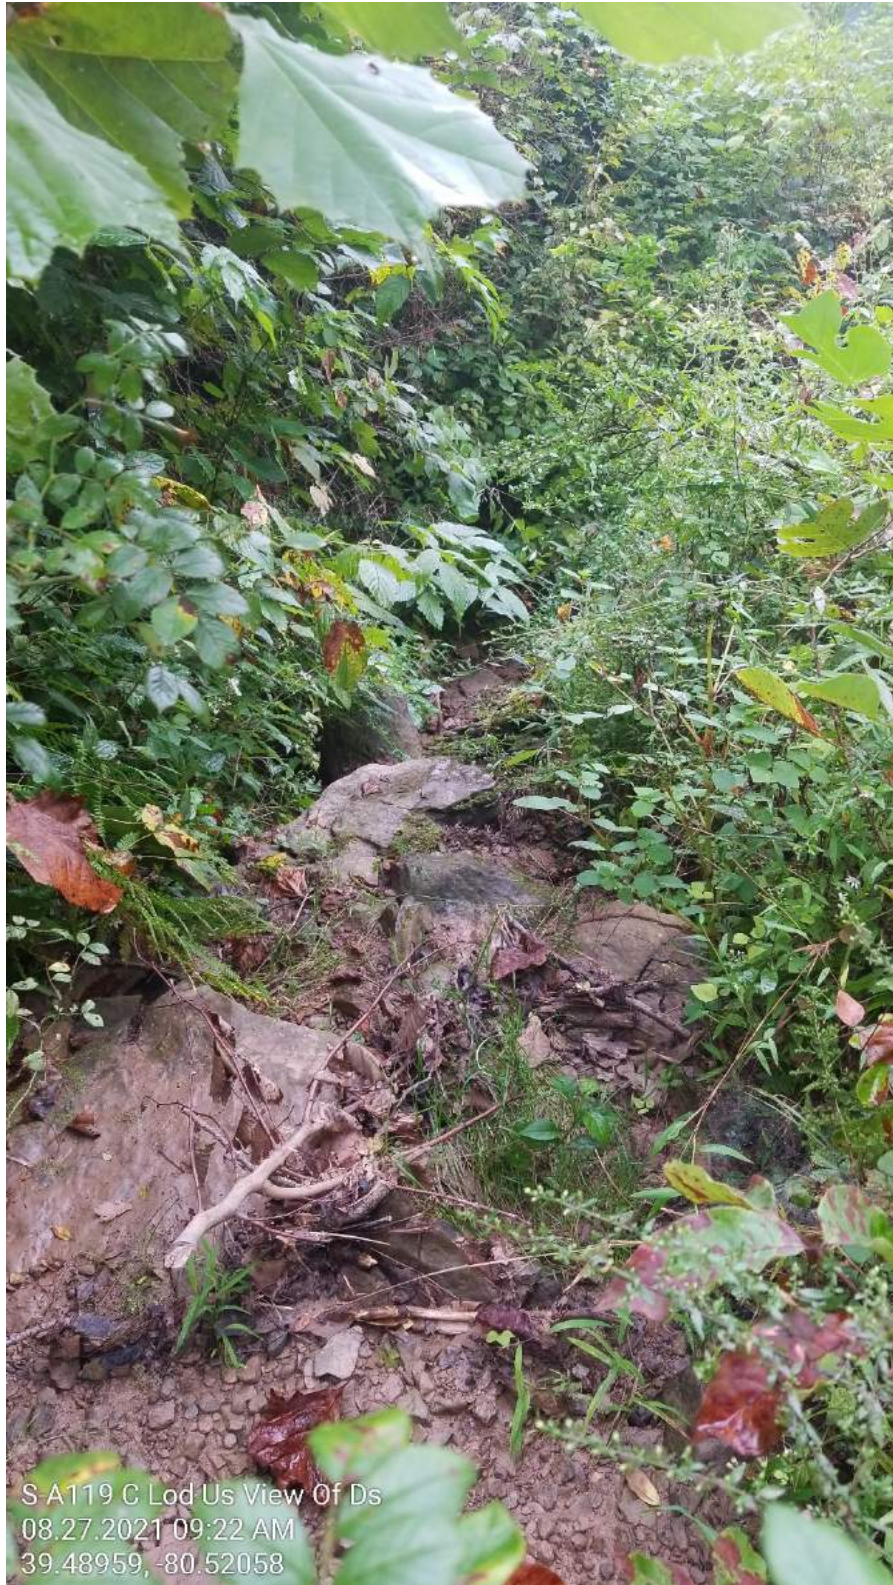
Spread A Stream S-A119 (Timber Mat Crossing) Wetzel County

Photo Type: US View at Center
Location, Orientation, Photographer Initials: Center ROW, Upstream View, JR/MB
Lat: 39.489589 Long: -80.520532

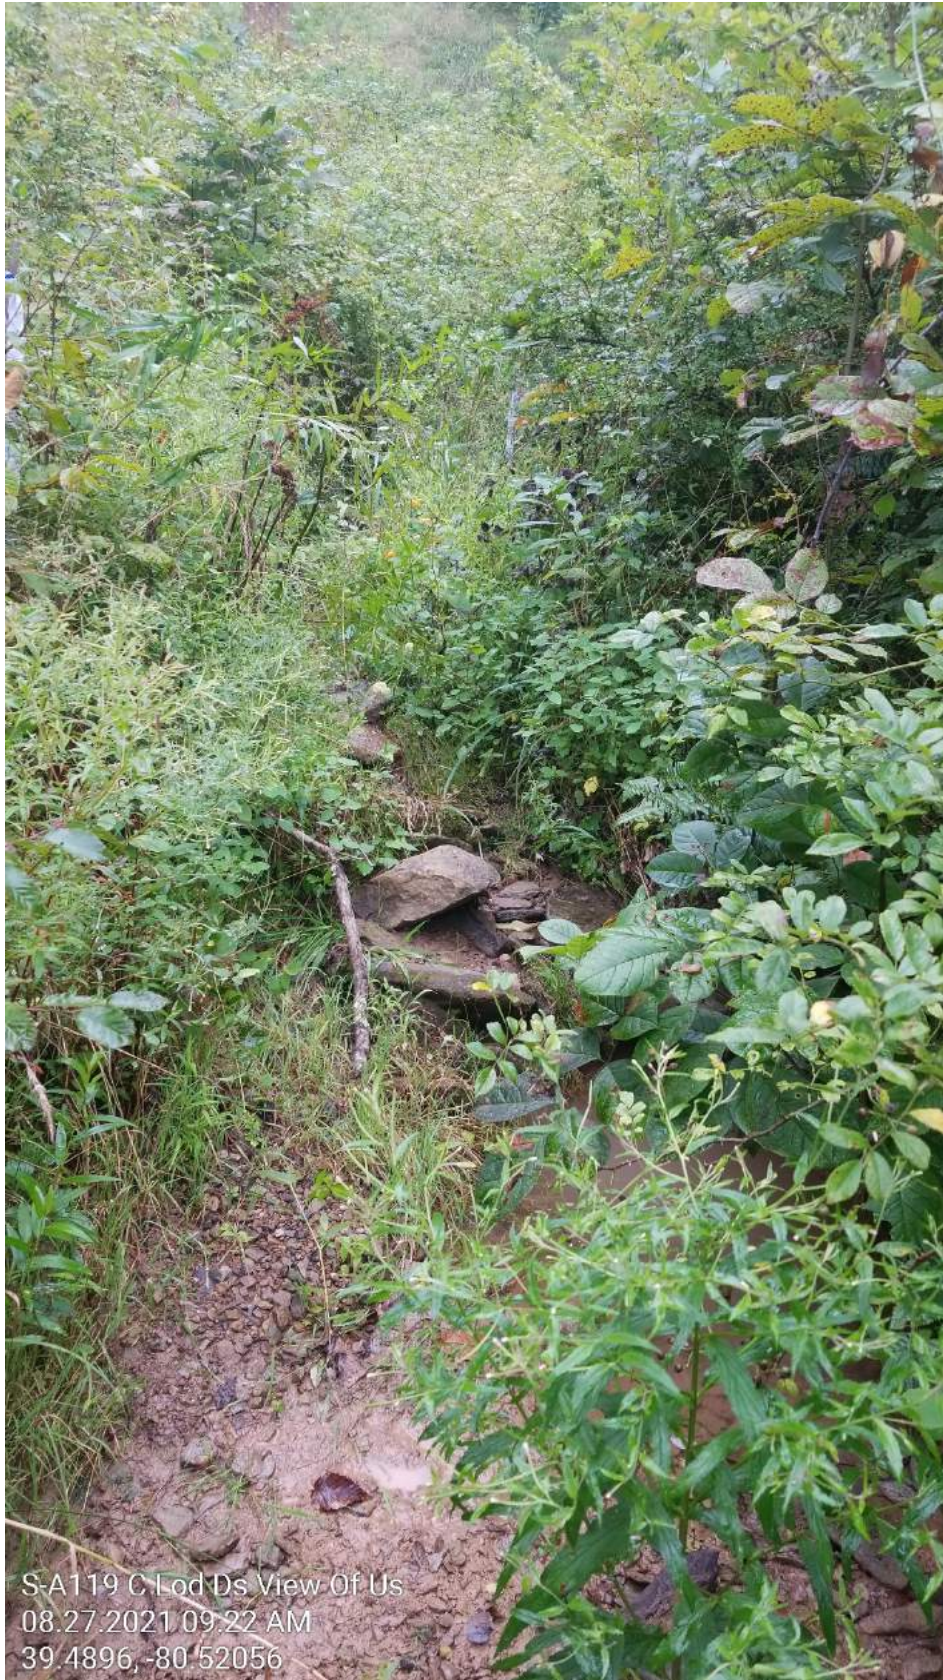
Spread A Stream S-A119 (Timber Mat Crossing) Wetzel County

S-A119 C.Lod Ds View Of Us
08.27.2021 09:22 AM
39.4896, -80.52056

Photo Type: DS View at Center

Location, Orientation, Photographer Initials: ROW Center, Downstream View, JR/MB
Lat: 39.489589 Long: -80.520532

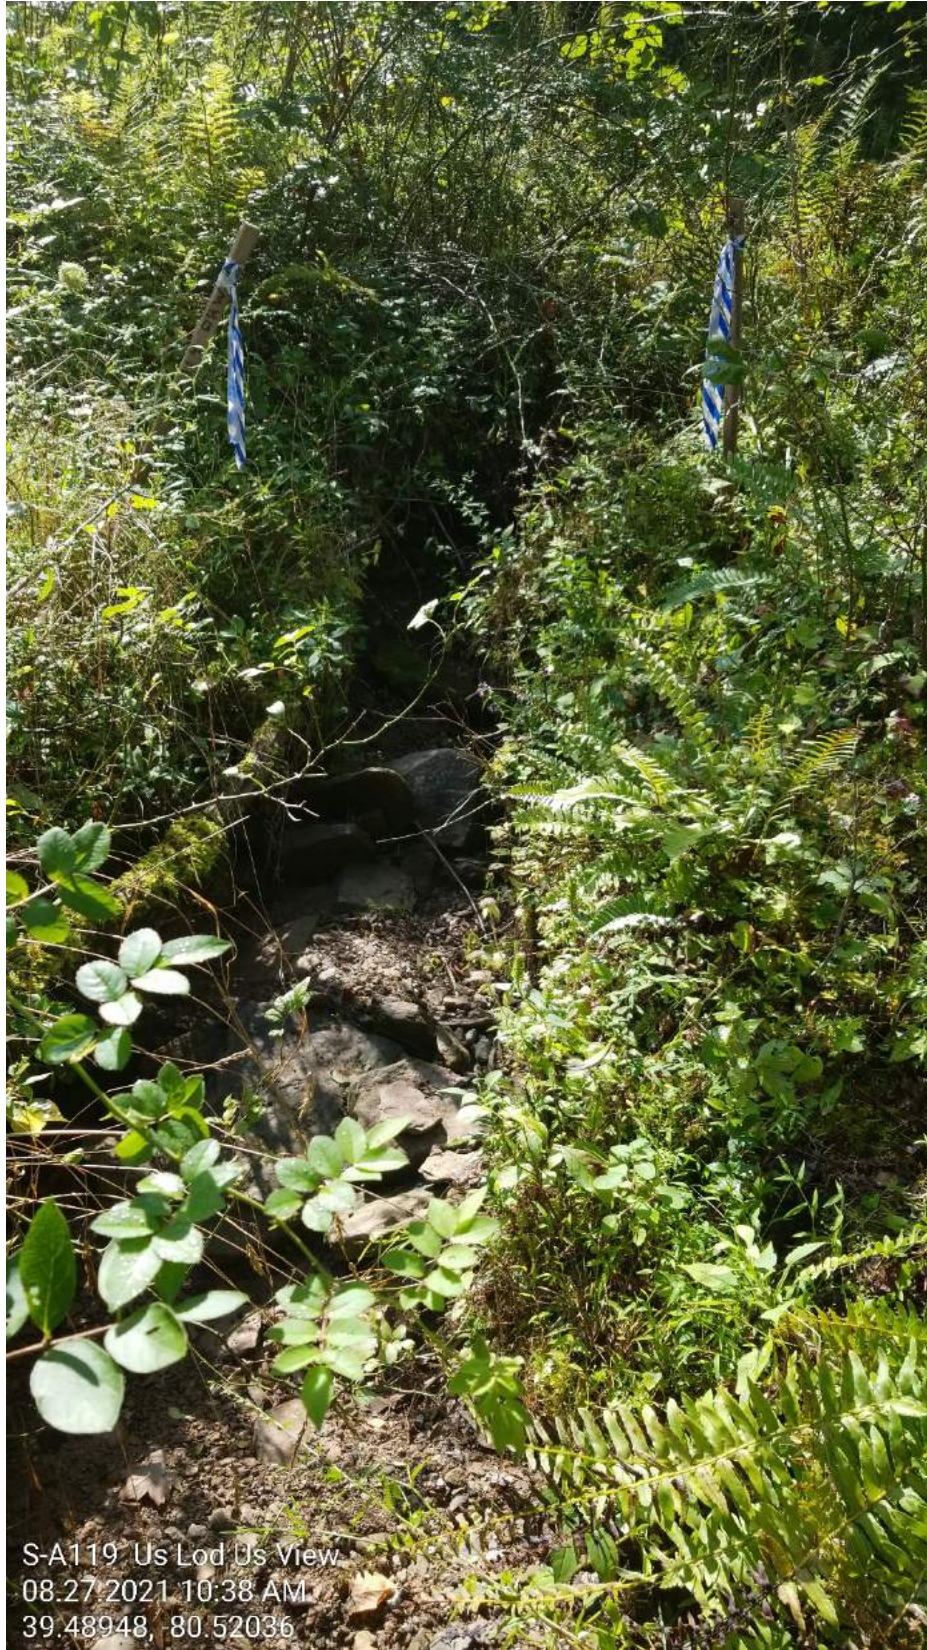
Spread A Stream S-A119 (Timber Mat Crossing) Wetzel County

Photo Type: US, US View

Location, Orientation, Photographer Initials: Upstream Edge of ROW, Upstream View, JR/MB
Lat: 39.489589 Long: -80.520532

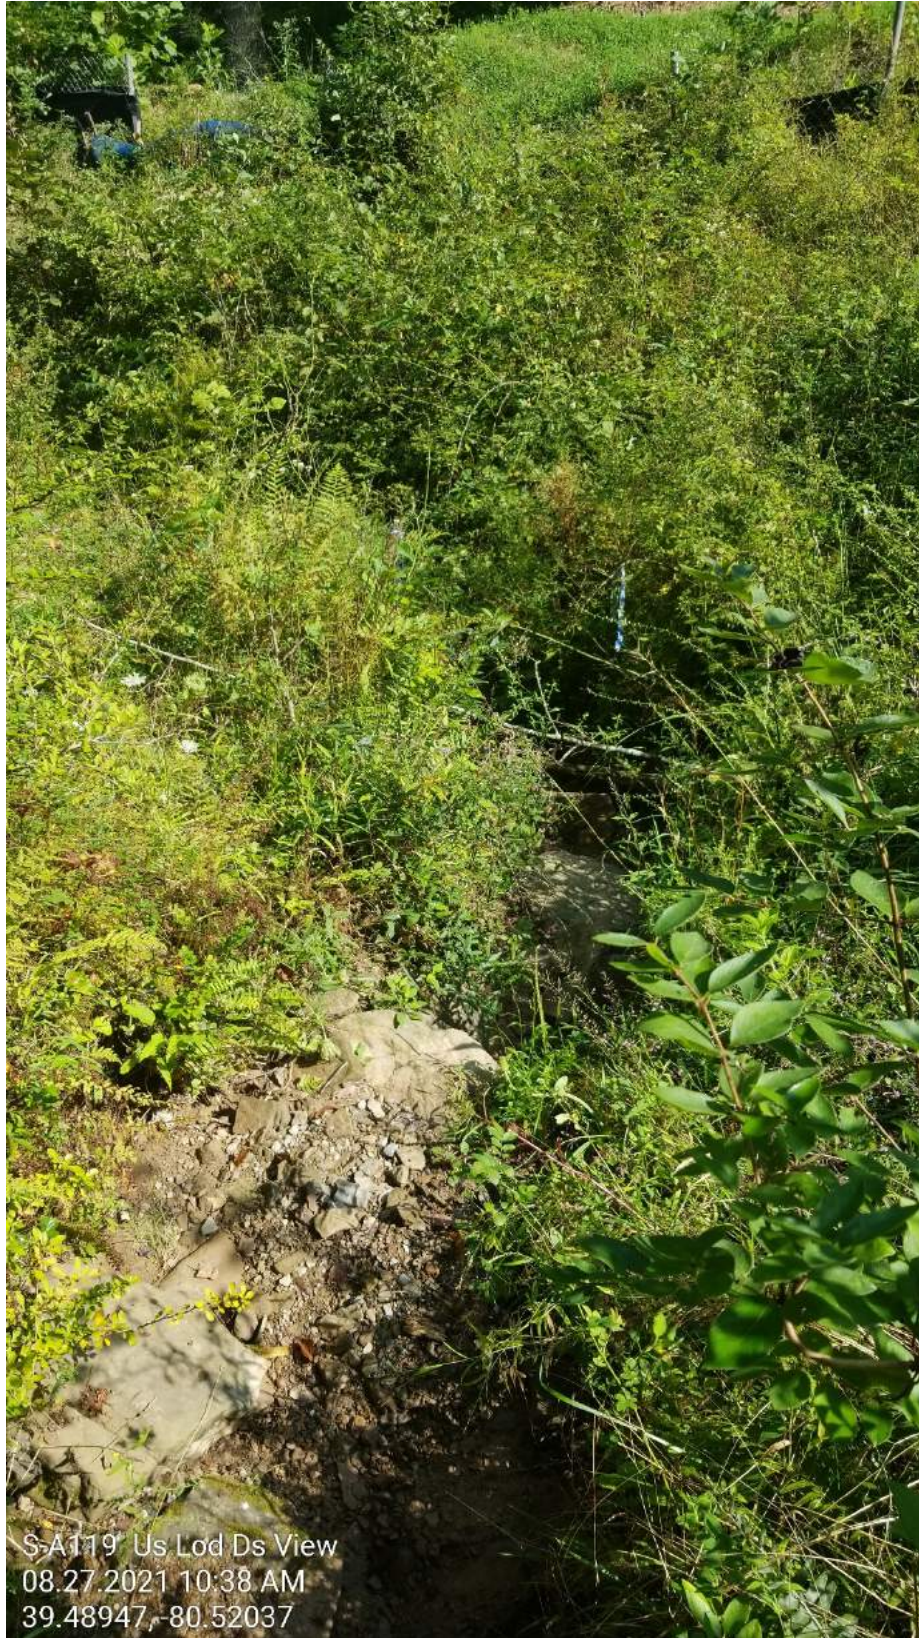
Spread A Stream S-A119 (Timber Mat Crossing) Wetzel County

S-A119 Us Lod Ds View
08.27.2021 10:38 AM
39.48947, -80.52037

Photo Type: US, DS View

Location, Orientation, Photographer Initials: Upstream Edge of ROW, Downstream View, JR/MB

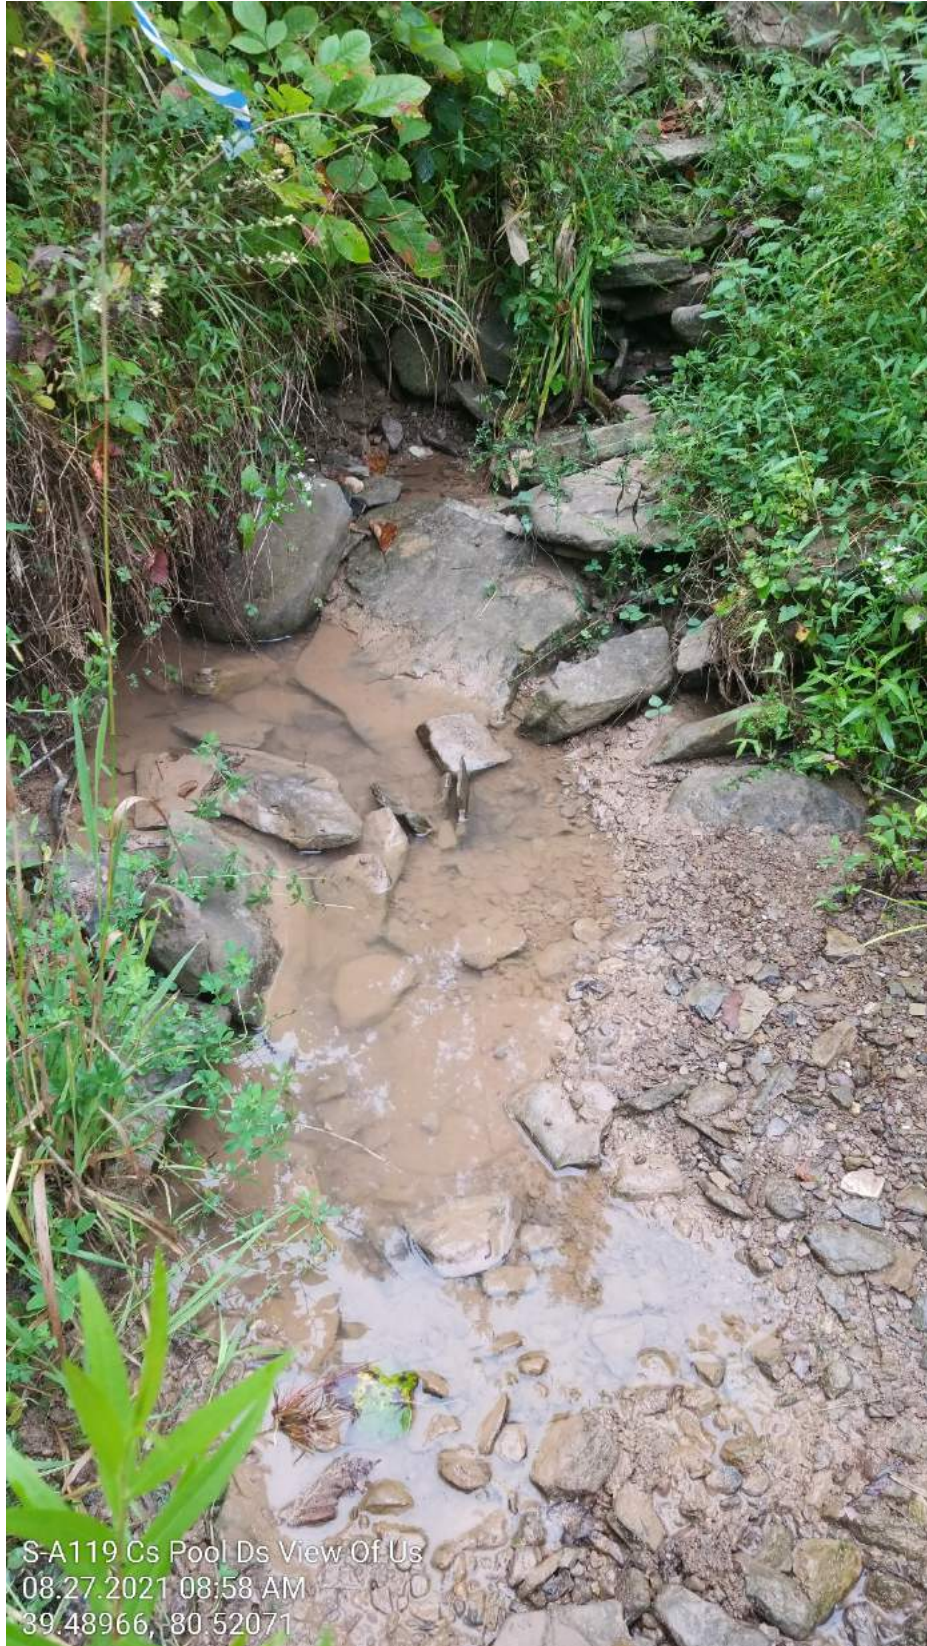
Spread A Stream S-A119 (Timber Mat Crossing) Wetzel County

S-A119 Cs Pool Ds View Of Us
08.27.2021 08:58 AM
39.48966, -80.52071

Photo Type: Pool, DS View

Location, Orientation, Photographer Initials: Upstream of Pool, Downstream View, JR/MB
Lat: 39.489589 Long: -80.520532

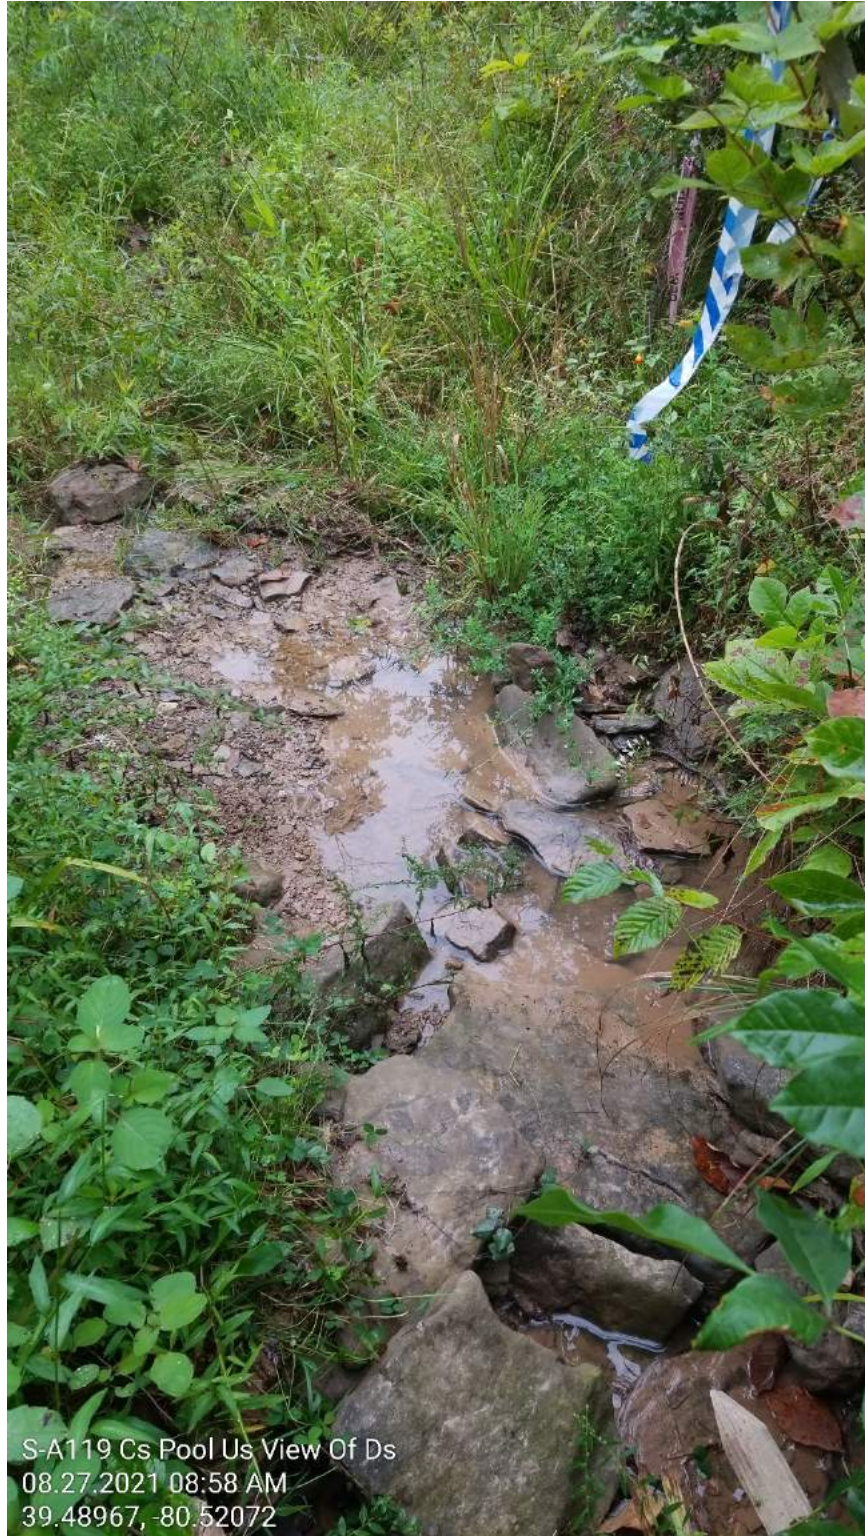
Spread A Stream S-A119 (Timber Mat Crossing) Wetzel County

S-A119 Cs Pool Us View Of Ds
08.27.2021 08:58 AM
39.48967, -80.52072

Photo Type: Pool, US View

Location, Orientation, Photographer Initials: Downstream of Pool, Upstream View, JR/MB

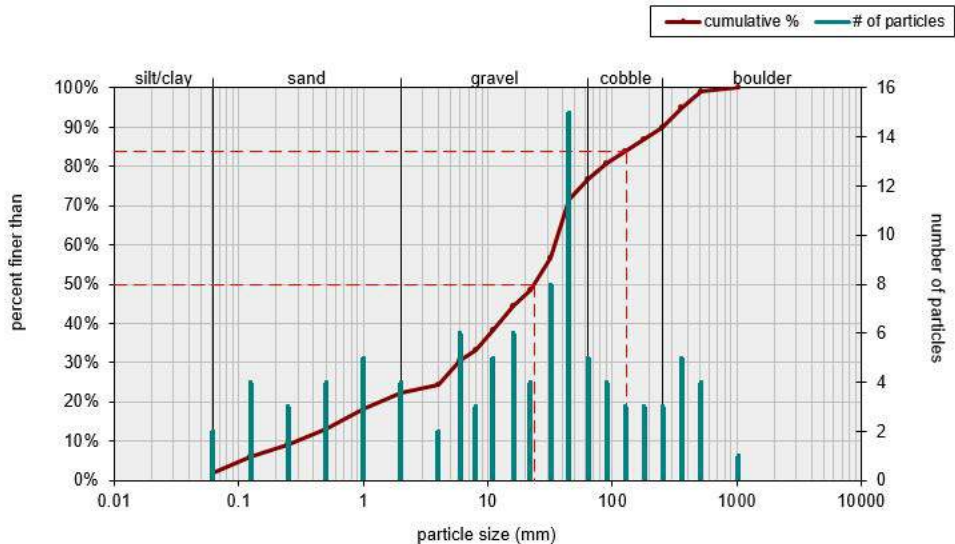
Bankfull Channel Pebble Count, S-A119 Stout Run

Size (mm)		Size Distribution		Type			
D16	0.74	mean	9.8	silt/clay	2%	bedrock	1%
D35	8.9	dispersion	18.9	sand	20%		
D50	24	skewness	-0.26	gravel	54%		
D65	39			cobble	13%		
D84	130			boulder	10%		
D95	360

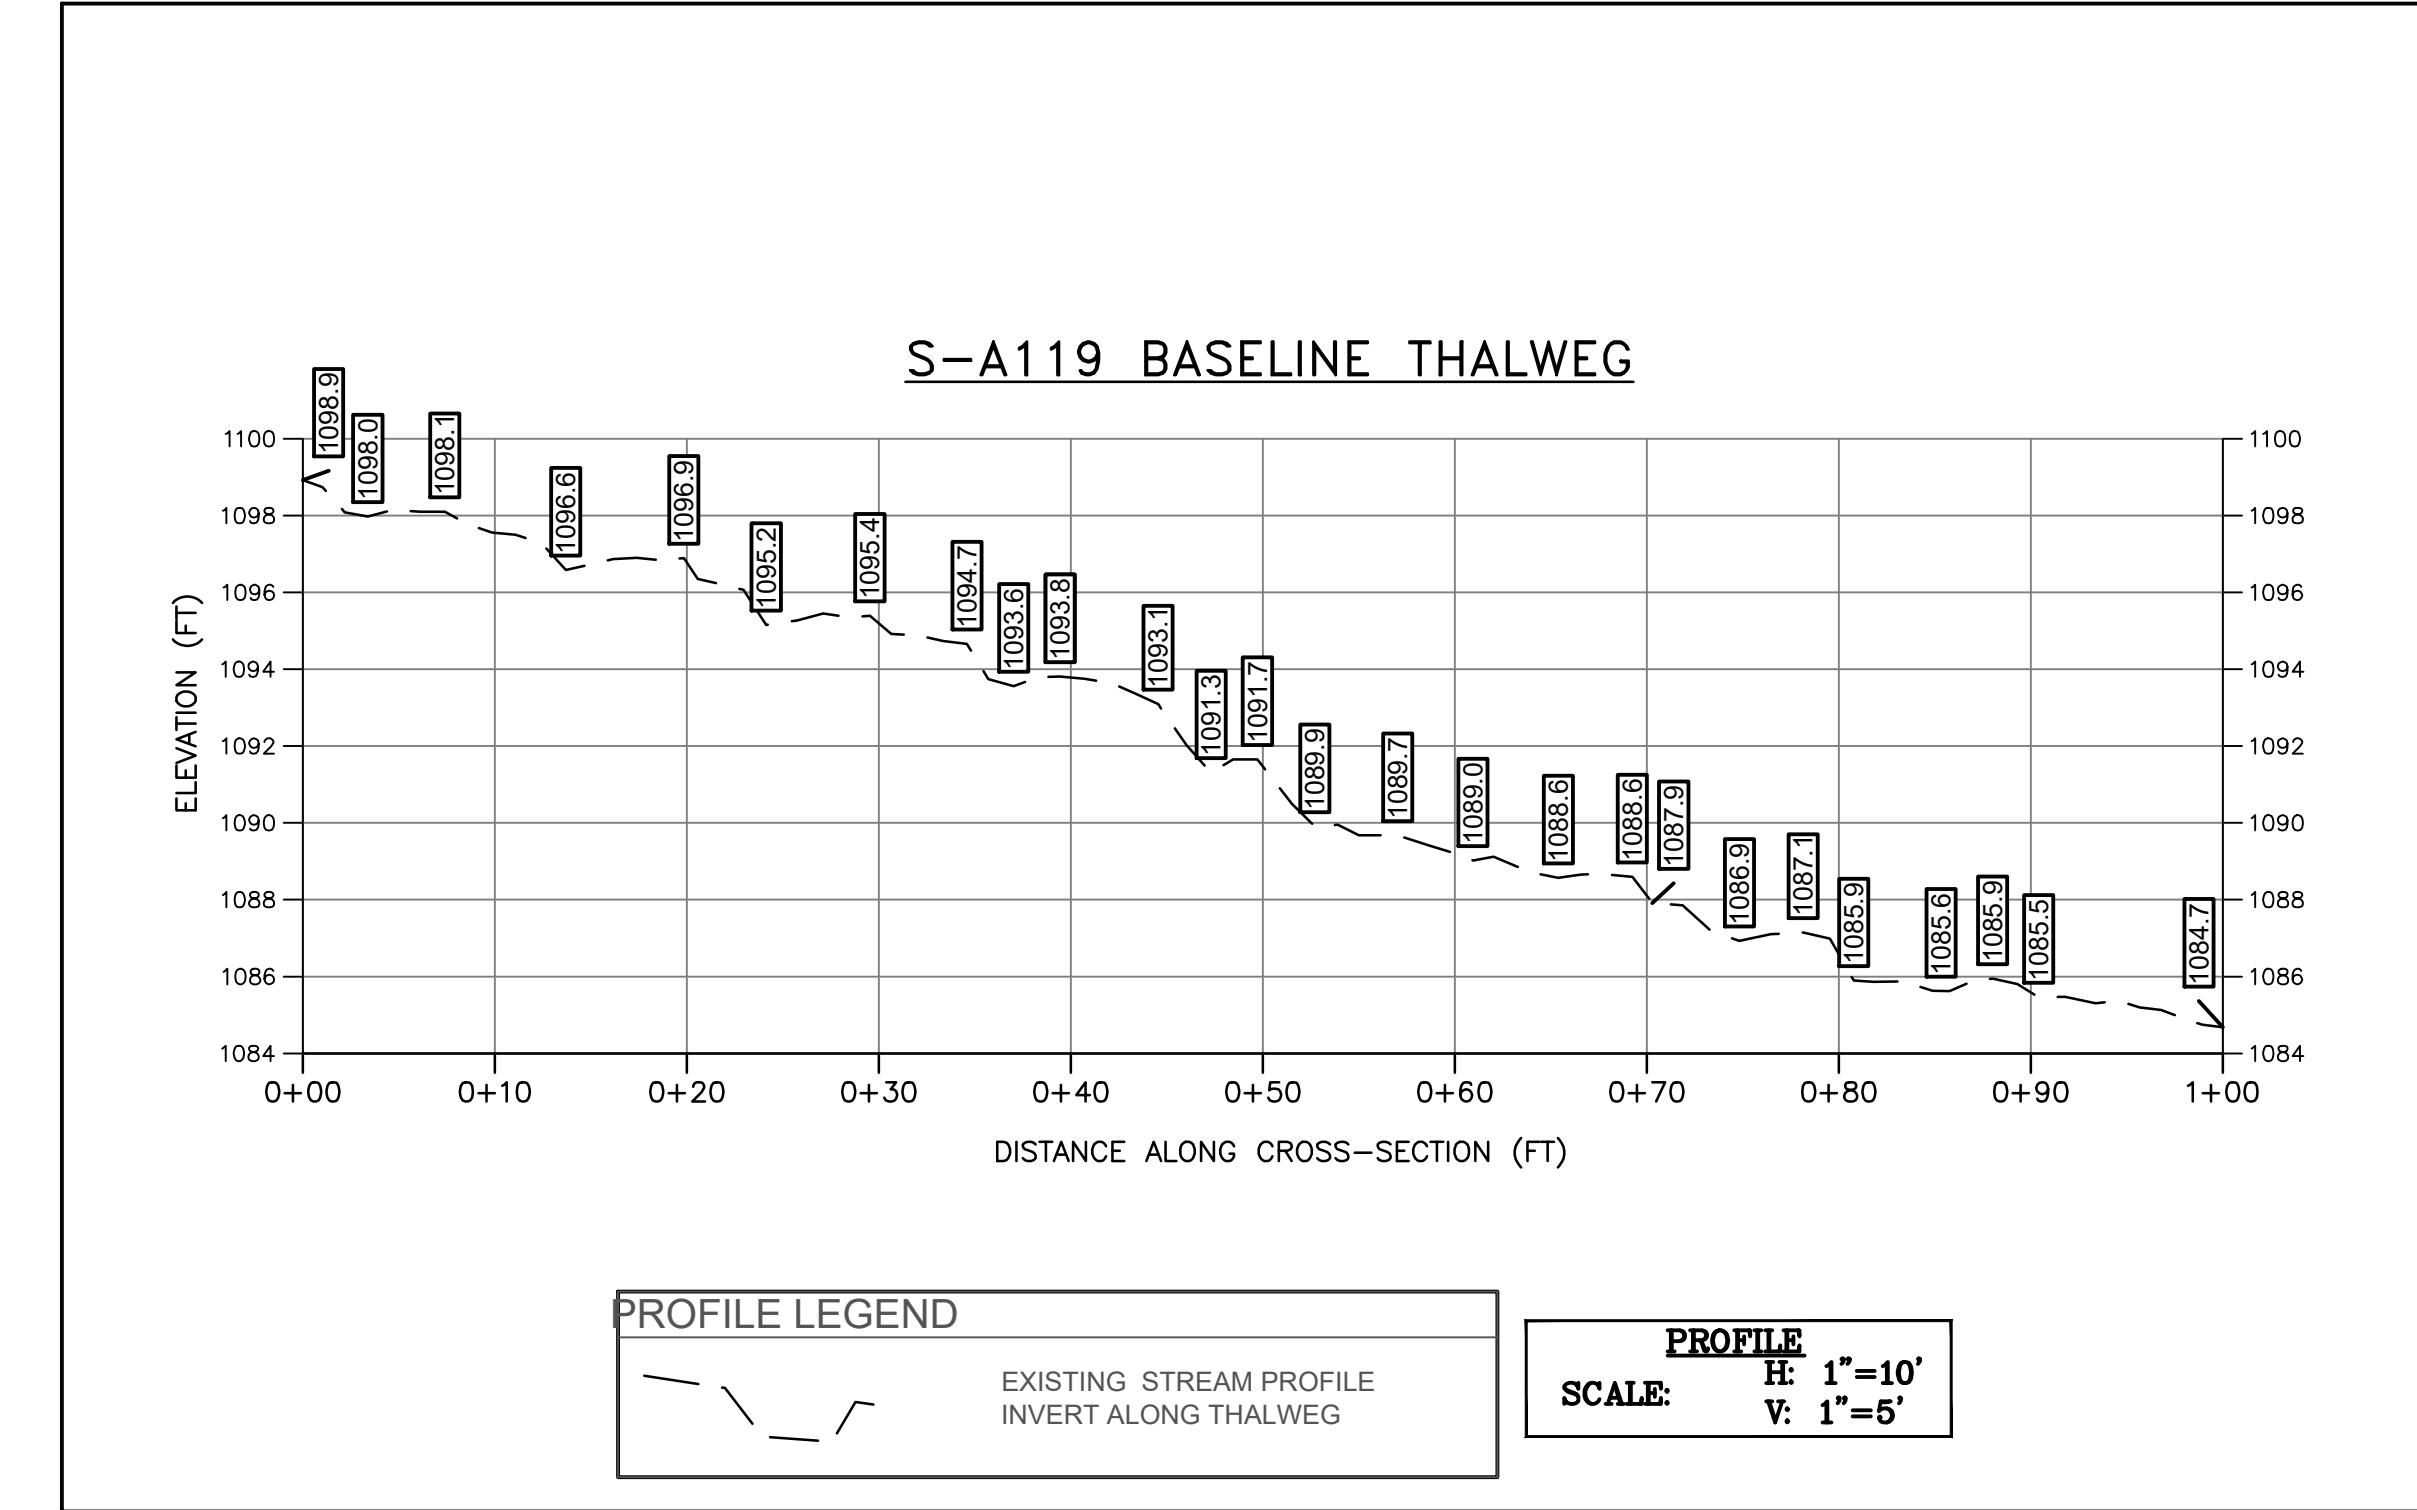
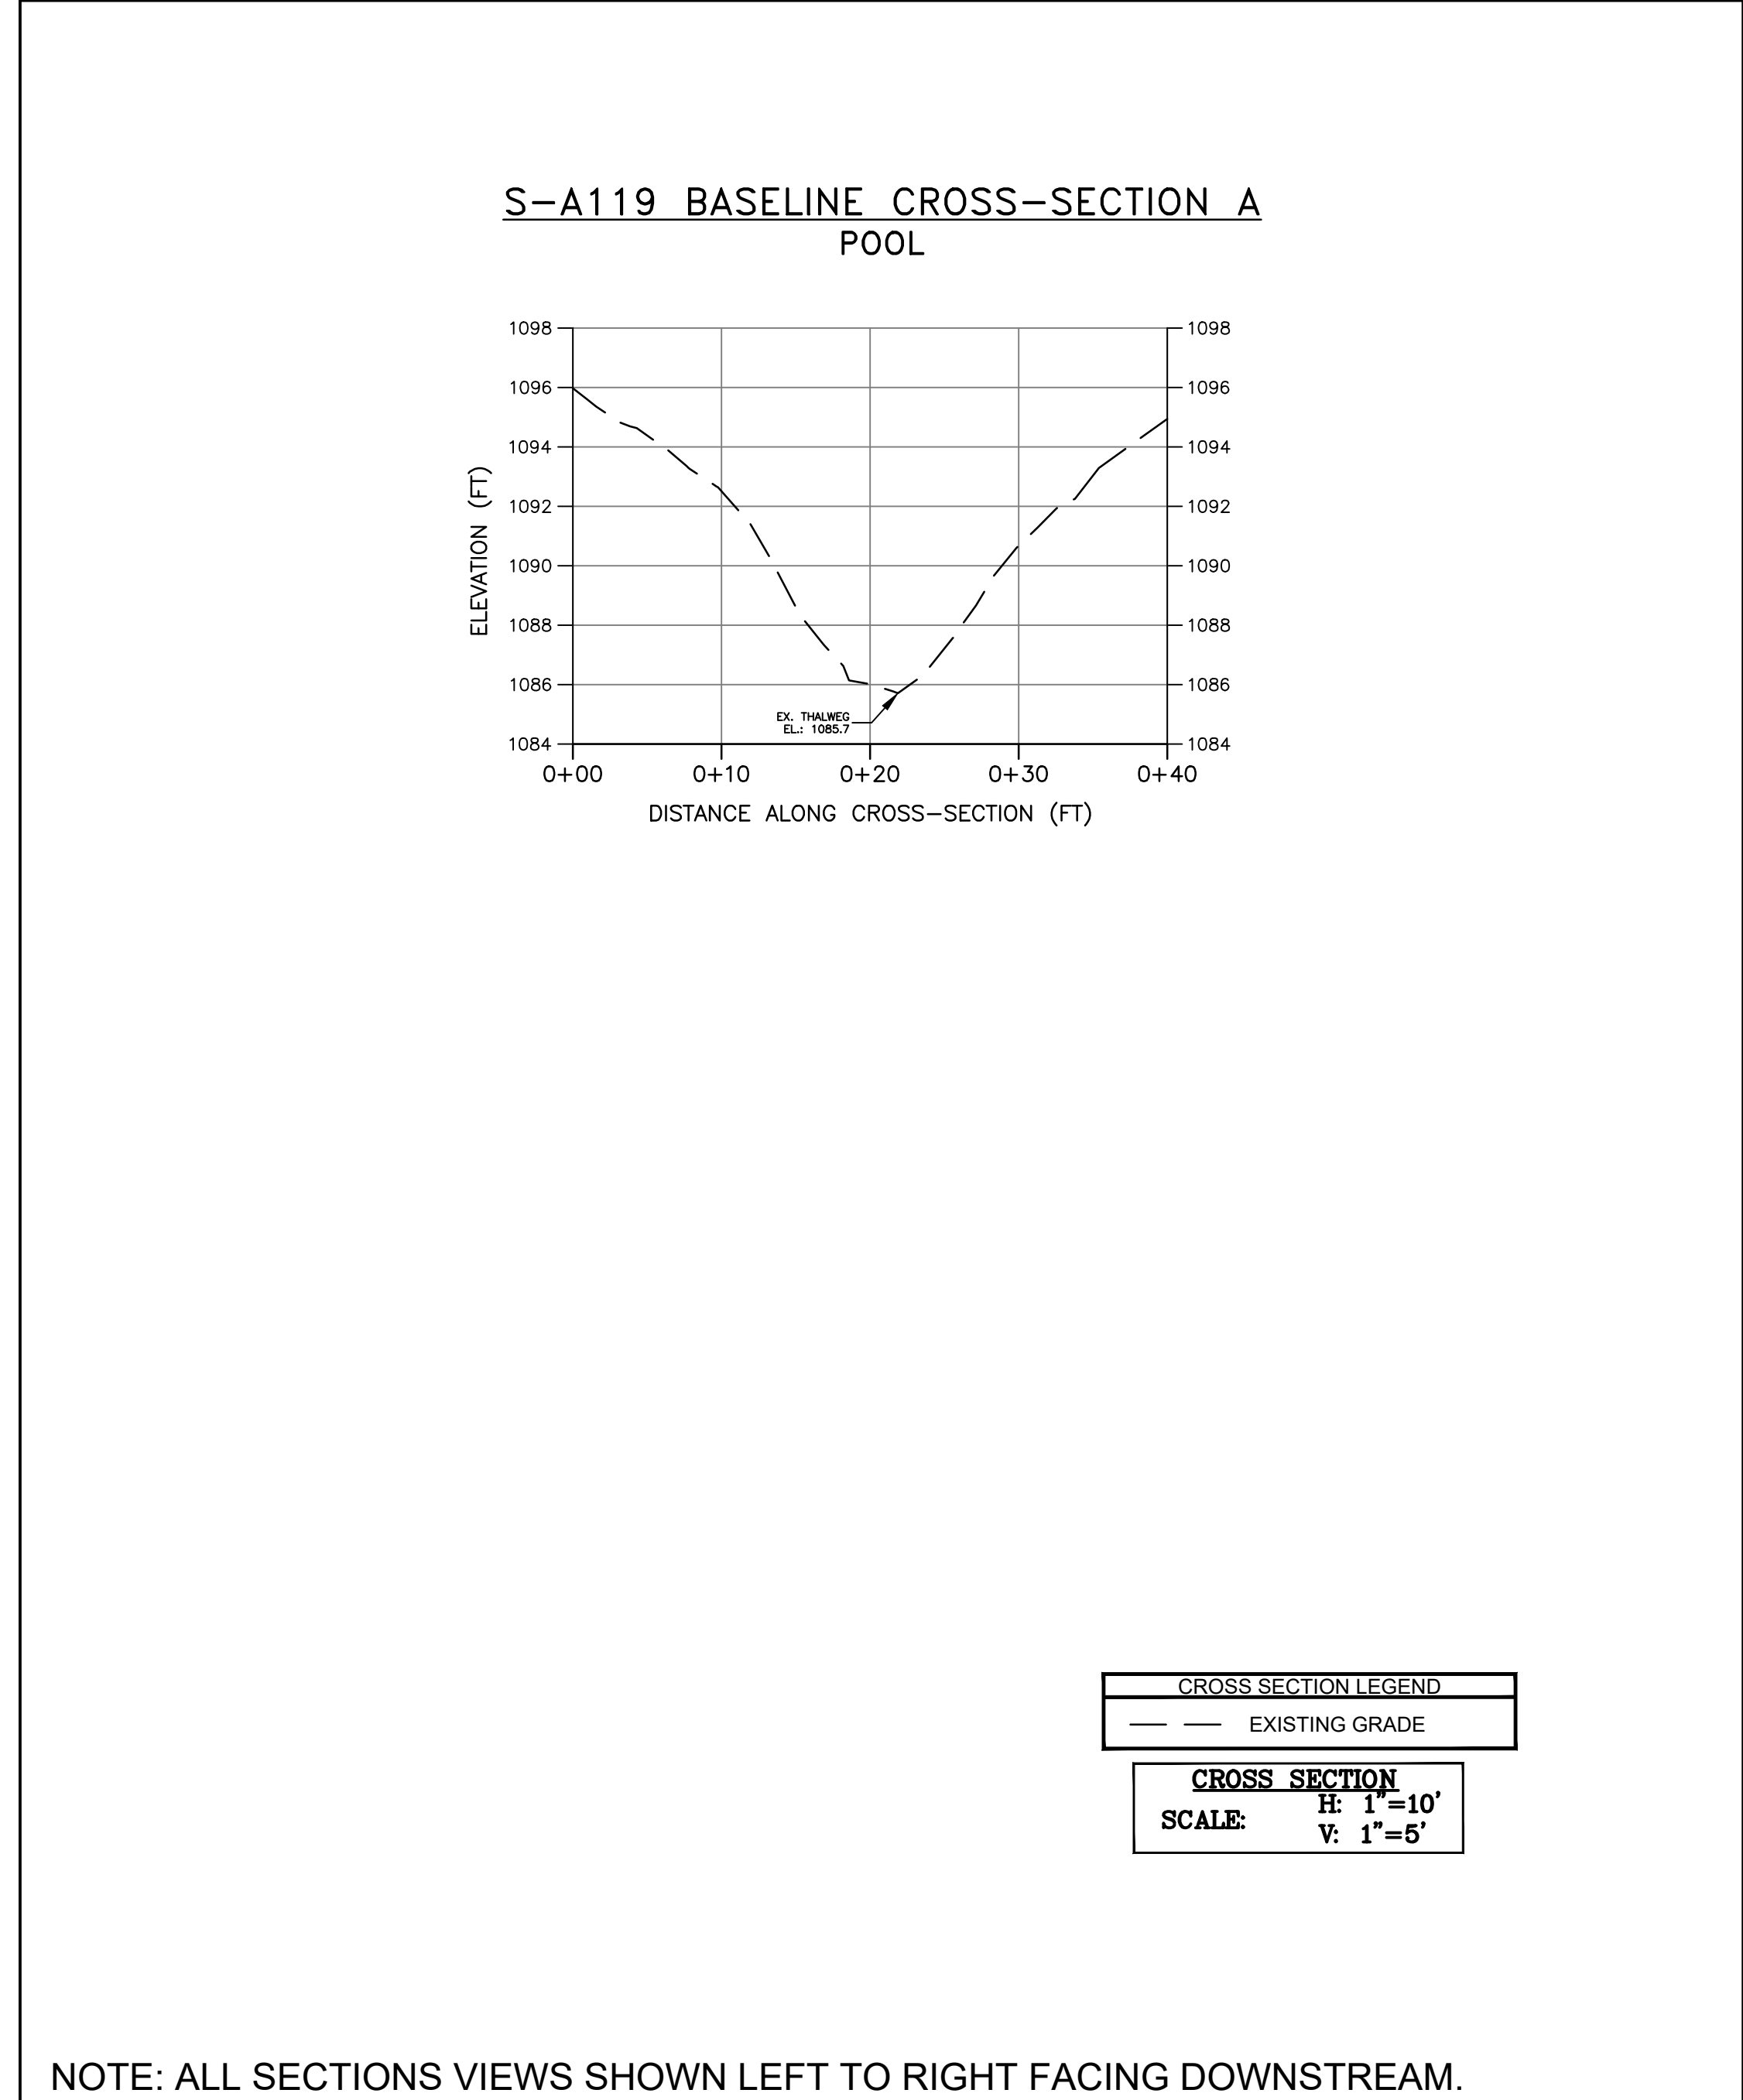
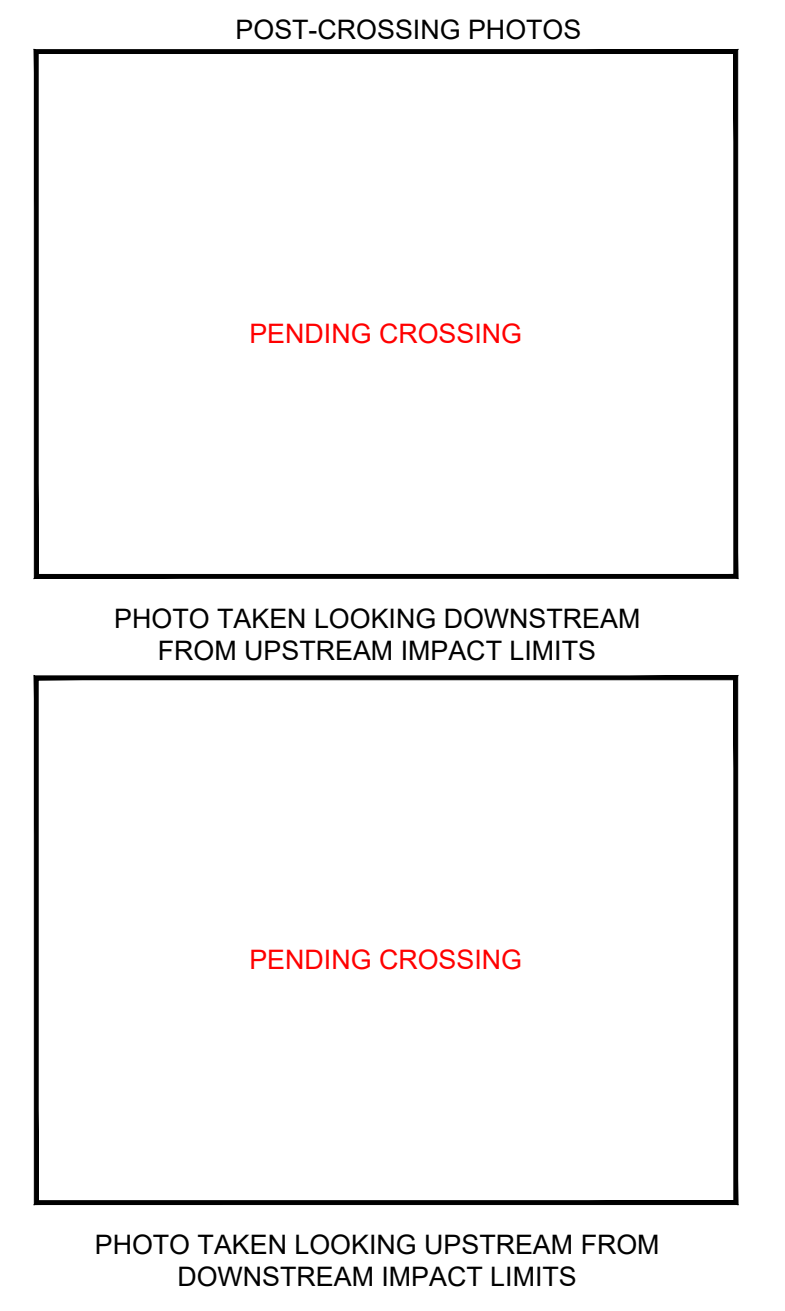
- ALL SECTION VIEWS SHOWN LEFT TO RIGHT FACING DOWNSTREAM.
 - POST-CROSSING SURVEY INFORMATION SHOWN IN RED. DATA PENDING.
 - POST-CROSSING SURVEY POINTS FOR CROSS SECTIONS AND THALWEG ARE PROJECTED ONTO PRE-CROSSING SECTION AND PROFILE VIEWS FOR COMPARISON.

AS-BUILT TABLE: S-A119 CROSS SECTION A					
PT. LOC.	PRE-CROSSING			AS-BUILT	
	NORTHING	EASTING	ELEV.	VERT. DIFF.	HORZ. DIFF.
TS-L	14341260.13	1775624.07	1095.98		
BS-L	14341270.98	1775639.16	1086.14		
THW	14341272.90	1775641.82	1085.70		
BS-R	14341273.92	1775643.25	1086.36		
TS-R	14341283.48	1775656.54	1094.94
