## Baseline Assessment – Stream Attributes

### Reach S-A11a Braid 2 (Pipeline ROW) Intermittent Spread A Harrison County, West Virginia

**Spread A Stream S-A11a-Braid-2 (Pipeline ROW) Harrison County**

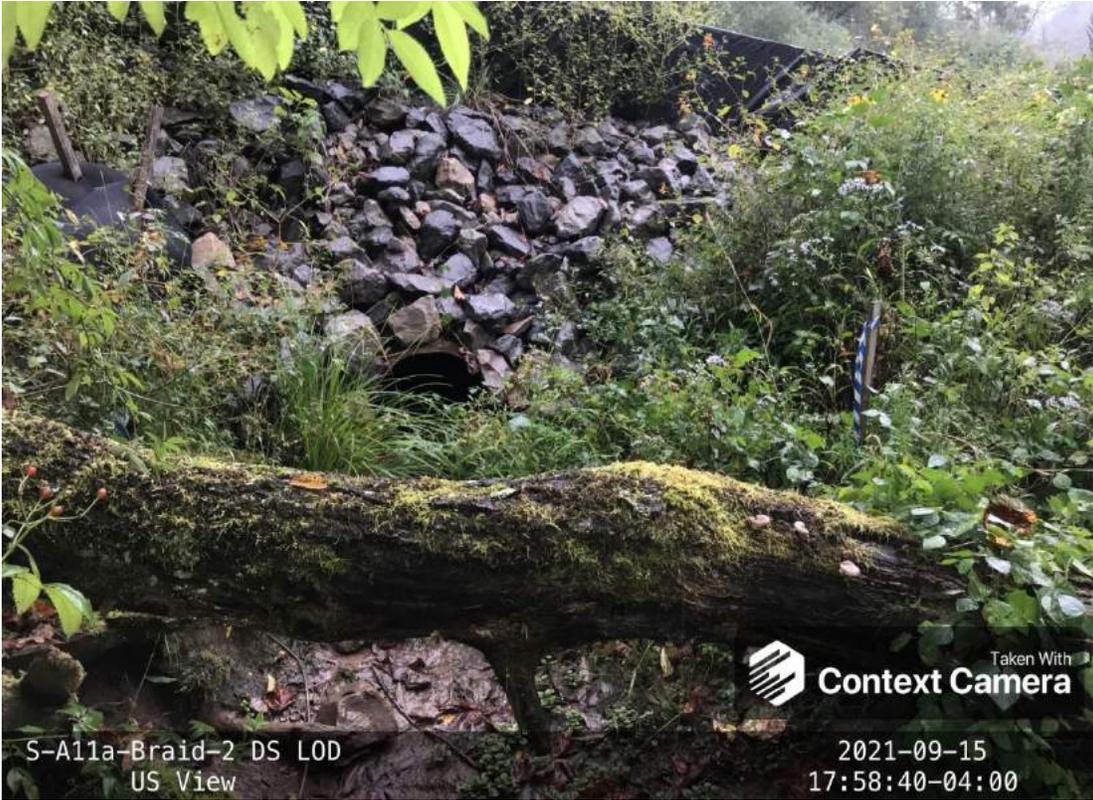
Photo Type: DS, US View  
Location, Orientation, Photographer Initials: Downstream Edge of ROW, Upstream View, AJE  
Lat: 39.33541 Long: -80.52236

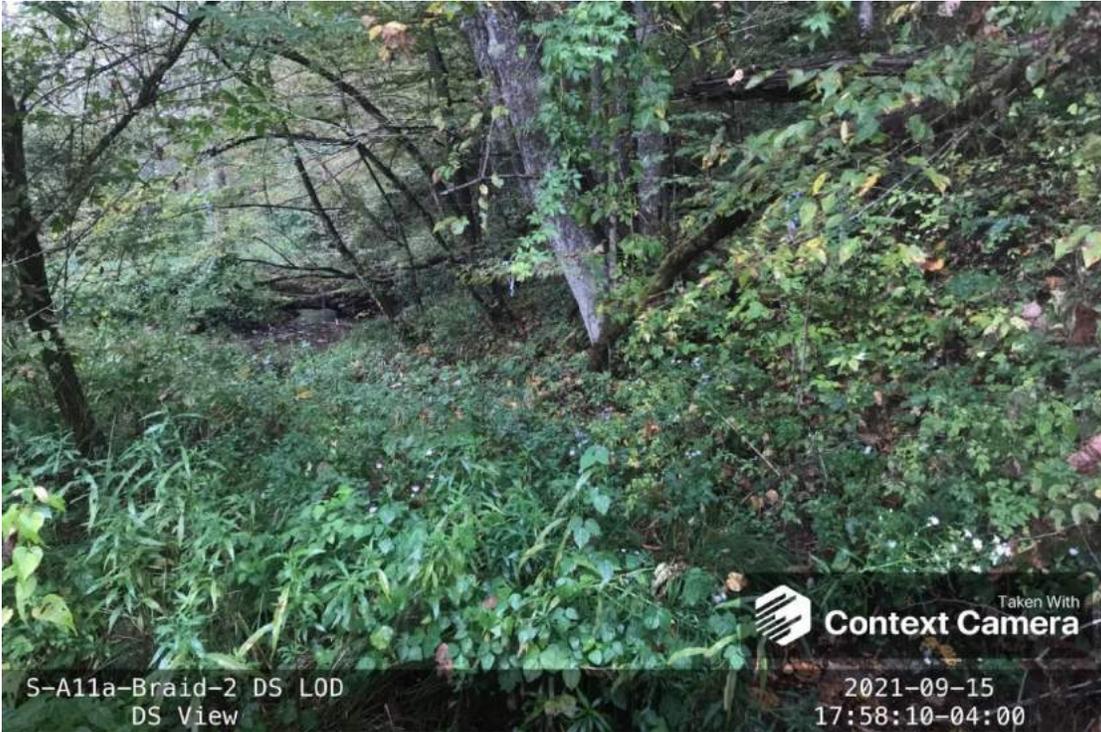
Photo Type: DS, DS View  
Location, Orientation, Photographer Initials: Downstream Edge of ROW, Downstream View, AJE  
Lat: 39.33541 Long: -80.52236

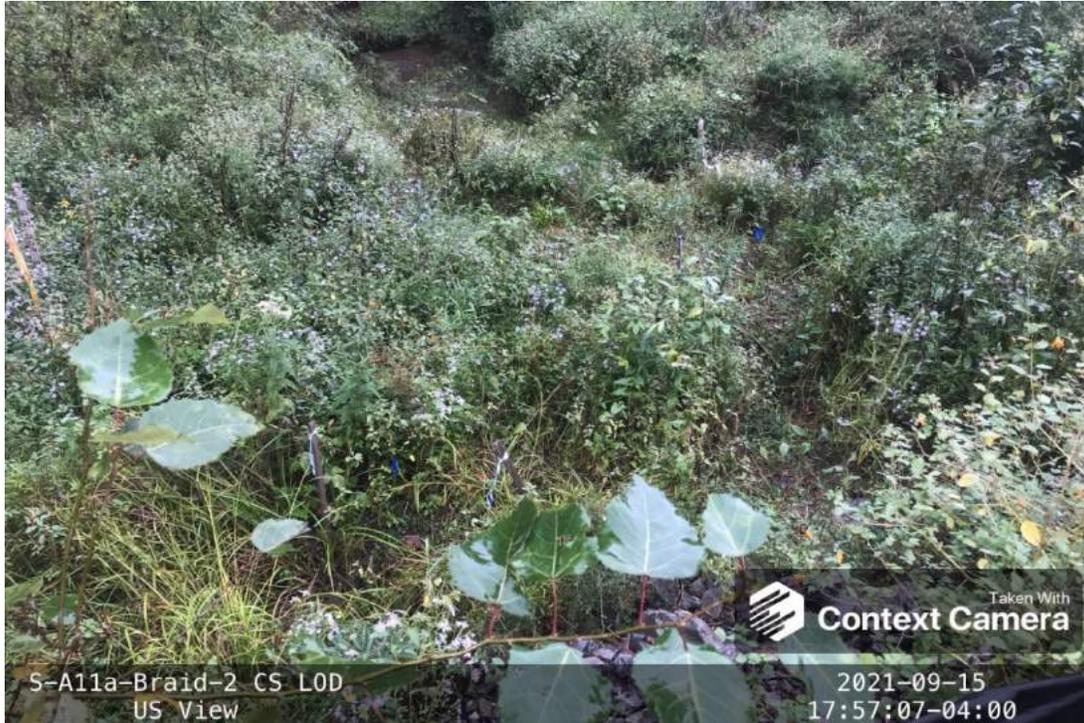
Photo Type: US View at Center  
Location, Orientation, Photographer Initials: Center ROW, Upstream View, AJE  
Lat: 39.33541 Long: -80.52236

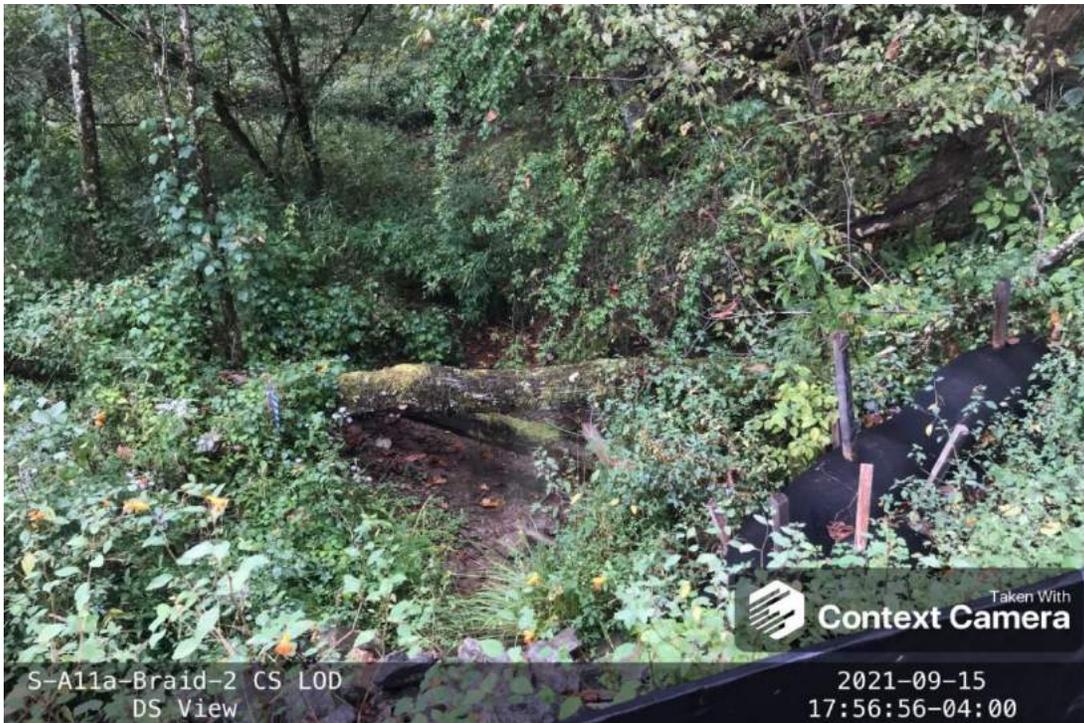
Photo Type: DS View at Center  
Location, Orientation, Photographer Initials: ROW Center, Downstream View, AJE  
Lat: 39.33541 Long: -80.52236

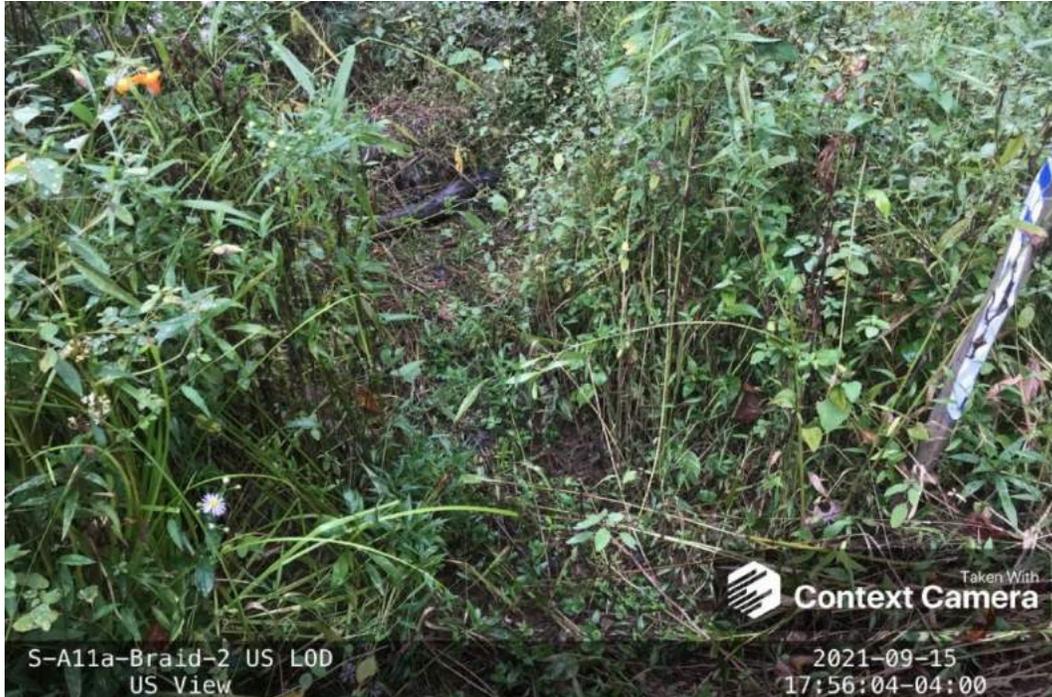
Photo Type: US, US View  
Location, Orientation, Photographer Initials: Upstream Edge of ROW, Upstream View, AJE  
Lat: 39.33541 Long: -80.52236

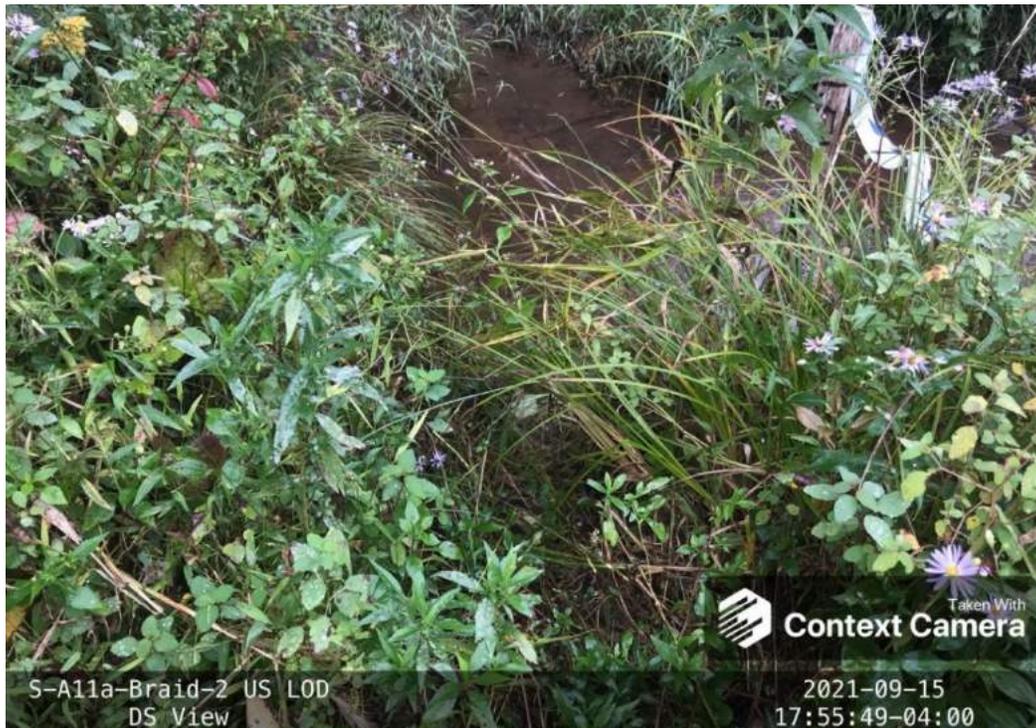
Photo Type: US, DS View  
Location, Orientation, Photographer Initials: Upstream Edge of ROW, Downstream View, AJE  
Lat: 39.33541 Long: -80.52236

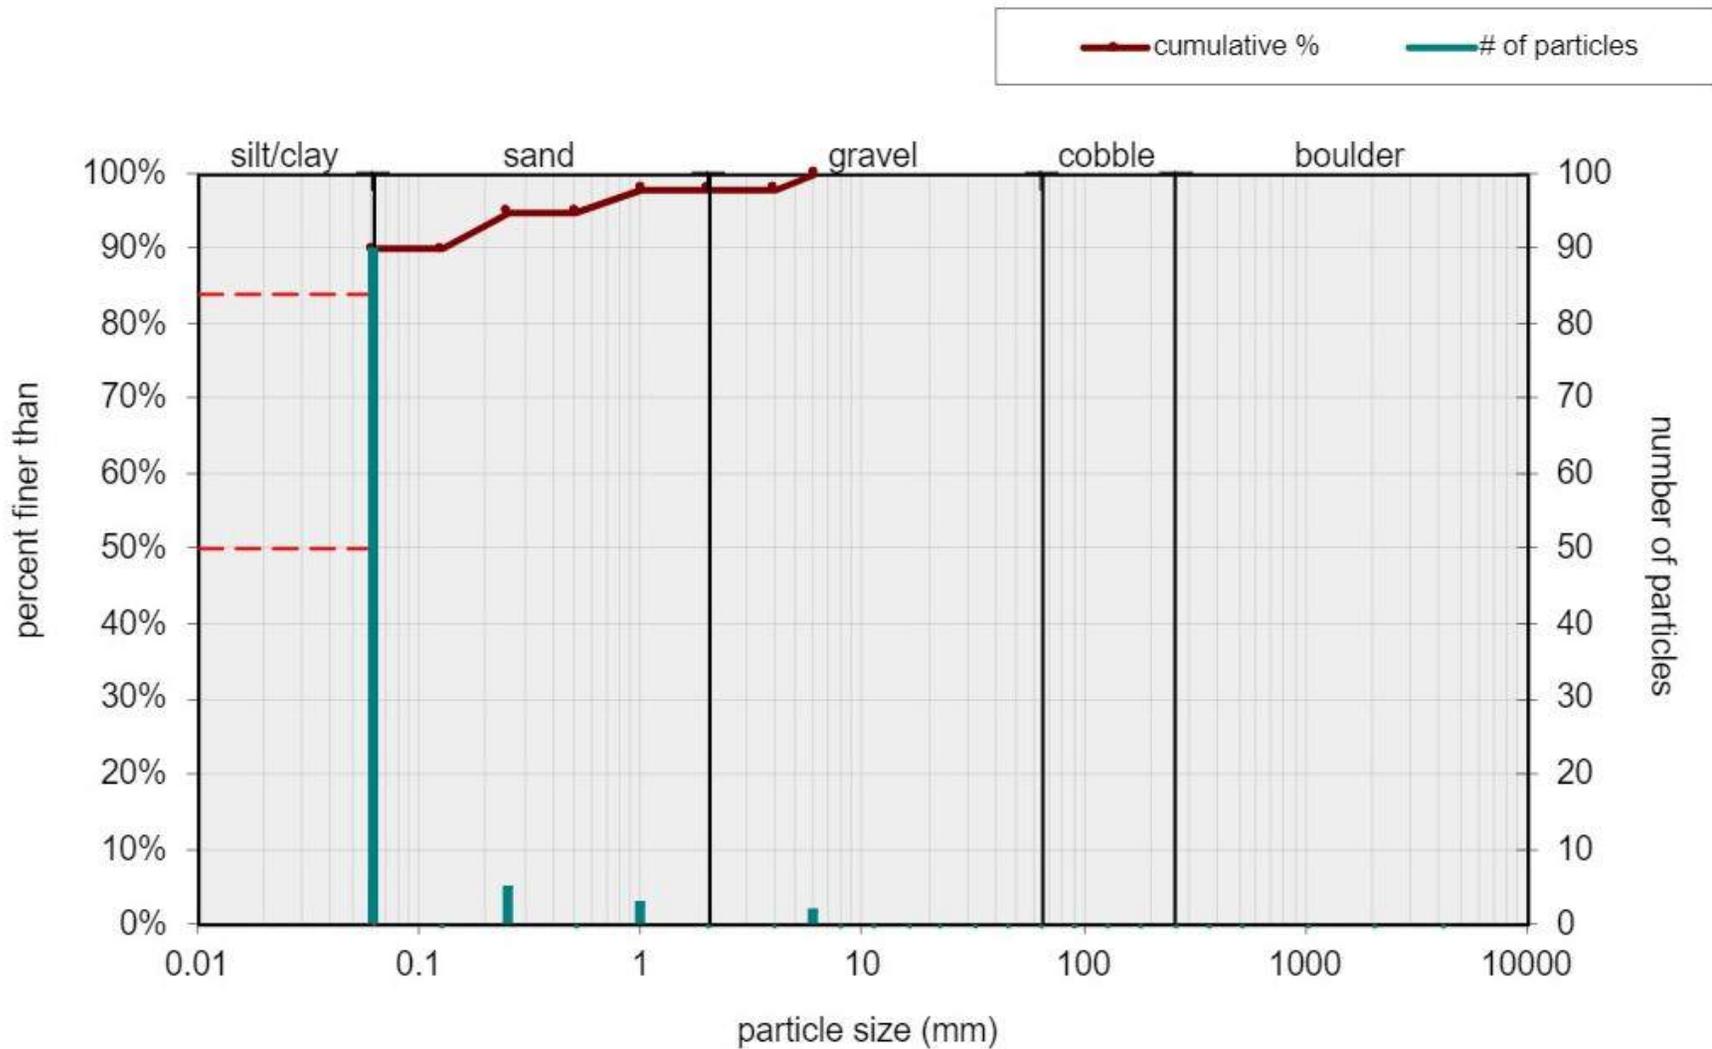
# Bankfull Channel Pebble Count, S-A11a Braid 2, Grass Run

Size (mm)		Size Distribution		Type	
D16	0.062	mean	0.1	silt/clay	90%
D35	0.062	dispersion	1.0	sand	8%
D50	0.062	skewness	---	gravel	2%
D65	0.062			cobble	0%
D84	0.062			boulder	0%
D95	0.5

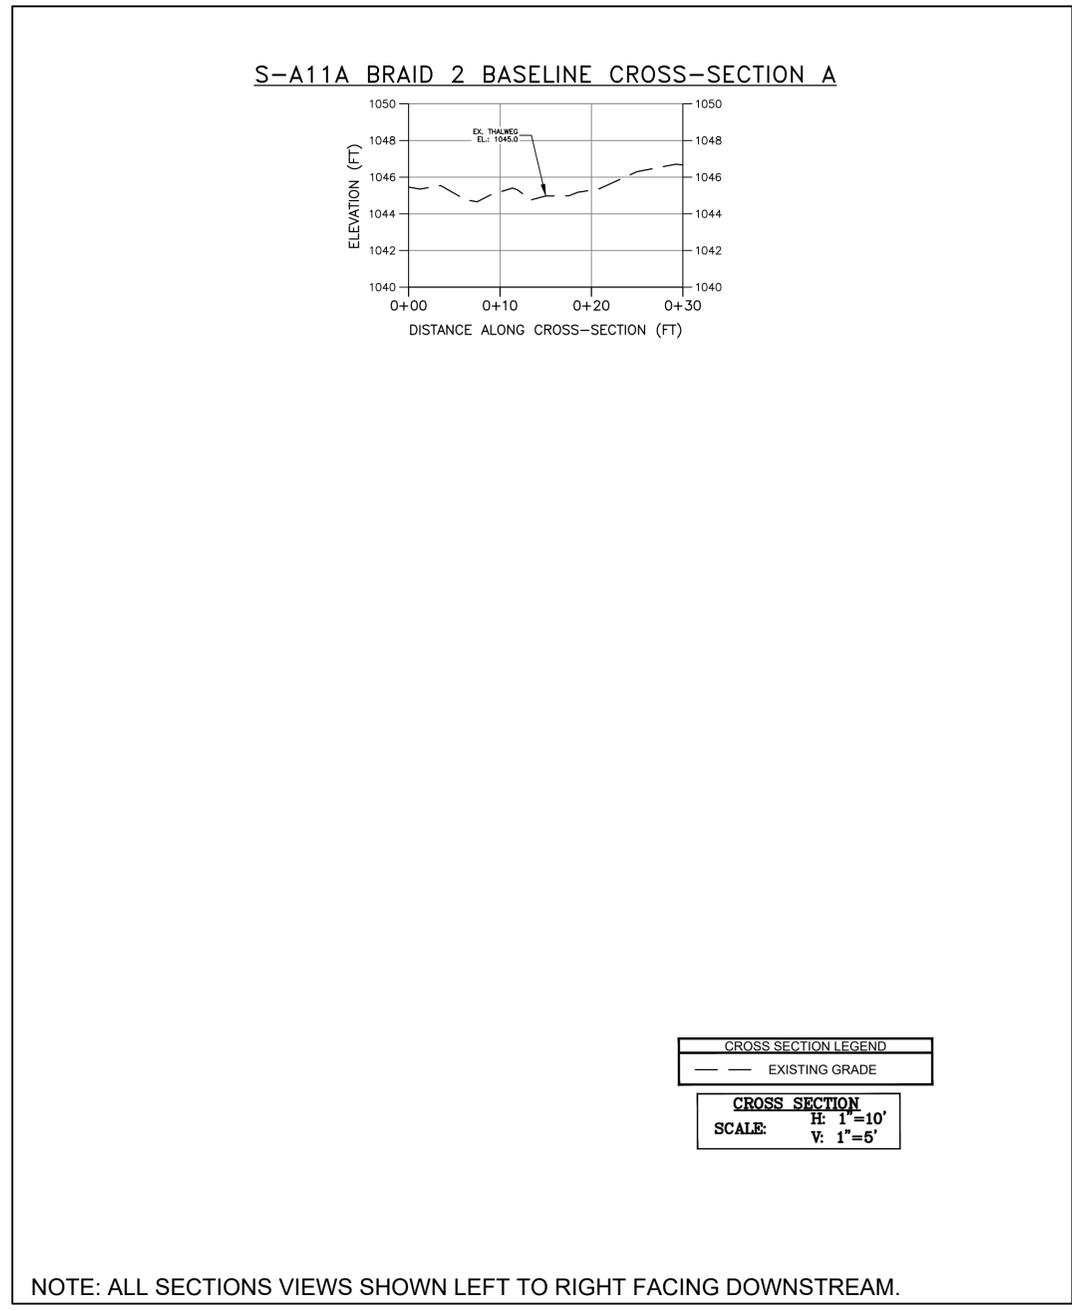
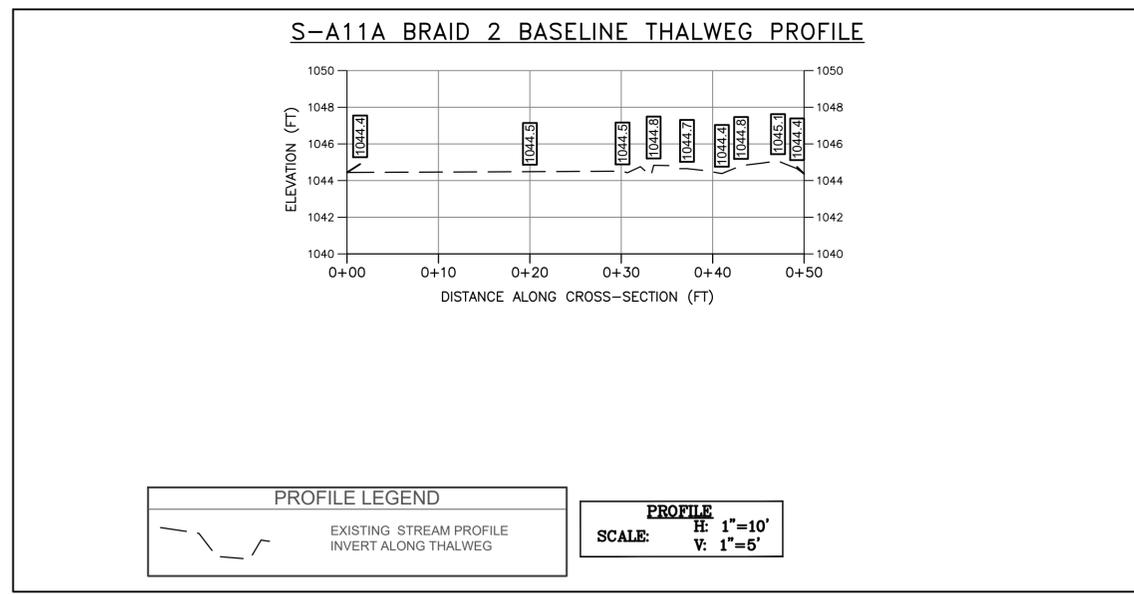
NOTE: ALL SECTIONS VIEWS SHOWN LEFT TO RIGHT FACING DOWNSTREAM.

AS-BUILT TABLE: S-A11A BRAID 2 CROSS SECTION A					
PT. LOC.	PRE-CROSSING			AS-BUILT	
	NORTHING	EASTING	ELEV.	VERT. DIFF.	HORZ. DIFF.
TS-L	14285105.5600	1775462.5940'	1044.944'		
BS-L	14285106.0000	1775463.2240'	1043.689'		
THW	14285106.8400	1775464.3130'	1044.809'		
BS-R	14285107.9000	1775465.7950'	1043.924'		
TS-R	14285108.3800	1775466.5150'	1044.987'
