Baseline Assessment – Stream Attributes

Reach S-B7a (Timber Mat Crossing) Intermittent Spread A Harrison County, West Virginia

Title: PROFILE AND CROSS-SECTIONS
BASELINE SURVEY
CROSSING S-B7A - UNT TO INDIAN
RUN (MP 23.1)
HARRISON COUNTY, WV

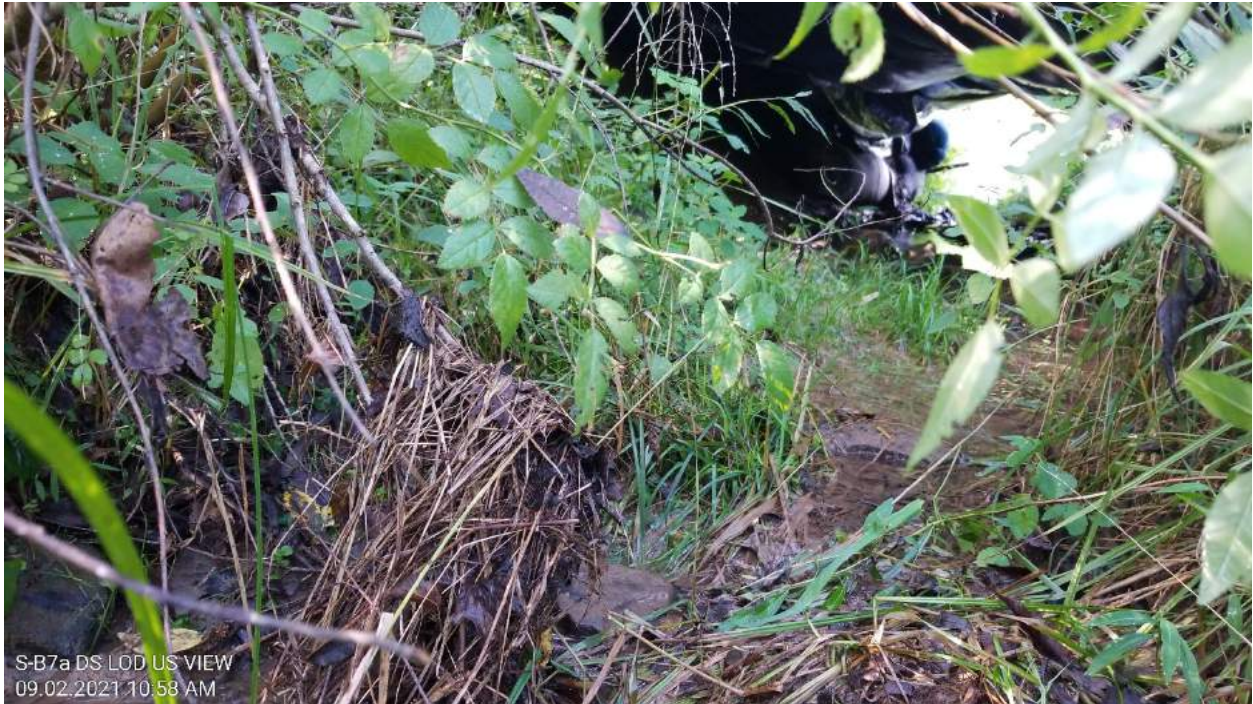
S-B7a DS LOD US VIEW
09.02.2021 10:58 AM

Photo Type: DS, US View

Location, Orientation, Photographer Initials: Downstream Edge of ROW, Upstream View, SM
Lat: 39.316755 Long: -80.526222

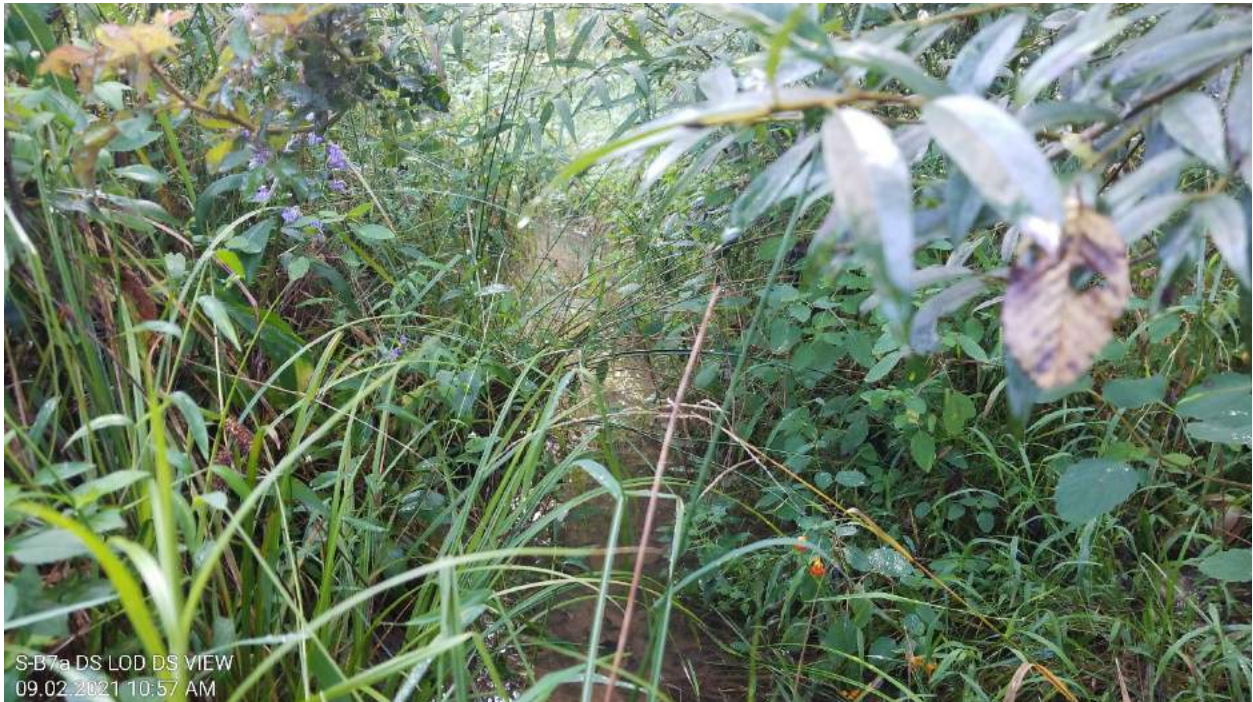
S-B7a DS LOD DS VIEW
09.02.2021 10:57 AM

Photo Type: DS, DS View

Location, Orientation, Photographer Initials: Downstream Edge of ROW, Downstream View, SM
Lat: 39.316755 Long: -80.526222

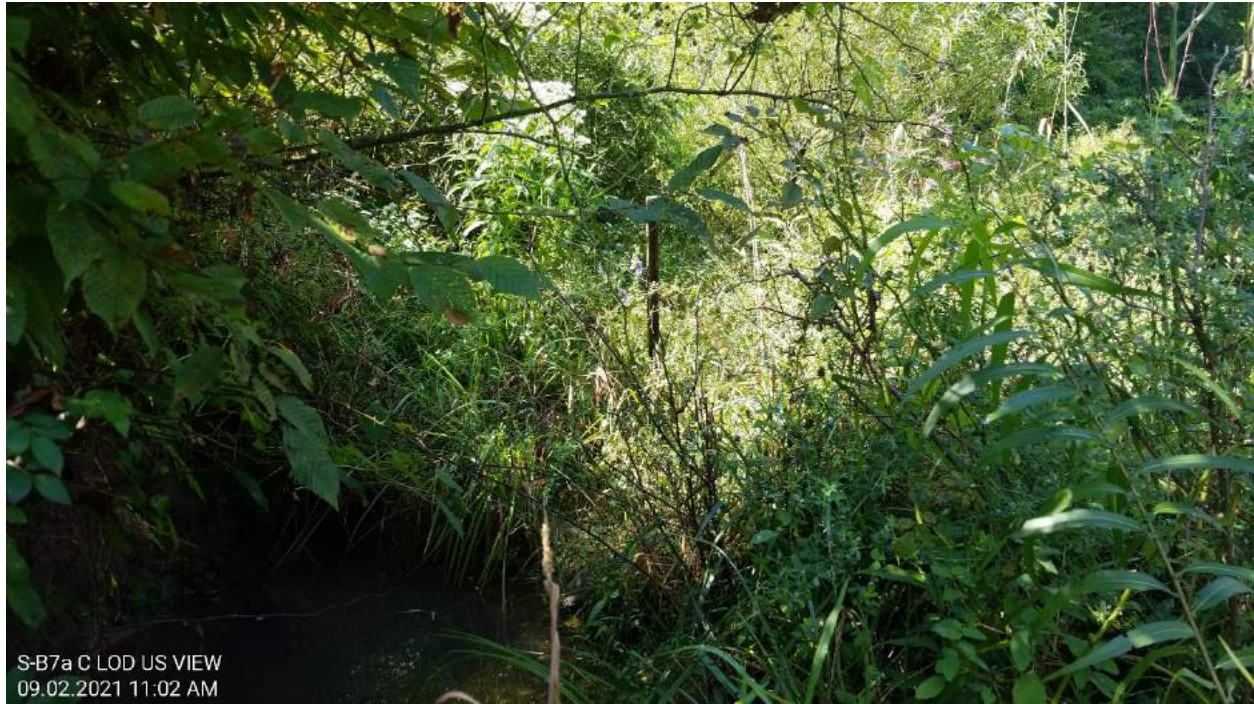
S-B7a C LOD US VIEW
09.02.2021 11:02 AM

Photo Type: US View at Center
Location, Orientation, Photographer Initials: Center ROW, Upstream View, SM
Lat: 39.316755 Long: -80.526222

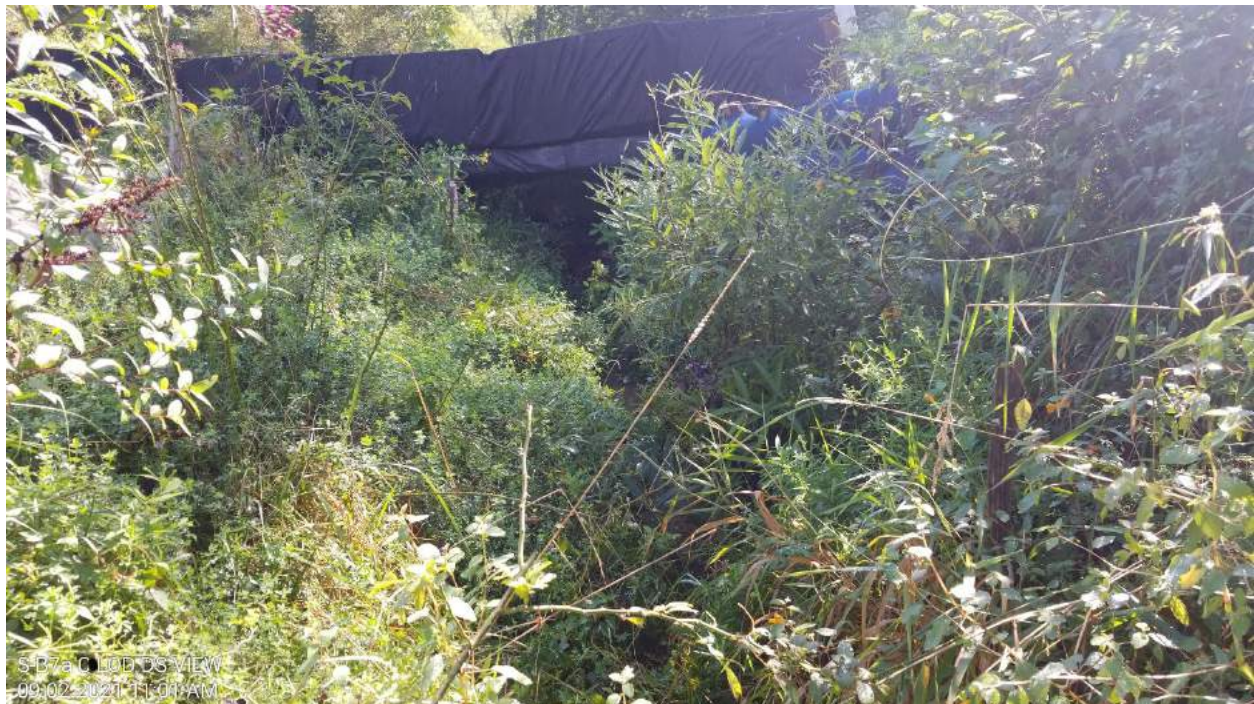
S-B7a C LOD DS VIEW
09.02.2021 11:04 AM

Photo Type: DS View at Center
Location, Orientation, Photographer Initials: ROW Center, Downstream View, SM
Lat: 39.316755 Long: -80.526222

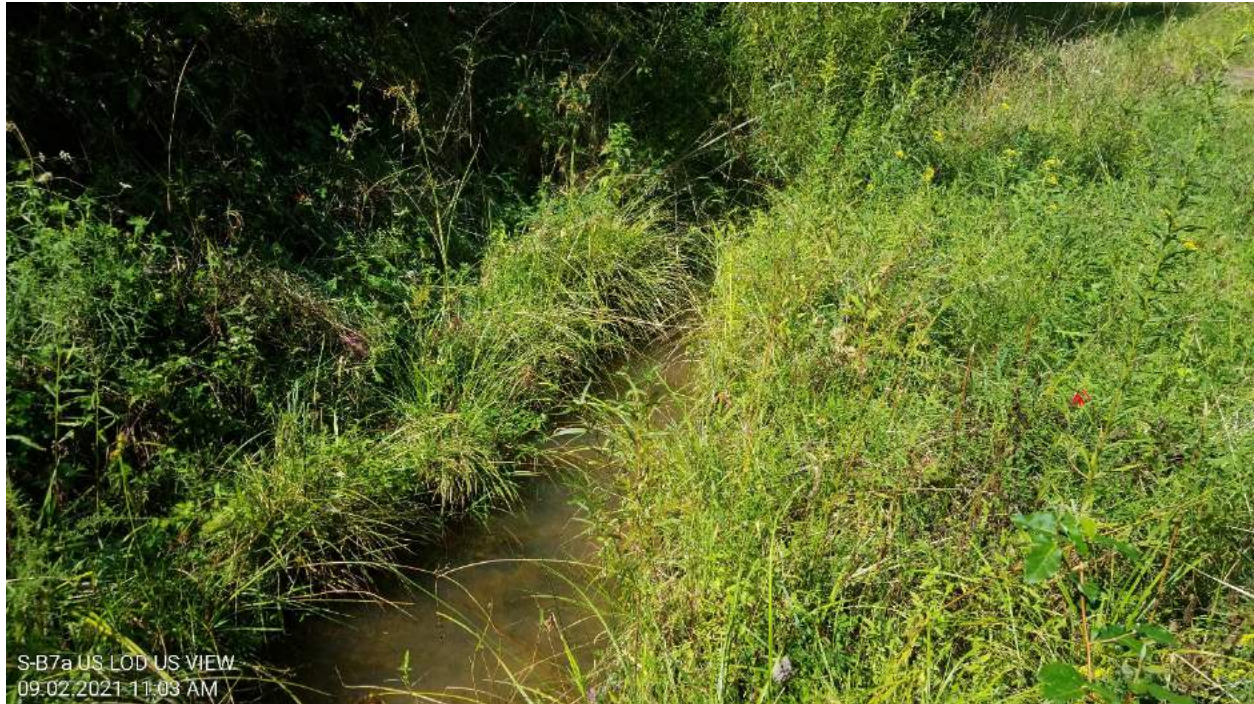
Photo Type: US, US View
Location, Orientation, Photographer Initials: Upstream Edge of ROW, Upstream View, SM
Lat: 39.316755 Long: -80.526222

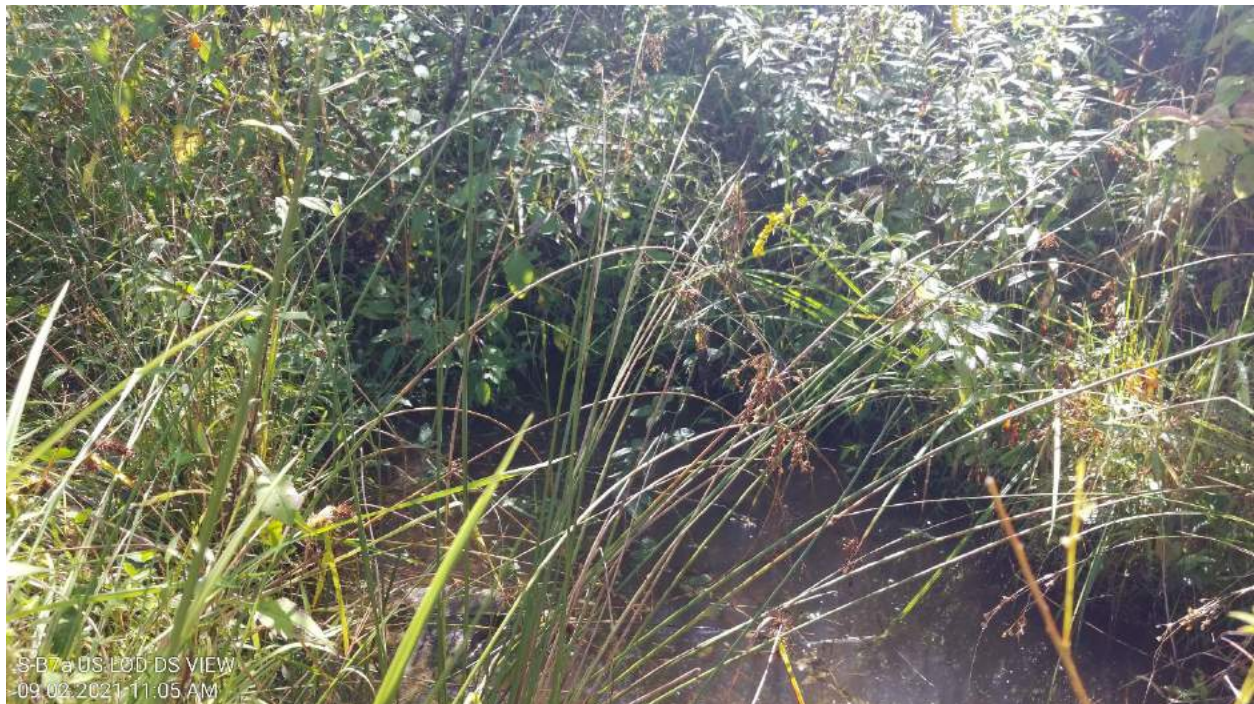
Photo Type: US, DS View
Location, Orientation, Photographer Initials: Upstream Edge of ROW, Downstream View, SM
Lat: 39.316755 Long: -80.526222

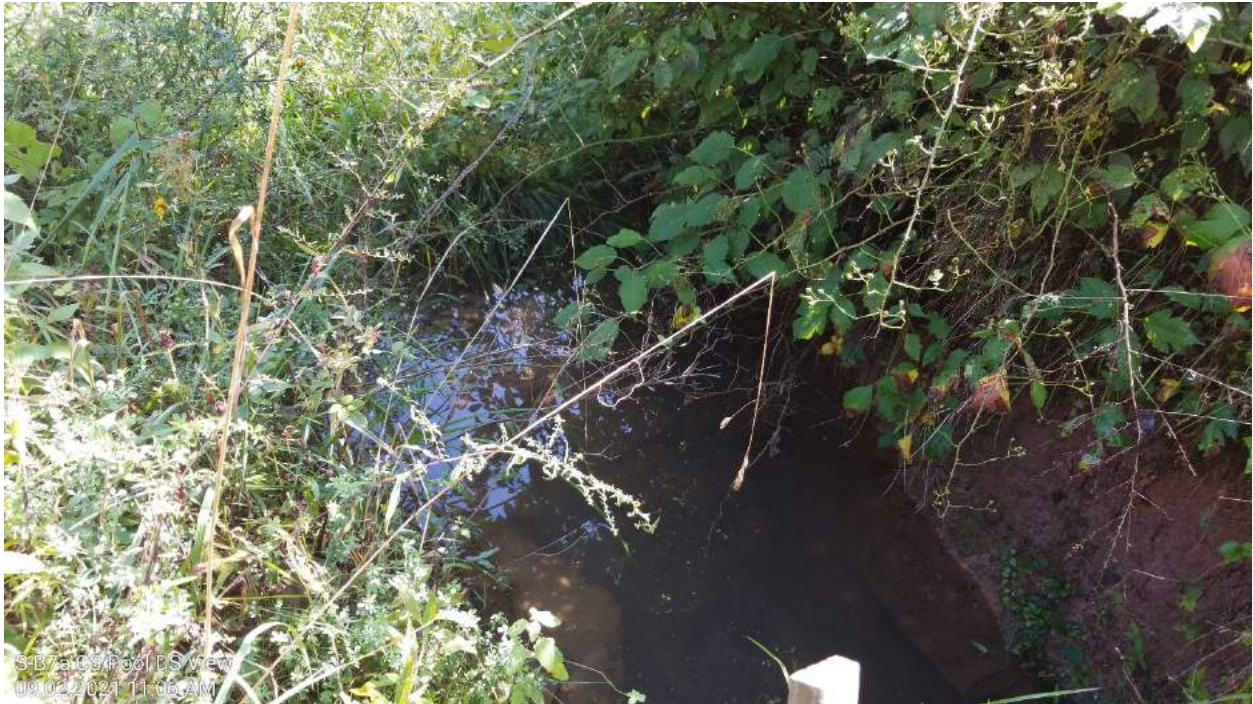
Photo Type: Pool, DS View
Location, Orientation, Photographer Initials: Upstream of Pool, Downstream View, SM
Lat: 39.316755 Long: -80.526222

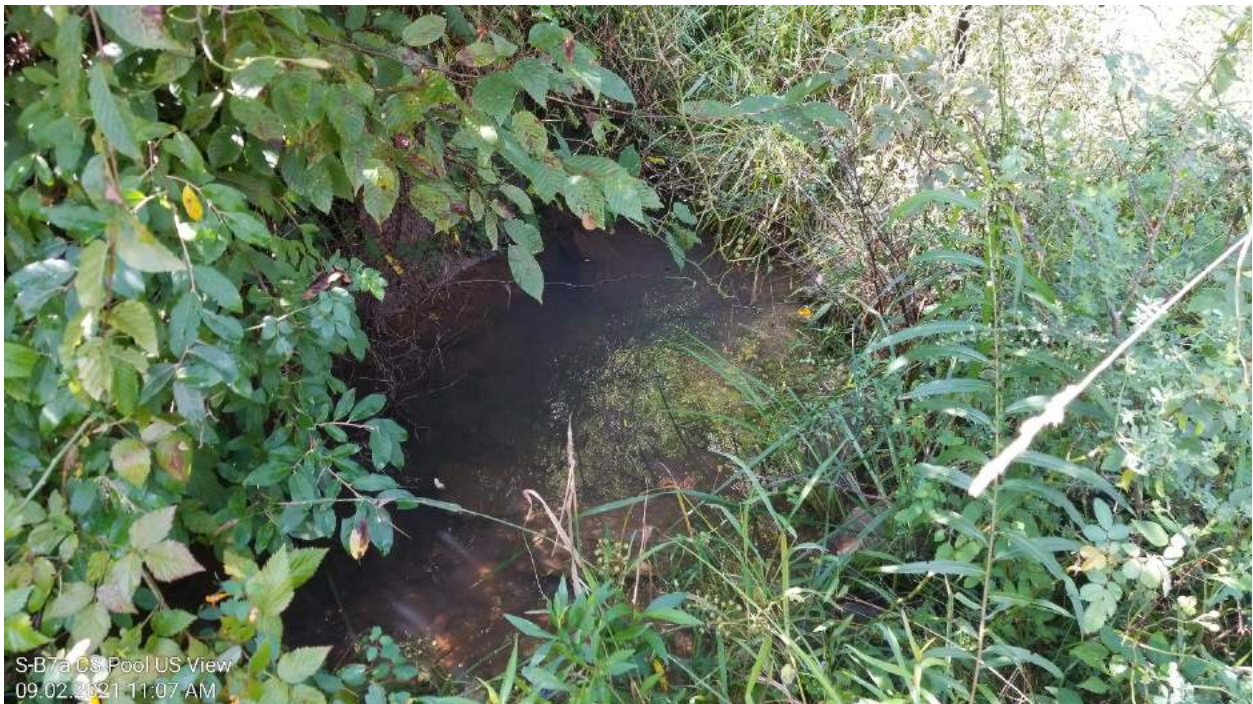
Photo Type: Pool, US View
Location, Orientation, Photographer Initials: Downstream of Pool, Upstream View, SM
Lat: 39.316755 Long: -80.526222

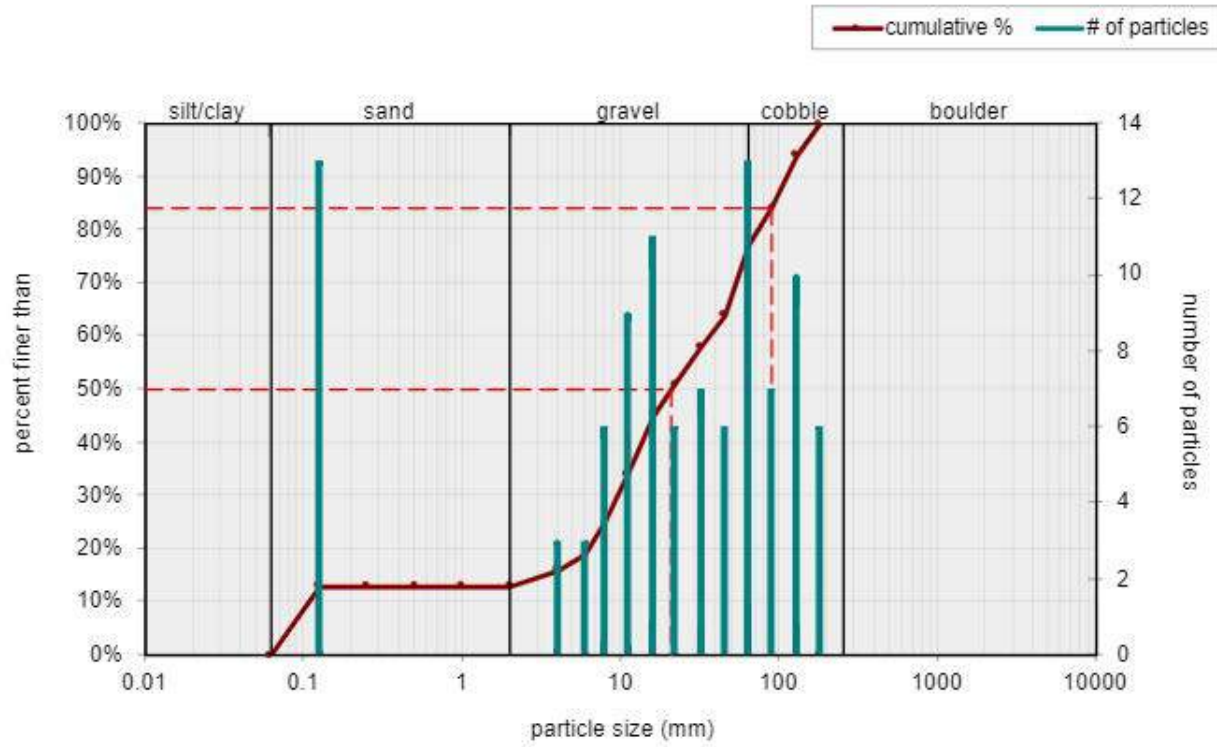
Bankfull Channel Pebble Count, S-B7a

| Size (mm) | |
|---|---|
| D16 | 4 |
| D35 | 11 |
| D50 | 21 |
| D65 | 46 |
| D84 | 90 |
| D95 | 140 |

| Type | |
|---|---|
| sand | 13% |
| gravel | 64% |
| cobble | 23% |

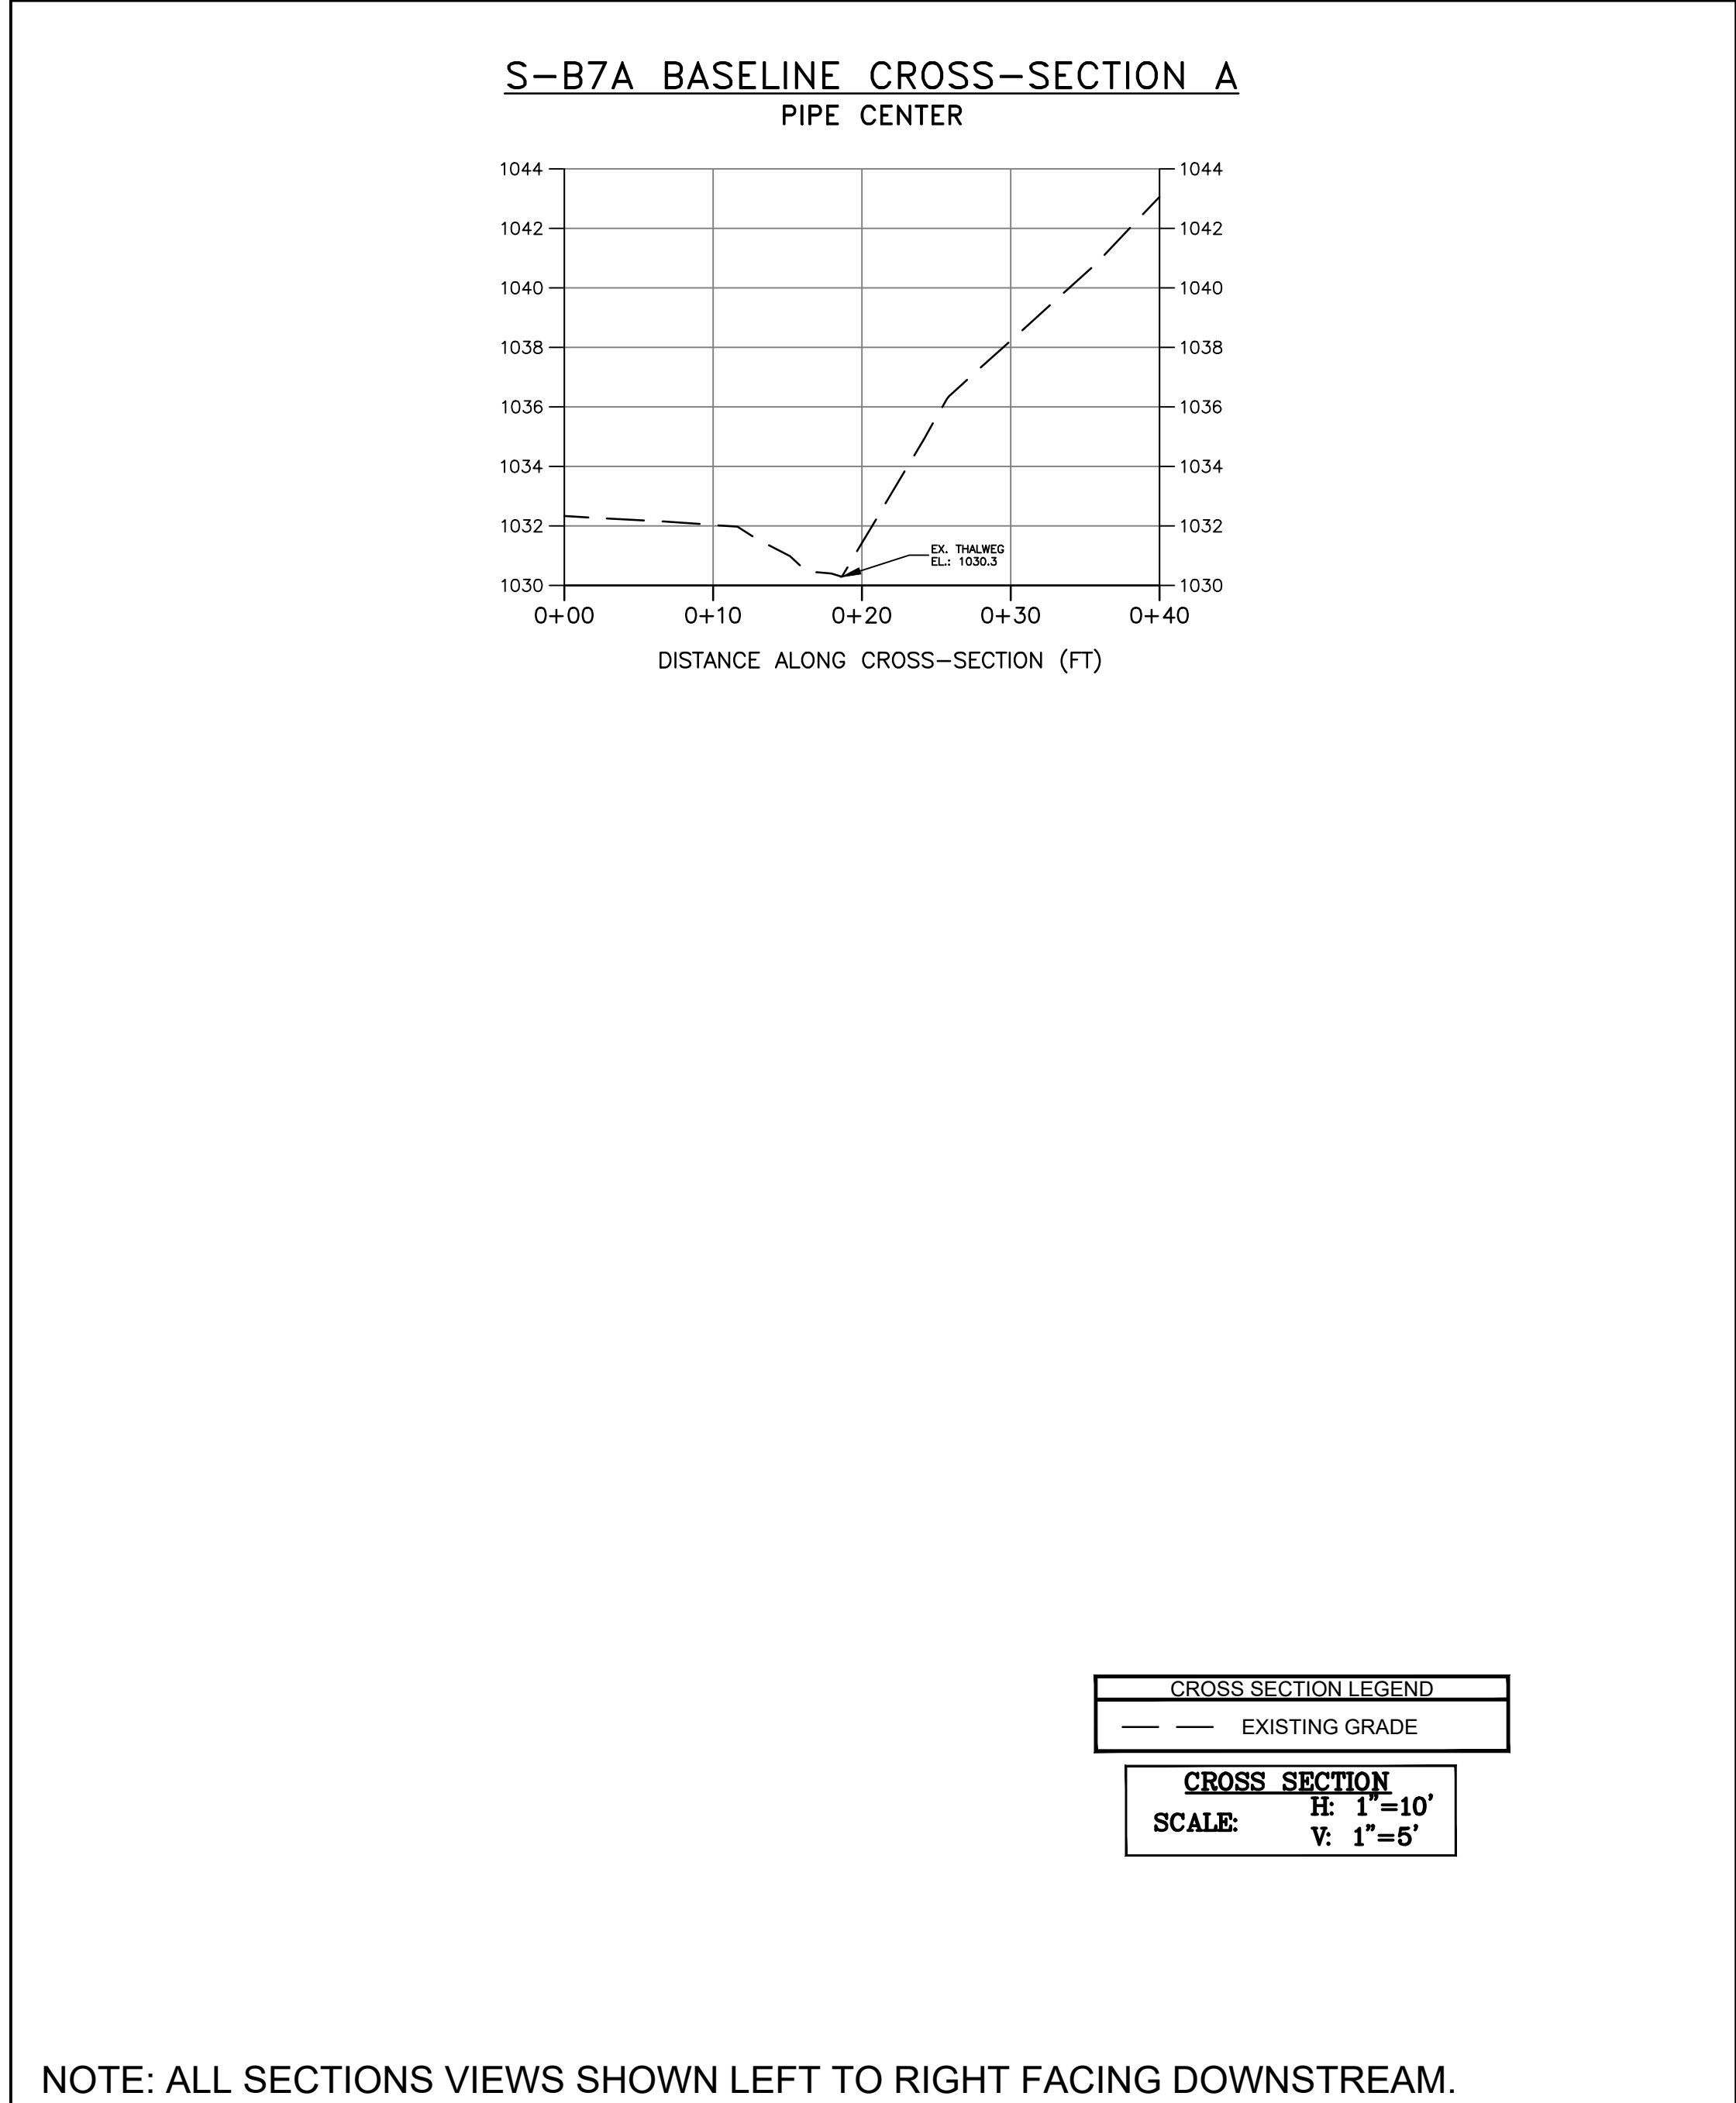
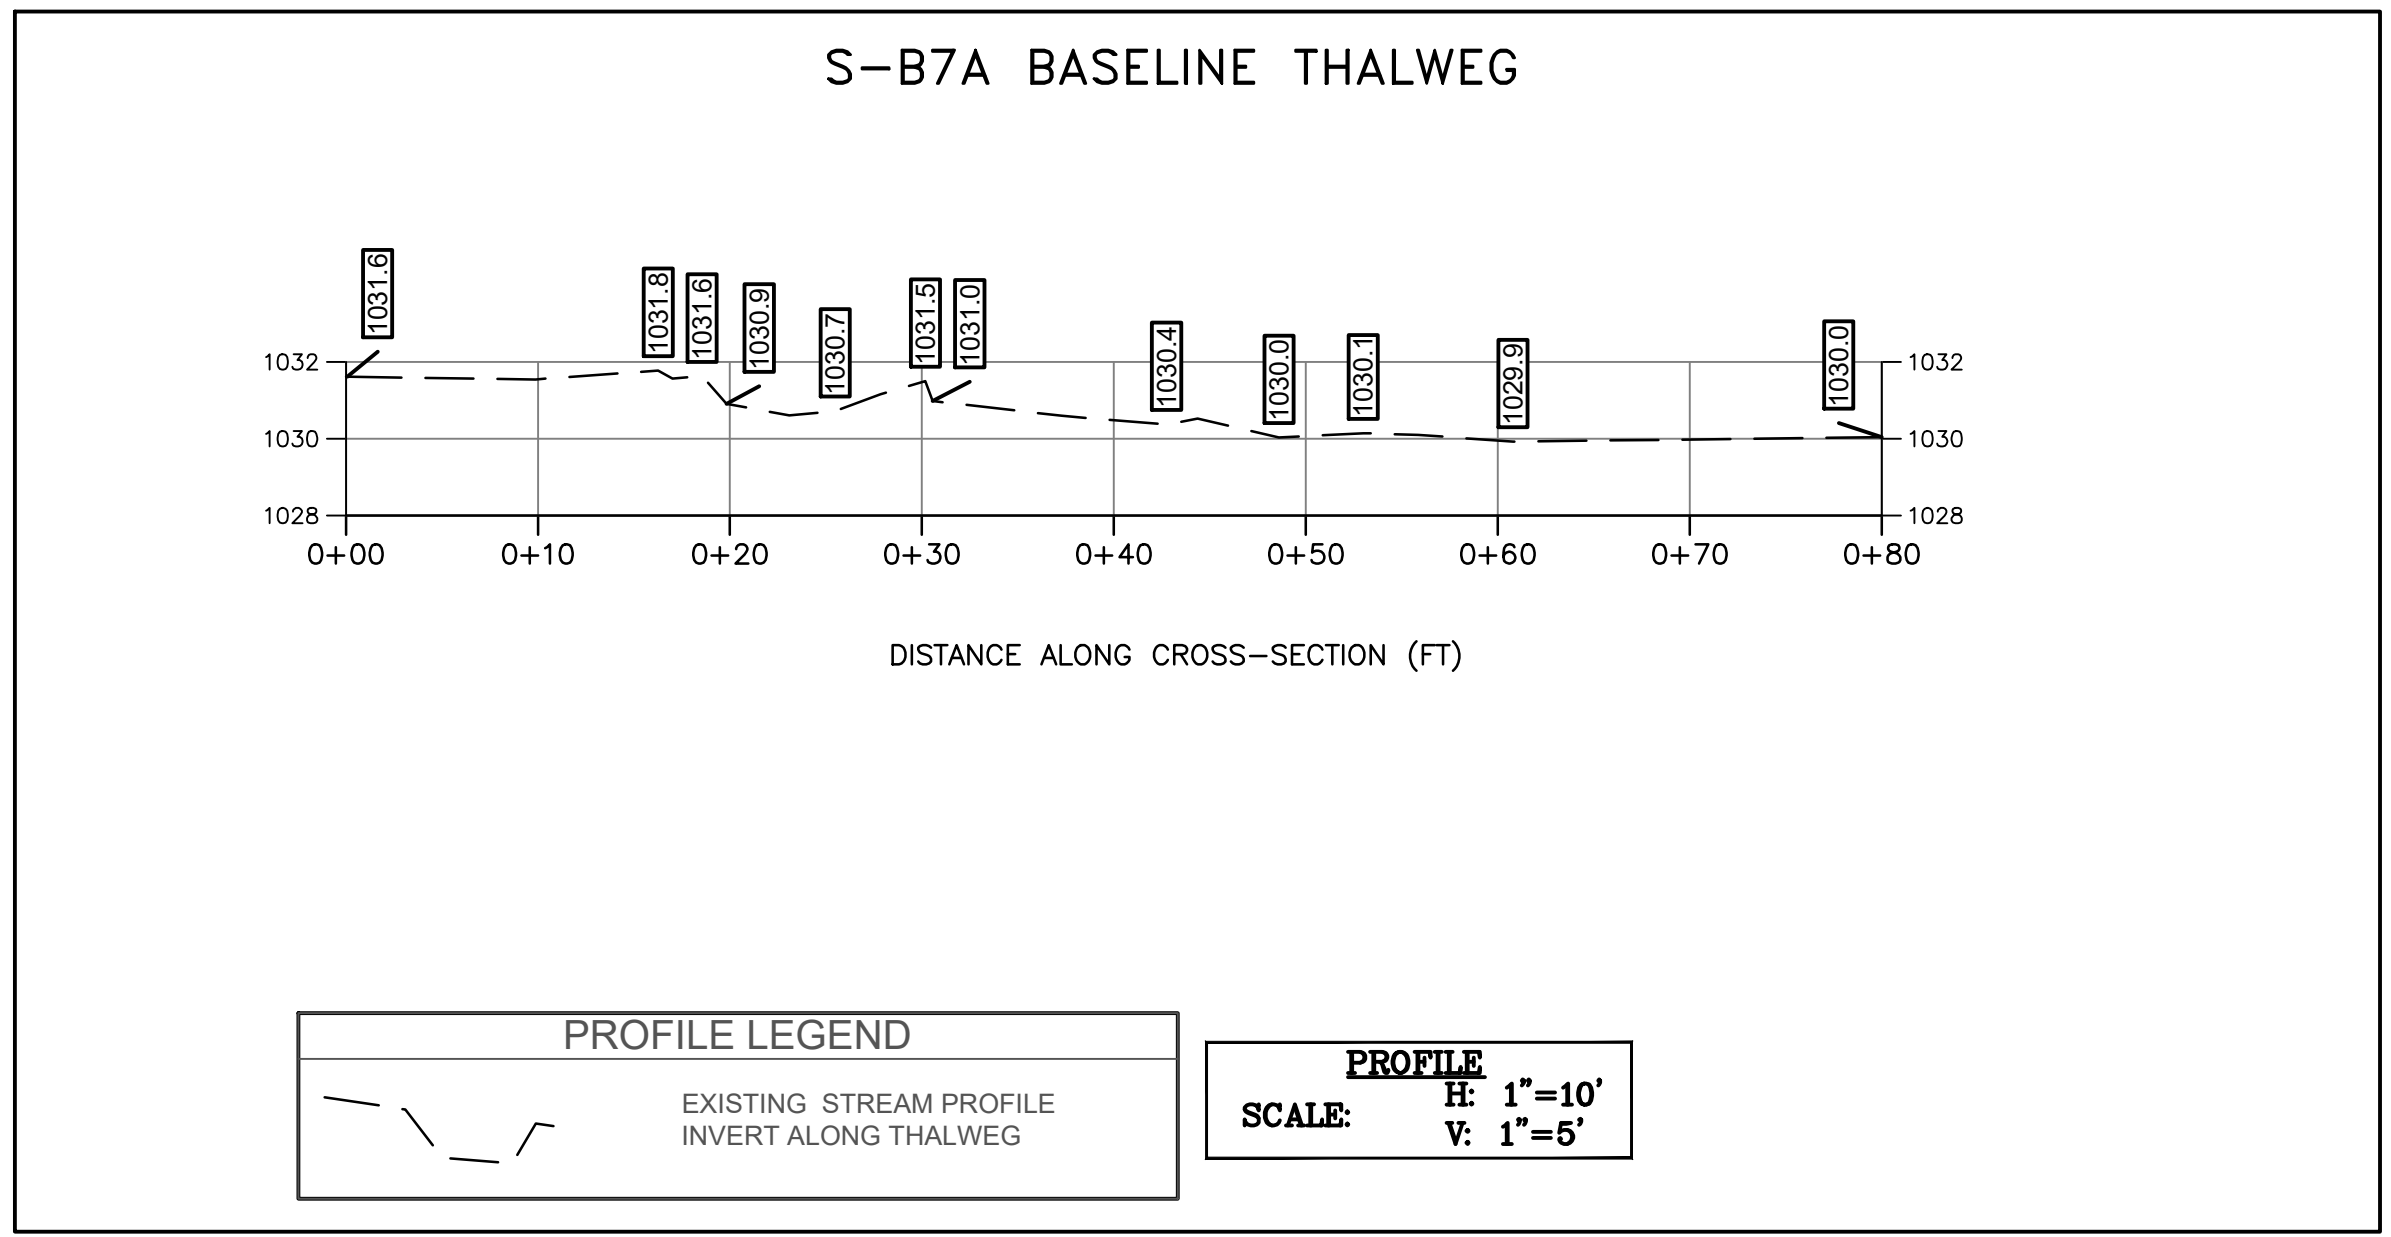
- SURVEY NOTES:**
- THIS MAP HAS BEEN ORIENTED TO NAD 1983 UTM ZONE 17N, AND VERTICALLY TO THE NORTH AMERICAN VERTICAL DATUM OF 1988 (NAVD 88), USING REAL TIME DGPS. FIELD LOCATIONS WERE COMPLETED ON AUGUST 25, 2021.

- EASEMENT LINES SHOWN ON PLAN VIEW WERE PROVIDED BY MOUNTAIN VALLEY PIPELINE.
 - SURVEY POINTS FOR CROSS SECTIONS AND THALWEG PROFILES COLLECTED IN 2021 HAVE BEEN USED IN COMBINATION WITH SURVEY POINTS COLLECTED PREVIOUSLY IN 2020 IN ORDER TO GENERATE THE PRE-CROSSING SURFACE SHOWN IN PLAN. DUE TO NATURAL EROSIONAL STREAM PROCESSES THAT CAN OCCUR OVER TIME, MINOR ADJUSTMENTS TO THE PROFILE ALIGNMENTS MAY HAVE BEEN REQUIRED IN ORDER TO GENERATE A CLEAN PRE-CROSSING SURFACE.

- ALL SECTION VIEWS SHOWN LEFT TO RIGHT FACING DOWNSTREAM.
 - CROSS SECTION A SHOT AT LOCATION OF PIPE CENTERLINE (BASED ON FIELD STAKES).
 - POST-CROSSING SURVEY INFORMATION SHOWN IN RED. DATA PENDING.

- POST-CROSSING SURVEY POINTS FOR CROSS SECTIONS AND THALWEG ARE PROJECTED ONTO PRE-CROSSING SECTION AND PROFILE VIEWS FOR COMPARISON.

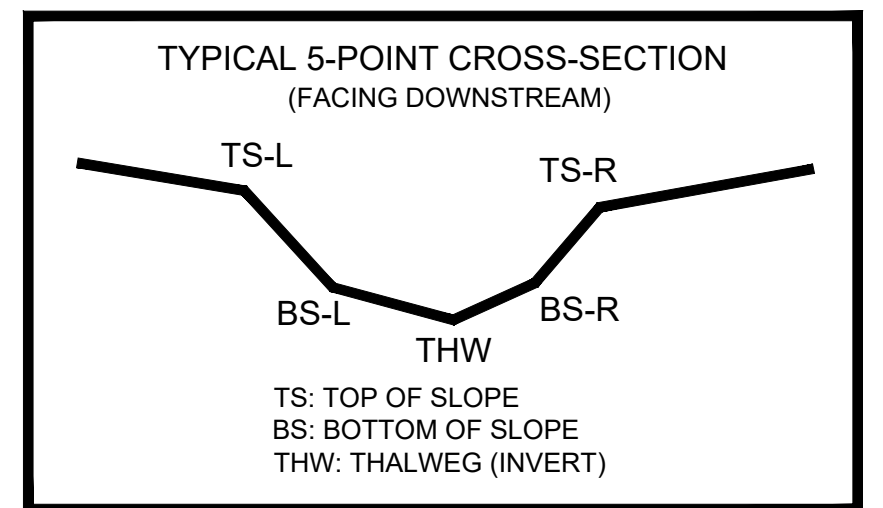
CROSS SECTION SCALE: H: 1"=10'
V: 1"=5'

NOTE: ALL SECTIONS VIEWS SHOWN LEFT TO RIGHT FACING DOWNSTREAM.
