Baseline Assessment – Stream Attributes

Reach S-F36a (3) (Temporary Access Road)

Spread D

Webster County, West Virginia

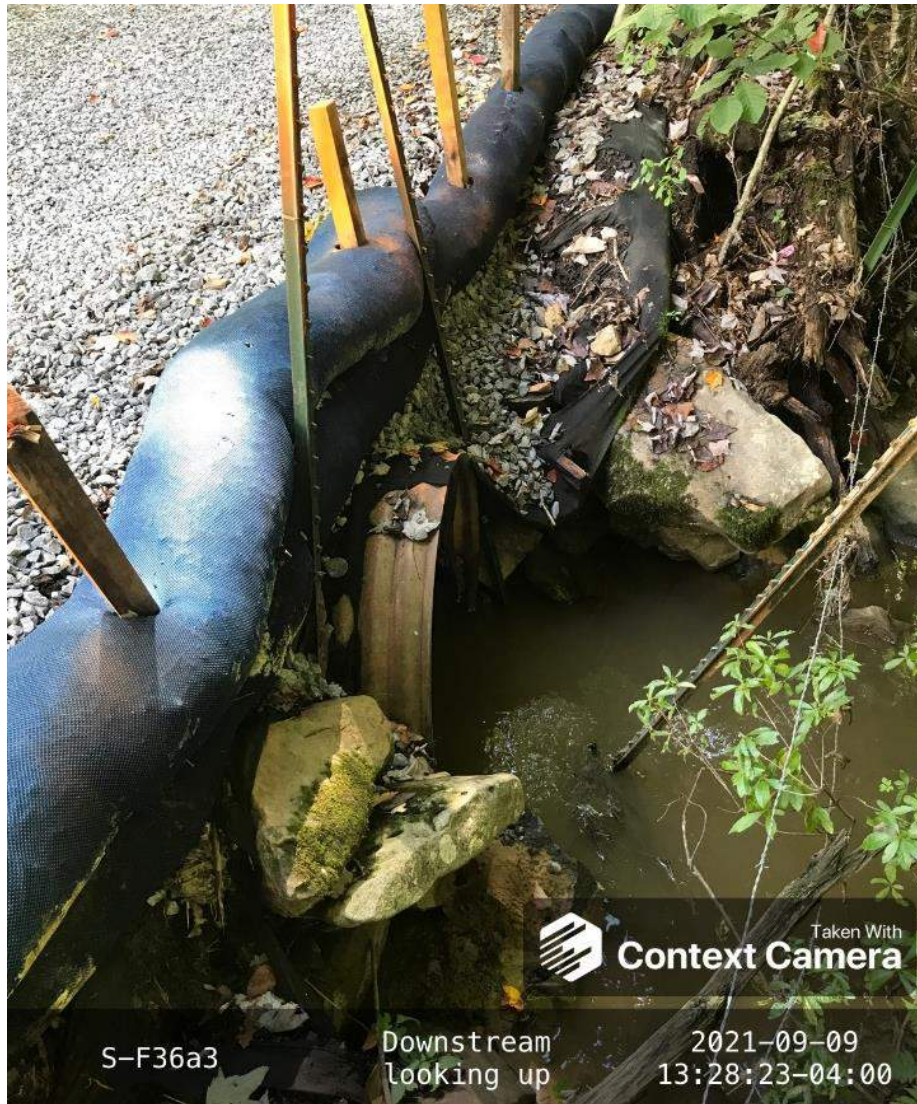
S-F36a3

Downstream
looking up

Photo Type: DS, US View

Location, Orientation, Photographer Initials: Downstream Edge of ROW, Upstream View, EG
Lat: 38.418662 Long: -80.573898

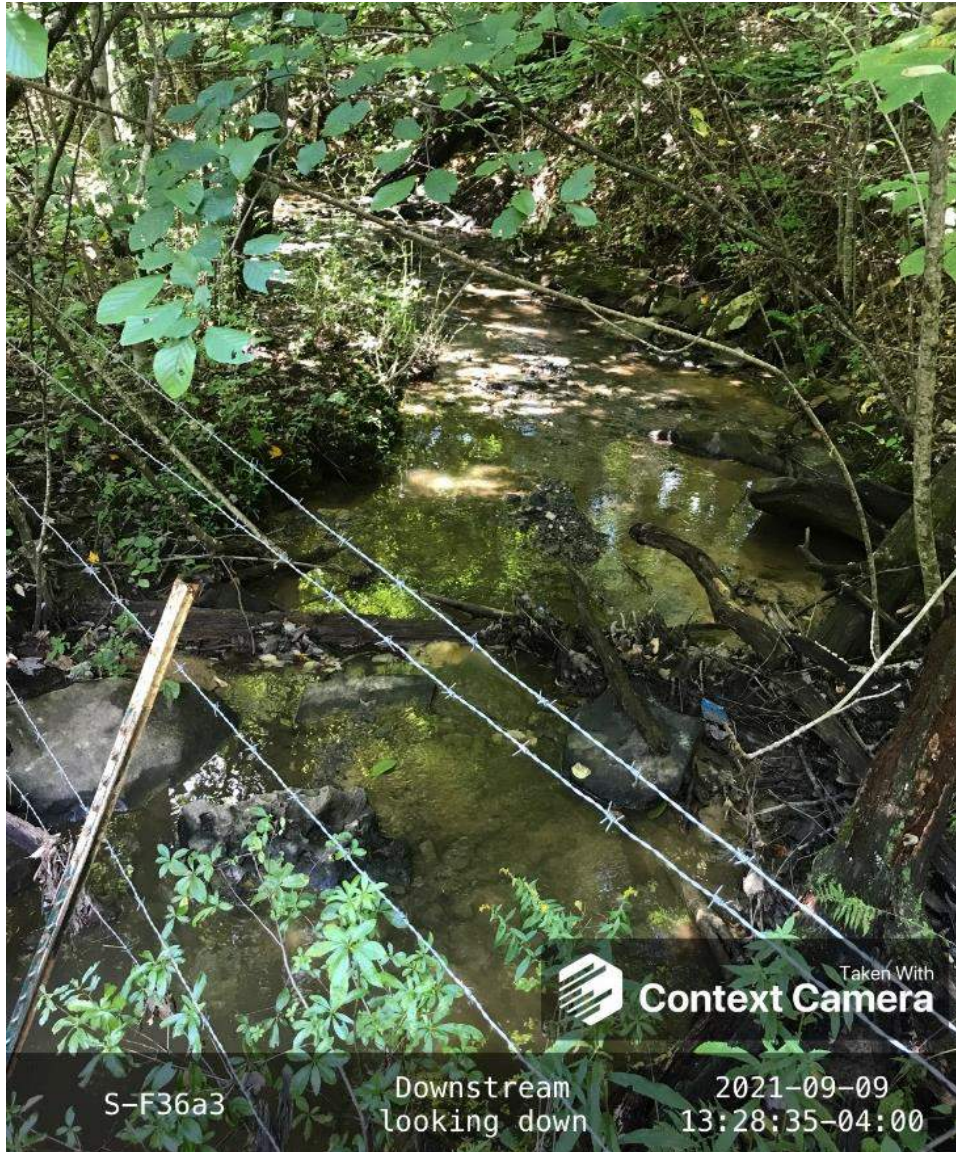
Photo Type: DS, DS View

Location, Orientation, Photographer Initials: Downstream Edge of ROW, Downstream View, EG
Lat: 38.418662 Long: -80.573898

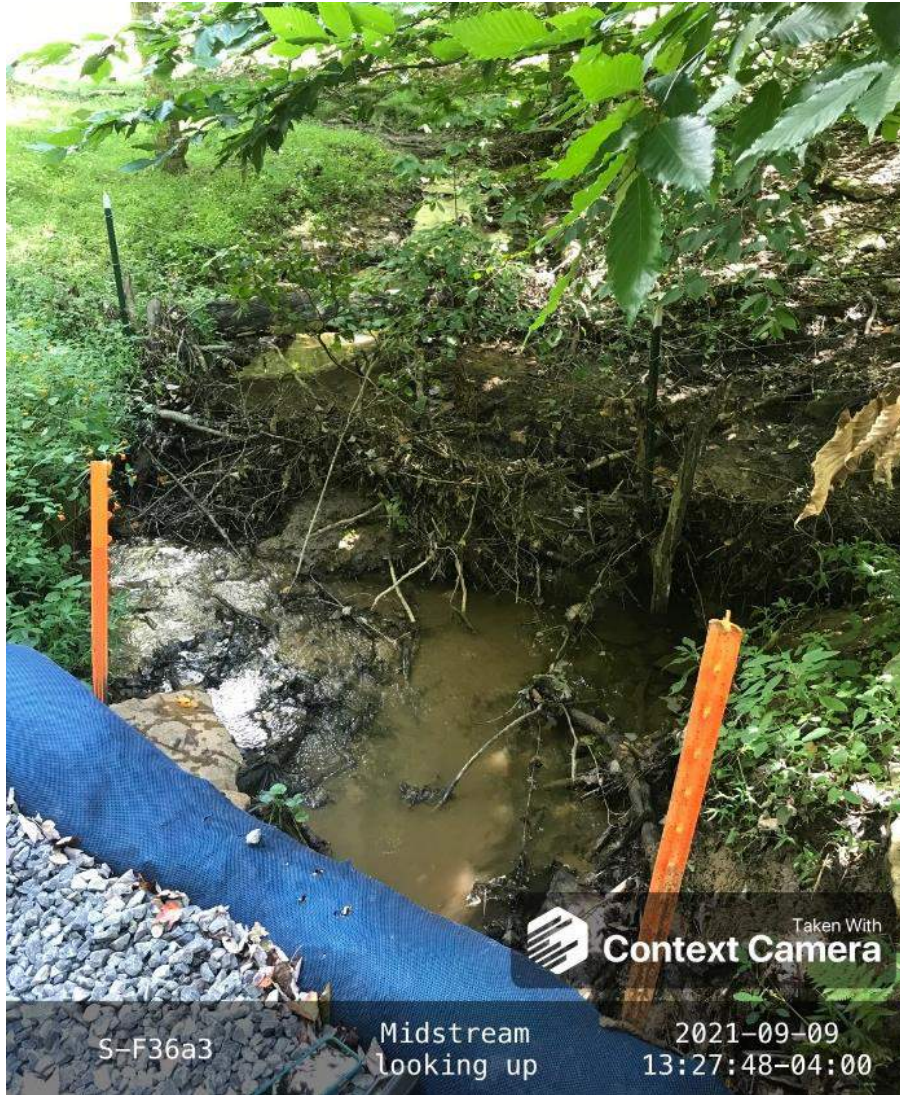
Photo Type: US View at Center
Location, Orientation, Photographer Initials: Center ROW, Upstream View, EG
Lat: 38.418662 Long: -80.573898

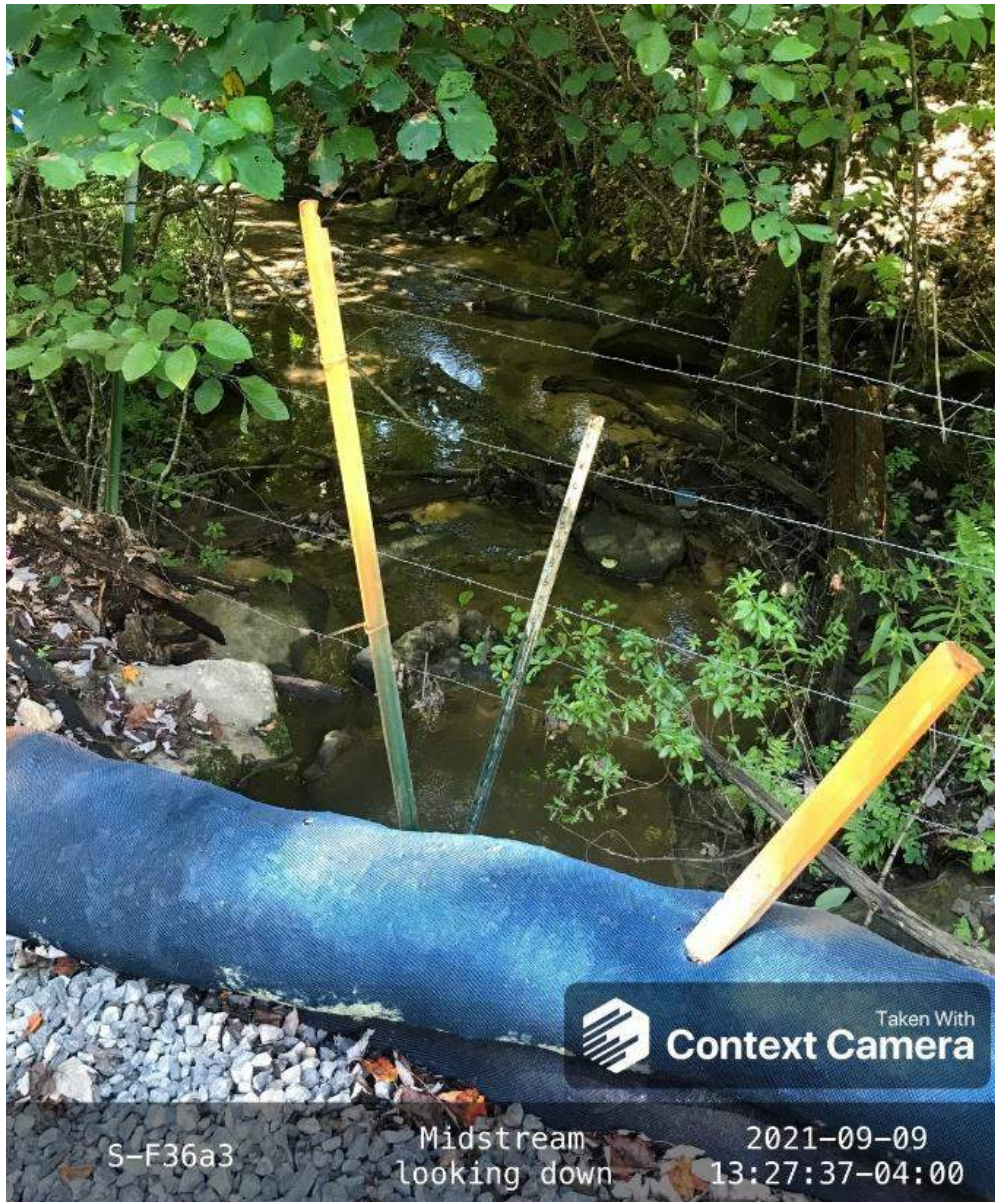
Photo Type: DS View at Center
Location, Orientation, Photographer Initials: ROW Center, Downstream View, EG
Lat: 38.418662 Long: -80.573898

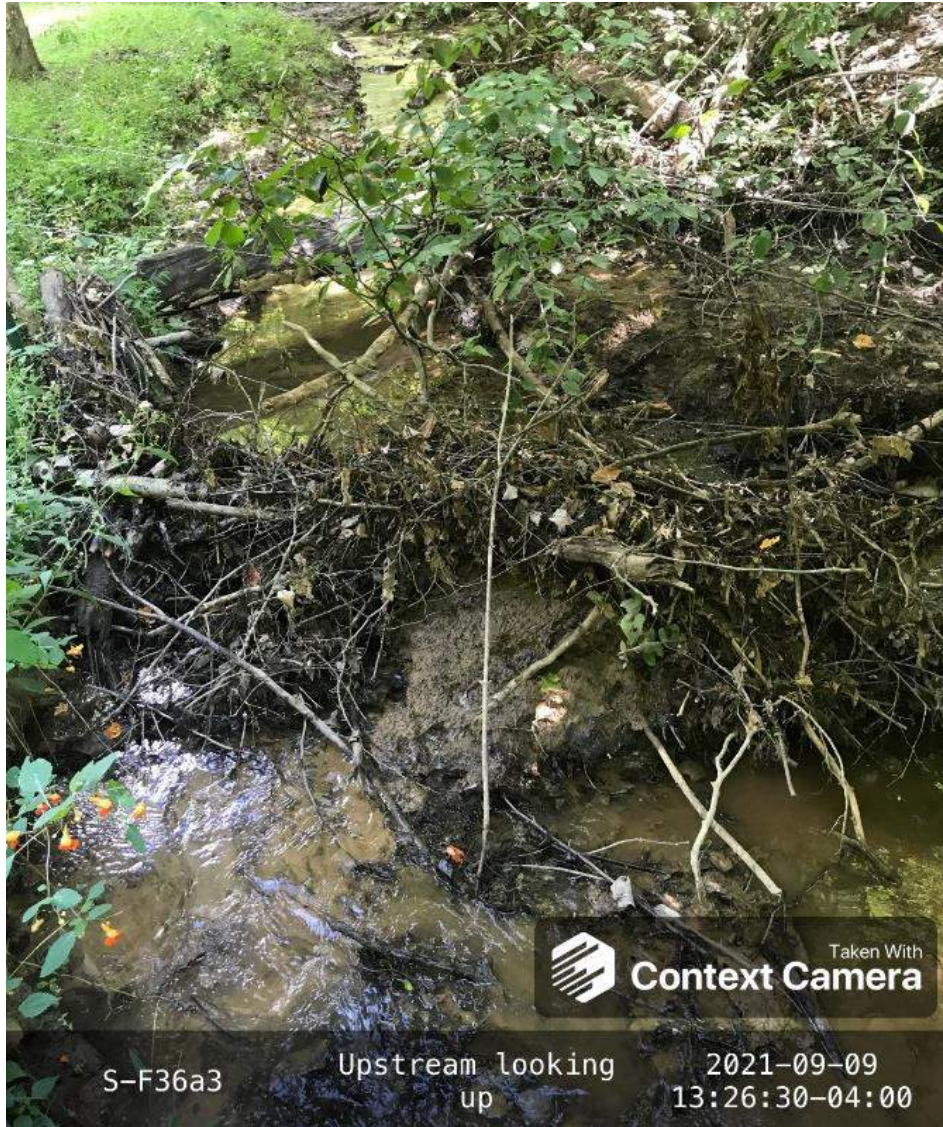
Photo Type: US, US View

Location, Orientation, Photographer Initials: Upstream Edge of ROW, Upstream View, EG
Lat: 38.418662 Long: -80.573898

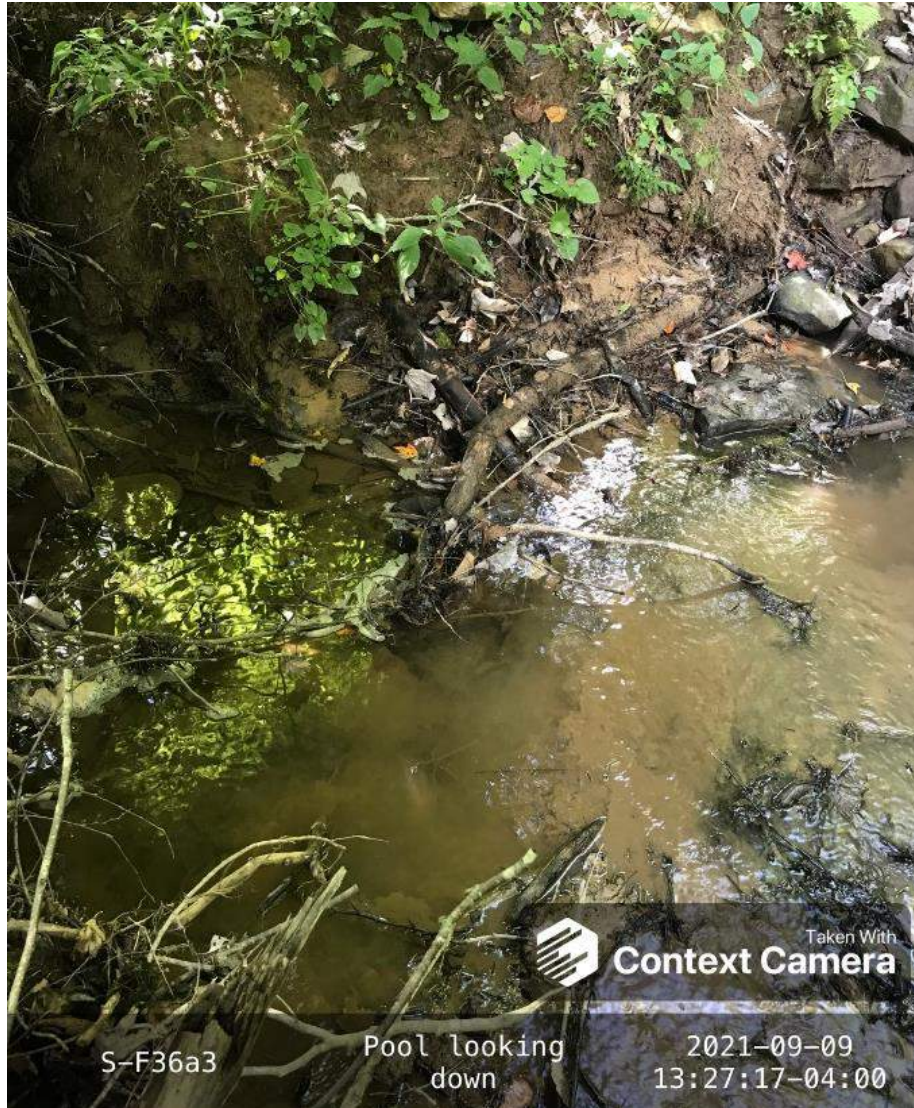
Photo Type: Pool, DS View
Location, Orientation, Photographer Initials: Upstream of Pool, Downstream View, EG
Lat: 38.418662 Long: -80.573898

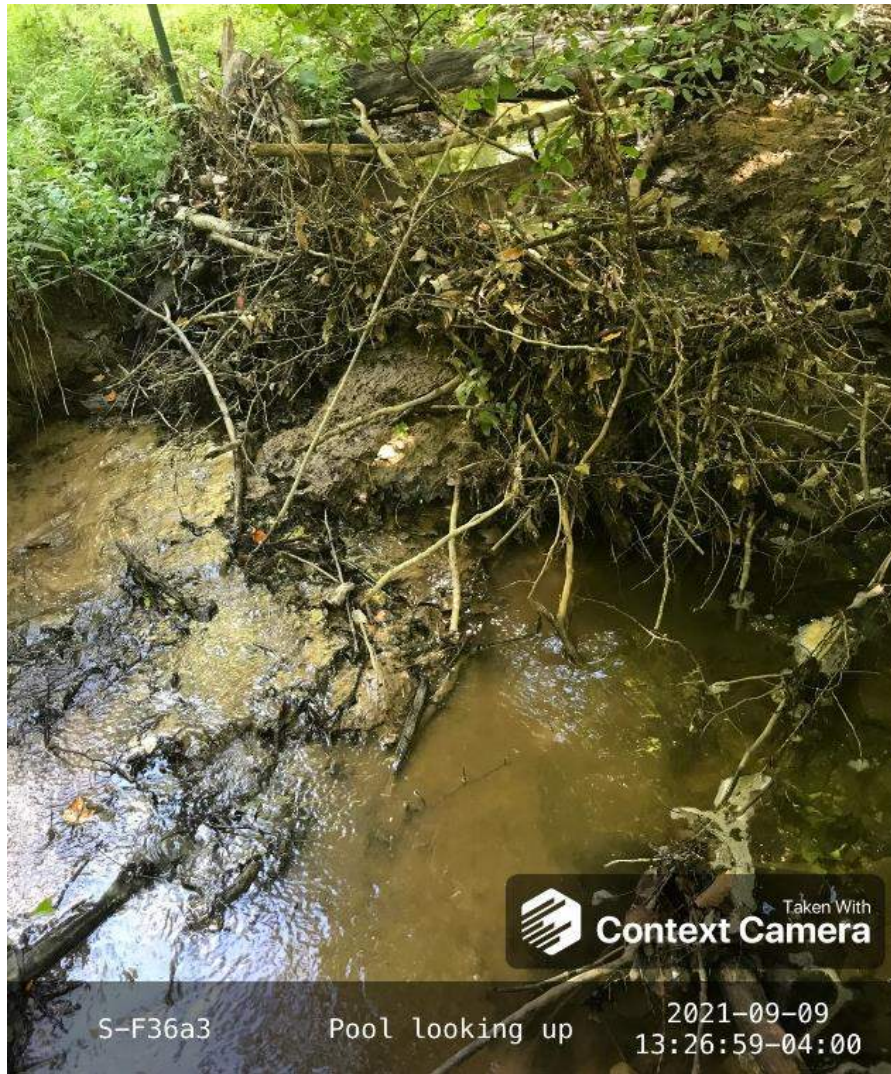
Photo Type: Pool, US View
Location, Orientation, Photographer Initials: Downstream of Pool, Upstream View, EG
Lat: 38.418662 Long: -80.573898

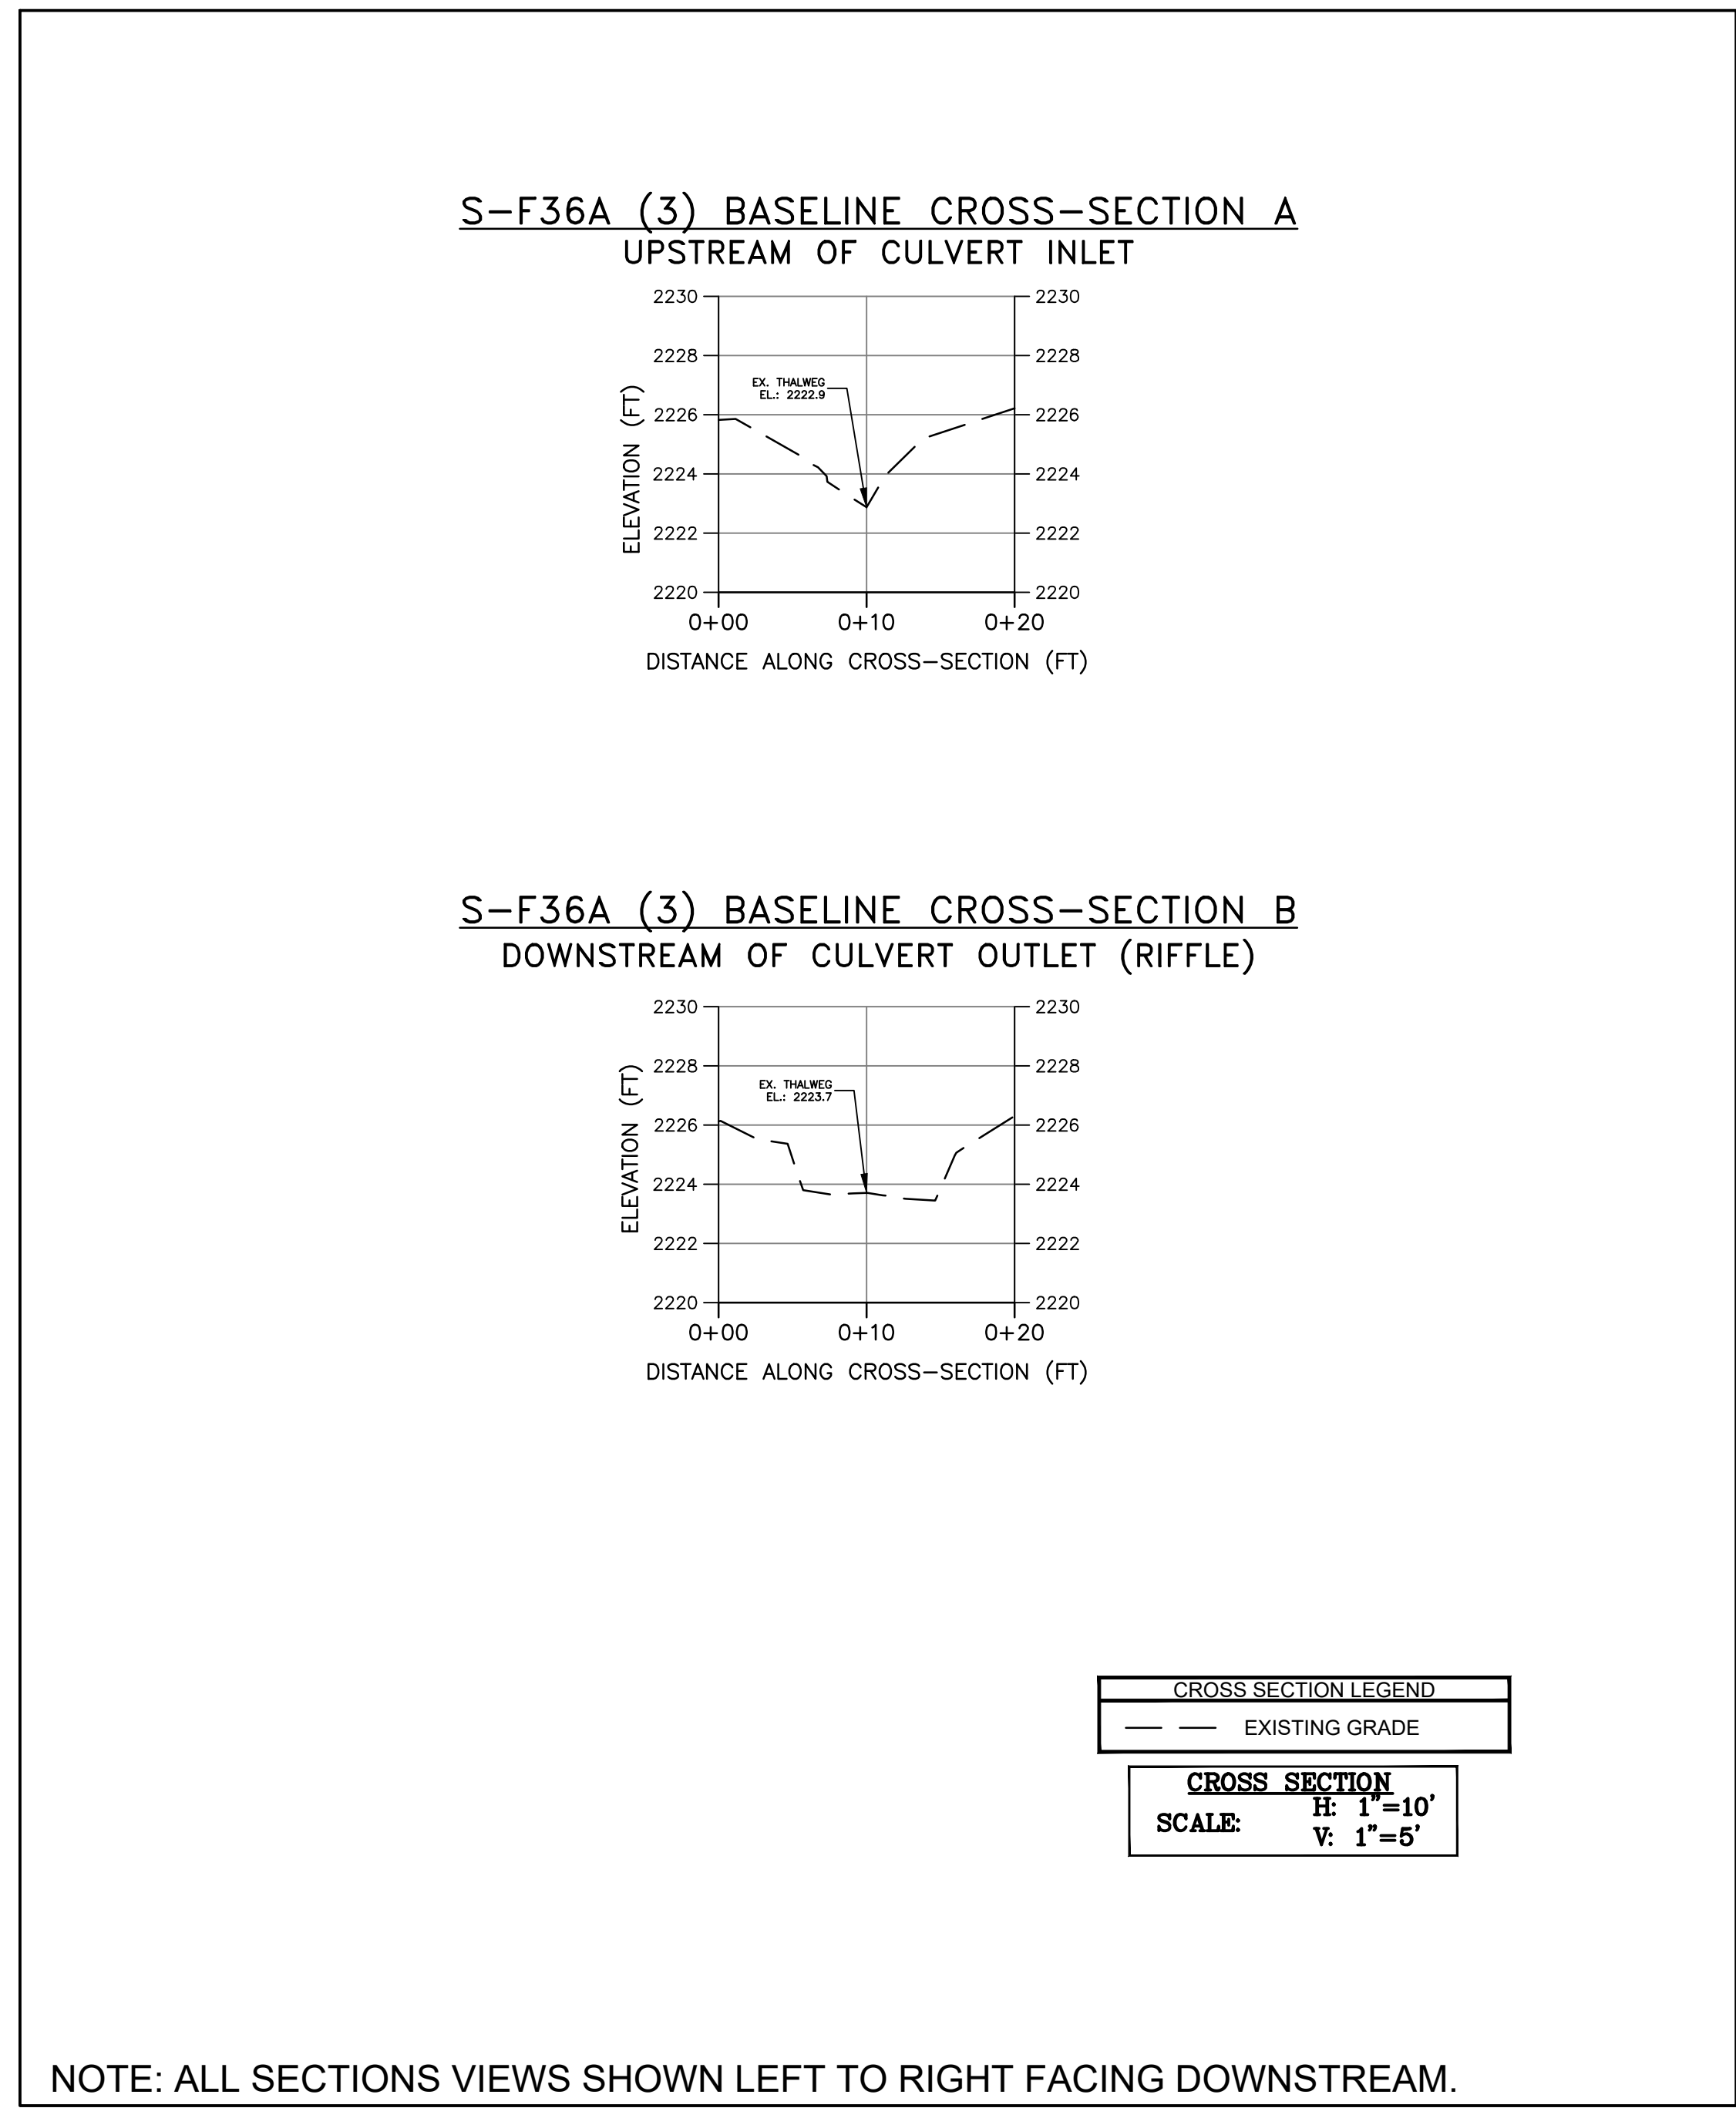
- ALL SECTION VIEWS SHOWN LEFT TO RIGHT FACING DOWNSTREAM.
 - POST-CROSSING SURVEY INFORMATION SHOWN IN RED. DATA PENDING.
 - POST-CROSSING SURVEY POINTS FOR CROSS SECTIONS AND THALWEG ARE PROJECTED ONTO PRE-CROSSING SECTION AND PROFILE VIEWS FOR COMPARISON.

AS-BUILT TABLE: S-F36A (3) CROSS SECTION B					
PT. LOC.	PRE-CROSSING			AS-BUILT	
	NORTHING	EASTING	ELEV.	VERT. DIFF.	HORZ. DIFF.
TS-L	13951269.2500	1762470.0790	2225.493'		
BS-L	13951268.0900	1762470.0120	2223.803'		
THW	13951266.6000	1762468.8020	2223.857'		
BS-R	13951259.9400	1762466.2620	2223.409'		
TS-R	13951258.5600	1762465.6730	2225.127'
