Baseline Assessment – Stream Attributes

Reach S-J22 (Pipeline ROW) Intermittent Spread D Nicholas County, West Virginia

TITLE
PROFILE AND CROSS-SECTIONS
BASELINE SURVEY
CROSSING S-J22 - UNNAMED TRIB. TO
LITTLE LAUREL CREEK (MP 122.3)
NICHOLAS COUNTY, WV

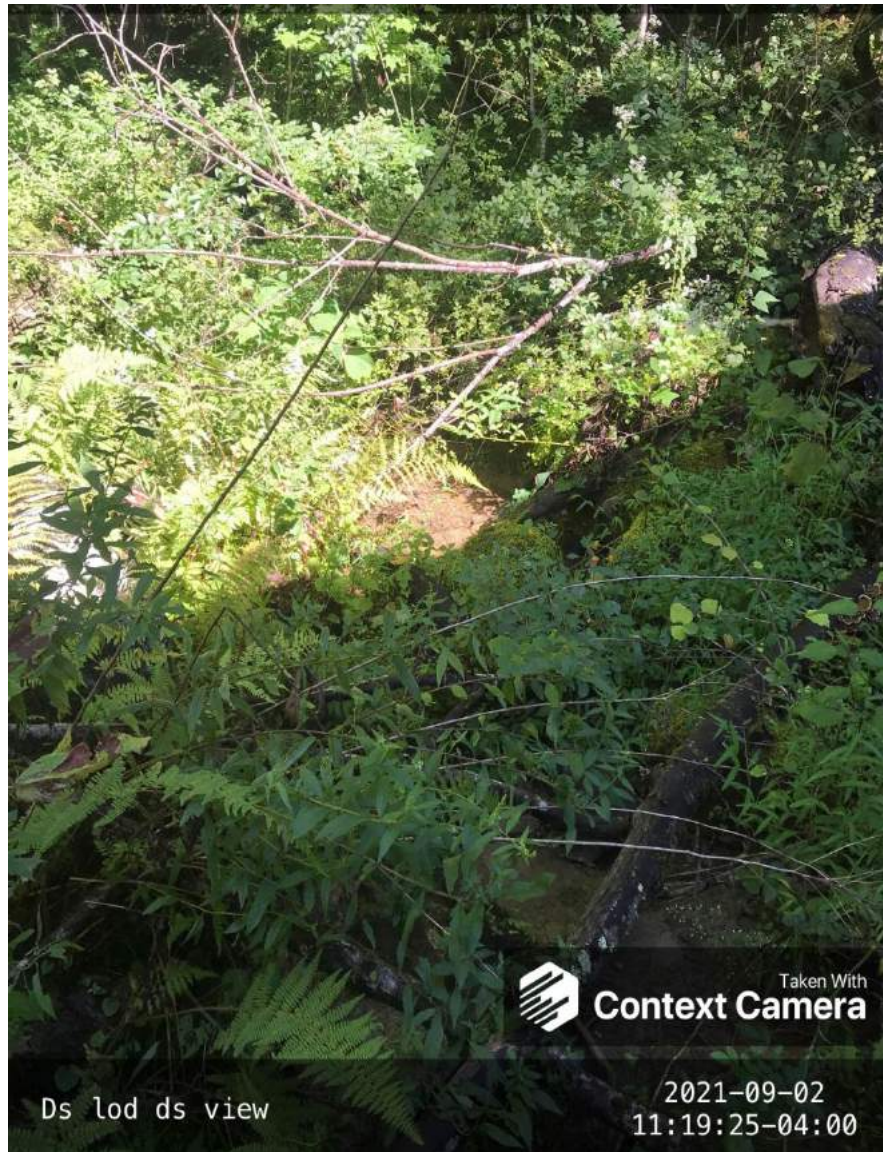
Photo Type: DS, DS View

Location, Orientation, Photographer Initials: Downstream Edge of ROW, Downstream View, SM/JM
Lat: 38.233718 Long: -80.708268

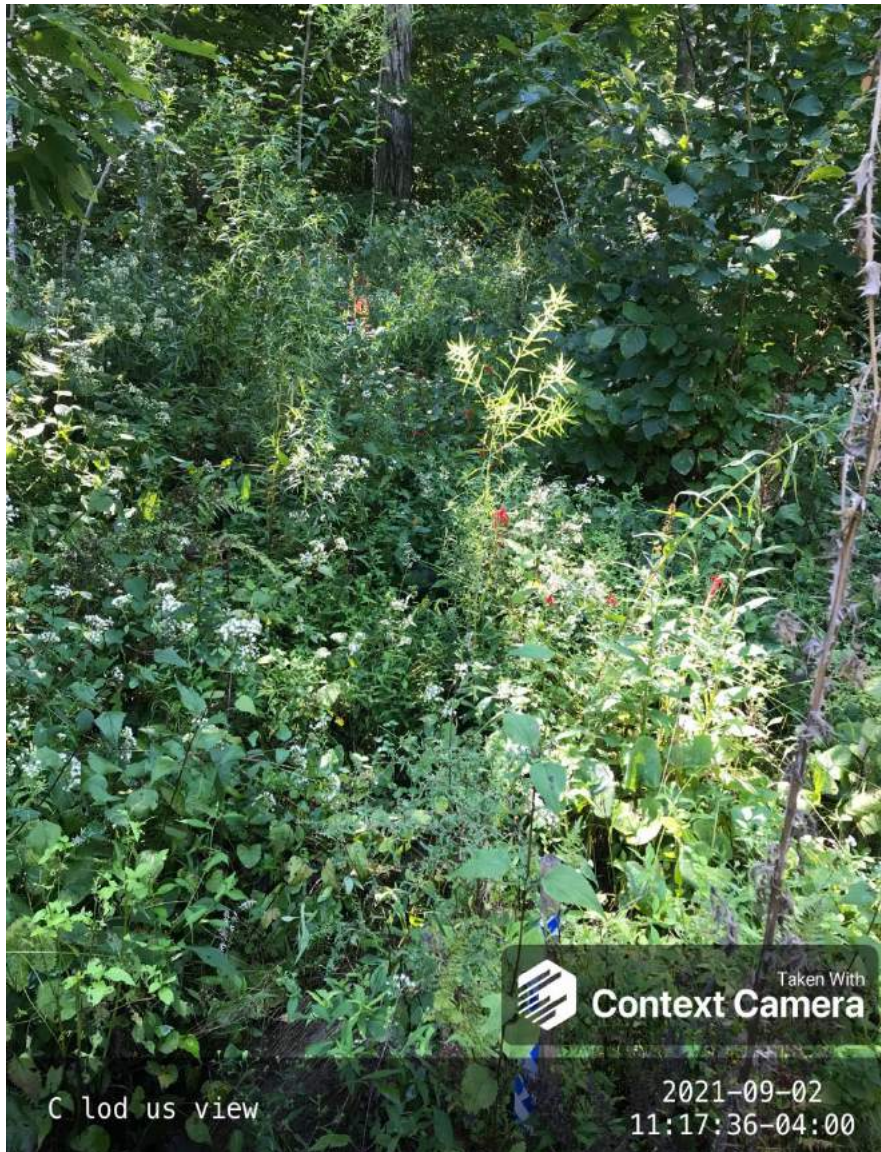
Photo Type: US View at Center
Location, Orientation, Photographer Initials: Center ROW, Upstream View, SM/JM
Lat: 38.233718 Long: -80.708268

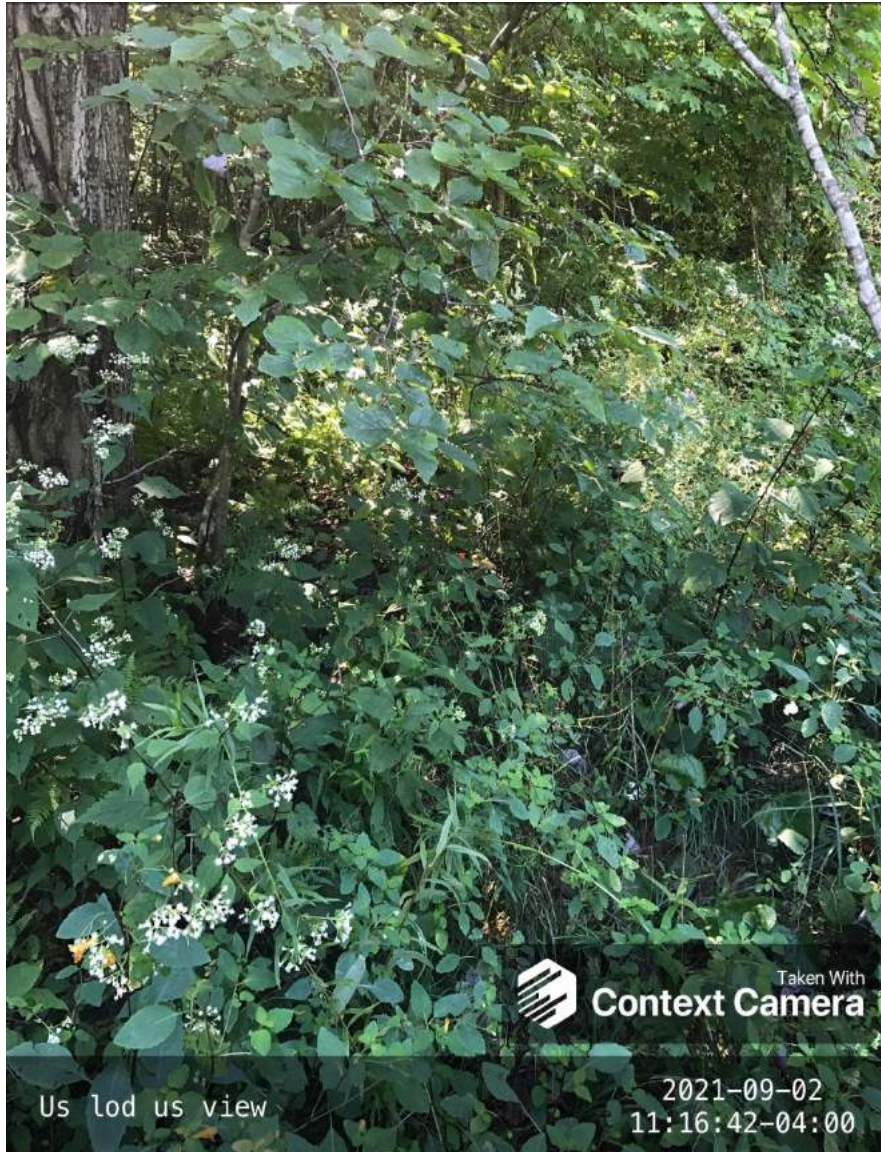
Photo Type: US, US View

Location, Orientation, Photographer Initials: Upstream Edge of ROW, Upstream View, SM/JM
Lat: 38.233718 Long: -80.708268

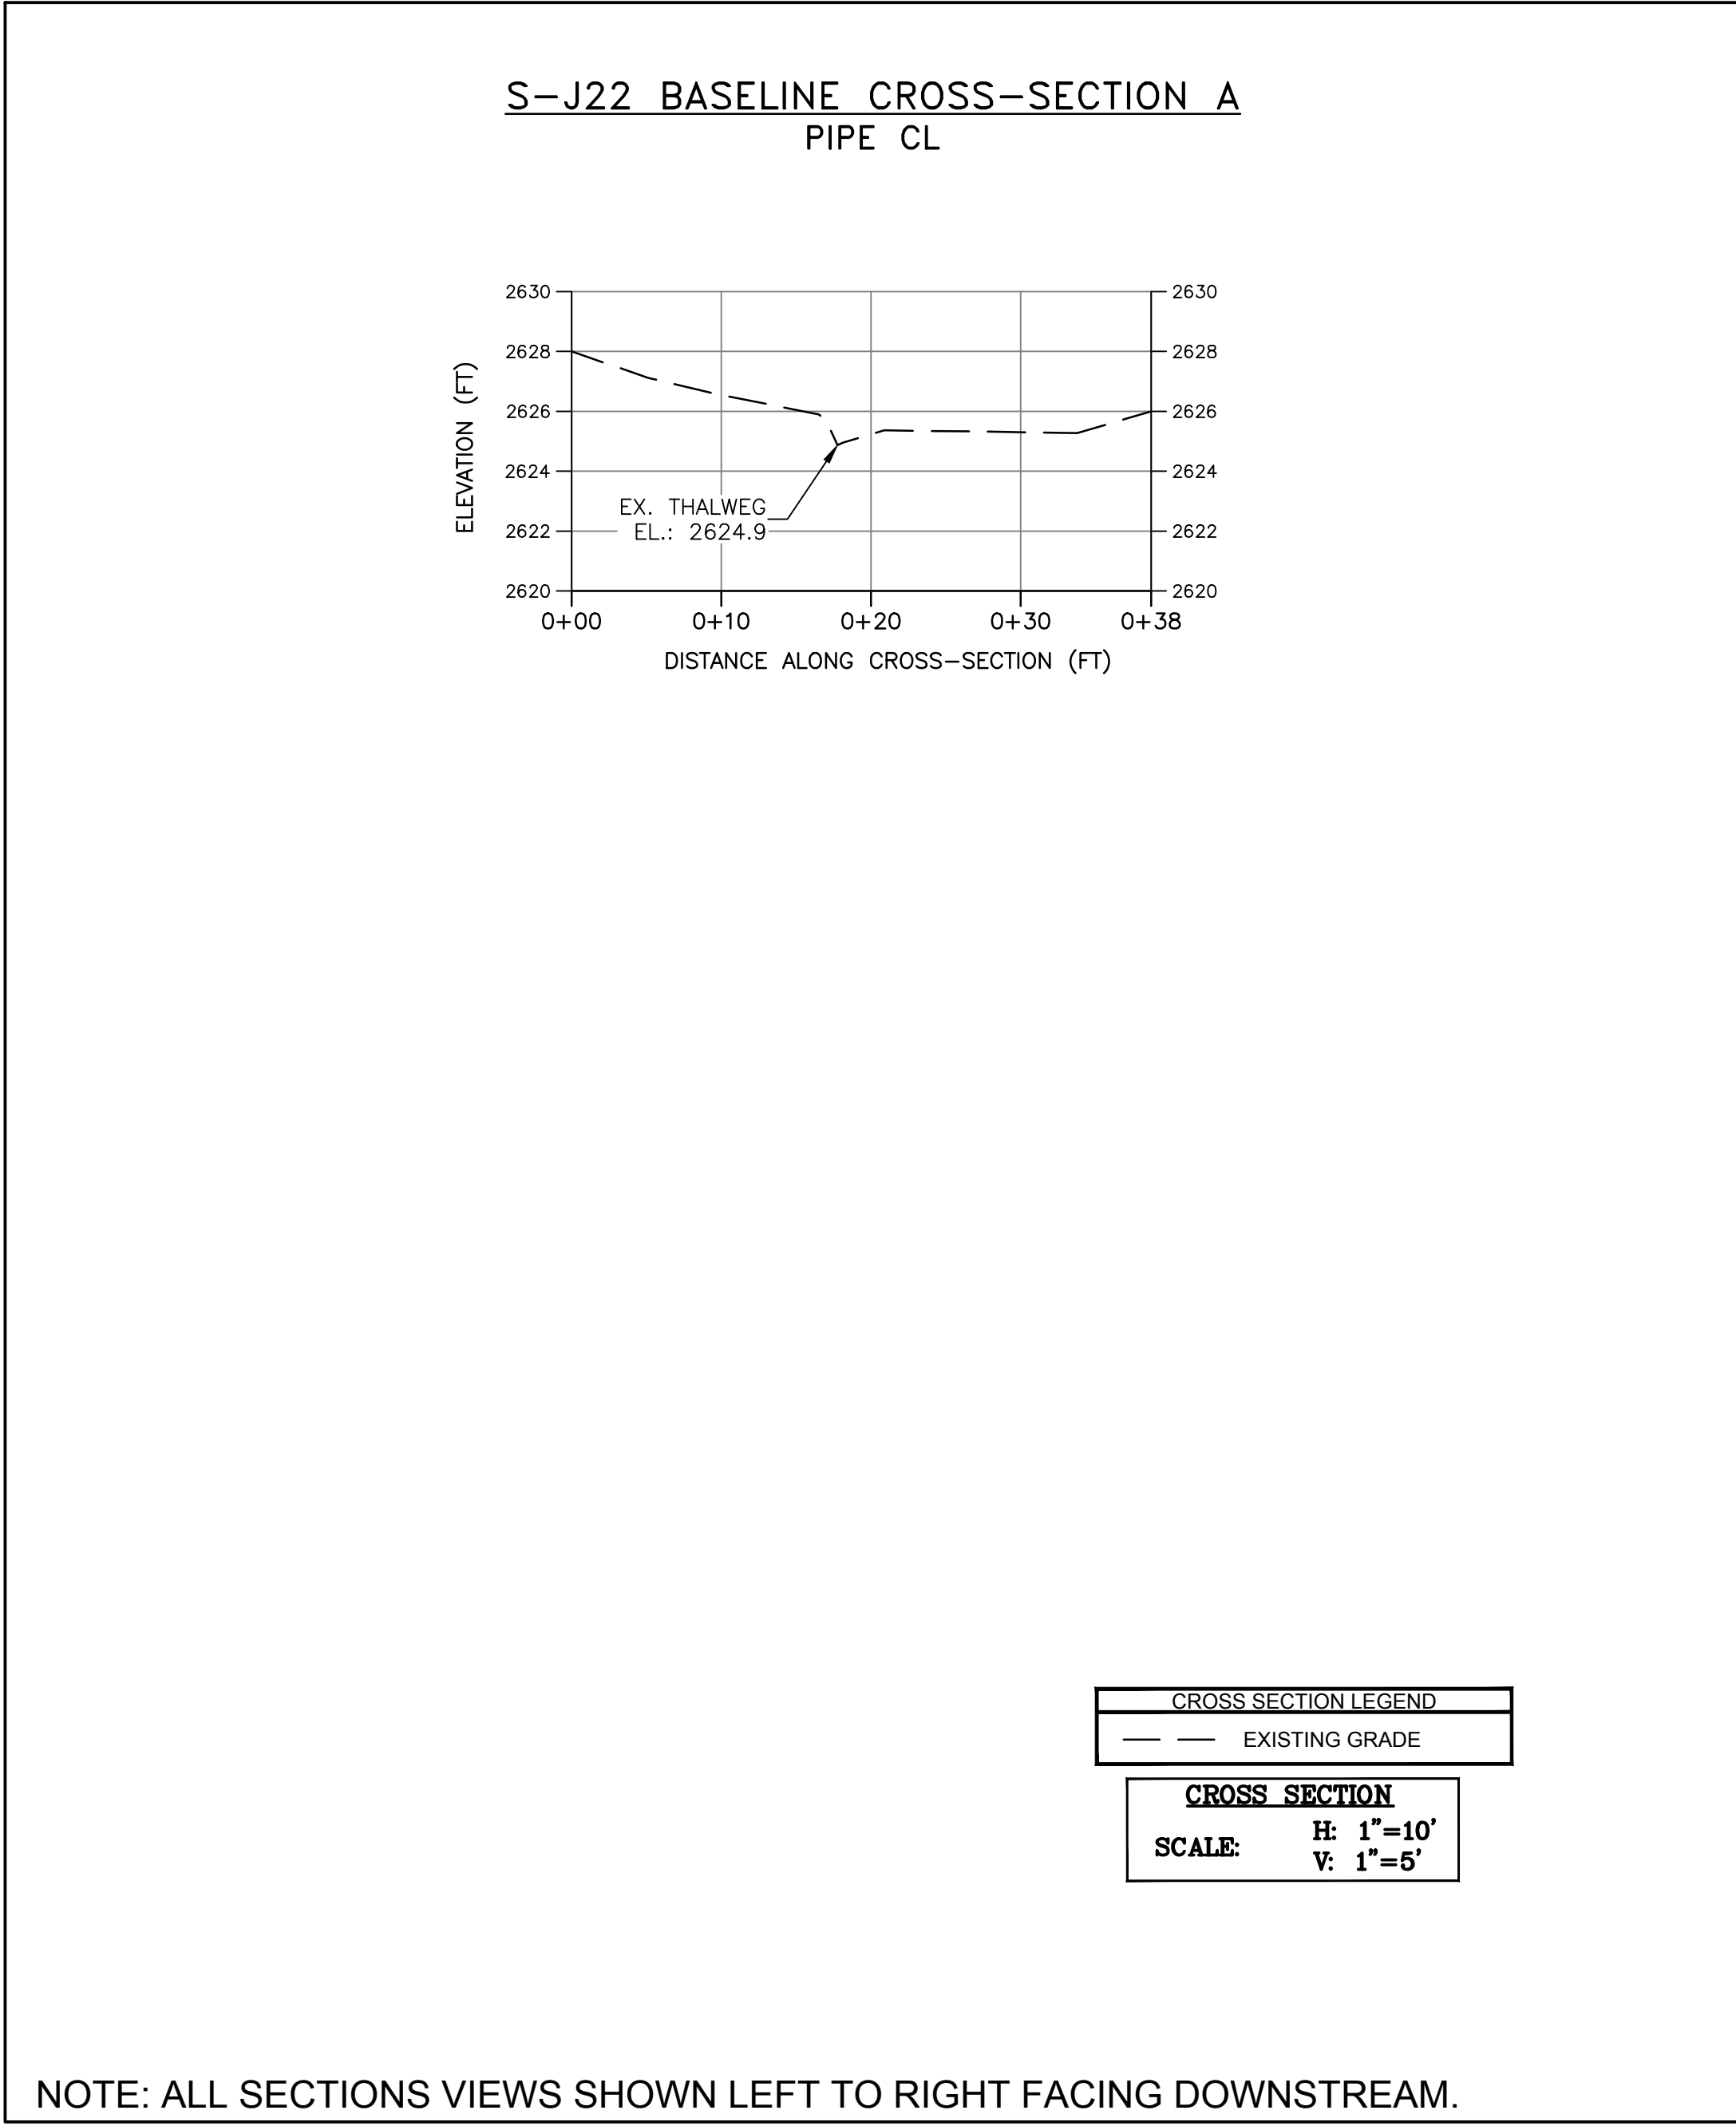
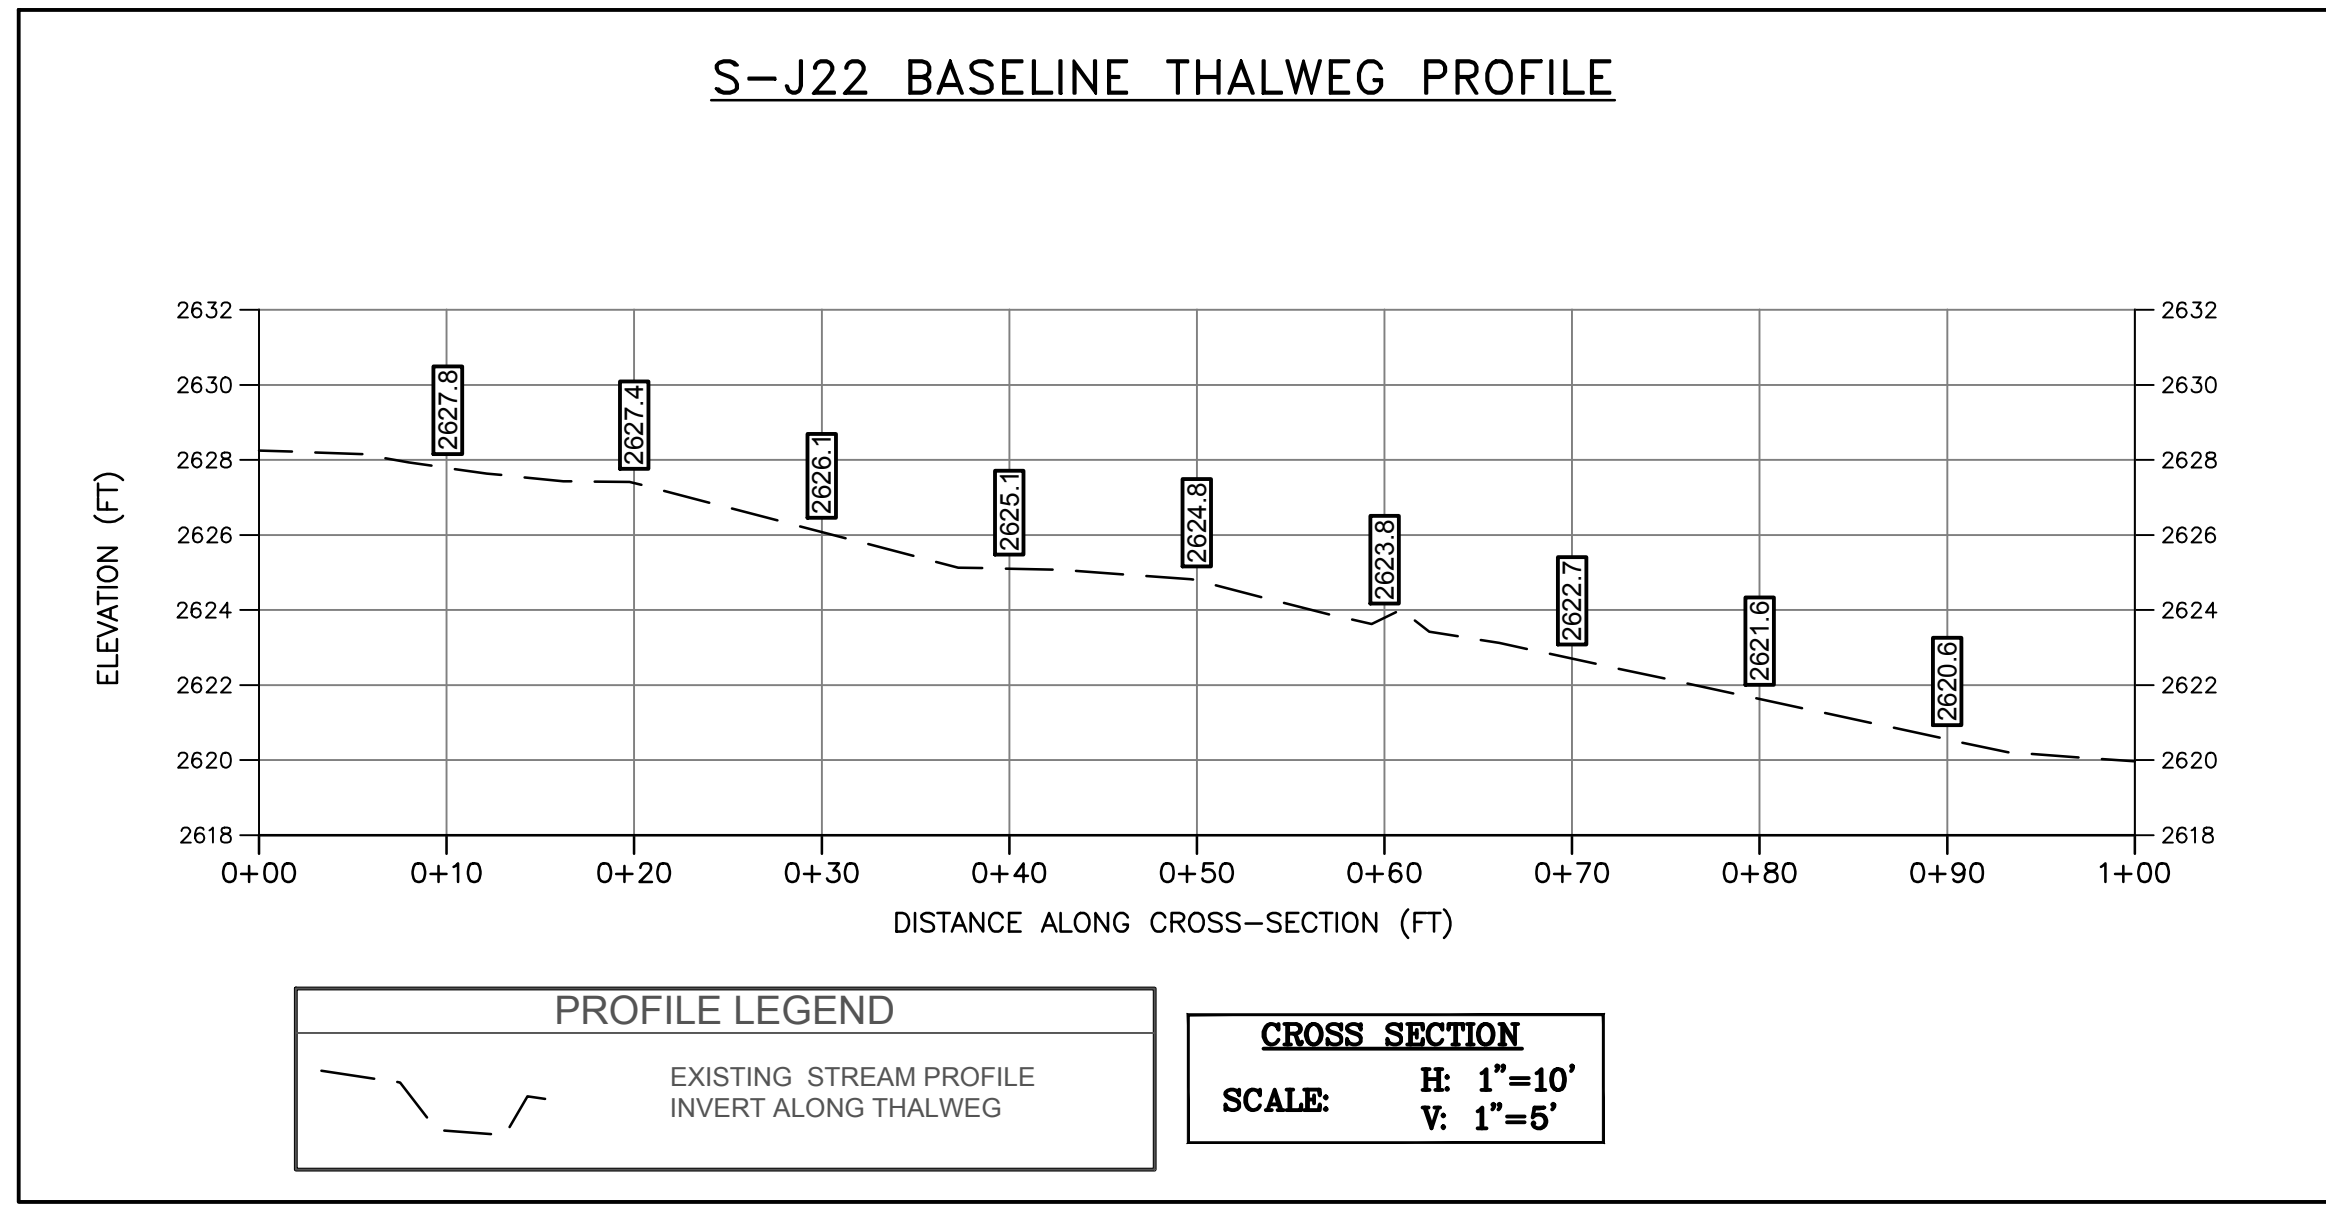
- ALL SECTION VIEWS SHOWN LEFT TO RIGHT FACING DOWNSTREAM.
 - POST-CROSSING SURVEY INFORMATION SHOWN IN RED. DATA PENDING.
 - POST-CROSSING SURVEY POINTS FOR CROSS SECTIONS AND THALWEG ARE PROJECTED ONTO PRE-CROSSING SECTION AND PROFILE VIEWS FOR COMPARISON.

AS-BUILT TABLE: S-J22 CROSS SECTION A					
PT. LOC.	PRE-CROSSING			AS-BUILT	
	NORTHING	EASTING	ELEV.	VERT. DIFF.	HORZ. DIFF.
TS-L	13883787.27	1724180.84	2625.90		
THW	13883788.26	1724181.59	2624.87		
TS-R	13883790.73	1724183.48	2625.36
