Baseline Assessment – Stream Attributes

Reach S-L60 (Pipeline ROW) Perennial Spread C Braxton County, West Virginia

Title: PROFILE AND CROSS-SECTIONS
BASELINE SURVEY
CROSSING S-L60 - LEFT FORK KNOWL
CREEK (MP 68.67)
BRAXTON COUNTY, WV

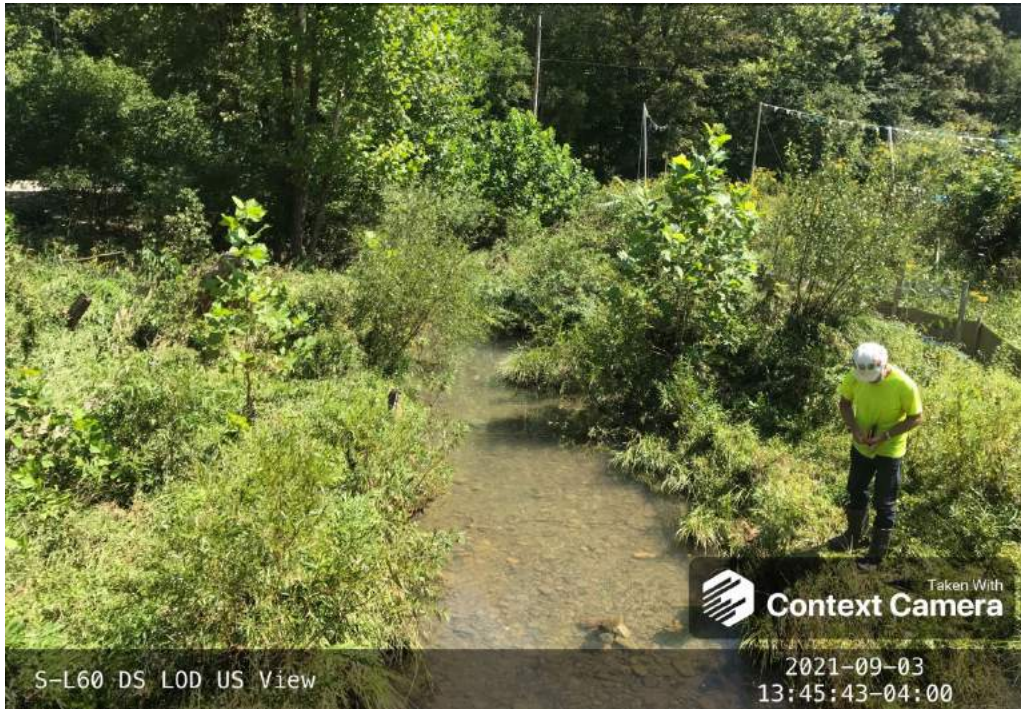
Photo Type: DS, US View
Location, Orientation, Photographer Initials: Downstream Edge of ROW, Upstream View, AJE, PI
Lat: 38.824034 Long: -80.524988

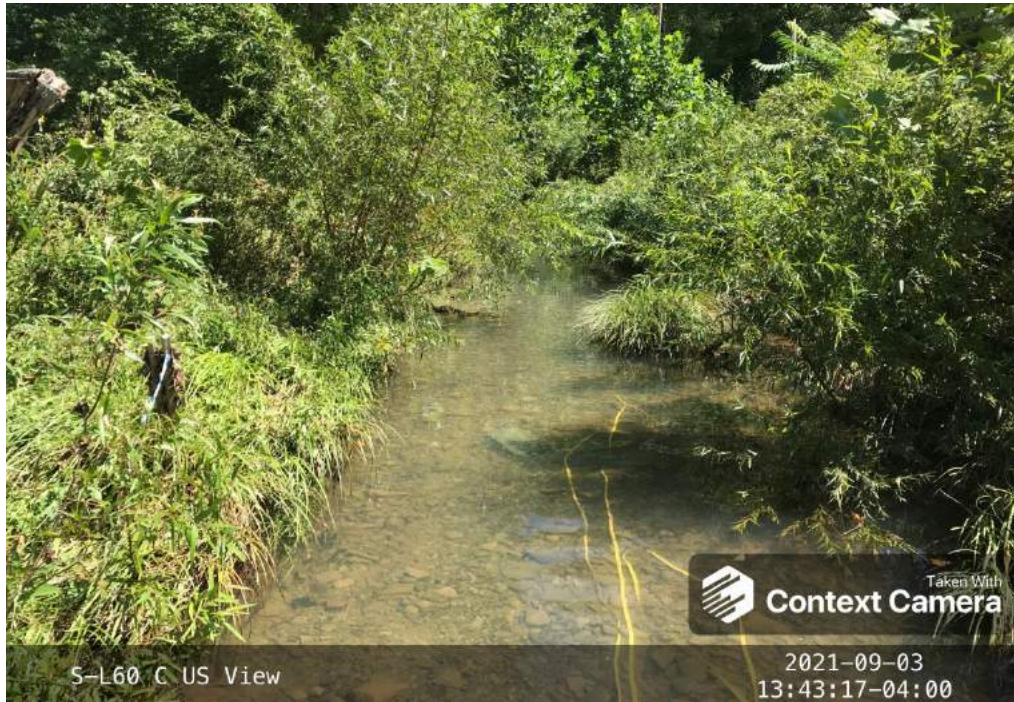
Photo Type: US View at Center
Location, Orientation, Photographer Initials: Center ROW, Upstream View, PI, AJE
Lat: 38.824034 Long: -80.524988

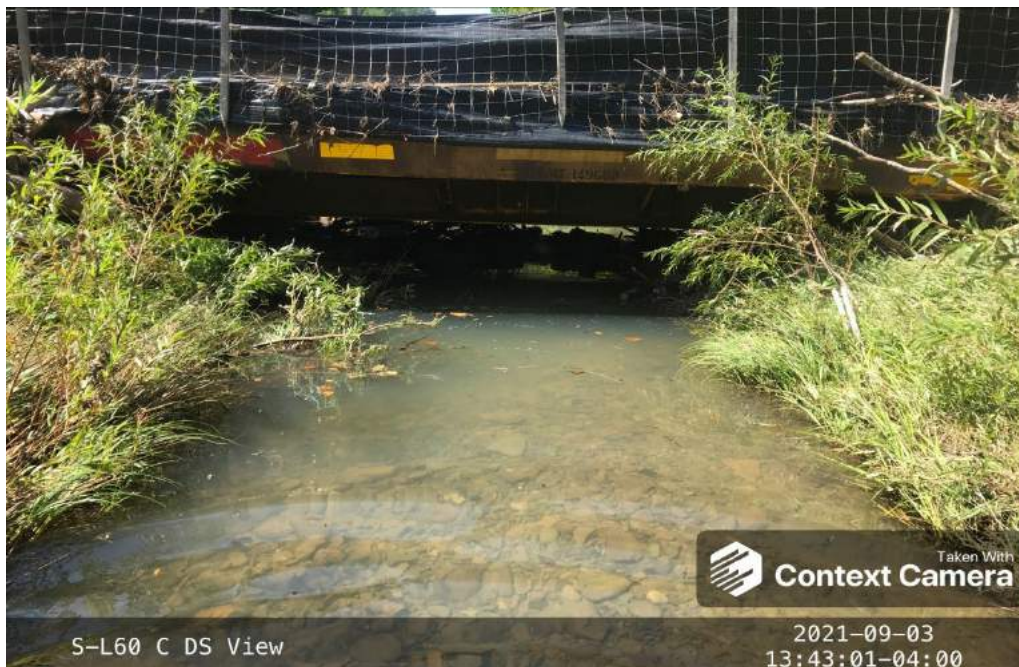
Photo Type: DS View at Center
Location, Orientation, Photographer Initials: ROW Center, Downstream View, AJE, PI
Lat: 38.824034 Long: -80.524988

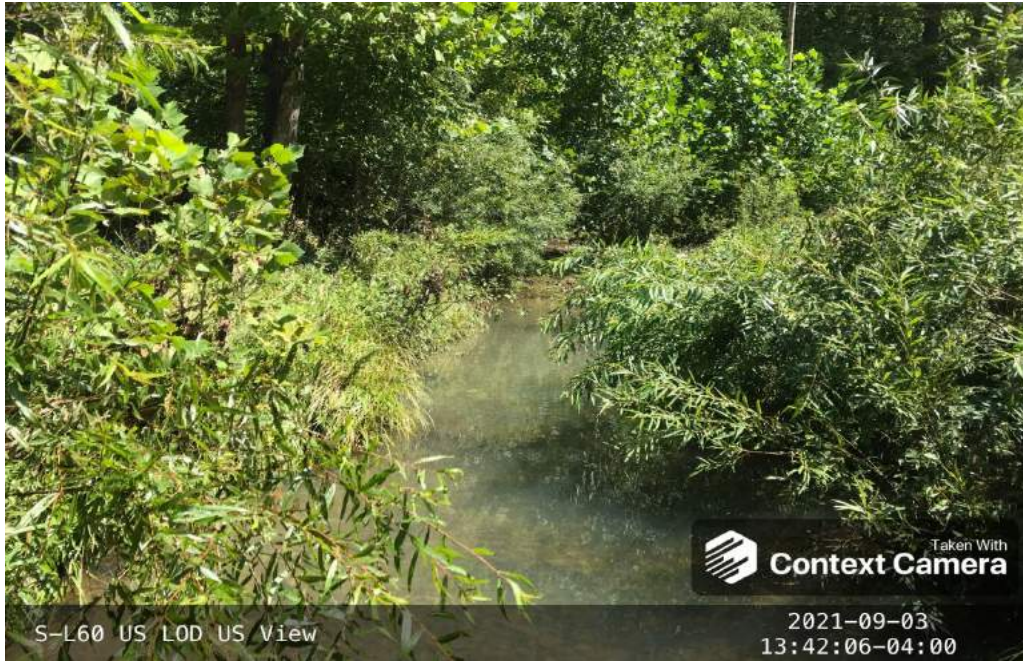
Photo Type: US, US View
Location, Orientation, Photographer Initials: Upstream Edge of ROW, Upstream View, AJE, PI
Lat: 38.824034 Long: -80.524988

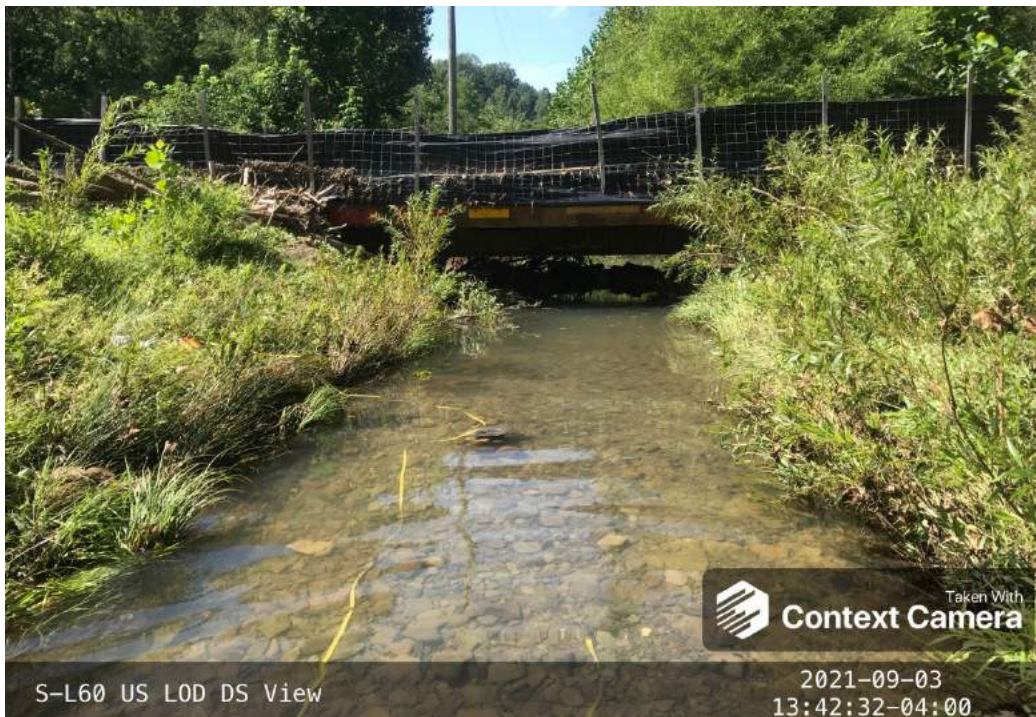
Photo Type: US, DS View
Location, Orientation, Photographer Initials: Upstream Edge of ROW, Downstream View, AJE, PI
Lat: 38.824034 Long: -80.524988

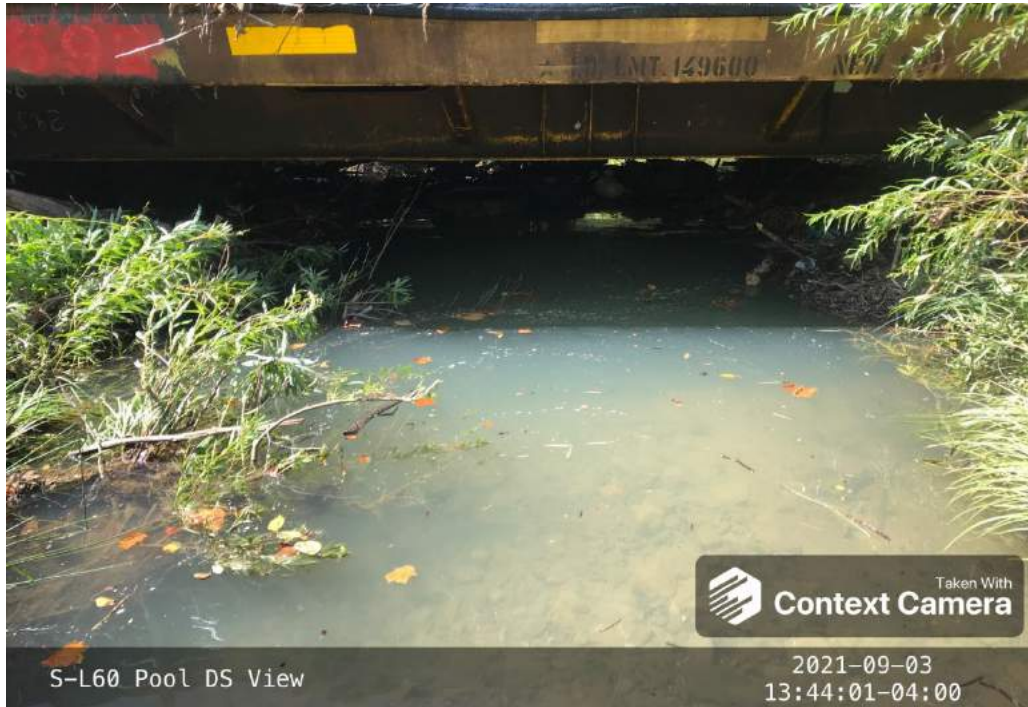
Photo Type: Pool, DS View
Location, Orientation, Photographer Initials: Upstream of Pool, Downstream View, AJE, PI
Lat: 38.824034 Long: -80.524988

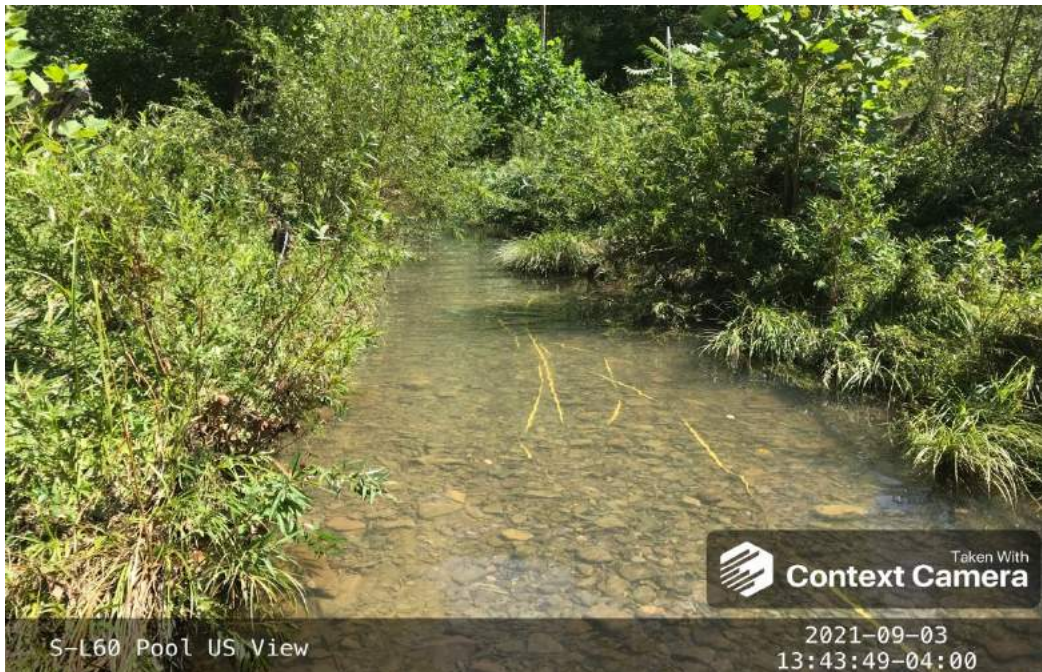
Photo Type: Pool, US View
Location, Orientation, Photographer Initials: Downstream of Pool, Upstream View, AJE, PI
Lat: 38.824034 Long: -80.524988

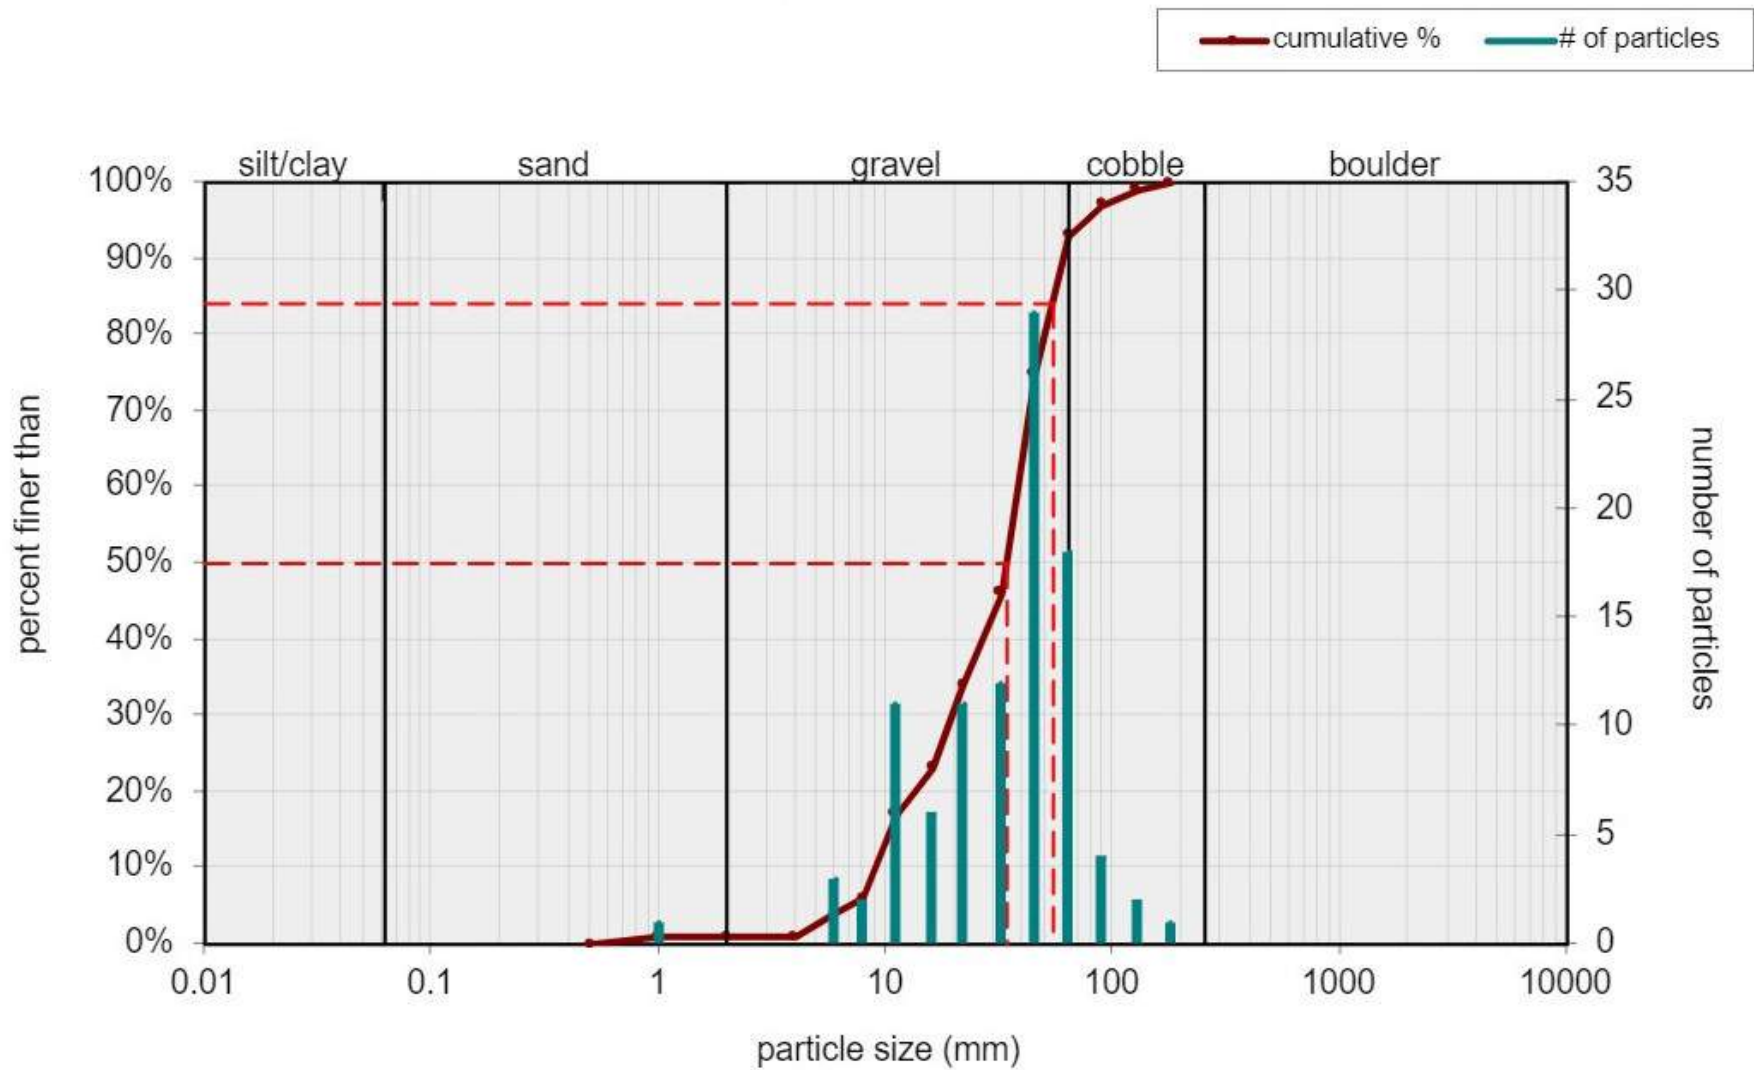
Bankfull Channel Pebble Count, S-L60, Left Fork Knawl Creek

Size (mm)	
D16	11
D35	23
D50	34
D65	40
D84	54
D95	76

Size Distribution	
mean	24.4
dispersion	2.3
skewness	-0.17

Type	
silt/clay	0%
sand	1%
gravel	92%
cobble	7%
boulder	0%

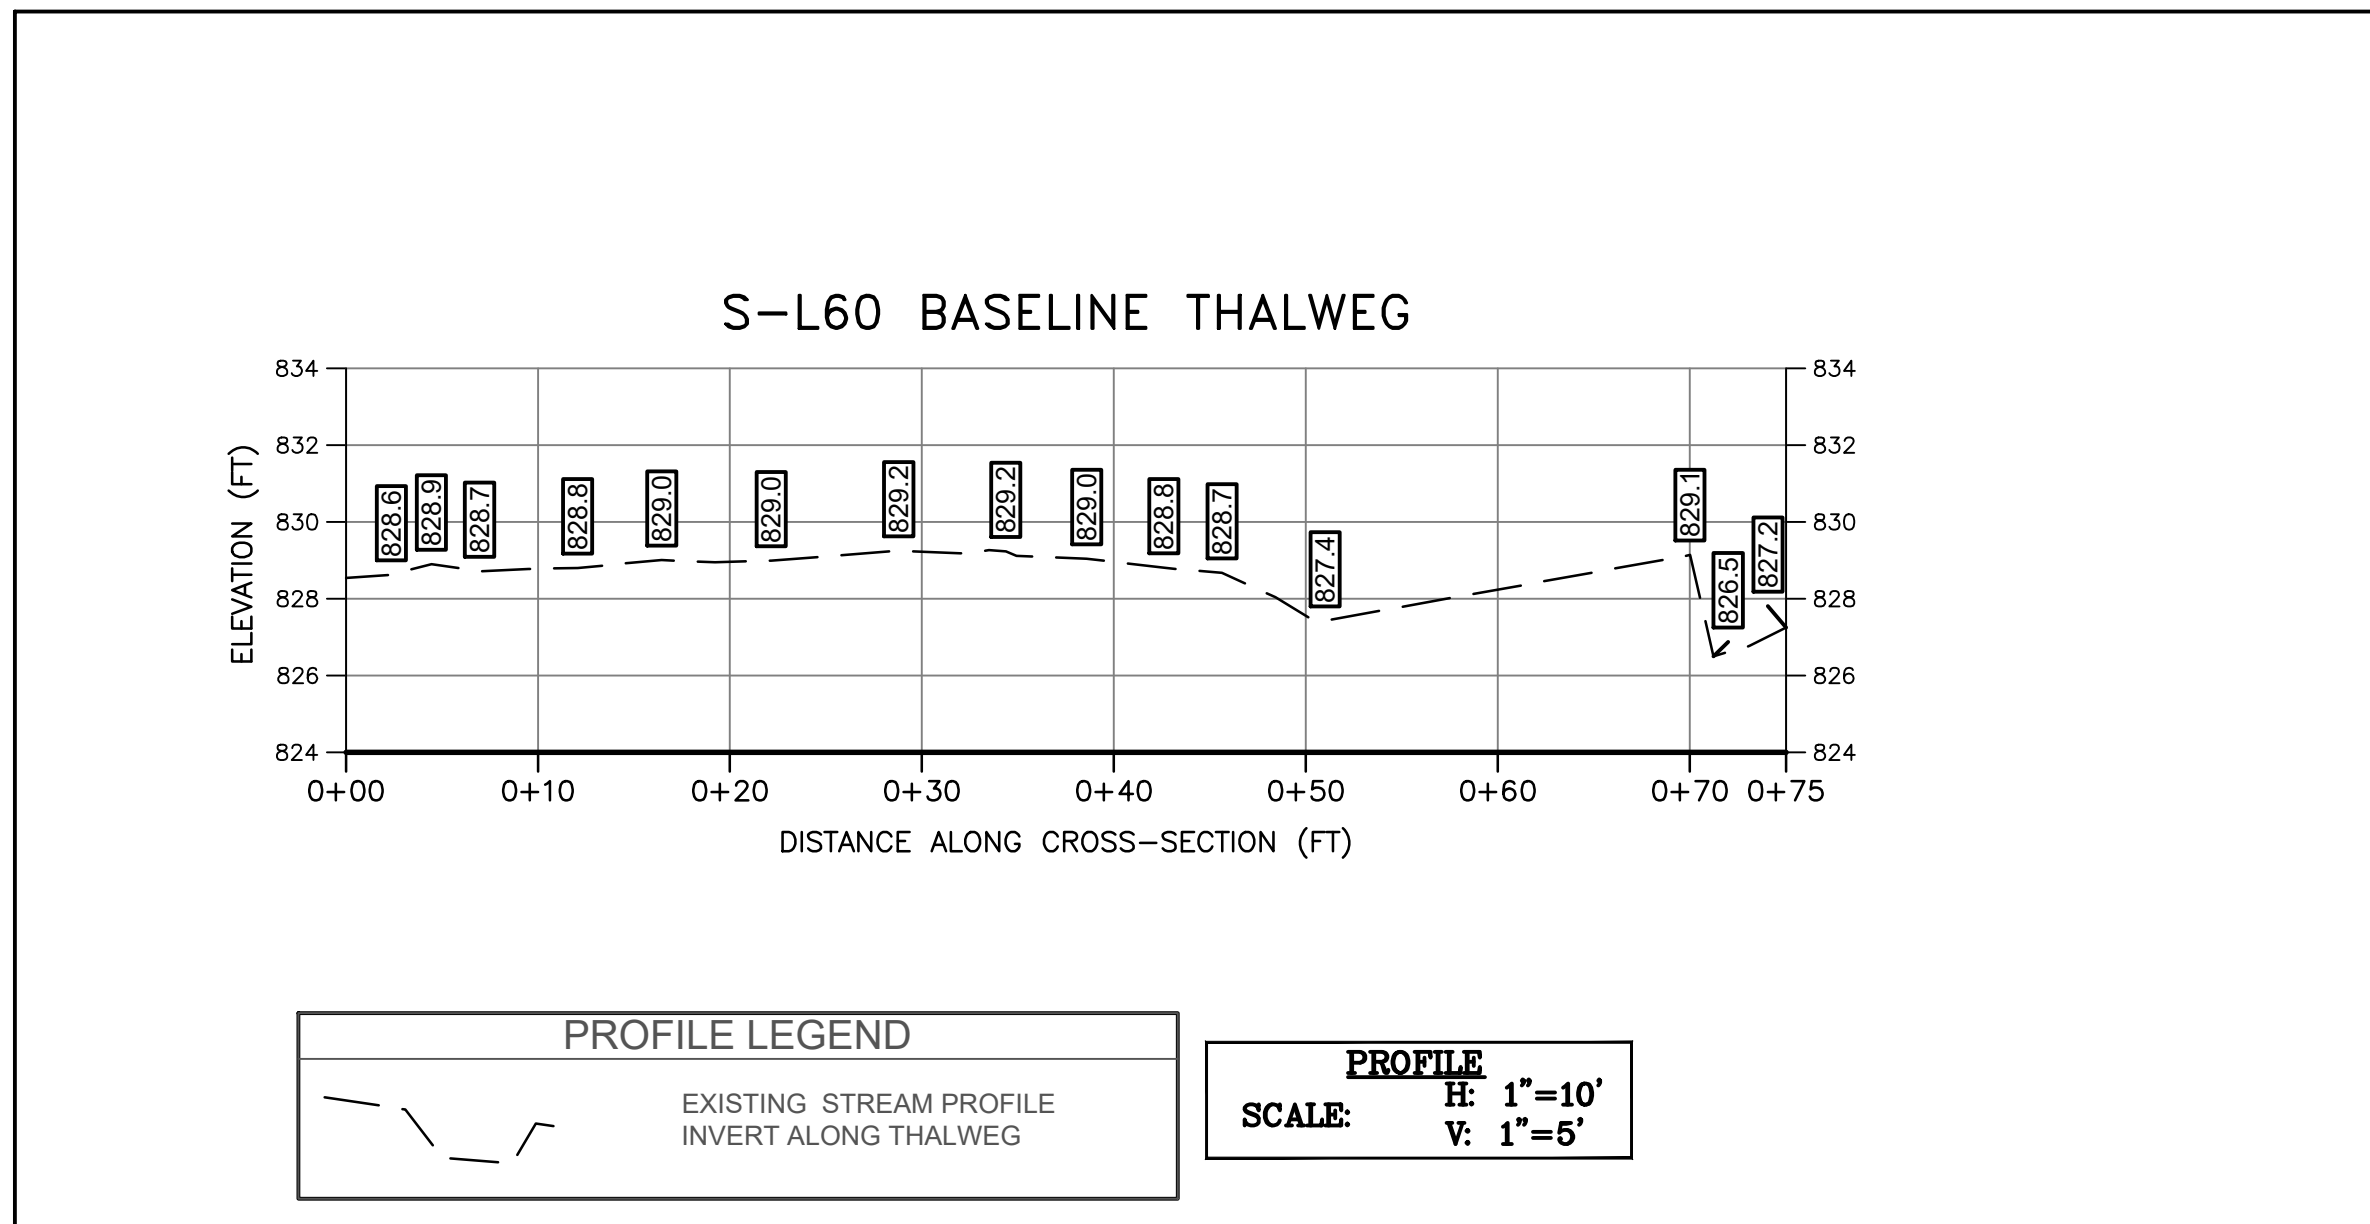
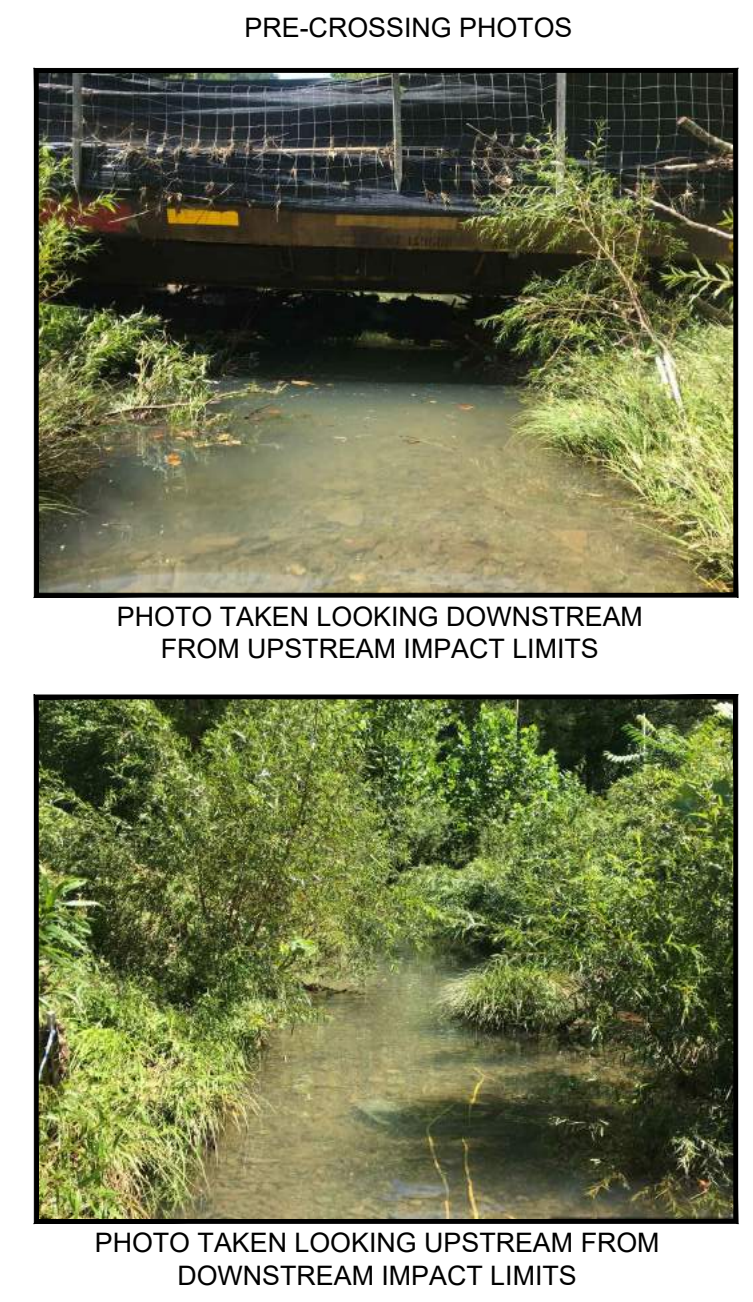
- ALL SECTION VIEWS SHOWN LEFT TO RIGHT FACING DOWNSTREAM.
 - POST-CROSSING SURVEY INFORMATION SHOWN IN RED. DATA PENDING.
 - POST-CROSSING SURVEY POINTS FOR CROSS SECTIONS AND THALWEG ARE PROJECTED ONTO PRE-CROSSING SECTION AND PROFILE VIEWS FOR COMPARISON.

AS-BUILT TABLE: S-L60 CROSS SECTION A					
PT. LOC.	PRE-CROSSING			AS-BUILT	
	NORTHING	EASTING	ELEV.	VERT. DIFF.	HORZ. DIFF.
TS-L	14098913.0750	1775701.1020	830.993'		
BS-L	14098911.7240	1775700.7140	830.146'		
THW	14098908.3470	1775698.2920	829.119'		
BS-R	14098902.6060	1775697.9640	830.038'		
TS-R	14098895.7180	1775696.4600	832.227'
