Baseline Assessment – Stream Attributes

Reach S-N14 (1) (Timber Mat Crossing) Perennial Spread D Nicholas County, West Virginia

Title
 PROFILE AND CROSS-SECTIONS
 BASELINE SURVEY
 CROSSING S-N14 (1) - GRANNY RUN
 (MP 117.02)
 NICHOLAS COUNTY, WV

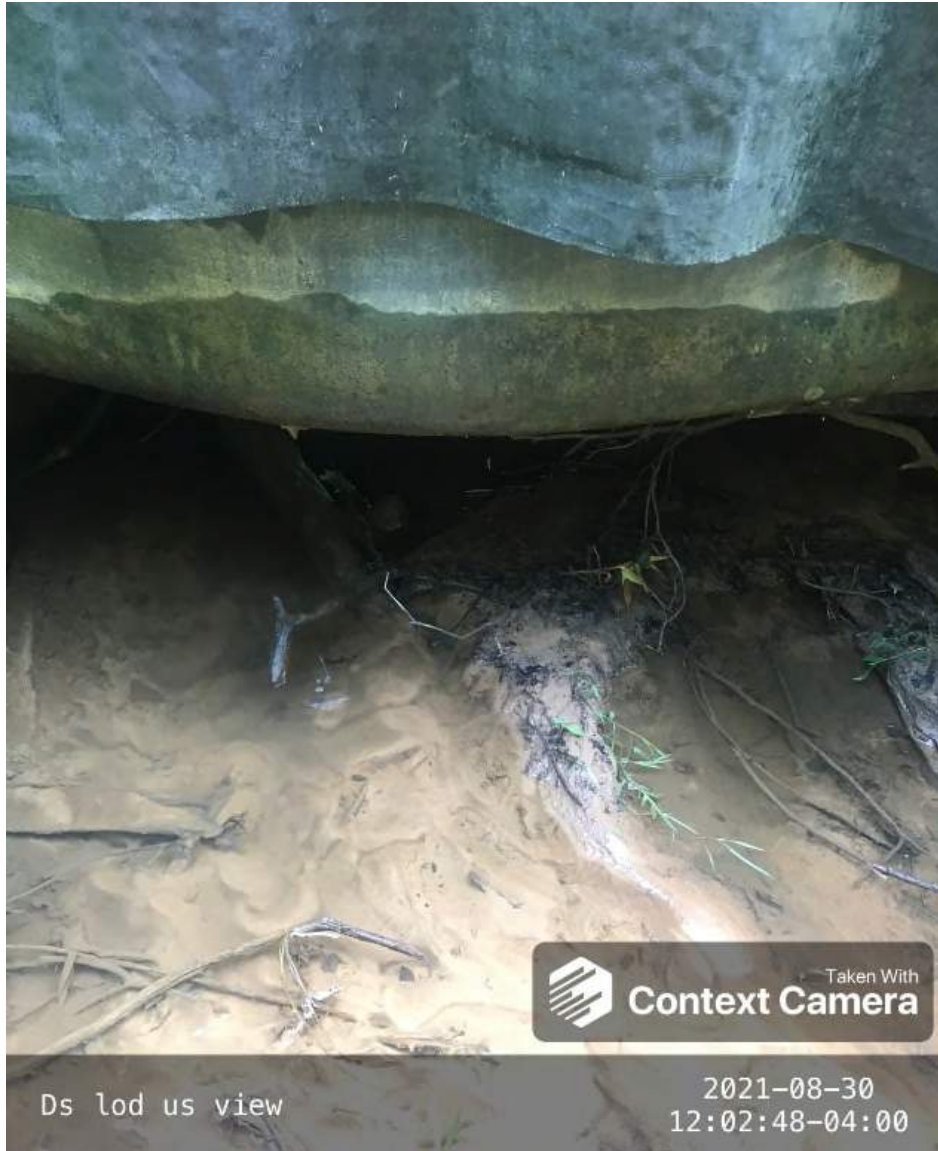
Photo Type: DS, US View

Location, Orientation, Photographer Initials: Downstream Edge of ROW, Upstream View, JM/SM
Lat: 38.297014 Long: -80.676341

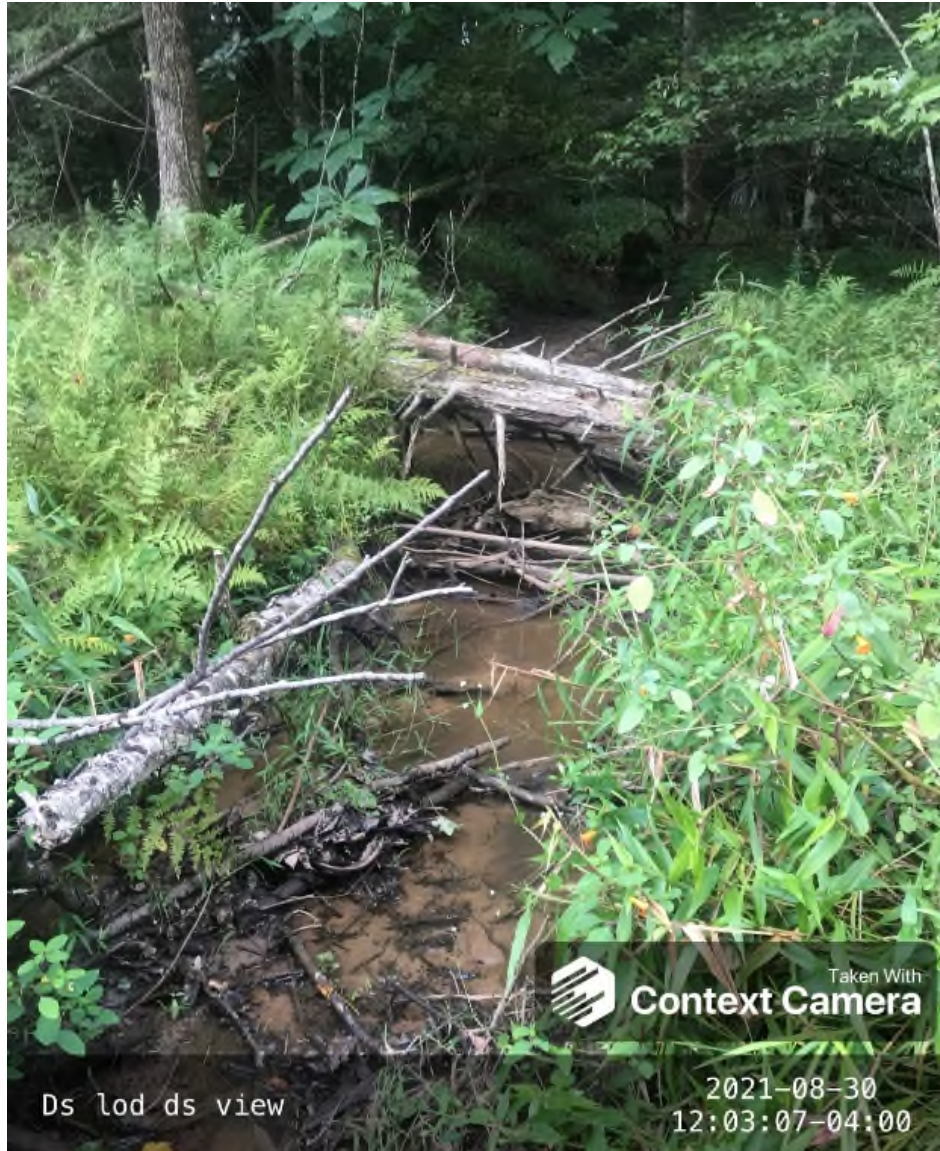
Photo Type: DS, DS View

Location, Orientation, Photographer Initials: Downstream Edge of ROW, Downstream View, JM/SM
Lat: 38.297014 Long: -80.676341

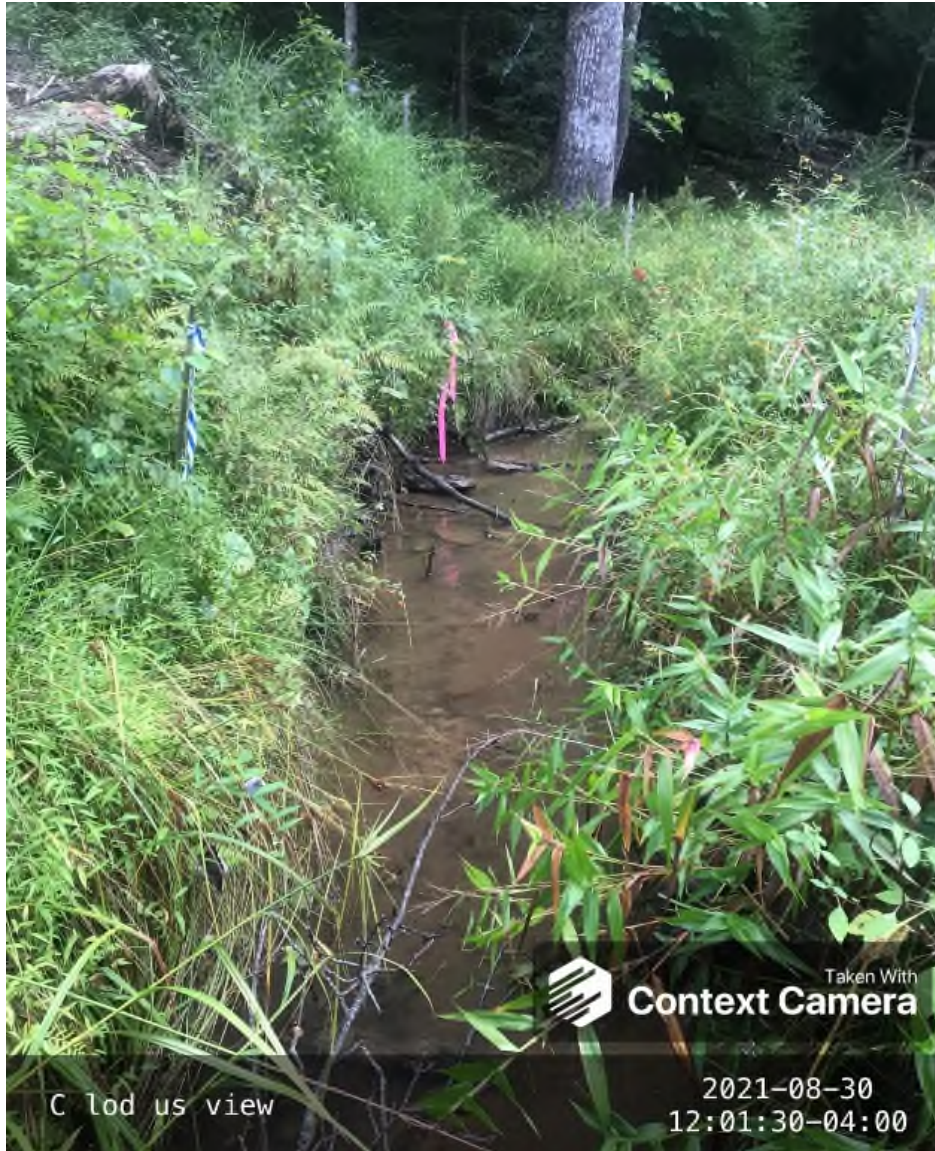
Photo Type: US View at Center
Location, Orientation, Photographer Initials: Center ROW, Upstream View, JM/SM
Lat: 38.297014 Long: -80.676341

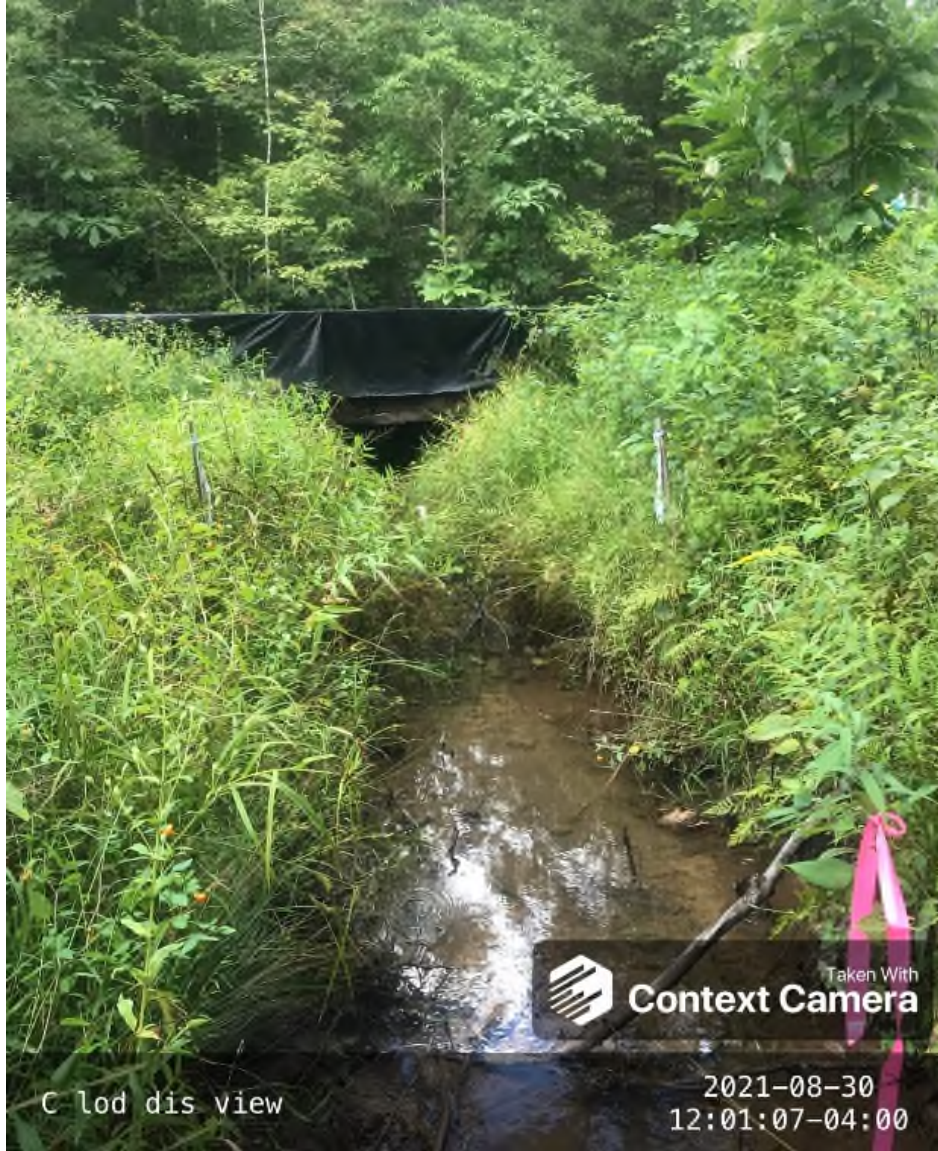
Photo Type: DS View at Center
Location, Orientation, Photographer Initials: ROW Center, Downstream View, JM/SM
Lat: 38.297014 Long: -80.676341

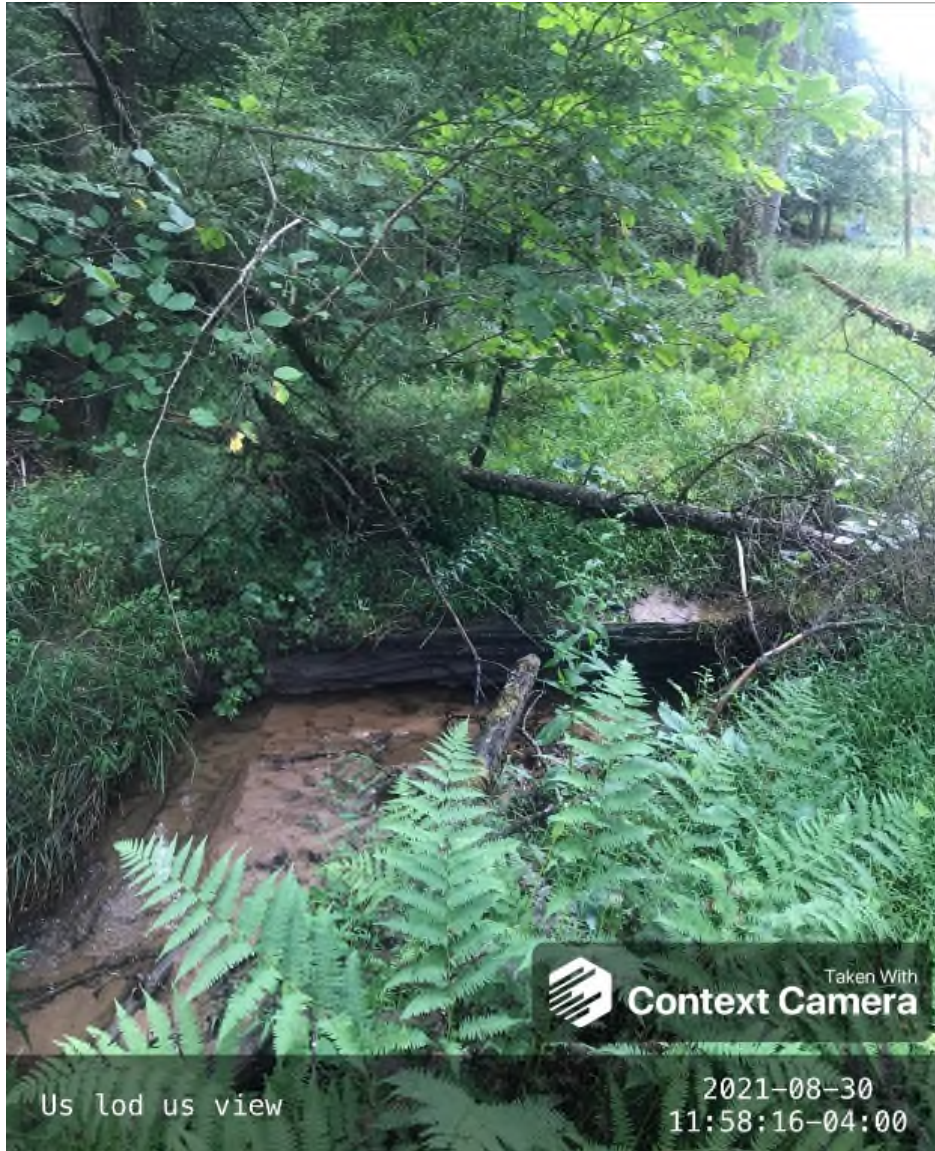
Photo Type: US, US View
Location, Orientation, Photographer Initials: Upstream Edge of ROW, Upstream View, JM/SM
Lat: 38.297014 Long: -80.676341

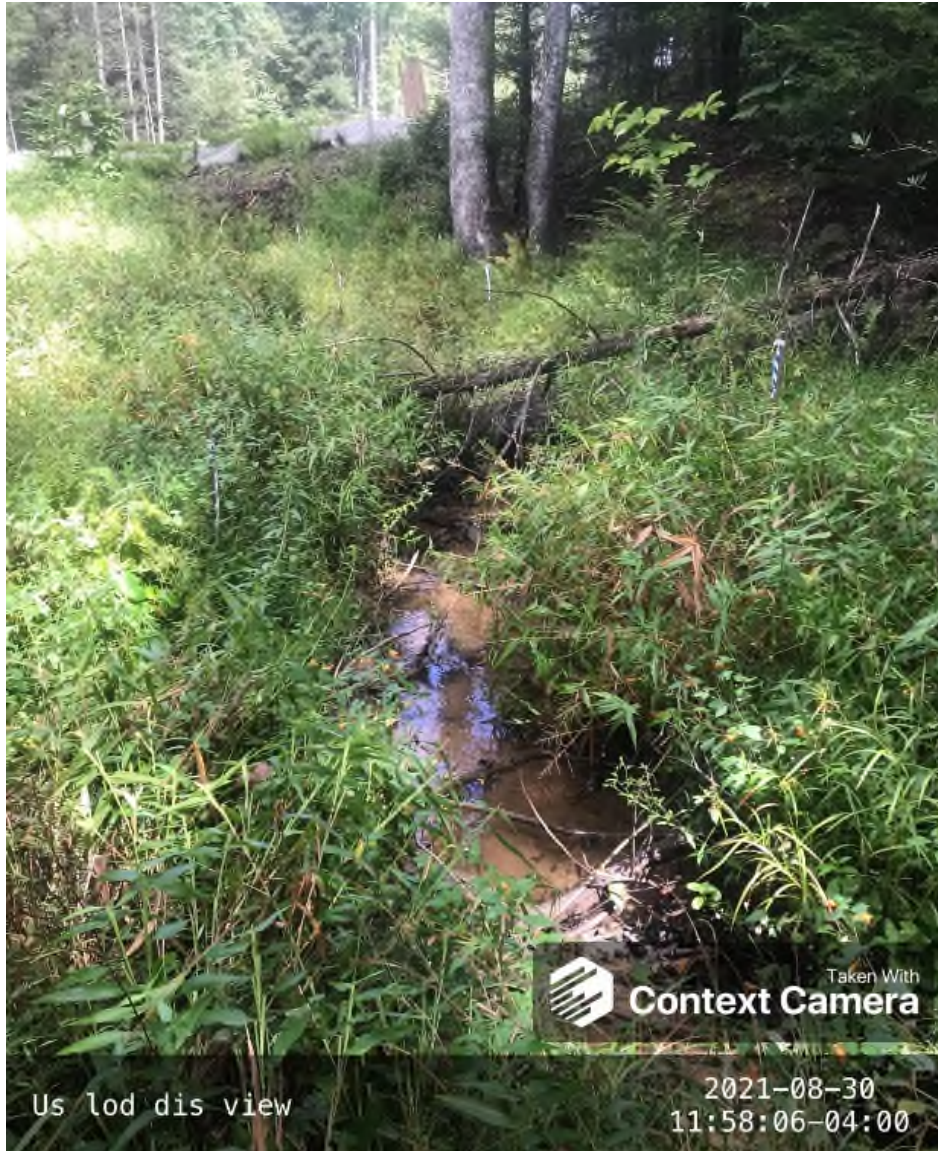
Photo Type: US, DS View

Location, Orientation, Photographer Initials: Upstream Edge of ROW, Downstream View, JM/SM
Lat: 38.297014 Long: -80.676341

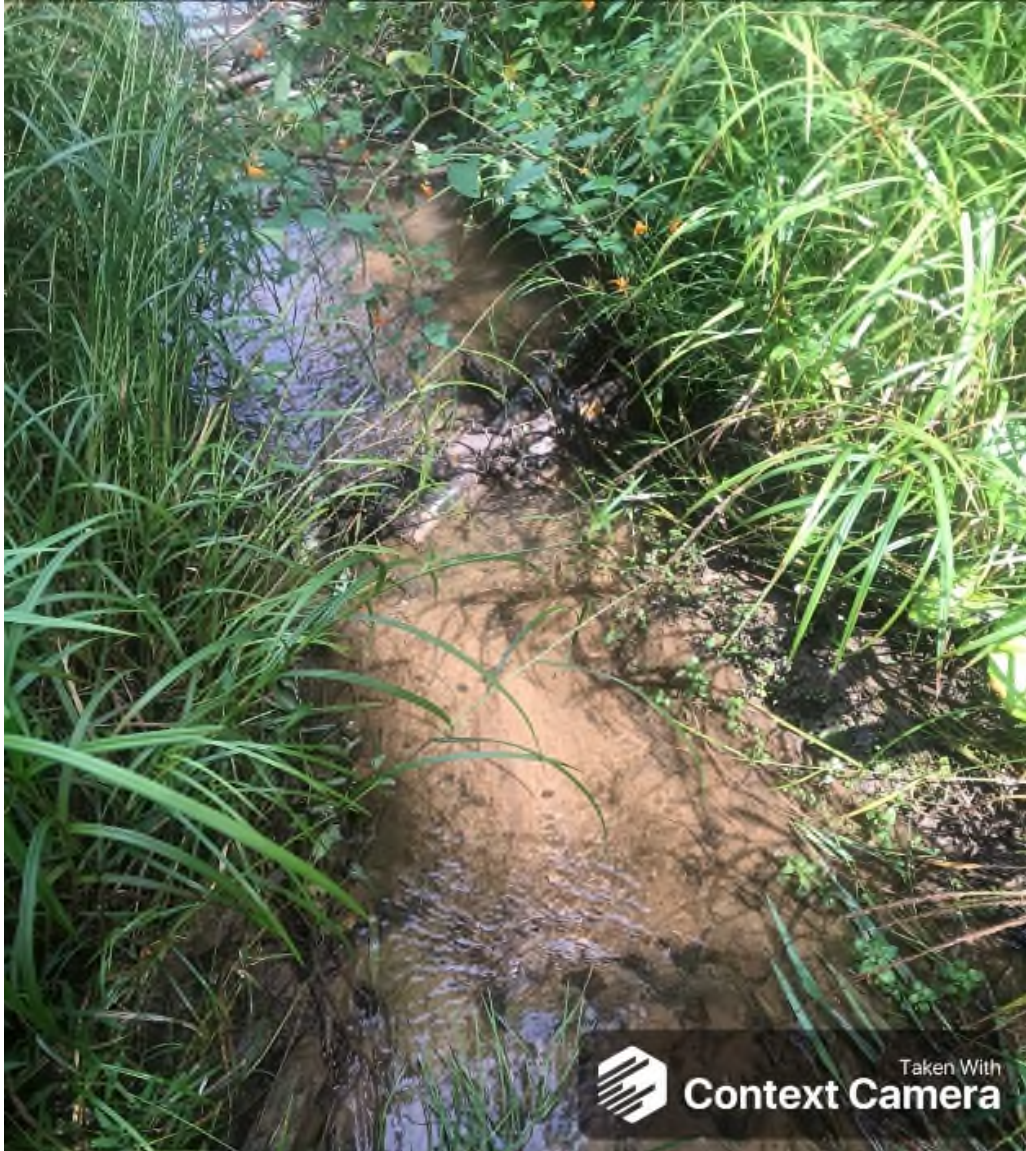
Photo Type: Pool, DS View
Location, Orientation, Photographer Initials: Upstream of Pool, Downstream View, JM/SM
Lat: 38.297014 Long: -80.676341

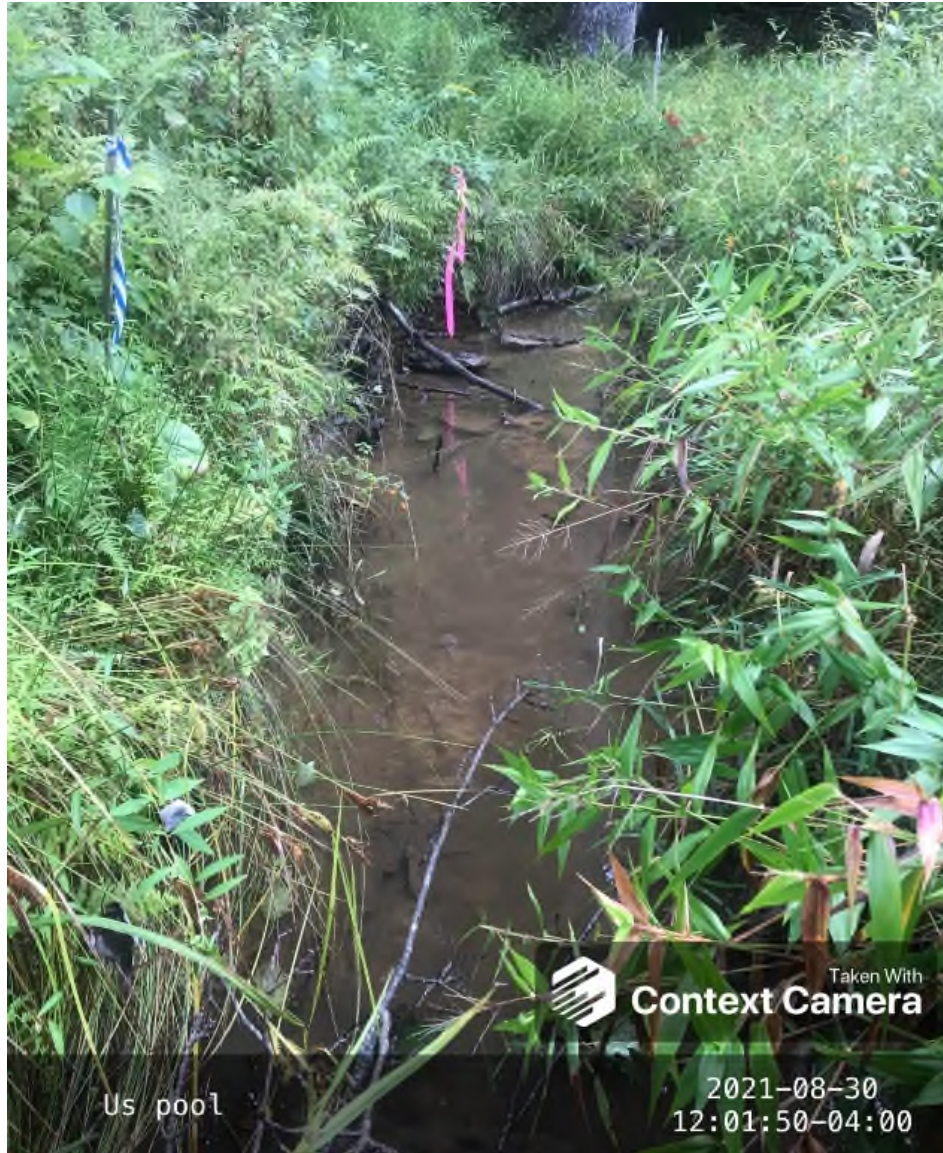
Photo Type: Pool, US View
Location, Orientation, Photographer Initials: Downstream of Pool, Upstream View, JM/SM
Lat: 38.297014 Long: -80.676341

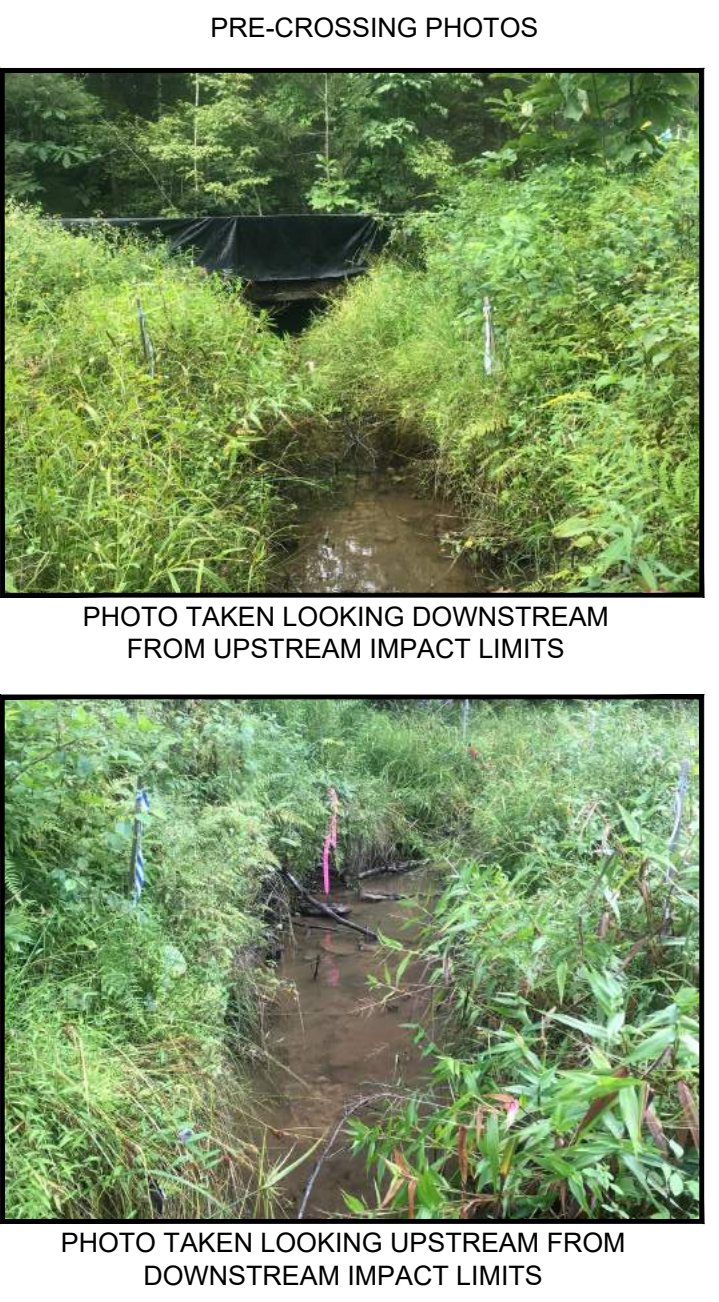
- EASEMENT LINES SHOWN ON PLAN VIEW WERE PROVIDED BY MOUNTAIN VALLEY PIPELINE.
 - SURVEY POINTS FOR CROSS SECTIONS AND THALWEG PROFILES COLLECTED IN 2021 HAVE BEEN USED IN COMBINATION WITH SURVEY POINTS COLLECTED PREVIOUSLY IN 2020 IN ORDER TO GENERATE THE PRE-CROSSING SURFACE SHOWN IN PLAN. DUE TO NATURAL EROSIONAL STREAM PROCESSES THAT CAN OCCUR OVER TIME, MINOR ADJUSTMENTS TO THE PROFILE ALIGNMENTS MAY HAVE BEEN REQUIRED IN ORDER TO GENERATE A CLEAN PRE-CROSSING SURFACE.

- ALL SECTION VIEWS SHOWN LEFT TO RIGHT FACING DOWNSTREAM.
 - POST-CROSSING SURVEY INFORMATION SHOWN IN RED. DATA PENDING.
 - POST-CROSSING SURVEY POINTS FOR CROSS SECTIONS AND THALWEG ARE PROJECTED ONTO PRE-CROSSING SECTION AND PROFILE VIEWS FOR COMPARISON.

AS-BUILT TABLE: S-N14 (1) CROSS SECTION A

PT. LOC.	PRE-CROSSING			AS-BUILT	
	NORTHING	EASTING	ELEV.	VERT. DIFF.	HORZ. DIFF.
TS-L	13906864.7800	1733257.8440'	2272.813'		
BS-L	13906870.9700	1733259.7970'	2271.946'		
THW	13906874.6000	1733259.3830'	2271.301'		
BS-R	13906877.3300	1733259.9330'	2272.286'		
TS-R	13906884.9300	1733262.4610'	2275.504'
