## Baseline Assessment – Stream Attributes

**Reach S-QR30 (Pipeline ROW)  
Perennial  
Spread C  
Braxton County, West Virginia**

# Spread C Stream S-QR30 (Pipeline ROW) Braxton County

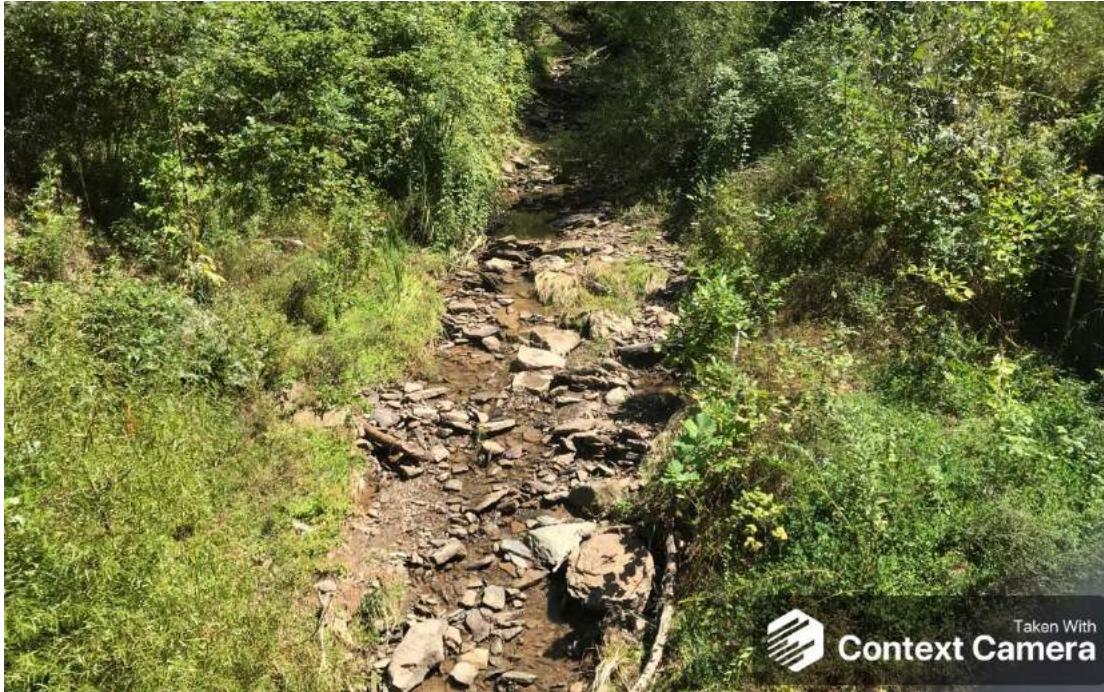
Photo Type: DS, US View  
Location, Orientation, Photographer Initials: Downstream Edge of ROW, Upstream View, DH, HK  
Lat: 38.80794 Long: -80.535715

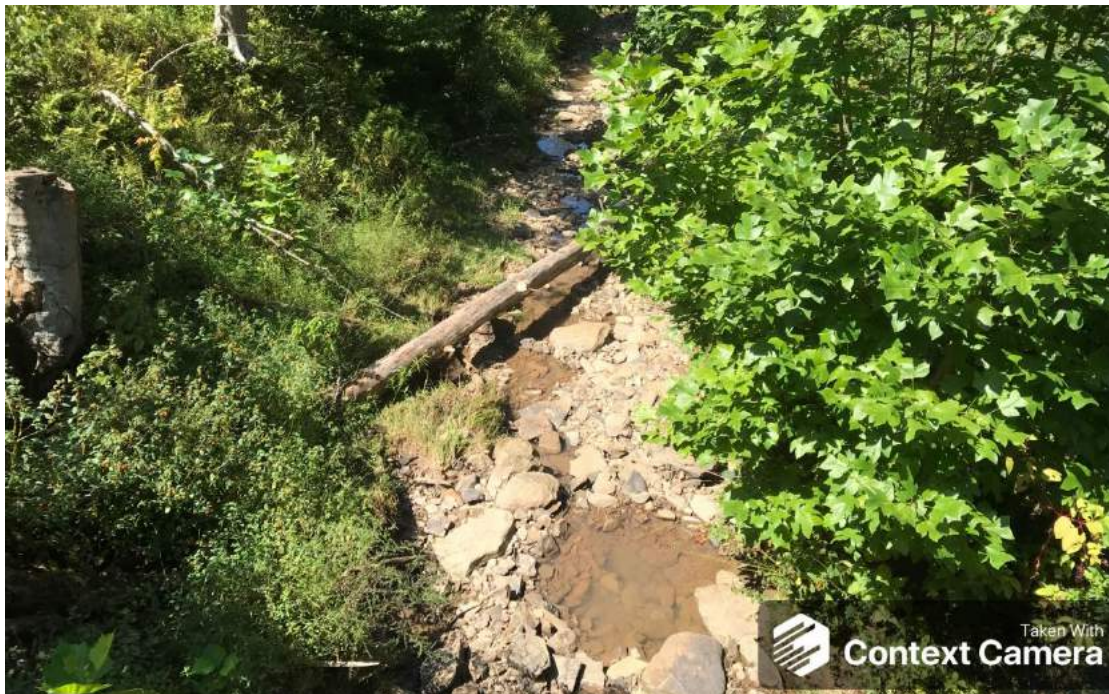
Photo Type: DS, DS View  
Location, Orientation, Photographer Initials: Downstream Edge of ROW, Downstream View, DH, HK  
Lat: 38.80794 Long: -80.535715

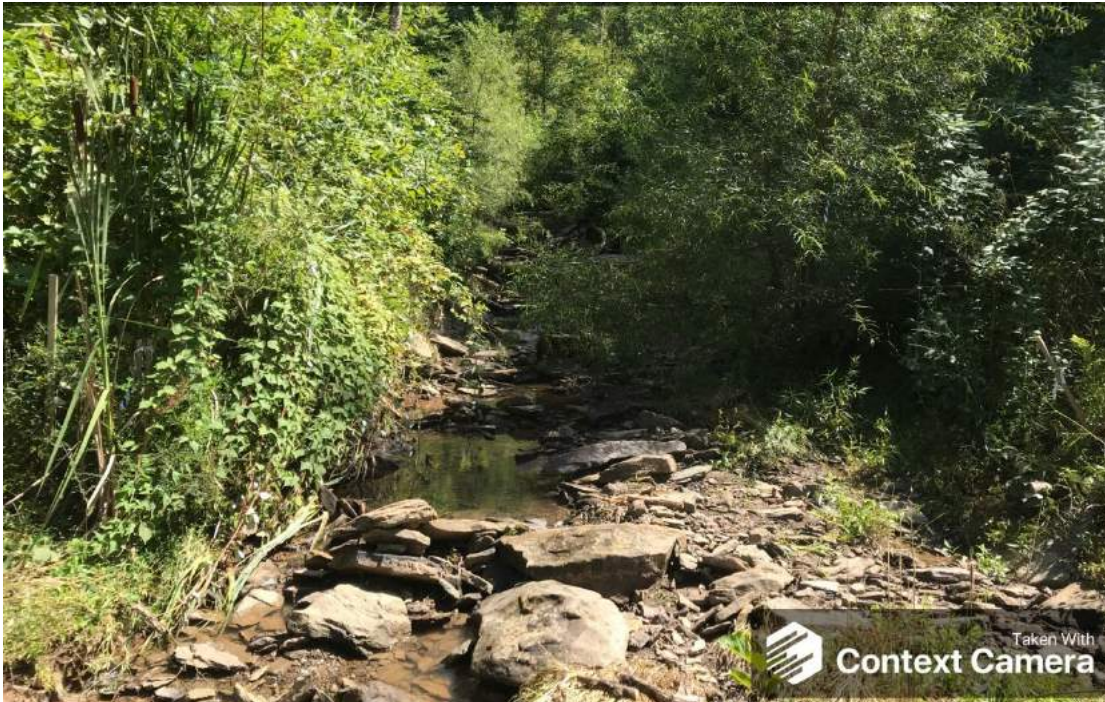
Photo Type: US View at Center  
Location, Orientation, Photographer Initials: Center ROW, Upstream View, DH, HK  
Lat: 38.80794 Long: -80.535715

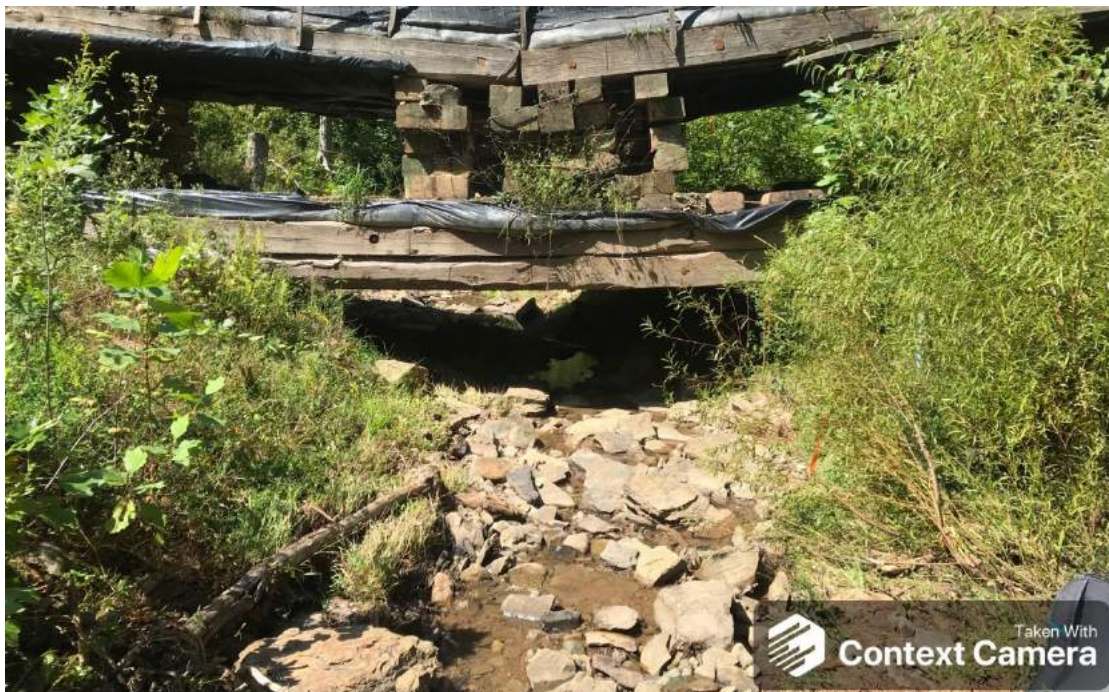
Photo Type: DS View at Center  
Location, Orientation, Photographer Initials: ROW Center, Downstream View, DH, HK  
Lat: 38.80794 Long: -80.535715

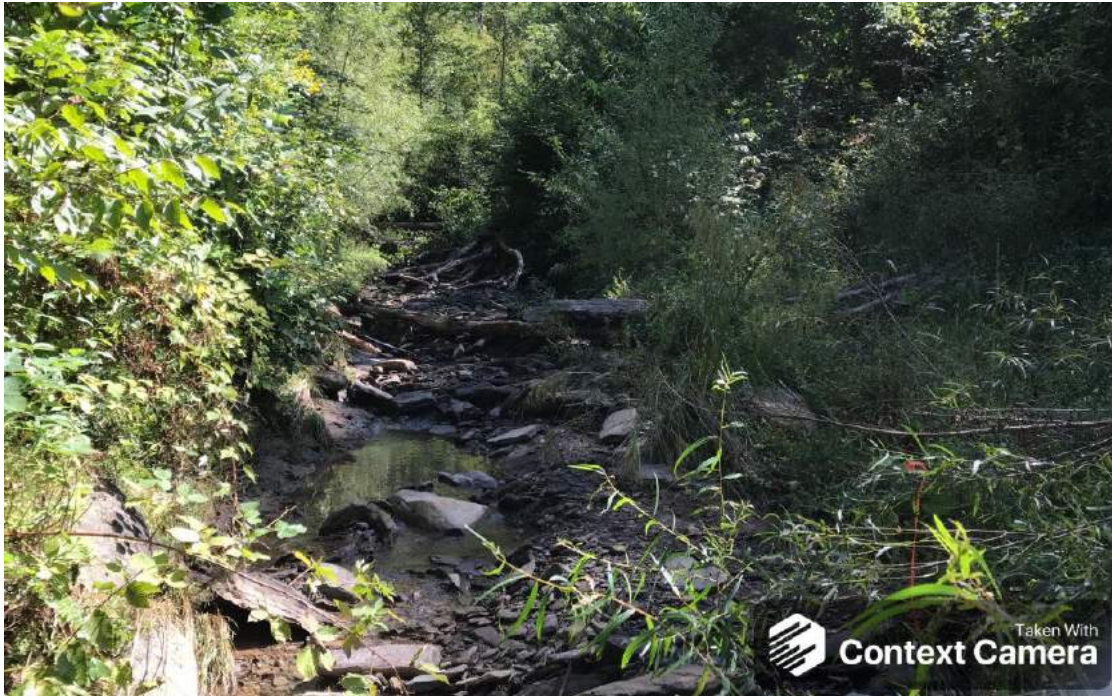
Photo Type: US, US View  
Location, Orientation, Photographer Initials: Upstream Edge of ROW, Upstream View, DH, HK  
Lat: 38.80794 Long: -80.535715

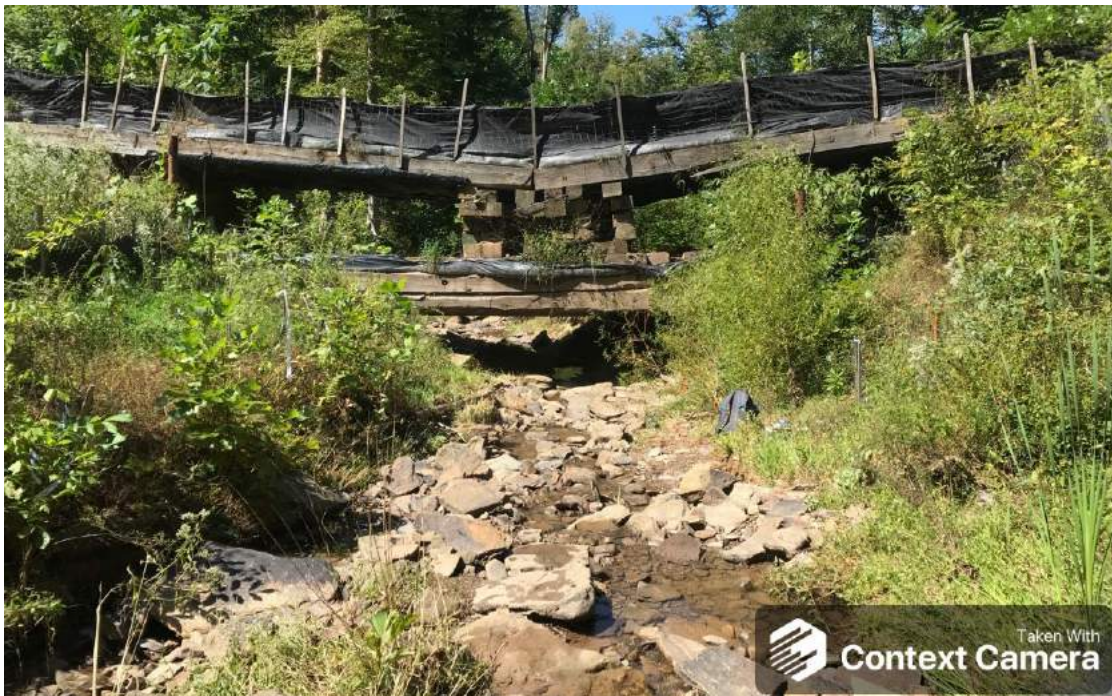
Photo Type: US, DS View  
Location, Orientation, Photographer Initials: Upstream Edge of ROW, Downstream View, DH, HK  
Lat: 38.80794 Long: -80.535715

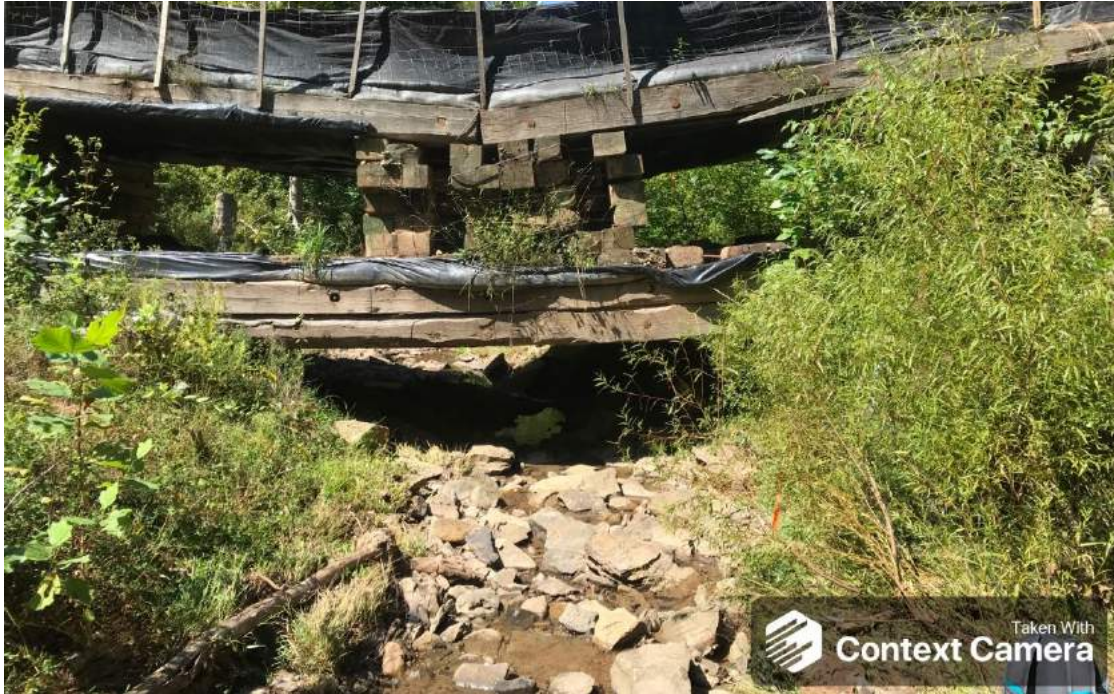
Photo Type: Riffle, DS View  
Location, Orientation, Photographer Initials: Upstream of Riffle, Downstream View, DH, HK  
Lat: 38.80794 Long: -80.535715

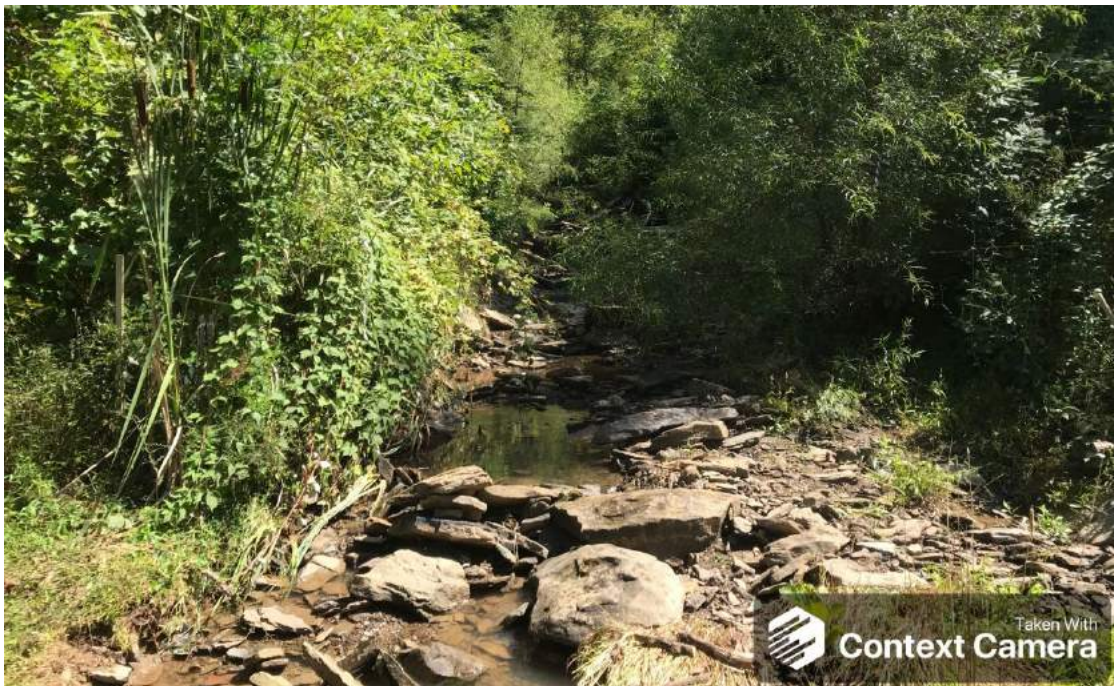
Photo Type: Riffle, US View  
Location, Orientation, Photographer Initials: Downstream of Riffle, Upstream View, DH, HK  
Lat: 38.80794 Long: -80.535715

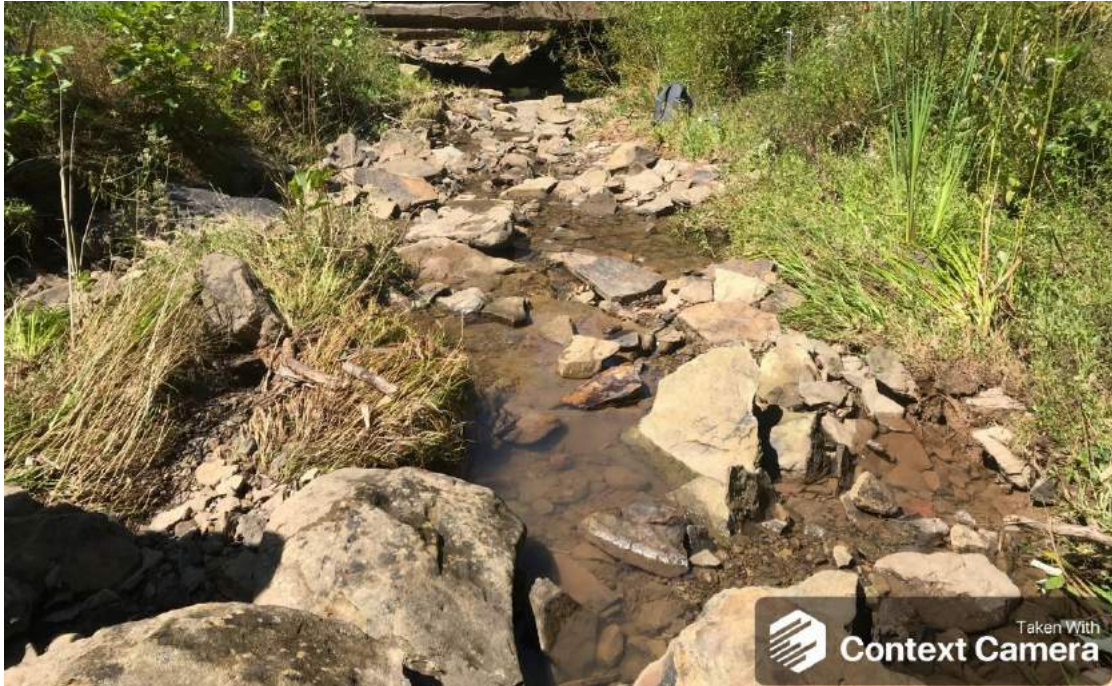
Photo Type: Pool, DS View  
Location, Orientation, Photographer Initials: Upstream of Pool, Downstream View, DH, HK  
Lat: 38.80794 Long: -80.535715

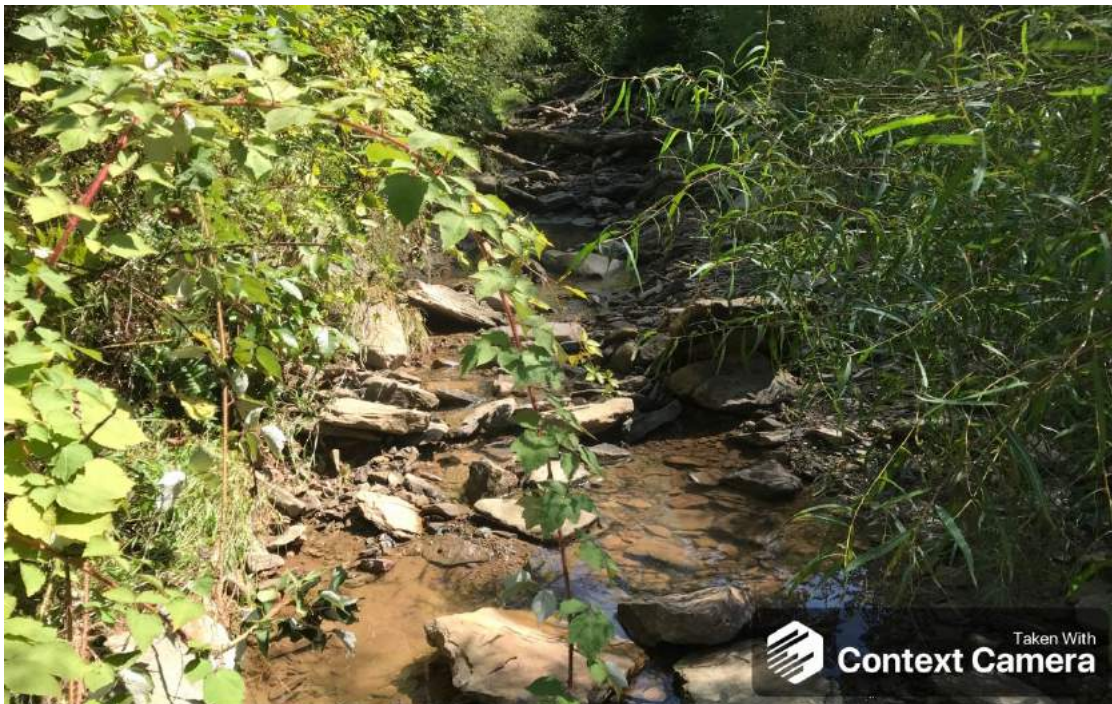
Photo Type: Pool, US View  
Location, Orientation, Photographer Initials: Downstream of Pool, Upstream View, DH, HK  
Lat: 38.80794 Long: -80.535715

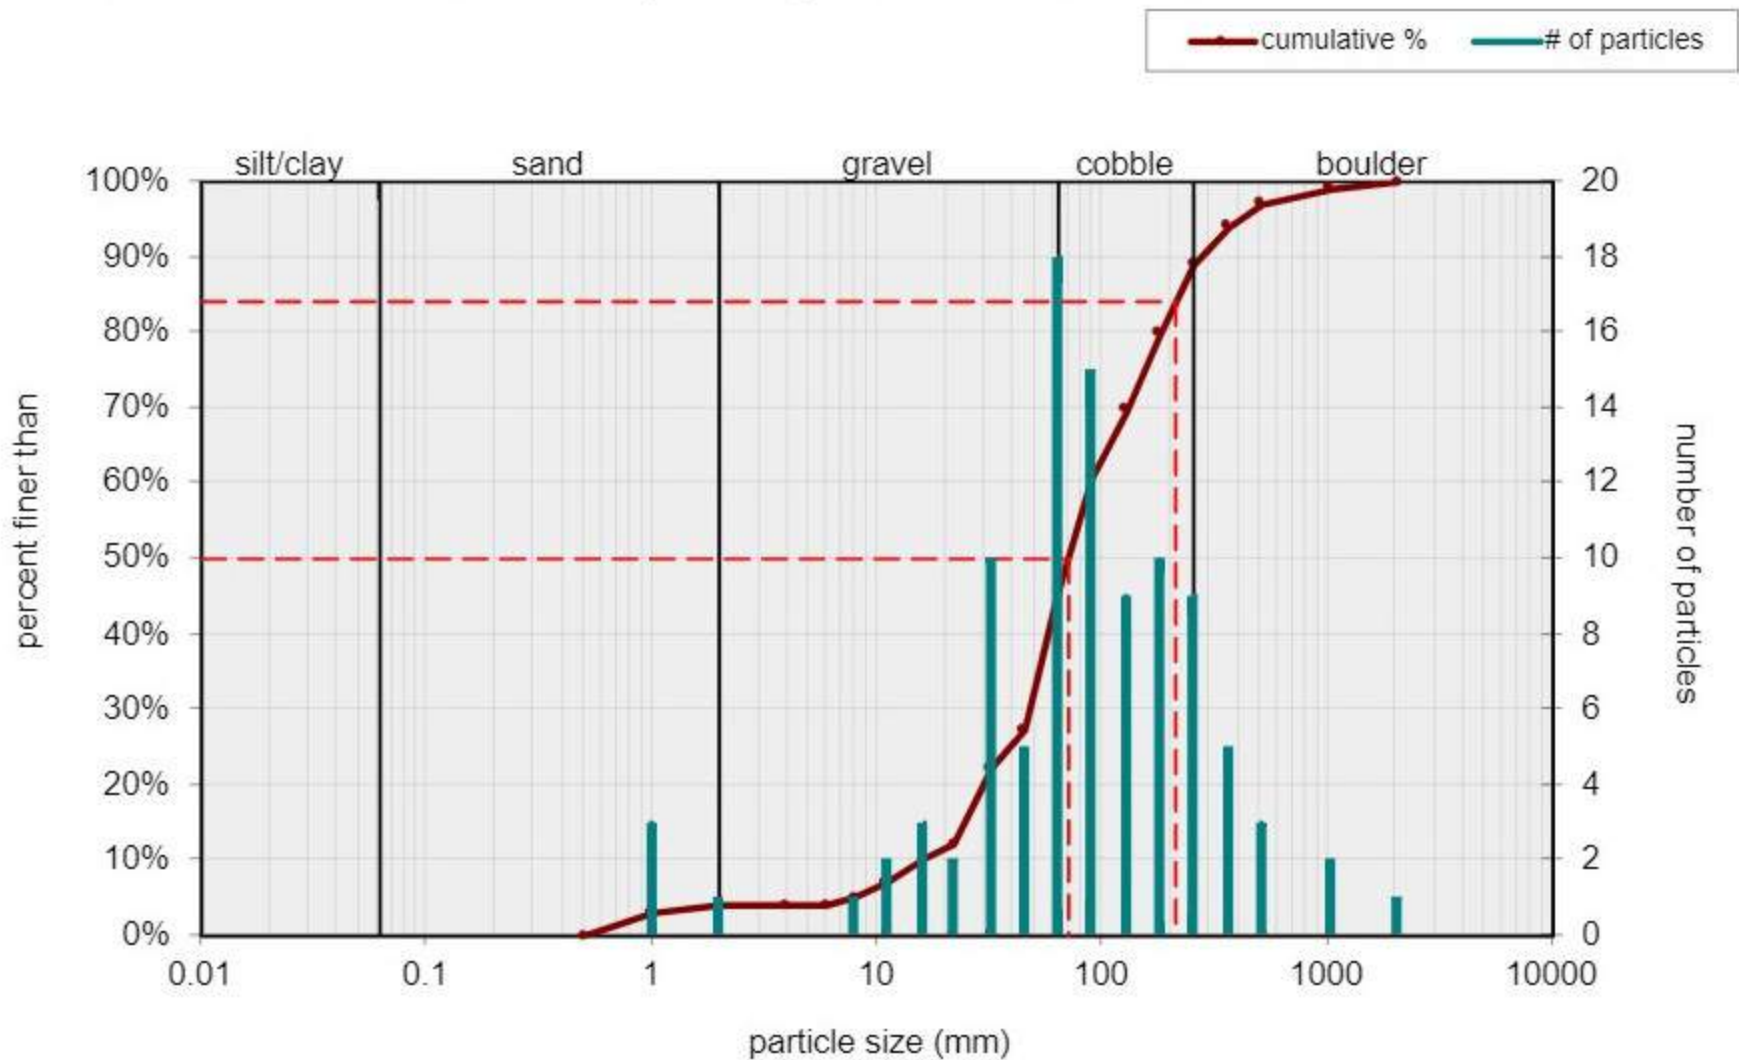
# Bankfull Channel Pebble Count, S-QR30, UNT to Little Knawl Creek

Size (mm)		Size Distribution		Type			
D16	25	mean	72.5	silt/clay	0%	bedrock	1%
D35	52	dispersion	2.9	sand	4%		
D50	71	skewness	0.01	gravel	41%		
D65	110			cobble	43%		
D84	210			boulder	11%		
D95	410
