Baseline Assessment – Stream Attributes

Reach S-UU3 (Pipeline ROW) Perennial Spread A Harrison County, West Virginia

Spread A Stream S-UU3 (Pipeline ROW) Harrison County

Client: MOUNTAIN VALLEY PIPELINE, LLC
Title: PROFILE AND CROSS-SECTIONS BASELINE SURVEY
CROSSING S-UU3 - UNNAMED TRIB. TO SALEM FORK (MP 25.90)
HARRISON COUNTY, WV

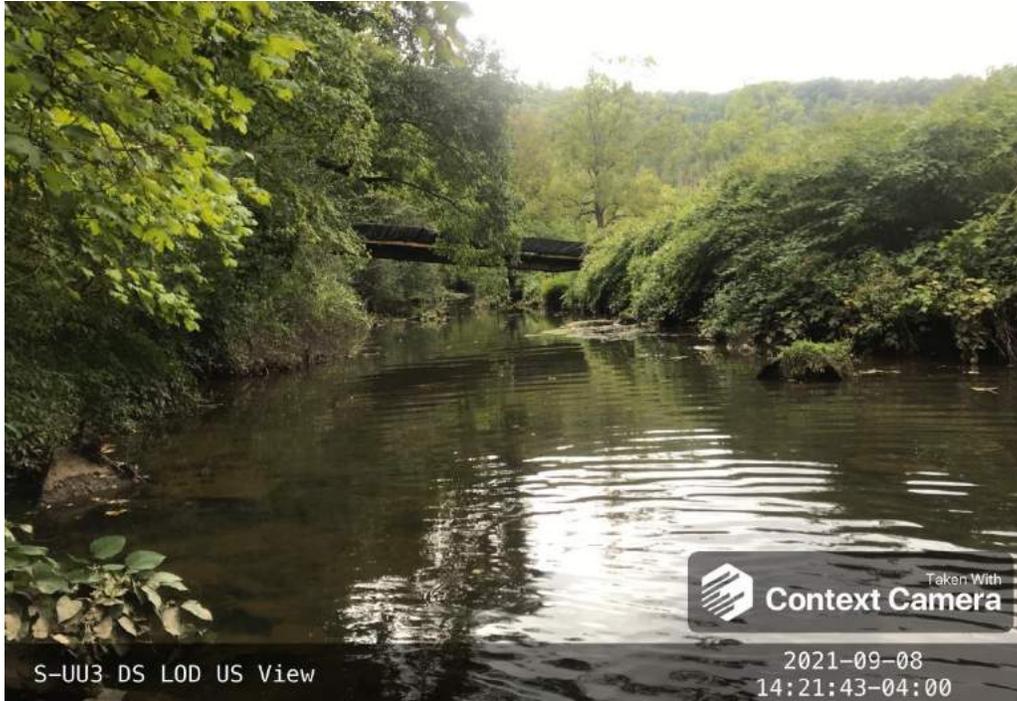
Photo Type: DS, US View
Location, Orientation, Photographer Initials: Downstream Edge of ROW, Upstream View, KY/AJ/DS
Lat: 39.28987 Long: -80.517903

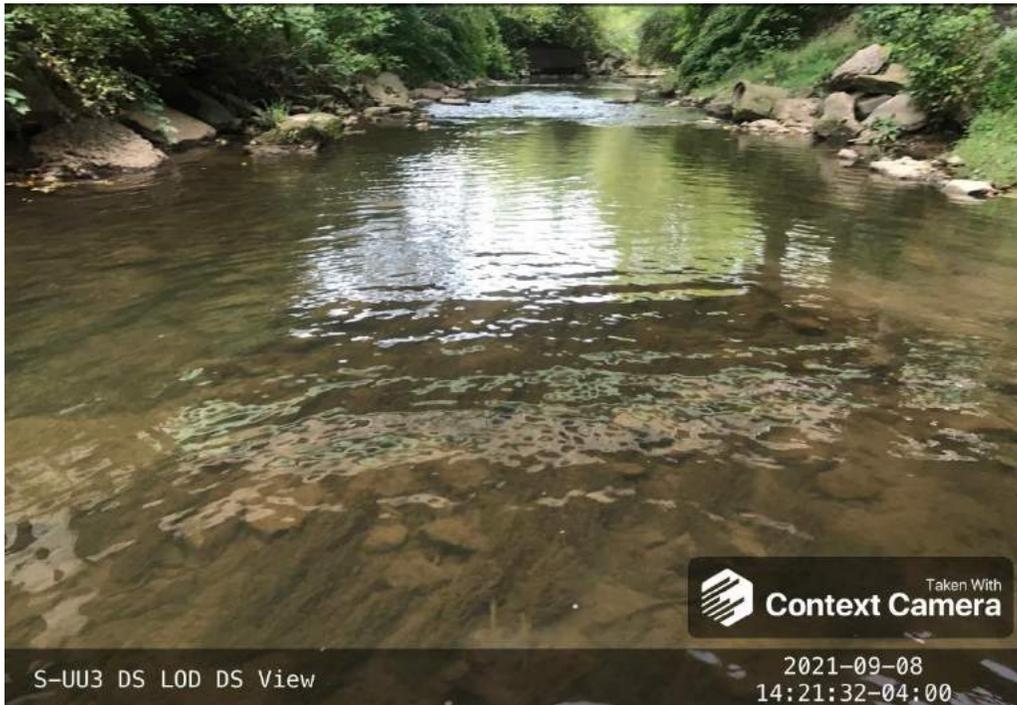
Photo Type: DS, DS View
Location, Orientation, Photographer Initials: Downstream Edge of ROW, Downstream View, KY/AJ/DS
Lat: 39.28987 Long: -80.517903

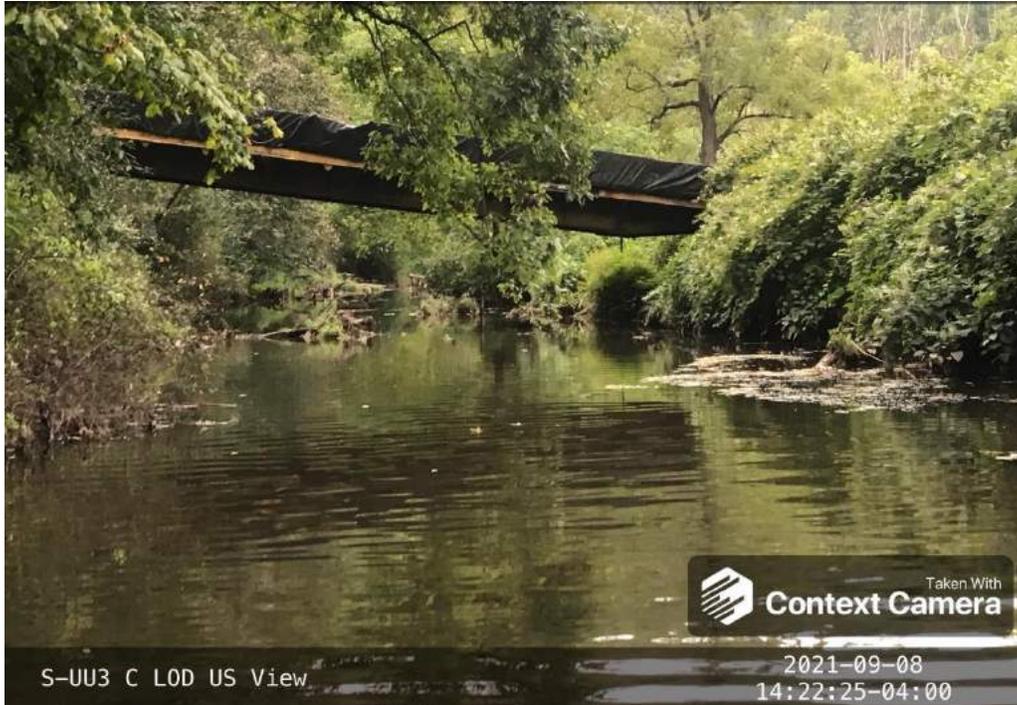
Photo Type: US View at Center
Location, Orientation, Photographer Initials: Center ROW, Upstream View, KY/ AJ/ DS
Lat: 39.28987 Long: -80.517903

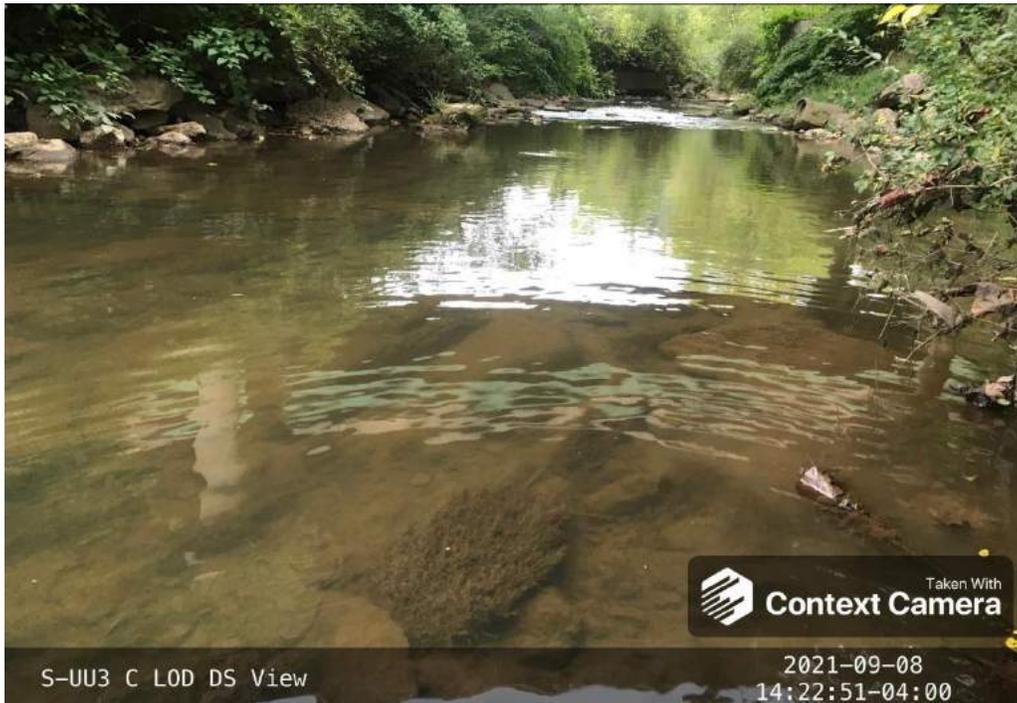
Photo Type: DS View at Center
Location, Orientation, Photographer Initials: ROW Center, Downstream View, KY/AJ/ DS
Lat: 39.28987 Long: -80.517903

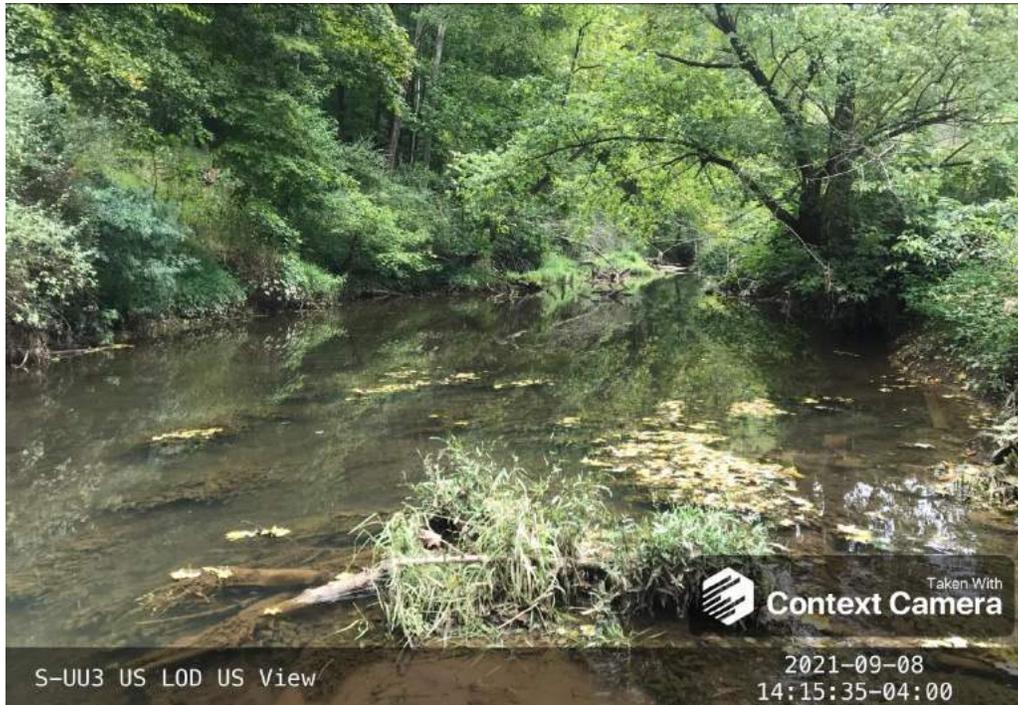
Photo Type: US, US View
Location, Orientation, Photographer Initials: Upstream Edge of ROW, Upstream View, KY/ AJ/ DS
Lat: 39.28987 Long: -80.517903

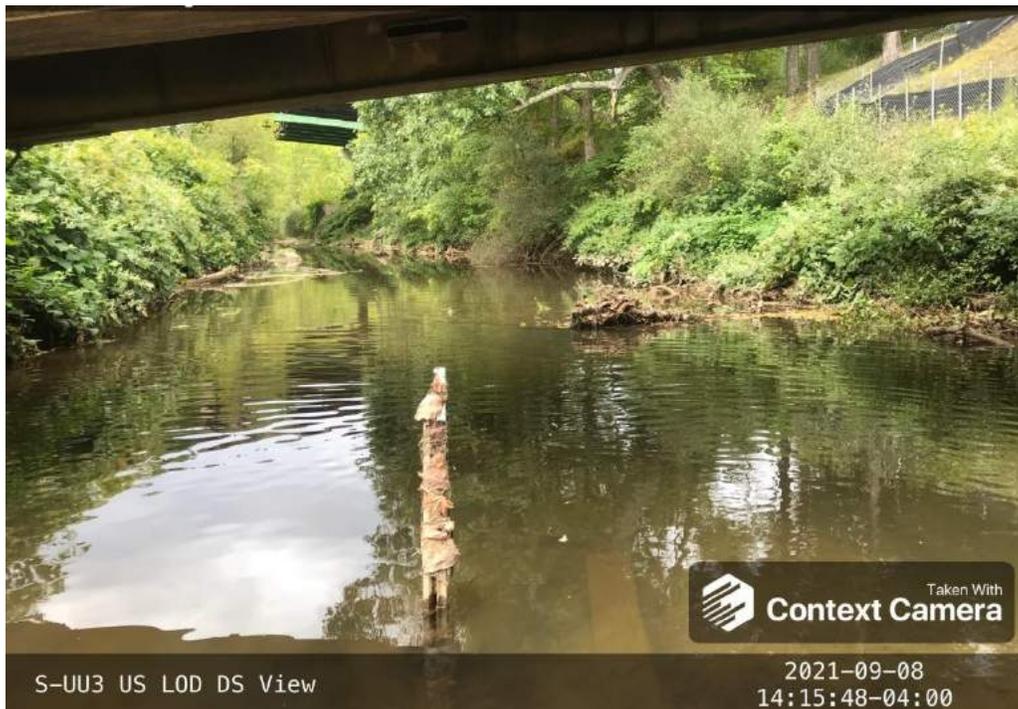
Photo Type: US, DS View
Location, Orientation, Photographer Initials: Upstream Edge of ROW, Downstream View, KY/AJ/ DS
Lat: 39.28987 Long: -80.517903

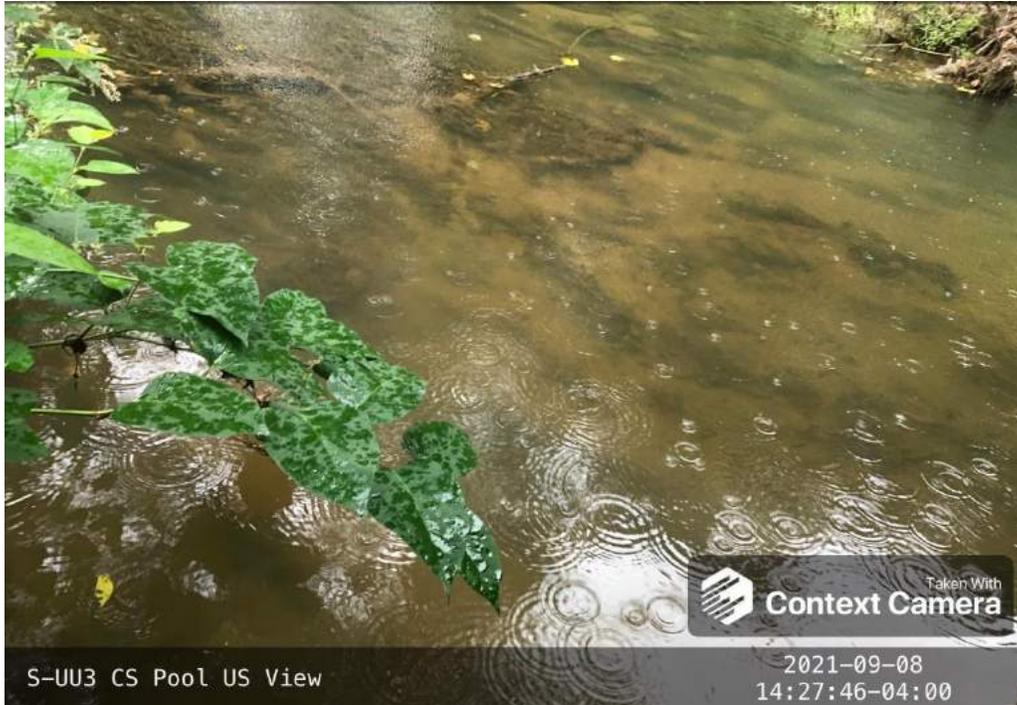
Photo Type: Pool, US View
Location, Orientation, Photographer Initials: Downstream of Pool, Upstream View, KY/AJ/DS
Lat: 39.28987 Long: -80.517903

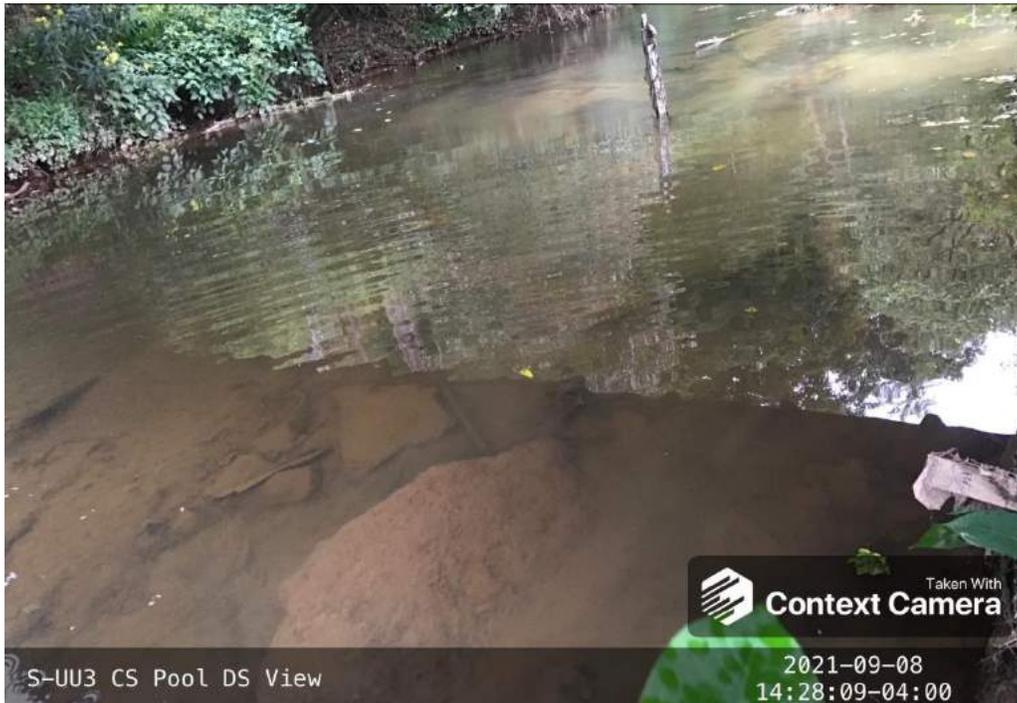
Photo Type: Pool, DS View
Location, Orientation, Photographer Initials: Upstream of Pool, Downstream View, KY/AJ/DS
Lat: 39.28987 Long: -80.517903

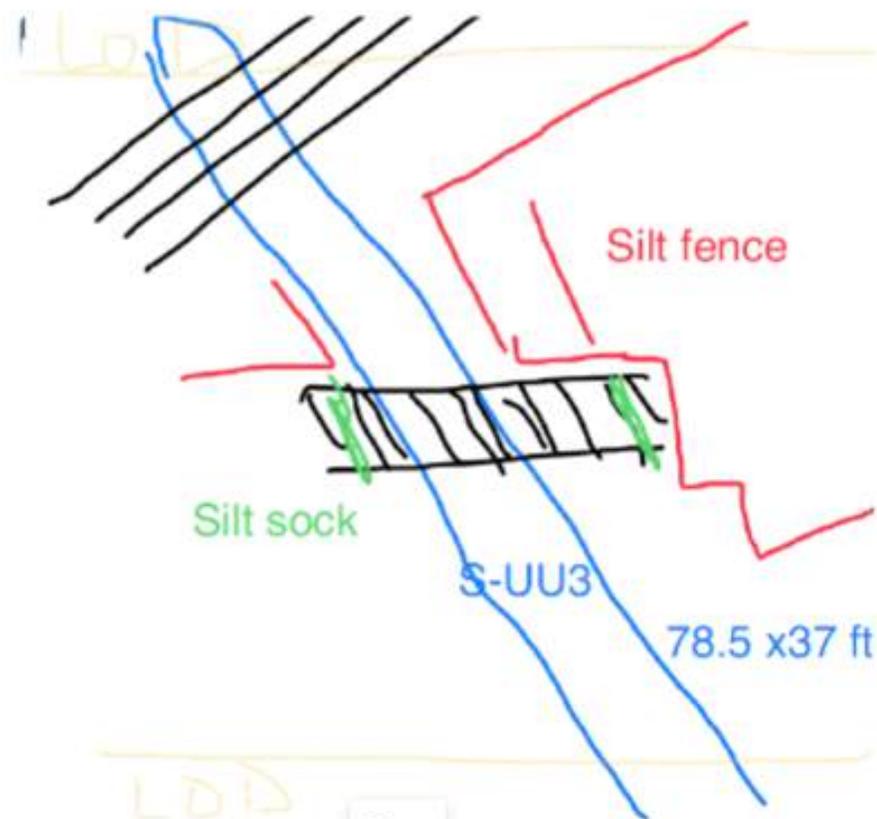
<p>The map shows a blue stream labeled 'S-UU3' flowing from the top left towards the bottom right. A red line representing a 'Silt fence' is drawn across the stream. A green rectangle labeled 'Silt sock' is placed in the stream just upstream of the silt fence. The stream's width is noted as '78.5 x 37 ft'. There are some handwritten 'LDD' markings on the map.</p>		
STREAM CHARACTERIZATION	Stream Subsystem Perennial Intermittent Tidal Stream Origin Glacial Non-glacial montane Swamp and bog Spring-fed Mixture of origins Other _____		
	Stream Type Coldwater Warmwater Catchment Area _____ km ²

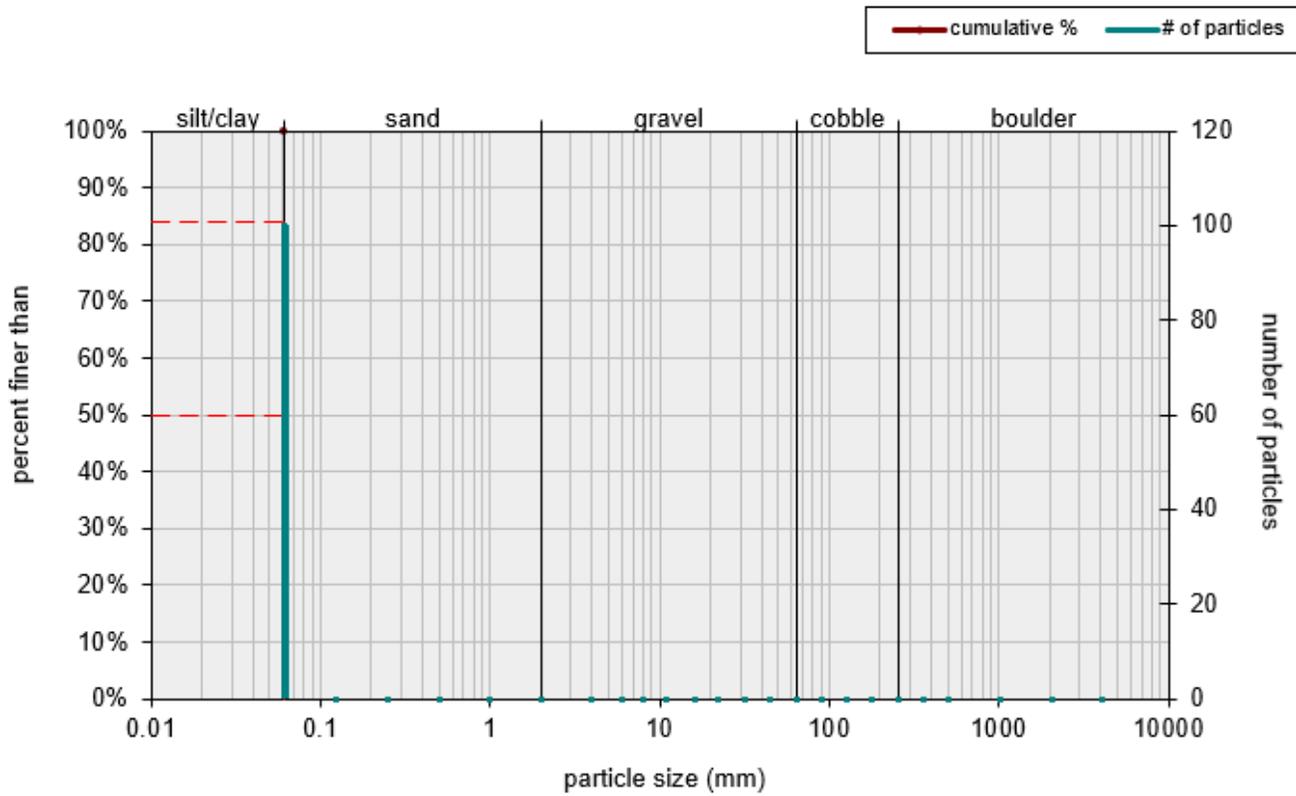
Bankfull Channel Pebble Count, S-UU3 Salem Fork

Size (mm)		Size Distribution		Type	
D16	0.062	mean	0.1	silt/clay	100%
D35	0.062	dispersion	1.0	sand	0%
D50	0.062	skewness	--	gravel	0%
D65	0.062			cobble	0%
D84	0.062			boulder	0%
D95	0.062

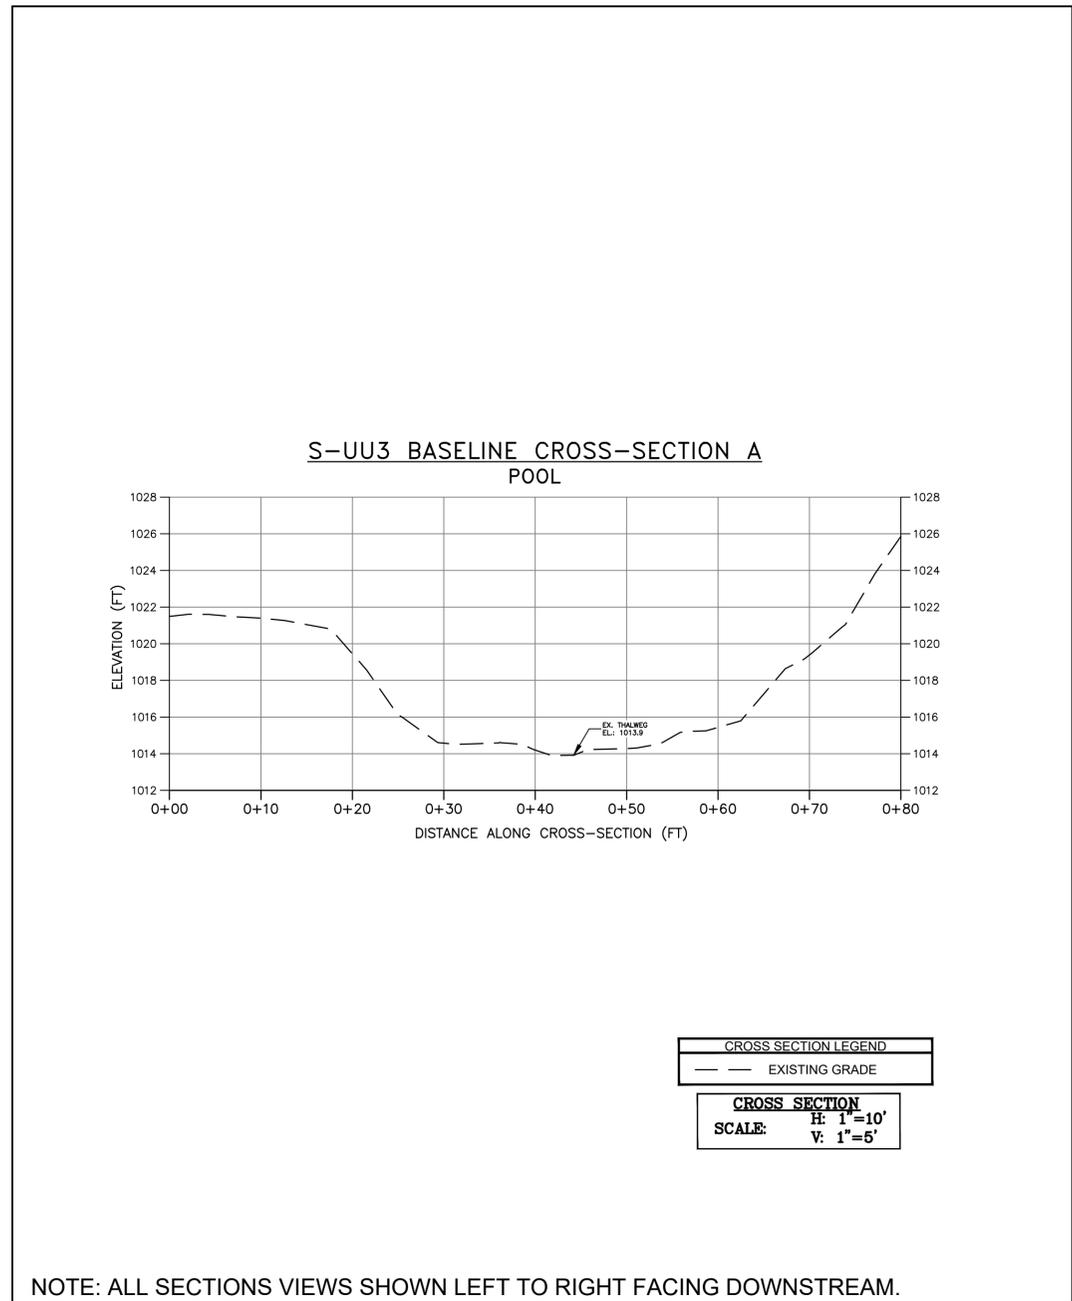
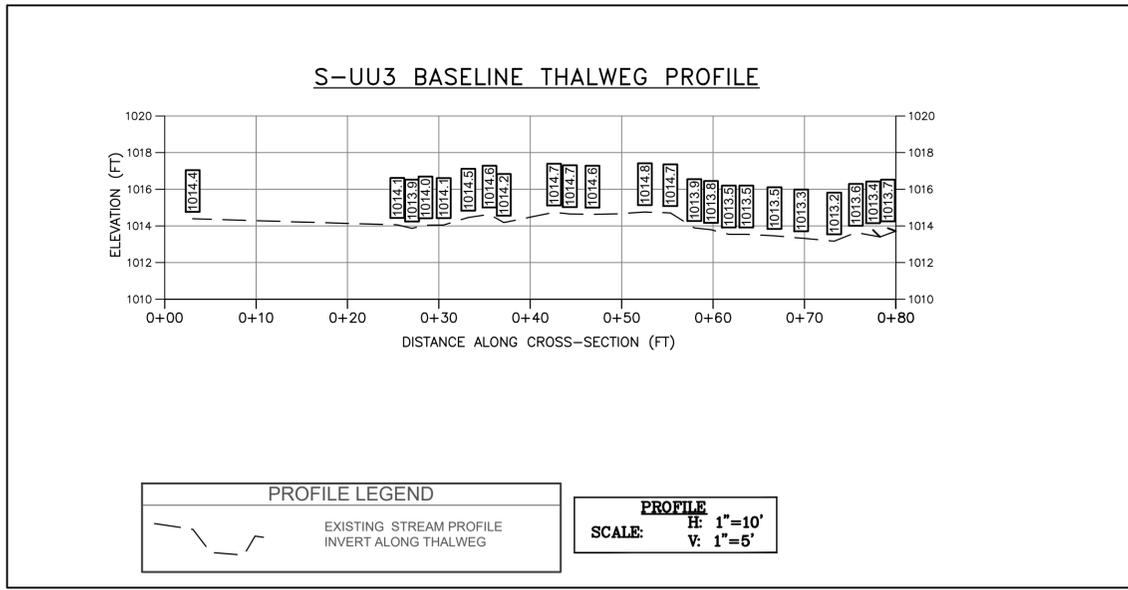
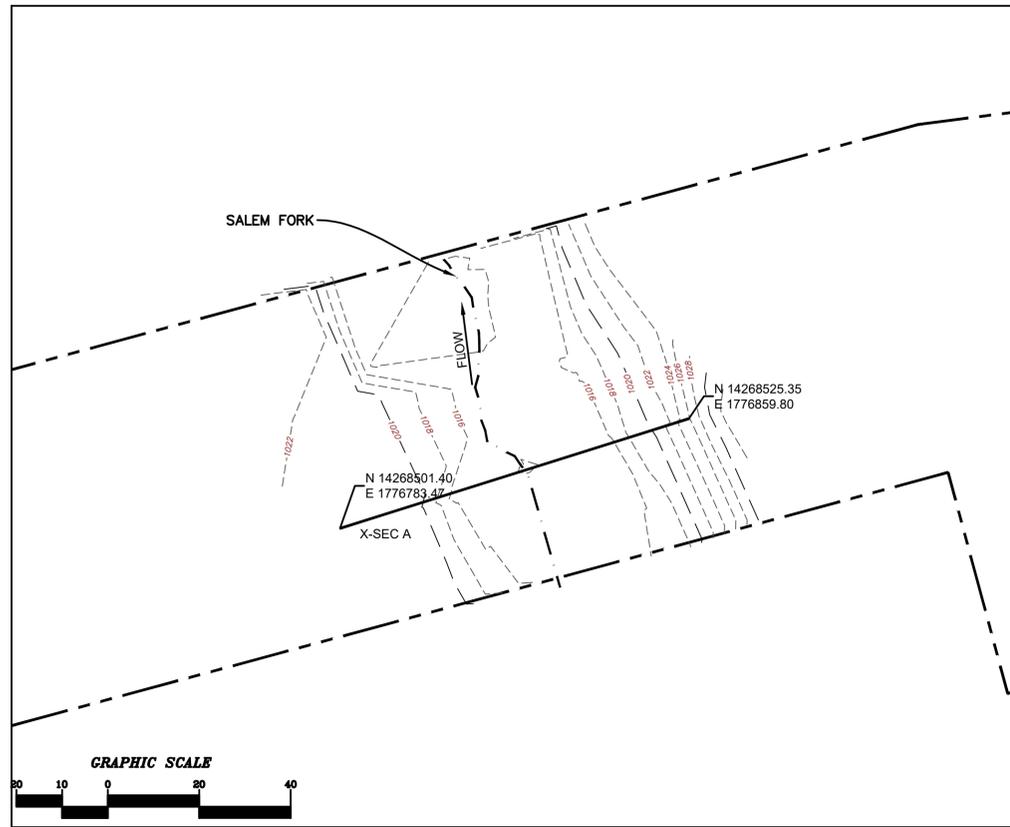
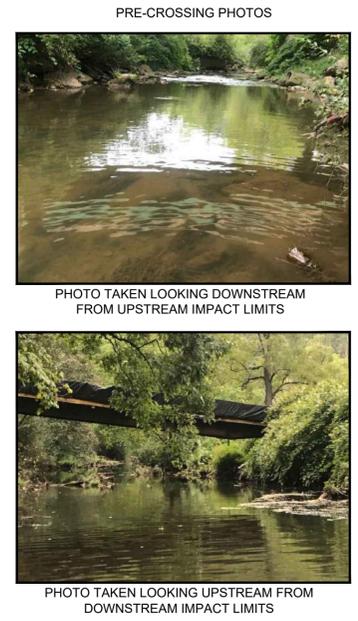
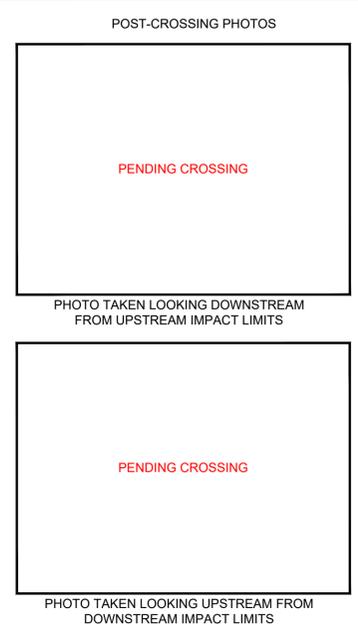
- SURVEY NOTES:**
- THIS MAP HAS BEEN ORIENTED TO NAD 1983 UTM ZONE 17N, AND VERTICALLY TO THE NORTH AMERICAN VERTICAL DATUM OF 1988 (NAVD 88), USING REAL TIME DGPS. FIELD LOCATIONS WERE COMPLETED ON SEPTEMBER 8, 2021.

- EASEMENT LINES SHOWN ON PLAN VIEW WERE PROVIDED BY MOUNTAIN VALLEY PIPELINE.
 - SURVEY POINTS FOR CROSS SECTIONS AND THALWEG PROFILES COLLECTED IN 2021 HAVE BEEN USED IN COMBINATION WITH SURVEY POINTS COLLECTED PREVIOUSLY IN 2020 IN ORDER TO GENERATE THE PRE-CROSSING SURFACE SHOWN IN PLAN. DUE TO NATURAL EROSIONAL STREAM PROCESSES THAT CAN OCCUR OVER TIME, MINOR ADJUSTMENTS TO THE PROFILE ALIGNMENTS MAY HAVE BEEN REQUIRED IN ORDER TO GENERATE A CLEAN PRE-CROSSING SURFACE.

- ALL SECTION VIEWS SHOWN LEFT TO RIGHT FACING DOWNSTREAM.
 - POST-CROSSING SURVEY INFORMATION SHOWN IN RED. DATA COLLECTED PENDING CONSTRUCTION.
 - POST-CROSSING SURVEY POINTS FOR CROSS SECTIONS AND THALWEG ARE PROJECTED ONTO PRE-CROSSING SECTION AND PROFILE VIEWS FOR COMPARISON.
