Visual Site Inspection Report

Project Name	H-600 Pipeline Spread G	AFE	124300137	Spread	H-600 Pipeline Spread G
Contractor	Precision			Report #	8059
Inspector	Jared Saunders			Date/Time	9/18/2018 3:33 PM
Permit #	TBD	Inspection Type	VA SWPP	Station Begin	10983+50
State	VA	Inspection Area	Partial	Station End	11237+00
County	Giles	Ground	Muddy	Temperature (°F)	78.00
Municipality	N/A	Weather	Light Rain	Rain Gauge (in)	0.50
GPS Location	37.3187005939309, -80.5532984063779			Rain Accumulation Time (days)	1.00

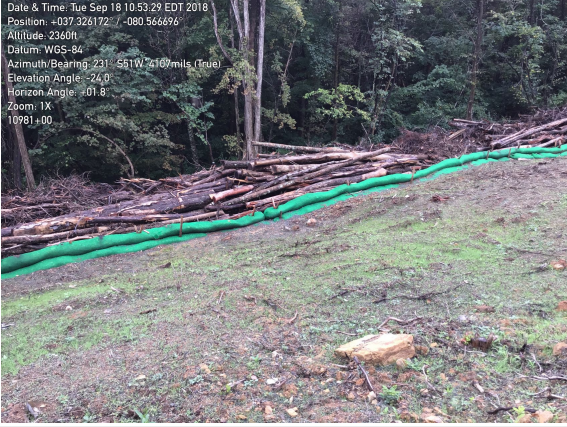
<p>Date & Time: Tue Sep 18 10:53:29 EDT 2018 Position: +037.326172, -80.566696 Altitude: 2360ft Datum: WGS-84 Azimuth Bearing: 231.551W-3169mils (True) Elevation Angle: -24.0 Horizon Angle: -01.8 Zoom: 1X 10981+00</p>

Description See photo for GPS location and station number. Sediment outside the LOD.		Description See photo for GPS location and station number. Sensitive resource buffer zone in place.		GPS Location 37.3187160166328, -80.5534683075552
