# Visual Site Inspection Report

<b>Project Name</b>	H-600 Pipeline Spread G		<b>AFE</b>	124300137	<b>Spread</b>	H-600 Pipeline Spread G	
<b>Contractor</b>	Precision				<b>Report #</b>	9976	
<b>Inspector</b>	Clinton Banks				<b>Date/Time</b>	10/26/2018 4:43 AM	
<b>Permit #</b>	TBD	<b>Inspection Type</b>	VA SWPP		<b>Station Begin</b>	+28	
<b>State</b>	VA	<b>Inspection Area</b>	Full		<b>Station End</b>	+28	
<b>County</b>	Giles	<b>Ground</b>	Wet		<b>Temperature (°F)</b>	47.00	
<b>Municipality</b>	N/A	<b>Weather</b>	Light Rain		<b>Rain Gauge (in)</b>	0.00	
<b>GPS Location</b>	37.3363111296258, -80.8085777456705			<b>Rain Accumulation Time (days)</b>	1.00

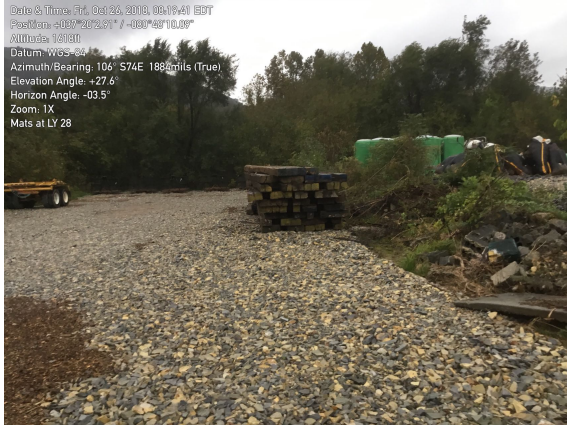
<p> Date &amp; Time: Fri, Oct 26, 2018 08:15:41 EDT  Position: +037°20'21.71" N, -080°48'10.05" W  Altitude: 189ft  Datum: WGS 84  Azimuth Bearing: 106° S74E 188mils (True)  Elevation Angle: +27.6°  Horizon Angle: -03.5°  Zoom: 1X  Mats at LY 28 </p>			
<b>GPS Location</b>	37.3362709069972, -80.8086124342688	<b>GPS Location</b>	37.334140059573, -80.8028020151712		
<b>Description</b>	Compost Filter Sock at LY 28	<b>Description</b>	Mats at LY 28		
Insert image here		Insert image here			
<b>GPS Location</b>		<b>GPS Location</b>			
<b>Description</b>		<b>Description</b>

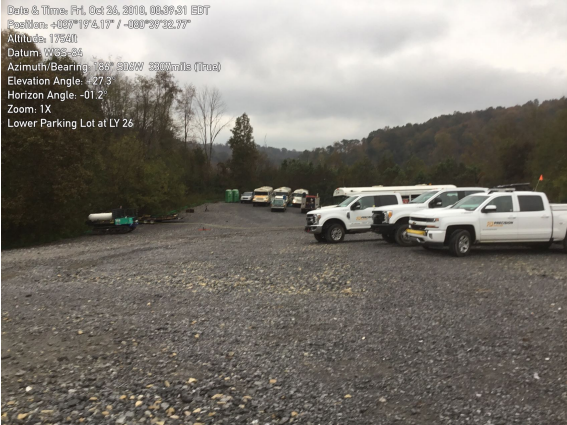
<p><small>Date &amp; Time: Fri, Oct 26, 2018, 06:36:31 EST Position: +03°19'4.17" / -080°38'32.77" Altitude: 1254ft Datum: WGS-84 Azimuth/Bearing: 330° NGS 320mils (True) Elevation Angle: +27.9 Horizon Angle: -01.2 Zoom: 1X Lower Parking Lot at LY 26</small></p>

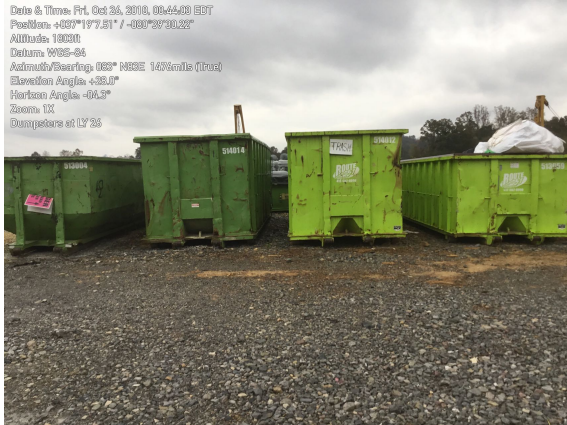
<p><small>Date &amp; Time: Fri, Oct 26, 2018, 06:44:08 EST Position: +03°19'7.51" / -080°38'30.22" Altitude: 1830ft Datum: WGS-84 Azimuth/Bearing: 000° NGS 140mils (True) Elevation Angle: +48.0° Horizon Angle: -04.3° Zoom: 1X Dumpsters at LY 26</small></p>			
<b>GPS Location</b>	37.3177850386475, -80.6590846461064	<b>GPS Location</b>	37.3187569622298, -80.6584288460022		
<b>Description</b>	Lower Parking Lot at LY 26	<b>Description</b>	Dumpsters at LY 26		
Insert image here		Insert image here			
<b>GPS Location</b>		<b>GPS Location</b>

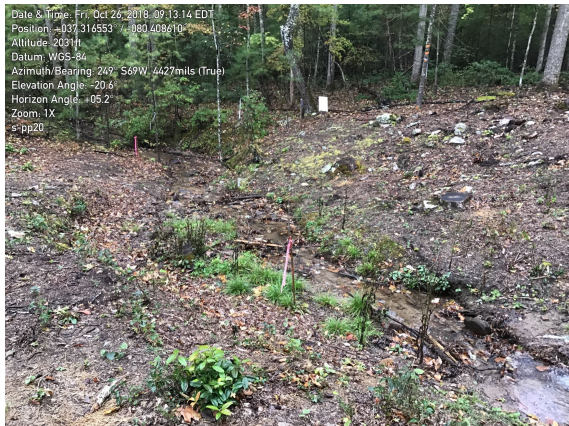
GPS Location	37.3143402859916, -80.4066238180552	GPS Location	37.3143402859916, -80.4066238180552		
Description	Waterbars above Craig creek access rd not reinstalled.	Description	Stream s-pp20 no impacts observed.		
<p>Date &amp; Time: Fri, Oct 26, 2018 09:13:14 EDT Position: +037.316553 / -080.408610 Altitude: 2031ft Datum: WGS-84 Azimuth/Bearing: 249° S69W 4427mils (True) Elevation Angle: -20.4° Horizon Angle: -06.2° Zoom: 1X s-pp20</p>

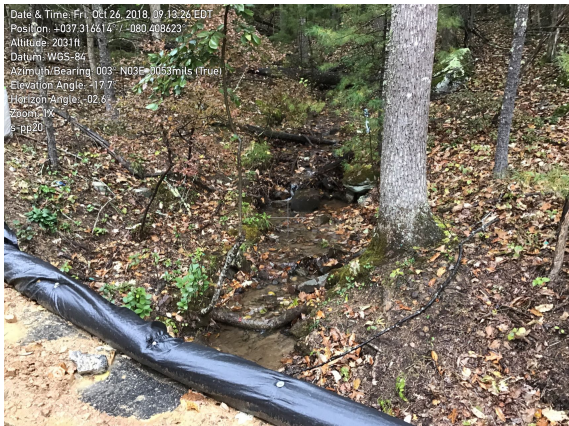
GPS Location	37.3144318163742, -80.4065476265553	GPS Location	37.3144318163742, -80.4065476265553		
Description	Stream s-pp20 no impacts observed.	Description	Stream s-pp21 no impacts observed.		
<p>Date &amp; Time: Fri, Oct 26, 2018 09:14:18 EDT Position: +037.317127 / -080.409179 Altitude: 2026ft Datum: WGS-84 Azimuth/Bearing: 275° N87W 4859mils (True) Elevation Angle: -23.2° Horizon Angle: -08.6° Zoom: 1X s-pp21</p>

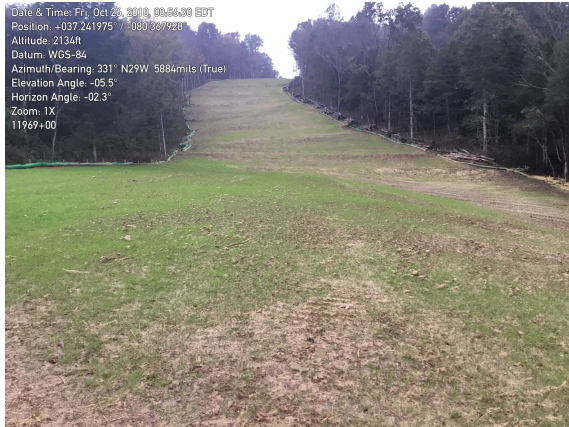
A/E	124300137	Date/Time	10/26/2018 1:45 PM	Report #	9997
Pictures					
<p>Date &amp; Time: Fri, Oct 26, 2018, 08:54:30 EDT Position: +037.241975 / -080.367928 Altitude: 2134ft Datum: WGS-84 Azimuth/Bearing: 331° N29W 5884mils (True) Elevation Angle: -05.5° Horizon Angle: -02.3° Zoom: 1X 11969+00</p>

GPS Location	37.3337692731212, -80.7502446764309	GPS Location	37.3337685447796, -80.7502449966479		
Description	Row 11969+00	Description	ECDs protecting karst feature 11979+00		
<p>Date &amp; Time: Fri, Oct 26, 2018, 09:06:40 EDT Position: +037.245957 / -080.360366 Altitude: 1637ft Datum: WGS-84 Azimuth/Bearing: 165° S15E 2933mils (True) Elevation Angle: -17.9° Horizon Angle: -01.3° Zoom: 1X 11779+00</p>

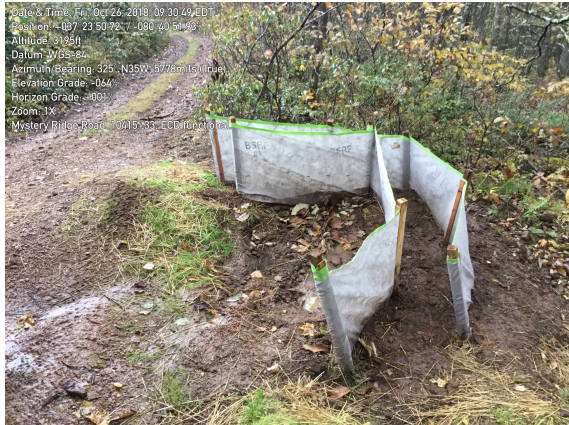
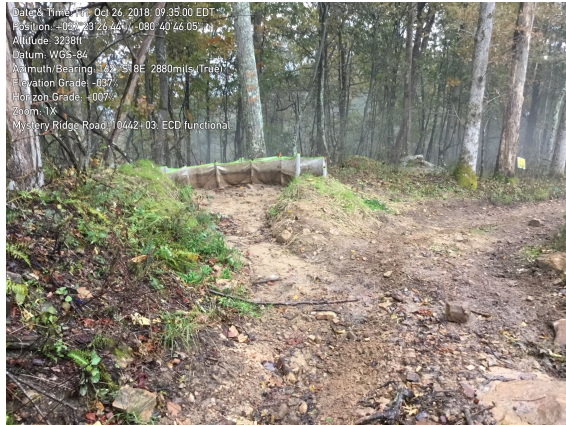
A/E	124300137	Date/Time	10/26/2018 3:12 PM	Report #	10001
Pictures					
<p>Date &amp; Time: Fri, Oct 26, 2018, 09:30:49 EDT Position: +037°23'50.92"N -080°40'54.93"W Altitude: 3195ft Datum: WGS-84 Azimuth/Bearing: 325° N35W 576mils (True) Elevation Grade: +04% Horizon Grade: +00% Zoom: 1X Mystery Ridge Road, 10215+03, ECD functional.</p>

<p>Date &amp; Time: Fri, Oct 26, 2018, 09:35:00 EDT Position: +037°23'24.46"N -080°40'46.05"W Altitude: 3238ft Datum: WGS-84 Azimuth/Bearing: 311° S18E 2880mils (True) Elevation Grade: +03% Horizon Grade: +00% Zoom: 1X Mystery Ridge Road, 10442+03, ECD functional.</p>

GPS Location	37.1331241680655, -80.3943795339022	GPS Location	37.1331241680655, -80.3943795339022		
Description	Correct coordinates on photo. Mystery Ridge Road controls functional.	Description	Correct coordinates on photo. Mystery Ridge Road controls functional.		
<p>Date &amp; Time: Fri, Oct 26, 2018, 10:07:33 EDT Position: +037°24'57.65"N -080°42'11.55"W Altitude: 3042ft Datum: WGS-84 Azimuth/Bearing: 165° S25E 276mils (True) Elevation Grade: +047% Horizon Grade: +007% Zoom: 1X Pocahontas Road, 165+50, ECD functional.</p>

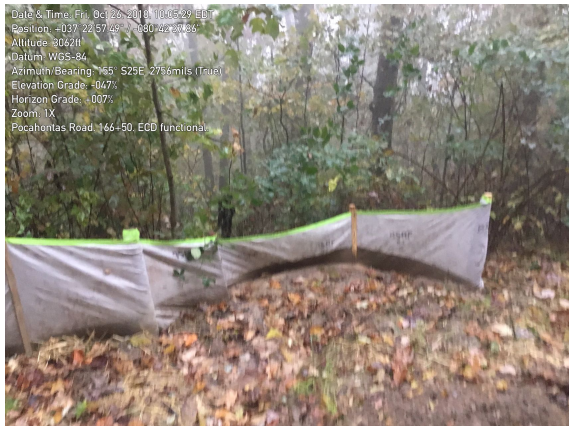
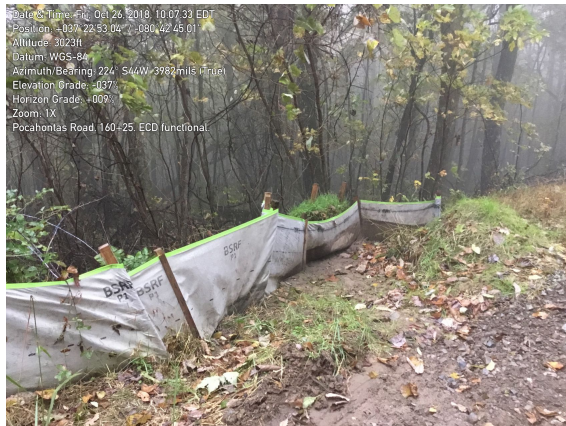
<p>Date &amp; Time: Fri, Oct 26, 2018, 10:07:33 EDT Position: +037°24'53.06"N -080°42'45.01"W Altitude: 3023ft Datum: WGS-84 Azimuth/Bearing: 224° S44W 3983mils (True) Elevation Grade: +037% Horizon Grade: +009% Zoom: 1X Pocahontas Road, 160+25, ECD functional.</p>

GPS Location	37.1330161253336, -80.3945991397653	GPS Location	37.1330161253336, -80.3945991397653		
Description	Correct coordinates on photo. Pocahontas Road controls functional.	Description	Correct coordinates on photo. Pocahontas Road controls functional.		
<p>Date &amp; Time: Fri, Oct 26, 2018, 10:12:46 EDT Position: +037°22'51.86"N -080°43'9.09"W Altitude: 2801ft Datum: WGS-84 Azimuth/Bearing: 343° N17W 6098mils (True) Elevation Grade: +037% Horizon Grade: +009% Zoom: 1X Pocahontas Road, 132+00, ECD functional.</p>

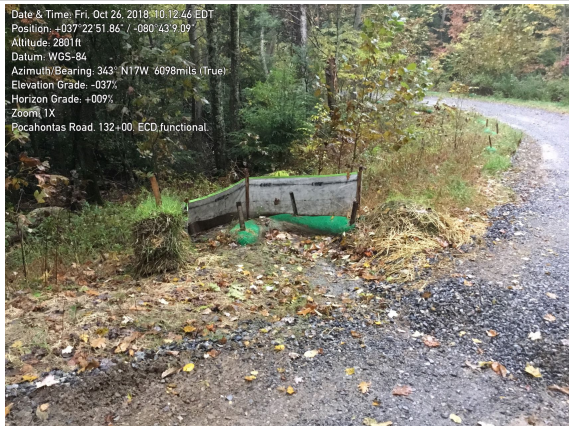
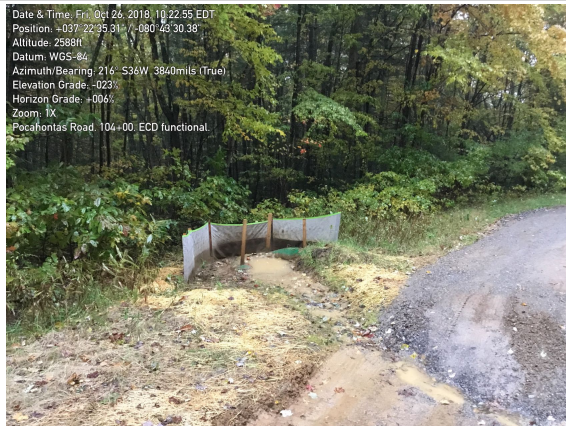
<p>Date &amp; Time: Fri, Oct 26, 2018, 10:22:55 EDT Position: +037°22'35.31"N -080°43'30.38"W Altitude: 2588ft Datum: WGS-84 Azimuth/Bearing: 216° S36W 3840mils (True) Elevation Grade: +023% Horizon Grade: +006% Zoom: 1X Pocahontas Road, 106+00, ECD functional.</p>

Description	Correct coordinates on photo. Pocahontas Road controls functional.	Description	Correct coordinates on photo. Pocahontas Road controls functional.

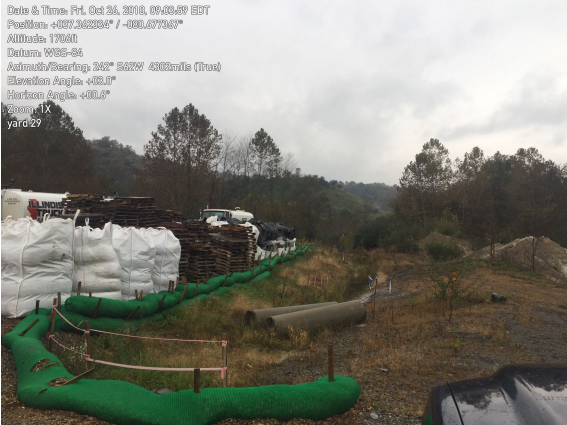
<b>GPS Location</b>	37.3327960213994, -80.7504062355317	<b>GPS Location</b>			
<b>Description</b>	Yard 29 area pipe and hay bails stored	<b>Description</b>			
<div style="text-align: center;">Insert image here</div>		<div style="text-align: center;">Insert image here</div>			
<b>GPS Location</b>		<b>GPS Location</b>			
<b>Description</b>		<b>Description</b>

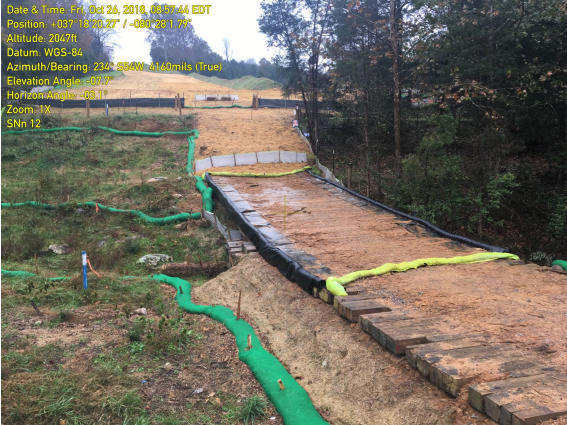
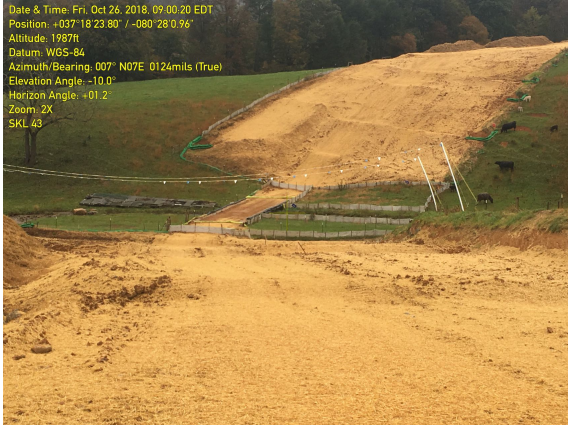
<p><b>GPS Location</b> 37.2426994471226, -80.4292635899786</p> <p><b>Description</b> ECD's and ROW conditions @ S-NN11</p>	
<p>Date &amp; Time: Fri, Oct 26, 2018, 09:12:59 EDT  Position: +037°18'24.03" / -080°28'20.57"  Altitude: 2133ft  Datum: WGS-84  Azimuth/Bearing: 250° 57'0W 444mils (True)  Elevation Angle: -01.2°  Horizon Angle: -00.6°  Zoom: 1X  Snn12</p>

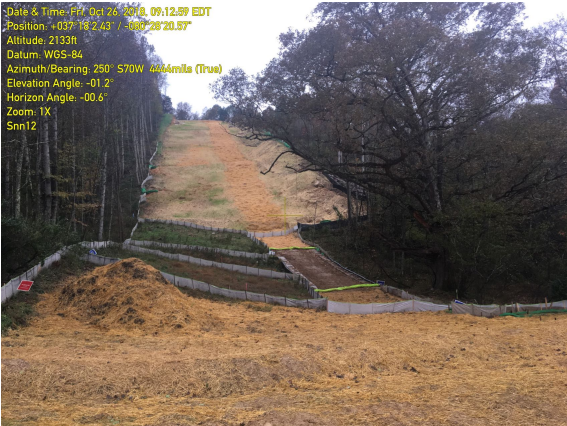
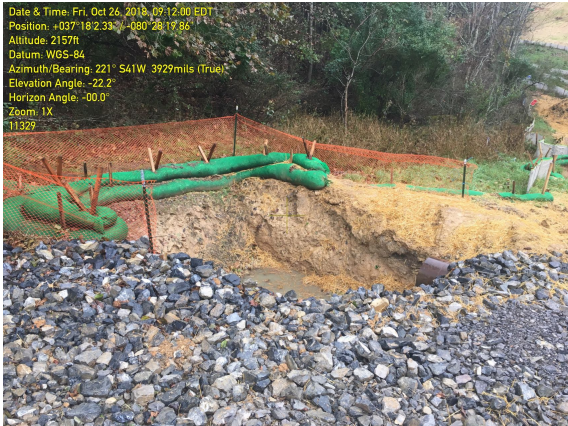
<p><b>GPS Location</b> 37.2427522112031, -80.4293075111512</p> <p><b>Description</b> ECD's and ROW conditions @ S-Nn12</p>

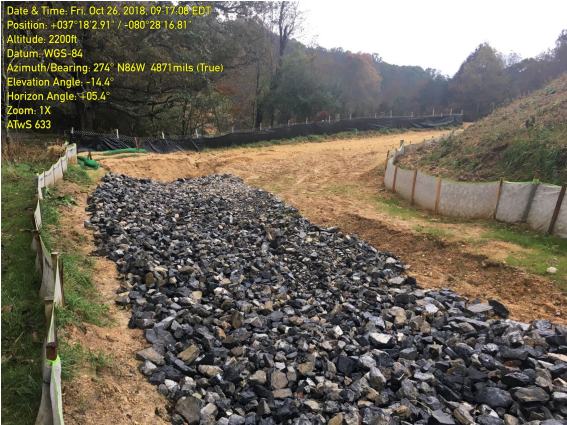
<p>Date &amp; Time: Fri, Oct 26, 2018, 09:17:06 EDT  Position: +037°18'24.91" / -080°28'16.81"  Altitude: 2200ft  Datum: WGS-84  Azimuth/Bearing: 274° N86W 4871mils (True)  Elevation Angle: -14.4°  Horizon Angle: +05.4°  Zoom: 1X  AtwS 633</p>

<p><b>GPS Location</b> 37.2427522112031, -80.4293075111512</p> <p><b>Description</b> Rock lined channel @ ATwS 633</p>	
<p><b>GPS Location</b> 37.2427522112031, -80.4293075111512</p> <p><b>Description</b> ECD's for KARST feature @ AR 256.02</p>		<p><b>GPS Location</b> 37.2427522112031, -80.4293075111512</p> <p><b>Description</b> Water bar and end treatment @ 11329+00</p>		<p><b>GPS Location</b> 37.2427522112031, -80.4293075111512</p> <p><b>Description</b> Rock lined channel @ ATwS 633</p>
