# Visual Site Inspection Report

<b>Project Name</b>	H-600 Pipeline Spread H	<b>AFE</b>	124300138	<b>Spread</b>	H-600 Pipeline Spread H
<b>Contractor</b>	Precision			<b>Report #</b>	9993
<b>Inspector</b>	Glenn Mike Renfro			<b>Date/Time</b>	10/26/2018 11:18 AM
<b>Permit #</b>	TBD	<b>Inspection Type</b>	VA SWPP	<b>Station Begin</b>	13415+00
<b>State</b>	VA	<b>Inspection Area</b>	Full	<b>Station End</b>	13670+00
<b>County</b>	Franklin	<b>Ground</b>	Wet	<b>Temperature (°F)</b>	42.00
<b>Municipality</b>	N/A	<b>Weather</b>	Light Rain	<b>Rain Gauge (in)</b>	0.25
<b>GPS Location</b>	36.971845140733, -79.8700781020481			<b>Rain Accumulation Time (days)</b>	1.00

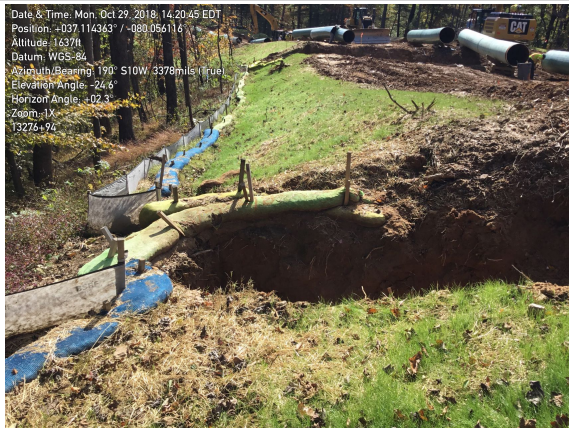
GPS Location	37.3331011286241, -80.0123496135824	GPS Location	37.3331011286241, -80.0123496135824		
Description	Please see photo for coordinates. ~Sta. No. 13276+94, outlet functioning acceptably, with small tear in CFS needing maintenance.	Description	Please see photo for coordinates. S-GH7, CIS, bridge cleaned and maintained, ECDs performing acceptably.

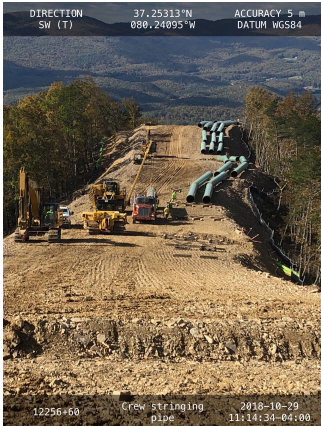
<p>DIRECTION SW (T) 37.25313°N 080.24095°W ACCURACY 5 m DATUM WGS84</p> <p>12256+60 Crew stringing pipe 2018-10-29 11:14:34-04:00</p>

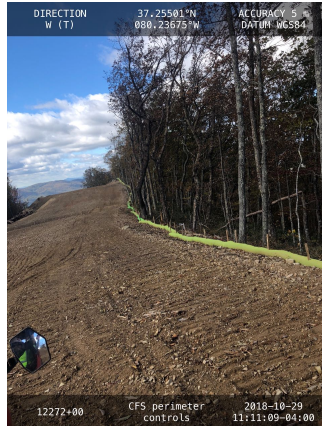
<p>DIRECTION W (T) 37.25801°N 080.22875°W ACCURACY 5 m DATUM WGS84</p> <p>12272+00 CFS perimeter controls 2018-10-29 11:11:09-04:00</p>		<b>GPS Location</b> 37.3313886998569, -79.9581132923066

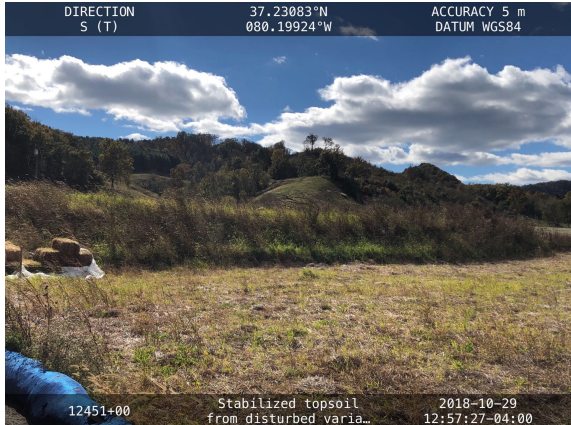
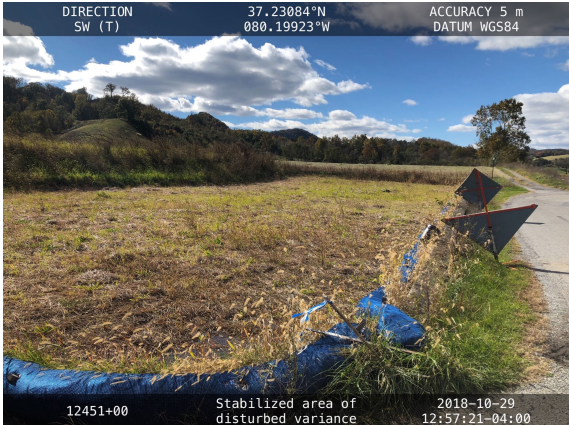
GPS Location	37.2357622487817, -80.2296830993893		GPS Location	37.2351779044021, -80.2296781540664	
Description	12451+00_102918 stabilized topsoil from disturbed variance. Looking S. See picture for GPS data.		Description	12451+00_102918 Stabilized Area of disturbed variance. Looking SW. See picture for GPS data.

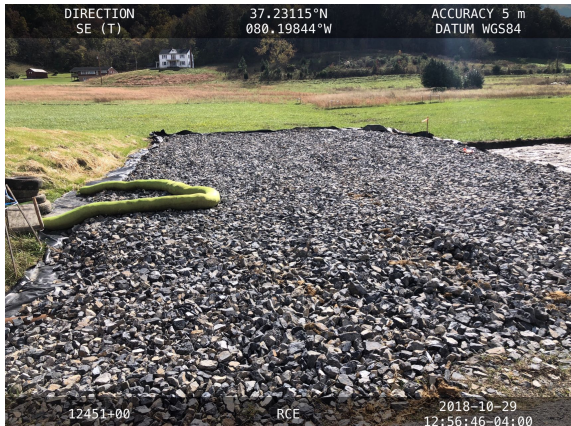
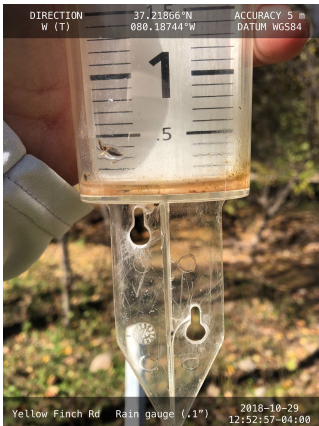
GPS Location	37.2352522518833, -80.2296684310587		GPS Location	37.2355234064509, -80.2296605520698	
Description	12451+00_102918 RCE. Looking SE. See picture for GPS data.		Description	Yellow Finch Rd_102918 Rain Gauge (.1") Looking W. See picture for GPS data.

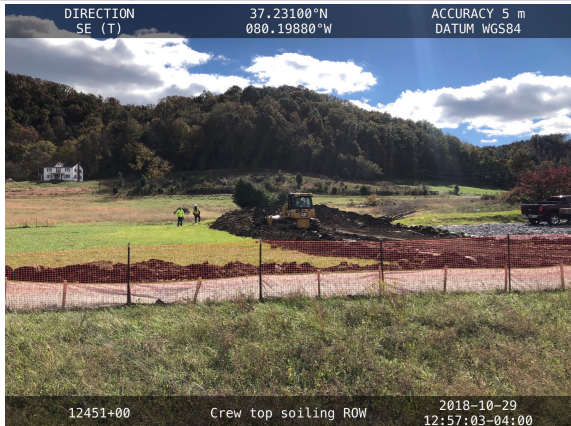
Insert image here		
GPS Location	37.2355234064509, -80.2296605520698		GPS Location		
Description	12451+00_102918 Crew top soiling ROW. Looking SE. See picture for GPS data.		Description
