Re: Mountain Valley Pipeline, LLC
Docket No. CP16-10-000
Weekly Status Report No. 90

Docket No. CP16-10-000
Weekly Report No. 90
Report Period: 07/13/19- 07/19/19

**Re: Mountain Valley Pipeline Project (Permit No. WVR310667)
Response to Notice of Violation No. W19-34-014-JTL**

STATE OF WEST VIRGINIA
Department of Environmental Protection
Environmental Enforcement
NOTICE OF VIOLATION

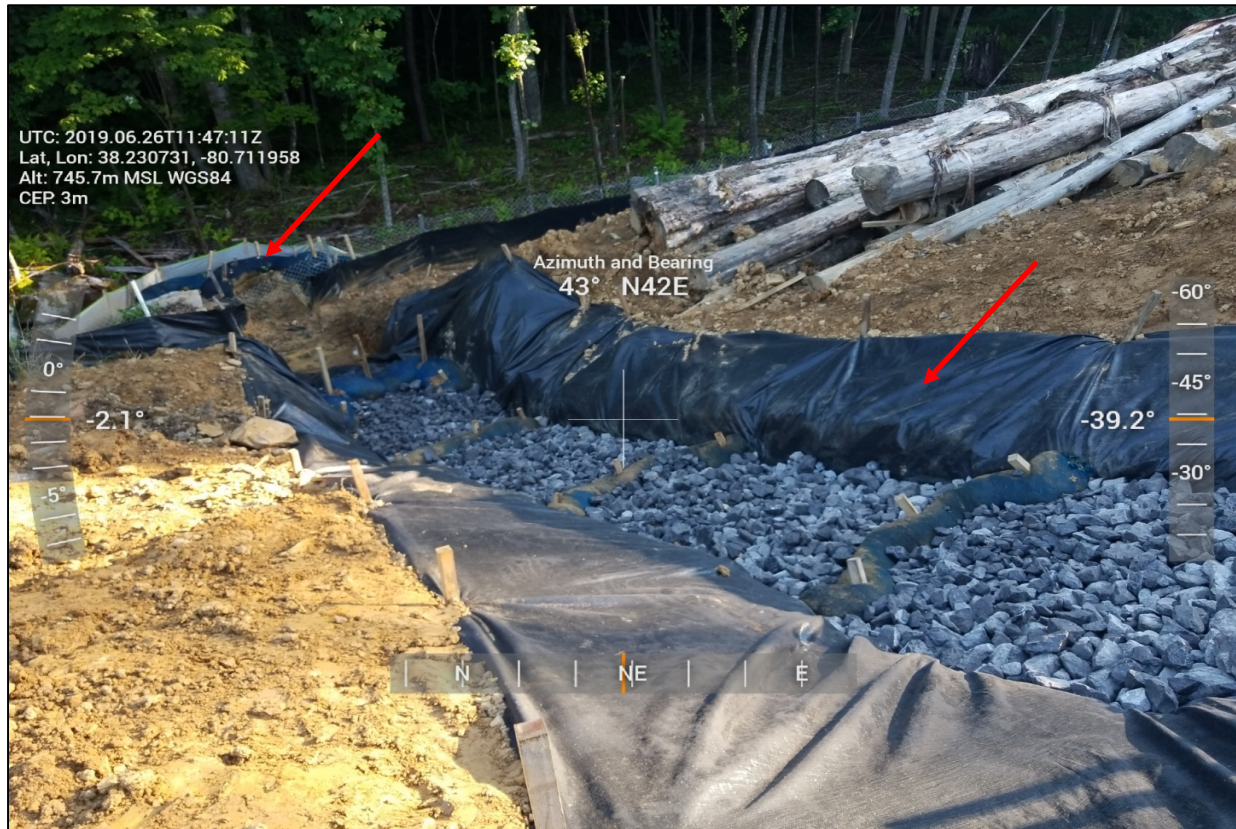
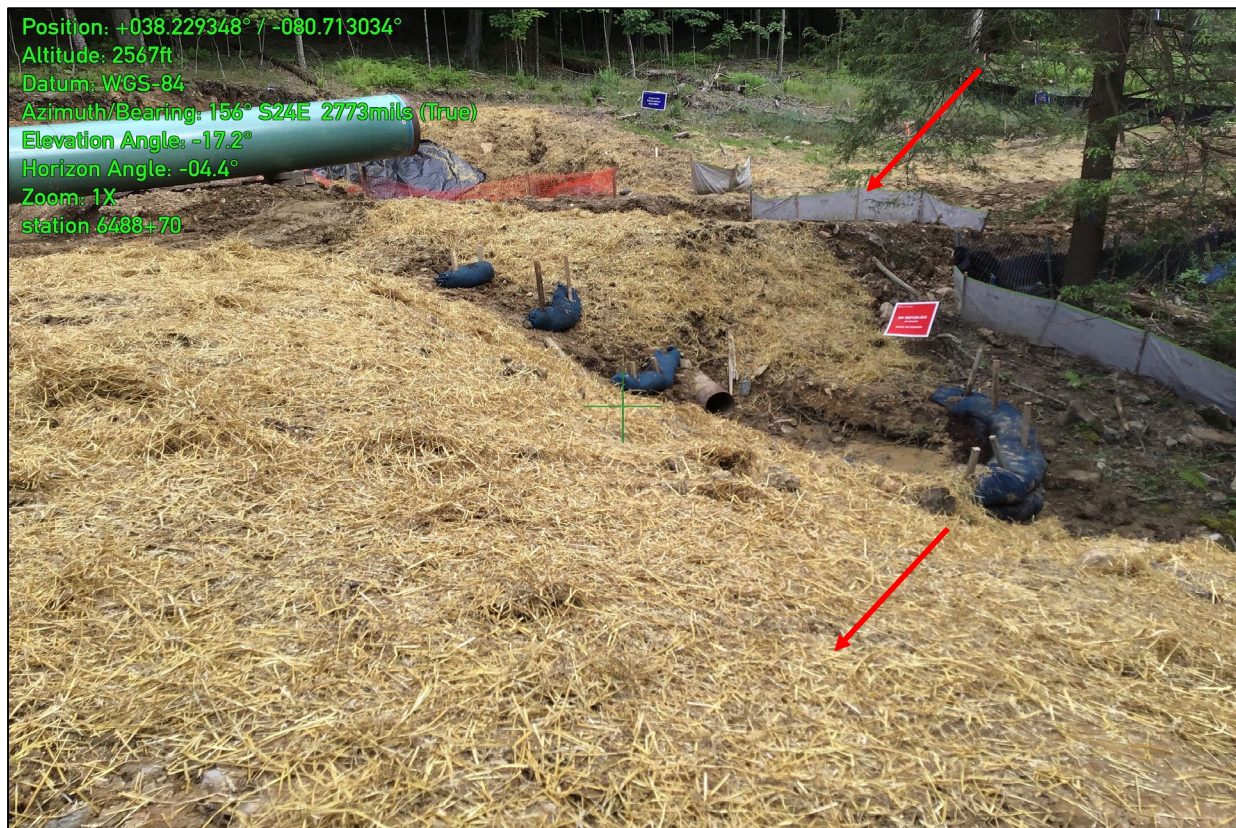
Photo 2: Photo illustrates the additional temporary stabilization that has been applied near Station 6474+16

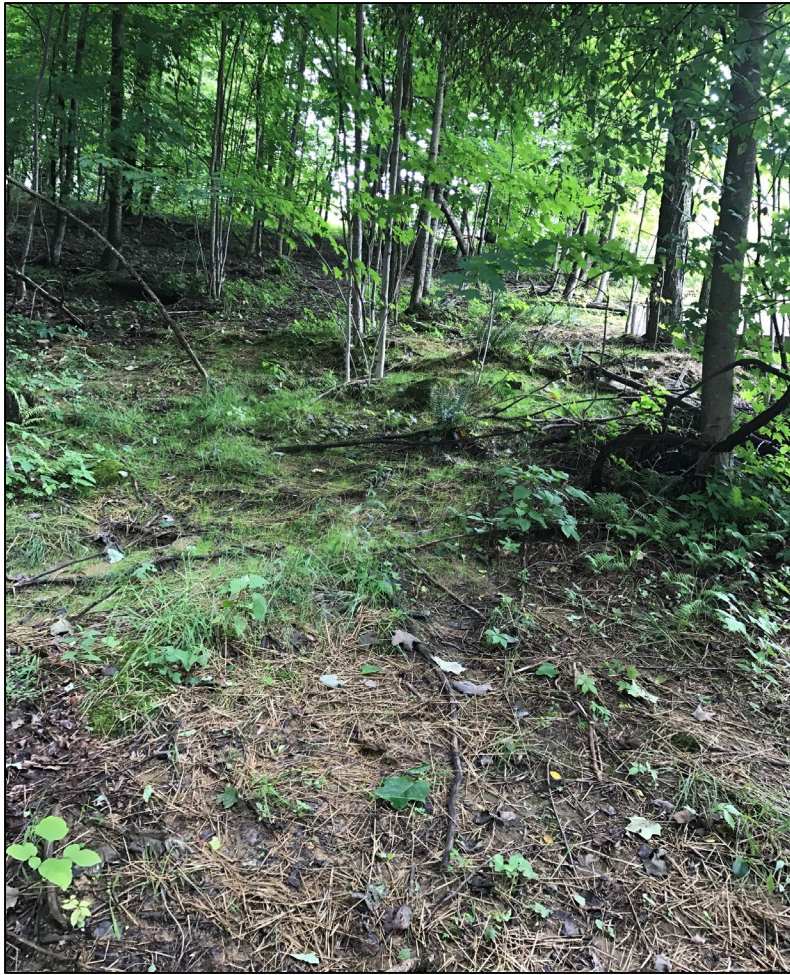
Photo 9: Photo shows stabilization near Station 6508+30 .

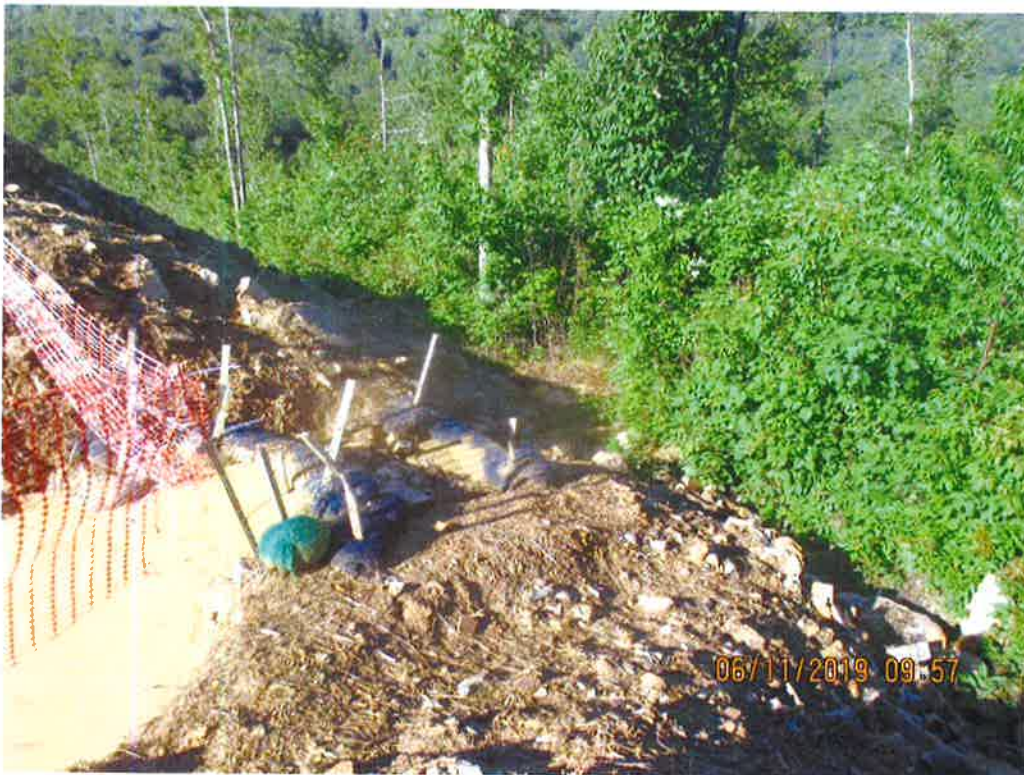
Station No. 7590. Waterbar outlet was overwhelmed with sediment and deposits were present past the LOD.

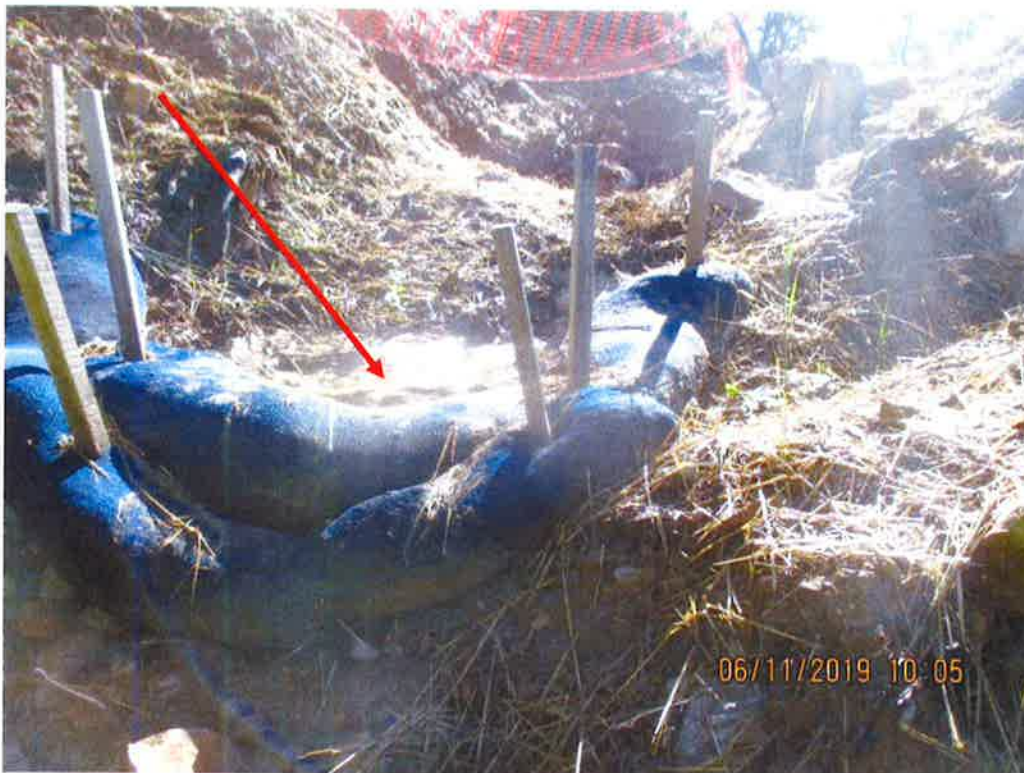
200-foot upslope of Krosier road crossing Waterbar outlet in need of maintenance. Controls overwhelmed with sediment. Deposits present past LOD.

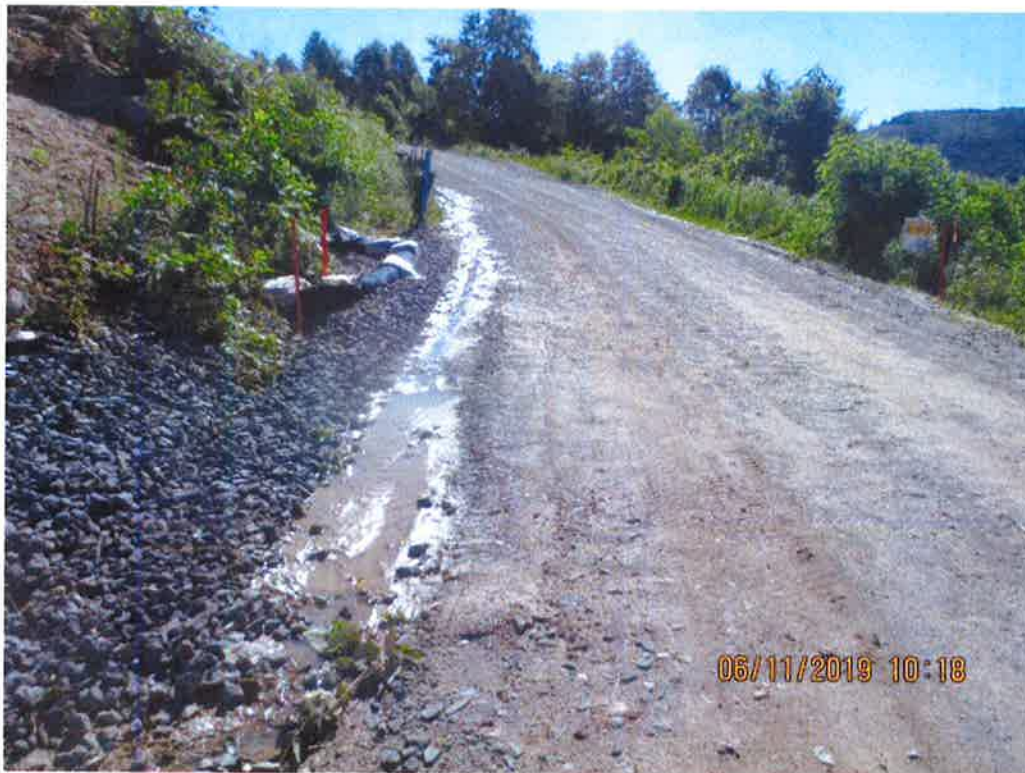
Upper Krosier Road Crossing facing East.

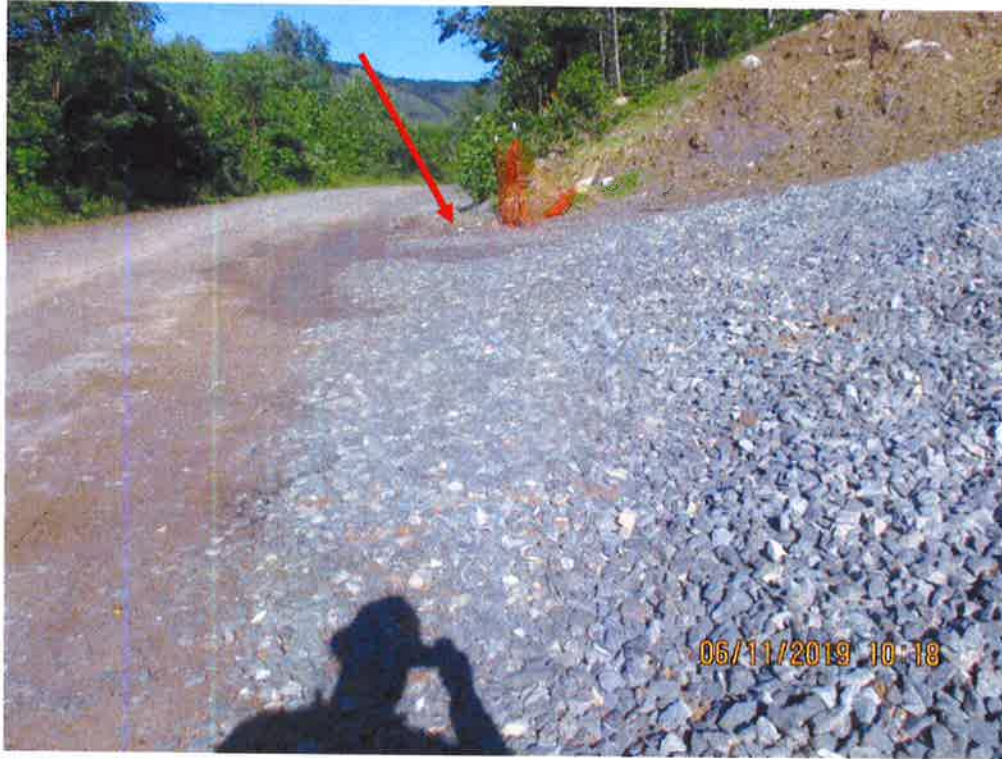
Upper Krosier Road Crossing facing West. Arrow depicts culvert outlets that flows downslope.

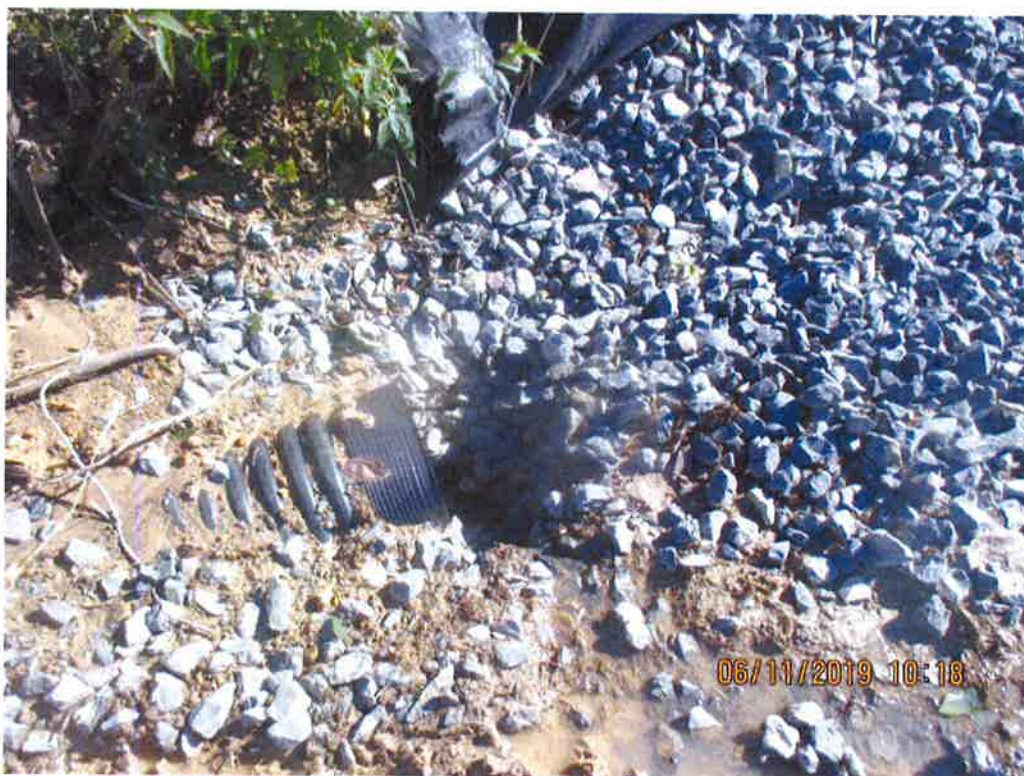
Culvert inlet with sediment present around the inlet at Krosier road ROW crossing. Downslope of Additional workspace and upslope of construction entrance and crossing.

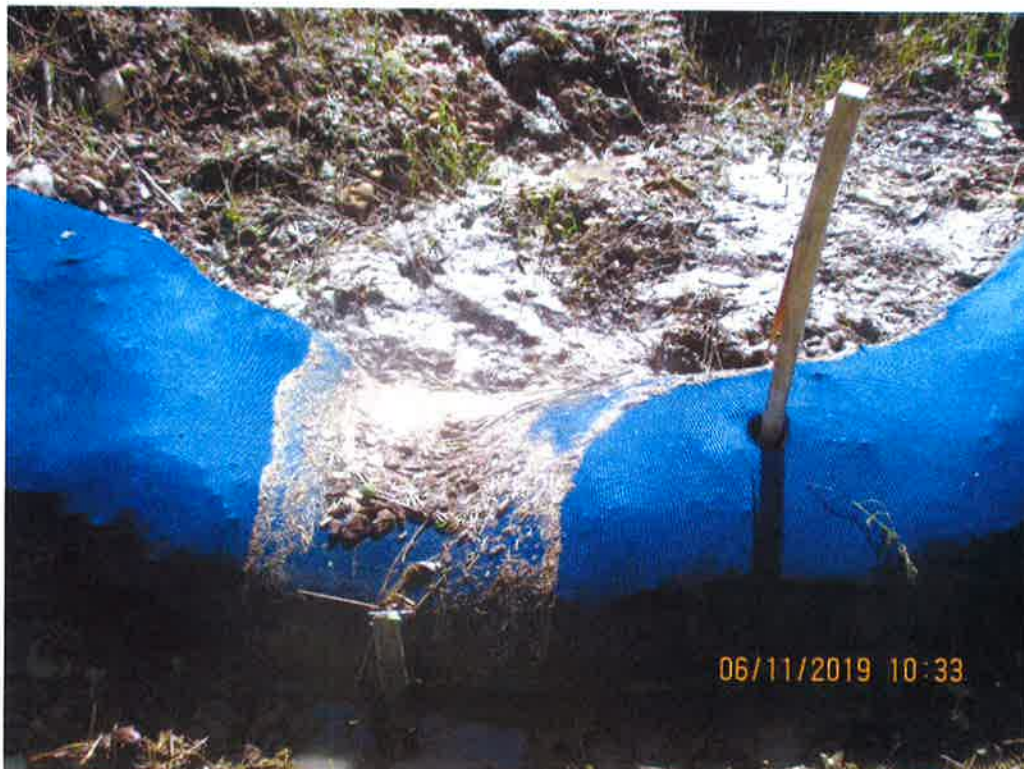
Perimeter control being overtopped with SLW and sediment backed up behind control.

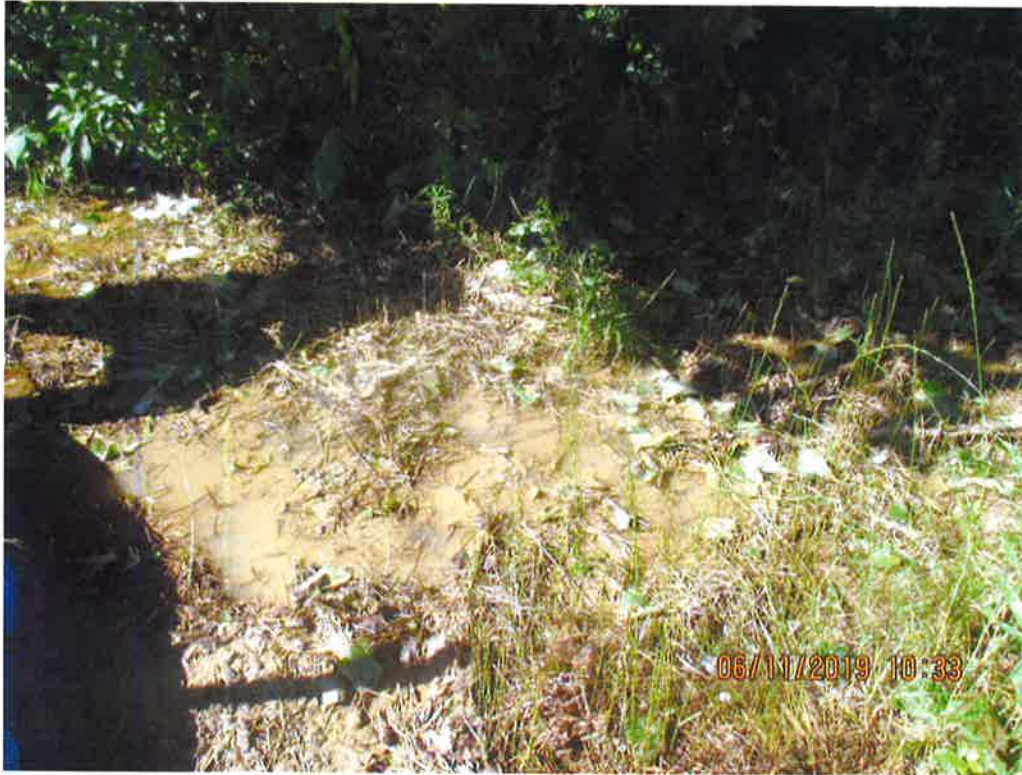
Downslope of Krosier Road Crossing near station No. 7576+01. Sediment laden water (SLW) and deposits were present past controls and LOD.

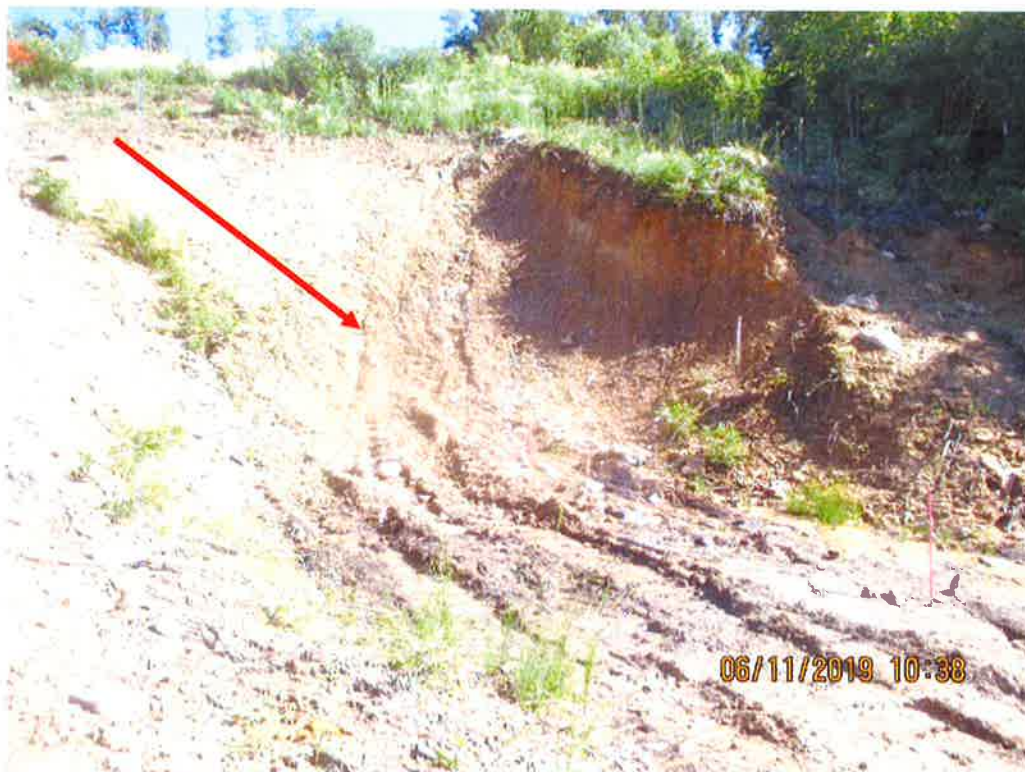
Below upper Krosier Road crossing near station no. 7576+01 facing North. Erosion present on slope due to seep running onto ROW.

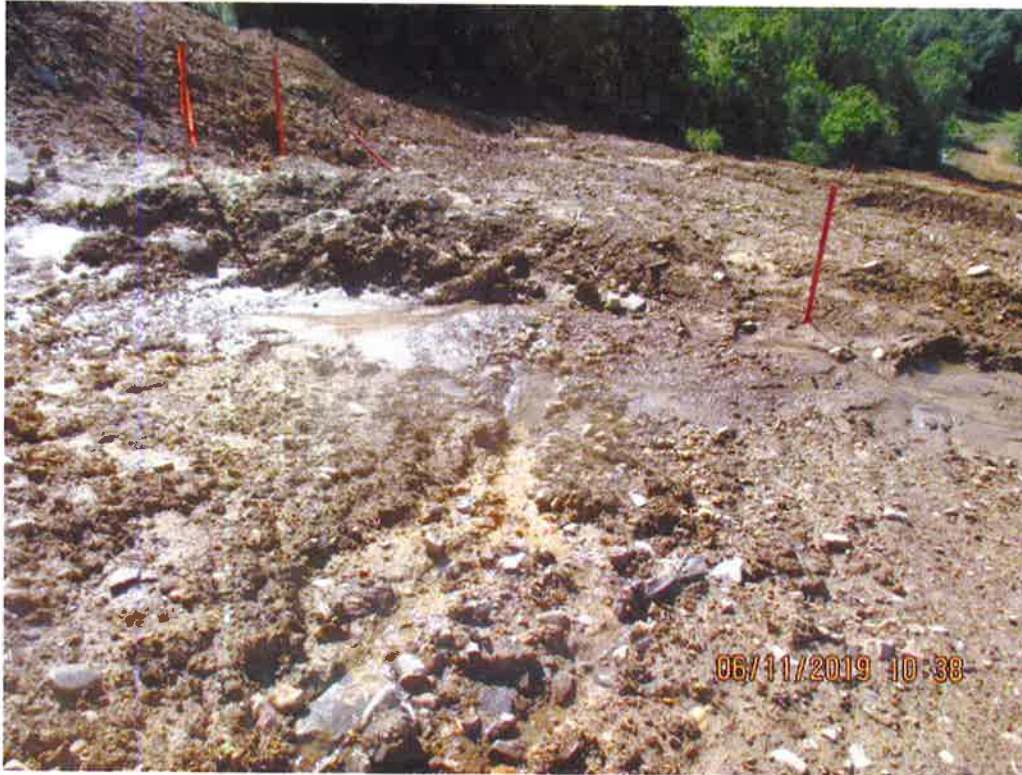
Below upper Krosier Road crossing near station no. 7576+01 facing South at Waterbar. Erosion present on slope due to seep running onto ROW. Sediment deposited in Waterbar.

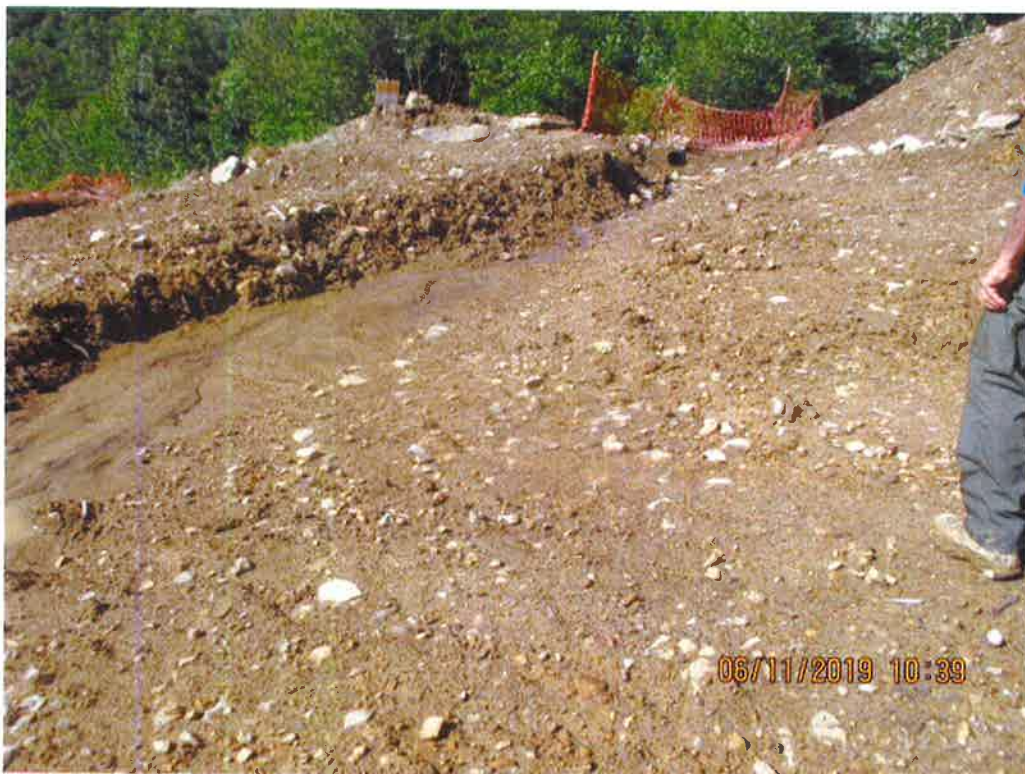
Below upper Krosier Road crossing near station no. 7576+01 facing towards Waterbar outlet. Erosion present on slope due to seep running onto ROW causing sediment to be deposited in Waterbar.

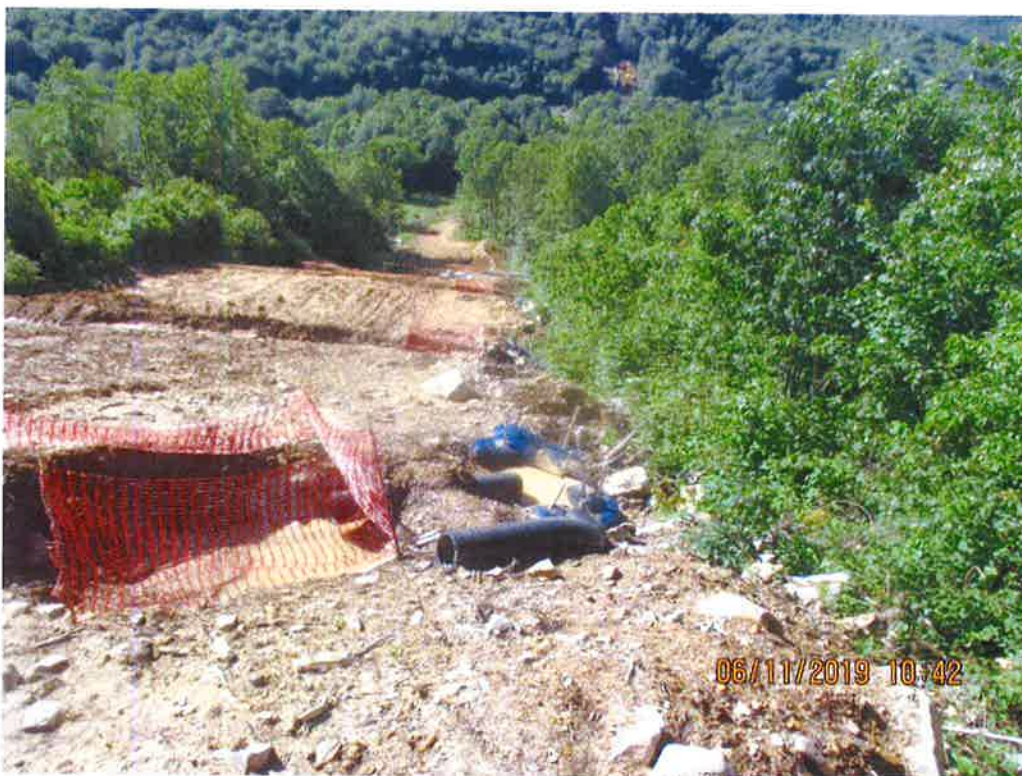
Facing South towards Route 60 and meadow River ROW crossing near station No. 7604+41.

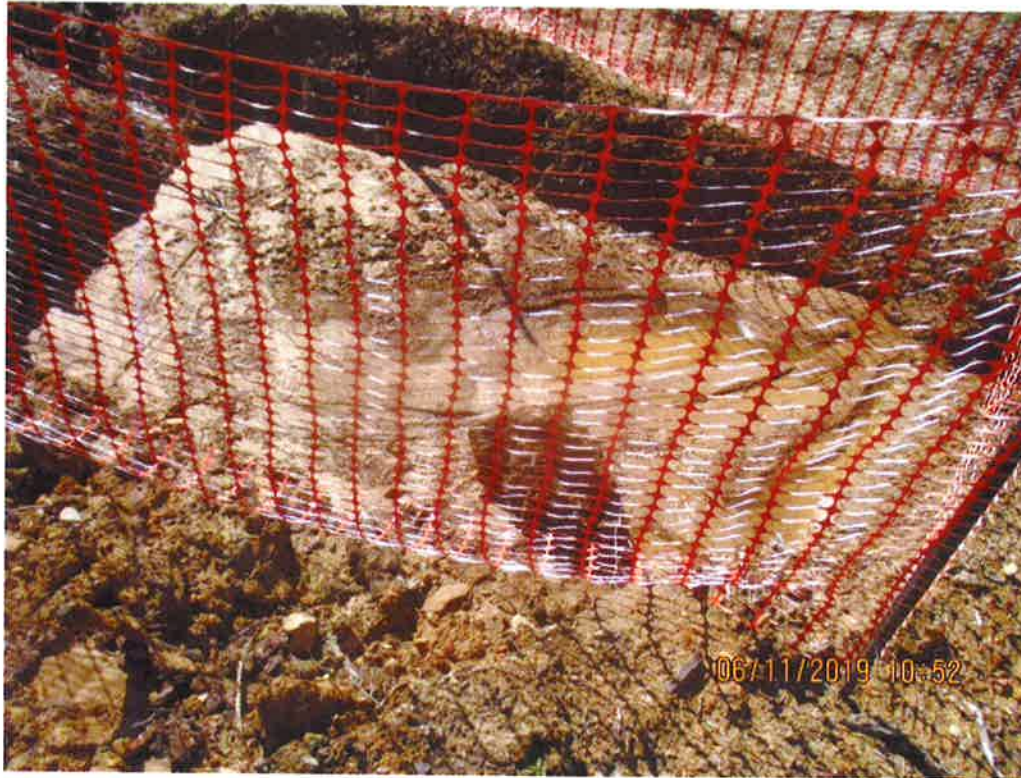
Standing above Station No. 7604+41. Waterbar had sediment being deposited in it from erosion causing sump to be full of sediment.

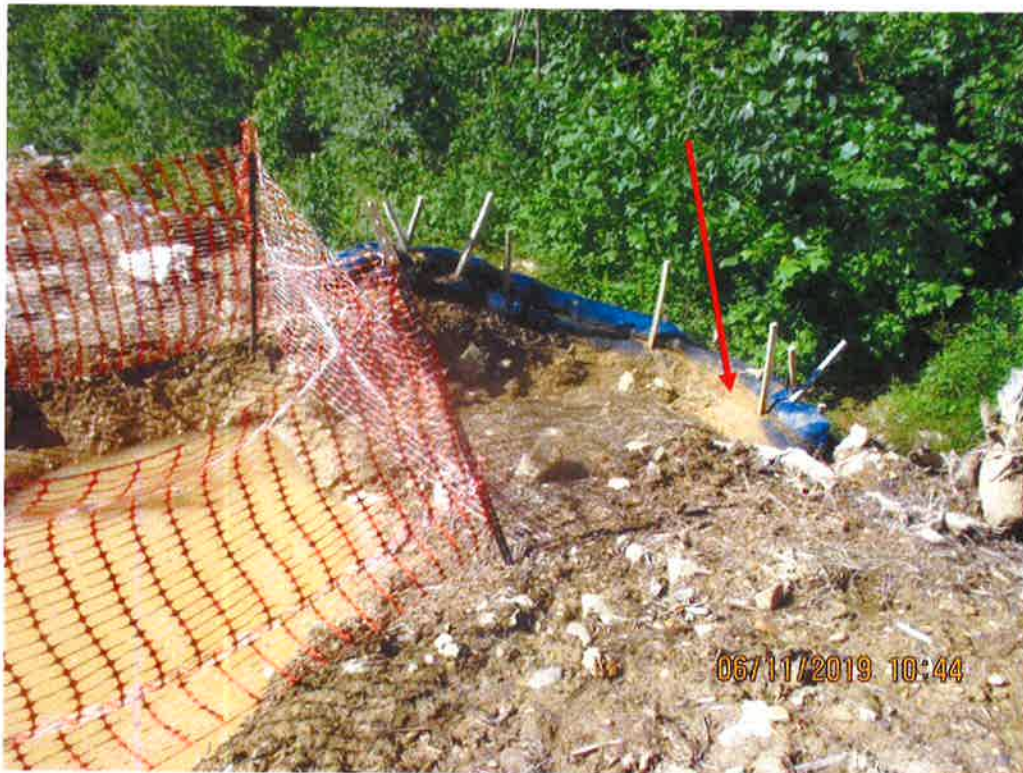
Standing above Station No. 7604+41. Controls below Waterbar and sump that had sediment present due to erosion. Perimeter controls being overwhelmed with sediment.

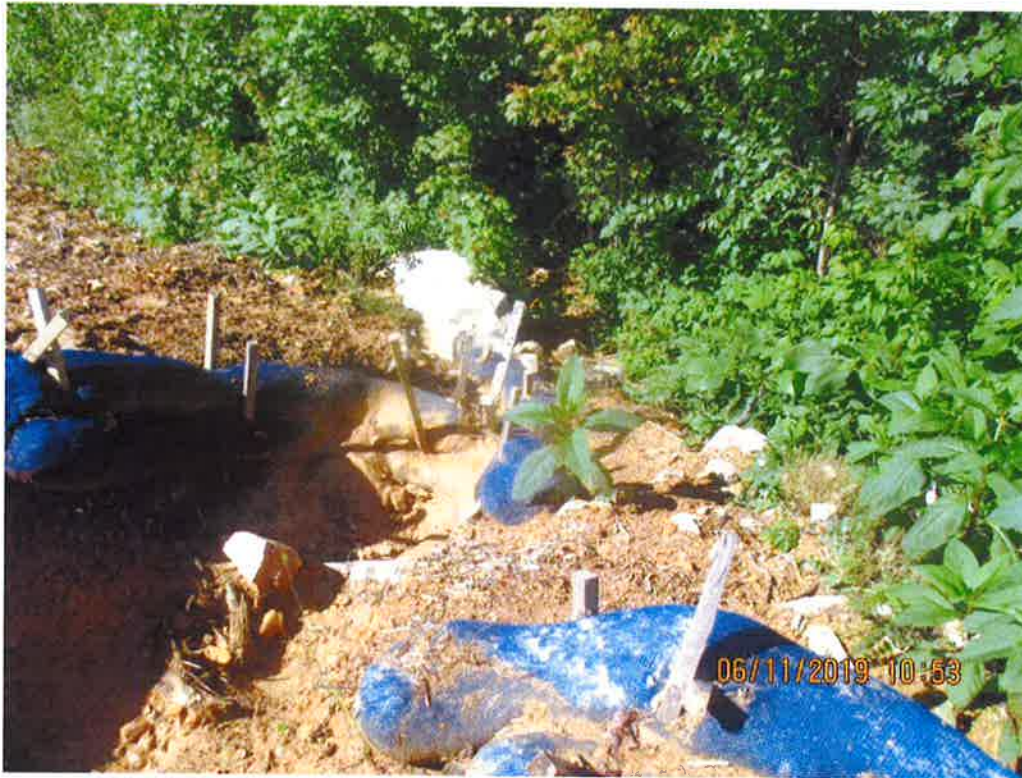
Standing above Station No. 7604+41. Perimeter controls overwhelmed with sediment.

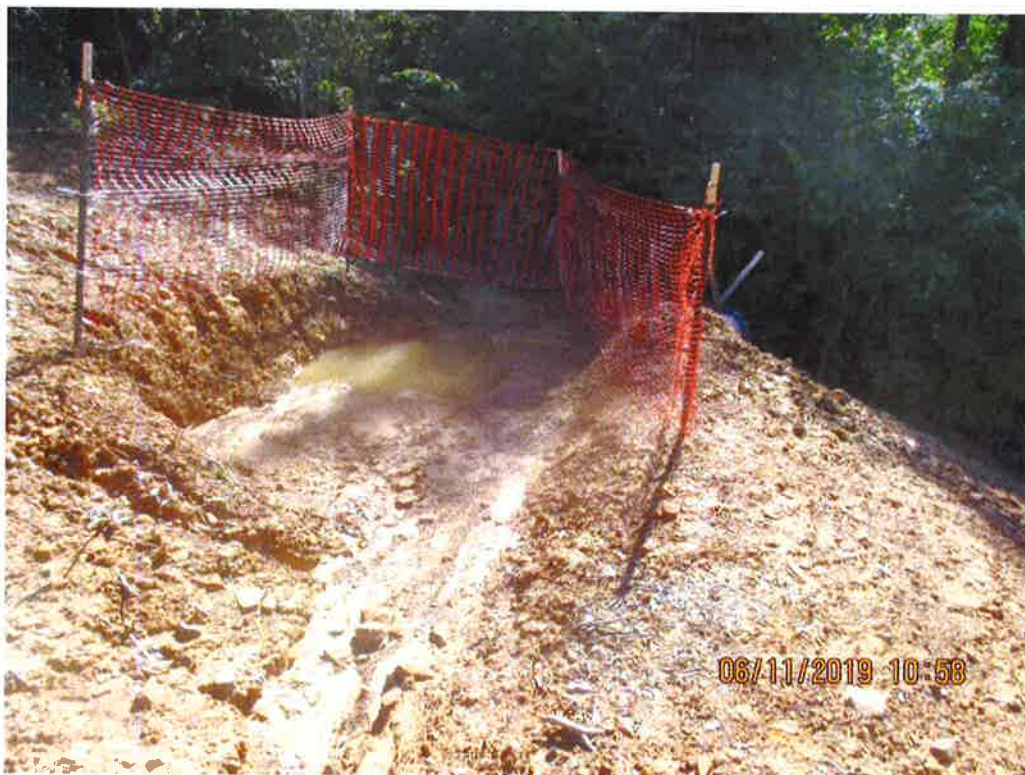
Above Lower Krosier Road crossing. Erosion present on ROW above Waterbar. Sediment being deposited in Waterbar and sump, overwhelming sump and perimeter controls near station no. 7604+41.

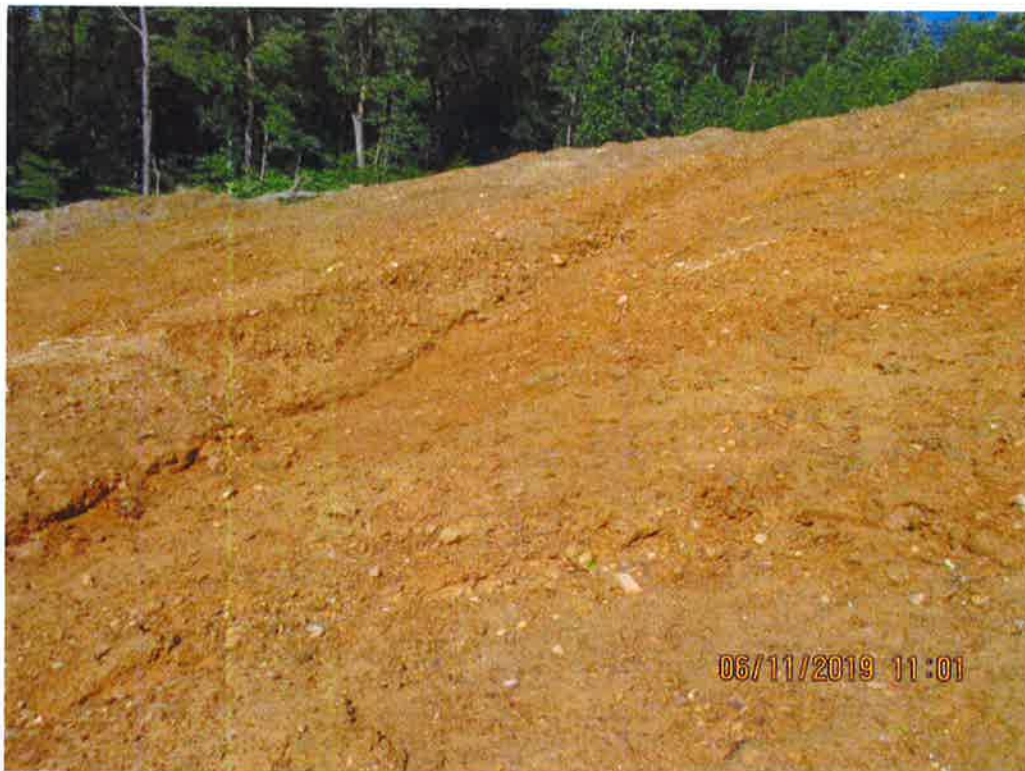
Above Lower Krosier Road crossing. Erosion present in Waterbar near station no. 7604+41.

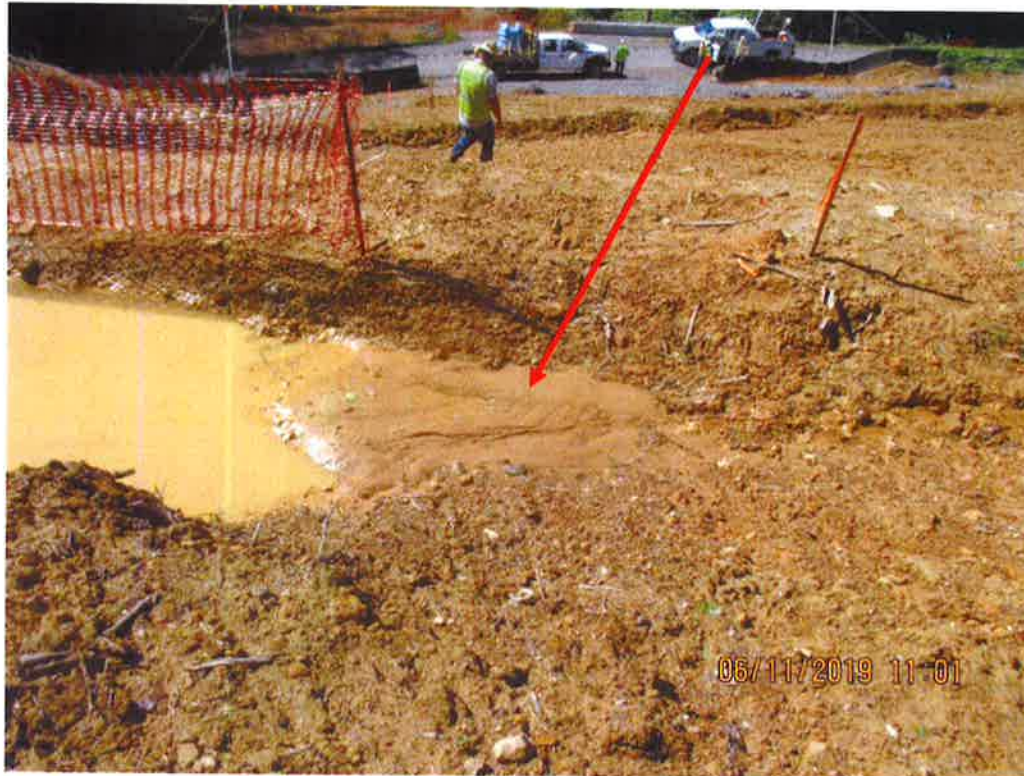
Above Lower Krosier Road crossing. Erosion present in Waterbar causing Sediment to be deposited in sump. Sump needed maintained.

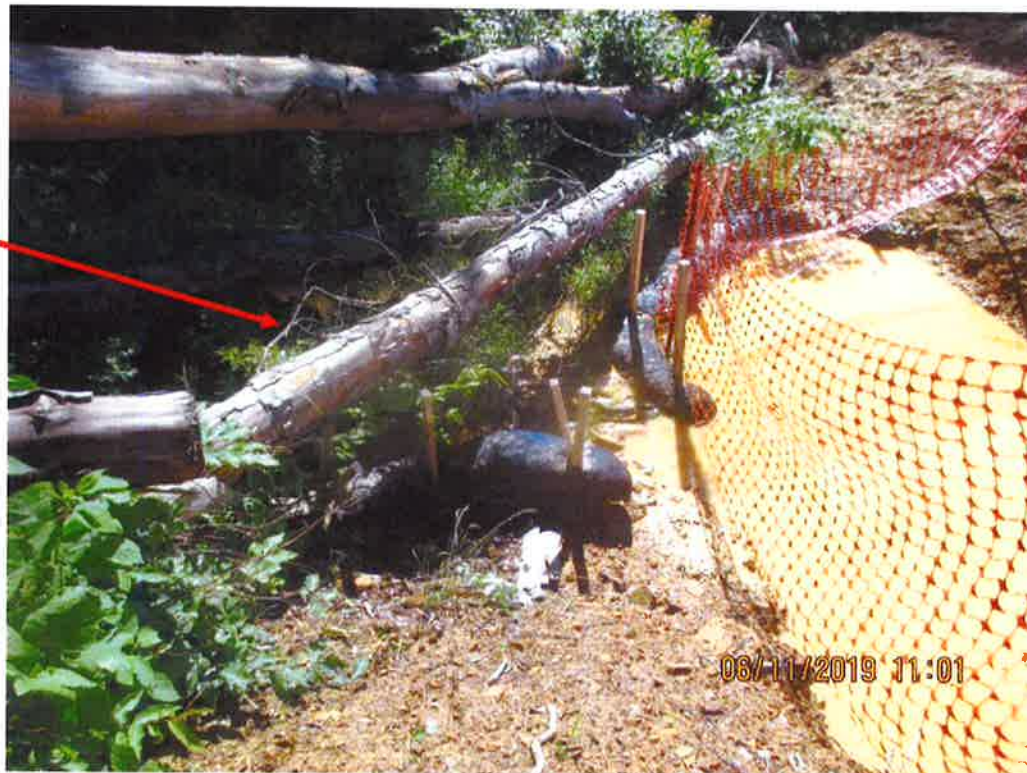
Above Lower Krosier Road crossing. Sediment and SLW overwhelming sump and perimeter controls near station no. 7604+41. Sediment deposits and SLW past controls and LOD.

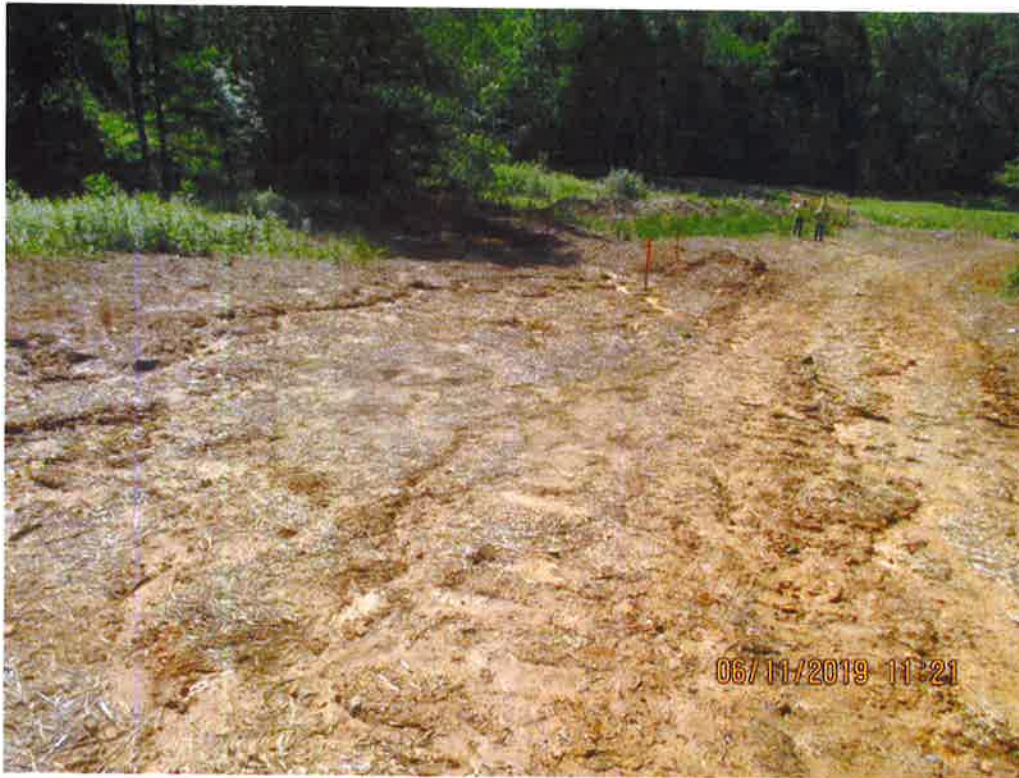
Facing South (Downslope) at station No. 7609+50. Waterbar receiving sediment due to erosion on slope.

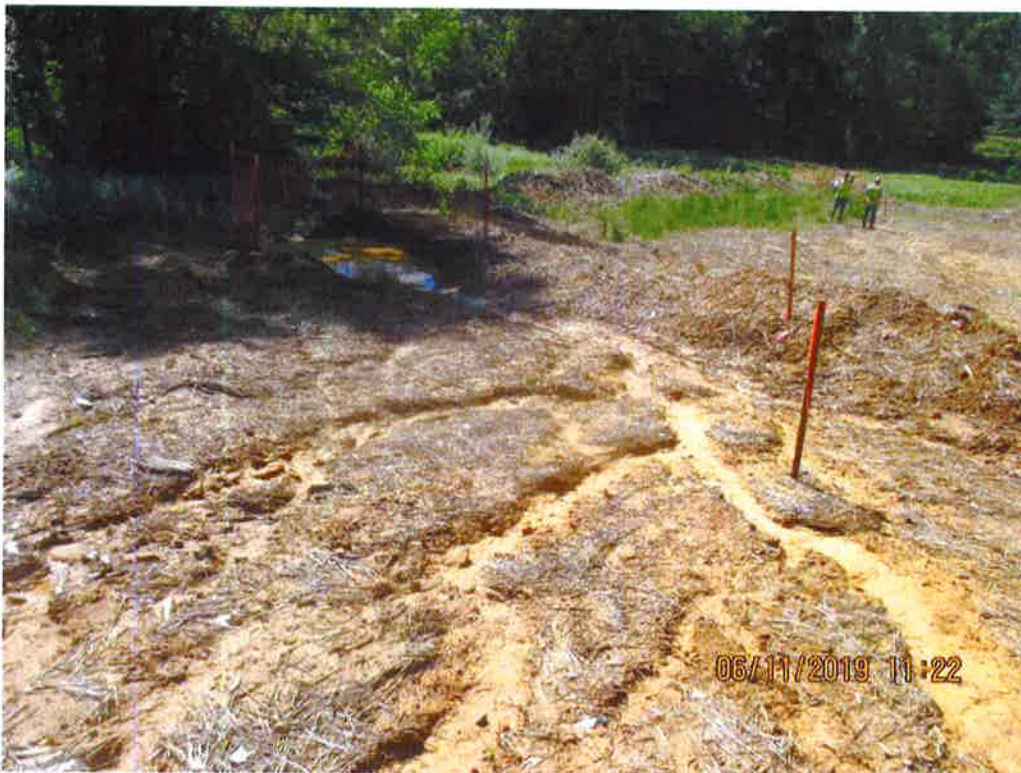
Facing South (Downslope) at station No. 7609+50. Waterbar receiving sediment due to erosion on slope. Controls overwhelmed with SLW and sediment.

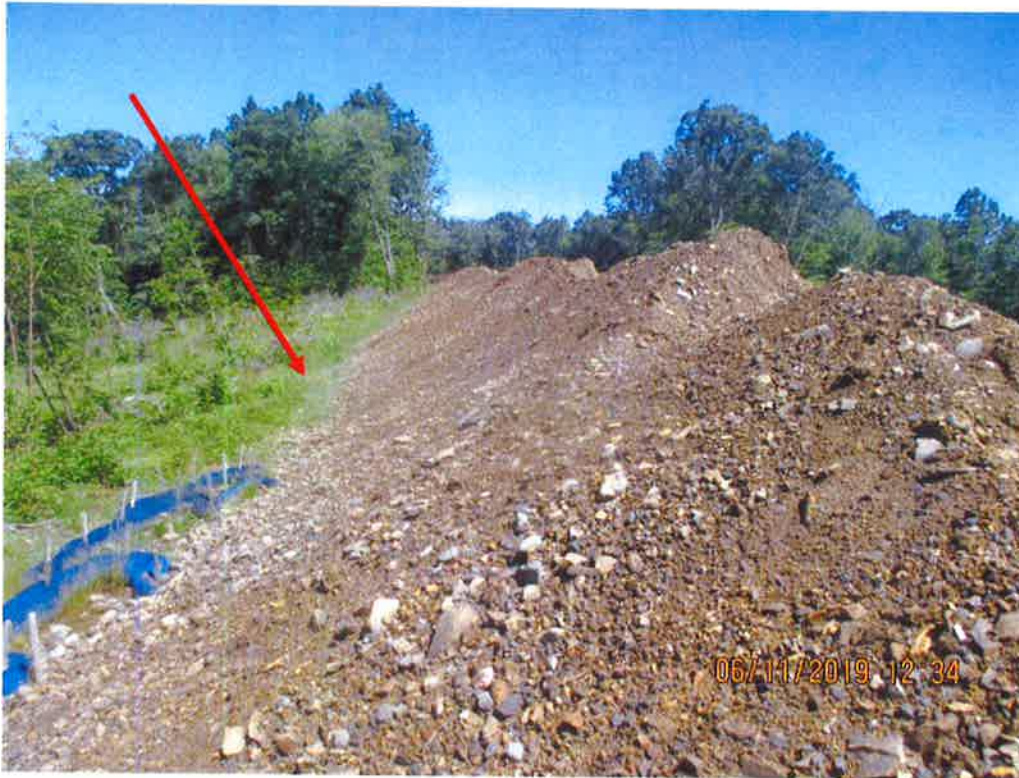
Spoil pile near station No. 7636+00. No perimeter controls at the base of pile. This is an area of concern due to the potential for sediment to be deposited past the LOD.

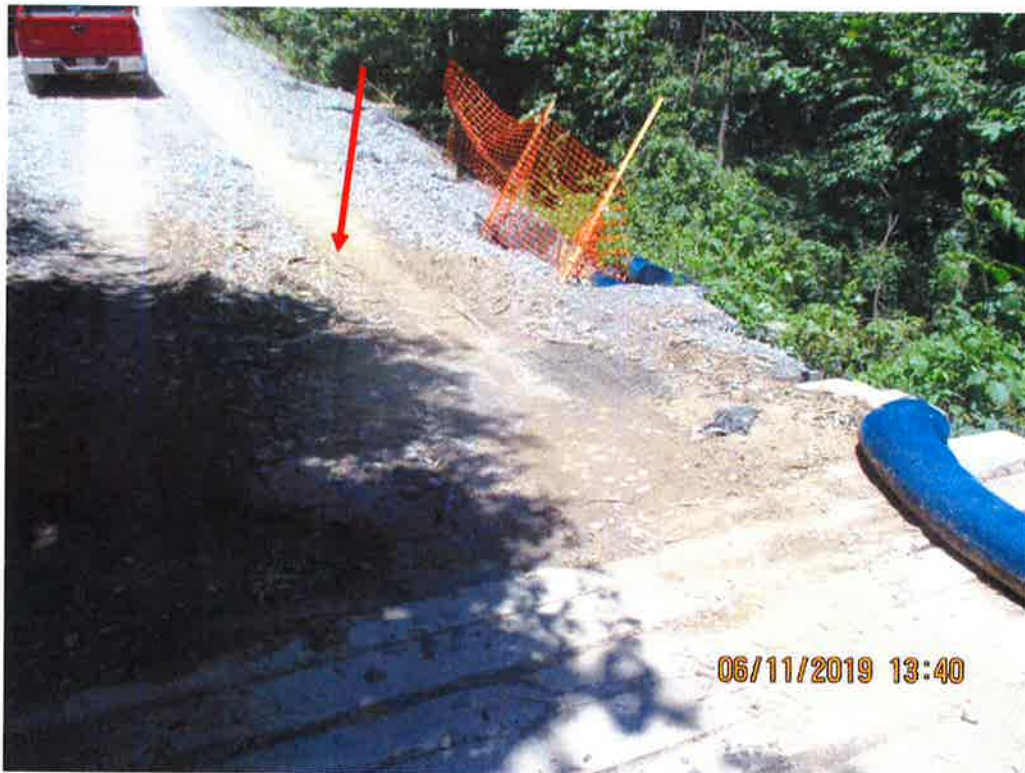
3. **(6).** Above the bridge along AR-182.5 a temporary Waterbar was installed but had been worn down and was barely distinguishable. This Waterbar needs maintained.
4. **(1, 6, 13, 19)** Bridge crossing at Wetland W-V6 on AR-182.5. Erosion present in the ditch upslope of this crossing; sediment deposits and SLW was observed past controls and LOD below wetland W-V6.

Facing up grade on Access Road 192.5 at wetland crossing W-V6. SWPPP detailed Waterbar above this crossing. Waterbar had been eroded and was barely distinguishable. Arrow depicts where Waterbar was installed and terminating on road bank (slope).

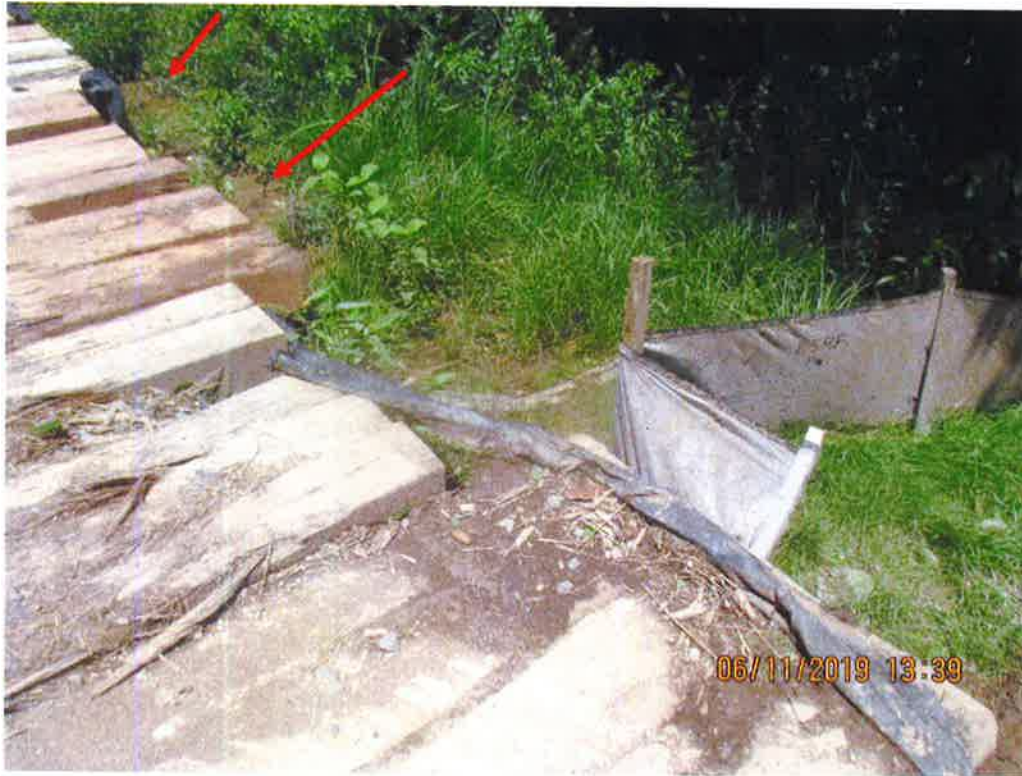
Wetland W-V2 crossing with AR-182.5. Sediment tracked onto bridge and has migrated past controls and into wetland. Arrow depicts deposits.

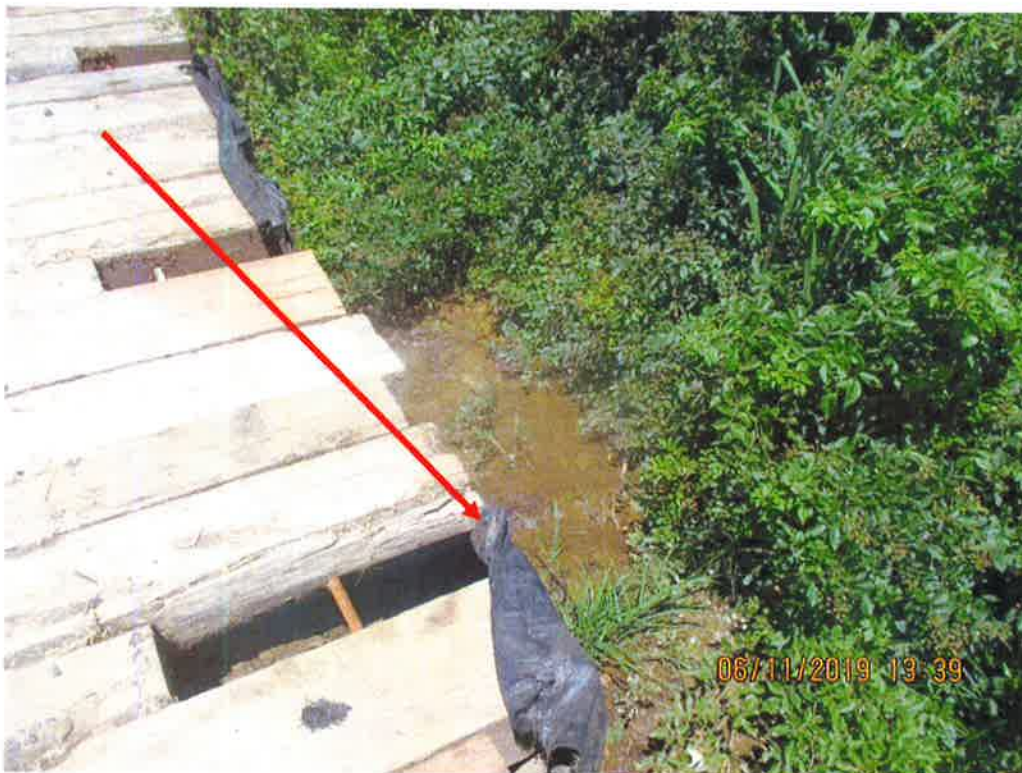
Wetland Crossing W-V6. Controls on bridge in need of maintenance. Impacts due to sediment migrating off bridge is an area of concern.
