Re: Mountain Valley Pipeline, LLC
Docket No. CP16-10-000
Weekly Status Report No. 90

Docket No. CP16-10-000
Weekly Report No. 90
Report Period: 07/13/19- 07/19/19

**Re: Mountain Valley Pipeline Project (Permit No. WVR310667)
Response to Notice of Violation No. W19-34-014-JTL**

STATE OF WEST VIRGINIA
Department of Environmental Protection
Environmental Enforcement
NOTICE OF VIOLATION

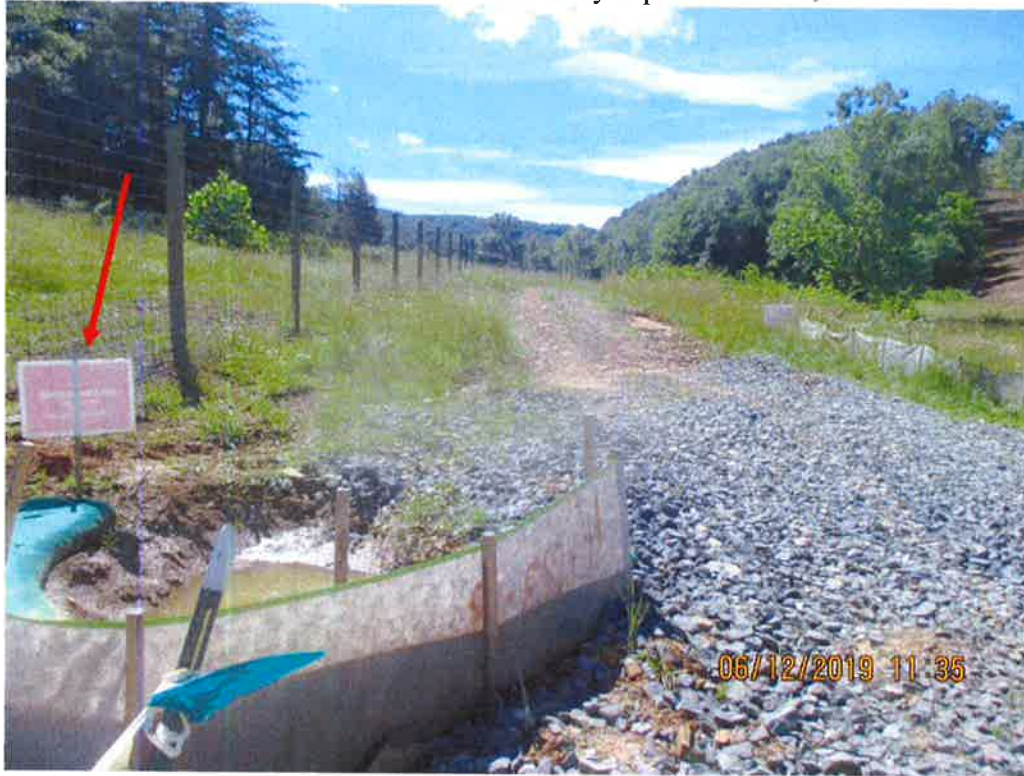
Above Anne's Branch crossing near station 9744+00. Facing upslope of MVP ROW. Erosion ongoing on road as well as slope above road. Arrow depicts LOD.

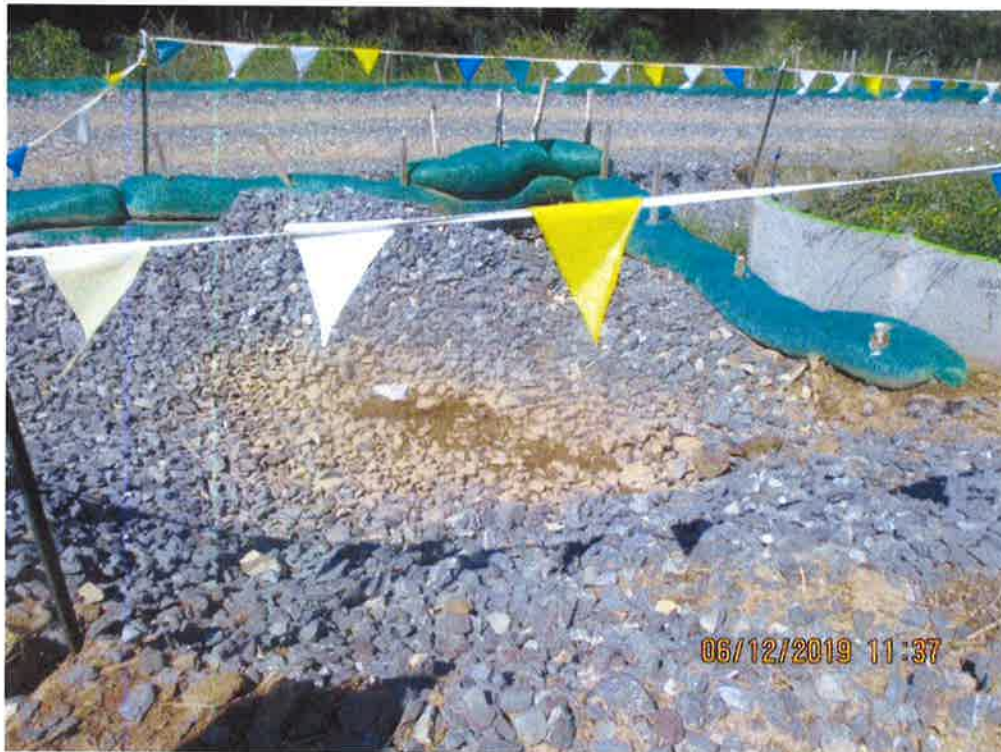
Anne's Branch crossing near station No. 9744+00 facing downstream. Past disturbance observed from land owner traffic across stream.

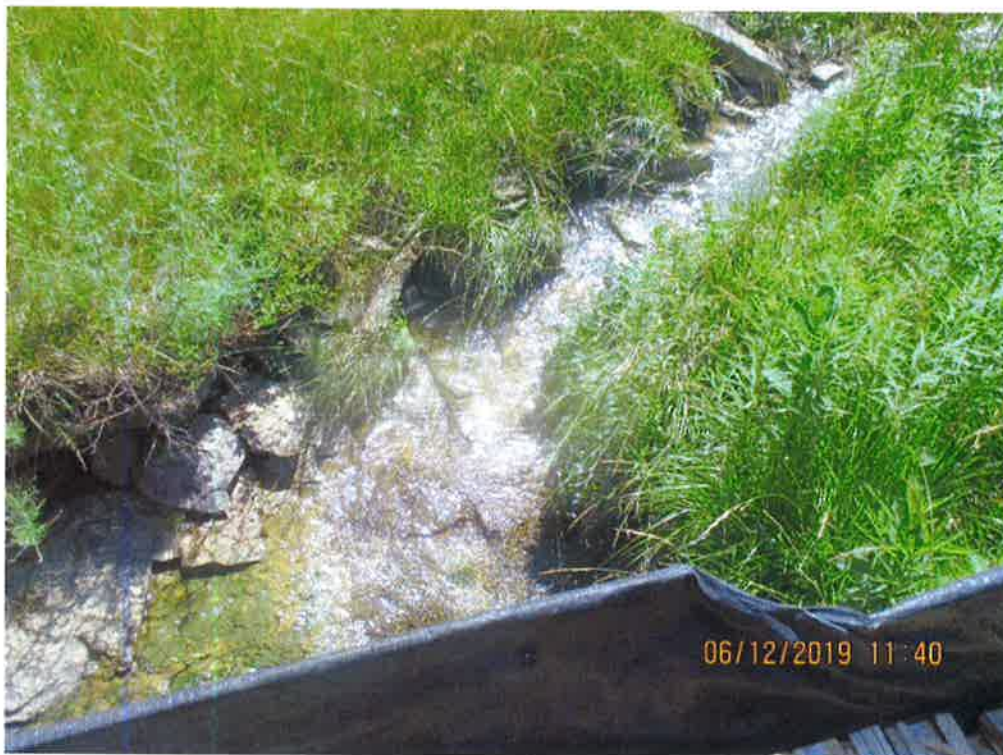
Facing North towards Anne's Branch at station No. 9745+00.

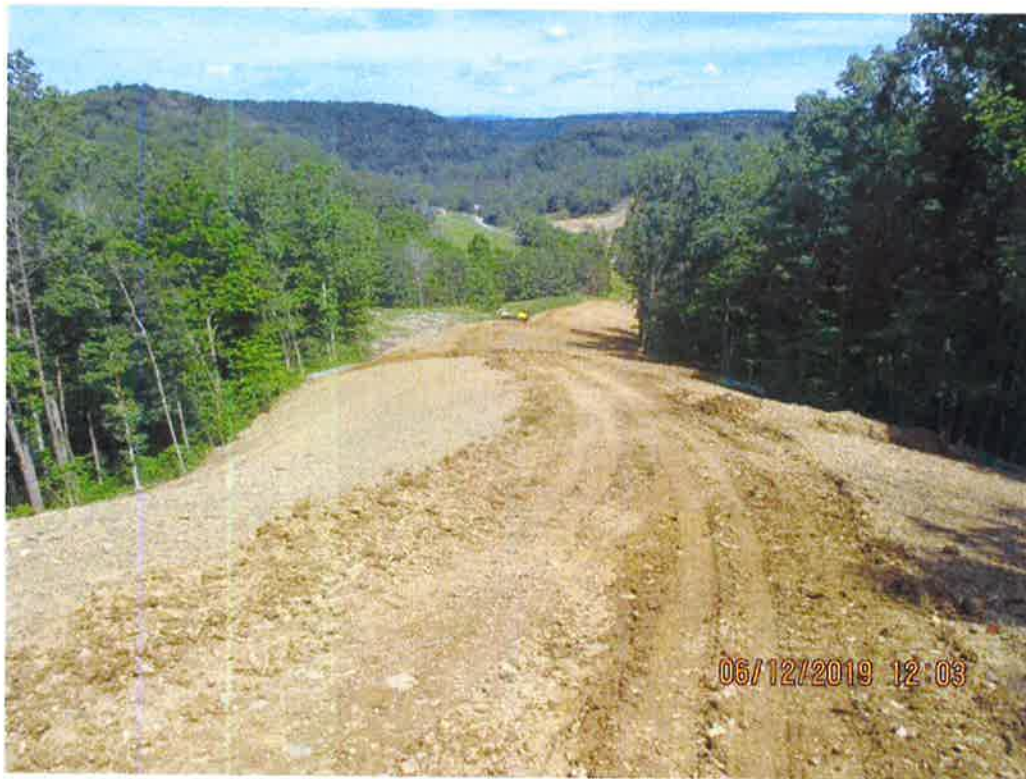
Facing South near station No. 9745+00 on North side slope. Arrow depicts location of Dargo silt fence.

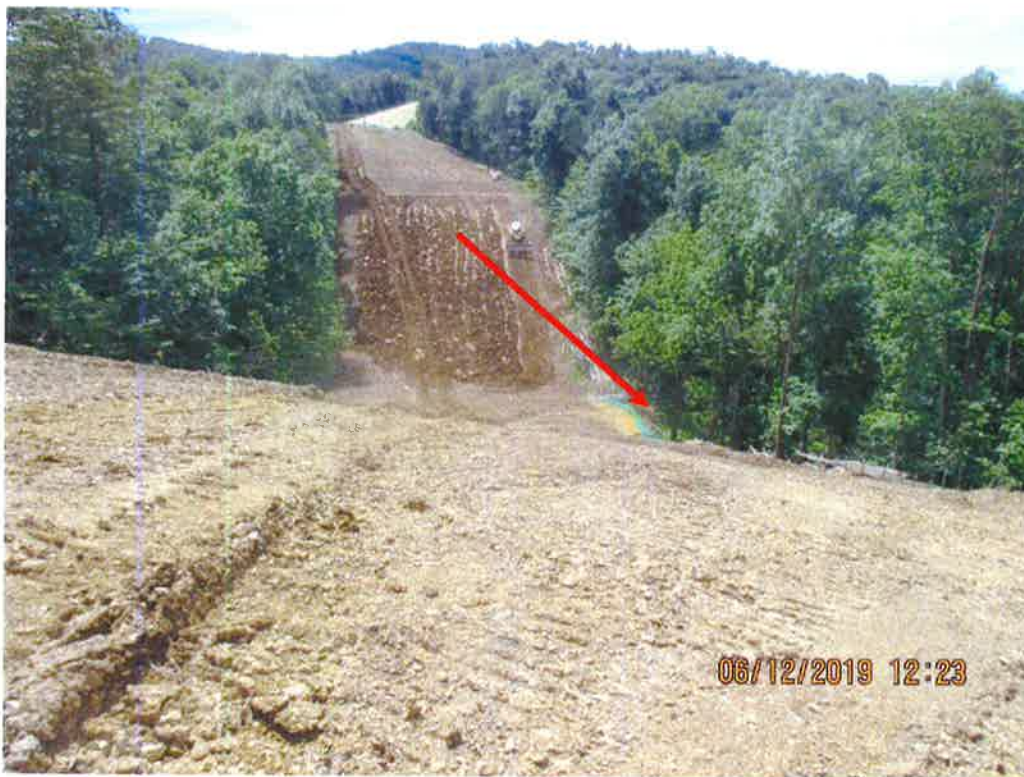
Facing Downslope at Dargo silt fence. Waterbar outlets in place with controls in foreground.

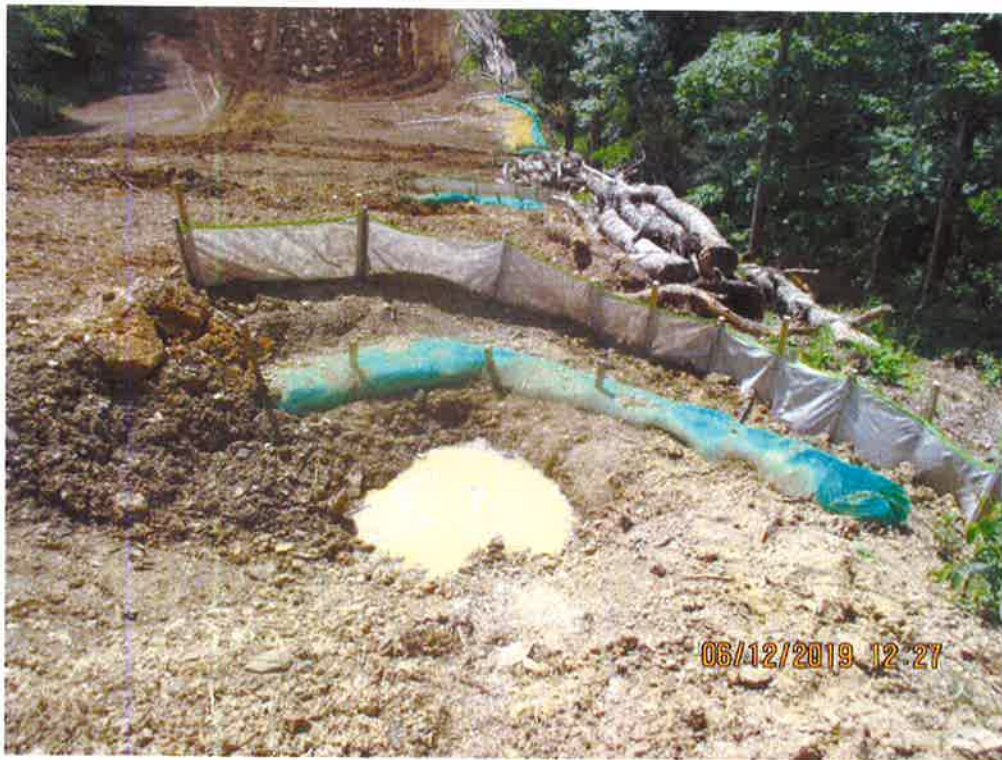
Dargo silt fence. Pipe slope drain terminating on ROW and not extended to edge of LOD. Arrow depicts slope drain outlet.

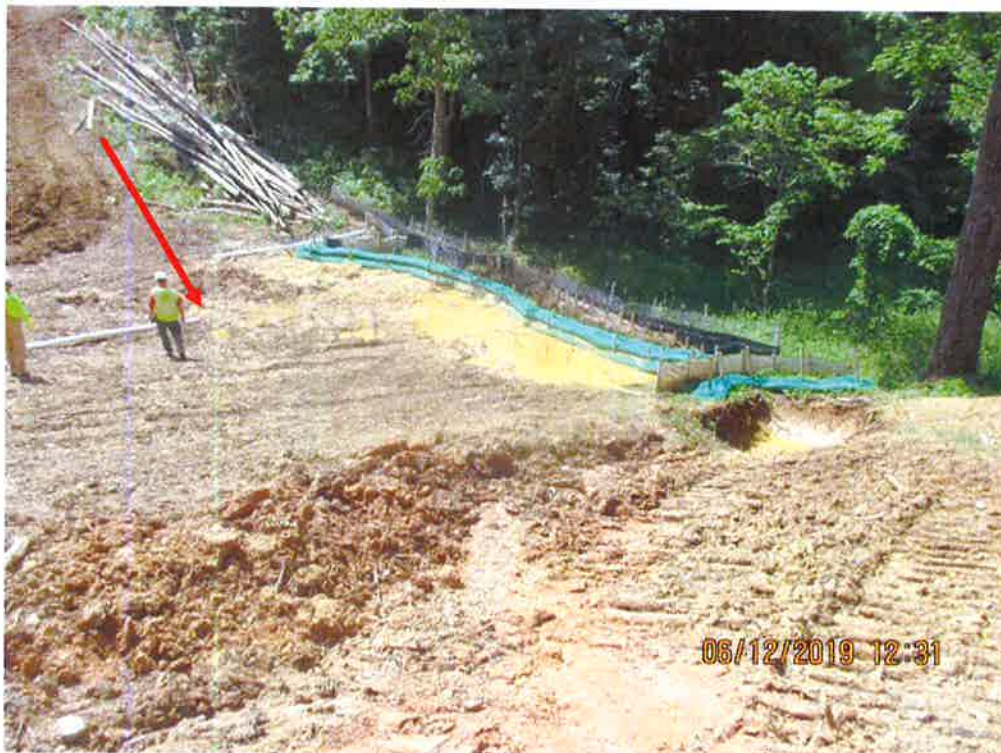
Pipe slope drain terminating onto ROW above controls (Dargo silt fence).

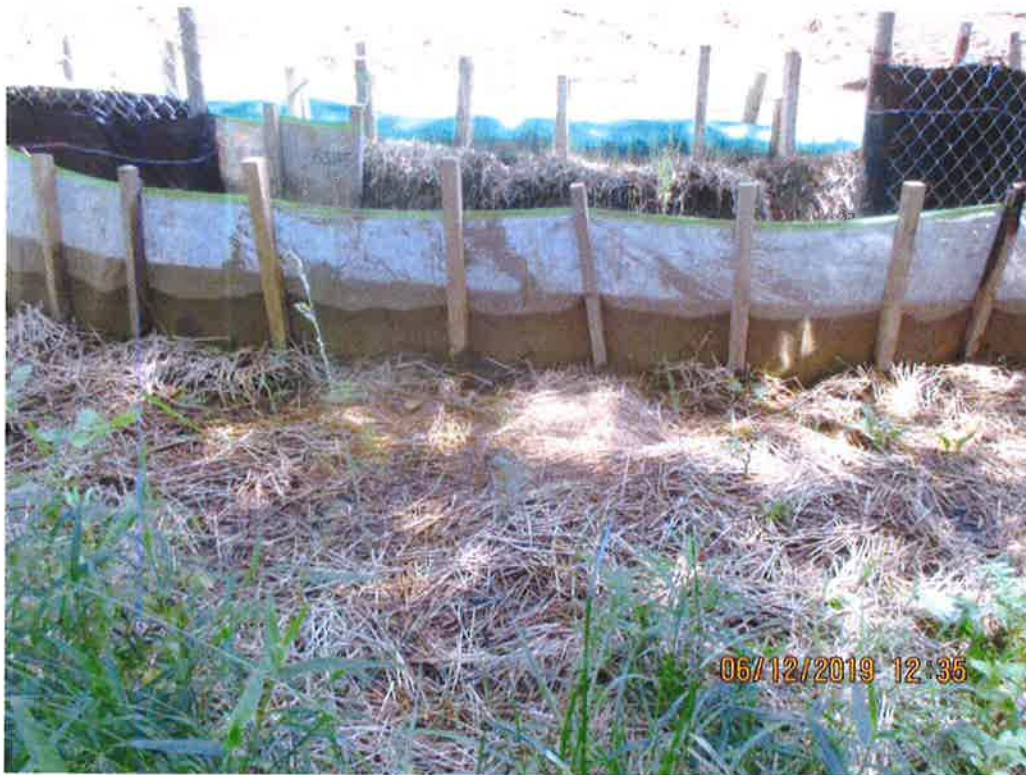
Below Dargo silt fence. Sediment deposits observed past LOD and low-lying area not delineated as a wetland.

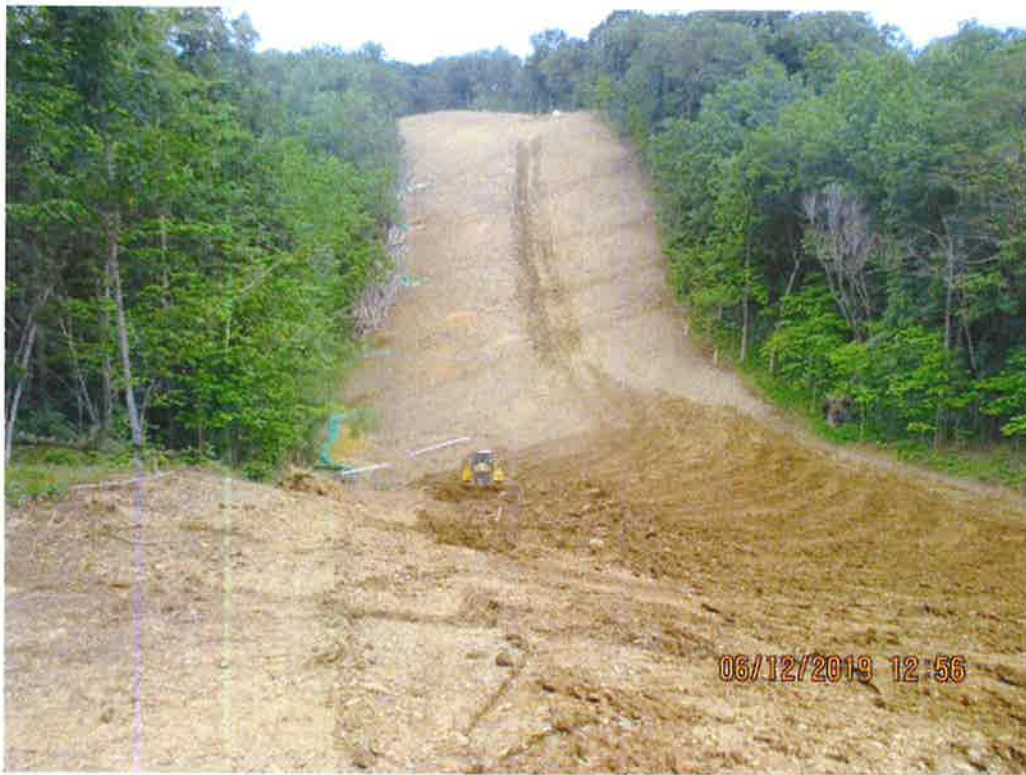
Upslope of Dargo silt fence. Facing South towards AR-221. Arrow depicts where dozer work was ongoing during inspection and controls needed maintenance.

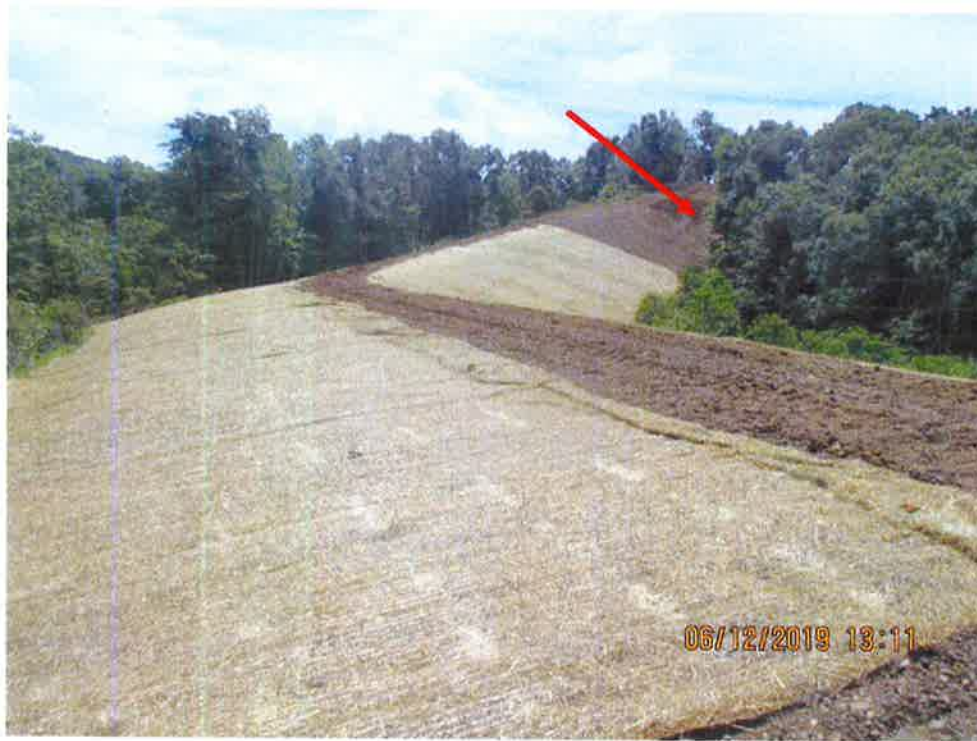
Controls below where dozer work was taking place. Sediment deposits observed below these controls at station No. 9780+00.

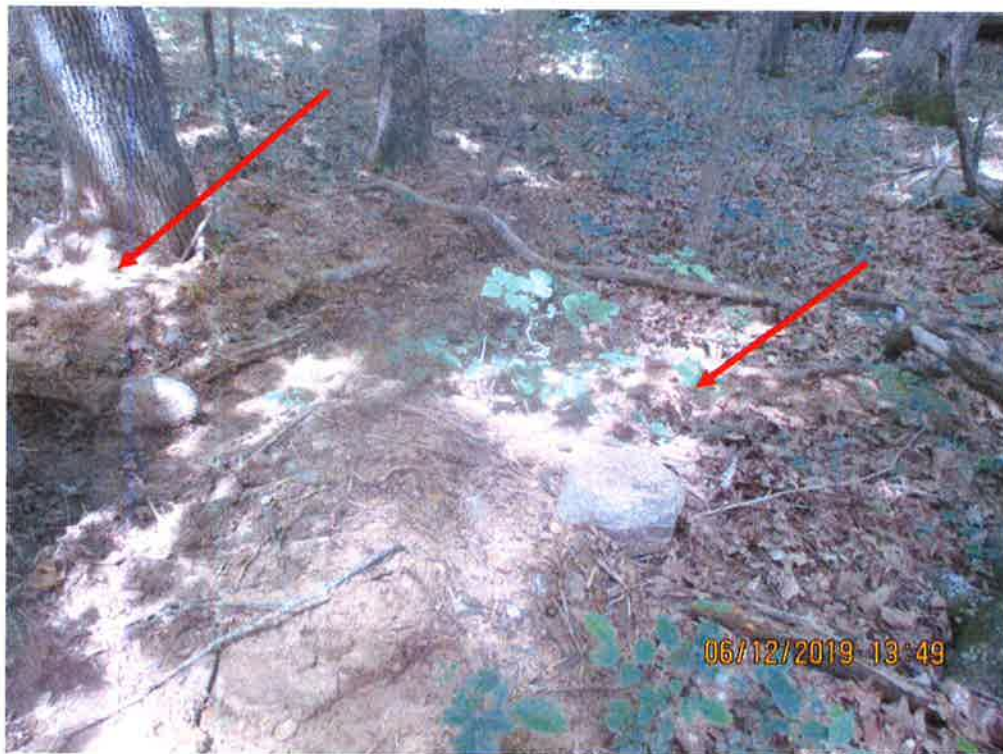
Section G.4.e.2.A.ii.j-Perimtte has allowed sediment laden to leave the site without going through and appropriate device: At station No. 9780+00 evidence that SLW had left the site was observed due to a significant amount of sediment deposits and scouring being present past controls and LOD. At the Dargo silt fence downslope of station No. 9780+00 sediment deposits was observed past controls and the LOD.

Sediment Deposits below and past controls/LOD at station No. 9780+00. Arrow depicts deposits.

Photo 8: Photo illustrates the permanent stabilization and CFS that have been installed near Station 9780+00.
