Visual Site Inspection Report

Project Name	H-600 Pipeline Spread G	AFE	124300137	Spread	H-600 Pipeline Spread G
Contractor	Precision			Report #	15871
Inspector	Garrett Barclay			Date/Time	4/15/2019 9:31 AM
Permit #	TBD	Inspection Type	VA SWPP	Station Begin	11023+00
State	VA	Inspection Area	Partial	Station End	11130+00
County	Giles	Ground	Muddy	Temperature (°F)	42.00
Municipality	N/A	Weather	Sunny	Rain Gauge (in)	2.20
				Rain Accumulation Time (days)	1.00

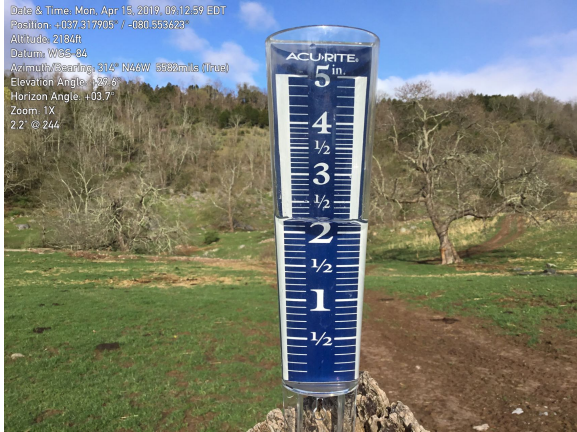
GPS Location	37.32	Field Station#	2+44	GPS Location	37.32
Description	2.2" of rain recorded @ AR 244		Description	2.1" of rain recorded @ AR 258.03	
<p>Date & Time: Mon, Apr 15, 2019, 19:21:29 EDT Position: +037° 19' 2179" / -080° 33' 5111" Altitude: 2403ft Datum: WGS-84 Azimuth/Bearing: 089° N89E 1582mils (True) Elevation Grade: -012% Horizon Grade: -010% Zoom: 1X 11025-00</p>

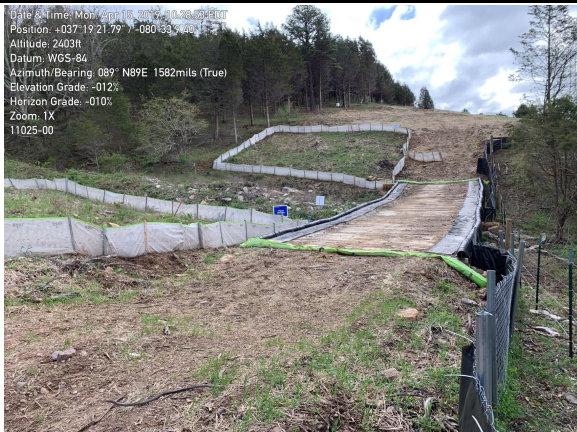
GPS Location	37.32	Field Station#	11025+00	GPS Location	37.32
Description	ECD's and ROW conditions		Description	ECD's and ROW conditions	
<p>Date & Time: Mon, Apr 15, 2019, 11:30:54 EDT Position: +037° 10' 5515" / -080° 32' 1623" Altitude: 2390ft Datum: WGS-84 Azimuth/Bearing: 130° S50E 2311mils (True) Elevation Grade: -015% Horizon Grade: +002% Zoom: 1X 11073-00</p>

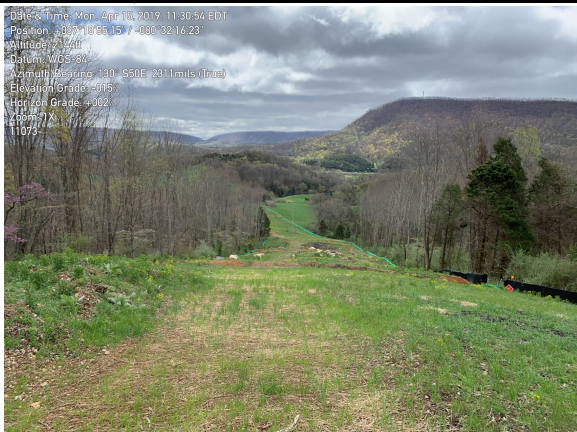
GPS Location	37.32	Field Station#	11073+00	GPS Location	37.32
Description	ECD's and ROW conditions		Description	ECD's and ROW conditions

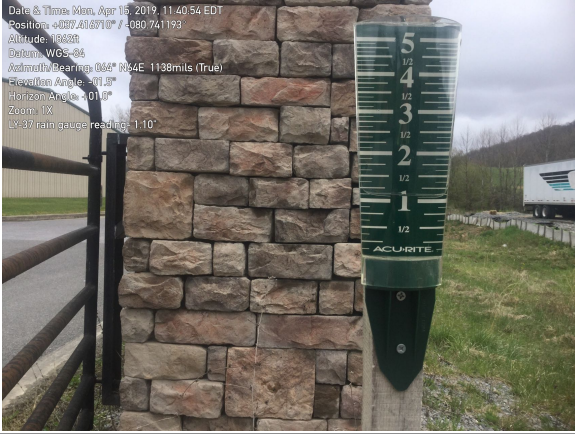
GPS Location	37.37	Field Station#	0+00	GPS Location	37.41
Field Station#	12005+00	Description	AR-234- Rain gauge reading-2.00"	Description	
Insert image here			Insert image here		
GPS Location		Field Station#		GPS Location	
Description		Description		Description

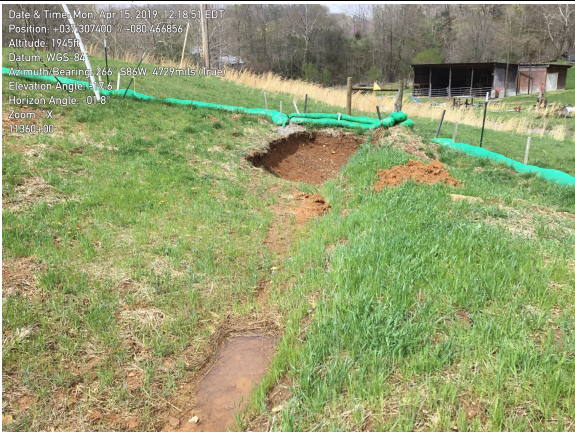
GPS Location	37.33	Field Station#	11360+00	GPS Location	37.33	Field Station#	11372+00
Description	Water breaker and end treatment			Description	Plunge pool for clean water diversion

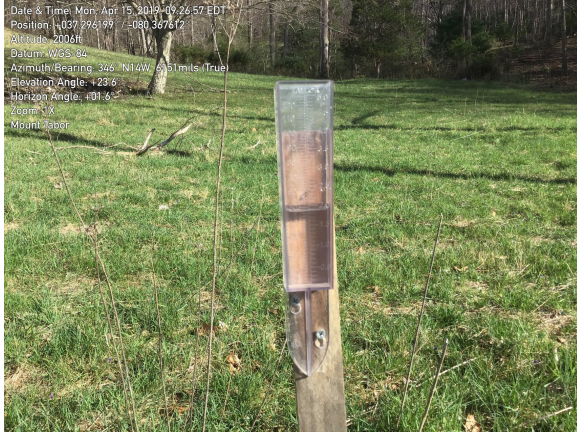
GPS Location	37.20	Field Station#	11767+00	GPS Location	37.20	Field Station#	11260+00
Description	See photo for GPS location. 1.9 inches of rain fall at Mount Tabor Road.			Description	See photo for GPS location. Slope drain with rock outlet in place.		
<p>Date & Time: Mon, Apr 15, 2019, 11:42:22 EDT Position: +037 296525 / -080 492426 Altitude: 2071ft Datum: WGS-84 Azimuth/Bearing: 137° S43E 2436mils (True) Elevation Angle: -21.4° Horizon Angle: +05.4° Zoom: 1X 11266+00</p>

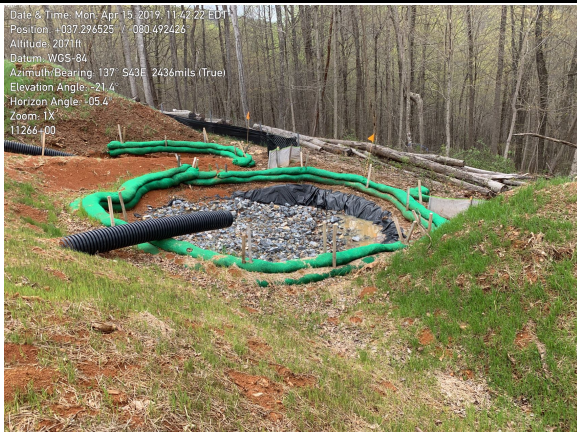
GPS Location	37.20	Field Station#	11266+00	GPS Location	37.20	Field Station#	11290+40
Description	See photo for GPS location. Plunge pool in place.			Description	See photo for GPS location. Sensitive resource buffer in place at stream S-MM18.		
<p>Date & Time: Mon, Apr 15, 2019, 12:56:29 EDT Position: +037 292701 / -080 421040 Altitude: 2193ft Datum: WGS-84 Azimuth/Bearing: 091° N04W 4210mils (True) Elevation Angle: -09.0° Horizon Angle: +00.3° Zoom: 1X 11489+00</p>

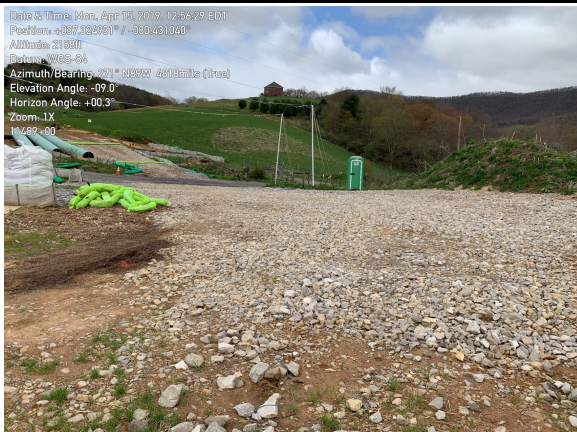
GPS Location	37.20	Field Station#	11489+00	GPS Location	37.20	Field Station#	11502+00
Description	See photo for GPS location. RCE in place at Stevens Gap Road crossing.			Description	See photo for GPS location. Conveyance channel with rock checks in place.

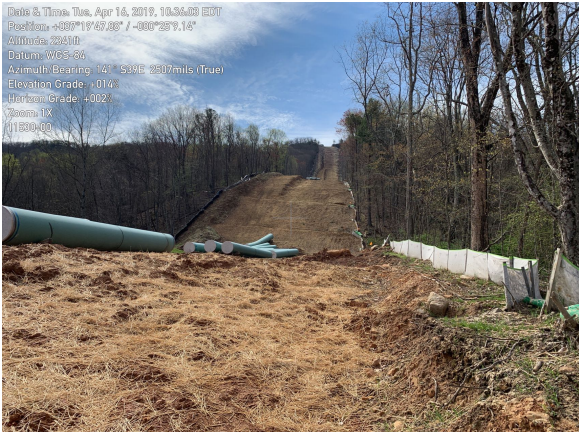
</div></div></div>				
GPS Location	37.32	Field Station#	11530+00	GPS Location	37.32	Field Station#	11535+00
Description	ECD's and ROW conditions			Description	ECD's and ROW conditions		
<div><div><div>Date & Time: Tue, Apr 16, 2019, 10:54:35 EDT Position: +037°19'43.25" / -080°25'5.87" Altitude: 2471ft Datum: WGS-84 Azimuth Bearing: 360° N20W 4044mils (True) Elevation Grade: +04% Horizon Grade: +012% Zoom: 1X 11548+00</div><div>

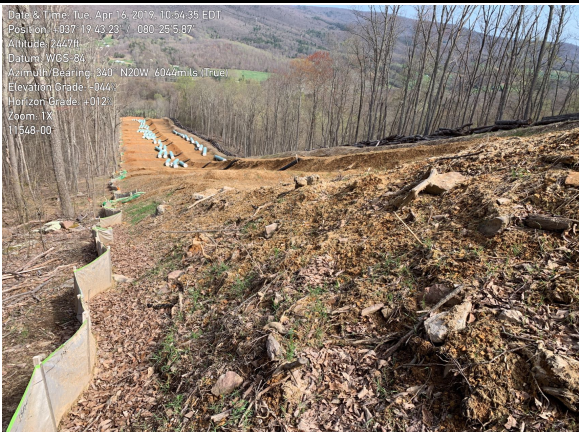
GPS Location	37.32	Field Station#	11548+00	GPS Location	37.32	Field Station#	11569+00
Description	ECD's and ROW conditions			Description	ECD's and ROW conditions		
<div><div><div>Date & Time: Tue, Apr 16, 2019, 12:01:00 EDT Position: +037°19'43.26" / -080°24'30.88" Altitude: 2048ft Datum: WGS-84 Azimuth Bearing: 117° S43E 2080mils (True) Elevation Grade: +033% Horizon Grade: +004% Zoom: 1X 11569+00</div><div>

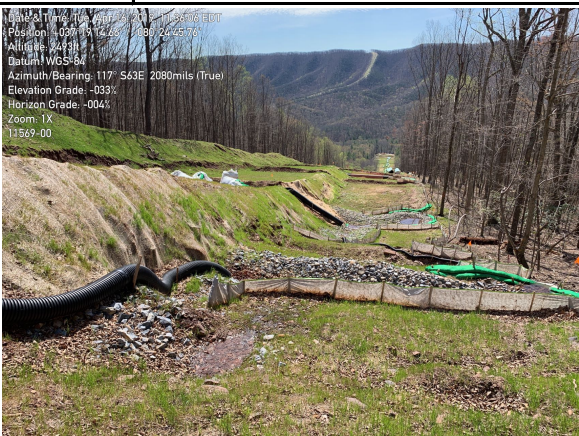
</div></div></div>				
GPS Location	37.32	Field Station#	11569+00	GPS Location	37.32	Field Station#	11590+97
Description	ECD's and ROW conditions			Description	ECD's and ROW conditions

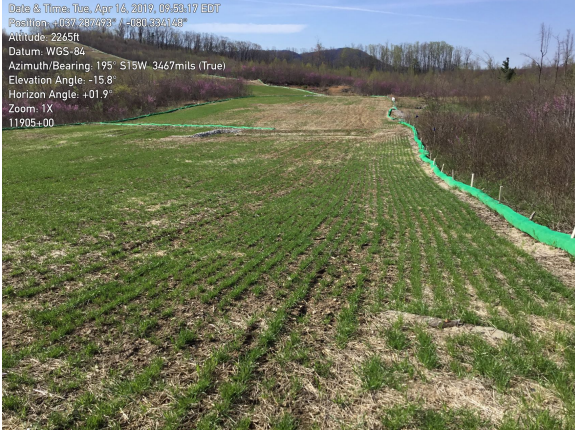
</div>				
GPS Location		37.32	Field Station#		11905+00			
Description		Row vegetation						
<div><p>Date & Time: Tue, Apr 16, 2019, 10:27:17 EDT Position: +037.270619 / -080.322895 Altitude: 1756ft Datum: WGS-84 Azimuth/Bearing: 197 S17W 3502mils (True) Elevation Angle: -21.9 Horizon Angle: +00.4 Zoom: 1X 11975+00</p>

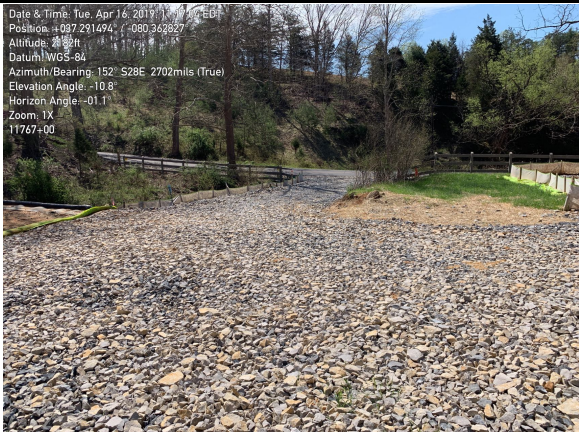
<p>Date & Time: Tue, Apr 16, 2019, 10:48:51 EDT Position: +037 295255° / -080 377320° Altitude: 2148ft Datum: WGS-84 Azimuth/Bearing: 139° N21W 4027mils (True) Elevation Angle: -40.3° Horizon Angle: +00.1° Zoom: 1X 11734+00</p>

<p>Date & Time: Tue, Apr 16, 2019, 11:01:07 EDT Position: +037 291494° / -080 368827° Altitude: 2148ft Datum: WGS-84 Azimuth/Bearing: 152° S28E 2702mils (True) Elevation Angle: -10.8° Horizon Angle: -01.1° Zoom: 1X 11767+00</p>				
GPS Location	37.33	Field Station#	11734+00	GPS Location	37.33	Field Station#	11767+00
Description	See photo for GPS location. End treatment undermined and sediment off ROW.			Description	See photo for GPS location. RCE in place at Main line valve 26.

GPS Location	37.31	Field Station#	11734+00		
Description	See photo for GPS location. Environmental crew replacing priority one silt fence end treatment with triple stack 12" CFS.				
Insert image here					
GPS Location	37.31	Field Station#	11734+00		
Description	See photo for GPS location. End treatment upgraded and replace.				
Insert image here					
GPS Location		Field Station#

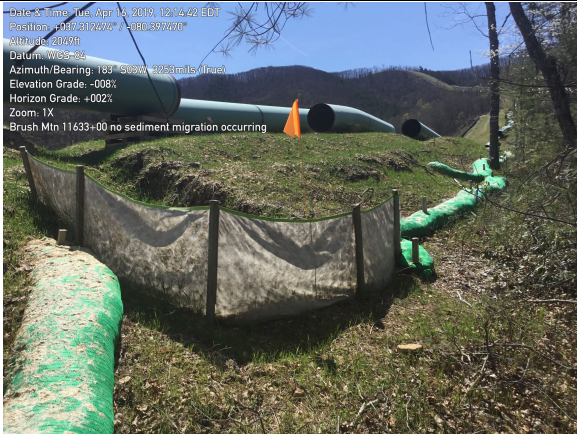
<p>Date & Time: Tue, Apr 16, 2019, 12:14:42 EDT Position: +037.312292° / -080.397470° Altitude: 2005ft Datum: WGS-84 Azimuth/Bearing: 183° S68W 323mils (True) Elevation Grade: -008% Horizon Grade: +002% Zoom: 1X Brush Mtn 11633+00 no sediment migration occurring</p>

Description		Correct coordinates on photo. End treatments are functioning properly.		Description	
<p>Date & Time: Tue, Apr 16, 2019, 12:22:28 EDT Position: +037.314063° / -080.396041° Altitude: 1886ft Datum: WGS-84 Azimuth/Bearing: 304° N54W 354mils (True) Elevation Grade: -041% Horizon Grade: +007% Zoom: 1X Brush Mtn 11626+04 S-HH18 crossing stable</p>

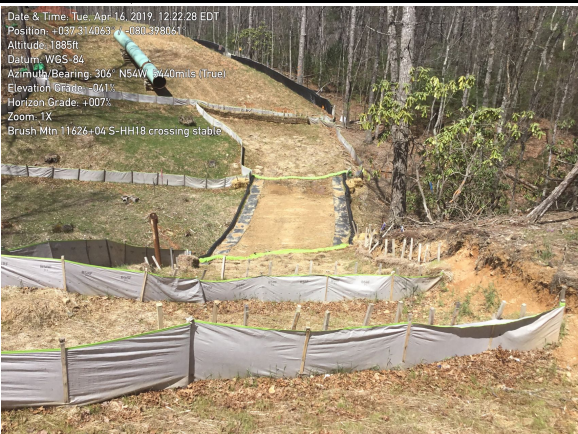
<p>GPS Location 37.13 Field Station# 11626+04</p> <p>GPS Location 37.13 Field Station# 11610+50</p>	
Description		Correct coordinates on photo. Resource crossings are stable with proper ECDSS installed.		Description	
Correct coordinates on photo. Plunge pools are in place.

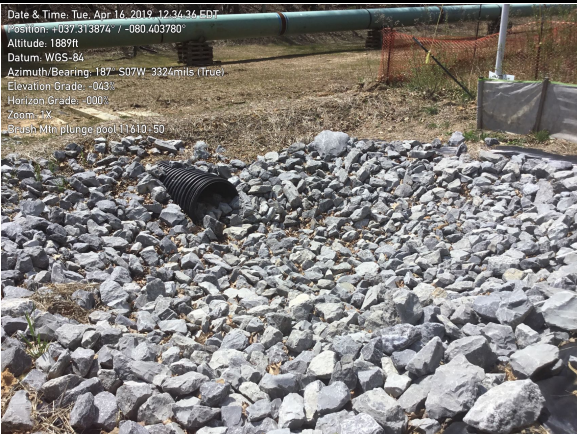
<p>Date & Time: Tue, Apr 16, 2019, 12:34:34 EDT Position: +037.313874° / -080.403780° Altitude: 1689ft Datum: WGS-84 Azimuth/Bearing: 187° S07W 332mils (True) Elevation Grade: -043% Horizon Grade: -000% Zoom: 1X Brush Mtn plunge pool 11610+50</p>

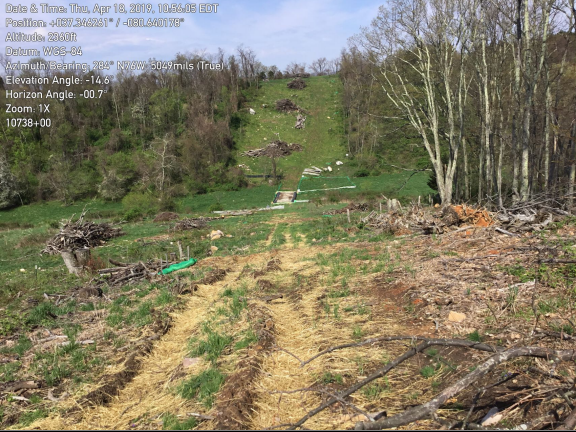
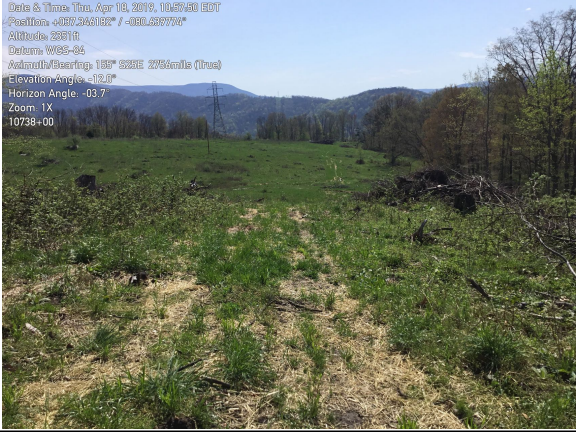
<p>GPS Location 37.33 Field Station# 10738+00</p> <p>Description Row stabilized</p>	
<p>Date & Time: Thu, Apr 18, 2019, 11:31:19 EDT Position: +037.349147° / +038.552232° Altitude: 2057ft Datum: WGS-84 Azimuth/Bearing: 119° S41°E 2710mils (True) Elevation Angle: -12.9° Horizon Angle: -04.1° Zoom: 1X 10677+00</p>

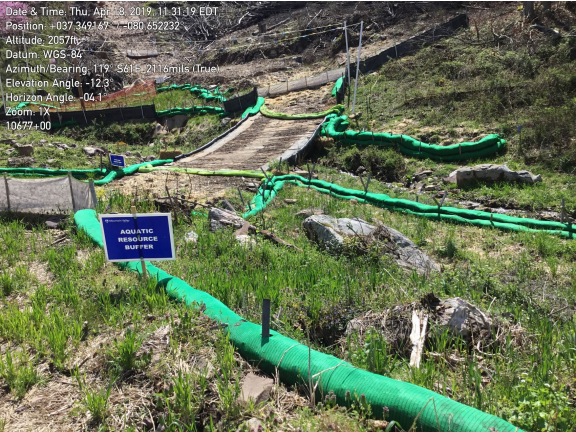
<p>GPS Location 37.33 Field Station# 10677+00</p> <p>Description Stream ECDs in good condition</p>

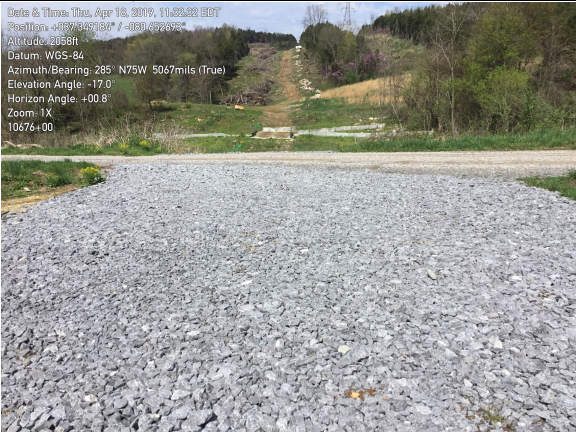
<p>GPS Location 37.33 Field Station# 10676+00</p> <p>Description Topsoil pile with good vegetation</p>	
		<p>GPS Location 37.33 Field Station# 10676+00</p> <p>Description RCE in good condition</p>

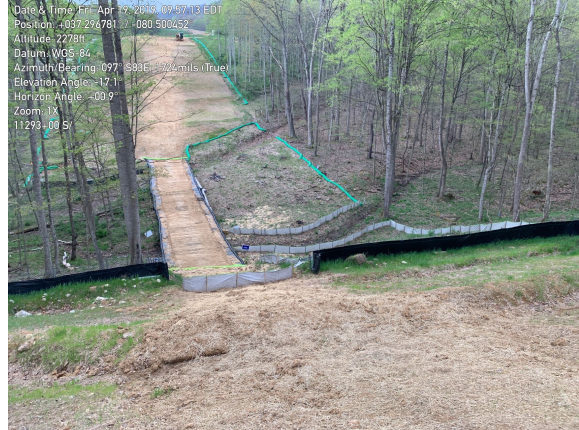
GPS Location	37.20	Field Station#	11268+00	GPS Location	37.20	Field Station#	11293+00
Description	See photo for GPS location. Plunge pool in place.			Description	See photo for GPS location. Sensitive resource buffer in place at stream S-MM18.

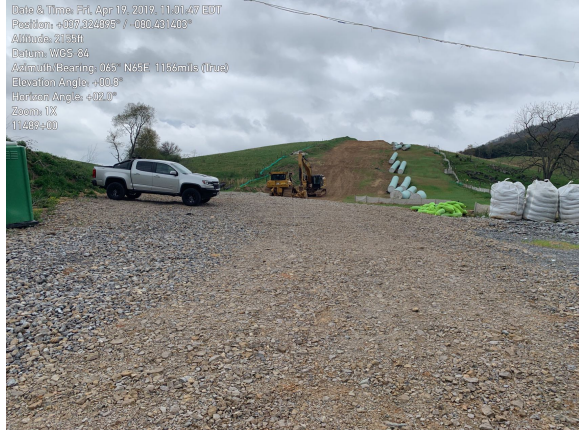
<p>Date & Time: Fri, Apr 19, 2019, 11:01:27 EDT Position: +037 284955 / -030 421403° Altitude: 2751ft Datum: WGS-84 Azimuth/Bearing: 065° N45E 1156mils (True) Elevation Angle: +06.8° Horizon Angle: +02.0° Zoom: 1X 11489+00</p>				
GPS Location	37.20	Field Station#	11332+00	GPS Location	37.20	Field Station#	11489+00
Description	See photo for GPS location. Rock lined channel in place.			Description	See photo for GPS location. RCE in place at Stevers Gap Road.

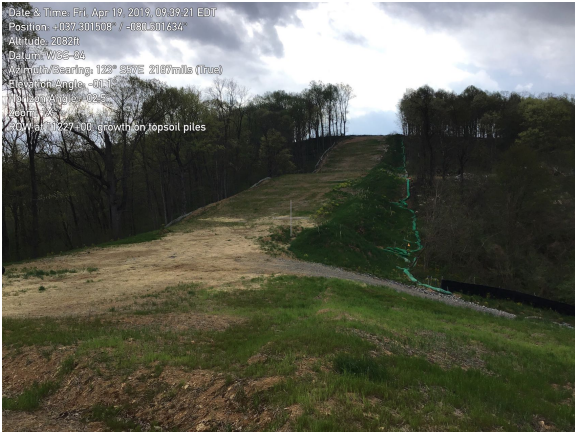
A/E	124300137	Date/Time	4/19/2019 3:08 PM	Report #	16046		
Pictures							
<div><div><div>Date & Time: Fri, Apr 19, 2019, 09:39:21 EDT Position: +037.301508° / -080.501634° Altitude: 2027ft Datum: WGS-84 Azimuth/Bearing: 129° NW 2187mils (True) Elevation Angle: -00.5° Horizon Angle: +00.5° Zoom: 1X View at 11227+00: growth on topsoil piles</div><div>

</div></div></div>				
GPS Location	37.13	Field Station#	11227+00	GPS Location	37.13	Field Station#	11208+00
Description	Vegetation beginning to grow.			Description	Vegetation beginning to grow.		
<div><div><div>Date & Time: Fri, Apr 19, 2019, 09:46:10 EDT Position: +037.301845° / -080.503994° Altitude: 2027ft Datum: WGS-84 Azimuth/Bearing: 237° S57W 4219mils (True) Elevation Angle: -20.9° Horizon Angle: -00.2° Zoom: 1X View at 11215+00: pipe slope drain</div><div>

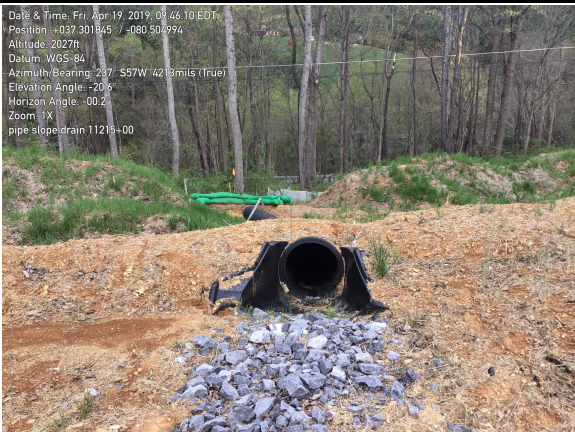
GPS Location	37.13	Field Station#	11215+00	GPS Location	37.13	Field Station#	11204+00
Description	Installed pipe slope drain			Description	Installed end treatment and sump		
<div><div><div>Date & Time: Fri, Apr 19, 2019, 10:02:45 EDT Position: +037.295760° / -080.493306° Altitude: 1997ft Datum: WGS-84 Azimuth/Bearing: 123° NW 2119mils (True) Elevation Angle: -00.5° Horizon Angle: +01.5° Zoom: 1X View at 11191+00: drainage feature at</div><div>

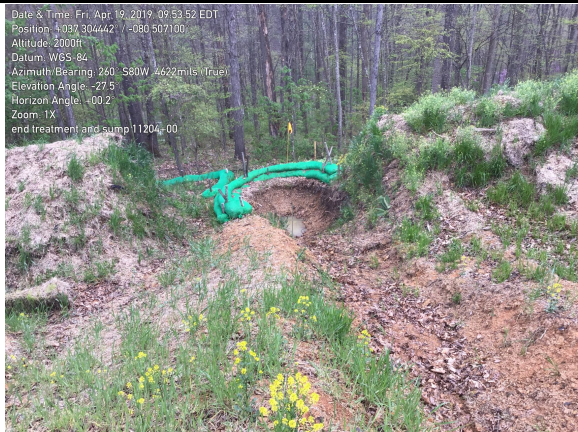
</div></div></div>			<div><div><div>Date & Time: Fri, Apr 19, 2019, 09:53:52 EDT Position: +037.304442° / -080.507100° Altitude: 2000ft Datum: WGS-84 Azimuth/Bearing: 260° S80W 4622mils (True) Elevation Angle: -27.5° Horizon Angle: -00.2° Zoom: 1X View at 11204+00: end treatment and sump</div><div>

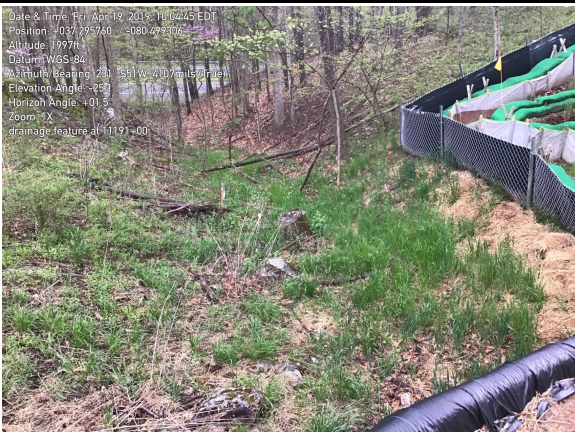
</div></div></div>				
GPS Location	37.13	Field Station#	11191+00	GPS Location	37.13	Field Station#	11471+00
Description	Drain feature downslope of ROW crossing			Description	Two tone stabilized per DEQ request.

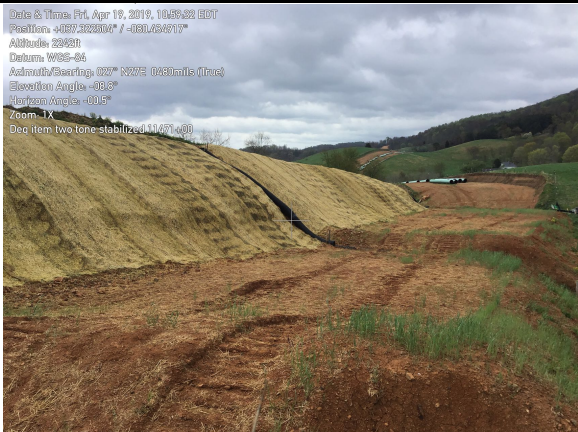
</div></div></div>			<div><div><div>Date & Time: Fri, Apr 19, 2019, 10:05:32 EDT Position: +037.292804° / -080.483917° Altitude: 2049ft Datum: WGS-84 Azimuth/Bearing: 122° NW 2063mils (True) Elevation Angle: -00.6° Horizon Angle: +00.6° Zoom: 1X View at 11471+00: Dec item two tone stabilized</div><div>

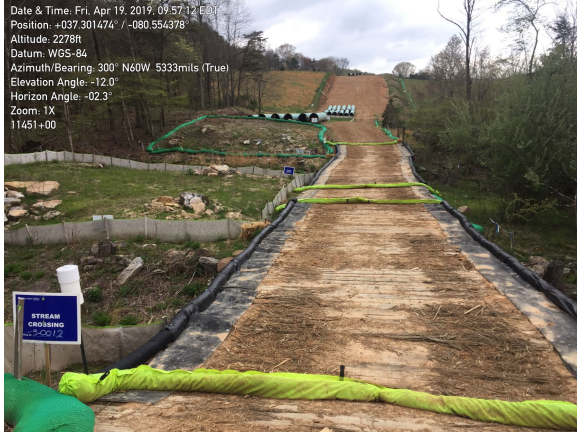
</div>		
GPS Location	37.33	Field Station#	11451+00	GPS Location	37.33
Description	Stream crossing with ECDs in good condition		Description	Soil pipe contained with ECDs	
<div><p>Date & Time: Fri, Apr 19, 2019, 10:12:42 EDT Position: +037.311183° / -080.453389° Altitude: 2228ft Datum: WGS-84 Azimuth/Bearing: 334° N34W 3038mils (True) Elevation Angle: -26.2° Horizon Angle: -02.3° Zoom: 1X 11405+00</p>

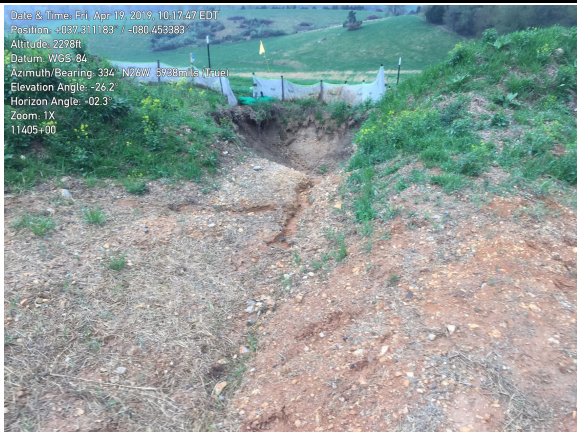
GPS Location	37.33	Field Station#	11405+00	GPS Location	37.33
Description	Water breaker with end treatment		Description	Water breaker with end treatment	
<div><p>Date & Time: Fri, Apr 19, 2019, 10:32:18 EDT Position: +037.309059° / -080.464063° Altitude: 2036ft Datum: WGS-84 Azimuth/Bearing: 172° S08E 3058mils (True) Elevation Angle: -08.0° Horizon Angle: -01.9° Zoom: 1X 11360+00</p>

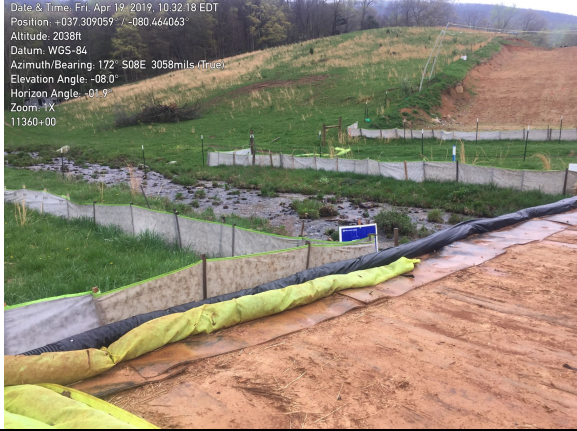
</div>		
GPS Location	37.33	Field Station#	11360+00	GPS Location	37.33
Description	Stream crossing, ECDs in good condition		Description	Row facing west
