Visual Site Inspection Report

Project Name	H-600 Pipeline Spread H	AFE	124300138	Spread	H-600 Pipeline Spread H	
Contractor	Precision			Report #	15621	
Inspector	Pat Davis			Date/Time	4/9/2019 6:39 PM	
Permit #	TBD	Inspection Type	VA SWPP	Station Begin	+0	
State	VA	Inspection Area	Partial	Station End	+0	
County	Montgomery	Ground	Muddy	Temperature (°F)	77.00	
Municipality	N/A	Weather	Cloudy	Rain Gauge (in)	0.40	
				Rain Accumulation Time (days)	0.00

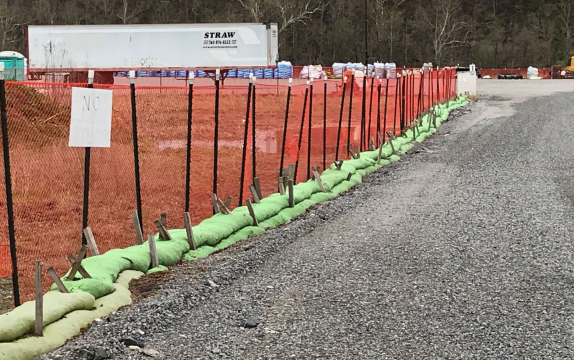
<div>2019-04-09 08:56:37-04:00</div>		
GPS Location	37.27	Field Station#	+0		
Description	MVP-LY-049_040919 condition of rock entrance. Looking S. See photo for gps data.				
<div>DIRECTION N (T)</div> <div>+37.27107° -080.12168°</div> <div>ACCURACY 16 ft DATUM WGS84</div>

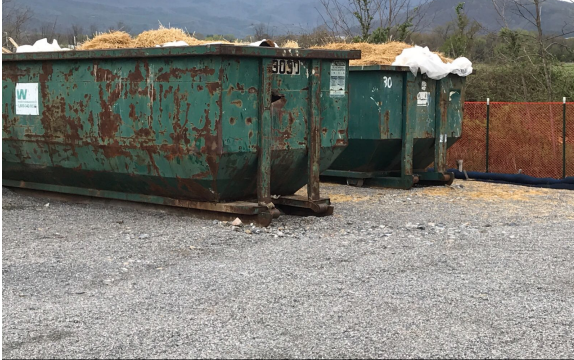
<div>2019-04-09 09:04:46-04:00</div>		
GPS Location	37.27	Field Station#	+0		
Description	MVP-LY-049_040919 dumpster area free of loose trash. Looking NE. See photo for gps data.				
<div>DIRECTION S (T)</div> <div>+37.27202° -080.12275°</div> <div>ACCURACY 16 ft DATUM WGS84</div>

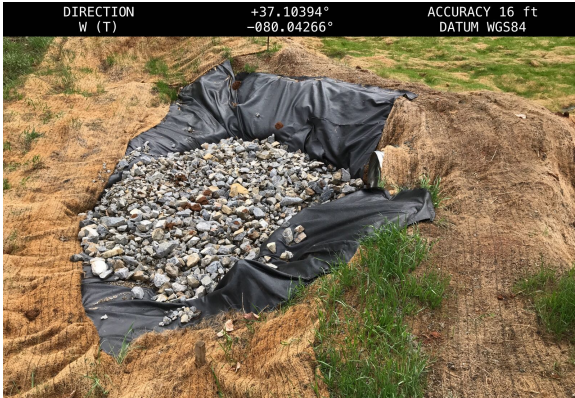
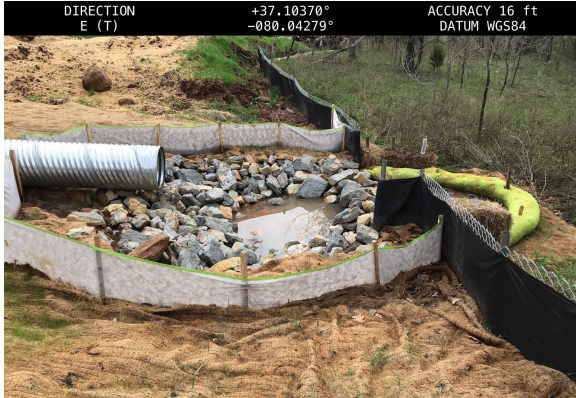
</div> <div>2019-04-09 10:47:38-04:00</div>		
GPS Location 37.10		Field Station# 13345+00		GPS Location 37.10	
Description		13345+00_040919 inlet for clean water cross over. Looking E. See photo for gps data.		Description 13345+00_040919 plunge pool for clean water cross over. Looking E. See photo for gps data.	
<div>DIRECTION W (T) <div>+37.10364° -080.04201°</div><div>ACCURACY 16 ft DATUM WGS84</div></div> <div>

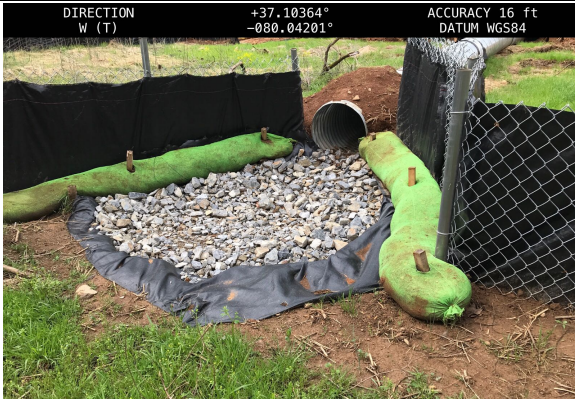
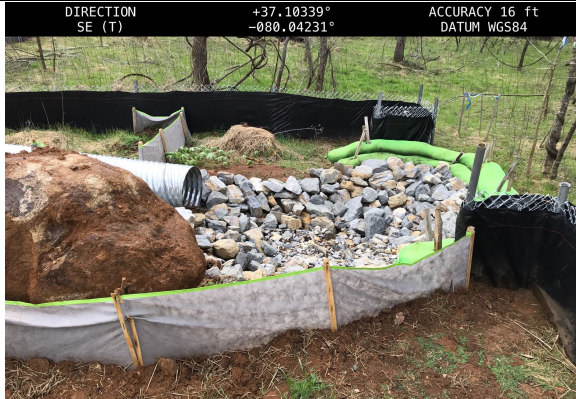
GPS Location 37.10		Field Station# 13348+00		GPS Location 37.10	
Description		13348+00_040919 inlet for clean water cross over. Looking E. See photo for gps data.		Description 13348+00_040919 plunge pool for clean water cross over. Looking SE. See photo for gps data.	
<div>DIRECTION S (T) <div>+37.10114° -080.03978°</div><div>ACCURACY 16 ft DATUM WGS84</div></div> <div>

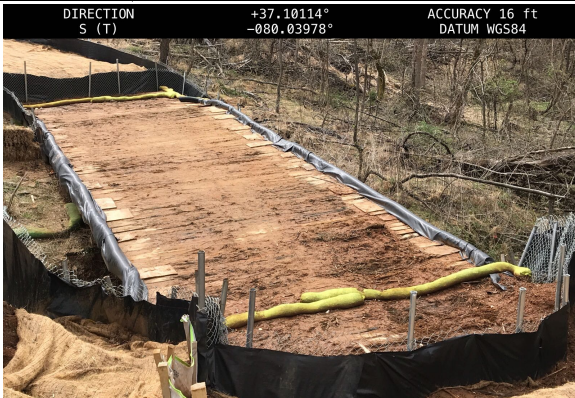
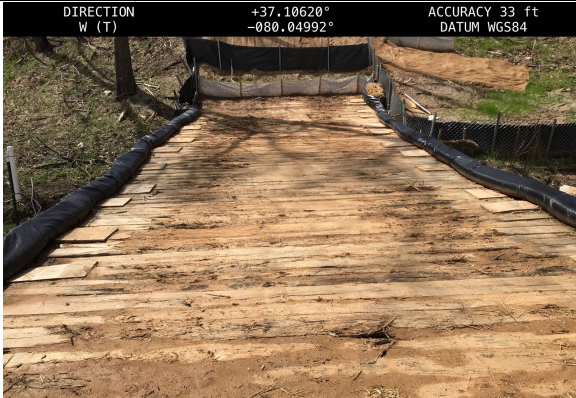
</div> <div>2019-04-09 14:56:14-04:00</div>		
GPS Location 37.10		Field Station# 13358+64		GPS Location 37.10	
Description		13358+64_040919 S-RR11 mat bridge clean and closed. Looking S. See photo for gps data.		Description 13321+47_040919 S-GH15 mat bridge clean and closed. Looking W. See photo for gps data.	
GPS Location 37.10		Field Station# 13321+47		GPS Location 37.10	
Description		13321+47_040919 S-GH15 mat bridge clean and closed. Looking W. See photo for gps data.		Description

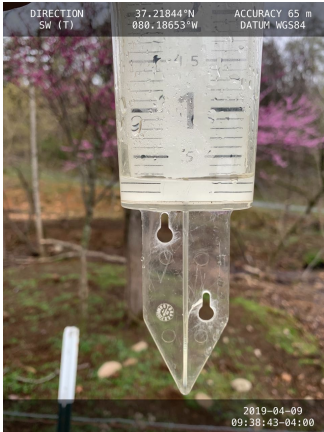
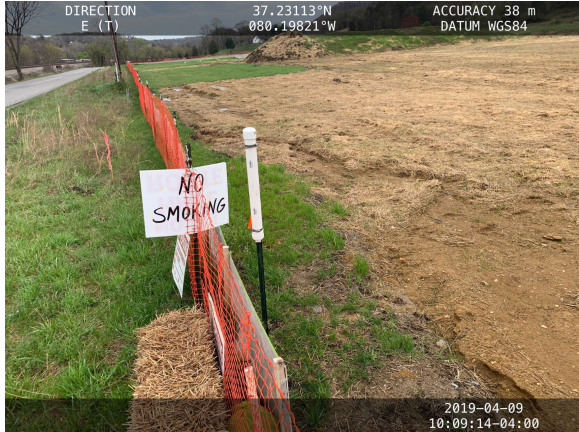
GPS Location		37.33		Field Station#		12543+56		GPS Location		37.33		Field Station#		12445+43									
Description		Rain Gauge at yellow finch road. Looking SW. See picture for GPS data.										Description		Stream crossing permit installed. Looking E. See picture for GPS data.

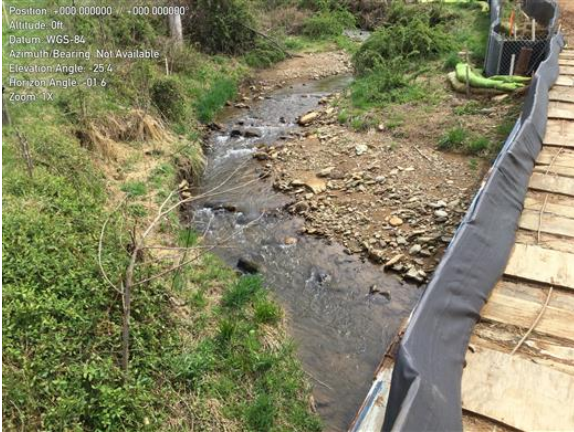
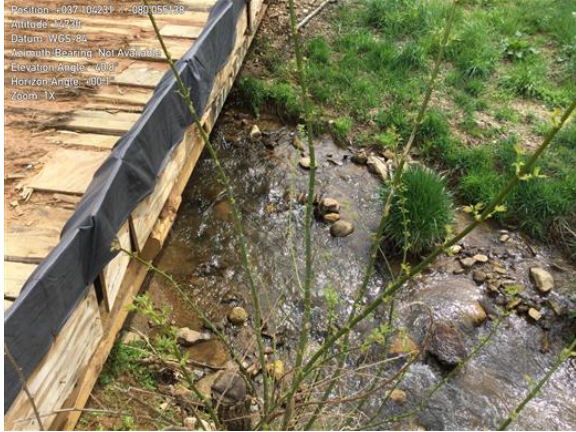
<p>Position: +037.104231 / -080.105110 Altitude: 1570ft Datum: WGS-84 Azimuth/Bearing: Not Available Elevation Angle: -28.4 Horizon Angle: -00.1 Zoom: 1X</p>					
GPS Location	37.23	Field Station#	13309+09	GPS Location	37.23	Field Station#	13309+09
Description	Water clarity at upstream side of stream S-GH7 from equipment bridge. View: east, see photo for GPS data.			Description	Water clarity at downstream side of stream S-GH7 from equipment bridge. View: east, see photo for GPS data.

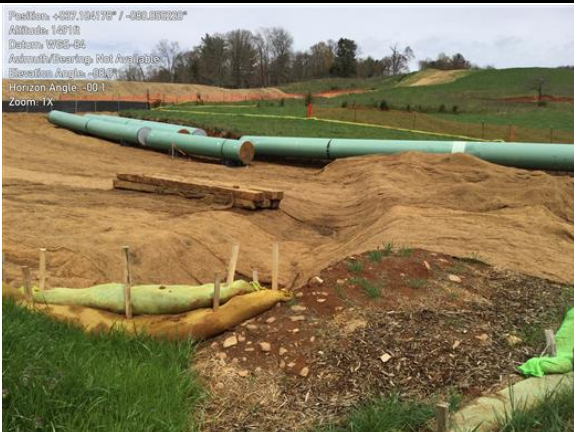
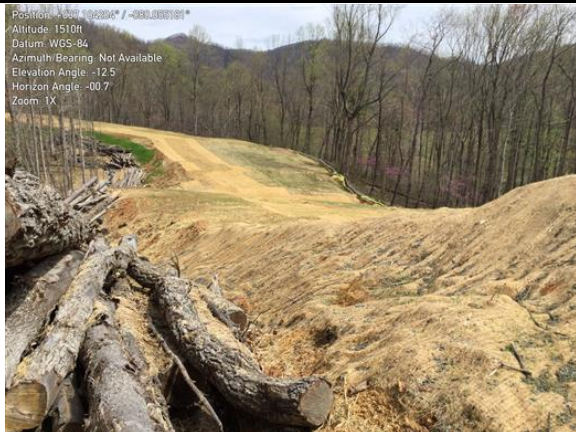
GPS Location	37.23	Field Station#	13307+50	GPS Location	37.23	Field Station#	13290+00
Description	Waterbar, ECB, & Sump outlet near the PI at the CIS of Waterway S-GH7. View: northwest, see photo for GPS data.			Description	Western edge of LOD, topsoil piles stabilized with ECB, and timber piles. View: north, see photo for GPS data.

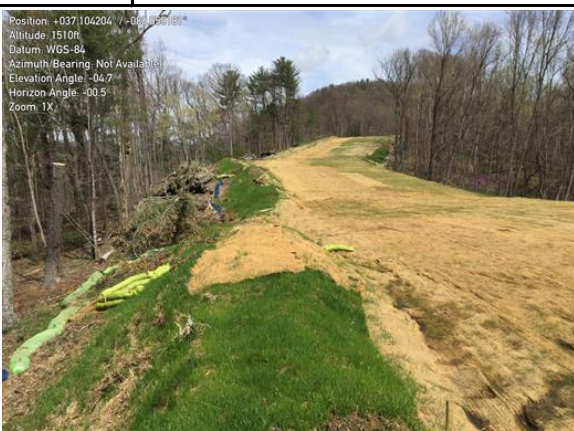
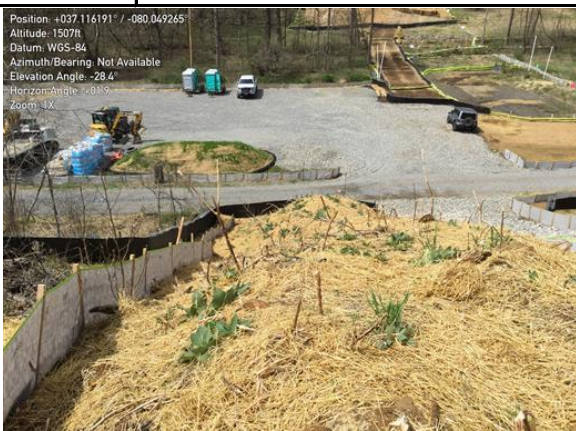
<p>Position: +037.116191 / -080.049265 Altitude: 1507ft Datum: WGS-84 Azimuth/Bearing: Not Available Elevation Angle: -28.4 Horizon Angle: -04.9 Zoom: 1X</p>					
GPS Location	37.23	Field Station#	13280+00	GPS Location	37.23	Field Station#	13264+00
Description	Western perimeter of LOD, stabilized topsoil piles with vegetation &/or ECB. View: north, see photo for GPS data.			Description	GAS of Flanders Road. Stabilized topsoil pile (with mulch &/or vegetation), south side of RCE. View: west, see photo for GPS data.

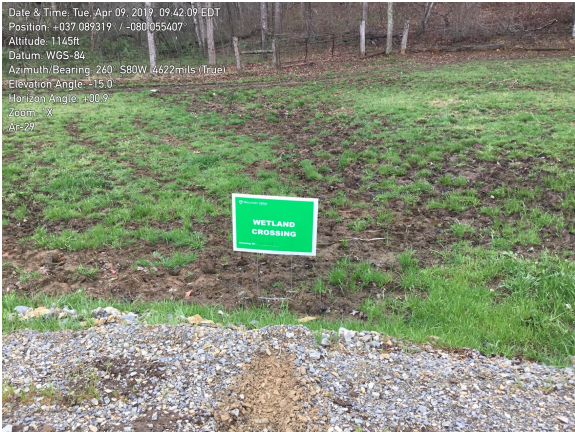
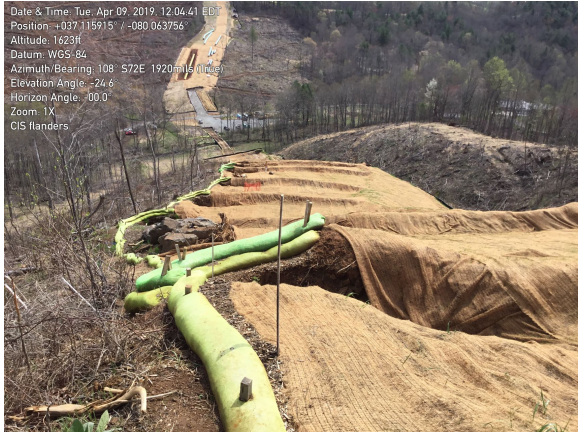
</div></div></div>				
GPS Location	37.23	Field Station#	13188+66	GPS Location	37.23	Field Station#	13254+00
Description	Please see photo for accurate coordinates. W-D4, wetland along MVP-MLV-AR-29.			Description	Please see photo for accurate coordinates. ROW, perimeter CFS and waterbar outlets functioning acceptably.

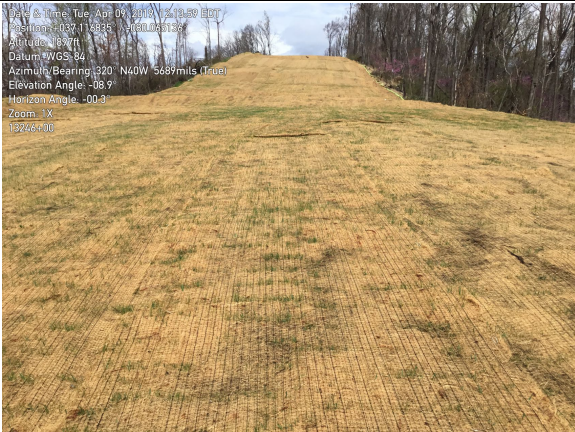
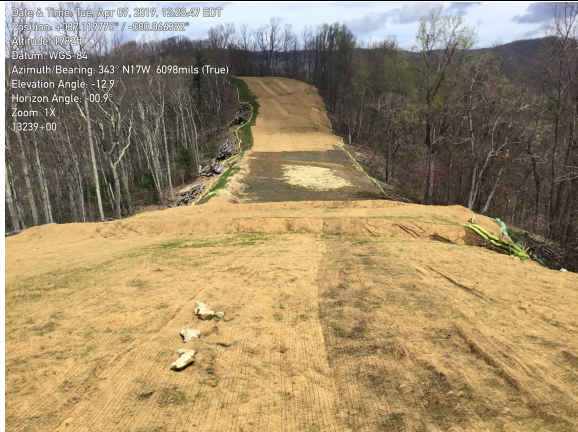
</div></div></div>				
GPS Location	37.23	Field Station#	13246+00	GPS Location	37.23	Field Station#	13239+00
Description	Please see photo for accurate coordinates. ROW, stabilized, approximate 15 percent vegetative cover establishing.			Description	Please see photo for accurate coordinates. ROW, stabilized with curlex and/or earth guard pellets, no environmental issues noted.		
<div><div><div>Date & Time: Tue, Apr 09, 2019, 13:08:40 EDT Position: +037.115526 / -080.064090 Altitude: 1722ft Datum: WGS-84 Azimuth/Bearing: 040 N40E 0711mils (True) Elevation Angle: -27.6 Horizon Angle: -01.6 Zoom: 1X 13250+00</div><div>

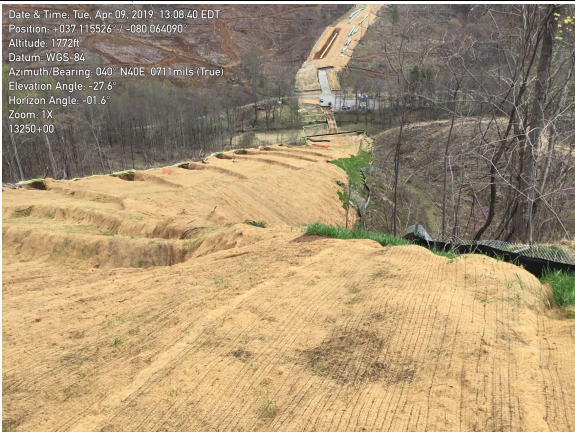
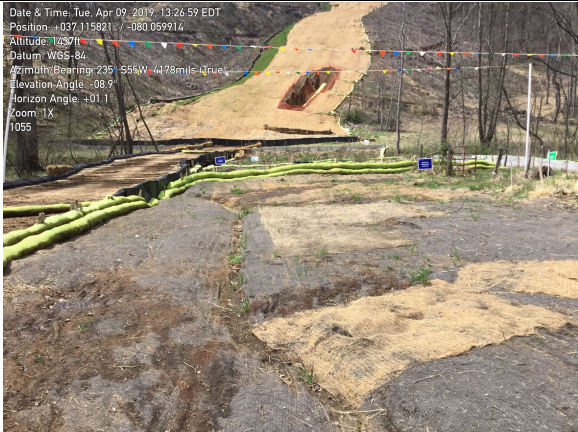
GPS Location	37.23	Field Station#	13250+00	GPS Location	37.23	Field Station#	13262+00
Description	Please see photo for accurate coordinates. ROW, stabilized, waterbars functioning acceptably, soil migration area stable.			Description	Please see photo for accurate coordinates. S-II4, clean water conveyance functioning acceptably, ECDs functioning acceptably.

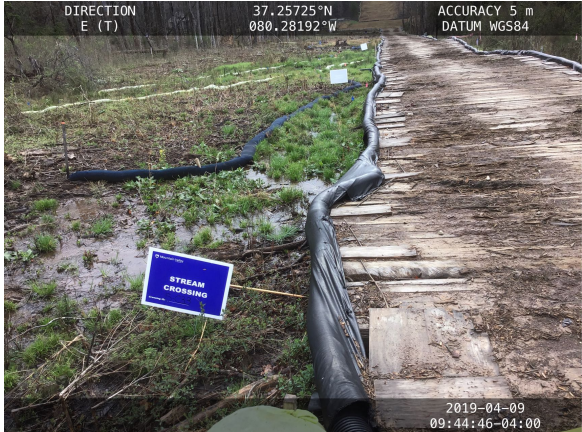
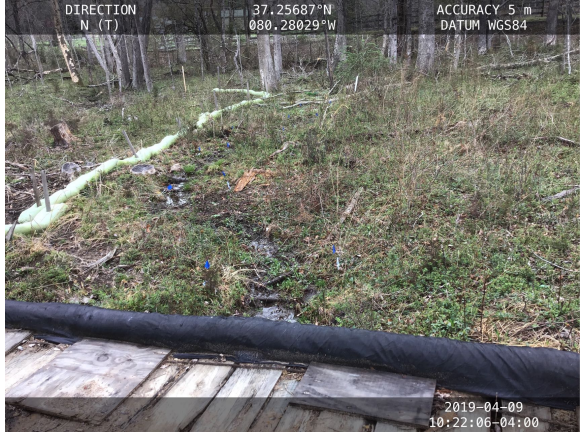
GPS Location	37.25	Field Station#	12121+00	GPS Location	37.25	Field Station#	12125+65
Description	Stream S-C33, facing east.			Description	Stream S-MM31, facing north.

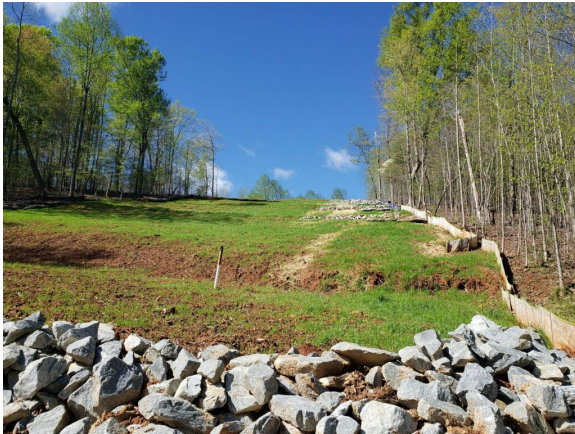
GPS Location		36.97		Field Station#		13631+00		GPS Location		36.97		Field Station#		13633+62	
Description		Stabilized RoW in good condition.						Description		Vegetative stabilization growing in and ECD's in place
