Visual Site Inspection Report

Project Name	H-600 Pipeline Spread H	AFE	124300138	Spread	H-600 Pipeline Spread H
Contractor	Precision			Report #	17125
Inspector	John Brcic			Date/Time	5/13/2019 6:52 AM
Permit #	TBD	Inspection Type	VA SWPP	Station Begin	12071+00
State	VA	Inspection Area	Partial	Station End	12195+50
County	Montgomery	Ground	Wet	Temperature (°F)	64.00
Municipality	N/A	Weather	Sunny	Rain Gauge (in)	1.00
				Rain Accumulation Time (days)	3.00

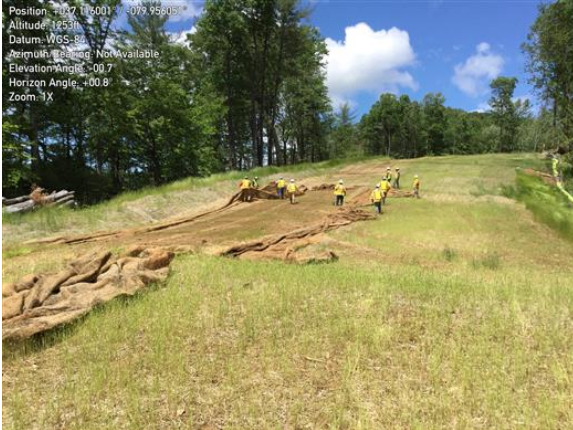
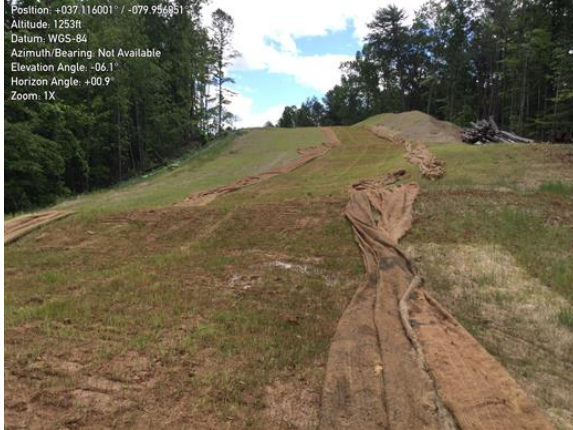
<p>Position: +037 116001 / -079 956951 Altitude: 1253ft Datum: WGS-84 Azimuth/Bearing: Not Available Elevation Angle: -06.1 Horizon Angle: +00.9 Zoom: 1X</p>				
GPS Location	37.23	Field Station#	13277+34	GPS Location	37.23	Field Station#	13290+00
Description	Personnel pulling back ECB in travel lane. View: North from center of LOD, see photo for GPS data.			Description	Temporary vegetation in travel lane where ECB has been pulled back. View: South from center of LOD, see photo for GPS data.

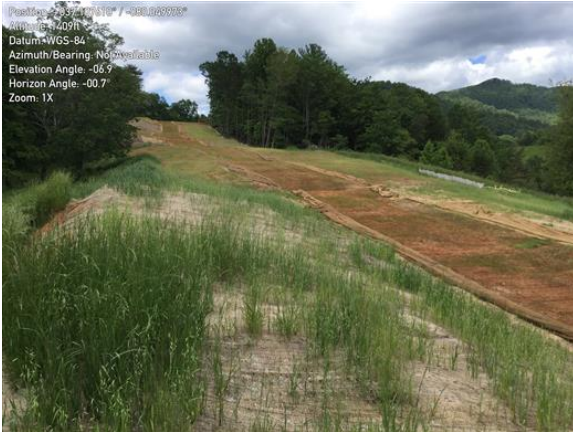
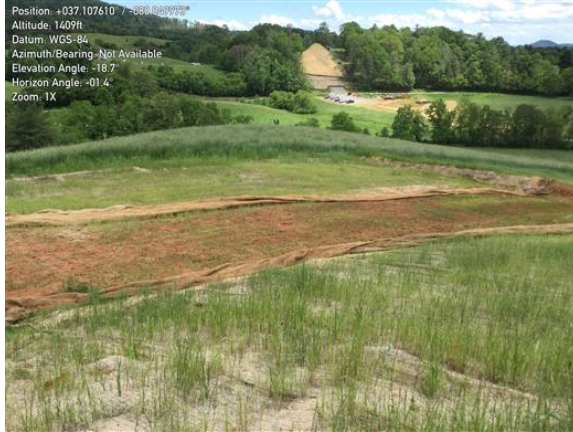
GPS Location	37.23	Field Station#	13299+00	GPS Location	37.23	Field Station#	13300+00
Description	Temporary vegetation in travel lane where ECB has been pulled back. View: North from western edge of LOD, see photo for GPS data.			Description	Temporary vegetation in travel lane where ECB has been pulled back. View: Southeast from western edge of LOD, see photo for GPS data.

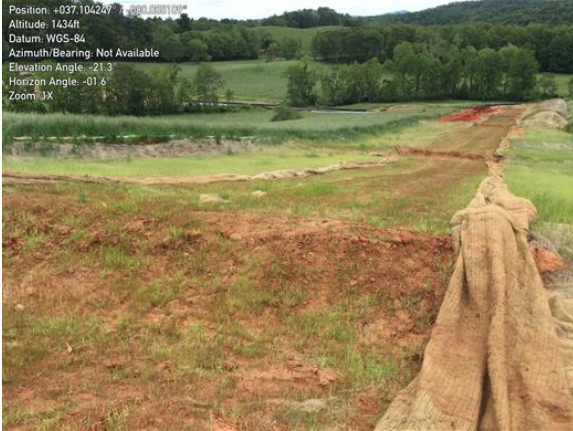
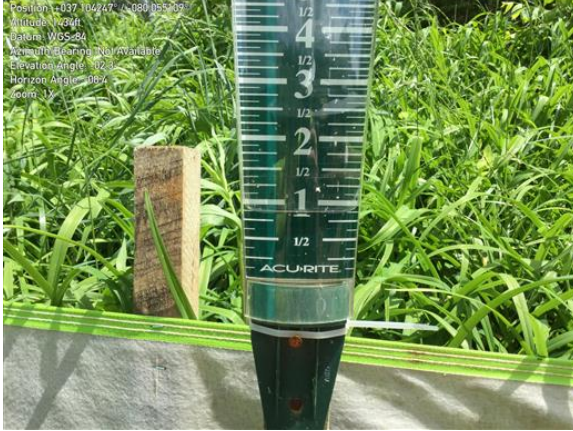
<p>Position: +037 104247 / -080 000100 Altitude: 1434ft Datum: WGS-84 Azimuth/Bearing: Not Available Elevation Angle: -21.3 Horizon Angle: -01.6 Zoom: 1X</p>				
GPS Location	37.23	Field Station#	13301+00	GPS Location	37.23	Field Station#	13316+00
Description	Temporary vegetation in travel lane where ECB has been pulled back. View: South from center of LOD, see photo for GPS data.			Description	Contractor's rain gauge at the CIS of Wade's Gap Road reads approximately 0.90". View: East, see photo for GPS data.

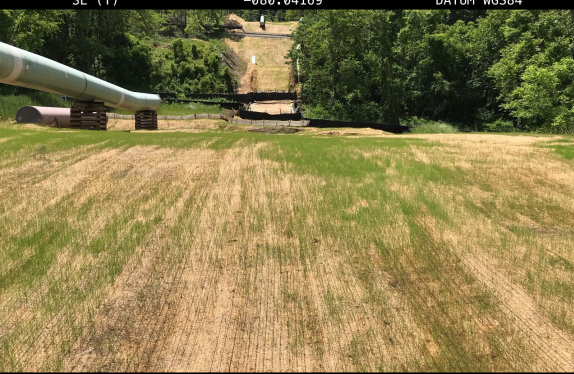
<div>13350+00_051319_PCD Vegetation growth on travel lane 2019-05-13 11:16:57-04:00</div>

GPS Location	37.27	Field Station#	13348+46	GPS Location	37.27	Field Station#	13350+00
Description	13348+46_051319 S-RR08 mat bridge clean and closed. Looking SE. See photo for gps data.			Description	13350+00_051319 vegetation growth on the ROW. Looking SE. See photo for gps data.		
<div>DIRECTION E (T)</div> <div>+37.09366° -080.03045°</div> <div>ACCURACY 98 ft DATUM WGS84</div>

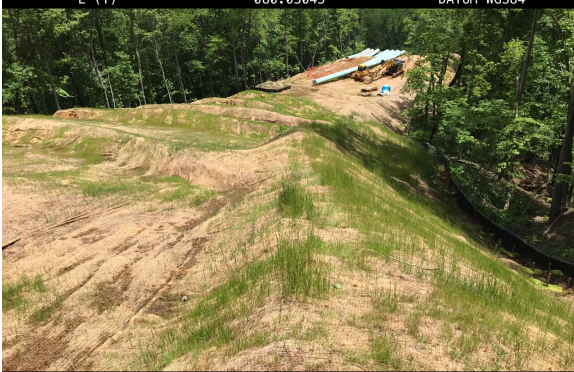
<div>13406+00_051319_PCD Vegetation growth on ROW 2019-05-13 12:58:10-04:00</div>			<div>DIRECTION W (T)</div> <div>+37.09294° -080.02778°</div> <div>ACCURACY 98 ft DATUM WGS84</div>

<div>13412+00_051319 Slope and travel lane stable 2019-05-13 10:25:02-04:00</div>				
GPS Location	37.27	Field Station#	13406+00	GPS Location	37.27	Field Station#	13412+00
Description	13406+00_051319 vegetation growth on the ROW. Looking E. See photo for gps data.			Description	13412+00_051319 slope and travel lane stabilized. Looking W. See photo for gps data.

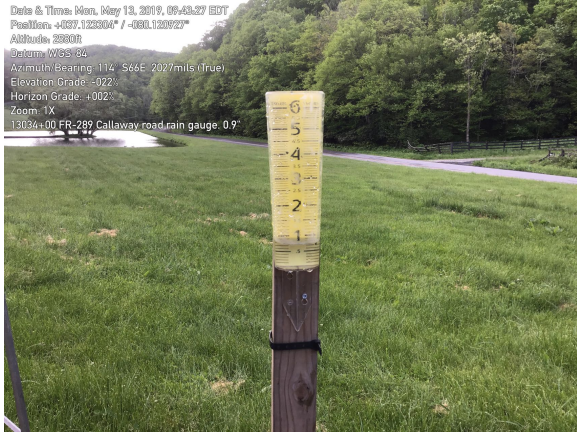
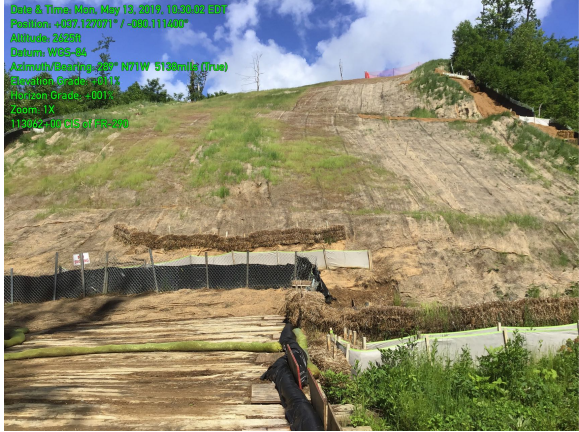
GPS Location	37.12	Field Station#	13034+00		GPS Location	37.12	Field Station#	13062+00
Description	13034+00 FR-289 Callaway Road rain gauge. 0.9" total precipitation.			Description	No issues or impacts on the CIS of FR-290.			
<p>Date & Time: Mon, May 13, 2019, 10:30:31 EDT Position: +037.126975° / -080.111374° Altitude: 2624ft Datum: WGS-84 Azimuth/Bearing: 103° S77E 1831mils (True) Elevation Grade: +001% Horizon Grade: +000% Zoom: 1X 113062+00 GAS at FR-290</p>

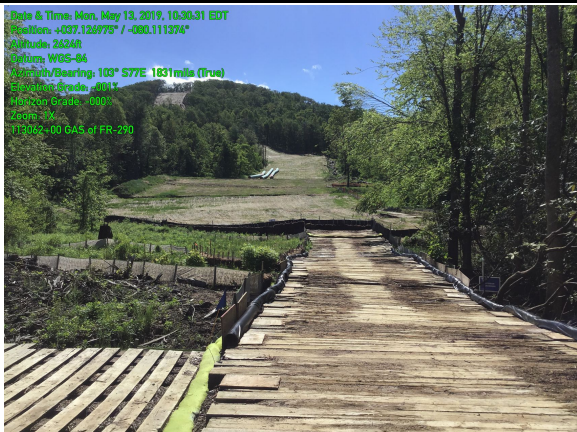
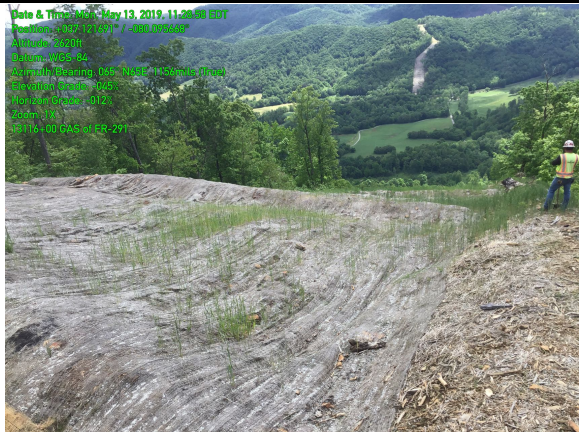
GPS Location	37.12	Field Station#	13062+00		GPS Location	37.12	Field Station#	13116+00
Description	No issues or impacts on the GAS of FR-290 after the weekend rain events.			Description	GAS of FR-291 remains well stabilized and no issues found in the area.			
<p>Date & Time: Mon, May 13, 2019, 11:29:33 EDT Position: +037.121770° / -080.095725° Altitude: 3625ft Datum: WGS-84 Azimuth/Bearing: 309° S09W 5776mils (True) Elevation Grade: +005% Horizon Grade: -002% Zoom: 1X 13116+00 CIS at FR-291</p>

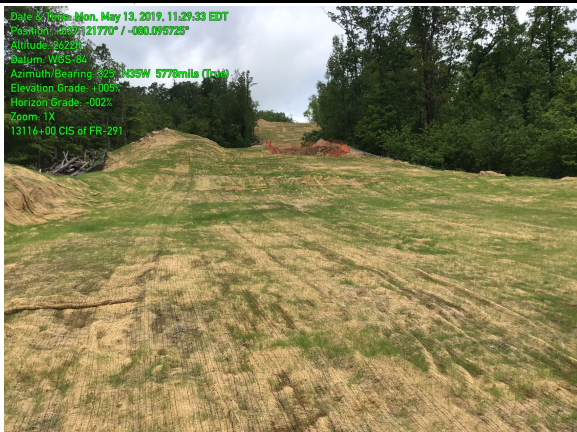
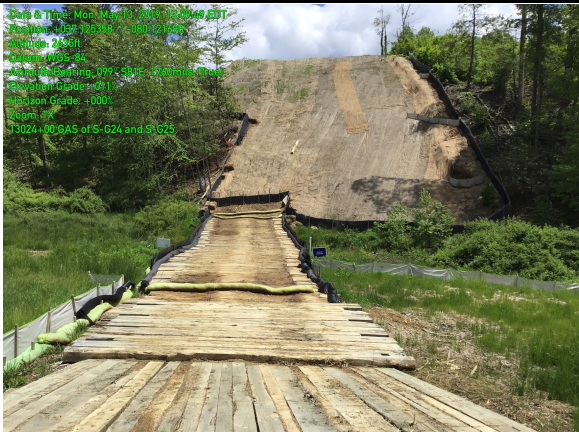
GPS Location	37.12	Field Station#	13116+00		GPS Location	37.12	Field Station#	13024+00
Description	CIS of FR-291 recently stabilized with Curlex and seeded. Good vegetation growth.			Description	GAS of the BRP. No issues or impacts observed.

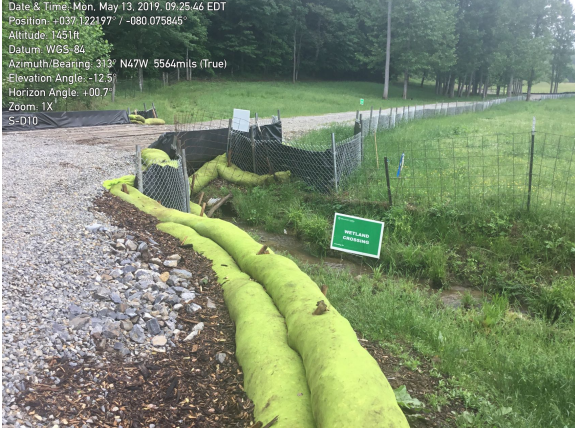
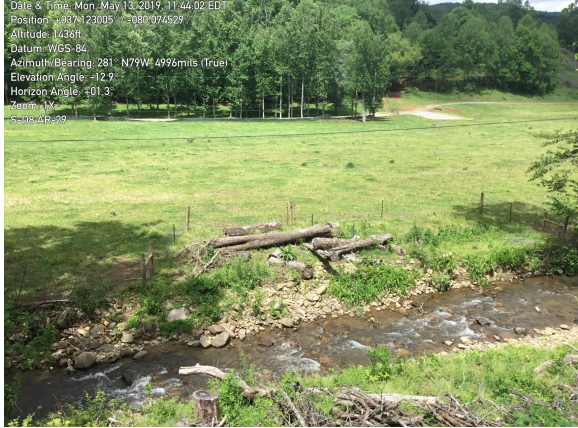
<p>Date & Time: Mon, May 13, 2019, 09:25:46 EDT Position: +037.122197° / -080.075845° Altitude: 1451ft Datum: WGS-84 Azimuth/Bearing: 312° N47W 5564mils (True) Elevation Angle: -12.5° Horizon Angle: +00.7° Zoom: 1X S-D10</p>		<p>Date & Time: Mon, May 13, 2019, 11:44:02 EDT Position: +037.123005° / -080.074529° Altitude: 1420ft Datum: WGS-84 Azimuth/Bearing: 281° N79W 4996mils (True) Elevation Angle: -12.9° Horizon Angle: +01.3° Zoom: 1X S-D8-D9</p>					
GPS Location	37.32	Field Station#	13188+66	GPS Location	37.32	Field Station#	13197+47
Description	Please see photo for accurate coordinates. S-D10, ECDs functioning acceptably along stream and access road.			Description	Please see photo for accurate coordinates. S-D8, no environmental issues noted at stream or road crossing.

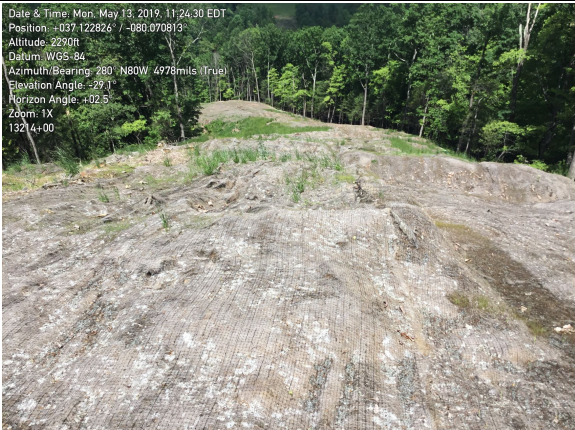
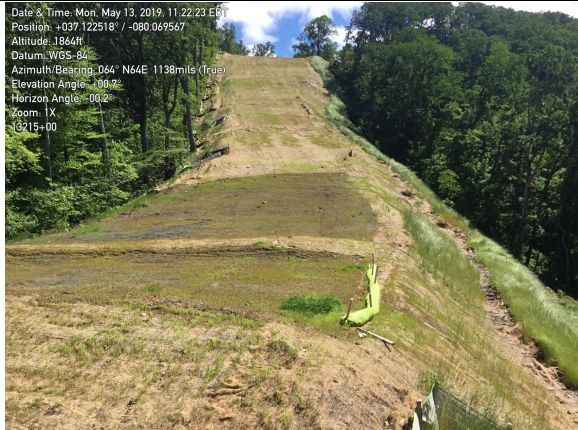
GPS Location	37.32	Field Station#	13214+00	GPS Location	37.32	Field Station#	13215+00
Description	Please see photo for accurate coordinates. ROW stabilized, sparse germination noted.			Description	Please see photo for accurate coordinates. ROW, soil piles well vegetated, ECDs functioning acceptably.

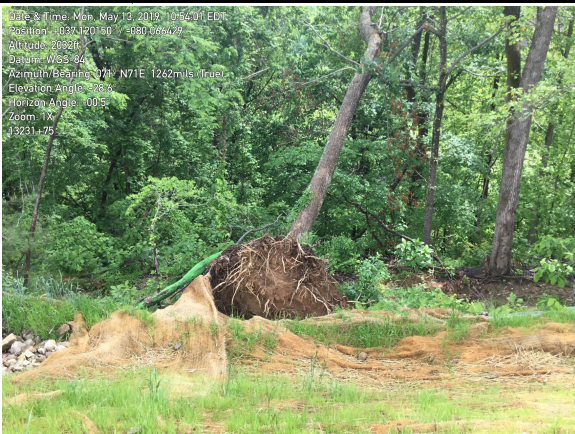
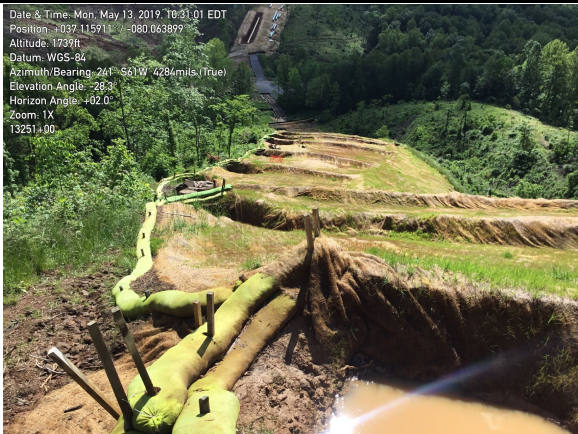
<p>Date & Time: Mon, May 13, 2019, 10:56:01 EDT Position: +037.120150° / -080.066479° Altitude: 2092ft Datum: WGS-84 Azimuth/Bearing: 211° N71E 1242mils (True) Elevation Angle: -26.8° Horizon Angle: +00.5° Zoom: 1X 13231+75</p>		<p>Date & Time: Mon, May 13, 2019, 10:31:01 EDT Position: +037.115911° / -080.063899° Altitude: 1739ft Datum: WGS-84 Azimuth/Bearing: 241° S61W 4284mils (True) Elevation Angle: -28.3° Horizon Angle: +02.0° Zoom: 1X 13251+00</p>					
GPS Location	37.32	Field Station#	13231+75	GPS Location	37.32	Field Station#	13251+00
Description	Please see photo for accurate coordinates. ROW, tree uprooted along LOD, damaged CFS.			Description	Please see photo for accurate coordinates. ROW, waterbar and waterbar outlets functioning acceptably.

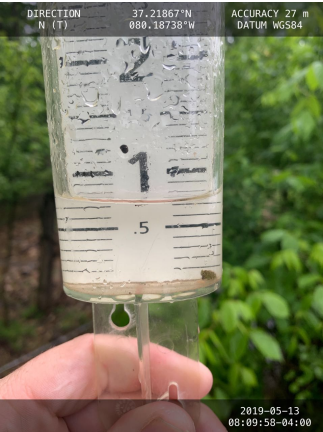
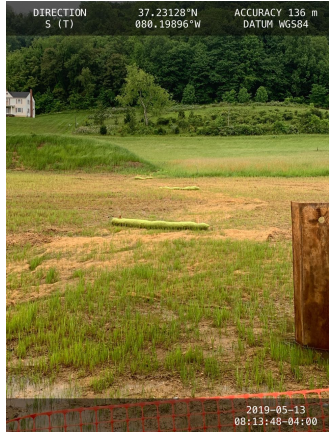
GPS Location		37.33		Field Station#		12543+56		GPS Location		37.33		Field Station#		12445+86	
Description		Yellow Finch rain gauge. Looking N. See picture for GPS data.						Description		Curlexed drain crossing the row to allow rain water across. Looking S. See picture for GPS data.

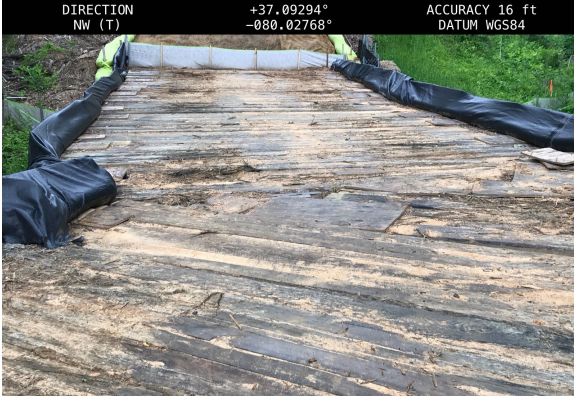
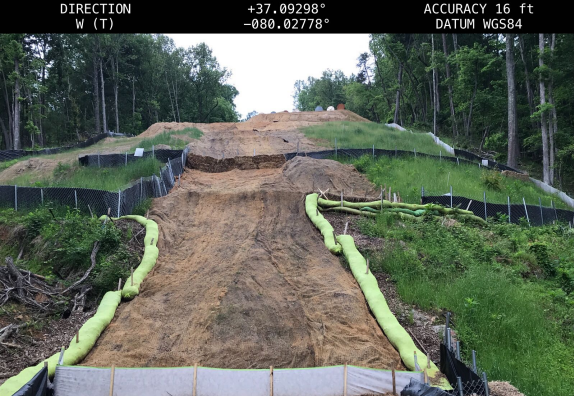
<p>DIRECTION NW (T) +37.09294° -080.02768° ACCURACY 16 ft DATUM WGS84</p> <p>13413+05_051719_S-IJ1 mat bridge clean & closed 2019-05-17 09:38:32-04:00</p>

<p>DIRECTION W (T) +37.09298° -080.02778° ACCURACY 16 ft DATUM WGS84</p> <p>13412+00_051719 Step slope & travel lane stabilized 2019-05-17 09:38:43-04:00</p>				
GPS Location	37.10	Field Station#	13413+05	GPS Location	37.10	Field Station#	13412+00
Description	13413+05_051719_S-IJ1 mat bridge clean ad closed. Looking NW. See photo for gps data.			Description	13412+00_051719 steep slope and travel lane stabilized. Looking W. See photo for gps data.

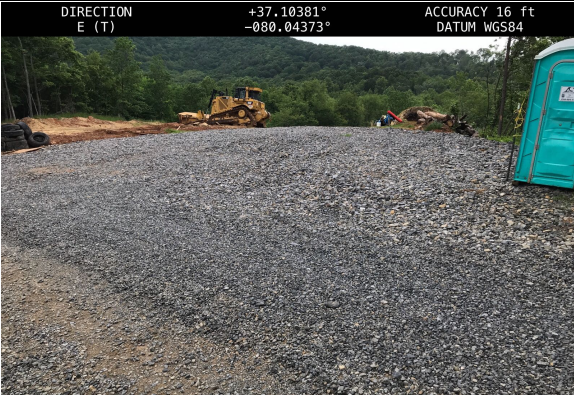
<p>DIRECTION E (T) +37.10381° -080.04373° ACCURACY 16 ft DATUM WGS84</p> <p>13342+67_051719 Webster Corner East rock entrance 2019-05-17 09:47:33-04:00</p>

GPS Location	37.10	Field Station#	13413+25	GPS Location	37.10	Field Station#	13342+67
Description	13413+25_051719 condition of compost filter sock along boundary. Looking SE. See photo for gps data.			Description	13342+67_051719 Webster Corner east rock entrance. Looking E. See photo for gps data.

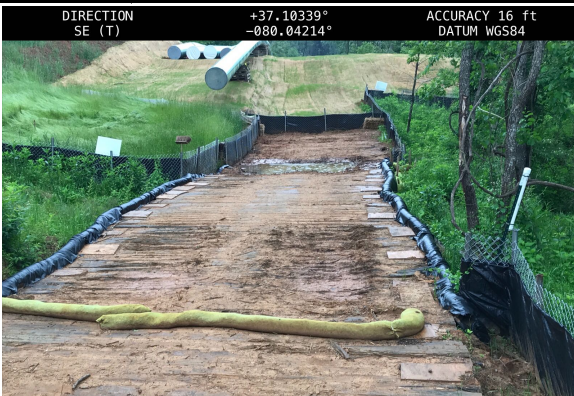
<p>DIRECTION SE (T) +37.10339° -080.04214° ACCURACY 16 ft DATUM WGS84</p> <p>13348+46_051719_S-RR08 Mat bridge clean & closed 2019-05-17 09:51:37-04:00</p>

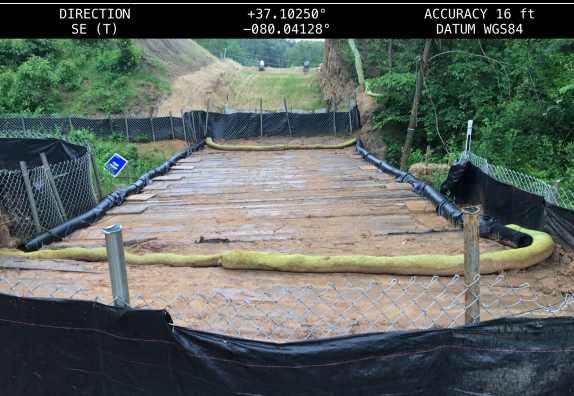
<p>DIRECTION SE (T) +37.10250° -080.04128° ACCURACY 16 ft DATUM WGS84</p> <p>13352+23_051719_SRR09 Mat ridge clean & closed 2019-05-17 09:54:28-04:00</p>				
GPS Location	37.10	Field Station#	13348+46	GPS Location	37.10	Field Station#	13352+23
Description	13348+46_051719 S-RR08 mat bridge clean and closed. Looking SE. See photo for gps data.			Description	13352+23_051719 S-RR09 mat bridge clean and closed. Looking SE. See photo for gps data.

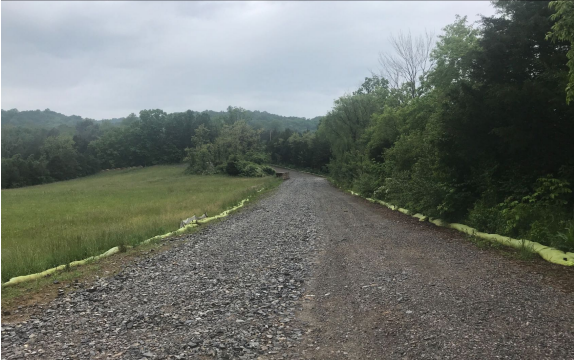
<div>MVP-MN-268 Access road and construction entrance 2019-05-17 10:01:56-04:00</div>			<div>DIRECTION 159 deg(T) +37.26871° -080.31324° ACCURACY 5 m DATUM WGS84</div>

<div>S-G36 ECDs downstream of bridge 2019-05-17 10:04:42-04:00</div>				
GPS Location	37.26	Field Station#	12005+00	GPS Location	37.26	Field Station#	12013+97
Description	See photo for gps data. Photo shows access road MVP-MN-268.0 and the construction entrance.			Description	See photo for gps data. Photo shows the ECDs along the bridge over SG36.		
<div>DIRECTION 173 deg(T) +37.26714° -080.31287° ACCURACY 5 m DATUM WGS84</div>

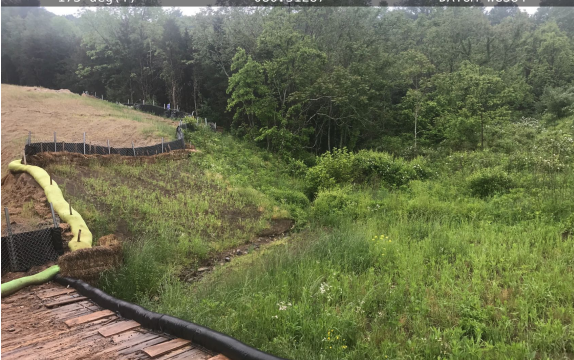
<div>S-G38 At ROW crossing 2019-05-17 10:08:43-04:00</div>			<div>DIRECTION 131 deg(T) +37.26746° -080.31335° ACCURACY 5 m DATUM WGS84</div>

GPS Location	37.26	Field Station#	12015+00	GPS Location	37.26	Field Station#	12012+00
Description	See photo for gps data. Photo shows stream S-G38 at the ROW crossing.			Description	See photo for gps data. Photo shows the ROW conditions from about 12012+00 to 12025+00.		
<div>DIRECTION 115 deg(T) +37.26864° -080.31459° ACCURACY 5 m DATUM WGS84</div>

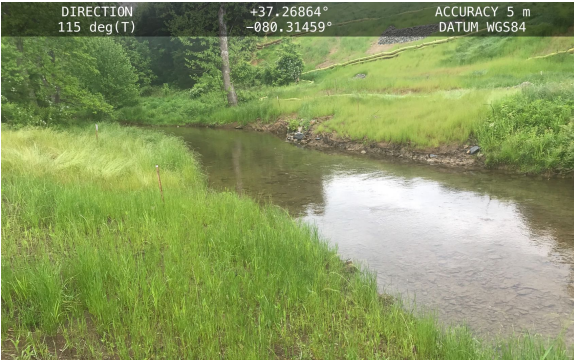
<div>12008+00 S-G36 at ROW crossing 2019-05-17 10:16:59-04:00</div>			<div>DIRECTION 261 deg(T) +37.26893° -080.31455° ACCURACY 5 m DATUM WGS84</div>   <div>12007+00 ATWS-473 2019-05-17 10:18:48-04:00</div>				
GPS Location	37.26	Field Station#	12008+00	GPS Location	37.26	Field Station#	12007+00
Description	See photo for gps data. Photo shows stream S-G36 at the ROW crossing.			Description	See photo for gps data. Photo shows workspace ATWS-473.

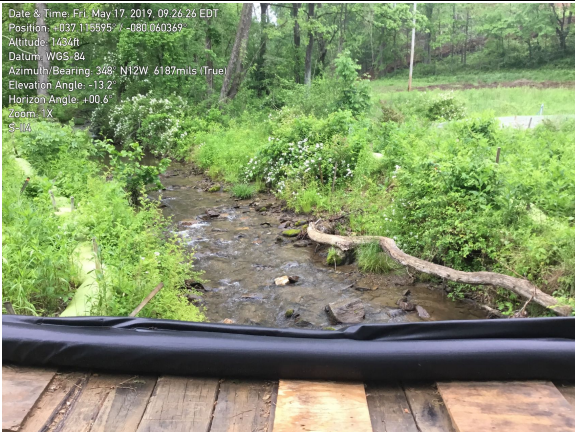
GPS Location	37.32	Field Station#	13260+60	GPS Location	37.32	
Description	Please see photo for accurate coordinates. S-II4, ECDs functioning acceptably along stream banks.			Description	Please see photo for accurate coordinates. Clean water diversion berm functioning acceptably, no environmental issues noted.	
<div><div><div>Date & Time: Fri May 17, 2019 09:34:11 EDT Position: +037.116622 / -080.060325 Altitude: 1427ft Datum: WGS-84 Azimuth/Bearing: 271° N89W 4818mils (True) Elevation Angle: +04.2° Horizon Angle: +02.8° Zoom: 1X S-II4 C15</div> </div></div>			<div><div><div>Date & Time: Fri May 17, 2019 13:40:10 EDT Position: +037.115698 / -080.056569 Altitude: 1429ft Datum: WGS-84 Azimuth/Bearing: 316° N44W 5618mils (True) Elevation Angle: -07.3° Horizon Angle: +01.9° Zoom: 1X Flanders</div>

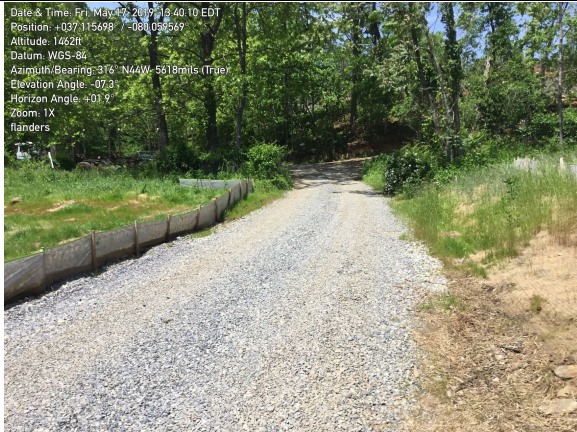
</div></div>			
GPS Location	37.32	Field Station#	13260+65	GPS Location	37.32	
Description	Please see photo for accurate coordinates. S-II4, equipment bridge maintained with no environmental concerns observed.			Description	Please see photo for accurate coordinates. Flanders Road, access road maintained, logging activity noted off ROW.

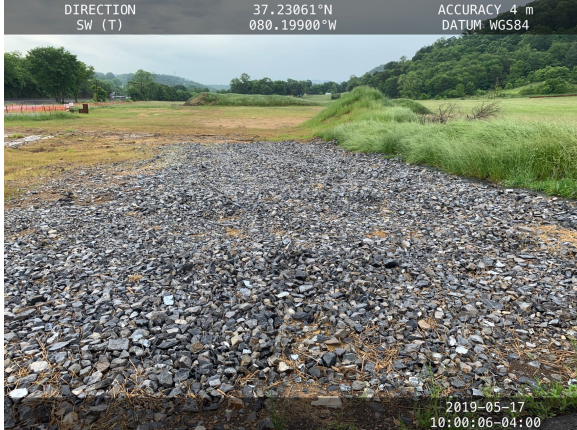
<div>2019-05-17 10:00:23-04:00</div>				
GPS Location	37.33	Field Station#	12448+12	GPS Location	37.33	Field Station#	12448+50
Description	RCE. Looking SW. See picture for GPS data.			Description	Stabilized ROW. Looking NE. See picture for GPS data.		
<div>DIRECTION N (T)</div> <div>37.23069°N 080.19914°W</div> <div>ACCURACY 4 m DATUM WGS84</div>

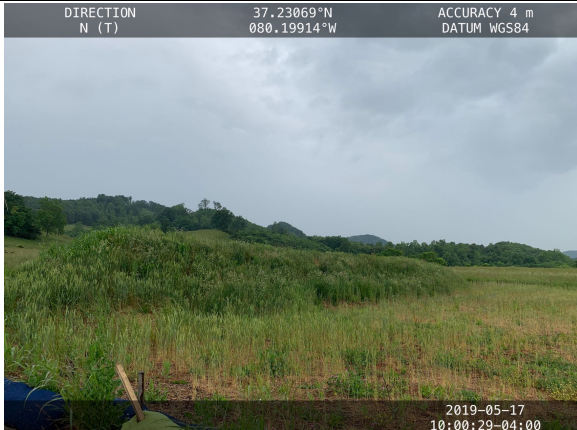
Description	Stabilized topsoil pile. Looking N. See picture for GPS data.			Description	Cap covering well point system. LySE. See picture for GPS.		
<div>DIRECTION S (T)</div> <div>37.23110°N 080.19832°W</div> <div>ACCURACY 35 m DATUM WGS84</div>

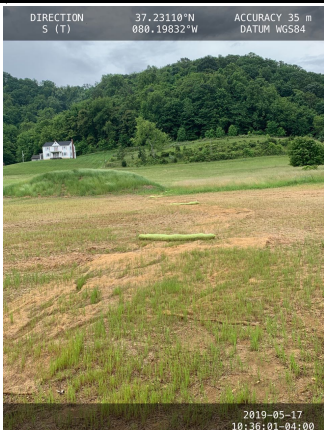
<div>2019-05-17 10:36:05-04:00</div>				
GPS Location	37.33	Field Station#	12445+86	GPS Location	37.33	Field Station#	12445+86
Description	Curlexed drain for rain water to cross row. Looking S. See picture for GPS data.			Description	Stabilized ROW. Looking SE. See picture for GPS data.

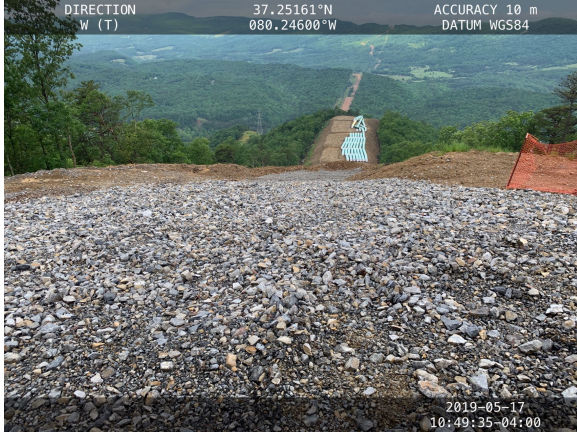
GPS Location	37.33	Field Station#	12234+34	GPS Location	37.33	Field Station#	12234+77
Description	RCE. Looking W. See picture for GPS data.			Description	RCE. Looking N. See picture for GPS data.

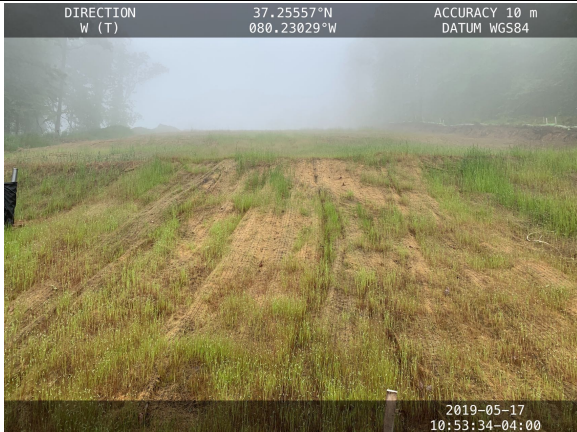
GPS Location	37.33	Field Station#	12284+00	GPS Location	37.33	Field Station#	12299+24
Description	Stabilized hillside. Looking W. See picture for GPS data.			Description	Stabilized access road MVP-MN-276.03. Looking SE. See picture for GPS data.

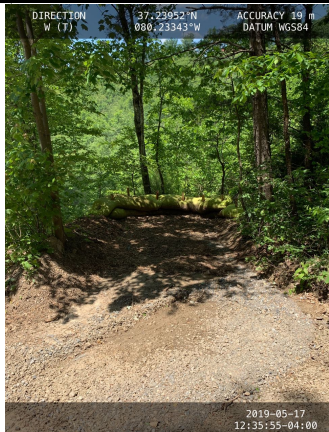
GPS Location	37.33	Field Station#	12234+50	GPS Location	37.33	Field Station#	12234+50
Description	Perimeter control down access road MVP-MN-276.03. Looking SW. See picture for GPS data.			Description	Outlet along access road MVP-MN-276.03. Looking W. See picture for GPS data.
