# Visual Site Inspection Report

<b>Project Name</b>	H-600 Pipeline Spread G	<b>AFE</b>	124300137	<b>Spread</b>	H-600 Pipeline Spread G
<b>Contractor</b>	Precision			<b>Report #</b>	11245
<b>Inspector</b>	Clinton Banks			<b>Date/Time</b>	11/26/2018 3:35 AM
<b>Permit #</b>	TBD	<b>Inspection Type</b>	VA SWPP	<b>Station Begin</b>	11552+77
<b>State</b>	VA	<b>Inspection Area</b>	Full	<b>Station End</b>	11436+00
<b>County</b>	Craig	<b>Ground</b>	Wet	<b>Temperature (°F)</b>	49.00
<b>Municipality</b>	N/A	<b>Weather</b>	Cloudy	<b>Rain Gauge (in)</b>	0.00
<b>GPS Location</b>	37.3214820027699, -80.4356293939803			<b>Rain Accumulation Time (days)</b>	1.00

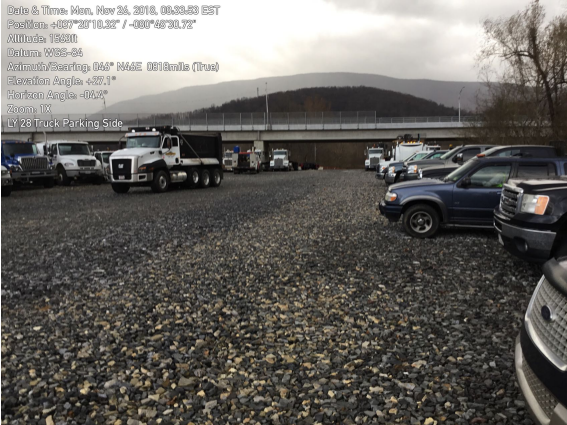
<p> <small> Date &amp; Time: Mon, Nov 26, 2018, 06:33:20 EST  Position: +037°20'10.32" / -080°48'20.72"  Altitude: 1560ft  Datum: WGS-84  Azimuth/Bearing: 045° N45E 0010mils (True)  Elevation Angle: +27.1°  Horizon Angle: +04.2°  Zoom: 1X  LY 28 Truck Parking Side </small> </p>

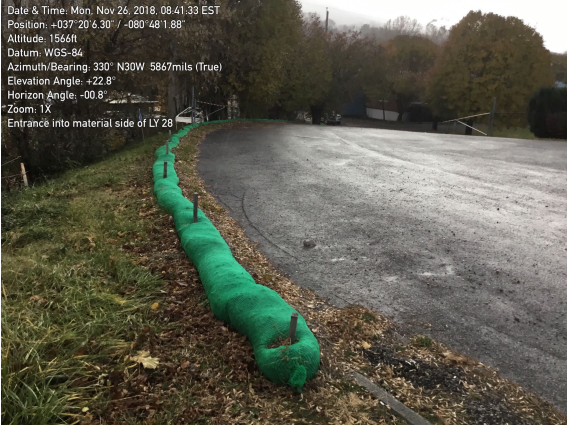
<p> <small> Date &amp; Time: Mon, Nov 26, 2018, 08:41:33 EST  Position: +037°20'6.30" / -080°48'1.88"  Altitude: 1566ft  Datum: WGS-84  Azimuth/Bearing: 330° N30W 5867mils (True)  Elevation Angle: +22.9°  Horizon Angle: -00.8°  Zoom: 1X  Entrance into material side of LY 28 </small> </p>			
<b>GPS Location</b>	37.3361639120032, -80.8085702732958	<b>GPS Location</b>	37.3346586479222, -80.8005496301509		
<b>Description</b>	LY 28 Truck Parking Side	<b>Description</b>	Entrance into material side of LY 28		
Insert image here		Insert image here

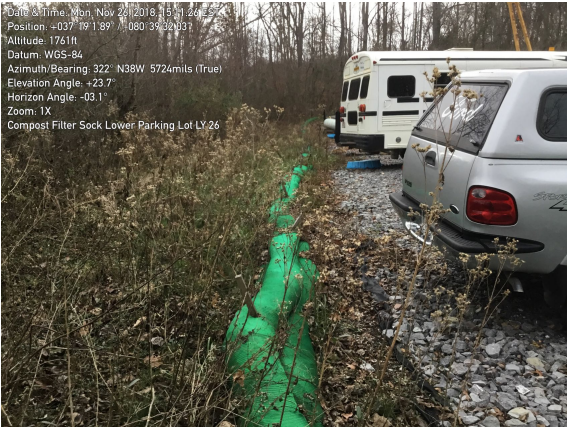
<p> <small> Date &amp; Time: Mon, Nov 26, 2018, 15:41:26 EST  Position: +037 19 1897 -080 39 3037  Altitude: 1761ft  Datum: WGS-84  Azimuth/Bearing: 322° N38W 5724mils (True)  Elevation Angle: +23.7°  Horizon Angle: -03.1°  Zoom: 1X  Compost Filter Sock Lower Parking Lot LY 26 </small> </p>

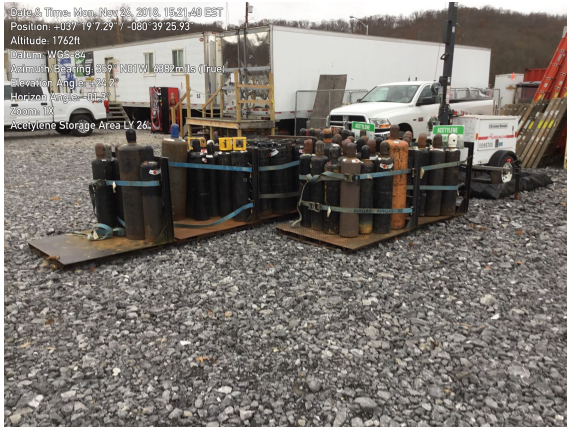
<p> <small> Date &amp; Time: Mon, Nov 26, 2018, 15:21:40 EST  Position: +037 19 7297 -080 39 2593  Altitude: 1762ft  Datum: WGS-84  Azimuth/Bearing: 322° N38W 5724mils (True)  Elevation Angle: +23.7°  Horizon Angle: -03.1°  Zoom: 1X  Acetylene Storage Area LY 26 </small> </p>			
<b>GPS Location</b>	37.3170718644162, -80.658763870672	<b>GPS Location</b>	37.3187847482388, -80.6572022382921		
<b>Description</b>	Compost Filter Sock Lower Parking Lot LY 26	<b>Description</b>	Acetylene Storage Area LY 26

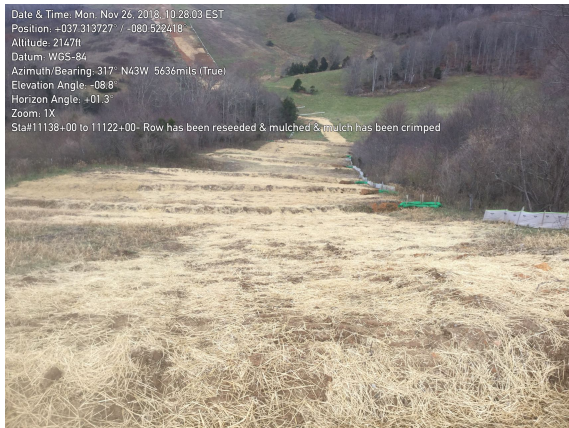
Inspection area; Sta#11254+88 to 10931+00. - MP- 213 to 206.2  
Sta#11225+00- Side slope has some erosion, ( see photo).  
Sta#11254+00 to 11162+00- ECD's in this area are in good working condition, this section has good growth so there is very little sediment movement, which helps with keeping sump pits clean.  
Sta#11151+00 to 11122+00- Row has been reseeded & mulched & mulch has been crimped for stabilization.  
Sta#11109+75- SSF fabric not attached to fence.  
Sta#11090+00 to 11069+00- Row has been reseeded & mulched, mulch has been crimped.  
Sta#11069+00 to 11045+00- Row has been reseeded & mulched but has not been stabilized by crimping or helicopter.  
Sta#11045+00 to 11012+00- Row has been reseeded, mulched & crimped.  
Sta#11029+00- Fabric has been reattached to SSF.  
Sta#11254+88 to 10931+00- ECD's in this area are working & in good condition, with the exception of, sta#11109+75, SSF fabric detached from fence.

<p>Date &amp; Time: Mon, Nov 26, 2018, 10:56:00 EST Position: +037.314992° / -080.530483° Altitude: 2171ft Datum: WGS-84 Azimuth/Bearing: 122° S58E 2149mils (True) Elevation Angle: -09.4° Horizon Angle: -01.1° Zoom: 1X Sta#11109+75- SSF fabric not attached to fence</p>

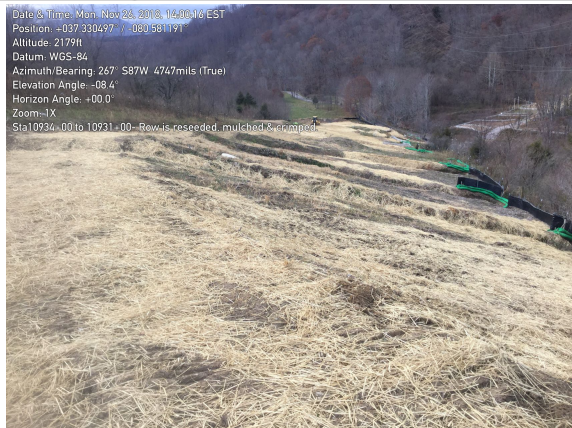
GPS Location	37.3247222369884, -80.5630397704249	GPS Location	37.3304501781588, -80.5811440107232		
Description	Sta10993+00 to 10986+00- Row reseeded & mulched, has not been stabilized.	Description	Sta#10934+00 to 10931+00- Row is reseeded, mulched & crimped.

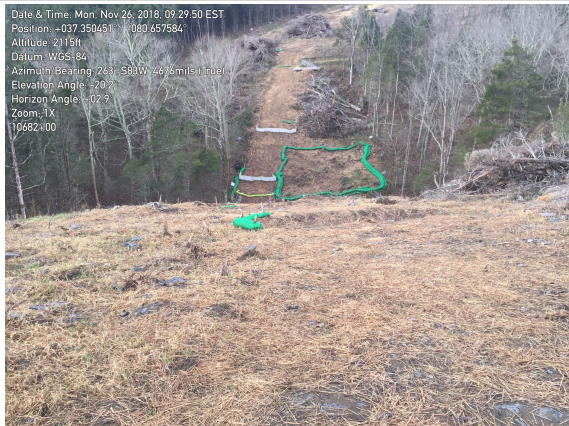
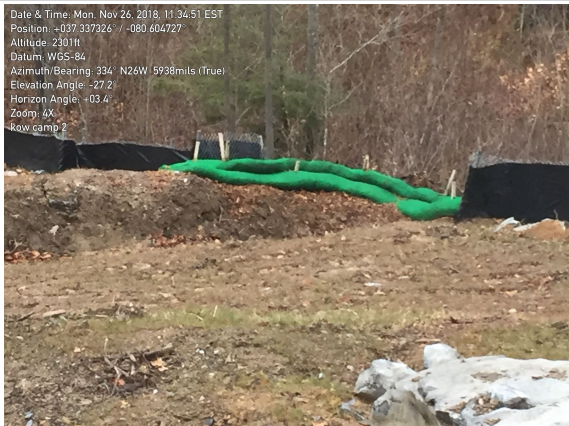
<b>GPS Location</b>	37.3699209792888, -80.6874179095781	<b>GPS Location</b>	37.3378105169209, -80.595181319259		
<b>Description</b>	Looking toward Big Stony Creek Rd 10682+00 use photo gps	<b>Description</b>	Kow Camp Rd 2 checked end treatments no issues use photo gps

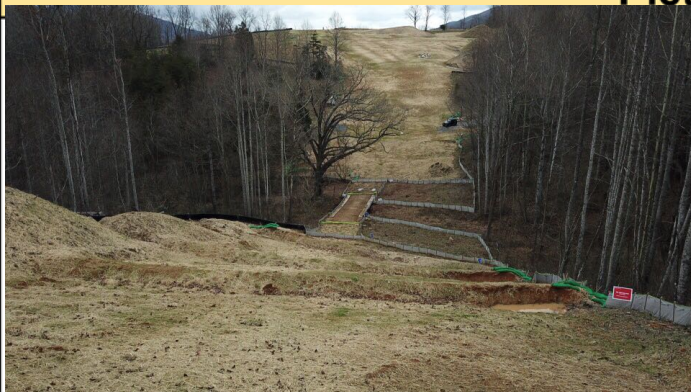
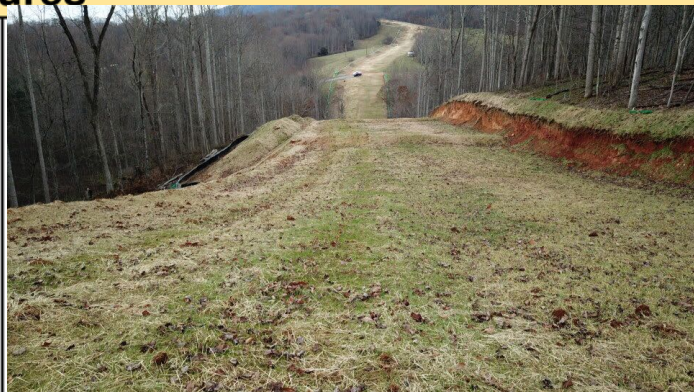
GPS Location			37.2966940328826, -80.4798594397311		
Description			ROW conditions @ MP 214

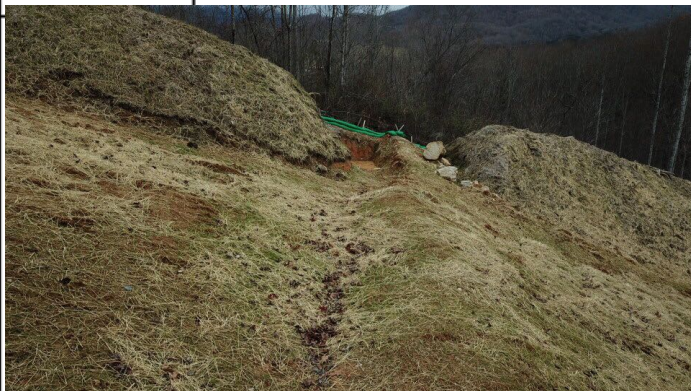
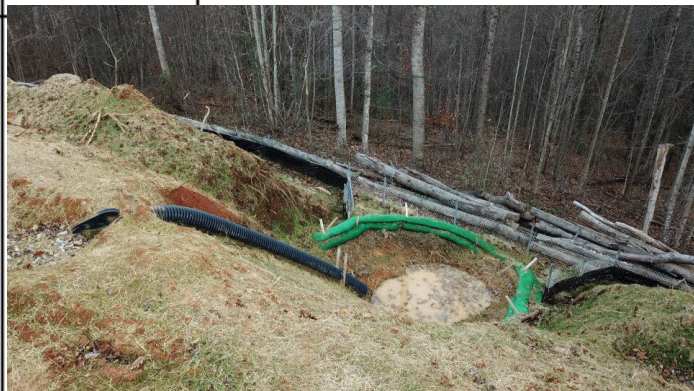
GPS Location			37.2966923145925, -80.4798465316002		
Description			Water bar and end treatment @ MP 213

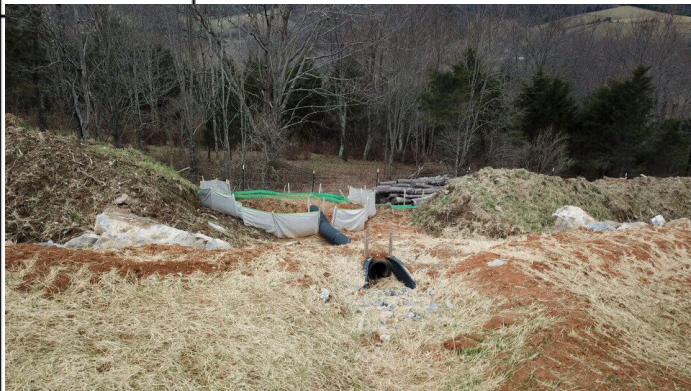
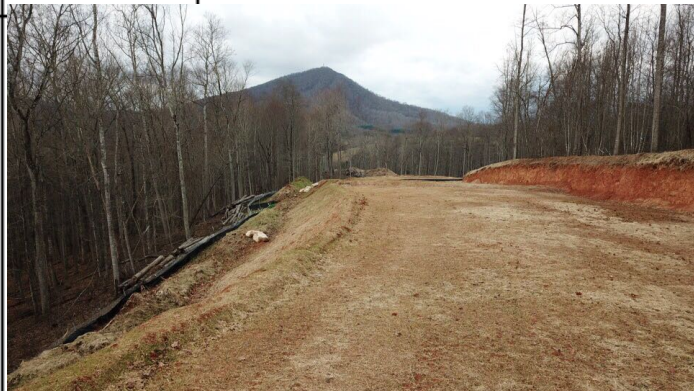
GPS Location			37.2966923145925, -80.4798465316002		
Description			End treatment @ MP 215		
GPS Location			37.2966923145925, -80.4798465316002		
Description			ROW conditions @ MP 213

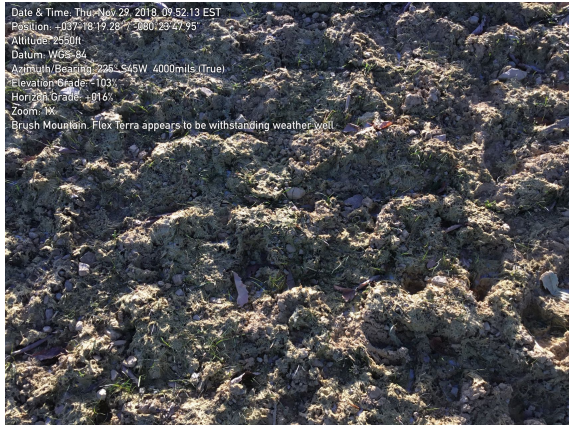
A/E	124300137	Date/Time	11/29/2018 5:07 PM	Report #	11491
Pictures					
<p>Date &amp; Time: Thu, Nov 29, 2018, 09:52:13 EST Position: +037°18'19.28" / -080°23'27.75" Altitude: 2250ft Datum: WGS-84 Azimuth/Bearing: 251° S45W 4000mils (True) Elevation Grade: +02% Horizon Grade: +014% Zoom: 1X Brush Mountain. Flex Terra appears to be withstanding weather well.</p>

GPS Location	37.313938248006, -80.4066237342361		GPS Location	37.313729370979, -80.406845267937	
Description	Brush Mountain. Flex Terra appears to be in good condition and not weakened by weather since application.		Description	Brush Mountain. End treatments and slope breakers are functional.

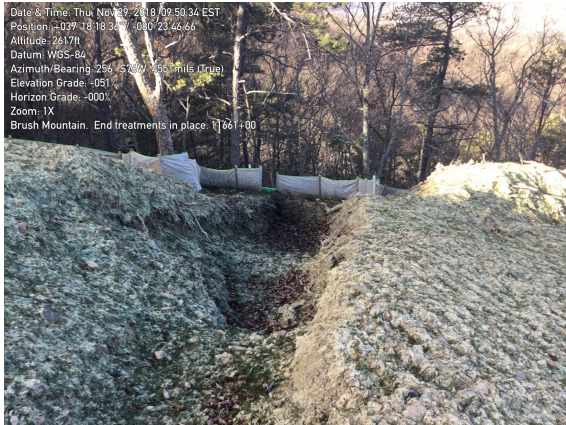
<p>Date &amp; Time: Thu, Nov 29, 2018, 09:50:34 EST Position: +037°18'18.35" / -080°23'46.66" Altitude: 2261ft Datum: WGS-84 Azimuth/Bearing: 251° S30W 3000mils (True) Elevation Grade: +02% Horizon Grade: +000% Zoom: 1X Brush Mountain. End treatments in place. 11661+00</p>

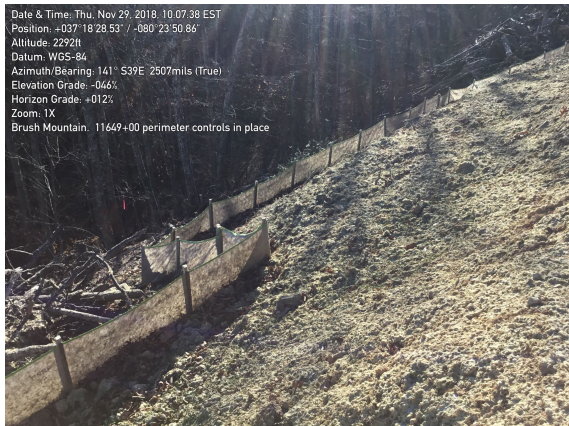
<p>Date &amp; Time: Thu, Nov 29, 2018, 10:07:38 EST Position: +037°18'28.53" / -080°23'50.86" Altitude: 2292ft Datum: WGS-84 Azimuth/Bearing: 141° S39E 2507mils (True) Elevation Grade: -046% Horizon Grade: +012% Zoom: 1X Brush Mountain. 11649+00 perimeter controls in place</p>

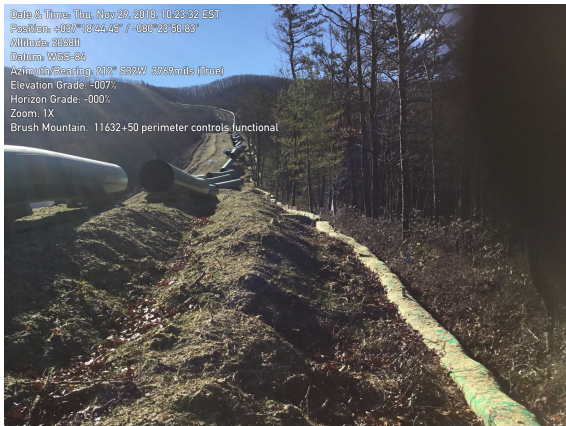
<p>Date &amp; Time: Thu, Nov 29, 2018, 10:06:02 EST Position: +037°18'24.43" / -080°23'50.03" Altitude: 2033ft Datum: WGS-84 Azimuth/Bearing: 017° S38W 3239mils (True) Elevation Grade: -007% Horizon Grade: +000% Zoom: 1X Brush Mountain. 11632+50 perimeter controls functional</p>

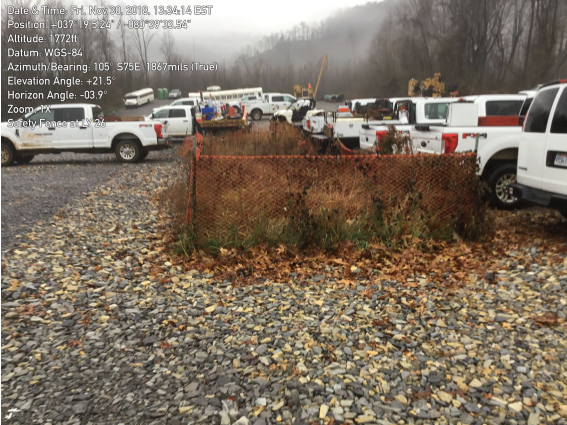
<p> <small> Date &amp; Time: Fri, Nov 30, 2018, 13:54:14 EST  Position: +037°19'22" / -80°37'33.54"  Altitude: 1772ft  Datum: WGS-84  Azimuth/Bearing: 105.575E 1867mils (True)  Elevation Angle: +21.5°  Horizon Angle: -03.9°  Zoom: 1X  Safety Fence at LY 26 </small> </p>

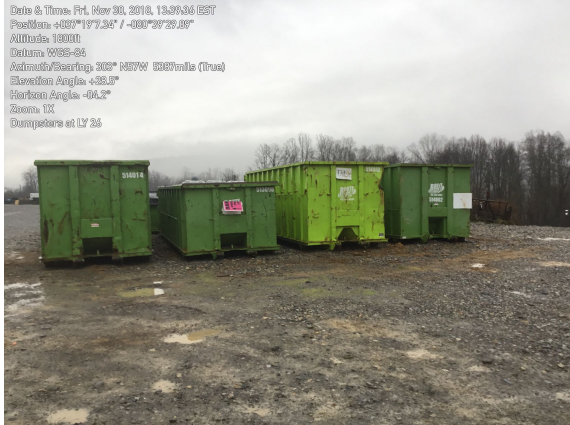
<p> <small> Date &amp; Time: Fri, Nov 30, 2018, 13:56:36 EST  Position: +037°19'23.4" / -80°37'33.85"  Altitude: 1800ft  Datum: WGS-84  Azimuth/Bearing: 303° 00'00" 3007mils (True)  Elevation Angle: +33.3°  Horizon Angle: -04.2°  Zoom: 1X  Dumpsters at LY 26 </small> </p>			
<b>GPS Location</b>	37.3182690097367, -80.6592808664596	<b>GPS Location</b>	37.3188654659663, -80.6583865173912		
<b>Description</b>	Safety Fence at LY 26	<b>Description</b>	Dumpsters at LY 26		
Insert image here		Insert image here			
<b>GPS Location</b>		<b>GPS Location</b>

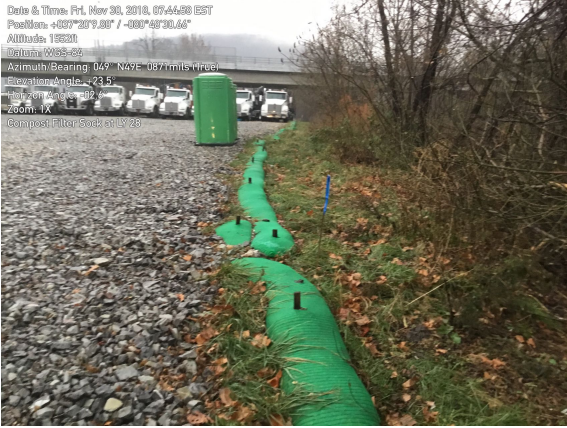
<p><small>Date &amp; Time: Fri, Nov 30, 2018, 07:44:50 EST Position: +037°20'9.00" / -080°48'30.66" Altitude: 1552ft Location: W35-37 Azimuth Bearing: 045 - N/A Description: Angle: +23.5 Elevation Angle: -03.0 Zoom: 1X Compost Filter Sock at LY 28</small></p>

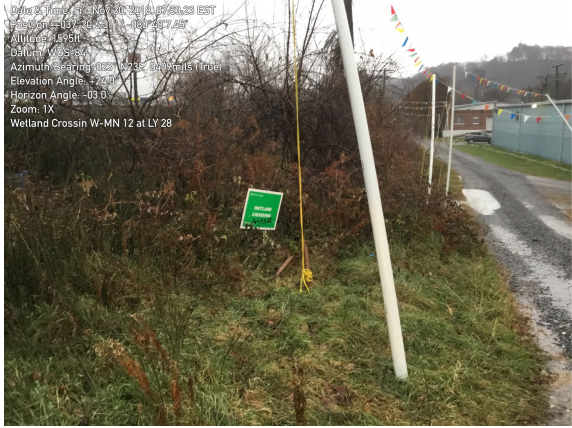
<p><small>Date &amp; Time: Fri, Nov 30, 2018, 07:56:20 EST Position: +037°20'9.00" / -080°48'30.66" Altitude: 1552ft Location: W35-37 Azimuth Bearing: 045 - N/A Description: Angle: +23.5 Elevation Angle: -03.0 Zoom: 1X Wetland Crossing W-MN 12 at LY 28</small></p>			
<b>GPS Location</b>	37.3361714976256, -80.8084773179896	<b>GPS Location</b>	37.334300195833, -80.8027124126263		
<b>Description</b>	Compost Filter Sock at LY 28	<b>Description</b>	Wetland Crossing W-MN 12 at LY 28		
Insert image here		Insert image here			
<b>GPS Location</b>		<b>GPS Location</b>

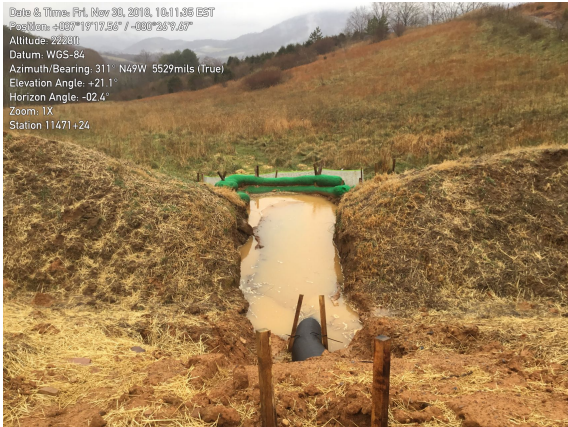
<p>Date &amp; Time: Fri, Nov 30, 2018, 10:11:36 EST Position: +037°19'17.56" / +080°25'57.67" Altitude: 2218ft Datum: WGS-84 Azimuth/Bearing: 311° N49W 5529mils (True) Elevation Angle: +21.1° Horizon Angle: -02.4° Zoom: 1X Station 11471+24</p>

GPS Location	37.3216756666427, -80.4358814378087	GPS Location	37.3216947773819, -80.4357824475322		
Description	Sump & EndTreatment at station 11436+00	Description	Sump & EndTreatment at station 11471+24 Steel Acres		
<p>Date &amp; Time: Fri, Nov 30, 2018, 10:41:16 EST Position: +037°19'28.34" / +080°25'55.72" Altitude: 2169ft Datum: WGS-84 Azimuth/Bearing: 353° N07W 6276mils (True) Elevation Angle: +25.4° Horizon Angle: -02.0° Zoom: 1X Plunge Pool elevation: 11436+13</p>

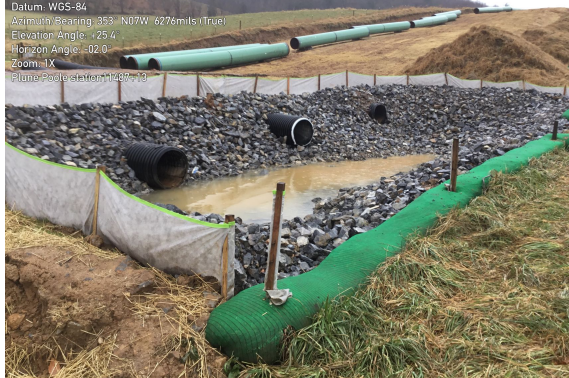
GPS Location	37.3245553532963, -80.4321371578429	GPS Location	37.3231788771575, -80.4335924238716		
Description	Plunge Poole at station 11487+13 Stevers Gap Trail	Description	Super Silt Fence looking toward Karst Area station 11479+65		
<p>Date &amp; Time: Fri, Nov 30, 2018, 12:42:58 EST Position: +037°19'43.76" / +080°24'59.94" Altitude: 2121ft Datum: WGS-84 Azimuth/Bearing: 308° N58W 7037mils (True) Elevation Angle: +37.2° Horizon Angle: -00.7° Zoom: 1X EndTreatment Sinking Creek station 11547+60</p>

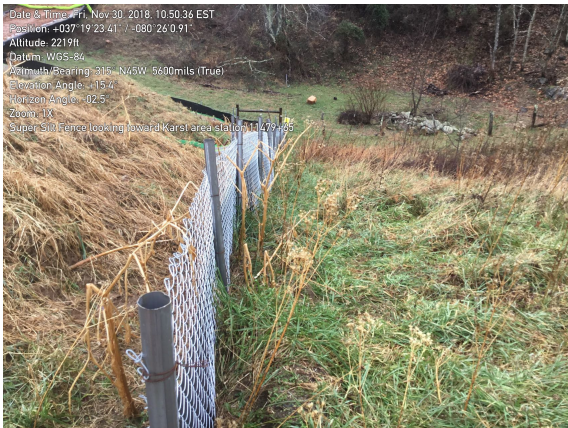
<p>Date &amp; Time: Fri, Nov 30, 2018, 10:50:36 EST Position: +037°19'23.41" / +080°26'0.91" Altitude: 2219ft Datum: WGS-84 Azimuth/Bearing: 315° N45W 5400mils (True) Elevation Angle: +15.4° Horizon Angle: -02.5° Zoom: 1X Super Silt Fence looking toward Karst area station 11479+65</p>

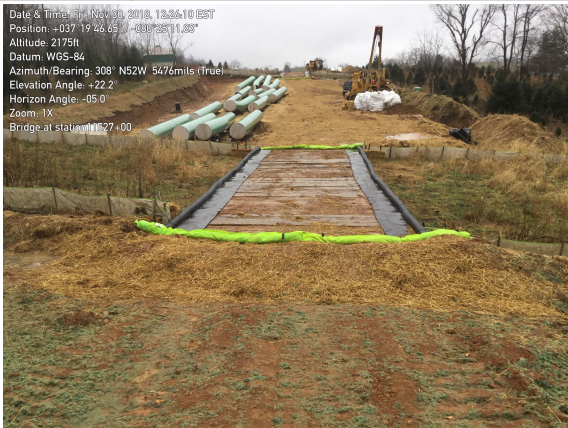
<p>Date &amp; Time: Fri, Nov 30, 2018, 12:56:10 EST Position: +037°19'46.65" / +080°25'11.88" Altitude: 2175ft Datum: WGS-84 Azimuth/Bearing: 308° N52W 5476mils (True) Elevation Angle: +22.2° Horizon Angle: -05.0° Zoom: 1X Bridge at station 11527+00</p>

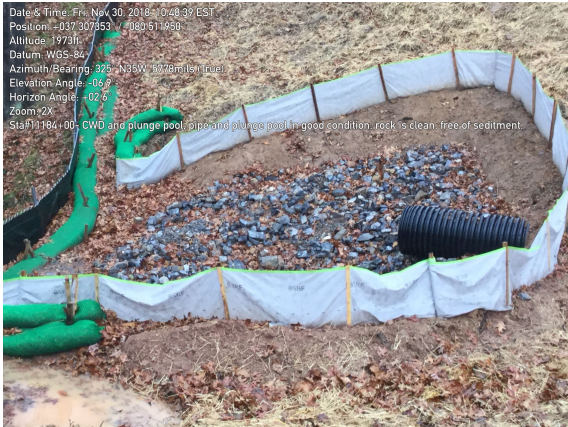
<p>Date &amp; Time: Fri, Nov 30, 2018, 10:48:35 EST Position: +037.307853° / -080.511950° Altitude: 1973ft Datum: WGS-84 Azimuth/Bearing: 325° N35W 10240mils (True) Elevation Angle: -02.9° Horizon Angle: -02.3° Zoom: 2X Sta#11184+00- CWD and plunge pool, pipe and plunge pool in good condition, rock is clean, free of sediment.</p>

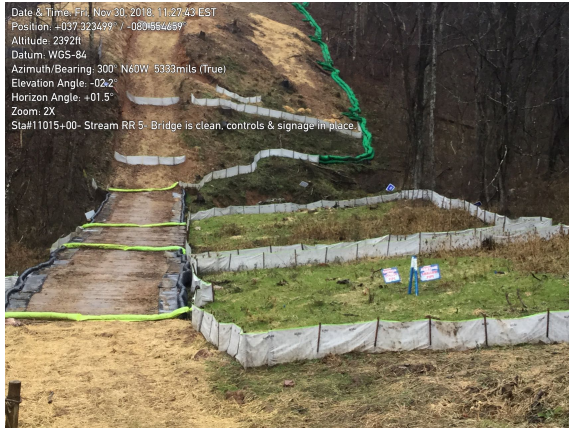
<p>Date &amp; Time: Fri, Nov 30, 2018, 11:27:43 EST Position: +037.323469° / -080.554697° Altitude: 2392ft Datum: WGS-84 Azimuth/Bearing: 300° N60W 5333mils (True) Elevation Angle: -02.2° Horizon Angle: +01.5° Zoom: 2X Sta#11015+00- Stream RR 5- Bridge is clean, controls &amp; signage in place.</p>

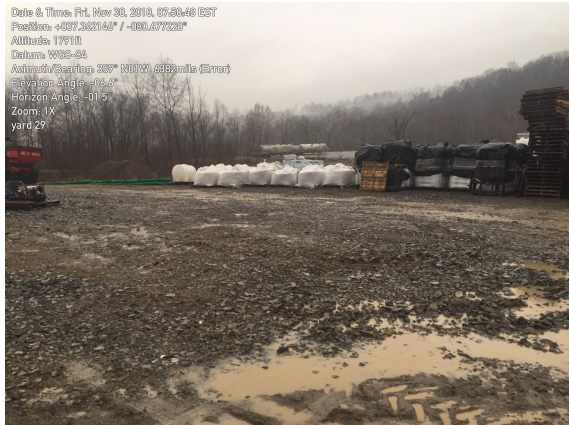
A/E	124300137	Date/Time	11/30/2018 7:52 AM	Report #	11538
Pictures					
<div><div><div>Date &amp; Time: Fri, Nov 30, 2018, 07:50:46 EST Position: +037.362146° / -080.677231° Altitude: 1791ft Datum: WGS-84 Azimuth/Bearing: 303° N0726 439mils (True) Elevation Angle: +05.4° Horizon Angle: -01.5° Zoom: 1X yard 29</div><div>

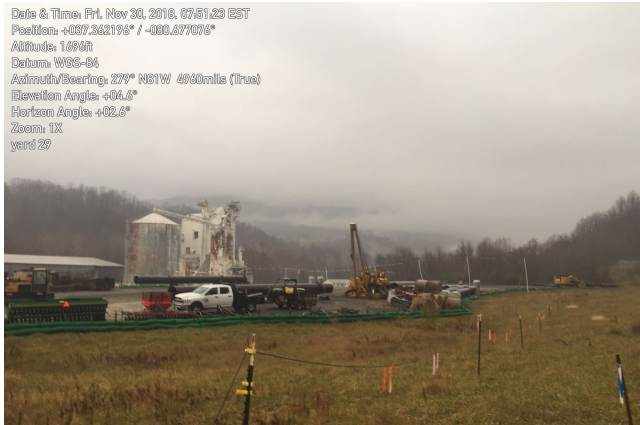
</div></div></div>		<div><div><div>Date &amp; Time: Fri, Nov 30, 2018, 07:51:23 EST Position: +037.362196° / -080.677076° Altitude: 1694ft Datum: WGS-84 Azimuth/Bearing: 279° N01W 4940mils (True) Elevation Angle: +06.6° Horizon Angle: +02.6° Zoom: 1X yard 29</div><div>

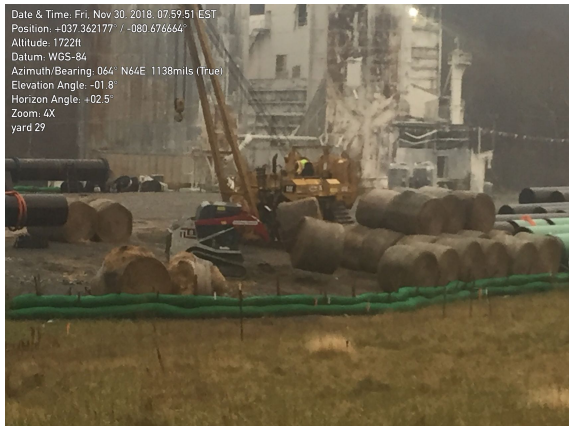
GPS Location	37.3622154957031, -80.6765503530211		GPS Location		
Description	Arnold's crew loading out hay bales observed		Description		
<div><div><div></div><div>Insert image here</div></div></div>		<div><div><div></div><div>Insert image here</div></div></div>			
GPS Location			GPS Location		
Description			Description
