# Visual Site Inspection Report

<b>Project Name</b>	H-600 Pipeline Spread G	<b>AFE</b>	124300137	<b>Spread</b>	H-600 Pipeline Spread G
<b>Contractor</b>	Precision			<b>Report #</b>	11673
<b>Inspector</b>	Rob Robertson			<b>Date/Time</b>	12/3/2018 3:52 PM
<b>Permit #</b>	TBD	<b>Inspection Type</b>	VA SWPP	<b>Station Begin</b>	10458+91
<b>State</b>	VA	<b>Inspection Area</b>	Full	<b>Station End</b>	10459+03
<b>County</b>	Giles	<b>Ground</b>	Damp	<b>Temperature (°F)</b>	56.00
<b>Municipality</b>	N/A	<b>Weather</b>	Sunny	<b>Rain Gauge (in)</b>	0.00
<b>GPS Location</b>	37.1340199609013, -80.3943157922492			<b>Rain Accumulation Time (days)</b>	1.00

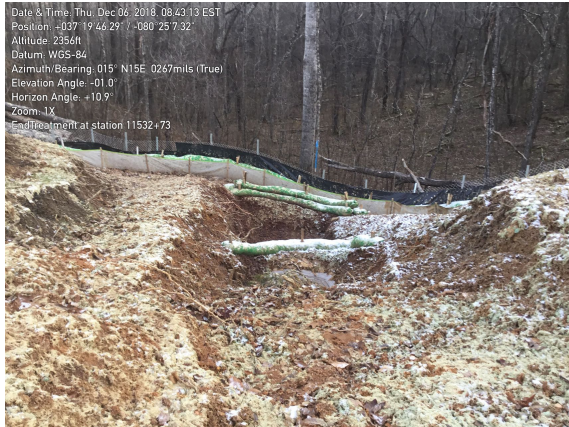
A/E	124300137	Date/Time	12/6/2018 3:29 AM	Report #	11782
Pictures					
<p>Date &amp; Time: Thu, Dec 06, 2018, 08:43:13 EST Position: +037°19'46.29" / -080°25'7.32" Altitude: 2356ft Datum: WGS-84 Azimuth/Bearing: 015° N15E 0267mils (True) Elevation Angle: +01.0° Horizon Angle: +10.9° Zoom: 1X EndTreatment at station 11532+73</p>

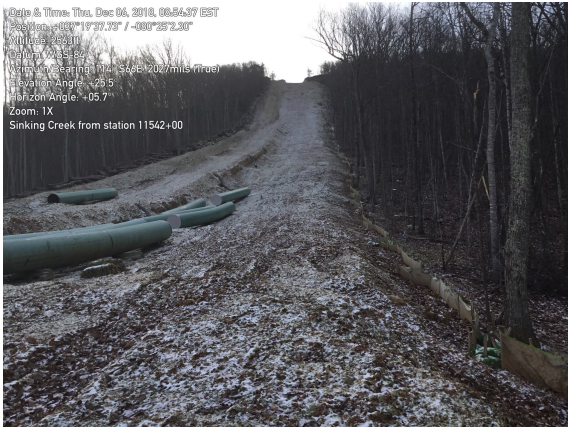
<p>Date &amp; Time: Thu, Dec 06, 2018, 08:54:37 EST Position: +037°19'37.73" / -080°25'7.30" Altitude: 2350ft Datum: WGS-84 Azimuth/Bearing: 132° N13W 6293mils (True) Elevation Angle: +05.7° Horizon Angle: +05.7° Zoom: 1X Sinking Creek from station 11542+00</p>

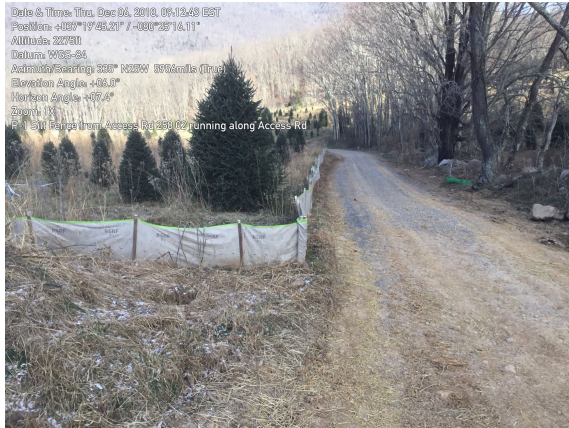
GPS Location	37.3294823617091, -80.4186618235711	GPS Location	37.3271151865249, -80.4174176976834		
Description	EndTreatment at station 11532+73	Description	Sinking Creek from station 11542+00		
<p>Date &amp; Time: Thu, Dec 06, 2018, 09:13:49 EST Position: +037°19'55.20" / -080°25'16.11" Altitude: 2270ft Datum: WGS-84 Azimuth/Bearing: 330° N30W 6066mils (True) Elevation Angle: +03.0° Horizon Angle: +07.4° Zoom: 1X P-1 Silt Fence from Access Rd 258.02 running along Access Rd</p>

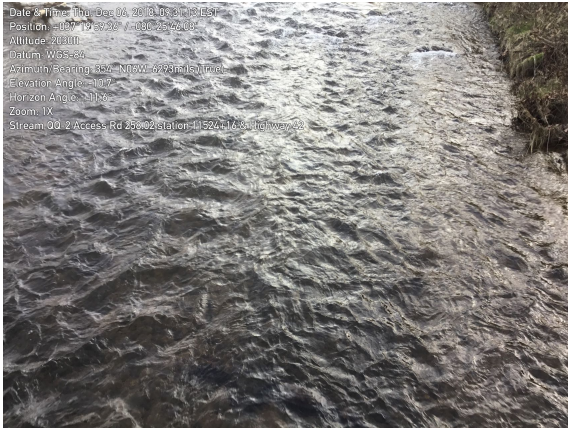
<p>Date &amp; Time: Thu, Dec 06, 2018, 10:03:49 EST Position: +037°19'17.99" / -080°26'9.06" Altitude: 2220ft Datum: WGS-84 Azimuth/Bearing: 396° N06W 6293mils (True) Elevation Angle: +0.7° Horizon Angle: +0.0° Zoom: 1X Stream QQ-2 Access Rd 258.02 station 11524+16 Highway 42</p>

GPS Location	37.3293452756827, -80.421021580771	GPS Location	37.3331325967212, -80.429489146993		
Description	P-1 Silt Fence from Access Rd 258.02 station 11524+16 running along Access Rd	Description	Stream QQ-2 Access Rd 258.02 station 11524+16 & Highway 42 Observed no Sediment in Stream		
<p>Date &amp; Time: Thu, Dec 06, 2018, 10:10:28 EST Position: +037°19'22.24" / -080°26'3.74" Altitude: 2248ft Datum: WGS-84 Azimuth/Bearing: 064° N64E 1138mils (True) Elevation Angle: +06.5° Horizon Angle: +10.4° Zoom: 1X Slop Drain Pipe at station 11478+78</p>

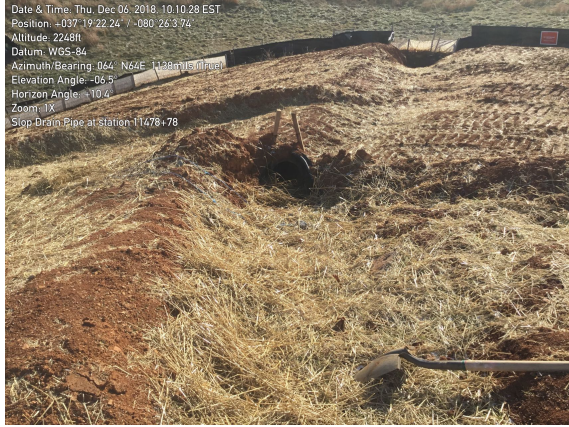
Description	Slop Drain Pipe at station 11478+78	Description	Rock Entrance at Steel Acres station 11471+52

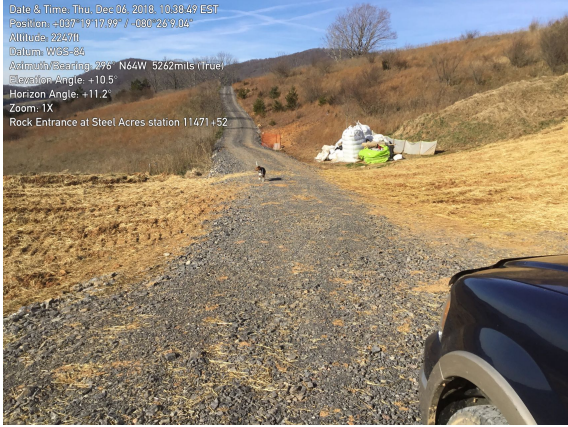
<p>Date &amp; Time: Thu, Dec 06, 2018, 10:38:49 EST Position: +037°19'17.99" / -080°26'9.06" Altitude: 2220ft Datum: WGS-84 Azimuth/Bearing: 396° N06W 5262mils (True) Elevation Angle: +10.5° Horizon Angle: +11.2° Zoom: 1X Rock Entrance at Steel Acres station 11471+52</p>

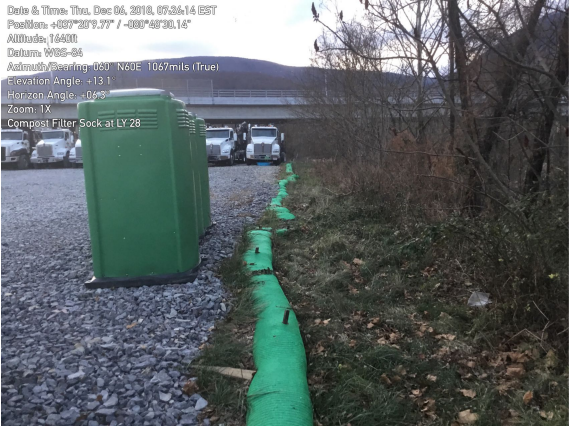
<p> Date &amp; Time: Thu, Dec 06, 2018, 07:34:14 EST  Position: +037°20'9.77" / -080°48'30.14"  Altitude: 1440ft  Datum: WGS-84  Datum/Grounding: 000 N60E 1067mils (True)  Elevation Angle: +13.1°  Horizon Angle: -04.3°  Zoom: 1X  Compost Filter Sock at LY 28 </p>

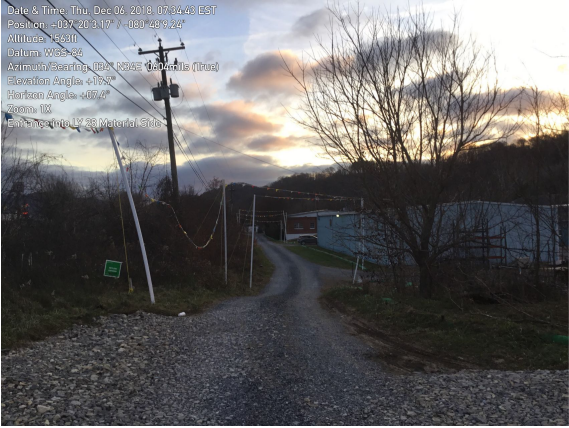
<p> Date &amp; Time: Thu, Dec 06, 2018, 07:34:46 EST  Position: +037°20'3.17" / -080°48'9.24"  Altitude: 1429ft  Datum: WGS-84  Datum/Grounding: 000 N60E 1067mils (True)  Elevation Angle: +13.1°  Horizon Angle: -04.3°  Zoom: 1X  Entrance into LY 28 Materials Side </p>			
<b>GPS Location</b>	37.3360071285044, -80.8082892280825	<b>GPS Location</b>	37.3342976812621, -80.8026662283398		
<b>Description</b>	Compost Filter Sock at LY 28	<b>Description</b>	Entrance into LY 28 Materials Side		
<div>Insert image here</div>		<div>Insert image here</div>

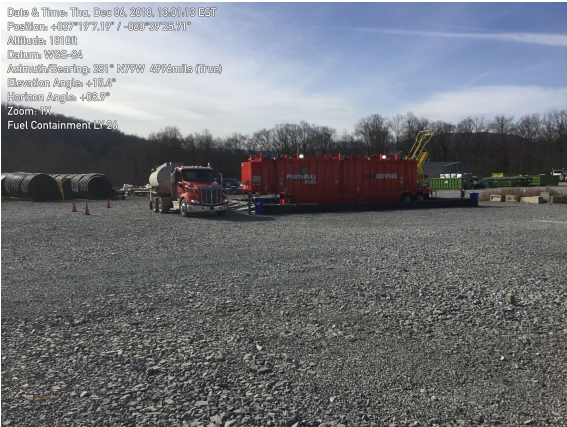
<p><small>Date &amp; Time: Thu, Dec 06, 2018, 13:01:18 EST Position: +037°19'7.19" / -080°39'35.91" Altitude: 1800ft Datum: WGS-84 Azimuth Bearing: 281° 00'00" 494mils (True) Elevation Angle: +11.4° Horizon Angle: +08.9° Zoom: 1X Fuel Containment LY 26</small></p>

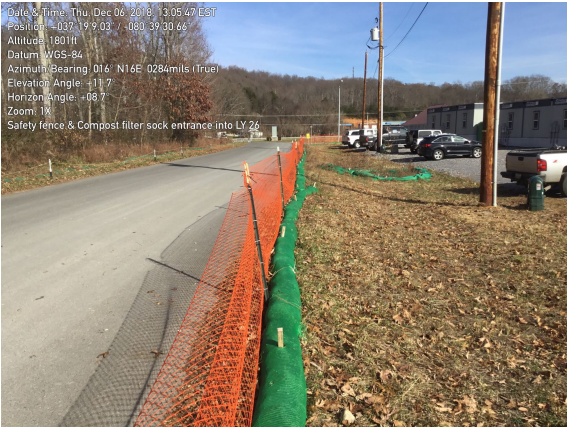
<p><small>Date &amp; Time: Thu, Dec 06, 2018, 13:05:47 EST Position: +037°19'9.03" / -080°39'30.66" Altitude: 1801ft Datum: WGS-84 Azimuth Bearing: 016° N14E 0284mils (True) Elevation Angle: -11.7° Horizon Angle: +08.7° Zoom: 1X Safety fence &amp; Compost filter sock entrance into LY 26</small></p>			
<b>GPS Location</b>	37.3186723469173, -80.6570894178754	<b>GPS Location</b>	37.3192265164455, -80.6584346295154		
<b>Description</b>	Fuel Containment at LY 26	<b>Description</b>	Safety Fence & Compost Filter Sock along Entrance into LY 26

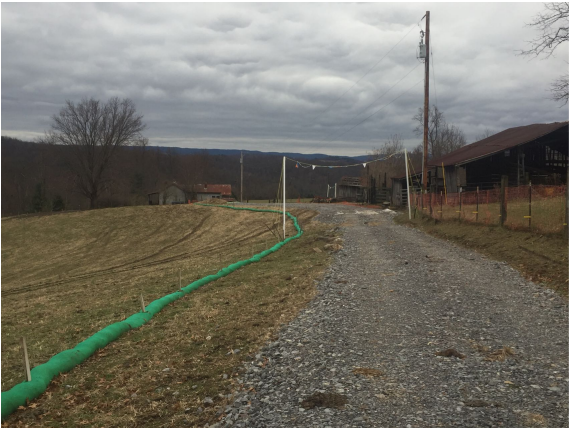
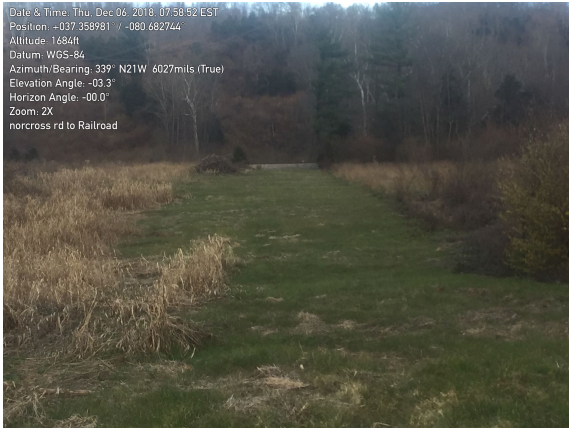
<b>GPS Location</b>	37.3755293526104, -80.6794265192753	<b>GPS Location</b>	37.370189912652, -80.6780870911485		
<b>Description</b>	Access 237 off Gravely Hill Rd,no issues	<b>Description</b>	Norcross Rd toward railroad no issues 10591+00 MP200.5

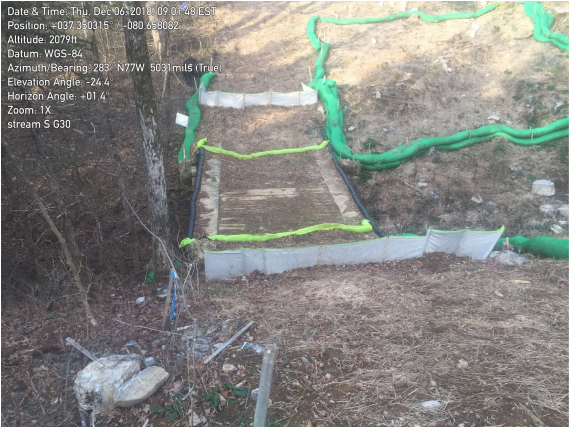
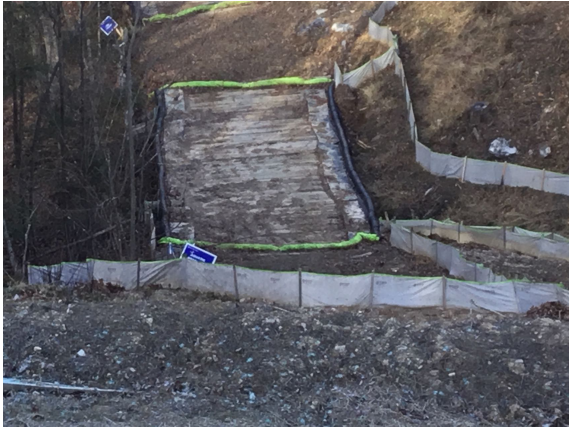
<b>GPS Location</b>	37.3474296484533, -80.6552524249467	<b>GPS Location</b>	37.3291741809016, -80.610501079039		
<b>Description</b>	Big Stoney Creek rd Stream S G 30 10679+36 Mp 202.1	<b>Description</b>	Stream S A33&34 off Kow camp rd 2 no issues

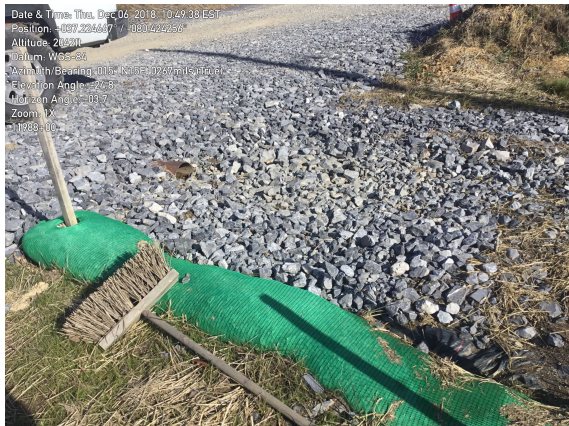
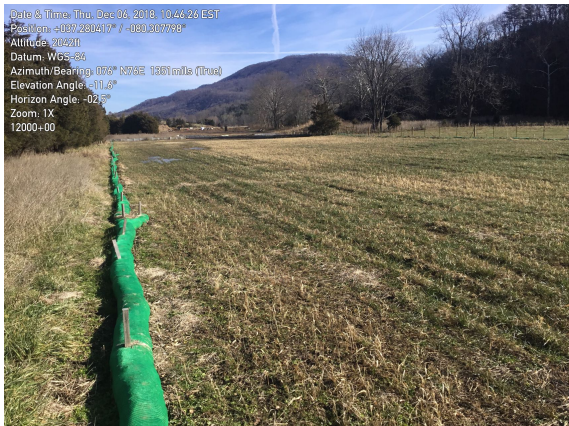
GPS Location	37.3337550056229, -80.7506771799119	GPS Location	37.3337375127618, -80.7507773379939		
Description	Culvert outlet 11988+00	Description	Row 12000+00

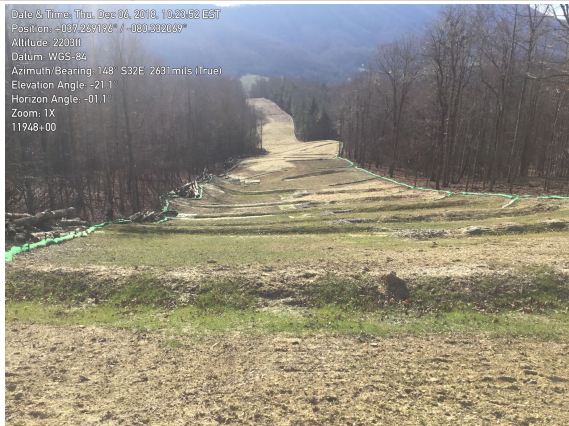
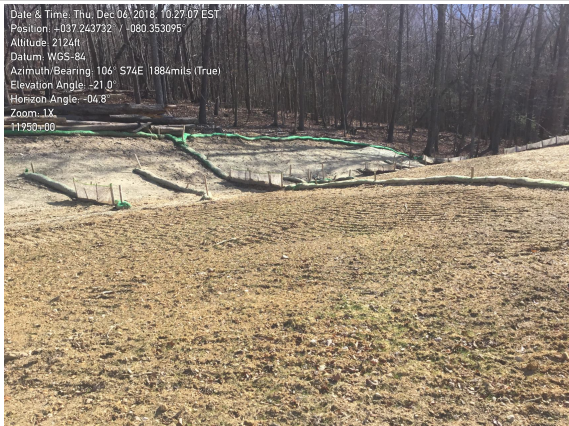
GPS Location	37.3337407848809, -80.7507676560527	GPS Location	37.333765669891, -80.7502830319923		
Description	Row 11948+00	Description	11950+00 ECDs

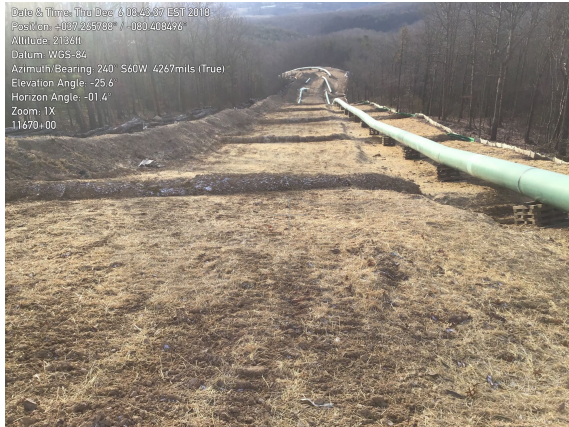
A/E	124300137	Date/Time	12/6/2018 2:22 PM	Report #	11816
Pictures					
<p>Date &amp; Time: Thu Dec 6 08:45:37 EST 2018 Position: +037 265788° / -080 408476° Altitude: 2196ft Datum: WGS-84 Azimuth/Bearing: 240° S60W 4267mils (True) Elevation Angle: -25.6° Horizon Angle: -01.4° Zoom: 1X 11670+00</p>

GPS Location	37.2060357492035, -80.3941750866101	GPS Location	37.2060246017786, -80.3941273659065		
Description	See photo for GPS location and station number. ROW is stabilized and water bars in place.	Description	See photo for GPS location and station number. End treatment for water bar in place and functional.		
<p>Date &amp; Time: Thu Dec 6 09:45:41 EST 2018 Position: +037 297652° / -080 371307° Altitude: 2262ft Datum: WGS-84 Azimuth/Bearing: 176° S02E 3164mils (True) Elevation Angle: -20.1° Horizon Angle: +06.5° Zoom: 1X 11687+00 S-MN21</p>

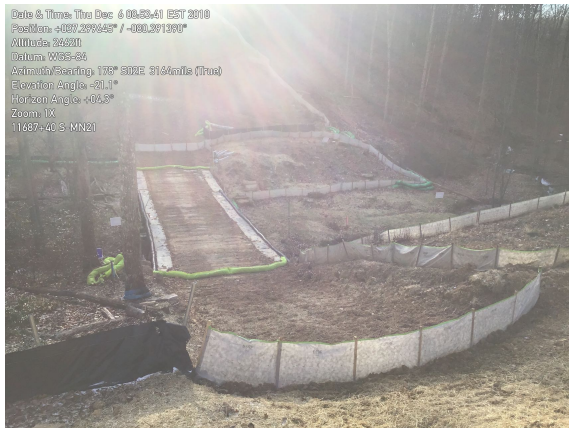
GPS Location	37.2060237220044, -80.3941333155644	GPS Location	37.2060246382164, -80.3941273680433		
Description	See photo for GPS location and station number. Stream S-MN21 with ECDs installed and buffer zone in place.	Description	See photo for GPS location and station number. Sump pit with fractured rock leading to stream S-MN21 impact. Filtration in place now.		
<p>Date &amp; Time: Thu Dec 6 09:45:04 EST 2018 Position: +037 294502° / -080 373352° Altitude: 2029ft Datum: WGS-84 Azimuth/Bearing: 101° S79E 1796mils (True) Elevation Angle: -21.3° Horizon Angle: -15.6° Zoom: 1X 11750+00</p>

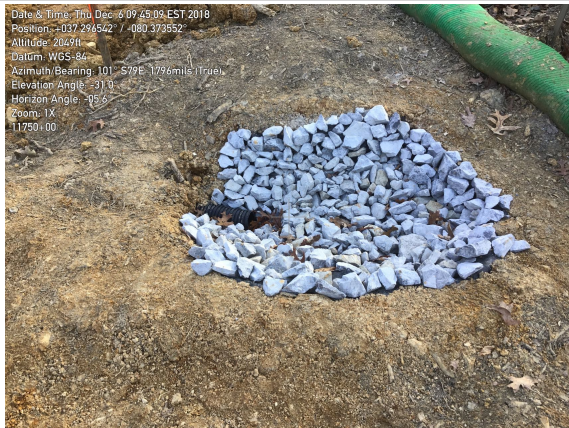
Description	See photo for GPS location and station number. Trench breaker day light drain.	Description	See photo for GPS location and station number. RCE in place and will assist in prevention of track out.
