# Visual Site Inspection Report

<b>Project Name</b>	H-600 Pipeline Spread G	<b>AFE</b>	124300137	<b>Spread</b>	H-600 Pipeline Spread G	
<b>Contractor</b>	Precision			<b>Report #</b>	12568	
<b>Inspector</b>	Brian Shields			<b>Date/Time</b>	1/2/2019 12:03 PM	
<b>Permit #</b>	TBD	<b>Inspection Type</b>	VA SWPP	<b>Station Begin</b>	+0	
<b>State</b>	VA	<b>Inspection Area</b>	Partial	<b>Station End</b>	+0	
<b>County</b>	Giles	<b>Ground</b>	Damp	<b>Temperature (°F)</b>	46.00	
<b>Municipality</b>	N/A	<b>Weather</b>	Cloudy	<b>Rain Gauge (in)</b>	0.00	
<b>GPS Location</b>	37.3631716613074, -80.6766270474351			<b>Rain Accumulation Time (days)</b>	1.00

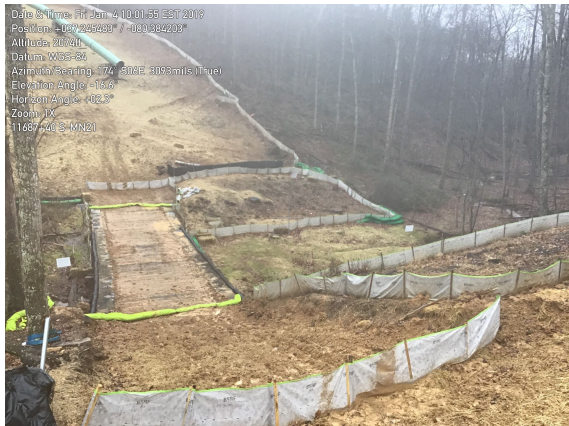
GPS Location	37.2061275368457, -80.3943495957838	GPS Location	37.2061275368457, -80.3943495957838		
Description	See photo for GPS location and station number. Stream S-MN21 sensitive resource buffer in place.	Description	See photo for GPS location and station number. Geotextile lined sump with rock to filter water going through fractured limestone.		
<p>Date &amp; Time: Fri Jan 4 10:42:57 EST 2019 Position: +037.245483° / -080.384203° Altitude: 2074ft Datum: WGS-84 Azimuth/Bearing: 338° S00W 5867mils (True) Elevation Angle: +02.2° Horizon Angle: +01.9° Zoom: 1X 11768+00</p>

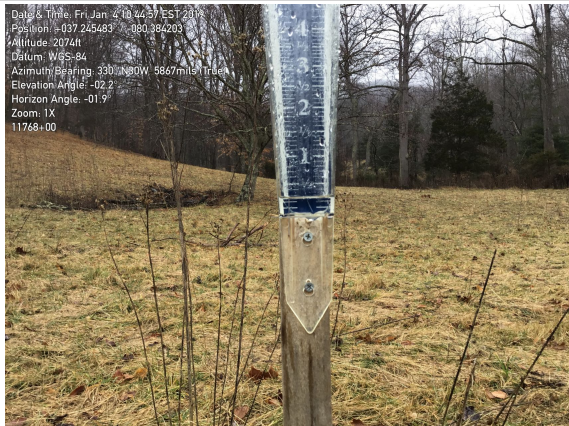
Description	See photo for GPS location and station number. 0.3 inches of rain fall at Mount Tabor.	Description	See photo for GPS location and station number. Permanent water bar in place with rock level spreader.
