Visual Site Inspection Report

Project Name	H-600 Pipeline Spread G	AFE	124300137	Spread	H-600 Pipeline Spread G
Contractor	Precision			Report #	12952
Inspector	Len Kruizenga			Date/Time	1/14/2019 8:40 AM
Permit #	TBD	Inspection Type	VA SWPP	Station Begin	10311+28
State	WV	Inspection Area	Full	Station End	10310+84
County	Monroe	Ground	Frozen	Temperature (°F)	30.00
Municipality	N/A	Weather	Cloudy	Rain Gauge (in)	0.00
GPS Location	37.3958897683752, -80.7932302305229			Rain Accumulation Time (days)	1.00

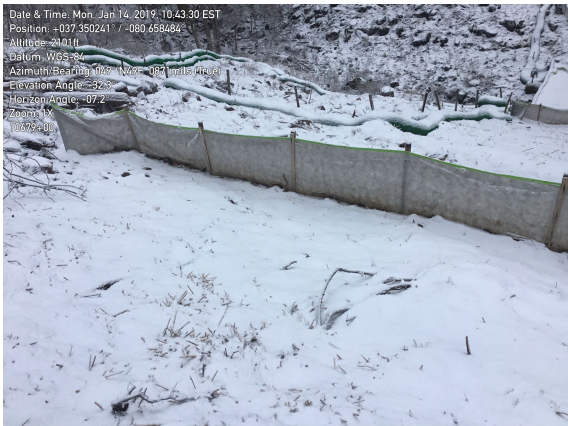
GPS Location	37.3339001337826, -80.7501667929335		GPS Location	37.3338999104612, -80.7501671586036	
Description	10679+36 S-G30 ECDs in good condition		Description	10679+00 ECDs in good condition	
<p>Date & Time: Mon, Jan 14, 2019, 10:54:55 EST Position: +037.349404° / -080.653530° Altitude: 2052ft Datum: WGS-84 Azimuth/Bearing: 136.5° S18W 3520mils (True) Elevation Angle: +27.5° Horizon Angle: -01.3° Zoom: 1X 10695+00</p>

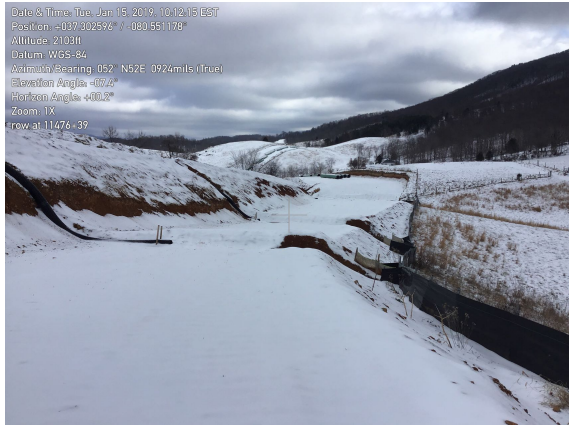
GPS Location	37.1361417400703, -80.3942000601276	GPS Location	37.1360884781012, -80.3942102662631		
Description	Row at 11476+39	Description	ROW looking back towards Stevers Gap Road Crossing		
<p>Date & Time: Tue, Jan 15, 2019, 10:30:07 EST Position: +037.322591° / -080.426909° Altitude: 2227ft Datum: WGS-84 Azimuth/Bearing: 120° N42W 11477mils (True) Elevation Angle: +1.7° Horizon Angle: +02.5° Zoom: 1X Stream s-pp3</p>

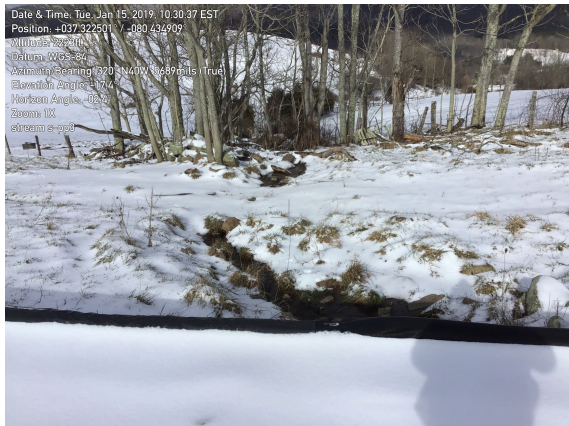
GPS Location	37.1360760229054, -80.3939418309186	GPS Location	37.1360604325655, -80.3939606902007		
Description	Stream s-pp3	Description	Sump, slope drain and end treatment 11517+00		
<p>Date & Time: Tue, Jan 15, 2019, 10:37:07 EST Position: +037.328233° / -080.422755° Altitude: 2225ft Datum: WGS-84 Azimuth/Bearing: 089° N89E 1173mils (True) Elevation Angle: +03.9° Horizon Angle: +00.7° Zoom: 1X Buffer around stream s-pp4</p>

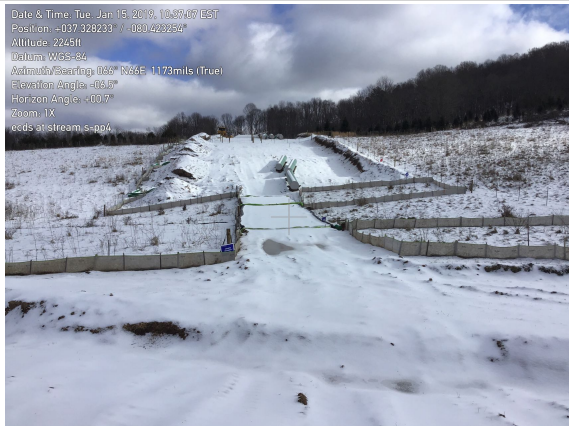
GPS Location	37.1360604325655, -80.3939606902007	GPS Location	37.1360604325655, -80.3939606902007		
Description	Buffer around s-pp4	Description	Stream s-pp4

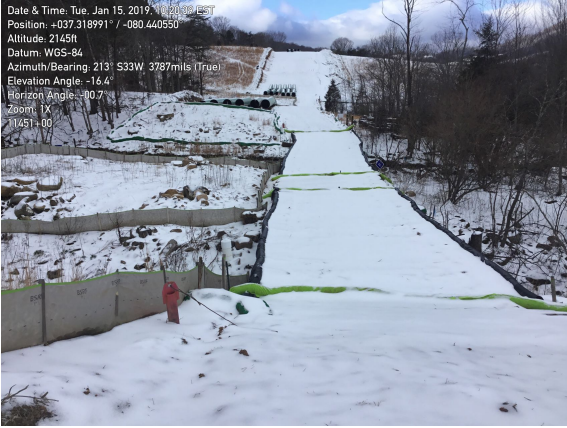
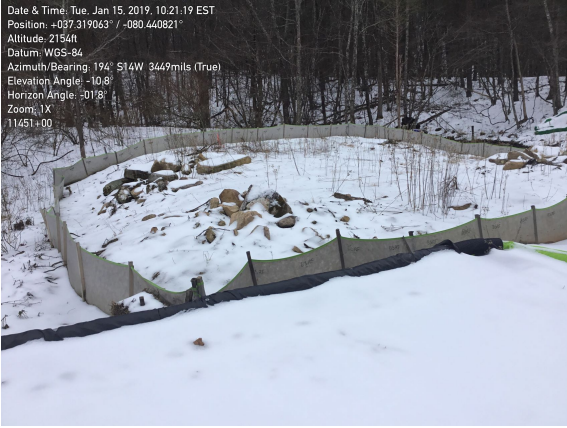
<p>GPS Location 37.3339528867128, -80.7501130323012</p> <p>Description ECDs in good condition 11451+00</p>	
<p>Date & Time: Tue, Jan 15, 2019, 11:13:54 EST Position: +037.307414° / -080.446887° Altitude: 1934ft Datum: WGS-84 Azimuth/Bearing: 219° S39W 3893mils (True) Elevation Angle: +00.8° Horizon Angle: -08.5° Zoom: 1X 11360+00</p>

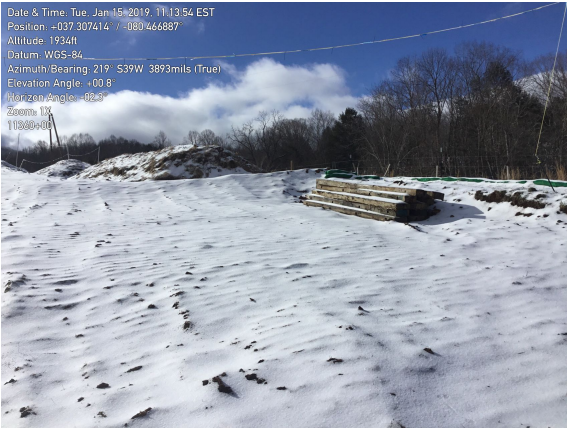
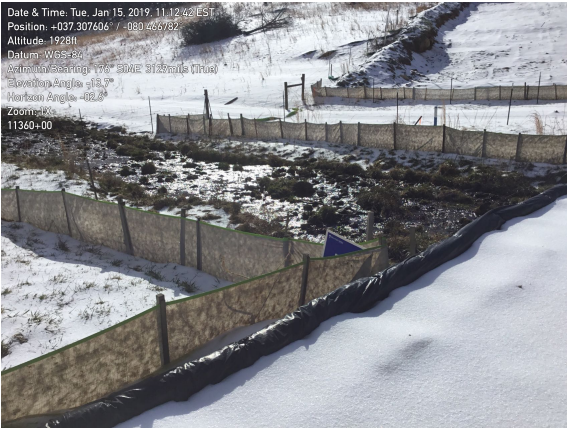
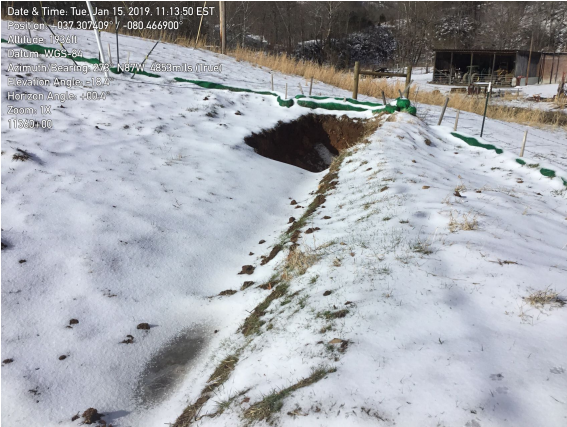
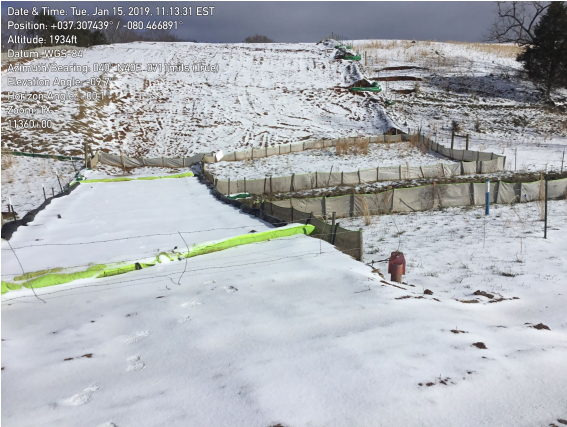
<p>GPS Location 37.3339736184425, -80.7501070099929</p> <p>Description Row 11360+00</p>

<p>GPS Location 37.3330637812962, -80.7502684370435</p> <p>Description Sump 11360+00</p>	
<p>GPS Location 37.3338875280336, -80.7501307999686</p> <p>Description ECDs in good condition 11451+00</p>		<p>GPS Location 37.3339709280668, -80.7501079646422</p> <p>Description ECDs in good condition 11360+40</p>		<p>GPS Location 37.3330300022264, -80.7503227517761</p> <p>Description ECDs in good condition 11360+30</p>

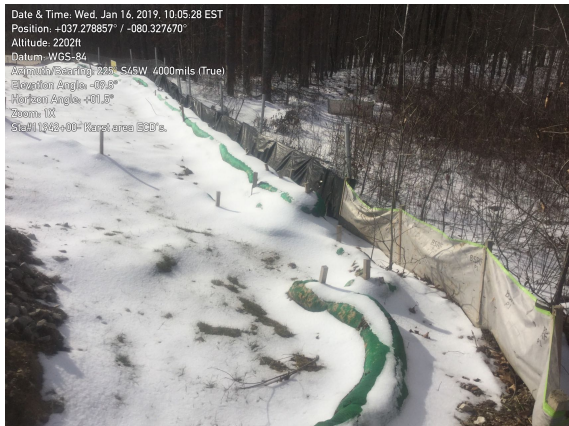
<p>Date & Time: Wed, Jan 16, 2019, 10:05:28 EST Position: +037 276857° / -080 327670° Altitude: 2202ft Datum: WGS-84 Azimuth/Bearing: 131° S45W 4000mils (True) Elevation Angle: -08.5° Horizon Angle: +00.5° Zoom: 1X Sta#11942+00- Karst area ECD's.</p>

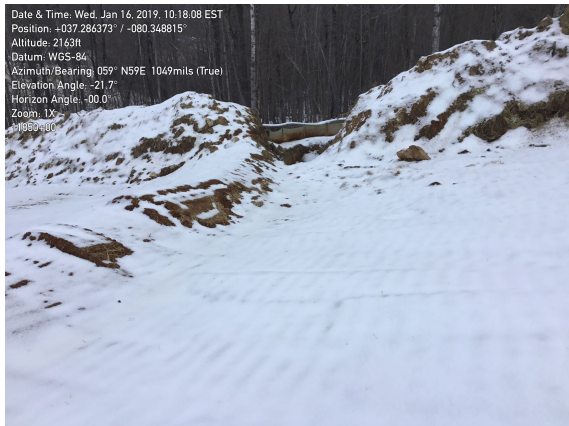
GPS Location	37.2680878127341, -80.3201815021041		GPS Location	37.2680051671688, -80.3202165384594	
Description	Water breaker and sump 11850+00		Description	Mt tabor rd crossing 11788+00	
<div><div><div>Date & Time: Wed, Jan 16, 2019, 10:56:04 EST Position: +037 286387° / -080 348867° Altitude: 2121ft Datum: WGS-84 Azimuth/Bearing: 181° S01W 3218mils (True) Elevation Angle: -13.7° Horizon Angle: -01.4° Zoom: 1X 11878+00</div><div>

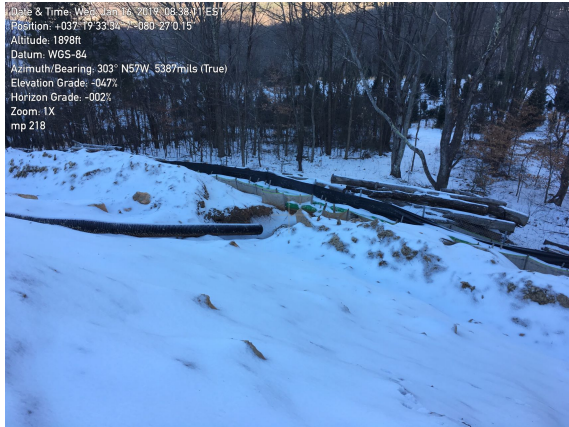
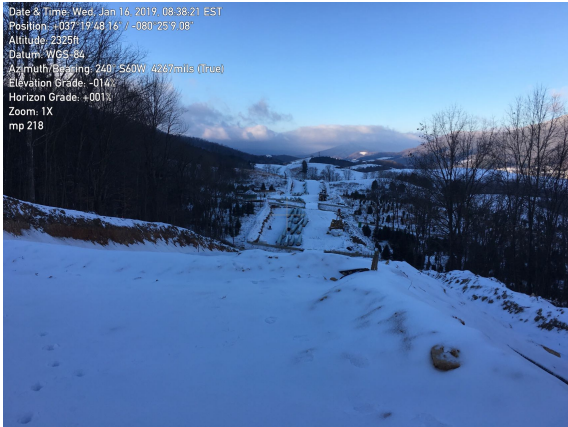
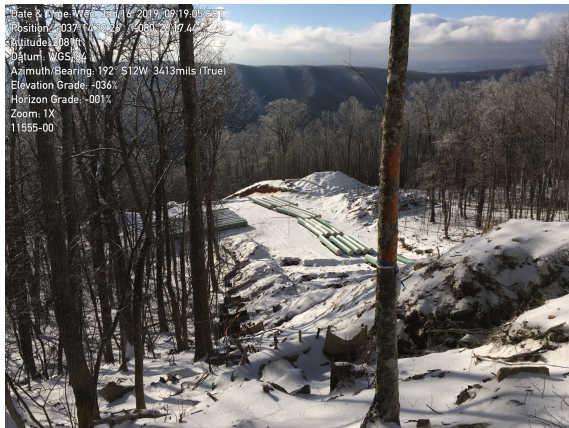
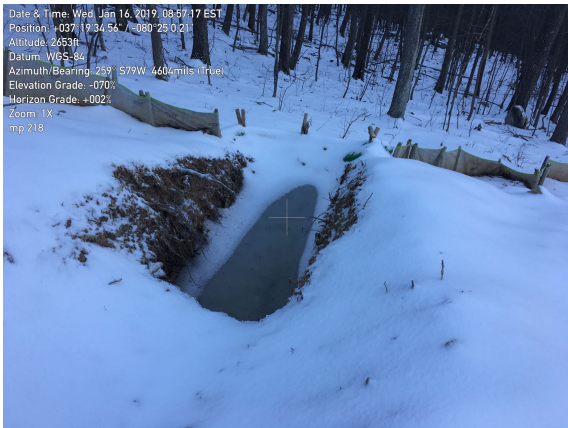
GPS Location	37.2427518340174, -80.429164180607	GPS Location	37.2429364852855, -80.4291289902158		
Description	ROW and ECD conditions @ MP 219	Description	ROW and ECD conditions @ MP 218		
<p>Date & Time: Wed, Jan 16, 2019, 09:19:00 EST Position: +037-19.34.54 / -080-26.9.02 Altitude: 2653ft Datum: WGS-84 Azimuth/Bearing: 192° S12W, 3413mils (True) Elevation Grade: +036% Horizon Grade: +001% Zoom: 1X 11555-00</p>

GPS Location	37.2427614312966, -80.4292608239506	GPS Location	37.2427614312966, -80.4292608239506		
Description	ROW and ECD conditions @ MP 219	Description	ROW and ECD conditions @ MP 218		
<p>Date & Time: Wed, Jan 16, 2019, 09:04:42 EST Position: +037-19.32.30 / -080-26.58.46 Altitude: 2753ft Datum: WGS-84 Azimuth/Bearing: 325° N25W, 5956mils (True) Elevation Grade: +030% Horizon Grade: +002% Zoom: 1X mm</p>

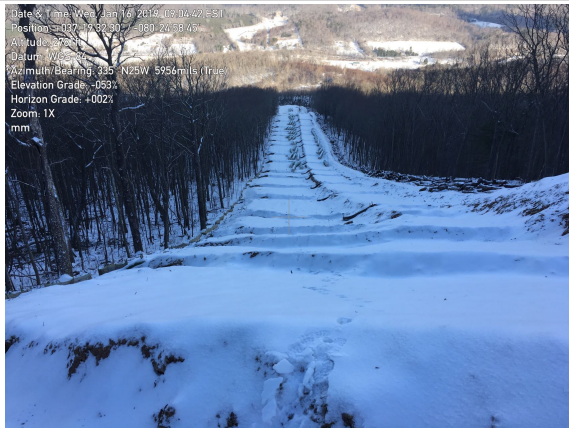
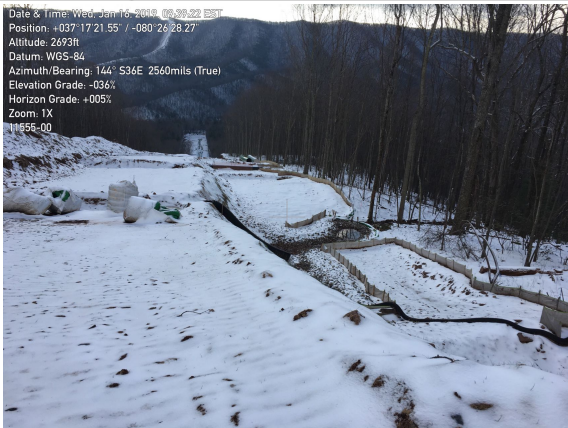
GPS Location	37.2427614312966, -80.4292608239506	GPS Location	37.2427614312966, -80.4292608239506		
Description	ROW and ECD conditions @ MP 218.5	Description	ROW and ECD conditions @ MP 219.5

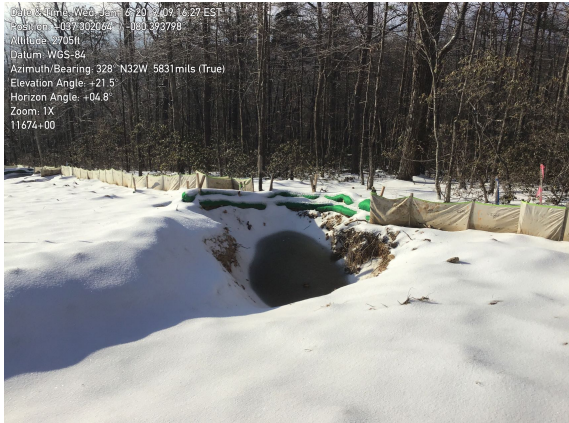
</div></div></div>		<div><div><div>Date & Time: Wed Jan 16 2019 10:09:16 EST Position: +037.302066 / -080.393798 Altitude: 1926ft Datum: WGS-84 Azimuth/Bearing: 328° N32W 5831mils (True) Elevation Angle: +21.5° Horizon Angle: +04.8° Zoom: 1X 11674+00</div><div>

</div></div></div>			
GPS Location	37.1504510636769, -80.4142783925943	GPS Location	37.1502219317075, -80.4142895273081		
Description	See photo for station number and GPS location. Water bars in place.	Description	See photo for station number and GPS location. Sump pit and end treatment in place.		
<div><div><div>Date & Time: Wed Jan 16 2019 09:31:22 EST Position: +037.257811 / -080.368397 Altitude: 2110ft Datum: WGS-84 Azimuth/Bearing: 347° N13W 6169mils (True) Elevation Angle: +20.4° Horizon Angle: +00.5° Zoom: 1X 11687+00 S MN21</div><div>

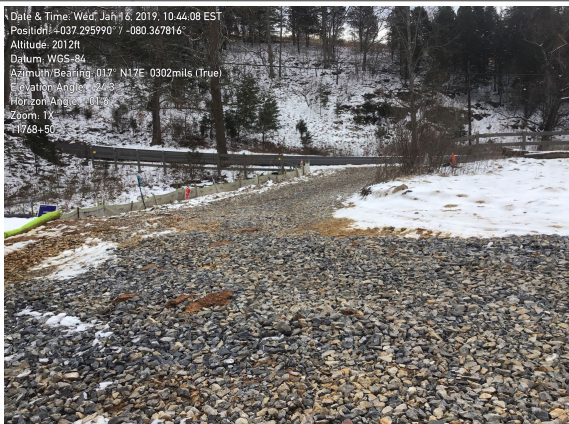
</div></div></div>		<div><div><div>Date & Time: Wed Jan 16 2019 10:44:08 EST Position: +037.295990 / -080.367816 Altitude: 2012ft Datum: WGS-84 Azimuth/Bearing: 017° N17E 0302mils (True) Elevation Angle: +24.5° Horizon Angle: +01.6° Zoom: 1X 11768+00</div><div>

GPS Location	37.1502235175477, -80.4142893456643	GPS Location	37.1502231890159, -80.4142893839066		
Description	See photo for station number and GPS location. Sensitive resource buffer in place.	Description	See photo for station number and GPS location. RCE at main line valve 26 in place.		
<div><div><div>Date & Time: Wed Jan 16 2019 10:50:08 EST Position: +037.296006 / -080.367124 Altitude: 2140ft Datum: WGS-84 Azimuth/Bearing: 026° N26E 0462mils (True) Elevation Angle: +24.1° Horizon Angle: +00.7° Zoom: 1X 11778+00</div><div>

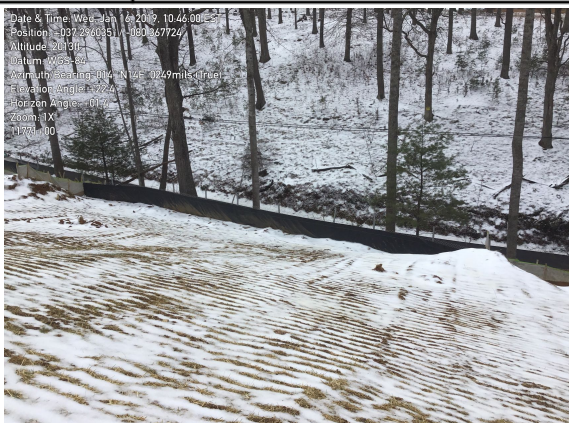
</div></div></div>		<div><div><div>Date & Time: Wed Jan 16 2019 10:46:00 EST Position: +037.296051 / -080.367724 Altitude: 2019ft Datum: WGS-84 Azimuth/Bearing: 017° N17E 0302mils (True) Elevation Angle: +24.5° Horizon Angle: +01.6° Zoom: 1X 11771+00</div><div>

Description	See photo for station number and GPS location. Clean water drain pipe in place.	Description	See photo for station number and GPS location. Reinforced silt fence in place.

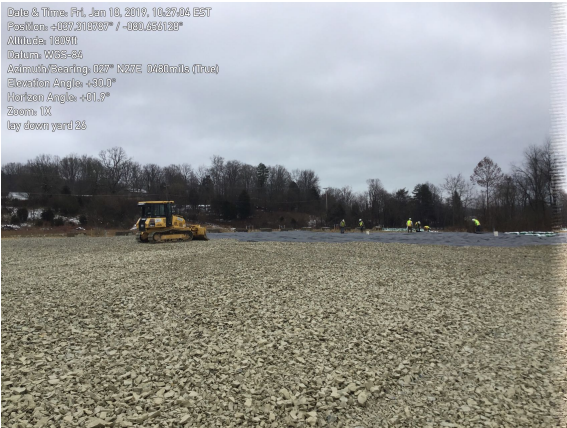
<p>Date & Time: Fri, Jan 18, 2019, 10:27:44 EST Position: +037.300927° / -080.665137° Altitude: 1930ft Datum: WGS-84 Azimuth/Bearing: 027° N27E 0430mils (True) Elevation Angle: +50.0° Horizon Angle: +01.5° Zoom: 1X Key down yard 26</p>			
GPS Location	37.3193796119069, -80.657788720057	GPS Location	37.3193796119069, -80.657788720057		
Description	See photo for station number and GPS location. Rain gauge at Craig's Creek Road.	Description	See photo for station number and GPS location. Environmental crew spreading rock at yard 26.		
<p>Insert image here</p>		<p>Insert image here</p>			
GPS Location		GPS Location			
Description		Description

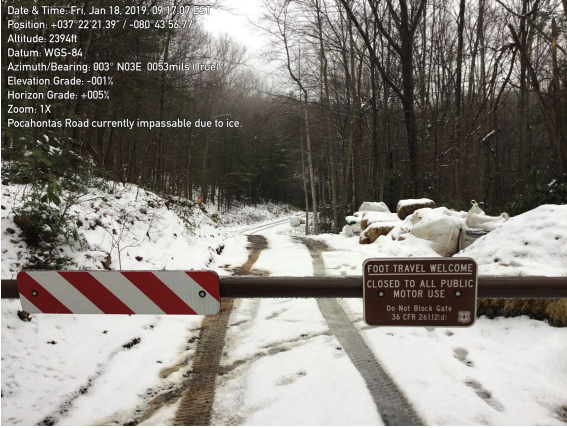
AFE	124300137	Date/Time	1/18/2019 3:12 PM	Report #	13140
Pictures					
<p>Date & Time: Fri, Jan 18, 2019 09:17:07 EST Position: +037°22'21.39" / -080°43'56.7" Altitude: 2394ft Datum: WGS-84 Azimuth/Bearing: 003° N03E 0053mils (True) Elevation Grade: +001% Horizon Grade: +005% Zoom: 1X Pocahontas Road currently impassable due to ice.</p>

GPS Location	37.1331945341426, -80.3945413884524	GPS Location	37.1331945341426, -80.3945413884524		
Description	Correct coordinates on photo. Pocahontas Road frozen beyond the gate.	Description	Correct coordinates on photo. Lower portion of Pocahontas Road is passable. No environmental issues located.

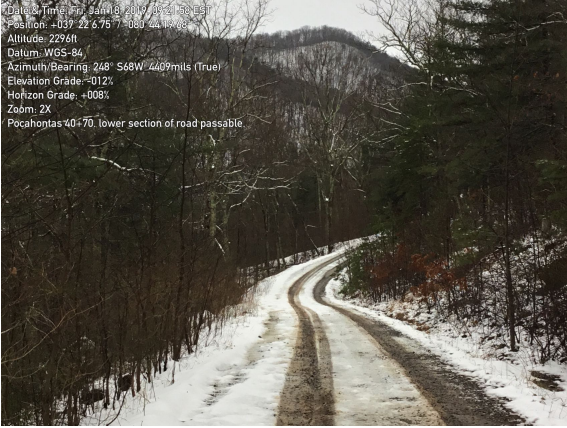
<p>Date & Time: Fri, Jan 18, 2019 09:21:50 EST Position: +037°22'6.75" / -080°44'11.15" Altitude: 2296ft Datum: WGS-84 Azimuth/Bearing: 248° S68W 4409mils (True) Elevation Grade: +012% Horizon Grade: +008% Zoom: 2X Pocahontas +0+70, lower section of road passable.</p>

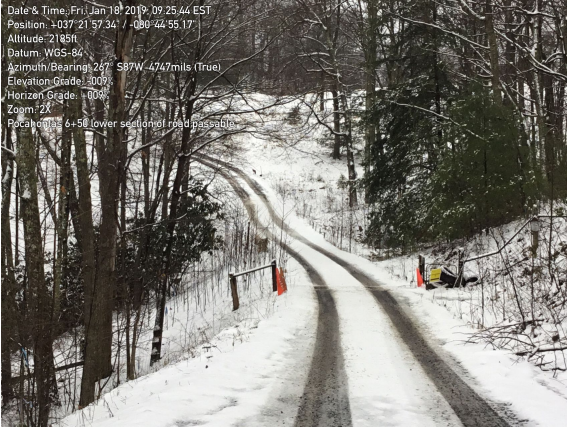
<p>Date & Time: Fri, Jan 18, 2019 09:25:44 EST Position: +037°21'57.34" / -080°44'55.17" Altitude: 2185ft Datum: WGS-84 Azimuth/Bearing: 267° S87W 4747mils (True) Elevation Grade: +007% Horizon Grade: +004% Zoom: 2X Pocahontas +6+50 lower section of road passable.</p>

Insert image here			
GPS Location	37.1330877067867, -80.3946658597145	GPS Location			
Description	Correct coordinates on photo. The lower portion of Pocahontas Road is currently passable. No environmental concerns noted.	Description			
Insert image here		Insert image here			
GPS Location		GPS Location			
Description		Description
