Visual Site Inspection Report

Project Name	H-600 Pipeline Spread G	AFE	124300137	Spread	H-600 Pipeline Spread G
Contractor	Precision			Report #	13409
Inspector	Len Kruizenga			Date/Time	1/28/2019 7:06 AM
Permit #	TBD	Inspection Type	VA SWPP	Station Begin	11670+00
State	WV	Inspection Area	Full	Station End	11788+43
County	Monroe	Ground	Frozen	Temperature (°F)	30.00
Municipality	N/A	Weather	Cloudy	Rain Gauge (in)	0.00
GPS Location	37.2962808050563, -80.3611486405883			Rain Accumulation Time (days)	2.00

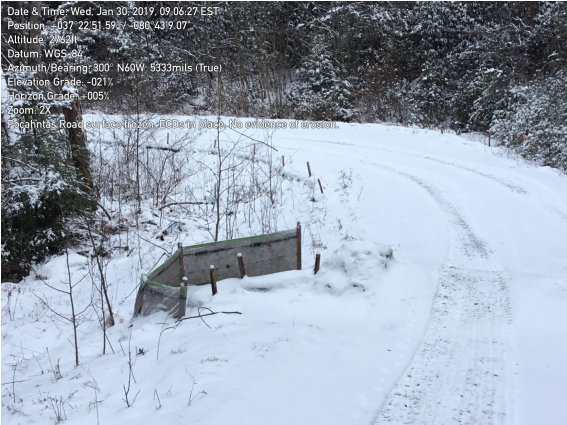
<p>Date & Time: Wed Jan 30, 2019, 09:08:38 EST Position: +037° 22' 36.56" / -080° 43' 27.68" Altitude: 2574ft Datum: WGS-84 Azimuth/Bearing: 209° S29W 3716mils (True) Elevation Grade: +029% Horizon Grade: +004% Zoom: 1X Pocahontas Road surface frozen; ECDs in place. No evidence of erosion.</p>

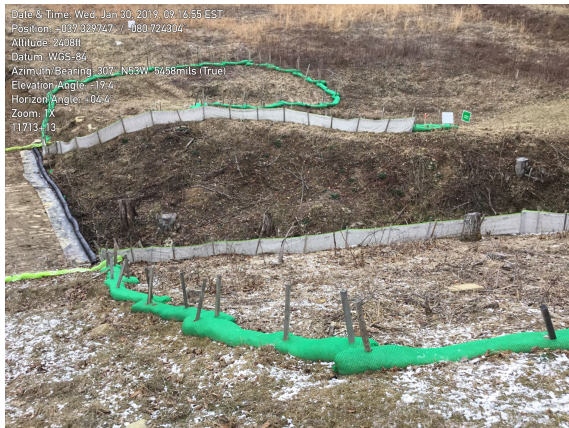
GPS Location	37.2959219757815, -80.3609970119599	GPS Location	37.2959219757815, -80.3609970119599		
Description	10713+13	Description	Stream 10698+00		
<p>Date & Time: Wed, Jan 30, 2019, 09:27:47 EST Position: +037.349118° / -080.652047° Altitude: 2047ft Datum: WGS-84 Azimuth/Bearing: 330° N30W 5867mils (True) Elevation Angle: -14.7° Horizon Angle: -02.0° Zoom: 1X 10698+00</p>

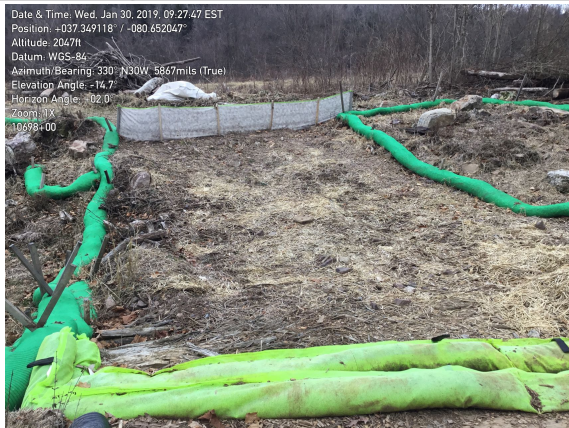
GPS Location	37.2958808206369, -80.36097882323	GPS Location	37.2957781004135, -80.3610942420366		
Description	ECDs in good condition 10698+00	Description	RCE 10698+00

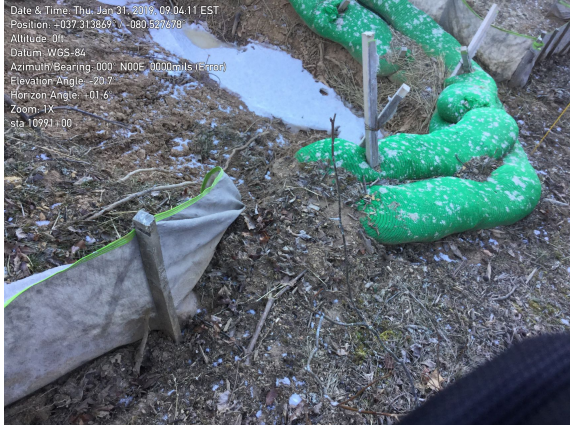
<p>Date & Time: Thu, Jan 31, 2019, 09:04:11 EST Position: +037.313667° / -080.527778° Altitude: 0ft Datum: WGS-84 Azimuth/Bearing: 000° N00E 3000mils (True) Elevation Angle: +00.7° Horizon Angle: +01.6° Zoom: 1X Sta#10991+00</p>		GPS Location 37.3023158353744, -80.5344555321273 Description Sta#11015+00- Stream S-RR5,	
  <p>Date & Time: Thu, Jan 31, 2019, 09:08:52 EST Position: +037.312920° / -080.451349° Altitude: 0ft Datum: WGS-84 Azimuth/Bearing: 296° N64W 5262mils (True) Elevation Angle: -09.3° Horizon Angle: +00.6° Zoom: 1X Sta#10986+00- Stream crossing</p>

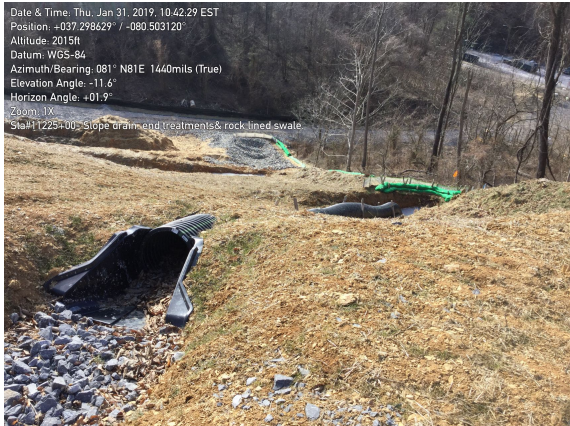
<p>Date & Time: Thu, Jan 31, 2019, 10:42:29 EST Position: +037.298629° / -080.503120° Altitude: 2015ft Datum: WGS-84 Azimuth/Bearing: 081° N81E 1440mils (True) Elevation Angle: -11.6° Horizon Angle: +01.9° Zoom: 1X Sta#11225+00- Slope drain end treatments & rock lined swale</p>		GPS Location 37.3023158353744, -80.5344555321273 Description Sta#10986+00- Stream crossing, buffer & ECD's.

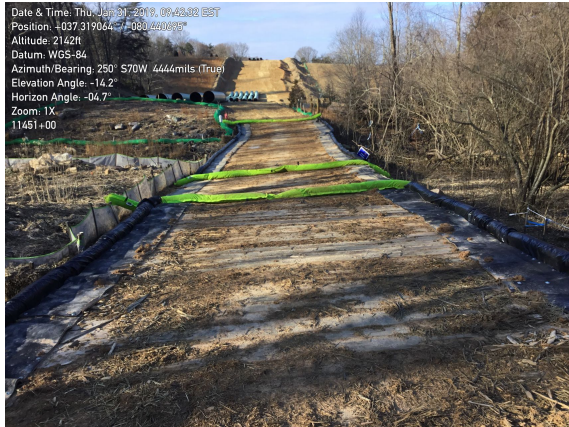
GPS Location	37.2961240634669, -80.3675113432858	GPS Location	37.2961189924155, -80.3675004468116		
Description	Plunge pool in good condition 11372+00	Description	11451+00 ECDs in good condition		
<p>Date & Time: Thu, Jan 31, 2019, 10:34:55 EST Position: +037.3076201, -80.3676730 Altitude: 1948ft Datum: WGS-84 Azimuth/Bearing: 151° S29E 2684mils (True) Elevation Angle: -12.2° Horizon Angle: -01.5° Zoom: 1X 11360+00</p>

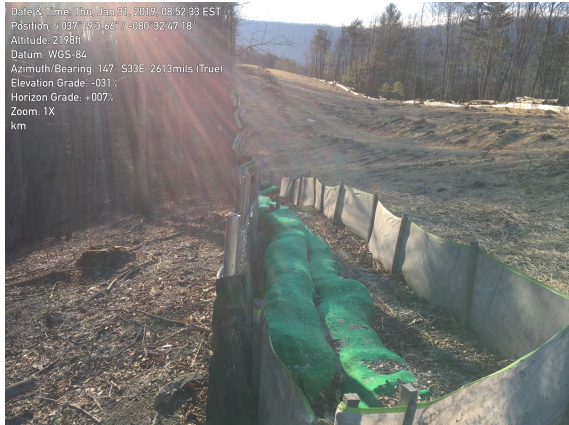
GPS Location	37.2968711787835, -80.3603824725278	GPS Location	37.2968711787835, -80.3603824725278		
Description	3 sets of ECD's for KARST feature @ Mp 209.5	Description	Row conditions and ECD's @ MP 208		
<p>Date & Time: Thu, Jan 31, 2019, 09:57:09 EST Position: +037°18'57.10" / -080°31'42.41" Altitude: 2094ft Datum: WGS-84 Azimuth/Bearing: 294° N64W 5227mils (True) Elevation Grade: -016% Horizon Grade: -003% Zoom: 1X 11119-00</p>

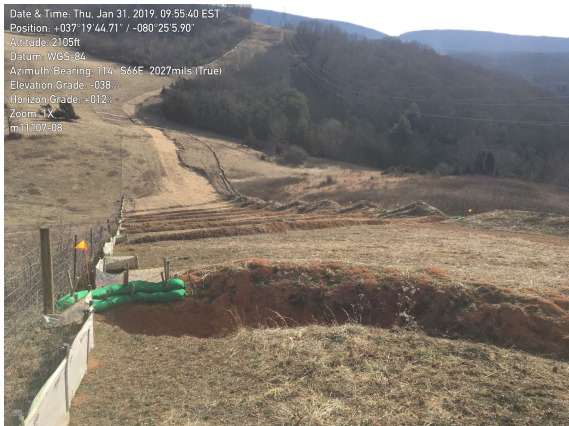
GPS Location	37.2959694173534, -80.36096666694704	GPS Location	37.2959694173534, -80.36096666694704		
Description	Broken P1 ECD @ 11119+00	Description	ROW conditions and ECD's @ MP 209		
<p>Date & Time: Thu, Jan 31, 2019, 12:20:05 EST Position: +037°17'50.88" / -080°28'30.82" Altitude: 2254ft Datum: WGS-84 Azimuth/Bearing: 316° N64W 5618mils (True) Elevation Grade: +051% Horizon Grade: +006% Zoom: 1X 11310-49</p>

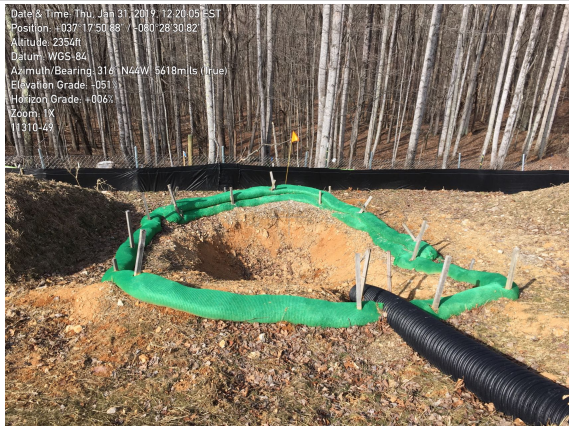
GPS Location	37.2959694173534, -80.36096666694704	GPS Location	37.2959694173534, -80.36096666694704		
Description	End treatment @ 11310+49	Description	ROW conditions and ECD's @ MP 214
