# Visual Site Inspection Report

<b>Project Name</b>	H-600 Pipeline Spread H	<b>AFE</b>	124300138	<b>Spread</b>	H-600 Pipeline Spread H
<b>Contractor</b>	Precision			<b>Report #</b>	11390
<b>Inspector</b>	Dawn McCullough			<b>Date/Time</b>	11/26/2018 9:52 PM
<b>Permit #</b>	TBD	<b>Inspection Type</b>	VA SWPP	<b>Station Begin</b>	13188+66
<b>State</b>	VA	<b>Inspection Area</b>	Partial	<b>Station End</b>	13315+79
<b>County</b>	Franklin	<b>Ground</b>	Damp	<b>Temperature (°F)</b>	60.00
<b>Municipality</b>	N/A	<b>Weather</b>	Sunny	<b>Rain Gauge (in)</b>	1.00
<b>GPS Location</b>	37.3255697731276, -80.0288225245476			<b>Rain Accumulation Time (days)</b>	1.00

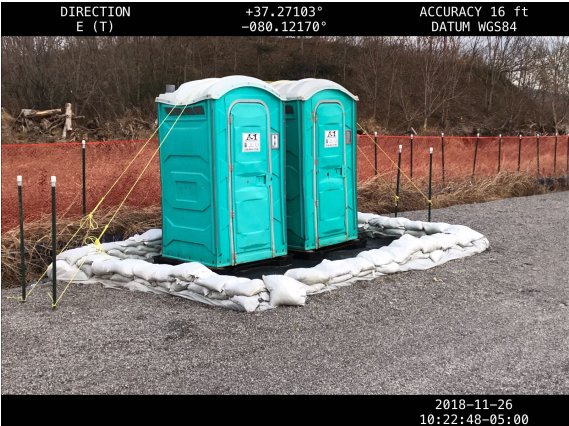
2018-11-26 10:21:16-05:00		<b>GPS Location</b> 37.0930804638538, -80.0252651610226  <b>Description</b> MVP-LY-049_112618 RCE in good condition. Looking S. See photo for gps data.	
DIRECTION E (T)      +37.27103° -080.12170°      ACCURACY 16 ft DATUM WGS84

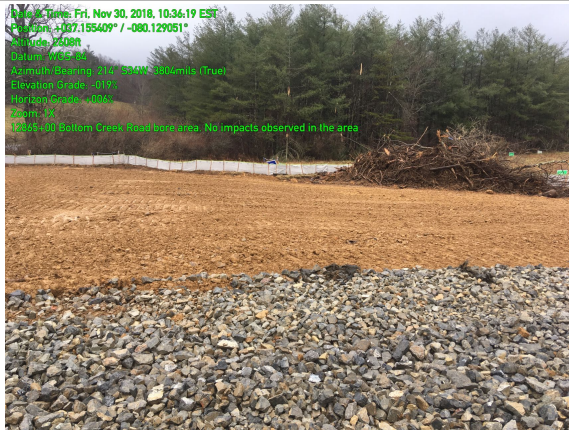
A/E	124300138	Date/Time	11/30/2018 2:21 PM	Report #	11564
Pictures					
<p>Date &amp; Time: Fri, Nov 30, 2018, 10:34:19 EST Position: +037.155409° / -080.129051° Altitude: 2708ft Datum: WGS-84 Azimuth/Bearing: 214° S 204W 380mils (True) Elevation Grade: -0.19% Horizon Grade: +0.05% Zoom: 1X 1243761014539, -80.1145702321828 no impacts observed in the area</p>

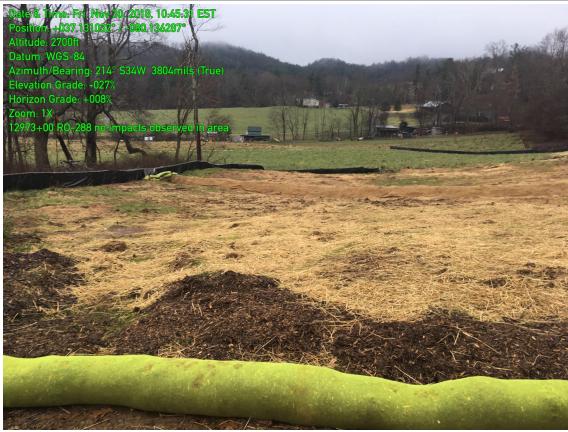
<p>Date &amp; Time: Fri, Nov 30, 2018, 10:45:31 EST Position: +037.151003° / -080.134287° Altitude: 2708ft Datum: WGS-84 Azimuth/Bearing: 214° S 204W 380mils (True) Elevation Grade: +0.27% Horizon Grade: +0.08% Zoom: 1X 1243761014539, -80.1145702321828 no impacts observed in the area</p>

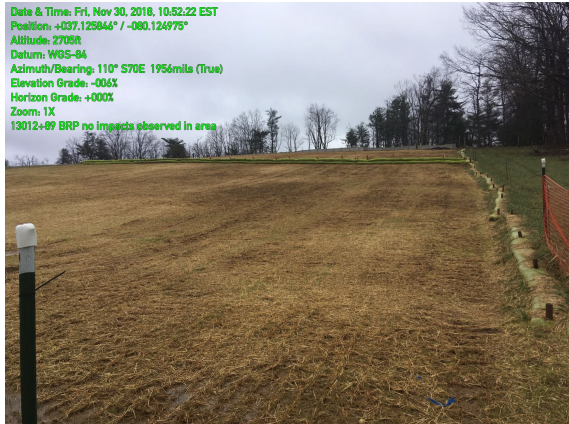
<p>Date &amp; Time: Fri, Nov 30, 2018, 10:52:22 EST Position: +037.125846° / -080.124975° Altitude: 2705ft Datum: WGS-84 Azimuth/Bearing: 110° S 70E 195mils (True) Elevation Grade: -0.06% Horizon Grade: +0.00% Zoom: 1X 13012+BY BRP no impacts observed in the area</p>

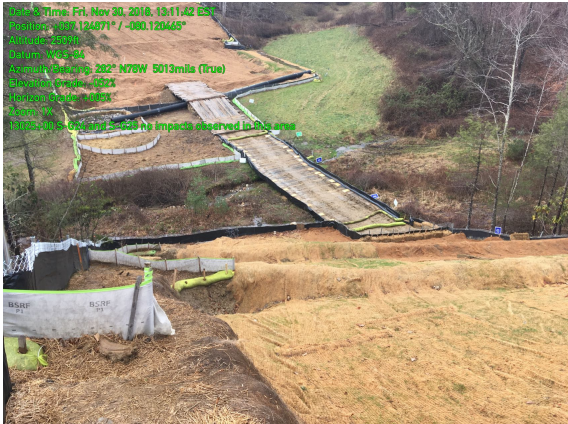
<p>Date &amp; Time: Fri, Nov 30, 2018, 13:11:42 EST Position: +037.124871° / -080.120465° Altitude: 2705ft Datum: WGS-84 Azimuth/Bearing: 282° N 78W 501mils (True) Elevation Grade: -0.02% Horizon Grade: +0.00% Zoom: 1X 13025+G24, -80.1145268139244 no impacts observed in the area</p>

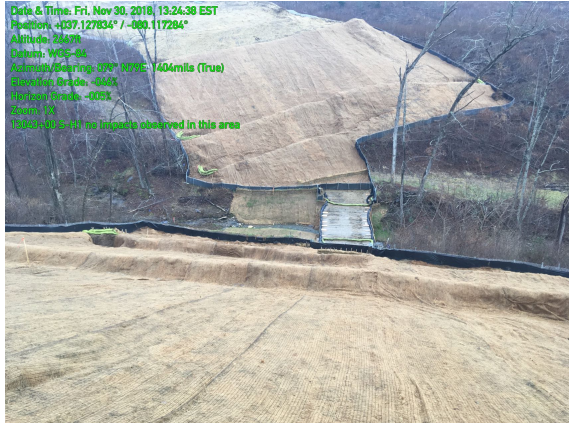
GPS Location	37.1245153667751, -80.1145268139244	GPS Location	37.1245153667751, -80.1145268139244		
Description	No impacts observed in the BRP area. Silt sock berms and perimeter is still in good condition.	Description	S-G24 and S-G25 no issues observed. Area was recently cleaned up and many ECD's were replaced.		
<p>Date &amp; Time: Fri, Nov 30, 2018, 13:24:38 EST Position: +037.127834° / -080.117284° Altitude: 2657ft Datum: WGS-84 Azimuth/Bearing: 070° N 75E 140mils (True) Elevation Grade: -0.04% Horizon Grade: -0.02% Zoom: 1X 13062+G24, -80.1145268139244 no impacts observed in this area</p>

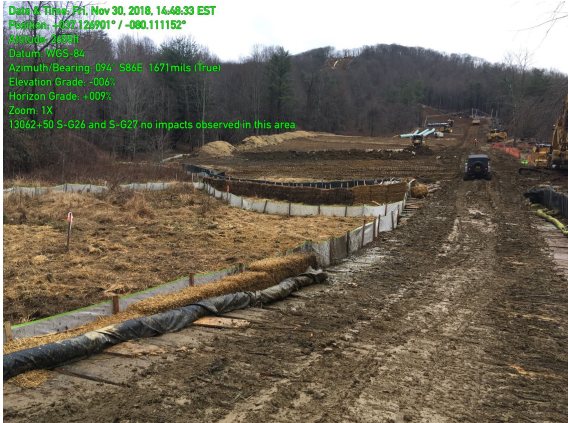
<p>Date &amp; Time: Fri, Nov 30, 2018, 14:48:33 EST Position: +037.126901° / -080.111152° Altitude: 2657ft Datum: WGS-84 Azimuth/Bearing: 090° S 88E 167mils (True) Elevation Grade: -0.06% Horizon Grade: +0.09% Zoom: 1X 13062+G24, -80.1145268139244 no impacts observed in this area</p>

GPS Location	37.1245682565841, -80.1145209465922	GPS Location	37.1245682565841, -80.1145209465922		
Description	S-H1 no impacts observed. Both slopes above stream have been seeded, EarthGaurd applied and curlexed.	Description	Clean up crew was working in the area. No impacts observed.

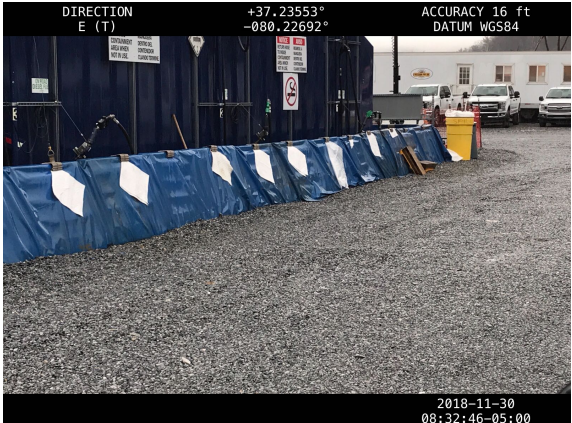
<p>DIRECTION E (T)      +37.23553° -080.22692°      ACCURACY 16 ft DATUM WGS84</p> <p>2018-11-30 08:32:46-05:00</p>

<p>DIRECTION NW (T)      +37.23561° -080.22661°      ACCURACY 16 ft DATUM WGS84</p> <p>2018-11-30 08:33:05-05:00</p>		
GPS Location	37.2356883623053, -80.2296367474648		GPS Location	37.2356883623053, -80.2296367474648	
Description	MVP-PY-006_113018 no fluid deposits on the south side of the bulk fuel tanks. Looking E. See photo for gps data.		Description	MVP-PY-006_113018 containment under light plant. Looking NW. See photo for gps data.

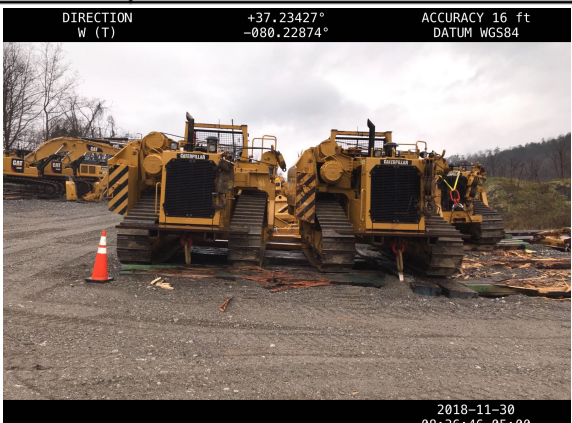
<p>DIRECTION W (T)      +37.23427° -080.22874°      ACCURACY 16 ft DATUM WGS84</p> <p>2018-11-30 08:36:46-05:00</p>			  <p>DIRECTION NW (T)      +37.23550° -080.22638°      ACCURACY 16 ft DATUM WGS84</p> <p>2018-11-30 08:34:24-05:00</p>		
GPS Location	37.2356806090448, -80.2296222467723		GPS Location	37.2356806090448, -80.2296222467723	
Description	MVP-PY-006_113018 no fluid deposits around the parked equipment. Looking W. See photo for gps data.		Description	MVP-PY-006_113018 containment under light plant and supplies. Looking NW. See photo for gps data.
