Visual Site Inspection Report

Project Name	H-600 Pipeline Spread H	AFE	124300138	Spread	H-600 Pipeline Spread H
Contractor	Precision			Report #	11972
Inspector	Glenn Mike Renfro			Date/Time	12/11/2018 10:48 AM
Permit #	TBD	Inspection Type	VA SWPP	Station Begin	13415+00
State	VA	Inspection Area	Full	Station End	13670+00
County	Franklin	Ground	Frozen	Temperature (°F)	31.00
Municipality	N/A	Weather	Sunny	Rain Gauge (in)	0.10
GPS Location	36.9718772713661, -79.8700529687872			Rain Accumulation Time (days)	6.00

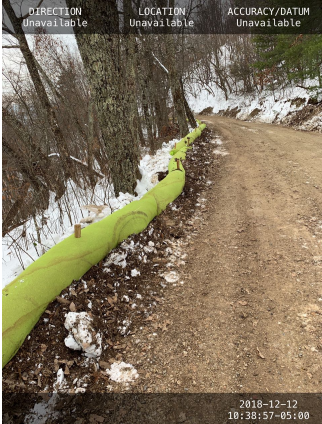
2018-12-12 10:38:57-05:00			
GPS Location	37.3314675470071, -79.9582891475454	GPS Location	37.3314330688824, -79.9583009083648		
Description	MVP-MN-276.03_121218 New CFS along the road side. Looking NE. See picture for GPS data.	Description	MVP-MN-276.03_121218 New CFS along the road side.

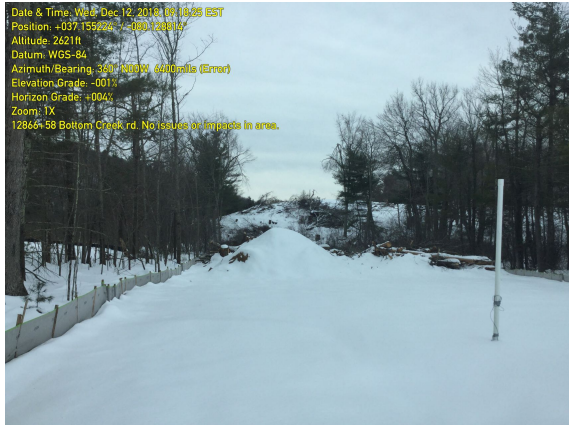
A/E	124300138	Date/Time	12/12/2018 9:14 AM	Report #	12011
Pictures					
<p>Date & Time: Wed Dec 12, 2018, 09:08:58 EST Position: +037.155022° / -080.128940° Altitude: 2621ft Datum: WGS-84 Azimuth/Bearing: 309° 503W 4498mils (Error) Elevation Grade: -001% Horizon Grade: +004% Zoom: 1X 12866+58 Bottom Creek rd. No issues or impacts in areas.</p>

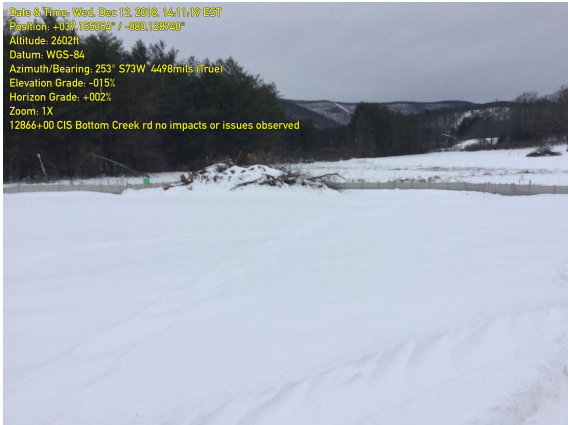
<p>Date & Time: Wed, Dec 12, 2018, 14:11:19 EST Position: +037.185054° / -080.138940° Altitude: 2602ft Datum: WGS-84 Azimuth/Bearing: 253° 573W 4498mils (True) Elevation Grade: -015% Horizon Grade: +002% Zoom: 1X 12866+00 CIS Bottom Creek rd no impacts or issues observed</p>

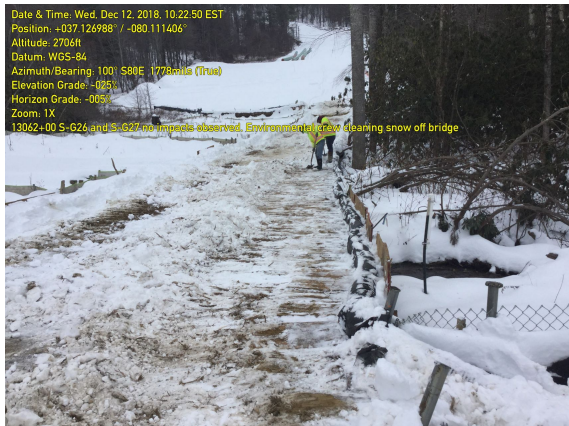
<p>Date & Time: Wed Dec 12, 2018, 10:22:50 EST Position: +037.126988° / -080.111406° Altitude: 2704ft Datum: WGS-84 Azimuth/Bearing: 100° 580E 1778mils (True) Elevation Grade: -025% Horizon Grade: -005% Zoom: 1X 13062+00 S-G26 and S-G27 no impacts observed. Environmental crew cleaning snow off bridge</p>

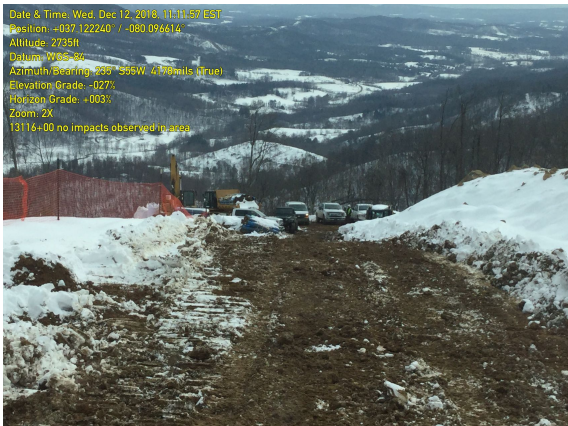
<p>Date & Time: Wed Dec 12, 2018, 11:11:57 EST Position: +037.122240° / -080.096616° Altitude: 2735ft Datum: WGS-84 Azimuth/Bearing: 230° 306W 4718mils (True) Elevation Grade: -027% Horizon Grade: +003% Zoom: 2X 13116+00 no impacts observed in areas</p>

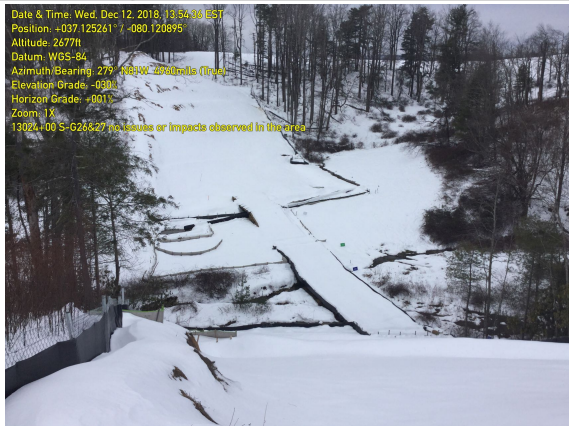
GPS Location	37.1264744690034, -80.1120120753349		GPS Location	37.1254145773473, -80.1209600922466	
Description	The environmental crew cleaned off the mat bridges and insured the plywood was over all of the holes.		Description	The cleanup crew was working from 13096+00 to 13116+00.	
<p>Date & Time: Wed Dec 12, 2018, 13:54:16 EST Position: +037.125261° / -080.120895° Altitude: 2677ft Datum: WGS-84 Azimuth/Bearing: 279° 484W 4550mils (True) Elevation Grade: -03% Horizon Grade: -001% Zoom: 1X 13024+00 S-G26&27 no issues or impacts observed in areas</p>

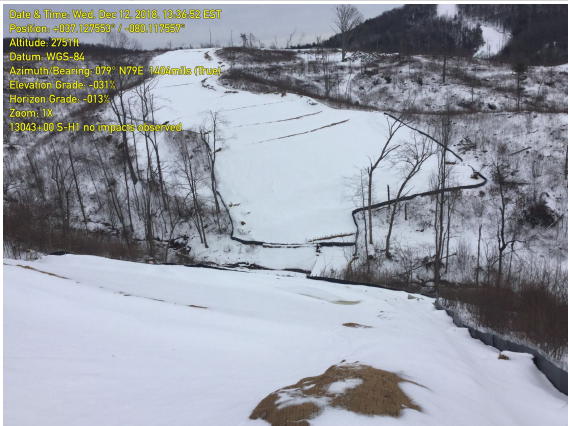
<p>Date & Time: Wed Dec 12, 2018, 13:56:23 EST Position: +037.127553° / -080.117553° Altitude: 2751ft Datum: WGS-84 Azimuth/Bearing: 270° N79E 1404mils (True) Elevation Grade: -031% Horizon Grade: -013% Zoom: 1X 13043+00 S-H1 no impacts observed</p>

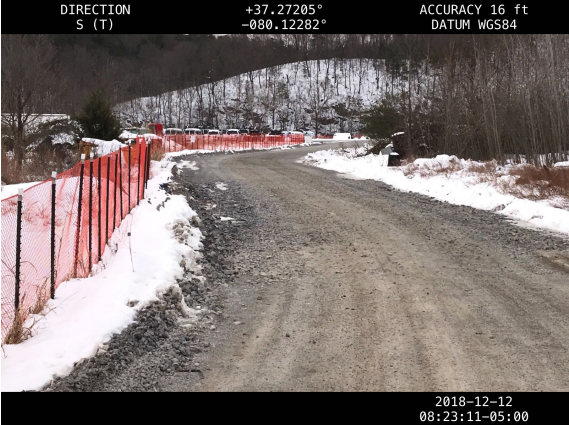
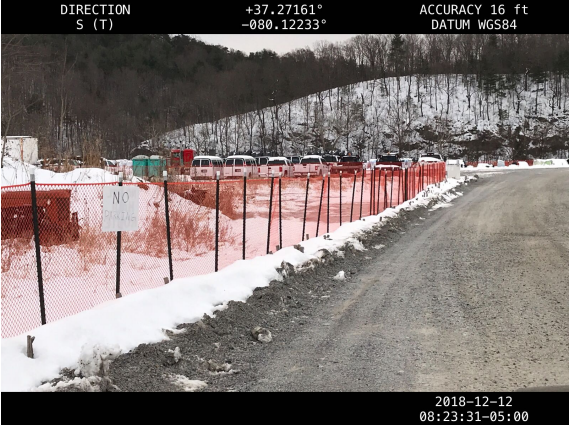
2018-12-12 08:23:31-05:00			
GPS Location	37.2356411721904, -80.2295862884077	GPS Location	37.2356411721904, -80.2295862884077		
Description	MVP-LY-049_121218 condition of rock entrance. Looking S. See photo for gps data.	Description	MVP-LY-049_121218 condition of safety fence and compost filter shock along driveway. Looking S. See photo for gps data.		
DIRECTION NE (T) +37.27151° ACCURACY 16 ft -080.12049° DATUM WGS84

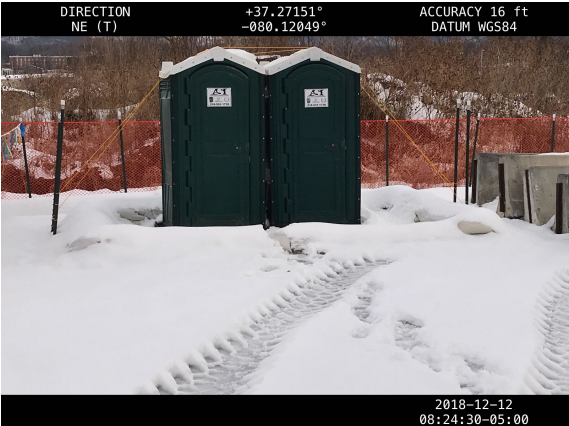
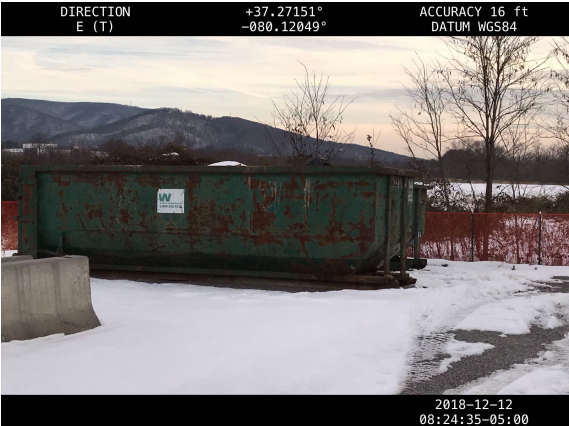
2018-12-12 08:24:35-05:00			
GPS Location	37.2356338380251, -80.2296048962327	GPS Location	37.2709148191263, -80.1238510106505		
Description	MVP-LY-049_121218 condition of containment under porta toilets. Looking NE. See photo for gps data.	Description	MVP-LY-049_121218 dumpster area clean and free of loose trash. Looking E. See photo for gps data.

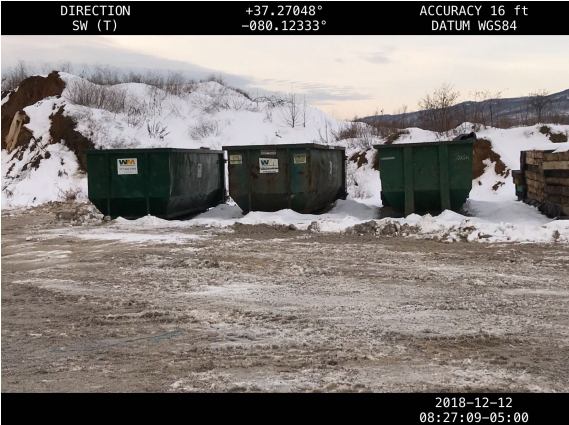
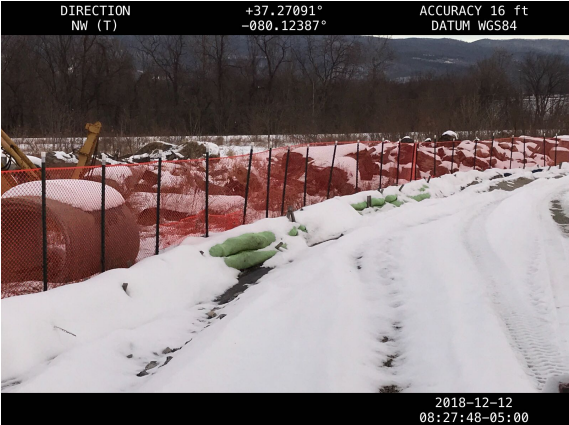
2018-12-12 08:27:48-05:00			
GPS Location	37.2709148610358, -80.1238512621076	GPS Location	37.2709148610358, -80.1238512621076		
Description	MVP-LY-049_121218 dumpster area clean and free of loose trash. Looking SW. See photo for gps data.	Description	MVP-LY-049_121218 condition of compost filter sock and safety fence along north drive. Looking NW. See photo for gps data.
