Visual Site Inspection Report

Project Name	H-600 Pipeline Spread H	AFE	124300138	Spread	H-600 Pipeline Spread H
Contractor	Precision			Report #	12294
Inspector	Dustin Lyons			Date/Time	12/18/2018 3:21 PM
Permit #	TBD	Inspection Type	VA SWPP	Station Begin	12005+00
State	VA	Inspection Area	Partial	Station End	12372+00
County	Montgomery	Ground	Damp	Temperature (°F)	45.00
Municipality	N/A	Weather	Sunny	Rain Gauge (in)	0.00
GPS Location	37.0698564829035, -80.6152265500649			Rain Accumulation Time (days)	1.00

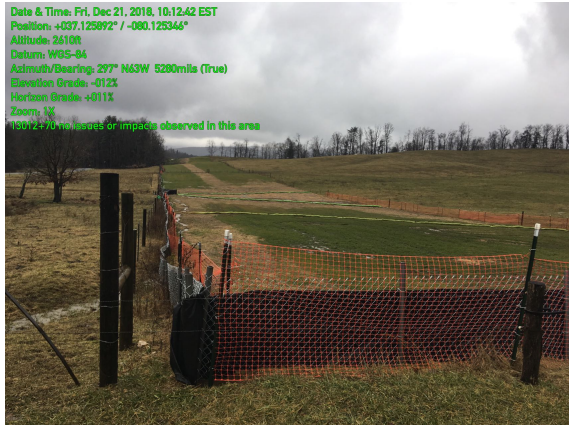
A/E	124300138	Date/Time	12/21/2018 6:13 PM	Report #	12422
Pictures					
<p>Date & Time: Fri, Dec 21, 2018, 10:12:42 EST Position: +037.125892° / -080.125344° Altitude: 2610ft Datum: WGS-84 Azimuth/Bearing: 297° N43W 5280mils (True) Elevation Grade: -012% Horizon Grade: +011% Zoom: 1X 13073+00 no impacts or impacts observed in this area</p>

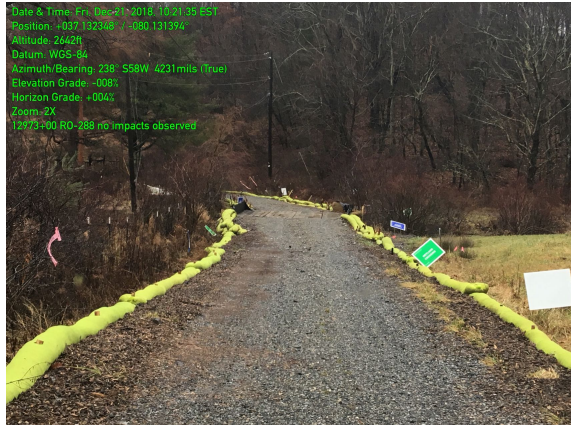
<p>Date & Time: Fri, Dec 21, 2018, 10:21:39 EST Position: +037.132308° / -080.131392° Altitude: 2642ft Datum: WGS-84 Azimuth/Bearing: 238° S58W 4231mils (True) Elevation Grade: -00% Horizon Grade: +004% Zoom: 2X 13073+00 RO-288 no impacts observed</p>

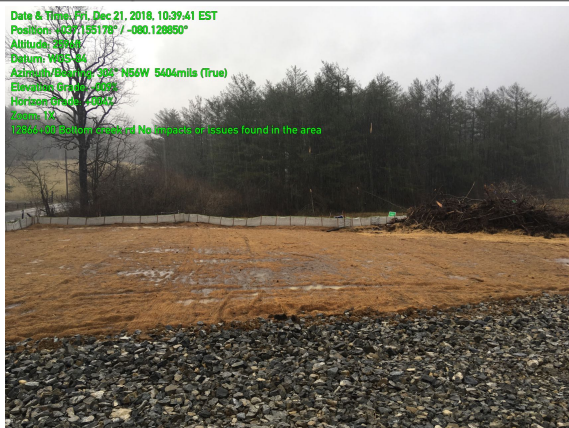
GPS Location	37.2938006418173, -80.0227343291789	GPS Location	37.2939132945959, -80.0227414537966		
Description	No impacts or deficiencies found in this area.	Description	No impacts or issues were found along access road or the ROW.		
<p>Date & Time: Fri, Dec 21, 2018, 10:39:41 EST Position: +037.155178° / -080.128850° Altitude: 2774ft Datum: WGS-84 Azimuth/Bearing: 308° N56W 5404mils (True) Elevation Grade: -00% Horizon Grade: +004% Zoom: 1X 13084+00 no impacts or issues found in the area</p>

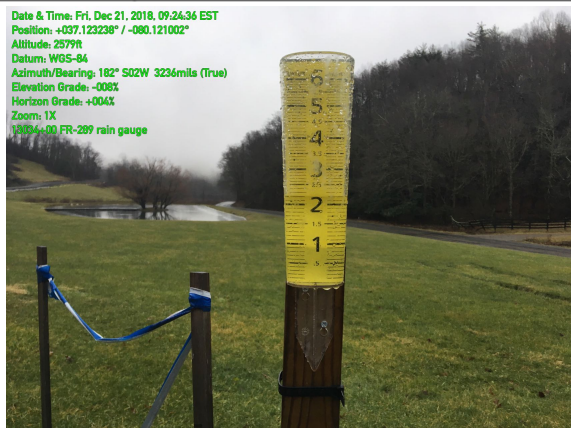
<p>Date & Time: Fri, Dec 21, 2018, 09:24:34 EST Position: +037.123239° / -080.121002° Altitude: 2579ft Datum: WGS-84 Azimuth/Bearing: 182° S02W 3236mils (True) Elevation Grade: -008% Horizon Grade: +004% Zoom: 1X 13094+00 FR-289 rain gauge</p>

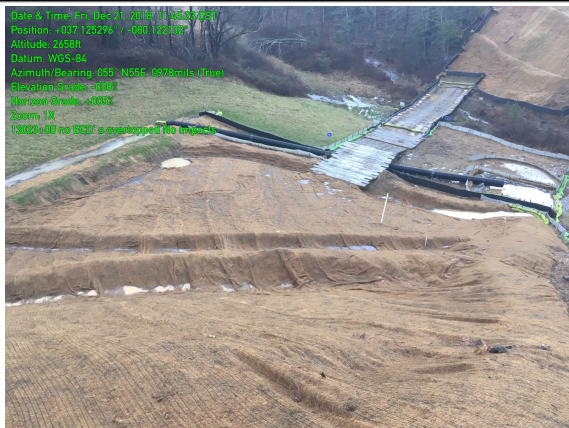
GPS Location	37.2937614983295, -80.0228614826501	GPS Location	37.293743016233, -80.0227610674501		
Description	All ECD's were in place and in good condition. No impacts found.	Description	2.25" of rainfall total at FR-289		
<p>Date & Time: Fri, Dec 21, 2018, 11:45:07 EST Position: +037.125295° / -080.125120° Altitude: 2658ft Datum: WGS-84 Azimuth/Bearing: 88° N88E 5978mils (True) Elevation Grade: +00% Horizon Grade: +00% Zoom: 1X 13023+00 no ECD's overlapped No impacts</p>

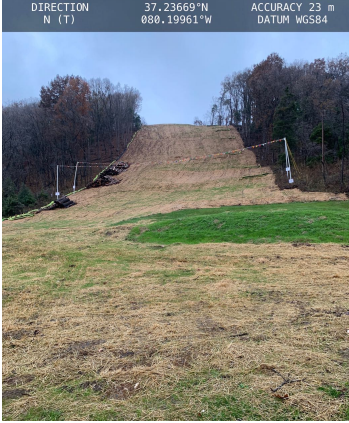
GPS Location	37.3311727244712, -79.9583697866751	GPS Location	37.3311468647995, -79.9584236443556		
Description	12420+00_122218 Stabilized hillside. Looking N. See picture for GPS data.	Description	12291+64_122218 Drainage feature. Looking S. See picture for GPS data.

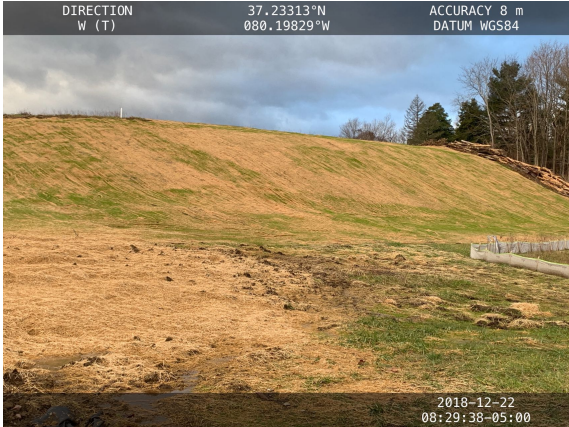
<div>2018-12-22 08:29:36-05:00</div>			
GPS Location	37.3314625195661, -79.9580908682698	GPS Location	37.3314234468771, -79.958062858935		
Description	12437+70_12218 Stabilized hill side. Looking W. See picture for GPS data.	Description	12437+70_122218 Mat road with CFS crossing it for protection. Looking SW. See picture for GPS data. See

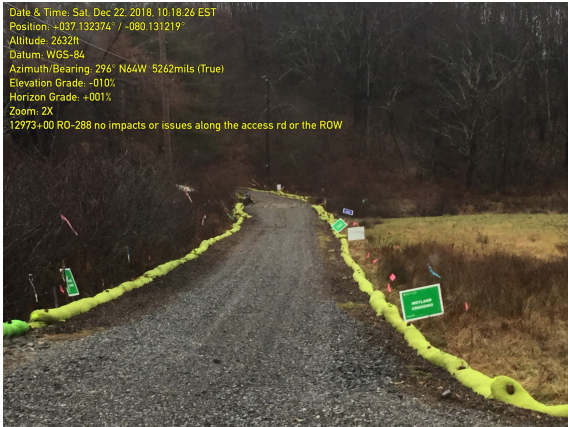
<p>Date & Time: Sat, Dec 22, 2018, 10:18:26 EST Position: +037.132374° / +080.131219° Altitude: 2632ft Datum: WGS-84 Azimuth/Bearing: 295° N64W 5262mils (True) Elevation Grade: -010% Horizon Grade: +001% Zoom: 2X 12973+00 RO-288 no impacts or issues along the access rd or the ROW</p>

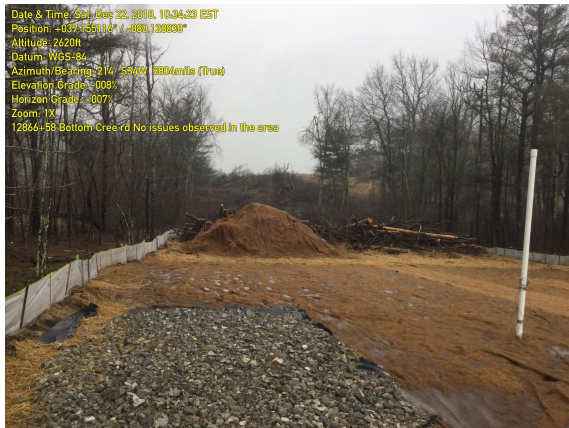
GPS Location	37.2356082313109, -80.2296023816617		GPS Location	37.2356082313109, -80.2296023816617	
Description	No impacts observed in the area.		Description	No impacts observed in the area.	
<p>Date & Time: Sat, Dec 22, 2018, 10:34:23 EST Position: +037.125139° / +080.128638° Altitude: 2620ft Datum: WGS-84 Azimuth/Bearing: 327° N33W 5813mils (True) Elevation Grade: -042% Horizon Grade: +007% Zoom: 1X 12866+58 Bottom Creek rd No issues observed in the area</p>

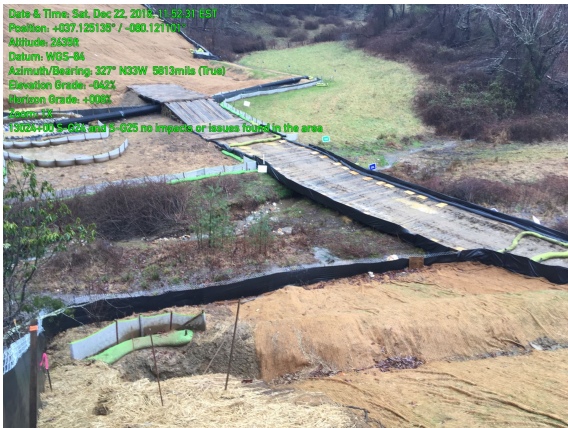
<p>Date & Time: Sat, Dec 22, 2018, 11:01:01 EST Position: +037.125139° / +080.121115° Altitude: 2635ft Datum: WGS-84 Azimuth/Bearing: 327° N33W 5813mils (True) Elevation Grade: -042% Horizon Grade: +005% Zoom: 1X 13024+00 S-026 and S-025 no impacts or issues found in the area</p>

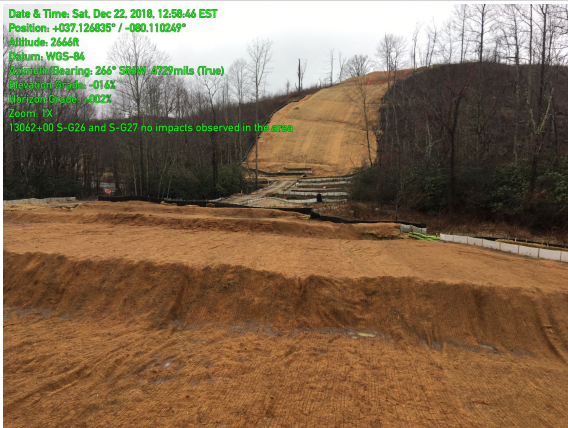
<p>Date & Time: Sat, Dec 22, 2018, 12:58:46 EST Position: +037.126835° / +080.110249° Altitude: 2666ft Datum: WGS-84 Azimuth/Bearing: 266° S84W 4729mils (True) Elevation Grade: -016% Horizon Grade: +002% Zoom: 1X 13062+00 S-026 and S-027 no impacts observed in the area</p>

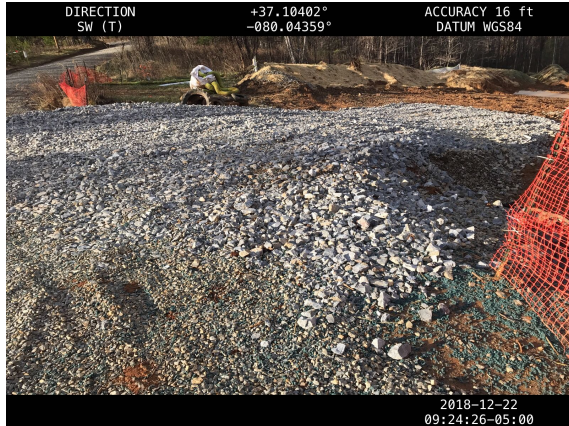
<p>DIRECTION SW (T) +37.10402° -080.04359° ACCURACY 16 ft DATUM WGS84</p> <p>2018-12-22 09:24:26-05:00</p>		GPS Location 37.1042063506666, -80.0434906036407 Description 13342+67_122218 Webster's Corner Road east rock approach. Looking E. See photo for gps data.	
  <p>DIRECTION S (T) +37.10401° -080.04307° ACCURACY 16 ft DATUM WGS84</p> <p>2018-12-22 09:26:38-05:00</p>

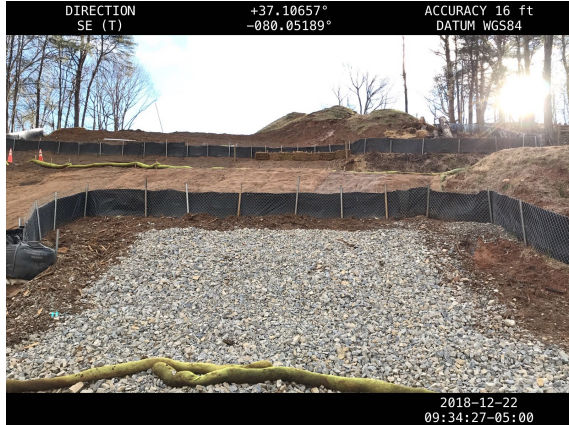
<p>DIRECTION SE (T) +37.10657° -080.05189° ACCURACY 16 ft DATUM WGS84</p> <p>2018-12-22 09:34:27-05:00</p>		GPS Location 37.1042063506666, -80.0434906036407 Description 13342+67_122218 Webster's Corner Road west rock approach. Looking SW. See photo for gps data.
