Visual Site Inspection Report

Project Name	H-600 Pipeline Spread H	AFE	124300138	Spread	H-600 Pipeline Spread H
Contractor	Precision			Report #	12597
Inspector	Glenn Mike Renfro			Date/Time	1/3/2019 2:11 PM
Permit #	TBD	Inspection Type	VA SWPP	Station Begin	13415+00
State	VA	Inspection Area	Full	Station End	13670+00
County	Franklin	Ground	Wet	Temperature (°F)	54.00
Municipality	N/A	Weather	Light Rain	Rain Gauge (in)	2.25
GPS Location	36.9720863923775, -79.8699340783803			Rain Accumulation Time (days)	6.00

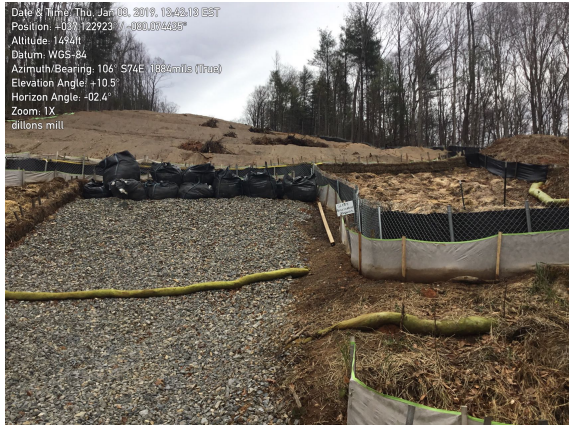
A/E	124300138	Date/Time	1/3/2019 7:12 PM	Report #	12625
Pictures					
<div><p>Date & Time: Thu Jan 03, 2019, 13:45:19 EST Position: +037.122923 / -80.028777 Altitude: 1430ft Datum: WGS-84 Azimuth/Bearing: 106.574E 103mils (True) Elevation Angle: +10.5 Horizon Angle: -02.4 Zoom: 1X dillon's mill</p>

</div>			
GPS Location	37.3255840358799, -80.0287658111423		GPS Location	37.3256123862697, -80.0287829314666	
Description	Please see photo for coordinates. Dillon's Mill Road crossing, no environmental issues observed.		Description	Please see photo for coordinates. Sta. No. 13244+00, ROW uniformly covered in earth guard.	
<div><p>Date & Time: Thu Jan 03, 2019, 11:05:16 EST Position: +037.115977 / -80.028391 Altitude: 1290ft Datum: WGS-84 Azimuth/Bearing: 238.558W 423mils (True) Elevation Angle: -04.3 Horizon Angle: +01.0 Zoom: 1X 13252+00</p>

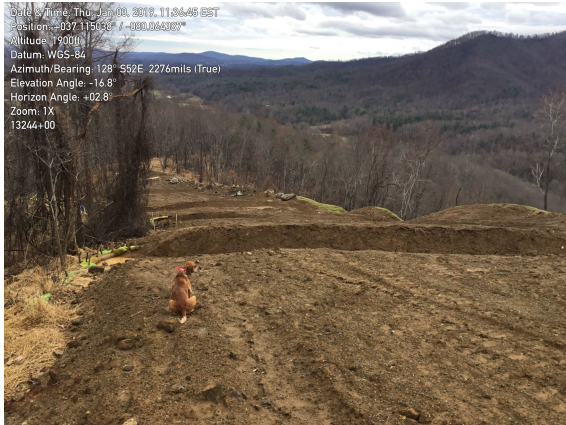
</div>		<div><p>Date & Time: Thu Jan 03, 2019, 11:54:45 EST Position: +037.115961 / -80.028400 Altitude: 1300ft Datum: WGS-84 Azimuth/Bearing: 128.552E 227mils (True) Elevation Angle: -16.8 Horizon Angle: +02.8 Zoom: 1X 13244+00</p>

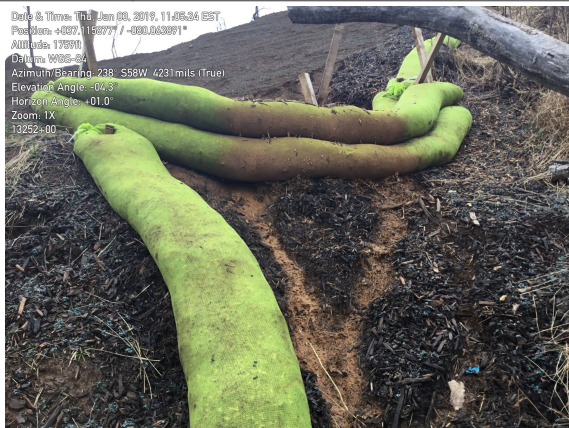
GPS Location	37.3254318908205, -80.0287175831199		GPS Location	37.3254725011413, -80.0287691318244	
Description	Please see photo for coordinates. Sta. No. 13252+00, sediment laden water bypassed outlet protection, sediment within LOD.		Description	Please see photo for coordinates. Sta. No. 13260+00, sump at capacity, CWD steadily flowing water, P1 at outlet needs repair.	
<div><p>Date & Time: Thu Jan 03, 2019, 13:04:04 EST Position: +037.106603 / -80.028593 Altitude: 1370ft Datum: WGS-84 Azimuth/Bearing: 233.553W 414mils (True) Elevation Angle: -10.1 Horizon Angle: -00.4 Zoom: 1X GAS S-GH7, waterbar ponding</p>

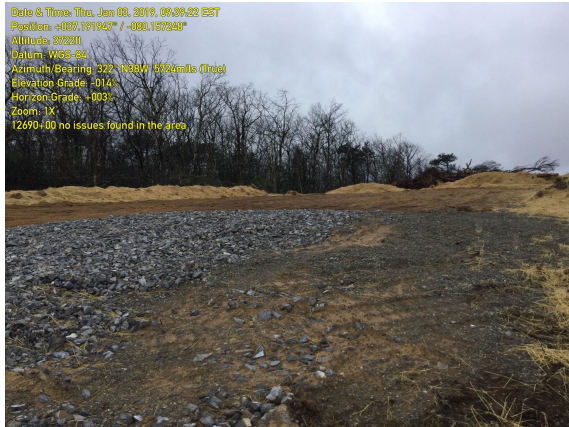
AFE	124300138	Date/Time	1/3/2019 9:31 AM	Report #	12585
Pictures					
<p>Date & Time: Thu, Jan 03, 2019, 09:29:22 EST Position: +439.191945° / -400.187348° Altitude: 3722ft Datum: WGS-84 Azimuth/Bearing: 228° N 288° 453mils (True) Elevation Grade: +014° Horizon Grade: +003° Zoom: 1X 12690+00 no issues found in the area.</p>

GPS Location	37.1916344622496, -80.1573219616713	GPS Location	37.155117441032, -80.1288332138957		
Description	Honeysuckle rd. Inspected ROW for environmental issues or impacts. No problems observed in the area.	Description	Bottom Creek rd. No issues or impacts were observed in this area.		
<p>Date & Time: Thu, Jan 03, 2019, 10:19:46 EST Position: +439.130993° / -400.136638° Altitude: 2725ft Datum: WGS-84 Azimuth/Bearing: 201° S 21W 3573mils (True) Elevation Grade: -032° Horizon Grade: +009° Zoom: 1X 12973+00 no problems found in this area.</p>

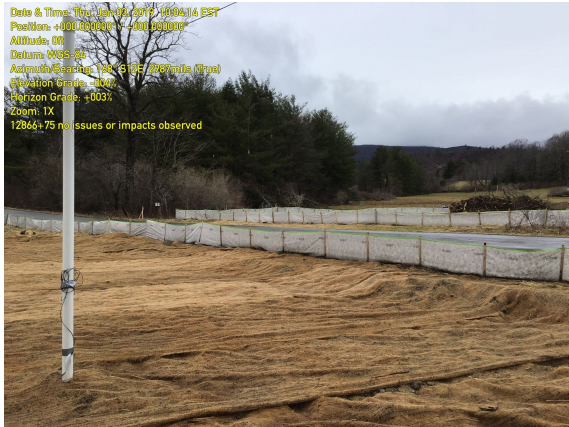
<p>Date & Time: Thu, Jan 03, 2019, 10:04:14 EST Position: +439.155117° / -400.128833° Altitude: 0ft Datum: WGS-84 Azimuth/Bearing: 280° N 28° 513mils (True) Elevation Grade: +000° Horizon Grade: +003° Zoom: 1X 12864+75 no issues or impacts observed</p>

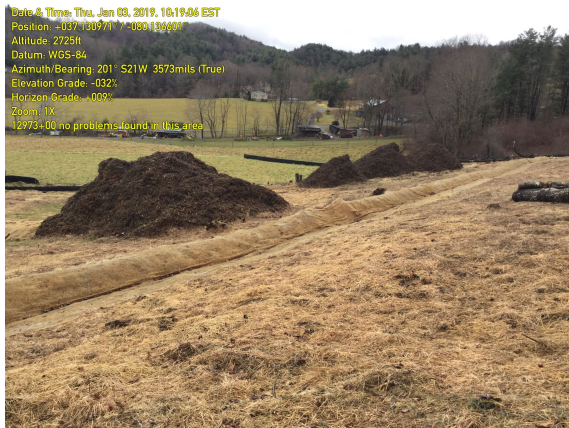
GPS Location	37.1309933206412, -80.1366387774052	GPS Location	37.126135169563, -80.1185913664104		
Description	No issues or impacts observed in the area.	Description	S-G24 and S-G25 no issues or impacts observed in the area.		
<p>Date & Time: Thu, Jan 03, 2019, 12:40:11 EST Position: +437.127711° / -400.111029° Altitude: 2741ft Datum: WGS-84 Azimuth/Bearing: 291° S 27E 1831mils (True) Elevation Grade: -005° Horizon Grade: +003° Zoom: 1X 13042+00 S-024 no issues or impacts observed in the area.</p>

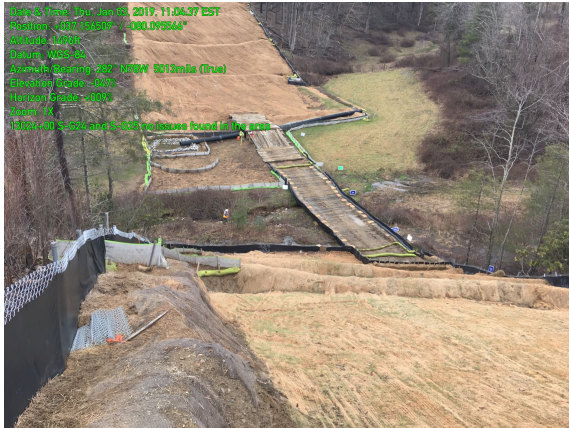
<p>Date & Time: Thu, Jan 03, 2019, 11:04:37 EST Position: +437.126135° / -400.095564° Altitude: 1626ft Datum: WGS-84 Azimuth/Bearing: 280° N 28W 5013mils (True) Elevation Grade: -002° Horizon Grade: +000° Zoom: 1X 13024+00 S-024 and S-025 no issues found in the area.</p>

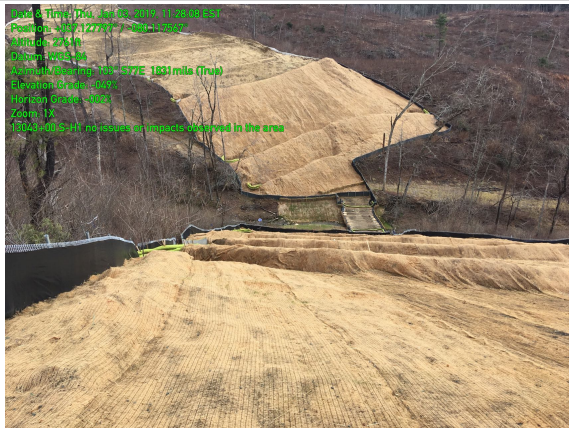
GPS Location	37.126135169563, -80.1185913664104	GPS Location	37.1184900356802, -80.0952574890853		
Description	S-H1 No issues or impacts observed in the area.	Description	S-G26 and S-G27 no issues or impacts found.

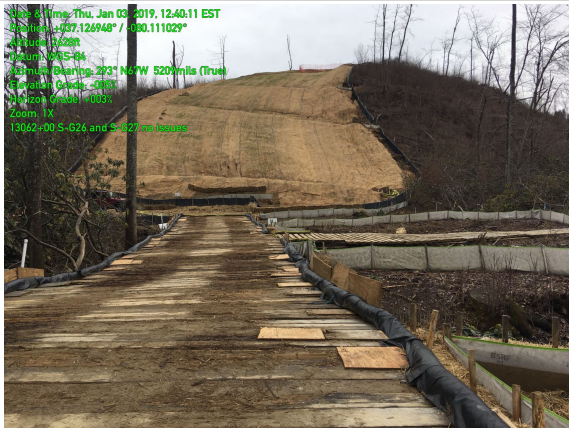
<p>Date & Time: Thu, Jan 03, 2019, 12:40:11 EST Position: +437.126948° / -400.111029° Altitude: 1626ft Datum: WGS-84 Azimuth/Bearing: 293° N 23W 5201mils (True) Elevation Grade: -001° Horizon Grade: +003° Zoom: 1X 13042+00 S-026 and S-027 no issues</p>
