Visual Site Inspection Report

Project Name	H-600 Pipeline Spread H	AFE	124300138	Spread	H-600 Pipeline Spread H
Contractor	Precision			Report #	13233
Inspector	Dawn McCullough			Date/Time	1/21/2019 8:52 PM
Permit #	TBD	Inspection Type	VA SWPP	Station Begin	13188+66
State	VA	Inspection Area	Partial	Station End	13315+18
County	Franklin	Ground	Frozen	Temperature (°F)	27.00
Municipality	N/A	Weather	Below Freezing Tem	Rain Gauge (in)	0.80
GPS Location	37.0916088712241, -80.051420237472			Rain Accumulation Time (days)	1.00

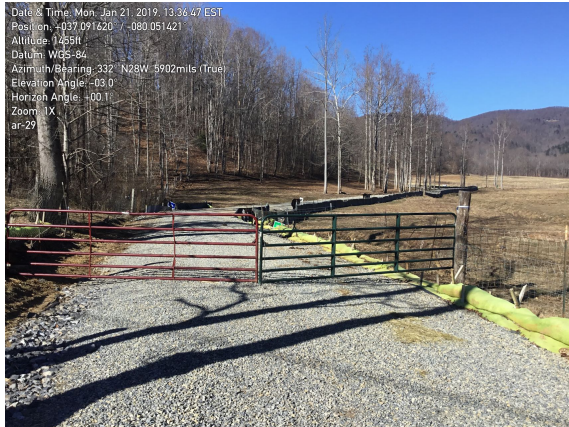
GPS Location	37.1157543501231, -80.059905974269	GPS Location	37.1157543501231, -80.059905974269		
Description	Please see photo for coordinates. MVP-AR-29, access road maintained, no environmental issues observed.	Description	Please see photo for coordinates. S-II/4, ECDs functioning acceptably at stream crossing.		
<p>Date & Time: Mon Jan 21, 2019, 12:18:48 EST Position: -037.115650 / -080.059854 Altitude: 1467ft Datum: WGS-84 Azimuth/Bearing: 169° S11E 3004mils (True) Elevation Angle: -05.8° Horizon Angle: -01.1° Zoom: 1X 1055</p>

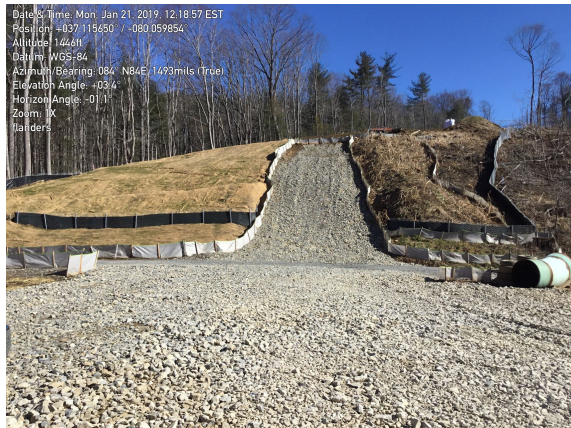
<p>Date & Time: Mon Jan 21, 2019, 12:18:57 EST Position: -037.115650 / -080.059854 Altitude: 1467ft Datum: WGS-84 Azimuth/Bearing: 084° N84E 1493mils (True) Elevation Angle: -03.4° Horizon Angle: -01.1° Zoom: 1X 1anders</p>

GPS Location	37.1157543501231, -80.059905974269	GPS Location	37.1156772366139, -80.0599286054075		
Description	Please see photo for coordinates. ATWS-1055, geotech and rocking additional workspace.	Description	Please see photo for coordinates. Flanders Road, rock construction entrance and road maintained.		
<p>Date & Time: Mon Jan 21, 2019, 11:08:38 EST Position: -037.106570 / -080.051934 Altitude: 1421ft Datum: WGS-84 Azimuth/Bearing: 263° S83W 4476mils (True) Elevation Angle: -10.4° Horizon Angle: -00.9° Zoom: 1X wades gap</p>

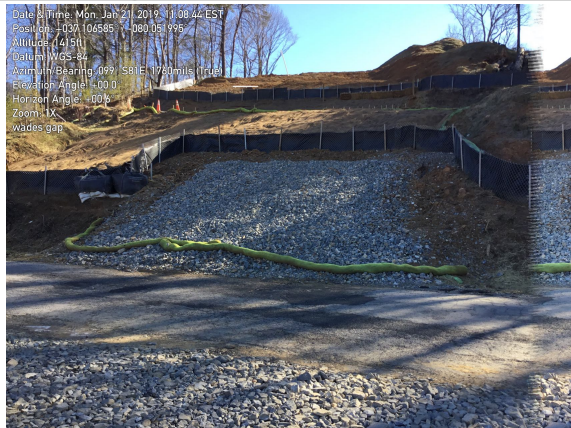
<p>Date & Time: Mon Jan 21, 2019, 11:08:44 EST Position: -037.106585 / -080.051936 Altitude: 1415ft Datum: WGS-84 Azimuth/Bearing: 099° S81E 1720mils (True) Elevation Angle: -00.0° Horizon Angle: -00.0° Zoom: 1X wades gap</p>

GPS Location	37.1156772366139, -80.0599286054075	GPS Location	37.1156517137188, -80.0598542579264		
Description	Please see photo for coordinates. ~Sta. No. 13315+00, ECDs functioning acceptably, no off ROW or stream impacts.	Description	Please see photo for coordinates. Wade's Gap, rock construction entrance and road crossing maintained.

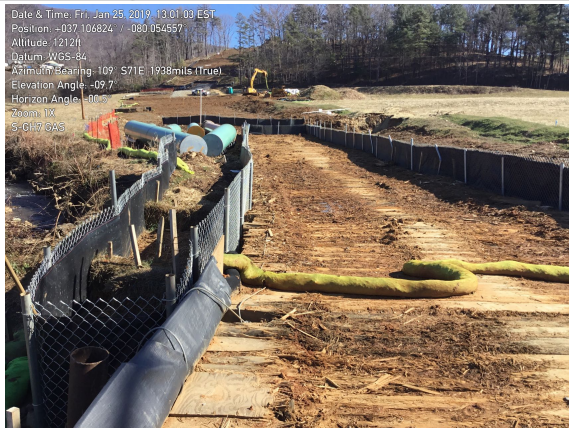
<p>Date & Time: Fri, Jan 25, 2019, 14:06:09 EST Position: -037.107023 / -080.056007 Altitude: 1291ft Datum: WGS-84 Azimuth/Bearing: 190.510W 3378mils (True) Elevation Angle: -15.9 Horizon Angle: -01.5 Zoom: 1X GIS S-GH7</p>  			
GPS Location	37.3256305977983, -80.0287361713863		GPS Location	37.3256306080555, -80.0287361572967	
Description	Please see photo for coordinates. ~Sta. No. 13309+09, S-GH7, ECDs functioning acceptably at stream crossing.		Description	Please see photo for coordinates. ~Sta. No. 13305+00, exclusion fence down around open ditch.
