Visual Site Inspection Report

Project Name	H-600 Pipeline Spread G	AFE	124300137	Spread	H-600 Pipeline Spread G
Contractor	Precision			Report #	19161
Inspector	Len Kruizenga			Date/Time	6/24/2019 7:38 AM
Permit #	TBD	Inspection Type	VA SWPP	Station Begin	11788+00
State	VA	Inspection Area	Full	Station End	12001+00
County	Montgomery	Ground	Dry	Temperature (°F)	83.00
Municipality	N/A	Weather	Sunny	Rain Gauge (in)	0.00
				Rain Accumulation Time (days)	3.00

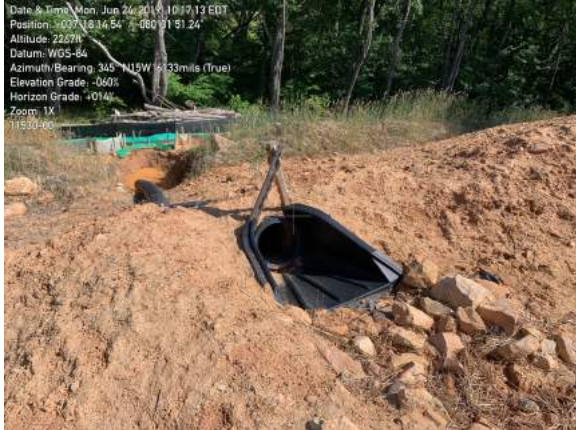
<p>Date & Time: Mon, Jun 24, 2019, 10:19:13 EDT Position: -037°18'14.54" / -080°01'31.24" Altitude: 2227ft Datum: WGS-84 Azimuth/Bearing: 345° N15W 6433mils (True) Elevation Grade: -060% Horizon Grade: -014% Zoom: 1X 11530+00</p>

<p>Date & Time: Mon, Jun 24, 2019, 10:29:19 EDT Position: -037°18'36.04" / -080°01'31.13" Altitude: 2269ft Datum: WGS-84 Azimuth/Bearing: 345° N15W 531mils (True) Elevation Grade: -063% Horizon Grade: -044% Zoom: 1X 11540+00</p>				
GPS Location	37.24	Field Station#	11530+00	GPS Location	37.24	Field Station#	11540+00
Description	ECD's and row conditions			Description	ECD's and row conditions

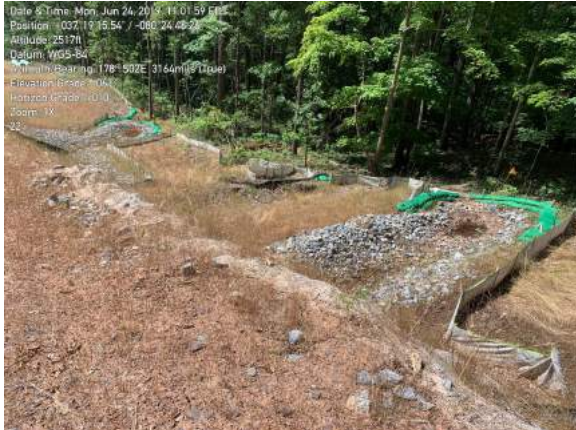
<p>Date & Time: Mon, Jun 24, 2019, 11:01:59 EDT Position: -037°19'35.54" / -080°24'48.21" Altitude: 2517ft Datum: WGS-84 Azimuth/Bearing: 178° S02E 3164mils (True) Elevation Grade: -04% Horizon Grade: -010% Zoom: 1X 11590+00</p>

GPS Location	37.24	Field Station#	11590+00	GPS Location	37.24	Field Station#	11630+00
Description	ECD's and row conditions			Description	ECD's and row conditions

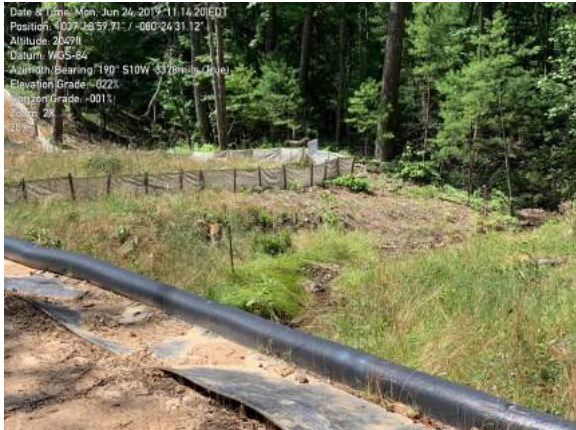
<p>Date & Time: Mon, Jun 24, 2019, 11:14:20 EDT Position: -037°19'59.71" / -080°24'31.12" Altitude: 2659ft Datum: WGS-84 Azimuth/Bearing: 199° S10W 4370mils (True) Elevation Grade: -022% Horizon Grade: -001% Zoom: 2X 11610+00</p>

<p>Date & Time: Mon, Jun 24, 2019, 12:29:38 EDT Position: -037°19'11.97" / -080°23'38.94" Altitude: 2660ft Datum: WGS-84 Azimuth/Bearing: 156° S24E 2773mils (True) Elevation Grade: -028% Horizon Grade: -002% Zoom: 2X 11721+00</p>				
GPS Location	37.24	Field Station#	11610+00	GPS Location	37.24	Field Station#	11721+00
Description	ECD's and row conditions			Description	ECD's and row conditions

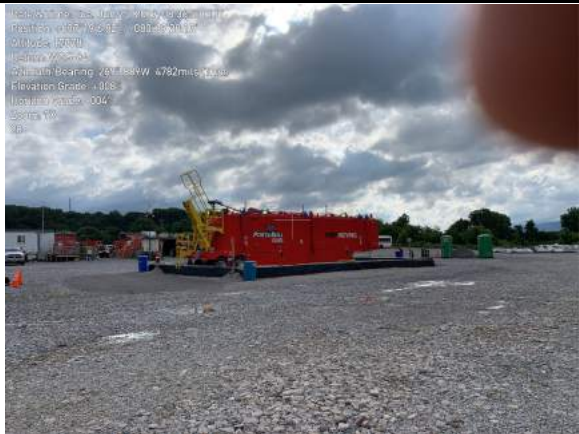
GPS Location		37.29	Field Station#		2+44		GPS Location		37.29	Field Station#		+28	
Description		1.1" and f rain collected @ 244						Description		ECD's and row conditions @ LDY 28

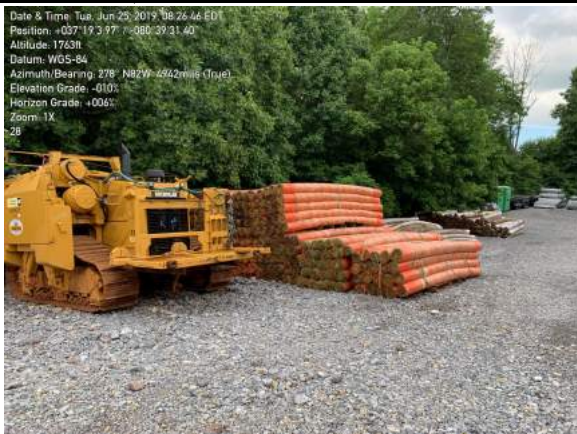
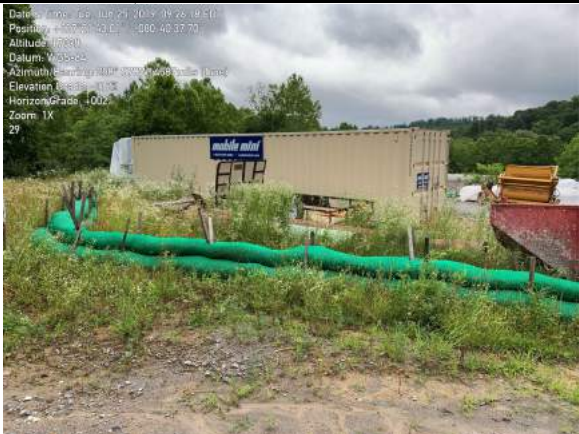
GPS Location		37.29	Field Station#		+28		GPS Location		37.29	Field Station#		+29	
Description		ECD's and row conditions @ LDY 28						Description		ECD's and row conditions @ LDY 29

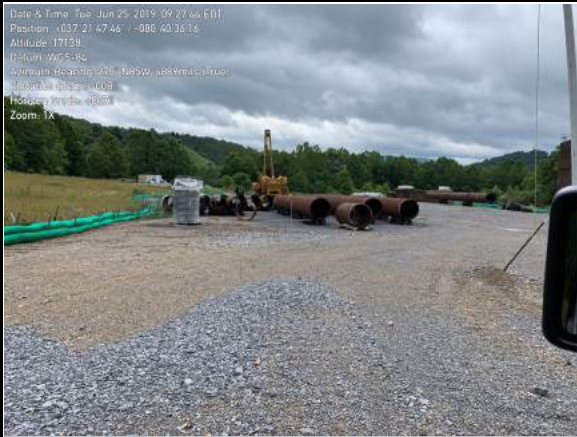
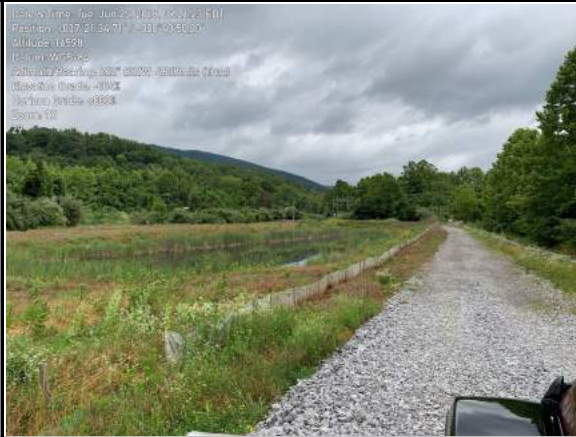
</div></div></div>			
GPS Location		37.29	Field Station#		+29		
Description		ECD's and row conditions @ LDY 29					
<div><div><div>Date & Time: Tue Jun 25 2019 11:33:55 EDT Position: +037 21 46.99 / -080 22 11.16 Altitude: 2069ft Datum: WGS-84 Azimuth/Bearing: 042° 147E, 084mils (True) Elevation Grade: -003% Horizon Grade: -003% Zoom: 1X 11743-00</div><div>
