# Visual Site Inspection Report

<b>Project Name</b>	H-600 Pipeline Spread G	<b>AFE</b>	124300137	<b>Spread</b>	H-600 Pipeline Spread G
<b>Contractor</b>	Precision			<b>Report #</b>	19898
<b>Inspector</b>	Rob Robertson			<b>Date/Time</b>	7/8/2019 11:16 AM
<b>Permit #</b>	TBD	<b>Inspection Type</b>	VA SWPP	<b>Station Begin</b>	10458+91
<b>State</b>	VA	<b>Inspection Area</b>	Full	<b>Station End</b>	10459+03
<b>County</b>	Giles	<b>Ground</b>	Damp	<b>Temperature (°F)</b>	78.00
<b>Municipality</b>	N/A	<b>Weather</b>	Sunny	<b>Rain Gauge (in)</b>	0.10
				<b>Rain Accumulation Time (days)</b>	1.00

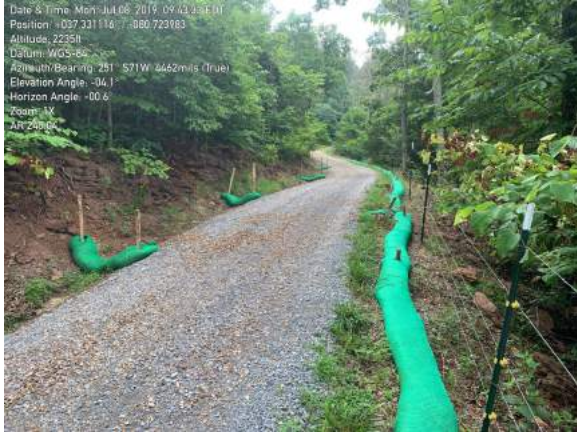
<b>GPS Location</b>	37.18	<b>Field Station#</b>	12005+00	<b>GPS Location</b>	37.18	<b>Field Station#</b>	10212+73
<b>Description</b>	See photo for GPS location. CFS and CFS checks in place along AR 241.04.			<b>Description</b>	See photo for GPS location. Sensitive resource buffer in place at stream S-G33.

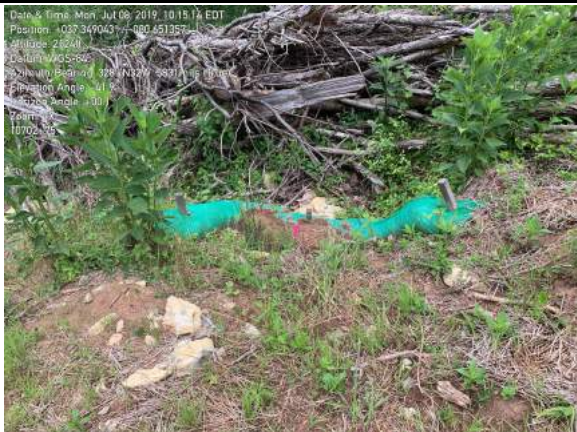
<b>GPS Location</b>	37.18	<b>Field Station#</b>	10701+00	<b>GPS Location</b>	37.18	<b>Field Station#</b>	10696+00
<b>Description</b>	See photo for GPS location. CFS overtopped with sediment.			<b>Description</b>	See photo for GPS location. Rain gauge at Buffalo Anklets Road.

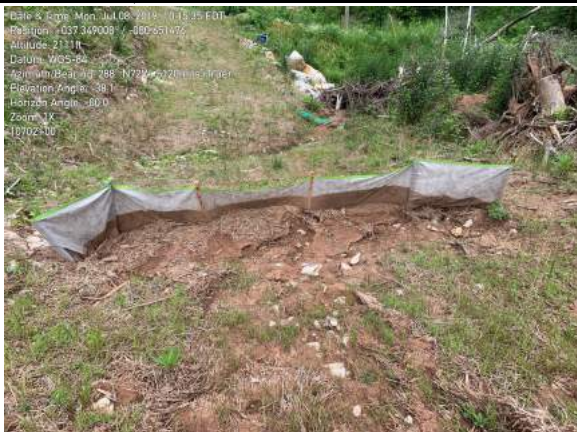
<b>GPS Location</b>	37.18	<b>Field Station#</b>	10702+00	<b>GPS Location</b>	37.18	<b>Field Station#</b>	10679+36
<b>Description</b>	See photo for GPS location. Sediment build up and undermined priority one silt fence.			<b>Description</b>	See photo for GPS location. Sensitive resource buffer in place at stream S-G30.

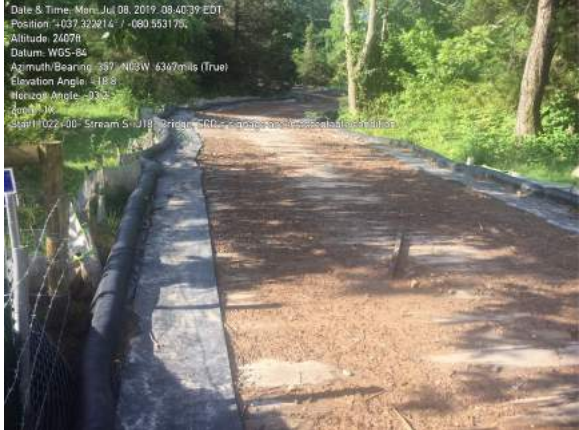
<p>Date &amp; Time: Mon, Jul 08, 2019, 08:40:39 EDT Position: +037.323714° / -090.553175° Altitude: 2407ft Datum: WGS-84 Azimuth/Bearing: 337° N03W 6347mils (True) Elevation Angle: +18.8° Horizon Angle: -00.3° Zoom: 1X Stall 11022+00- Stream S-IJ18- Bridge, ECD's, Signage are in acceptable condition.</p>

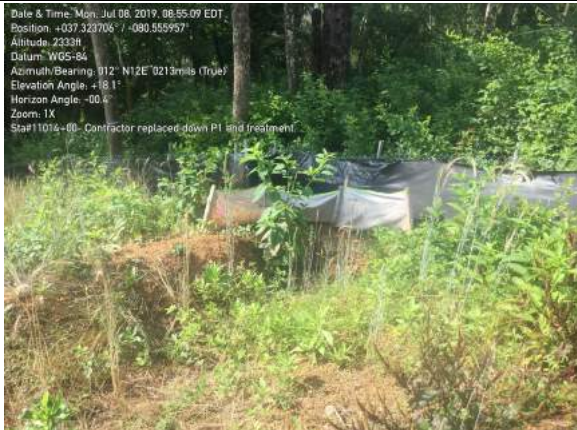
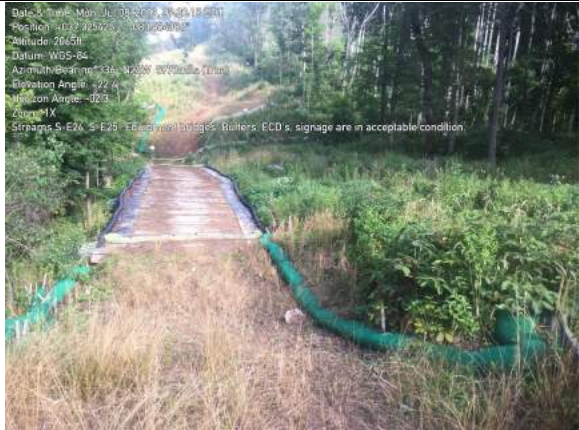
<p>Date &amp; Time: Mon, Jul 08, 2019, 08:55:09 EDT Position: +037.323705° / -090.555957° Altitude: 2333ft Datum: WGS-84 Azimuth/Bearing: 012° N12E 0213mils (True) Elevation Angle: +18.1° Horizon Angle: -00.4° Zoom: 1X Stall 11014-00- Contractor replaced down P1 end treatment</p>

GPS Location	37.32	Field Station#	11014+00	GPS Location	37.32	Field Station#	10986+00
Description	Contractor replaced down P1 end treatment			Description	Streams S-E24, S- E25- Bridges, controls, buffers, signage are in acceptable condition.		
<p>Date &amp; Time: Mon, Jul 08, 2019, 09:38:00 EDT Position: +037.327271° / -090.557284° Altitude: 2251ft Datum: WGS-84 Azimuth/Bearing: 341° N19W 8062mils (True) Elevation Angle: +23.1° Horizon Angle: -00.7° Zoom: 1X Stall 10965+00- Karst ECD's &amp; signage are in acceptable condition</p>

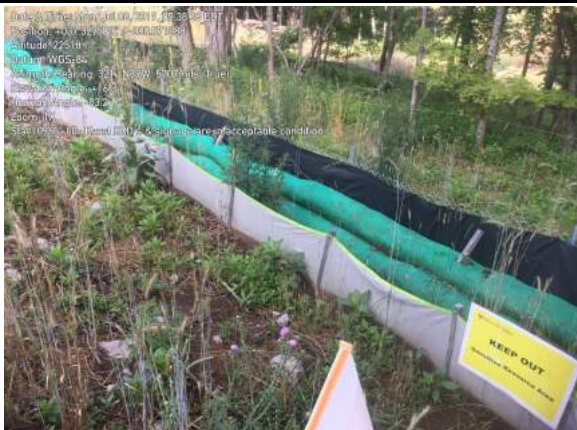
<p>Date &amp; Time: Mon, Jul 08, 2019, 09:38:00 EDT Position: +037.327271° / -090.557284° Altitude: 2251ft Datum: WGS-84 Azimuth/Bearing: 341° N19W 8062mils (True) Elevation Angle: +23.1° Horizon Angle: -00.7° Zoom: 1X Stall 10965+00- Karst ECD's &amp; signage are in acceptable condition</p>

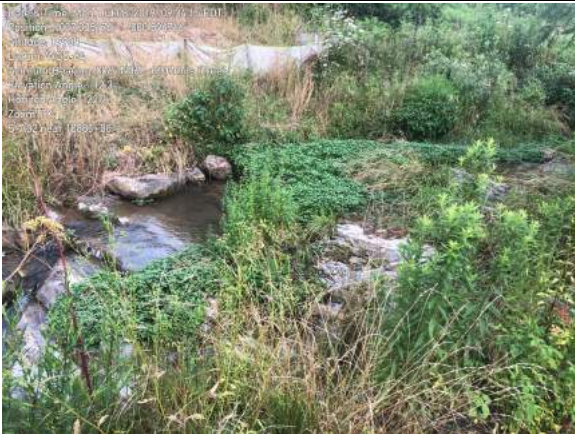
GPS Location	37.32	Field Station#	10883+00	GPS Location	37.32
Description	S-A32.			Description	Undercut end treatment resulting in sediment off RoW.

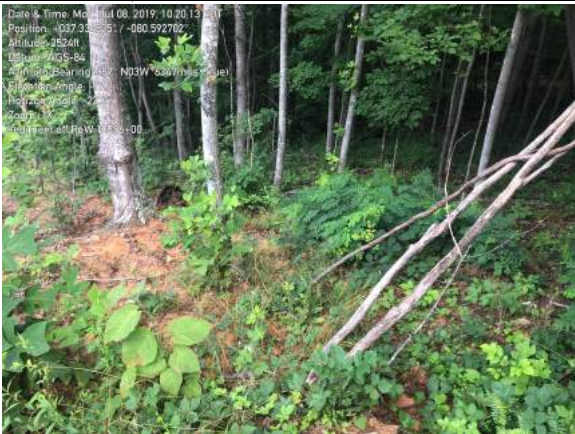
GPS Location	37.32	Field Station#	10896+00	GPS Location	37.32
Description	Sediment off RoW.			Description	Undercut end treatment.

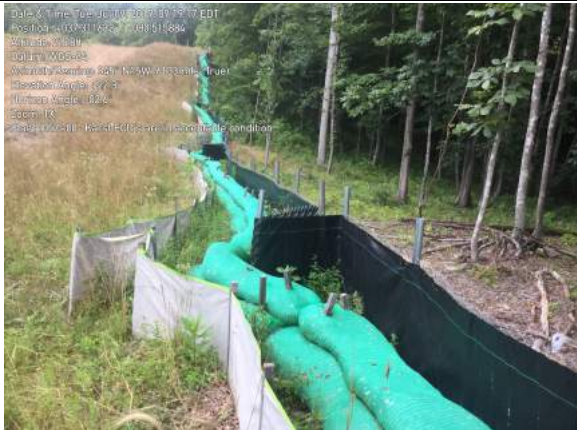
GPS Location	37.31	Field Station#	11057+00	GPS Location	37.31	Field Station#	11081+00
Description	Karst ECD's are in acceptable condition.			Description	SSF fabric down.

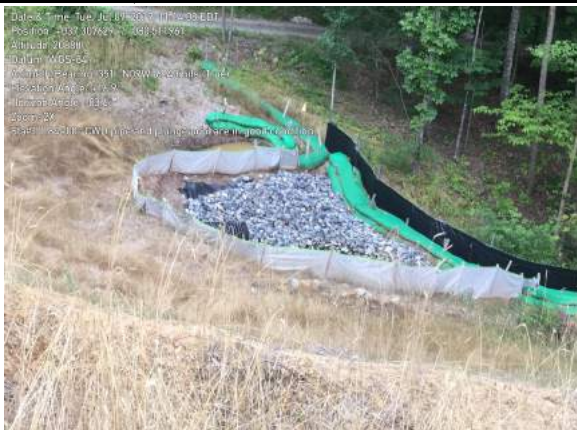
GPS Location	37.30	Field Station#	11184+00	GPS Location	37.30	Field Station#	11191+00
Description	CWD pipe & Plunge pool are in good condition			Description	Sensitive resource, drainage feature, signage, ECD's, bridge are in acceptable condition

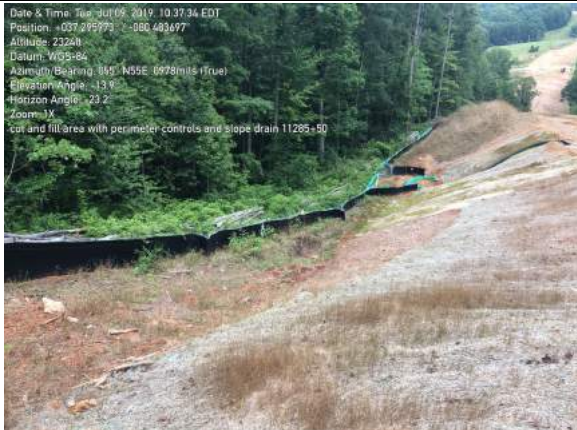
GPS Location	37.31	Field Station#	11285+50	GPS Location	37.31	Field Station#	11292+95
Description	Cut and fill side slope with temporary vegetation and perimeter controls.			Description	S-MM-18.

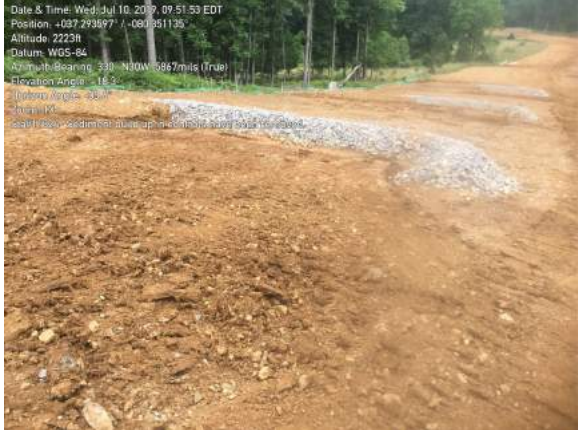
GPS Location		37.29		Field Station#		11797+00		GPS Location		37.29		Field Station#		11824+00	
Pic 1 Description		Sediment off row.						Pic 2 Description		Sediment has been removed from controls.

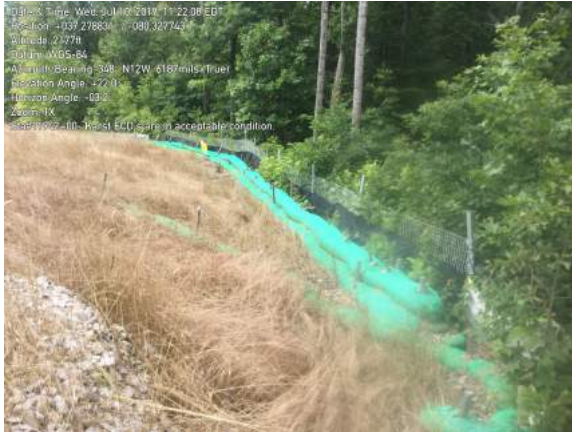
GPS Location		37.27		Field Station#		11942+00		GPS Location		37.27		Field Station#		11950+00	
Pic 3 Description		Karst ECD's are in acceptable condition						Pic 4 Description		Checks in drainage feature to Karst are in acceptable condition

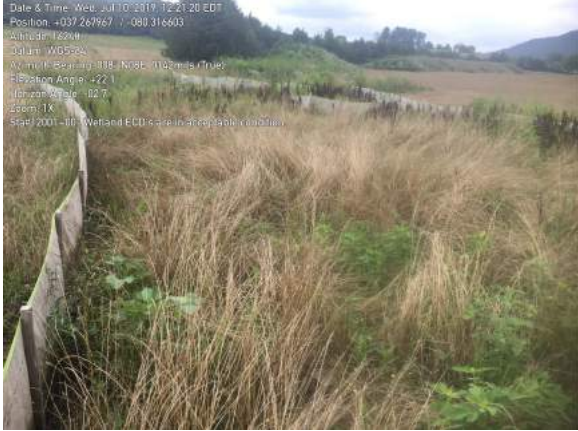
GPS Location		37.27		Field Station#		11976+00		GPS Location		37.26		Field Station#		12001+00	
Pic 5 Description		Karst Triple stack- There are signs of water over topping control and causing some rilling behind perimeter controls.						Pic 6 Description		Sta#12001+00- Wetland ECD's are in acceptable condition.

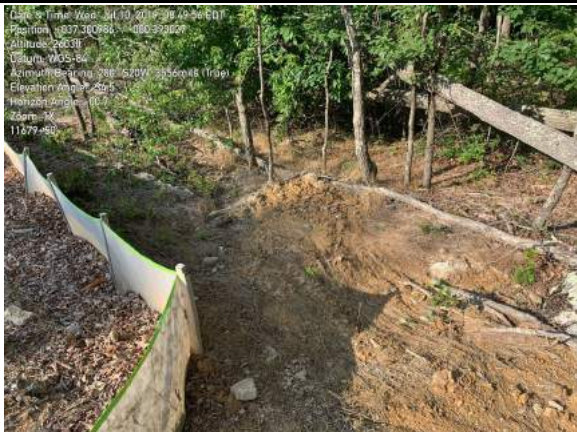
GPS Location	37.18	Field Station#	11679+50	GPS Location	37.18	Field Station#	11687+30
Pic 3 Description	See photo for GPS location. Sediment off ROW.			Pic 4 Description	See photo for GPS location. Coir logs placed off ROW.

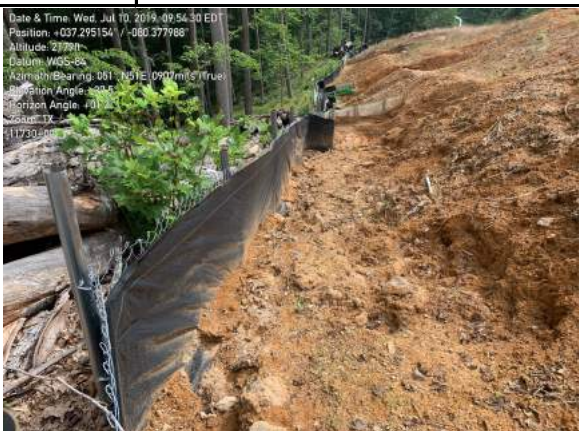
<p>Date &amp; Time: Wed, Jul 10, 2019, 09:54:30 EDT Position: +037.295154 / -080.377968 Altitude: 2797ft Datum: WGS-84 Azimuth Bearing: 081.19ftE / 090.1mils (True) Elevation Angle: 33.5 Horizon Angle: 0.0 Zoom: 1X 11733+50</p>				
GPS Location	37.18	Field Station#	11733+00	GPS Location	37.18	Field Station#	11733+50
Pic 5 Description	See photo for GPS location. Undermined priority one silt fence.			Pic 6 Description	See photo for GPS location. Reinforced silt fence needs retrenched.

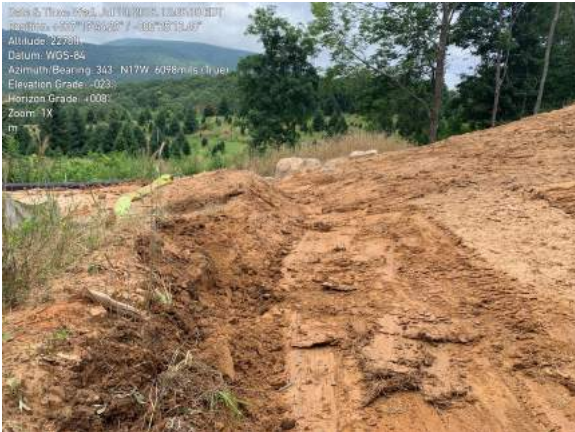
GPS Location	37.24	Field Station#	11530+00	GPS Location	37.24	Field Station#	11530+00
Pic 1 Description	Re worked water bars,			Pic 2 Description	Re worked water bars,

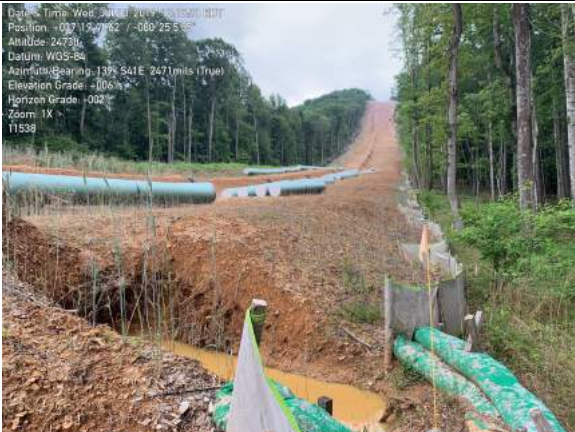
GPS Location	37.24	Field Station#	11538+00	GPS Location	37.24	Field Station#	11584+00
Pic 3 Description	ECD's and row conditions			Pic 4 Description	ECD's and row conditions

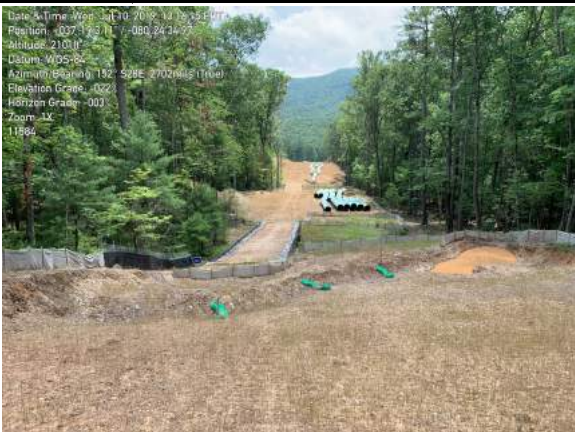
GPS Location	37.24	Field Station#	11585+00	GPS Location	37.24	Field Station#	11597+00
Pic 5 Description	ECD's and row conditions			Pic 6 Description	ECD's and row conditions

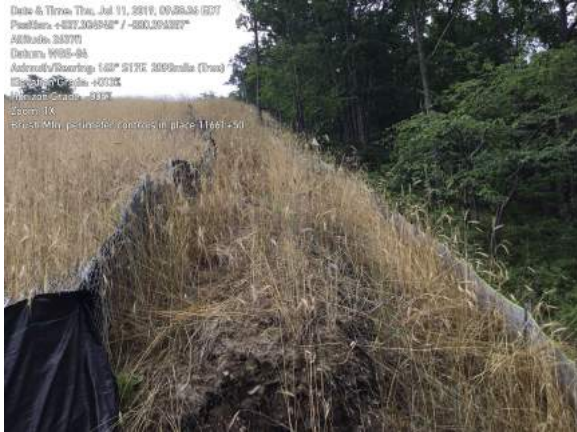
GPS Location	37.31	Field Station#	11661+50	GPS Location	37.31	Field Station#	11654+00
Pic 1 Description	Perimeter controls effective.			Pic 2 Description	Slope breakers working as designed.

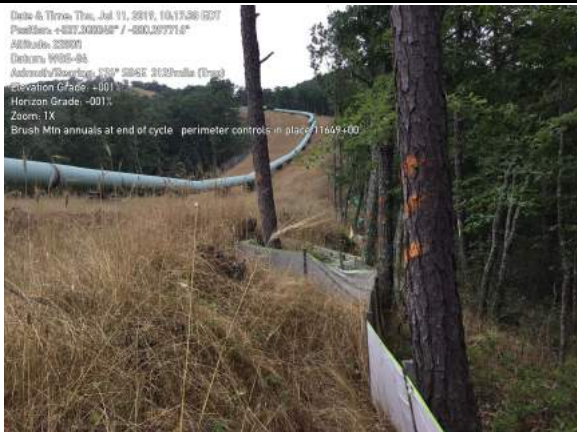
GPS Location	37.31	Field Station#	11649+00	GPS Location	37.31	Field Station#	11649+00
Pic 3 Description	Perimeter controls in place.			Pic 4 Description	Perennial grasses that have sprouted are sparse.

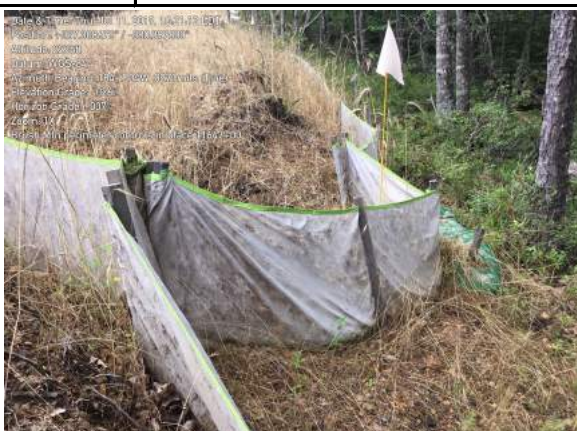
GPS Location	37.31	Field Station#	11647+00	GPS Location	37.31	Field Station#	11623+00
Pic 5 Description	End treatments functional.			Pic 6 Description	Slope pipe and end treatment functioning.

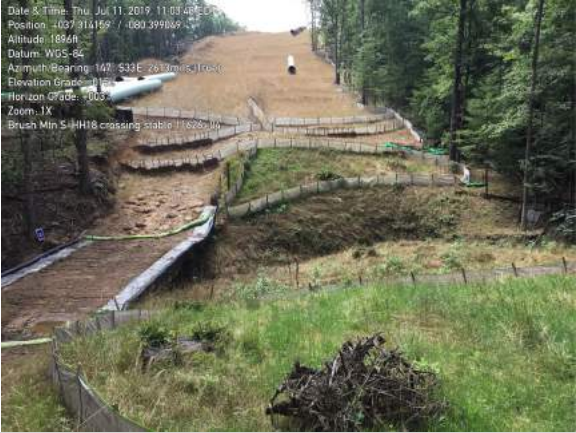
<b>AFE</b>	124300137	<b>Date/Time</b>	7/11/2019 1:48 PM	<b>Report #</b>	20090
<b>Pictures</b>					
<small>Date &amp; Time: Thu, Jul 11, 2019 11:03:52 EDT  Position: -037.314152° / -080.399869°  Altitude: 1886ft  Datum: WGS-84  Azimuth/Bearing: 147° S33E 26.7mils (1000')  Elevation Grade: +030°  Horizon Grade: +005°  Zoom: 1X  Brush Mtn S-HH18 crossing stable 11626+04</small>

<b>GPS Location</b>	37.31	<b>Field Station#</b>	11626+04	<b>GPS Location</b>	37.31
<b>Pic 7 Description</b>	S-HH18 crossing is stable.		<b>Pic 8 Description</b>	S-RR14 crossing is stable.	
<small>Date &amp; Time: Thu, Jul 11, 2019 11:16:57 EDT  Position: -037.303531° / -080.401782°  Altitude: 2198ft  Datum: WGS-84  Azimuth/Bearing: 340° N40W 518mils (1000')  Elevation Grade: +030°  Horizon Grade: +005°  Zoom: 1X  Brush Mtn S-RR14 crossing stable 11614+20</small>

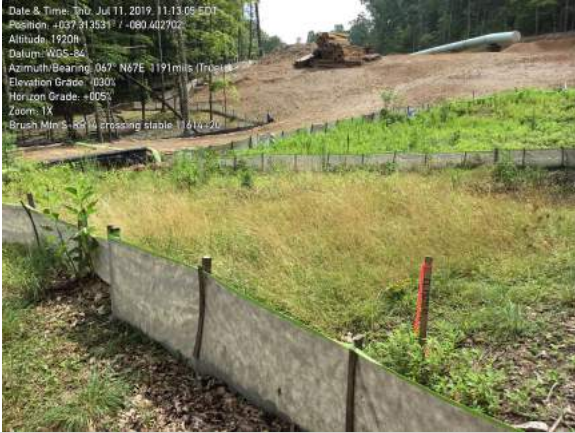
<small>Date &amp; Time: Thu, Jul 11, 2019 11:13:05 EDT  Position: -037.312531° / -080.402702°  Altitude: 1920ft  Datum: WGS-84  Azimuth/Bearing: 067° N67E 1191mils (1000')  Elevation Grade: +030°  Horizon Grade: +005°  Zoom: 1X  Brush Mtn S-RR14 crossing stable 11614+20</small>

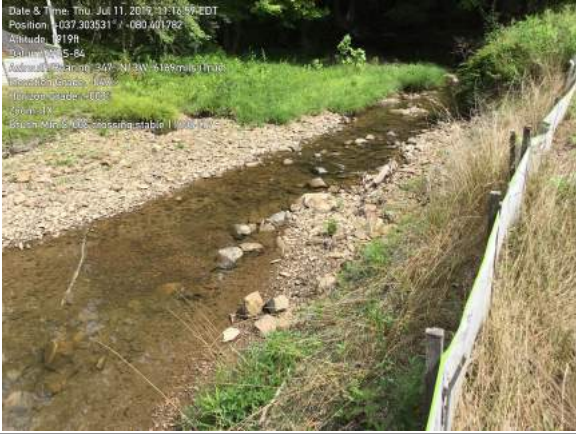
<b>GPS Location</b>	37.31	<b>Field Station#</b>	11608+17	<b>GPS Location</b>	
<b>Pic 9 Description</b>	Craig Creek crossing is stable.		<b>Pic 10 Description</b>		
Insert image here			Insert image here		
<b>GPS Location</b>		<b>Field Station#</b>		<b>GPS Location</b>	
<b>Pic 11 Description</b>			<b>Pic 12 Description</b>

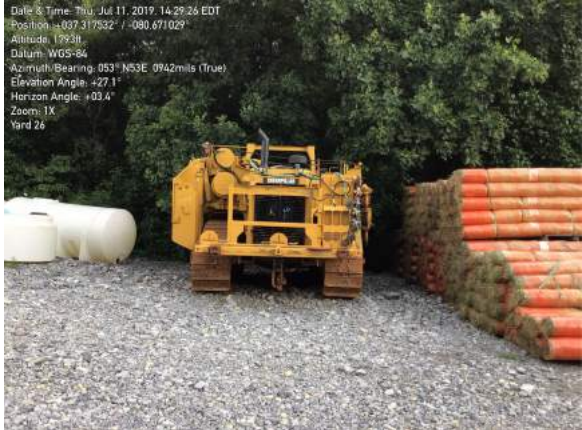
</div></div>				
GPS Location	37.18	Field Station#	12005+00	GPS Location	37.18	Field Station#	12005+00
Pic 1 Description	See photo for GPS location. No leaks observed under equipment.			Pic 2 Description	See photo for GPS location. 18 inch CFS in place along LOD.

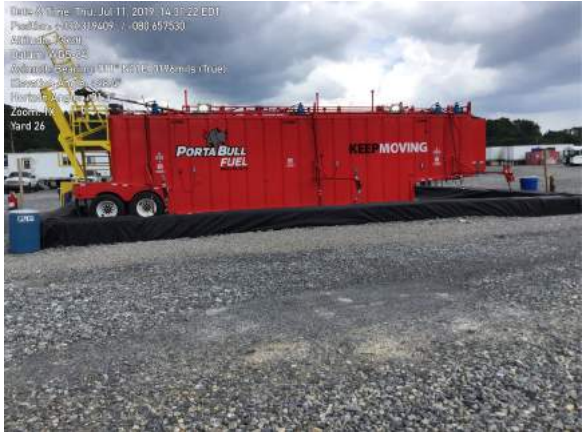
</div></div>				
GPS Location	37.18	Field Station#	12005+00	GPS Location	37.18	Field Station#	12005+00
Pic 3 Description	See photo for GPS location. Secondary containment in place under fuel cell.			Pic 4 Description	See photo for GPS location. RCE in place at employee parking.

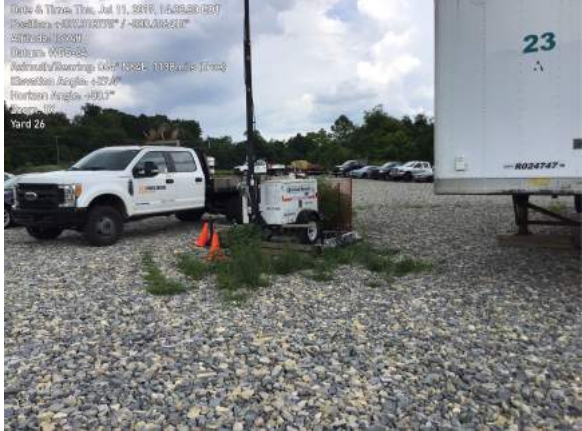
</div></div>			Insert image here				
GPS Location	37.18	Field Station#	12005+00	GPS Location		Field Station#	
Pic 5 Description	See photo for GPS location. Secondary containment in place under light plant.			Pic 6 Description

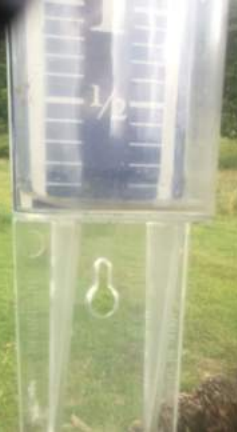
A/E	124300137	Date/Time	7/12/2019 8:19 AM	Report #	20149
Pictures					
<p>Date &amp; Time: Fri, Jul 12, 2019, 08:50:23 EDT Position: +037.318002° / -090.553592° Altitude: 2161ft Datum: WGS-84 Azimuth/Bearing: 325° N35W 5778mils (True) Elevation Angle: +24.3° Horizon Angle: -01.3° Zoom: 1X AR-244- Rain gauge reading- Trace</p>

GPS Location	37.32	Field Station#	11022+00	GPS Location	37.32
Pic 1 Description	AR-244- Rain gauge had trace amount		Pic 2 Description	Contractor backfilled washed out SSF.	
<p>Date &amp; Time: Fri, Jul 12, 2019, 09:40:32 EDT Position: +037.325775° / -090.564365° Altitude: 2379ft Datum: WGS-84 Azimuth/Bearing: 330° N30W 5667mils (True) Elevation Angle: +25.7° Horizon Angle: -02.5° Zoom: 1X State 11017+00- Stream S-RR5- Bridge, buffers, signage, ECD's are in acceptable condition.</p>

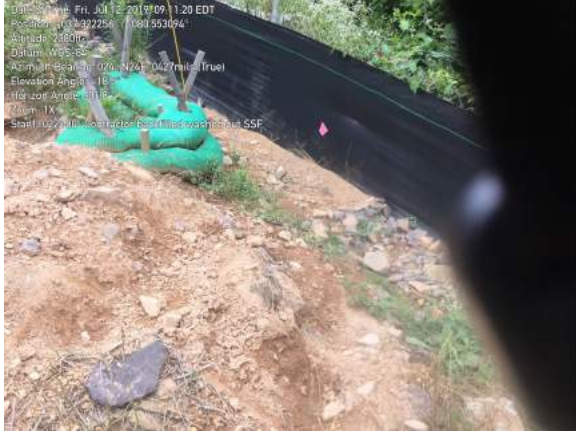
<p>Date &amp; Time: Fri, Jul 12, 2019, 09:11:20 EDT Position: +037.322254° / -090.553094° Altitude: 2160ft Datum: WGS-84 Azimuth/Bearing: 320° N42W 5047mils (True) Elevation Angle: +18° Horizon Angle: -01.8° Zoom: 1X State 11022+00- Contractor backfilled washed out SSF</p>

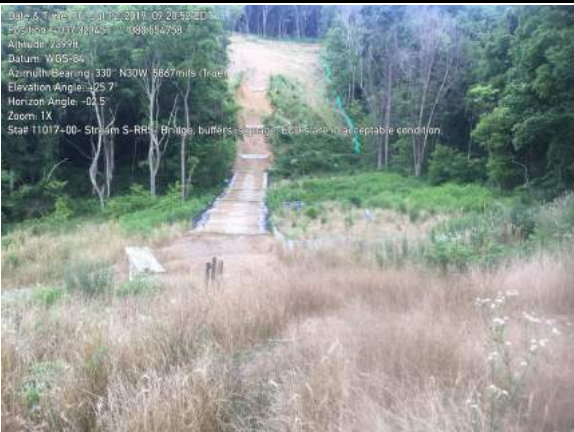
GPS Location	37.32	Field Station#	11017+00	GPS Location	37.32
Pic 3 Description	Stream S-RR5- Bridge, ECD's, signage, buffers are in acceptable condition.		Pic 4 Description	Streams S-E24 & S-E25- Bridges, ECD's, Buffers, & signage are in acceptable condition	
<p>Date &amp; Time: Fri, Jul 12, 2019, 10:04:18 EDT Position: +037.327355° / -090.570398° Altitude: 2359ft Datum: WGS-84 Azimuth/Bearing: 351° N09W 6240mils (True) Elevation Angle: +20.7° Horizon Angle: -00.3° Zoom: 1X State 10965+00- Karst ECD's are in good condition.</p>

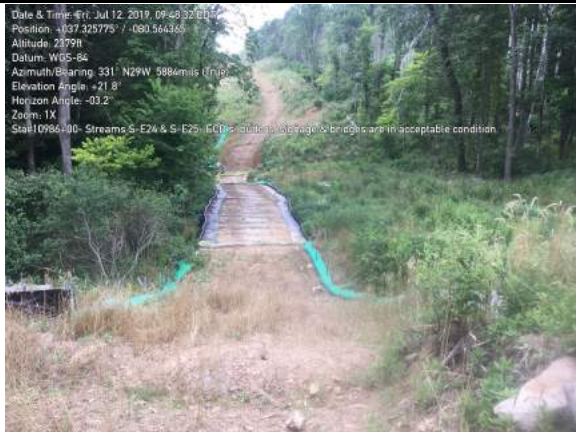
<p>Date &amp; Time: Fri, Jul 12, 2019, 09:40:32 EDT Position: +037.325775° / -090.564365° Altitude: 2379ft Datum: WGS-84 Azimuth/Bearing: 331° N29W 5886mils (True) Elevation Angle: +21.8° Horizon Angle: -03.2° Zoom: 1X State 10986+00- Streams S-E24 &amp; S-E25- Bridges, ECD's, buffers, signage are in acceptable condition.</p>

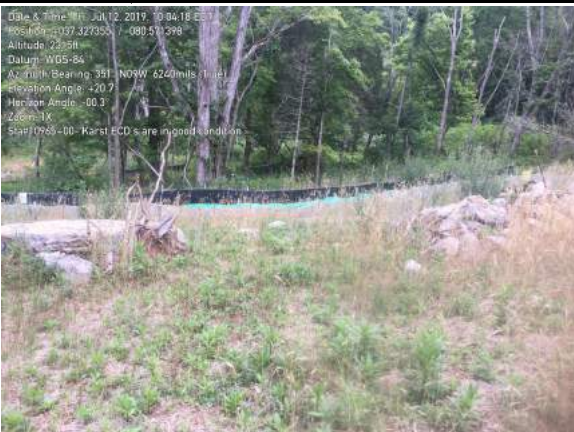
Pic 5 Description	Karst ECD's & signage are in good condition..		Pic 6 Description	The contractor removed sediment from sump by hand shoveling.

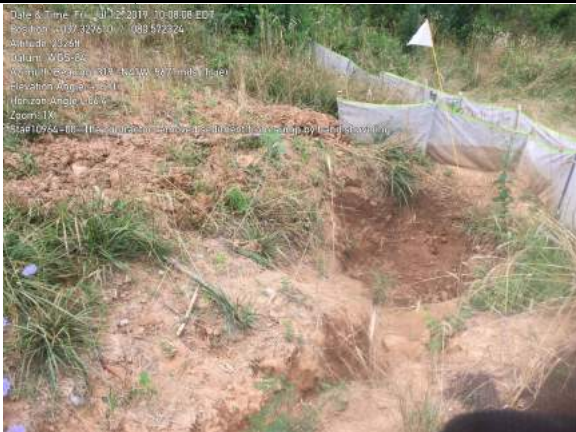
<p>Date &amp; Time: Fri, Jul 12, 2019, 10:08:08 EDT Position: +037.329600° / -090.572324° Altitude: 2358ft Datum: WGS-84 Azimuth/Bearing: 303° N63W 5977mils (True) Elevation Angle: +23.1° Horizon Angle: -01.5° Zoom: 1X State 10964+00- The contractor removed sediment from sump by hand shoveling.</p>

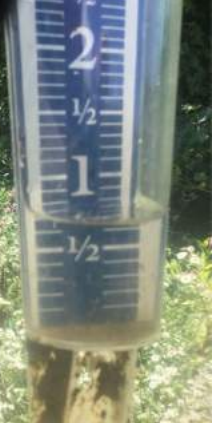
<b>AFE</b> 124300137		<b>Date/Time</b> 7/12/2019 8:19 AM		<b>Report #</b> 20149			
<b>Pictures</b>							
<small>           Date &amp; Time: Fri Jul 12, 2019 11:37:07 EDT            Position: -0037.901206° / -060.501333°            Altitude: 2118ft            Datum: WGS-84            Azimuth/Bearing: 034° N34E 0604mils (True)            Elevation Angle: +20.1°            Horizon Angle: -06.0°            Zoom: 1X            Winding Way rain gauge reading: 0.80"         </small>

<b>Pic 7 Description</b>	Winding Way rain gauge reading- 0.75"			<b>Pic 8 Description</b>	Steel Acres rain gauge reading- 0.40"		
Insert image here				Insert image here			
<b>GPS Location</b>		<b>Field Station#</b>		<b>GPS Location</b>		<b>Field Station#</b>	
<b>Pic 9 Description</b>				<b>Pic 10 Description</b>			
Insert image here				Insert image here			
<b>GPS Location</b>		<b>Field Station#</b>		<b>GPS Location</b>		<b>Field Station#</b>	
<b>Pic 11 Description</b>				<b>Pic 12 Description</b>

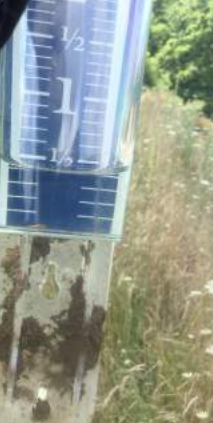
<small>           Date &amp; Time: Fri Jul 12, 2019 11:38:07 EDT            Position: -0037.741507° / -060.415107°            Altitude: 2267ft            Datum: WGS-84            Azimuth/Bearing: 050° N50E 076mils (True)            Elevation Angle: +22.9°            Horizon Angle: -03.0°            Zoom: 1X            Steel Acres rain gauge reading: 0.40"         </small>

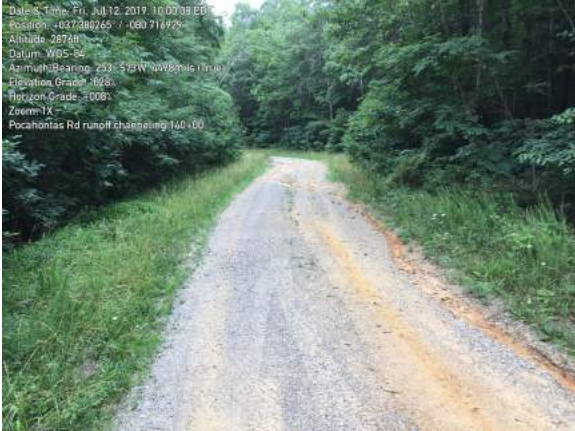
<small>Date &amp; Time: Fri Jul 12, 2019 10:09:38 EDT          Position: +037.388265 / -080.716929          Altitude: 2874ft          Datum: WGS-84          Azimuth/Bearing: 253° 57'0W 4458mils (True)          Elevation Grade: +028%          Horizon Grade: +008%          Zoom: 1X          Pocahontas Rd runoff channeling 140+00</small>

<b>Pic 7 Description</b>	Runoff channeling on road surface in several areas.			<b>Pic 8 Description</b>	Runoff channeling on road surface in several areas.		
Insert image here				Insert image here			
<b>GPS Location</b>		<b>Field Station#</b>		<b>GPS Location</b>		<b>Field Station#</b>	
<b>Pic 9 Description</b>				<b>Pic 10 Description</b>			
Insert image here				Insert image here			
<b>GPS Location</b>		<b>Field Station#</b>		<b>GPS Location</b>		<b>Field Station#</b>	
<b>Pic 11 Description</b>				<b>Pic 12 Description</b>

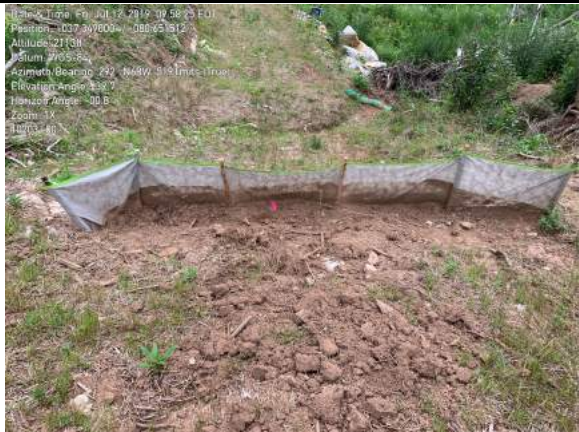
GPS Location	37.18	Field Station#	10696+00	GPS Location	37.18	Field Station#	10703+00
Pic 3 Description	See photo for GPS location. RCE in place at Buffalo Anklets Road.			Pic 4 Description	See photo for GPS location. Priority one silt fence replaced since last inspection.

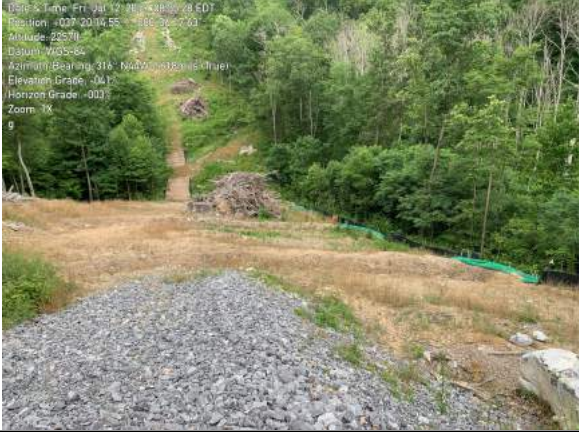
<p>Date &amp; Time: Fri, Jul 12, 2019, 12:18:37 EDT Position: +037°19'58.37" / +080°35'51.01" Altitude: 2289ft Datum: WGS-84 Azimuth/Bearing: 233° S=343m (1127ft) True Elevation Grade: +063° Horizon Grade: +014° Zoom: 1X 234</p>	
<b>GPS Location</b>	37.24	<b>Field Station#</b>	10852+00	<b>GPS Location</b>	37.24
<b>Pic 1 Description</b>	ECD's and row conditions

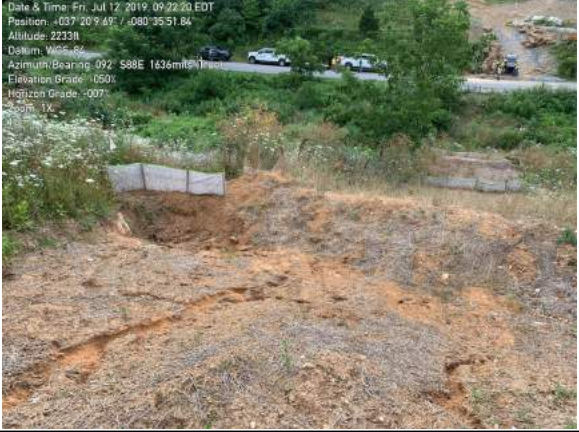
<b>Pic 2 Description</b>	ECD's and row conditions				
<b>GPS Location</b>	37.24	<b>Field Station#</b>	2+34	<b>GPS Location</b>	37.24
<b>Pic 3 Description</b>	ECD's and row conditions @ 234				
<b>Pic 4 Description</b>	End treatment				
<b>GPS Location</b>	37.24	<b>Field Station#</b>	10878+00	<b>GPS Location</b>	37.24
<b>Pic 5 Description</b>	ECD's and row conditions, crew stabilizing ROW				
<b>Pic 6 Description</b>	Empty rain gauge @ 234
