Visual Site Inspection Report

Project Name	H-600 Pipeline Spread G	AFE	124300137	Spread	H-600 Pipeline Spread G
Contractor	Precision			Report #	20656
Inspector	Len Kruizenga			Date/Time	7/22/2019 7:27 AM
Permit #	TBD	Inspection Type	VA SWPP	Station Begin	11900+00
State	VA	Inspection Area	Full	Station End	12001+00
County	Giles	Ground	Wet	Temperature (°F)	80.00
Municipality	N/A	Weather	Light Rain	Rain Gauge (in)	1.10
				Rain Accumulation Time (days)	1.00

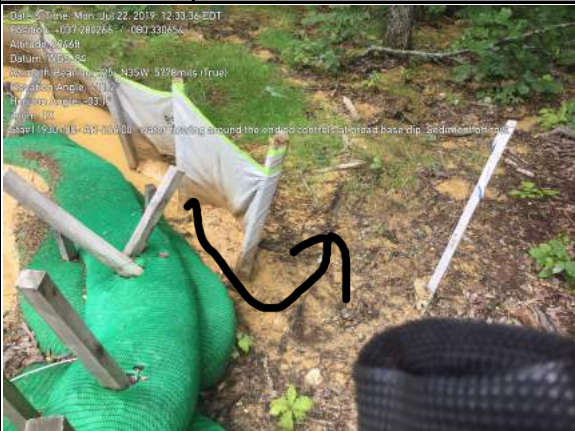
Insert image here				
GPS Location	37.28	Field Station#	119300-266.00	GPS Location		Field Station#	
Pic 11 Description	AR-266.00, towards top of AR- Sediment by passing controls, sediment off row.			Pic 12 Description

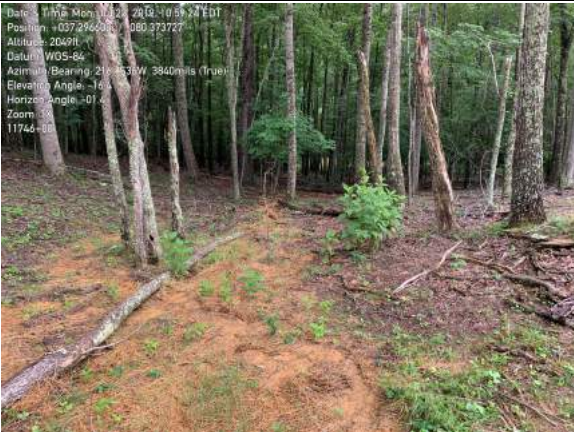
GPS Location	37.18	Field Station#	11747+50	GPS Location	37.18	Field Station#	11748+25
Pic 3 Description	See photo for GPS location. Off ROW sediment. Report to FERC.			Pic 4 Description	See photo for GPS location. Day light drain roach outlet needs refreshed.

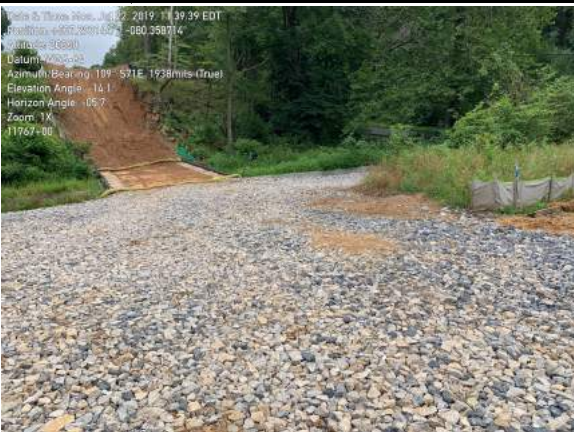
GPS Location	37.18	Field Station#	11767+00	GPS Location	37.18	Field Station#	11778+00
Pic 5 Description	See photo for GPS location. RCE in place at main line valve 26.			Pic 6 Description	See photo for GPS location. Clean water diversion pipe and plunge pool in place.

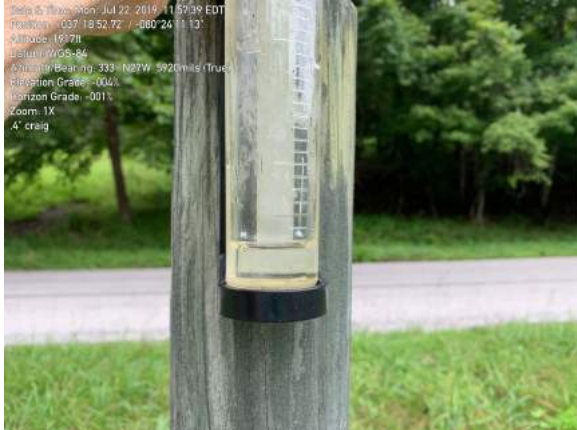
GPS Location		37.24	Field Station#		+1
Pic 1 Description		.4" recorded @ Craig's Creek

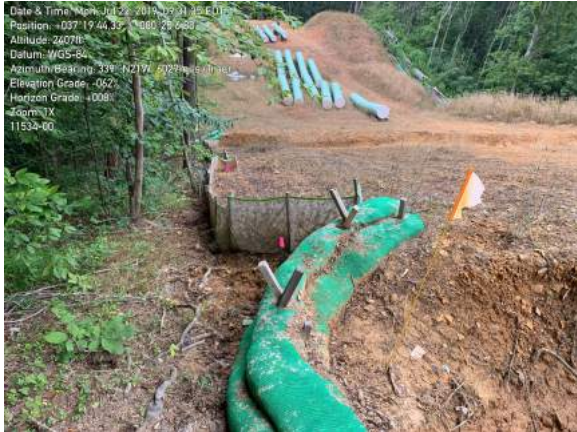
GPS Location		37.24	Field Station#		11534+00
Pic 3 Description		Undermined CFS

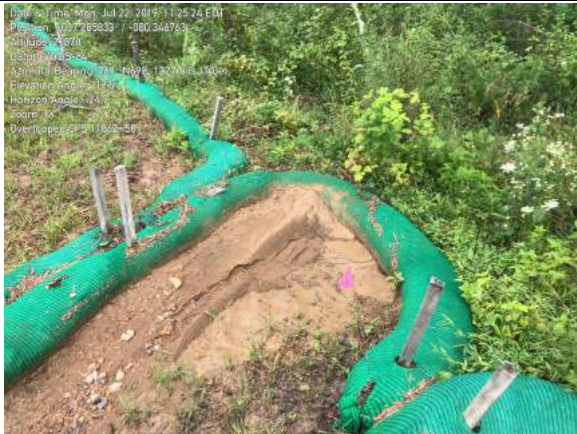
GPS Location	37.32	Field Station#	11862+50	GPS Location	37.32	Field Station#	11840+50
Pic 3 Description	Overtopped CFS.			Pic 4 Description	Crews replacing ECDs.

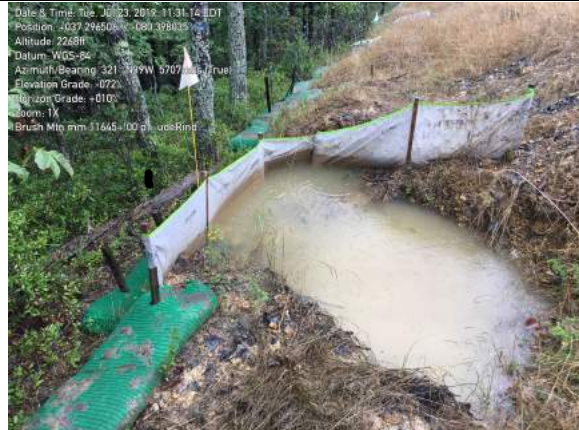
GPS Location	37.13	Field Station#	11661+00	GPS Location	37.13	Field Station#	11645+00
Pic 3 Description	Perimeter controls are in place where needed.			Pic 4 Description	End treatments are in place and functional but need frequent maintenance.

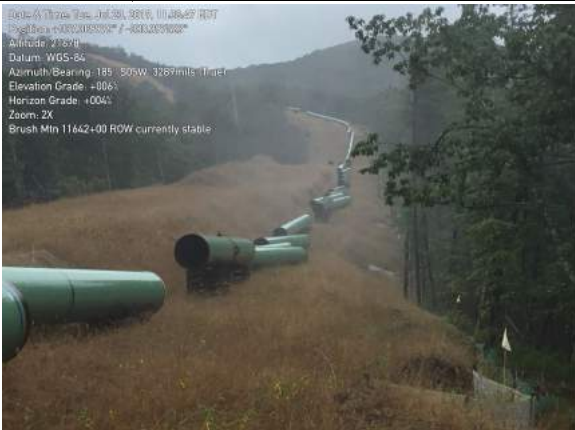
GPS Location	37.13	Field Station#	11642+00	GPS Location	37.13	Field Station#	11626+04
Pic 5 Description	ROW is stable currently. Annual grasses have died but are still standing.			Pic 6 Description	ROW is stable upslope of S-HH18 crossing. No impact located.

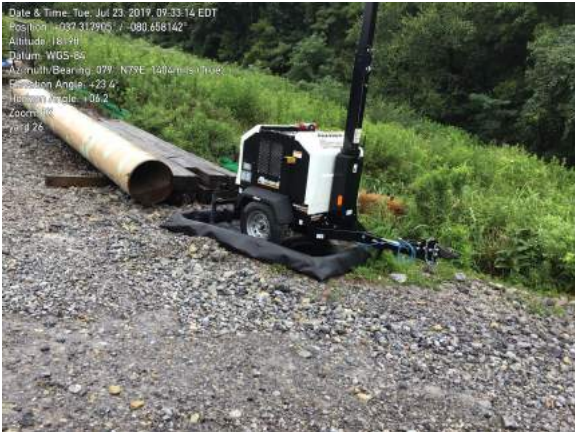
GPS Location	37.18	Field Station#	12005+00	GPS Location	37.18	Field Station#	11471+00
Pic 1 Description	See photo for GPS location. Light plant in place with secondary containment.			Pic 2 Description	See photo for GPS location. Rain gauge at Steele Acres reads 1 inch.

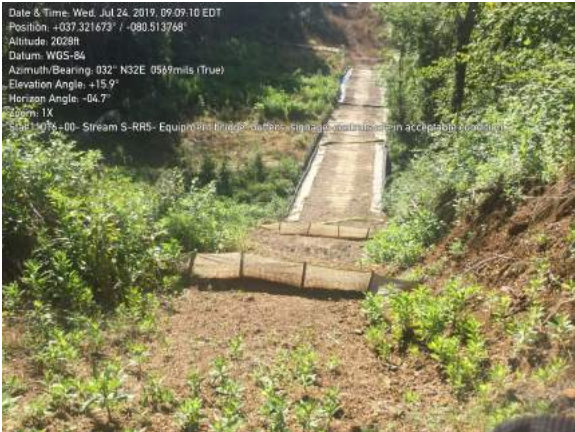
A/E	124300137	Date/Time	7/24/2019 7:55 AM	Report #	20795		
Pictures							
<p>Date & Time: Wed, Jul 24, 2019, 09:09:10 EDT Position: +037.321673° / -090.513768° Altitude: 2029ft Datum: WGS-84 Azimuth/Bearing: 032° N32E 059ftmils (True) Elevation Angle: +15.9° Horizon Angle: -04.7° Zoom: 1X Spot 11016+00- Stream S-RR5- Equipment bridge, buffers, signage, ECD's are in acceptable condition.</p>

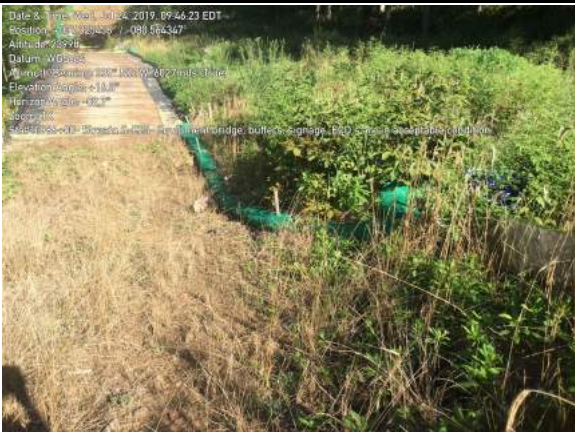
<p>Date & Time: Wed, Jul 24, 2019, 09:46:23 EDT Position: +037.323629° / -090.556347° Altitude: 2357ft Datum: WGS-84 Azimuth/Bearing: 032° N32E 470ftmils (True) Elevation Angle: +18.1° Horizon Angle: -02.1° Zoom: 1X Spot 10986+00- Stream S-E25- Equipment bridge, buffers, signage, ECD's are in acceptable condition.</p>

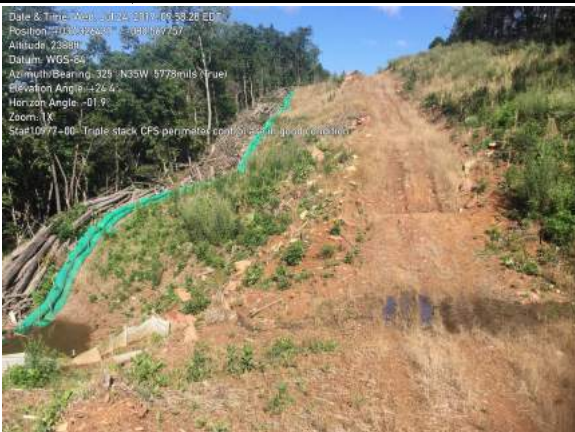
<p>Date & Time: Wed, Jul 24, 2019, 10:38:28 EDT Position: +037.323757° / -090.570757° Altitude: 2380ft Datum: WGS-84 Azimuth/Bearing: 325° N35W 577ftmils (True) Elevation Angle: +24.4° Horizon Angle: -01.9° Zoom: 1X Spot 10977+00- Triple stack CFS perimeter controls are in acceptable condition.</p>

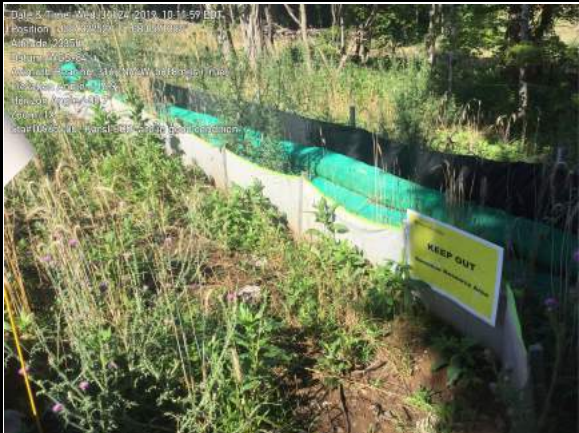
GPS Location	37.32	Field Station#	10965+00	GPS Location	37.32	Field Station#	10960+00
Pic 7 Description	Karst ECD's are in good condition.		Pic 8 Description	Doe Creek Farms- Landowner has removed P1 controls along driveway.

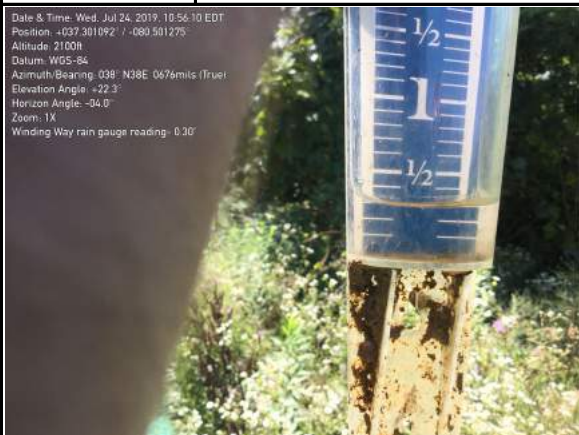
GPS Location	37.30	Field Station#	11227+00	GPS Location	37.32	Field Station#	11471+00
Pic 9 Description	Winding Way rain gauge reading- 0.30\"		Pic 10 Description	Steel Acres Rain Gauge reading- 0.10\"

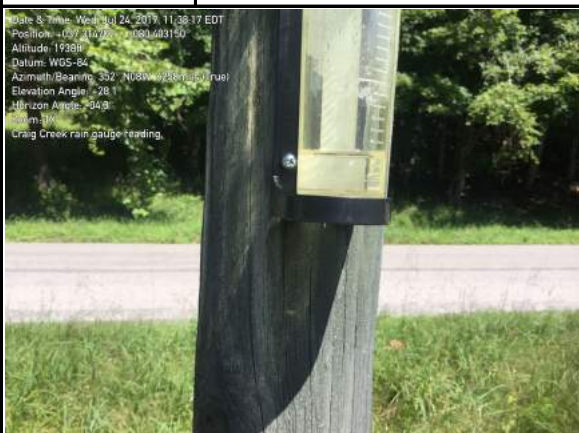
GPS Location	37.31	Field Station#	11600+00	GPS Location	37.26	Field Station#	11989+00
Pic 11 Description	Craig Creek rain gauge reading- 0.40\"		Pic 12 Description	Catawba rain gauge reading-0.30\"

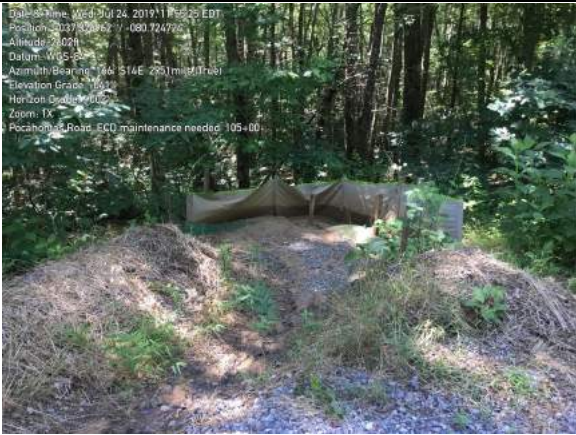
Insert image here		
GPS Location 37.31		Field Station# 105+00		GPS Location	
Field Station#					
Pic 9 Description		ECD maintenance needed.			
Pic 10 Description					
Insert image here			Insert image here		
GPS Location		Field Station#		GPS Location	
Field Station#					
Pic 11 Description		Pic 12 Description

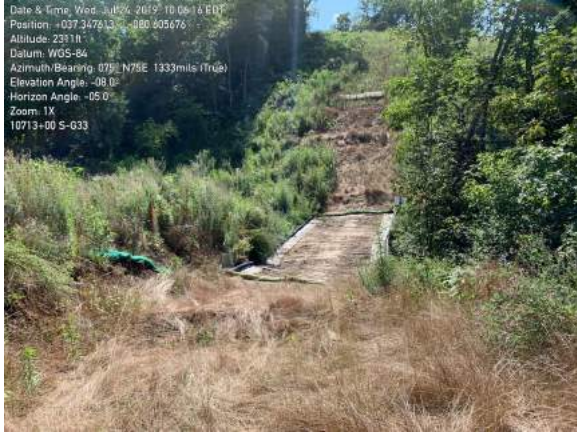
<p>Date & Time: Wed, Jul 24, 2019, 10:06:16 EDT Position: -037.347613, -080.605676 Altitude: 2311ft Datum: WGS-84 Azimuth/Bearing: 075° N75E 1333mils (True) Elevation Angle: -08.0° Horizon Angle: -05.0° Zoom: 1X 10713+00 S-G33</p>

<p>Date & Time: Wed, Jul 24, 2019, 10:28:01 EDT Position: -037.333091, -080.726719 Altitude: 2341ft Datum: WGS-84 Azimuth/Bearing: 121° N64W 1268mils (True) Elevation Angle: -11.5° Horizon Angle: -13.1° Zoom: 1X 10696+00</p>				
GPS Location	37.18	Field Station#	10713+00	GPS Location	37.18	Field Station#	10696+00
Pic 1 Description	See photo for GPS location. Sensitive resource buffer in place at stream S-G33.			Pic 2 Description	See photo for GPS location. RCE in place at Buffalo Anklets Road.

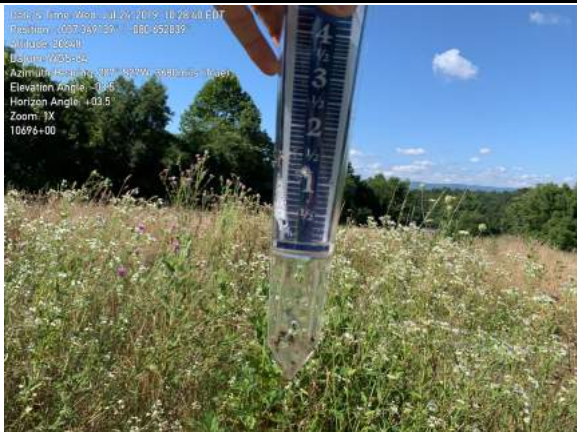
GPS Location	37.18	Field Station#	10696+00	GPS Location	37.18	Field Station#	11363+00
Pic 3 Description	See photo for GPS location. Rain gauge at Buffalo Anklets Road reads 0.1 inches.			Pic 4 Description	See photo for GPS location. Sediment recovered from off ROW, area stabilized with seed and mulch.

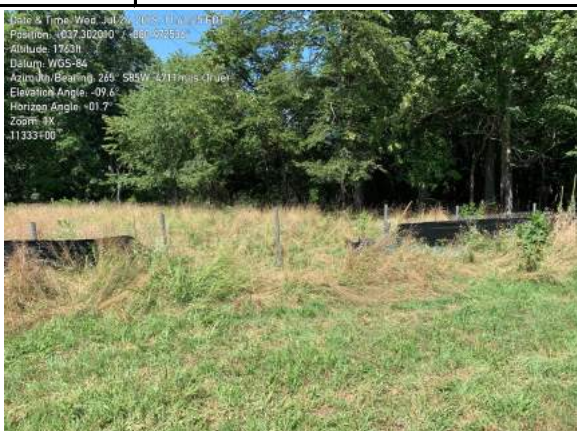
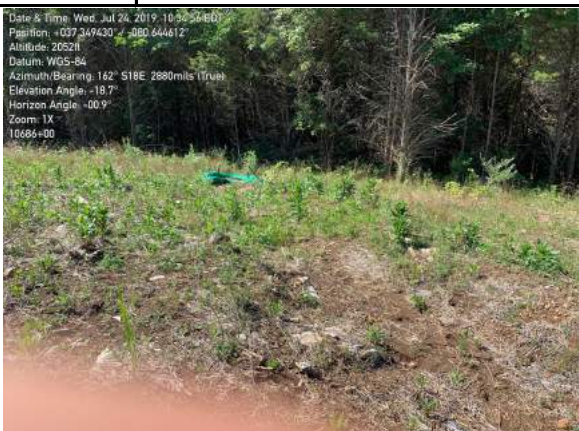
<p>Date & Time: Wed, Jul 24, 2019, 10:30:34 EDT Position: -037.349430, -080.644612 Altitude: 2026ft Datum: WGS-84 Azimuth/Bearing: 162° S18E 2880mils (True) Elevation Angle: -18.7° Horizon Angle: -00.9° Zoom: 1X 10686+00</p>				
GPS Location	37.18	Field Station#	11333+00	GPS Location	37.18	Field Station#	10686+00
Pic 5 Description	See photo for GPS location. Reinforced super silt fence removed by land owner.			Pic 6 Description	See photo for GPS location. Waterbar with triple stack CFS in place.

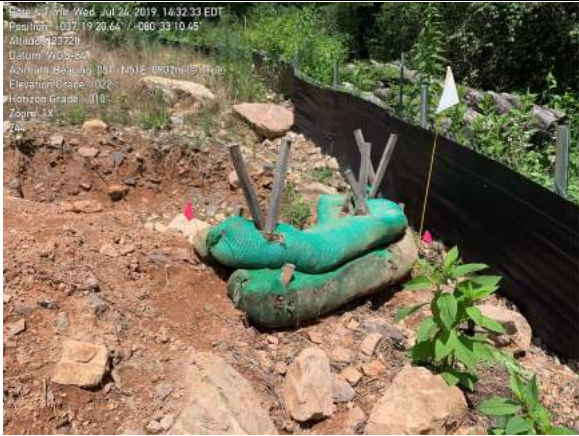
GPS Location			37.24	Field Station#			10889+00			GPS Location			37.24	Field Station#			1025+00		
Pic 5 Description			ECD's and row conditions						Pic 6 Description			Confirmed PL repairs

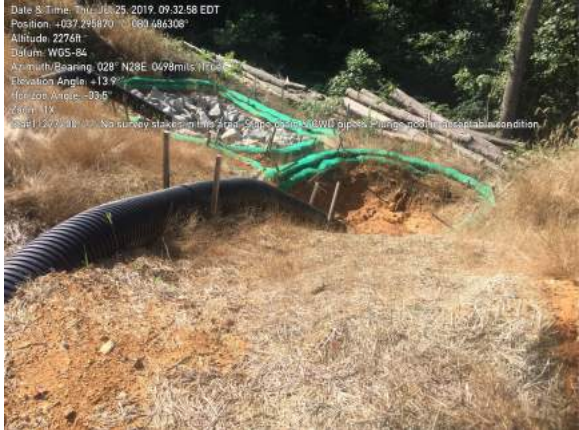
<p>Date & Time: Thu, Jul 25, 2019, 09:32:58 EDT Position: +037.296770° / -090.496308° Altitude: 2276ft Datum: WGS84 Azimuth/Bearing: 028° N28E 067mils.11ft Elevation Angle: +13.9° Horizon Angle: -93.6° Zoom: 1X Sta# 11277+00 - No survey stakes in this area, CWD pipes & plunge pool are in acceptable condition.</p>

GPS Location	37.29	Field Station#	11271+00	GPS Location	37.29	Field Station#	11277+00
Pic 1 Description	Slope drain inlet rock full of sediment, needs to be refreshed.			Pic 2 Description	Estimated sta#, Stakes fadded or none existent, Slope drain & CWD pipe & plunge pool are in acceptable condition.

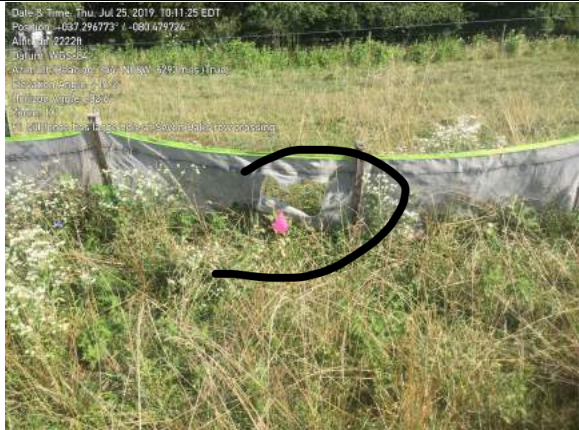
<p>Date & Time: Thu, Jul 25, 2019, 10:11:25 EDT Position: +037.296773° / -090.496308° Altitude: 2222ft Datum: WGS84 Azimuth/Bearing: 335° N28W 195mils.11ft Elevation Angle: +12.9° Horizon Angle: -82.7° Zoom: 1X Sta# 11298+00 - P1 perimeter controls has a large hole.</p>

GPS Location	37.29	Field Station#	11292+00	GPS Location	37.29	Field Station#	11298+00
Pic 3 Description	Stream- S- MM18- P1 silt fence fabric is washed out coming onto bridge at travel lane cut.			Pic 4 Description	P1 perimeter controls has a large hole.		
<p>Date & Time: Thu, Jul 25, 2019, 10:40:42 EDT Position: +037.309172° / -090.506689° Altitude: 2293ft Datum: WGS84 Azimuth/Bearing: 028° N28E 067mils.11ft Elevation Angle: +13.9° Horizon Angle: -93.6° Zoom: 1X Sta# 11300+10 - P1 perimeter controls has hole in it.</p>

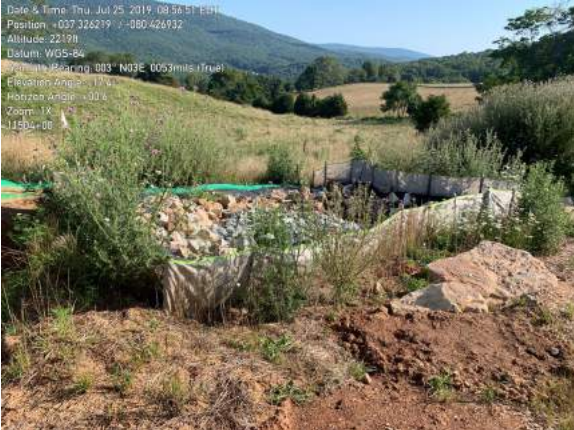
GPS Location		37.18	Field Station#		11504+00
Pic 1 Description		See photo for GPS location. Plunge pool in place.

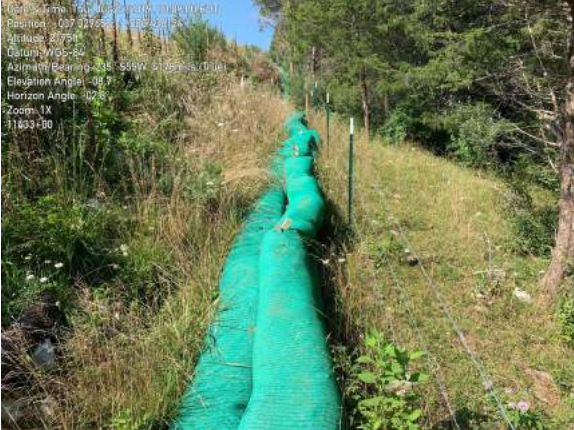
GPS Location		37.18	Field Station#		11433+00
Pic 3 Description		See photo for GPS location. Triple stack compost filter sock in place.

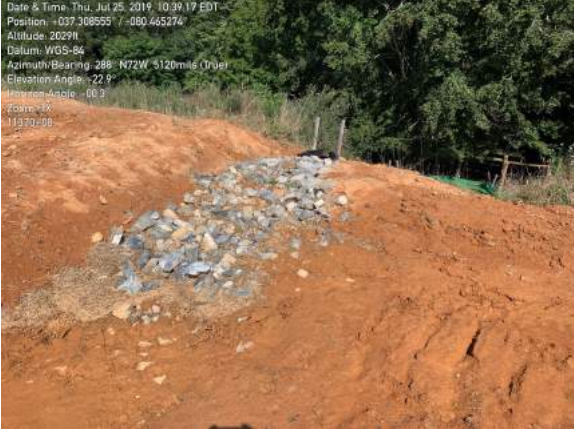
GPS Location		37.18	Field Station#		11370+00
Pic 5 Description		See photo for GPS location. Rock inlet in place at slope drain pipe.			
GPS Location		37.18	Field Station#		11489+00
Pic 2 Description		See photo for GPS location. RCE in place at Stevers Gap Road.			
GPS Location		37.18	Field Station#		11411+00
Pic 4 Description		See photo for GPS location. Environmental crew conducting waterbar maintenance.			
GPS Location		37.18	Field Station#		11383+00
Pic 6 Description		See photo for GPS location. Environmental crew seed, mulching, and crimping ROW.

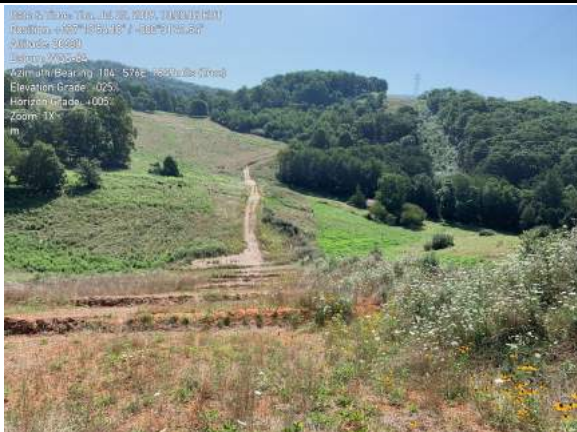
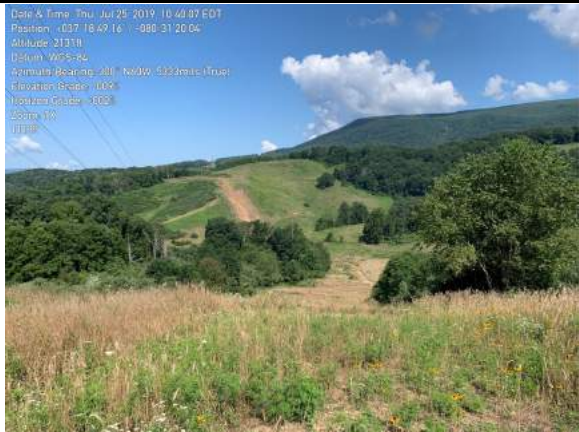
GPS Location		37.24	Field Station#		11135+00		GPS Location		37.24	Field Station#		11135+00	
Pic 3 Description		ECD's and row conditions						Pic 4 Description		ECD's and row conditions

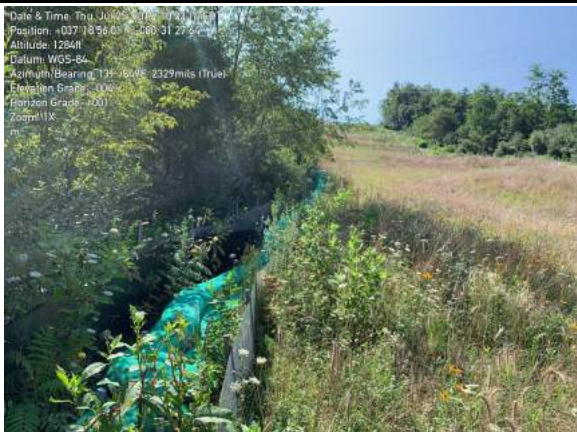
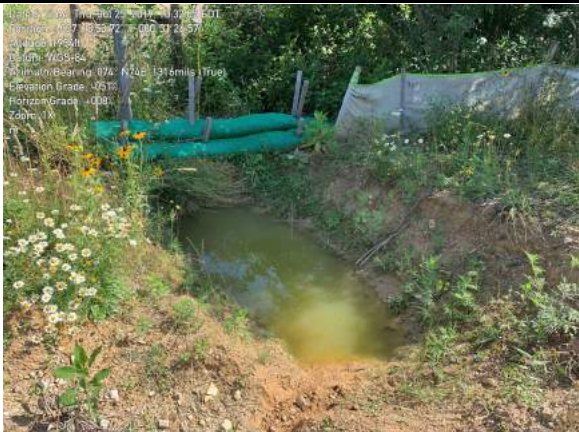
GPS Location		37.24	Field Station#		11140+00		GPS Location		37.24	Field Station#		11125+00	
Pic 5 Description		ECD's and row conditions						Pic 6 Description		ECD's and row conditions

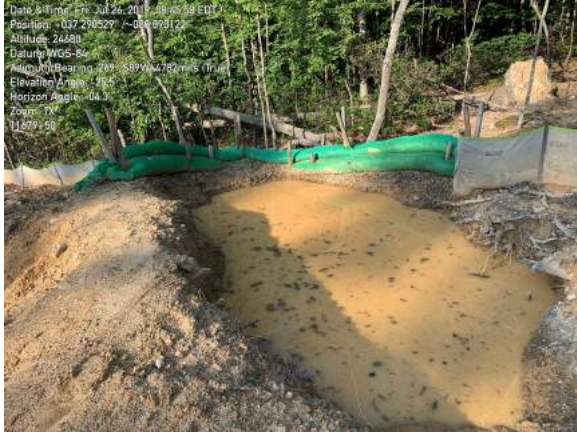
<p>Date & Time: Fri Jul 26, 2019 09:34:00 EDT Position: +037 297631 / -080 391394 Altitude: 2458ft Datum: WGS-84 Azimuth/Bearing: 145° S15E 34.3mils (True) Elevation Angle: -18.2 Horizon Angle: -06.9 Zoom: 1X 11687+00</p>				
GPS Location	37.18	Field Station#	11679+00	GPS Location	37.18	Field Station#	11687+40
Pic 1 Description	See photo for GPS location. Sump pit and waterbar end treatment in place.			Pic 2 Description	See photo for GPS location. Sensitive resource buffer in place at stream S-MN21.

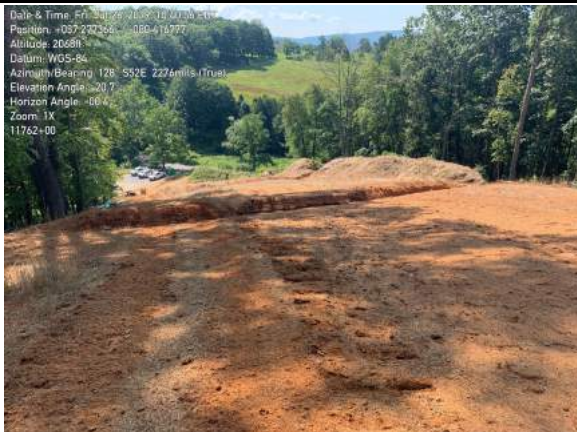
GPS Location	37.18	Field Station#	11762+00	GPS Location	37.18	Field Station#	11748+00
Pic 3 Description	See photo for GPS location. Waterbar in place.			Pic 4 Description	See photo for GPS location. Off ROW sediment cleaned up. Disturbed area stabilized with seed and mulch.

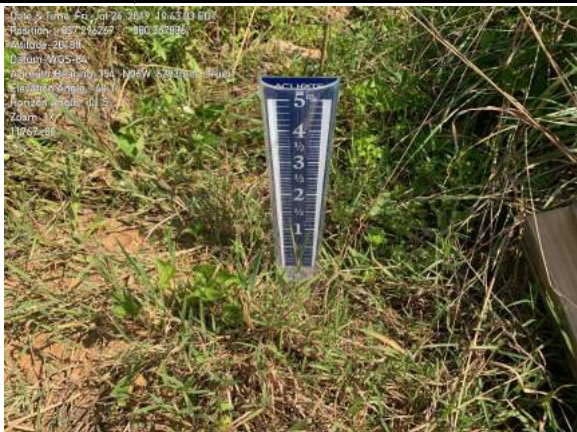
<p>Date & Time: Fri Jul 26, 2019 16:43:03 EDT Position: +037 296135 / -080 389338 Altitude: 2039ft Datum: WGS-84 Azimuth/Bearing: 124° S56E 220.4mils (True) Elevation Angle: -16.5 Horizon Angle: -10.0 Zoom: 1X 11767+00</p>				
GPS Location	37.18	Field Station#	11767+00	GPS Location	37.18	Field Station#	11767+00
Pic 5 Description	See photo for GPS location. Rain gauge at Mount Tabor Road reads 0.			Pic 6 Description	See photo for GPS location. RCE in place at Main Line Valve 26.
