Visual Site Inspection Report

Project Name H-600 Pipeline Spread G		AFE 124300137	Spread H-600 Pipeline Spread
Contractor Precision		Report # 100007	
Inspector Jared Saunders		Date/Time 9/9/2019 4:28 PM	
Permit # TBD	Inspection Type VA SWPP	Station Begin	10650+00
State VA	Inspection Area Partial	Station End	10832+00
County Giles	Ground Dry	Temperature (°F)	86.00
Municipality N/A	Weather Sunny	Rain Gauge (in)	0.00
			Rain Accumulation Time (days) 1.00

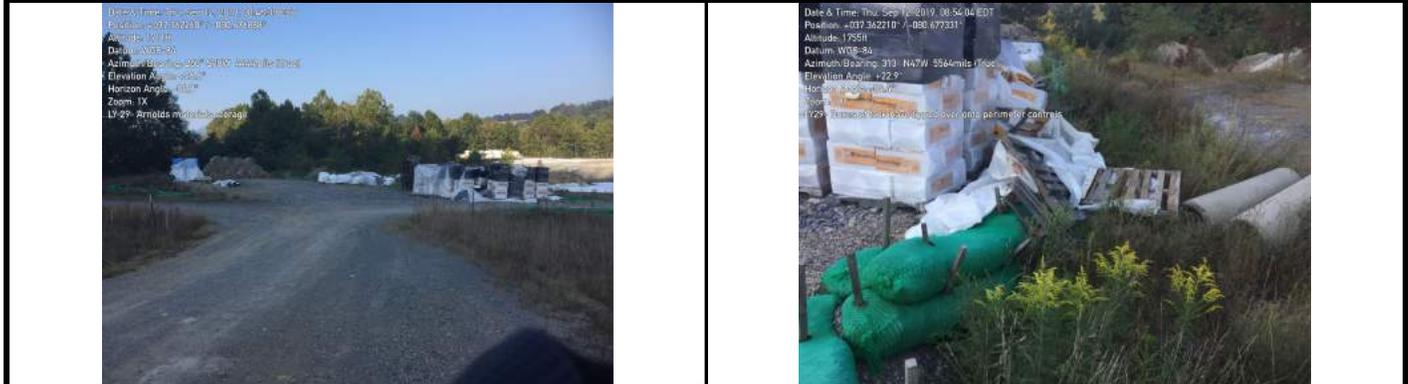
SWPPP inspection: LY-29
 Arnold's materials storage, plastic tarps over materials are shredded by wind, stockpiles boxes of tack have tipped over onto perimeter controls.
 Culvert and drainage feature are in acceptable condition.
 House keeping is acceptable.
 AR-238.00 is maintained in acceptable condition.
 CFS triple stack perimeter controls are in acceptable condition.
 Flags on over head goal posts are gone, shredded by wind.
 Rock surface of the yard is maintained in acceptable condition.

Pic 1 Desc.	Arnold's materials storage.	Pic 2 Desc.	Arnold's tack boxes have fallen over onto perimeter controls.
--------------------	-----------------------------	--------------------	---

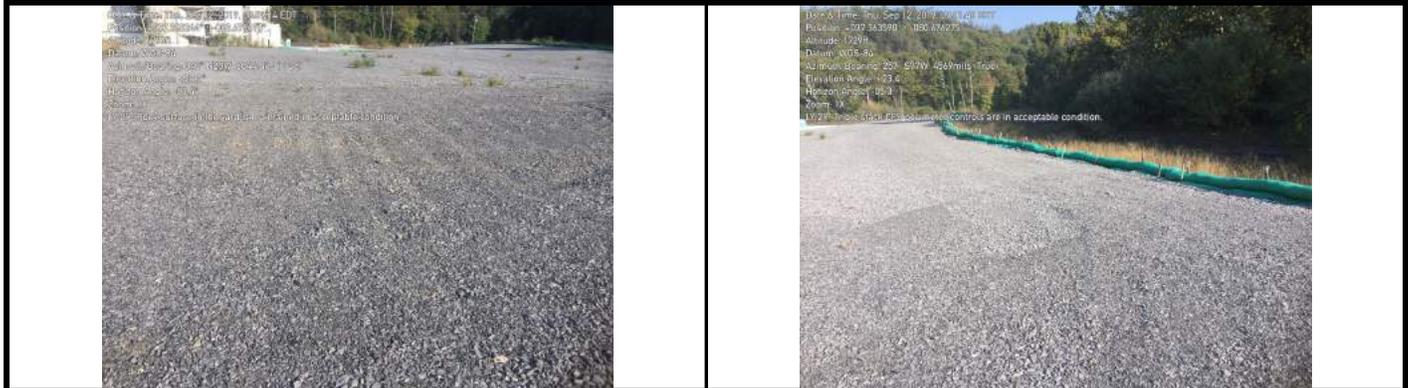
Pic 3 Desc.	Rock surface is maintained in acceptable condition.	Pic 4 Desc.	CFS triple stack perimeter controls are in acceptable condition
--------------------	---	--------------------	---

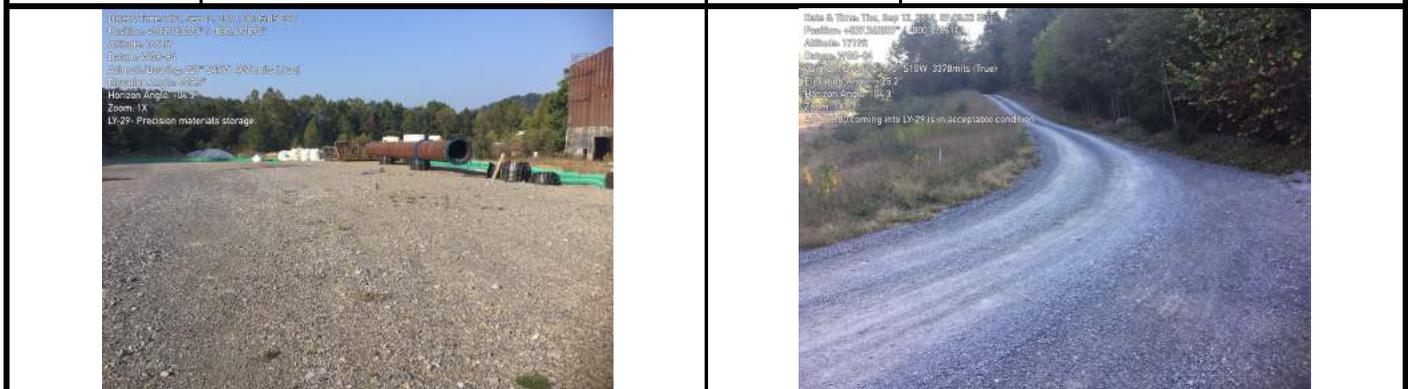
Pic 5 Desc.	Precision materials storage.	Pic 6 Desc.	AR-238.00- Road coming into the yard is in acceptable condition.
--------------------	------------------------------	--------------------	--

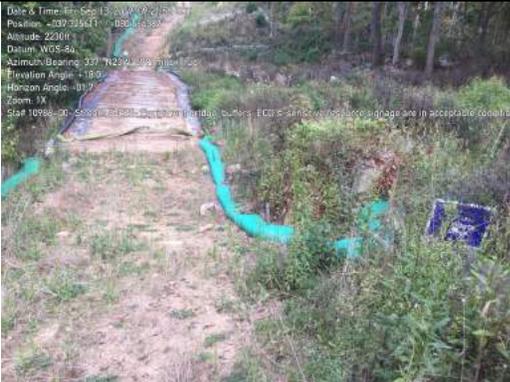
<p>Date & Time: Fri, Sep 13, 2019 7:39:05 EDT Position: -107.226431, 43.04399178 Altitude: 2230ft Datum: WGS 84 Azimuth Bearing: 332.7123E 0000mils (FPO) Elevation Angle: +18.0 Horizon Angle: -01.7 Zoom: IX Star#10986-00-525201- Equipment bridge, buffers, ECD's, sensitive resource signage are in acceptable condition.</p>

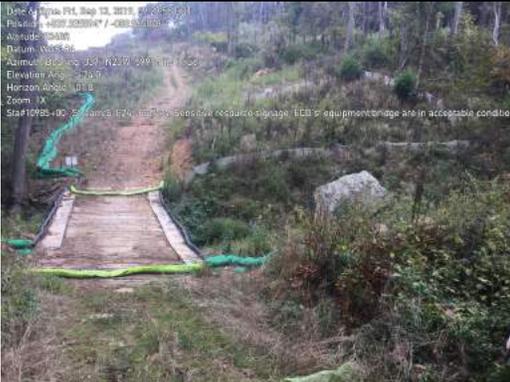
<p>Date & Time: Fri, Sep 13, 2019 7:39:05 EDT Position: -107.2309447, 43.04399178 Altitude: 2300ft Datum: WGS 84 Azimuth Bearing: 331.1123E 0000mils (FPO) Elevation Angle: +22.0 Horizon Angle: -01.8 Zoom: IX Star#10985+00-524201- Buffers, ECD's, Equipment bridge, sensitive resource signage are in acceptable condition.</p>			
GPS Location		See photo GPS		GPS Location	
Field Station#		10986+00		Field Station#	
Pic 3 Desc.		Stream S-E25- Equipment bridge, Sensitive resource signage, buffers, ECD's are in acceptable condition.		Pic 4 Desc.	
				Stream S-E24- Buffers, ECD's, Equipment bridge, sensitive resource signage are in acceptable condition.

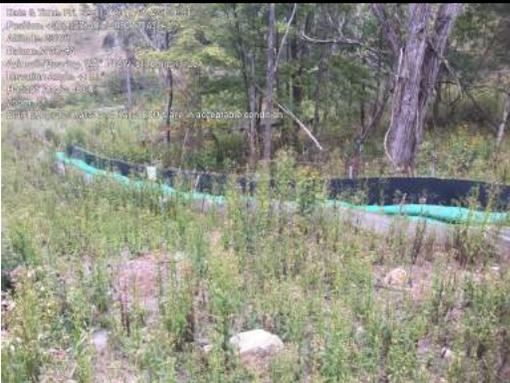
<p>Date & Time: Fri, Sep 13, 2019 7:39:05 EDT Position: -107.2309447, 43.04399178 Altitude: 2350ft Datum: WGS 84 Azimuth Bearing: 331.1123E 0000mils (FPO) Elevation Angle: +21.0 Horizon Angle: -01.8 Zoom: IX Star#10965+00-524201- Karst and Karst ECD's & signage are in acceptable condition.</p>

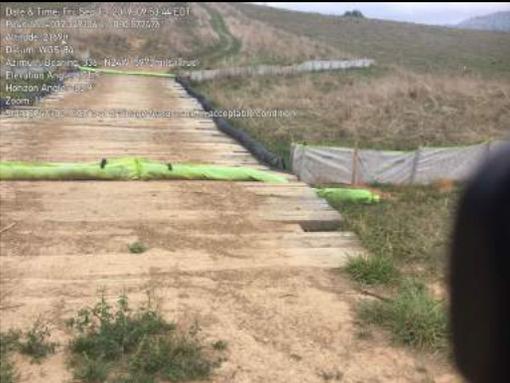
<p>Date & Time: Fri, Sep 13, 2019 7:39:05 EDT Position: -107.2309447, 43.04399178 Altitude: 2350ft Datum: WGS 84 Azimuth Bearing: 331.1123E 0000mils (FPO) Elevation Angle: +21.0 Horizon Angle: -01.8 Zoom: IX Star#10947+00-524201- Drainage feature and controls are in acceptable condition.</p>			
GPS Location		See photo GPS		GPS Location	
Field Station#		10965+00		Field Station#	
Pic 5 Desc.		Karst and Karst ECD's & signage are in acceptable condition.		Pic 6 Desc.	
				Drainage feature and controls are in acceptable condition.

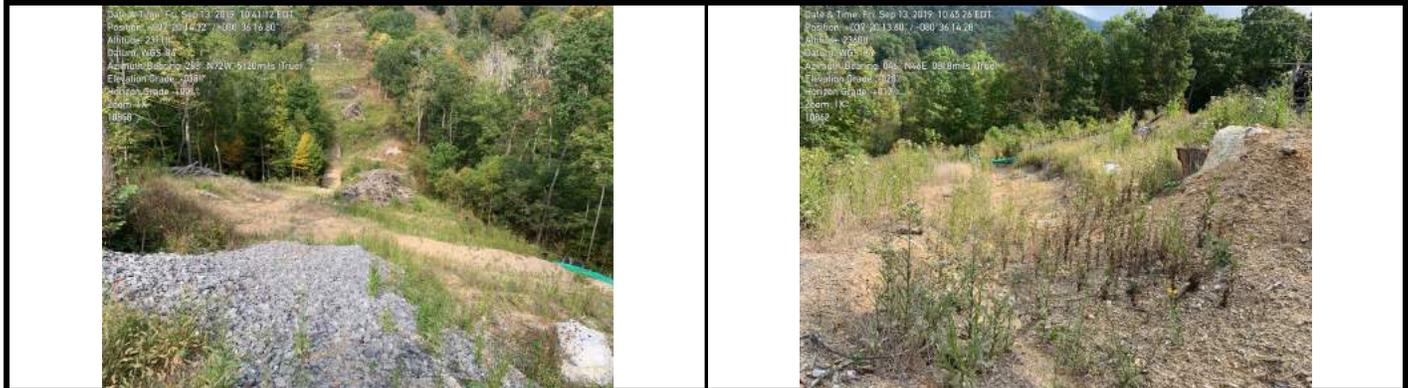
GPS Location	See picture above for GPS coordinates	GPS Location	See picture above for GPS coordinates
Field Station#	10858+00	Field Station#	10862+00
Pic 3 Desc.	ECD's and row conditions	Pic 4 Desc.	ECD's and row conditions

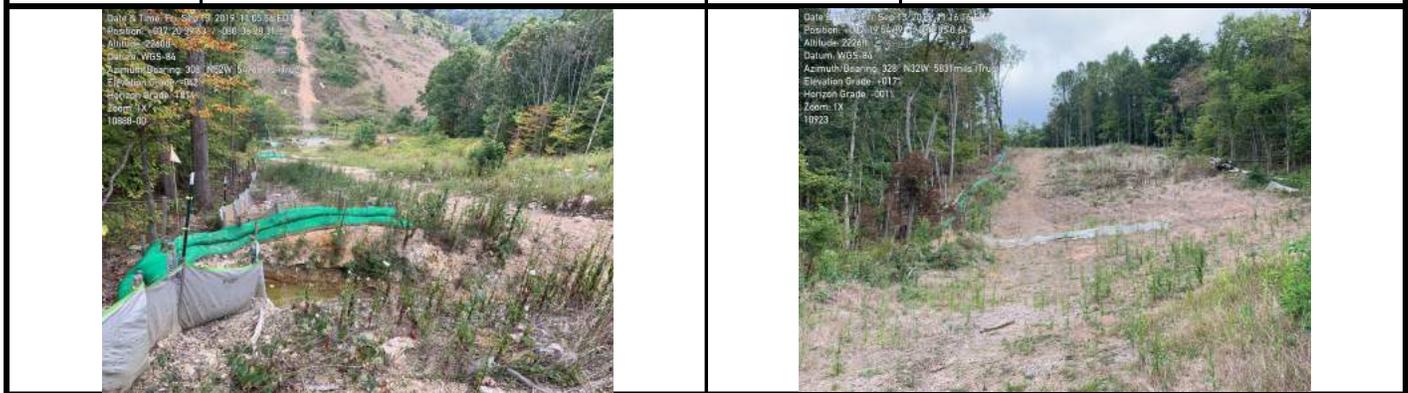
GPS Location	See picture above for GPS coordinates	GPS Location	See picture above for GPS coordinates
Field Station#	10888+00	Field Station#	10923+00
Pic 5 Desc.	ECD's and row conditions	Pic 6 Desc.	ECD's and row conditions

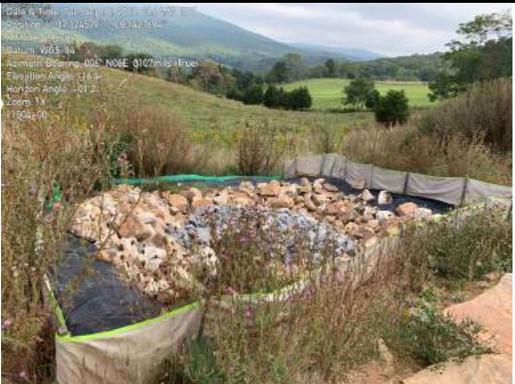
<p><small>Date & Time: Sat, Sep 14, 2019, 10:52:56 EDT Position: 33° 11' 42.50" N, -83° 42' 29.00" W Altitude: 225.00 Datum: WGS 84 Azimuth/ Bearing: 300° 2500Y 45.00m (1 True) Elevation Angle: 40.2° Horizon Angle: -108.0° Zoom: IX 11502+00</small></p>		
GPS Location	See photo for GPS location.		GPS Location	See photo for GPS location.	
Field Station#	11504+00		Field Station#	11502+00	
Pic 1 Desc.	Plunge pool in place.		Pic 2 Desc.	Conveyance channel with rock checks in place.

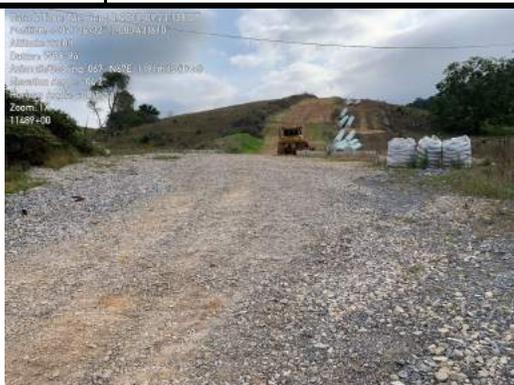
GPS Location	See photo for GPS location.		GPS Location	See photo for GPS location.	
Field Station#	11494+50		Field Station#	11489+00	
Pic 3 Desc.	Priority one silt fence with broken stake.		Pic 4 Desc.	RCE in place at Stevers Gap Road.

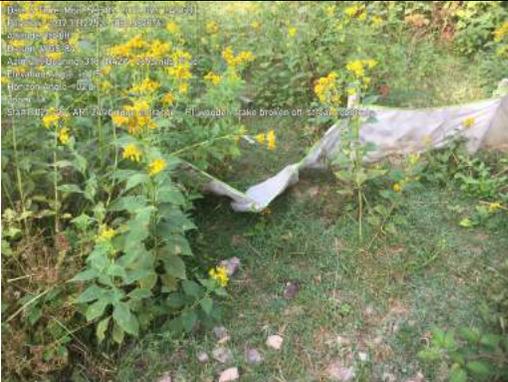
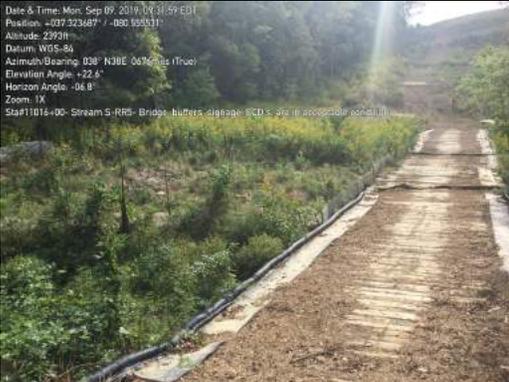
<p>Date & Time: Mon, Sep 09, 2019, 08:31:59 EDT Position: +037.323687° / -080.155531° Altitude: 2291ft Datum: WGS-84 Azimuth/Bearing: 038° N38E 057% (to True) Elevation Angle: +22.4° Horizon Angle: -06.8° Zoom: IX Sta#11016+00- Stream S-RR5- Bridge- buffers, signage, equipment bridge are in acceptable condition.</p>	
GPS Location	See photo GPS	GPS Location	See photo GPS		
Field Station#	11022+00	Field Station#	11016+00		
Pic 1 Desc.	P1 wooden stake broken off, stream control at entrance to bridge at AR- 244.	Pic 2 Desc.	Stream S-RR5- ECD's, buffers, signage, equipment bridge are in acceptable condition.

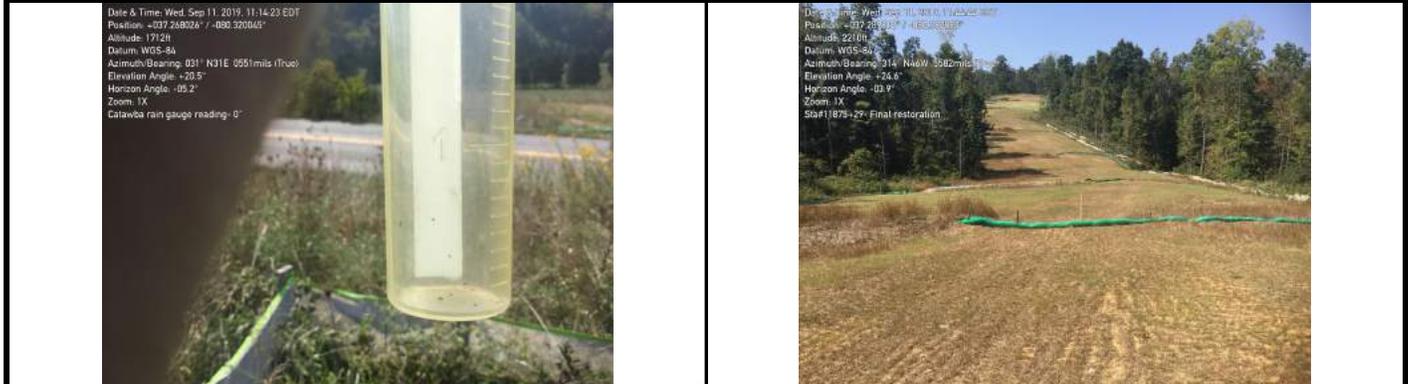
GPS Location	See photo GPS	GPS Location	See photo GPS
Field Station#	11998+00	Field Station#	11875+29
Pic 1 Desc.	Catawba rain gauge reading- 0.00"	Pic 2 Desc.	Final restoration

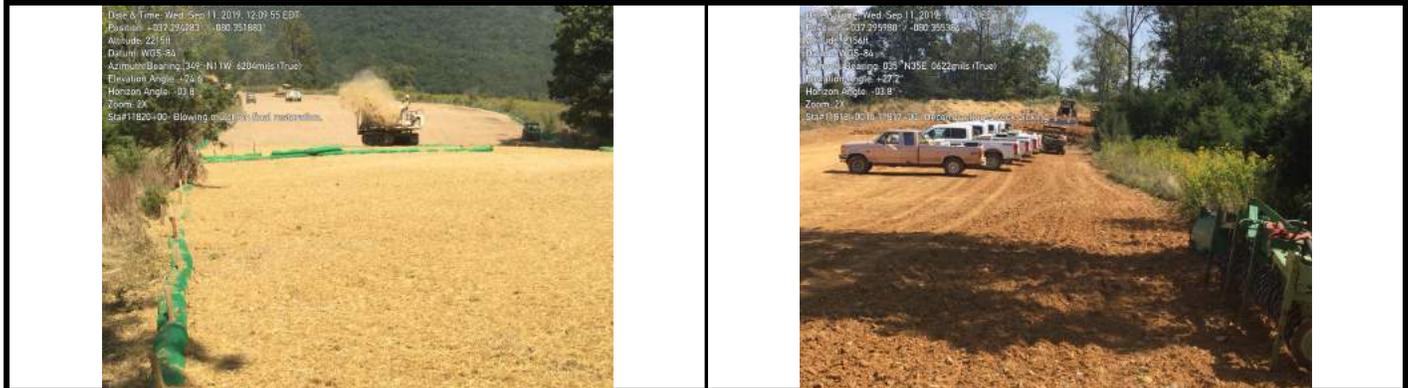
GPS Location	See photo GPS	GPS Location	See photo GPS
Field Station#	11820+00	Field Station#	11818+00
Pic 3 Desc.	Contractor blowing straw mulch on final restoration.	Pic 4 Desc.	Sta#11818 to 11817+00- Decompacting and rock picking in progress.

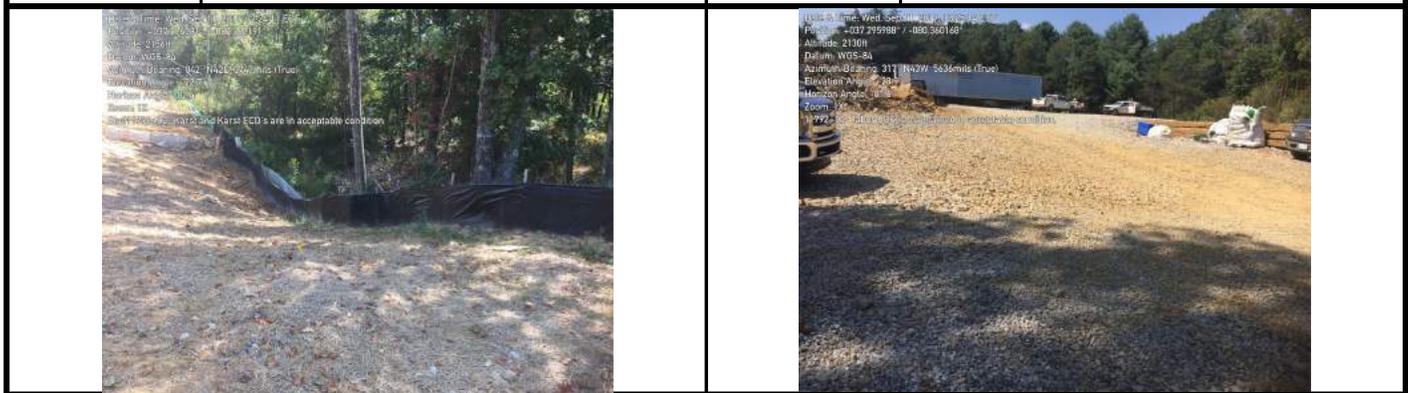
GPS Location	See photo GPS	GPS Location	See photo GPS
Field Station#	11792+00	Field Station#	11792+00
Pic 5 Desc.	Karst and Karst ECD's are in acceptable condition.	Pic 6 Desc.	Tabor RCE is in acceptable condition.

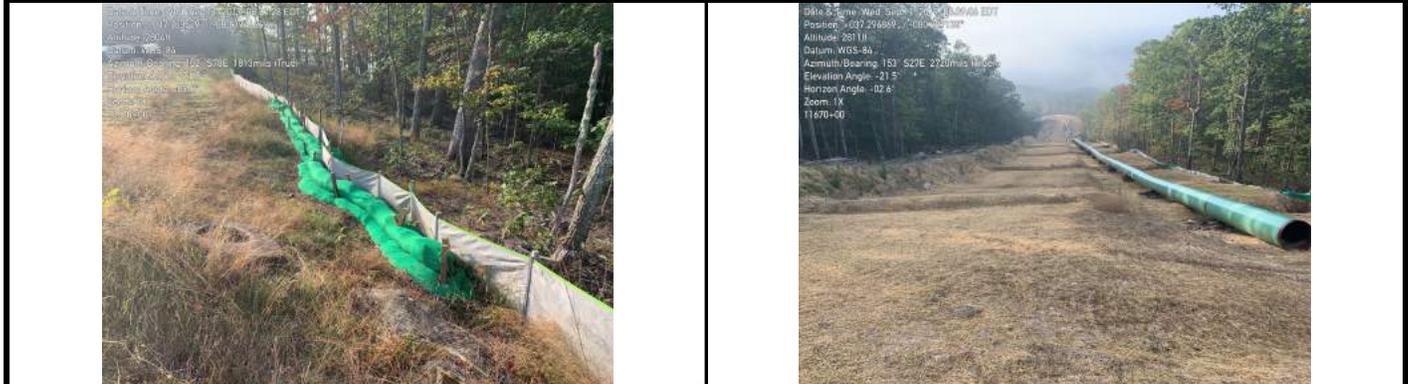
GPS Location	See photo for GPS location.	GPS Location	See photo for GPS location.
Field Station#	11670+00	Field Station#	11670+50
Pic 1 Desc.	Triple stack CFS and priority one silt fence in place.	Pic 2 Desc.	ROW has been stabilized with seed and mulch. Minor vegetation growth present.

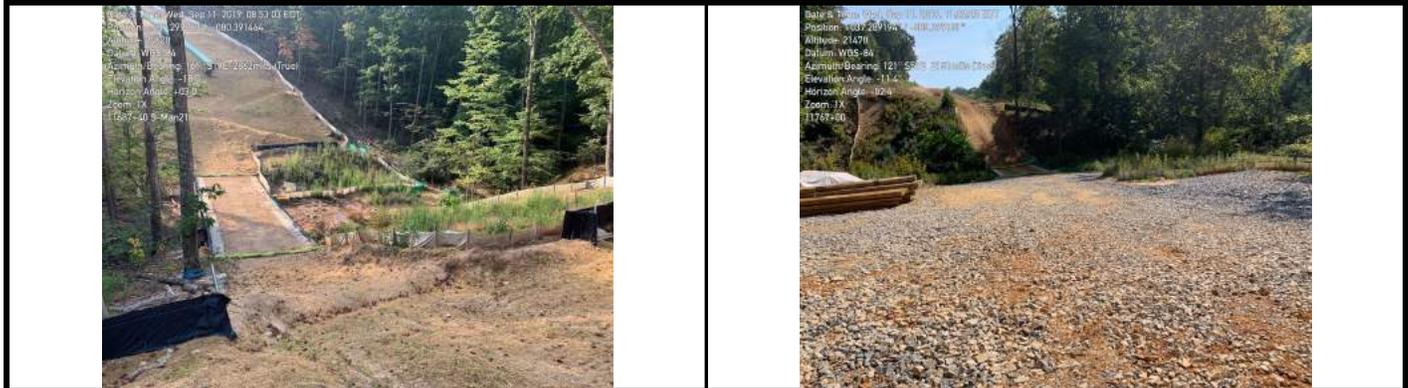
GPS Location	See photo for GPS location.	GPS Location	See photo for GPS location.
Field Station#	11687+40	Field Station#	11767+00
Pic 3 Desc.	Sensitive resource buffer in place at stream S-MN21.	Pic 4 Desc.	RCE in place at main line valve 26.

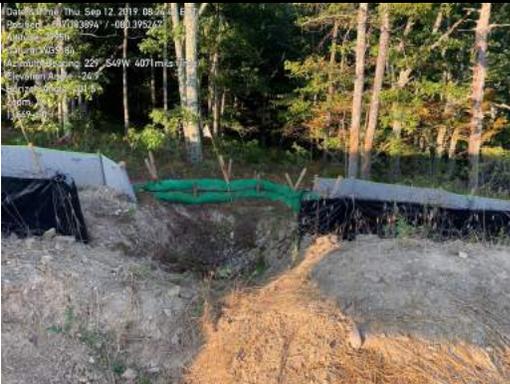
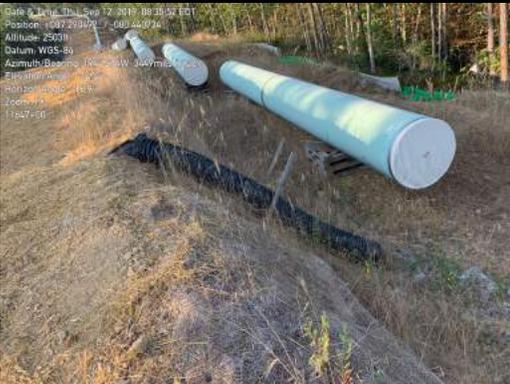
GPS Location	See photo for GPS location.	GPS Location	See photo for GPS location.		
Field Station#	11669+00	Field Station#	11647+00		
Pic 1 Desc.	Upgraded end treatment to triple stack CFS.	Pic 2 Desc.	Slope drain pipe with rock inlet and outlet in place over two-tone.

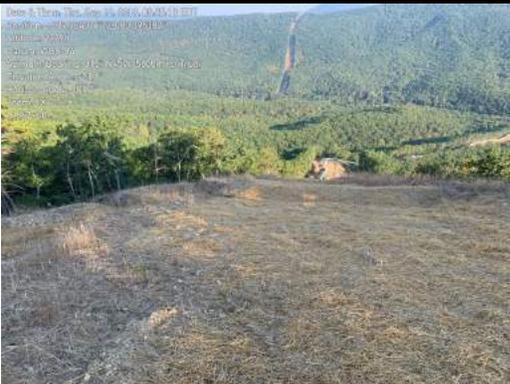
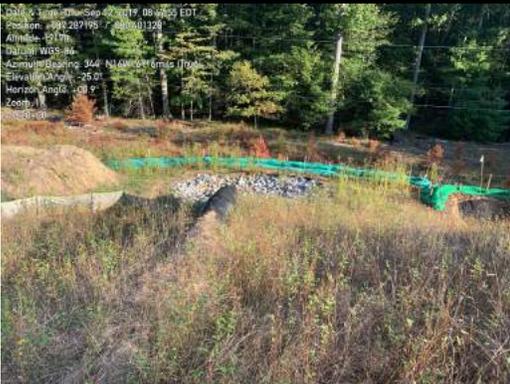
GPS Location	See photo for GPS location.	GPS Location	See photo for GPS location.		
Field Station#	11667+00	Field Station#	11620+00		
Pic 3 Desc.	Waterbar in place. Disturbed travel lane temporarily stabilized with seed and mulch.	Pic 4 Desc.	Plunge pool and clean water diversion pipe in place.

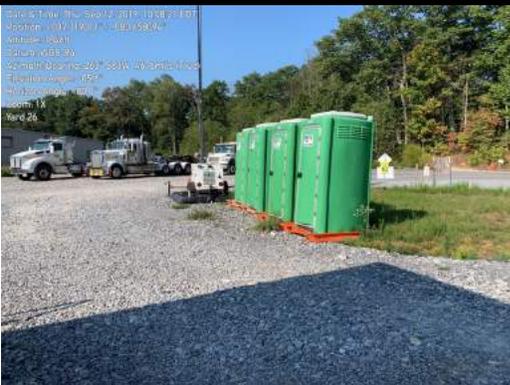
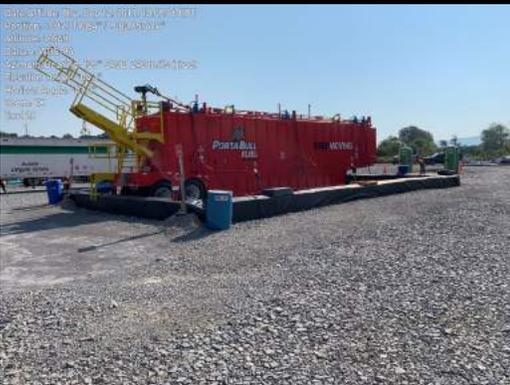
GPS Location	See photo for GPS location.	GPS Location	See photo for GPS location.		
Field Station#	12005+00	Field Station#	12005+00		
Pic 5 Desc.	Porta potties and light plant in secondary containment.	Pic 6 Desc.	Fuel cell in secondary containment and spill kit in place.

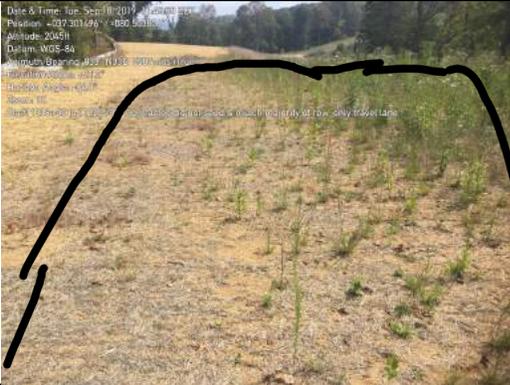
<p><small>Date & Time: Tue, Sep 10, 2019, 10:02:01 EDT Position: +037.301496 / +080.581008 Altitude: 2055ft Datum: WGS-84 Azimuth/Bearing: 032 N32E 000/mils (True) Elevation Angle: +21.7° Horizon Angle: -03.9° Zoom: IX Sta#11225+00- Contractor stabilized road & mulched travel lane.</small></p>

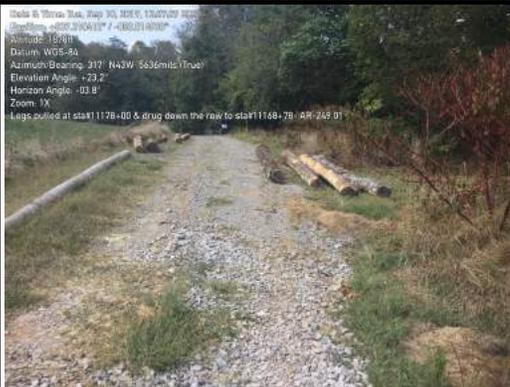
Sta#11178+76 to 11177+00- Landowner has pulled stockpiled logs on the edge of the lod across the CFS perimeter controls destroying the sock and filling the sump pit with logs. The logs were dragged down the row a 1000 ft to AR-249.01. I contacted EI lead Brian Shields and land agent Roland Dean. Roland and I met on site, (Tract VA GI - 200.012), he will talk to the landowner and a course of action will be discussed as to ECD repair.
Winter stabilization has been done between Winding Way and Mountain Lake, but there are area's where just the travel lane was seeded and mulched and not the entire row.

GPS Location	See photo GPS	GPS Location	
Field Station#	11168+78	Field Station#	
Pic 9 Desc.	Logs stockpiled on AR-249.01 from tract 200.012	Pic 10 Desc.

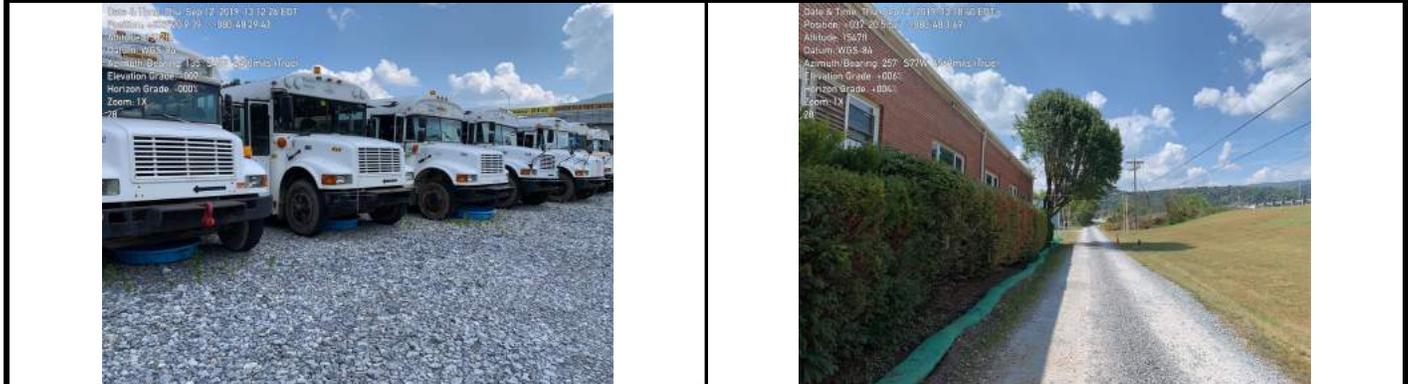
Field Station#	+28	Field Station#	+28
-----------------------	-----	-----------------------	-----

Drove to Roanoke to take DEQ SWPPP test
 Performed SWPPP inspection for LDY 28
 No damaged ECD's observed during inspection
 ECD's installed per spec and per E&S plans
 No signs of sediment outside of LOD or impacting any sensitive resources
 Proper secondary containment observed

Pic 1 Desc.	ECD's and row conditions @ LDY 28	Pic 2 Desc.	ECD's and row conditions @ LDY 28
--------------------	-----------------------------------	--------------------	-----------------------------------

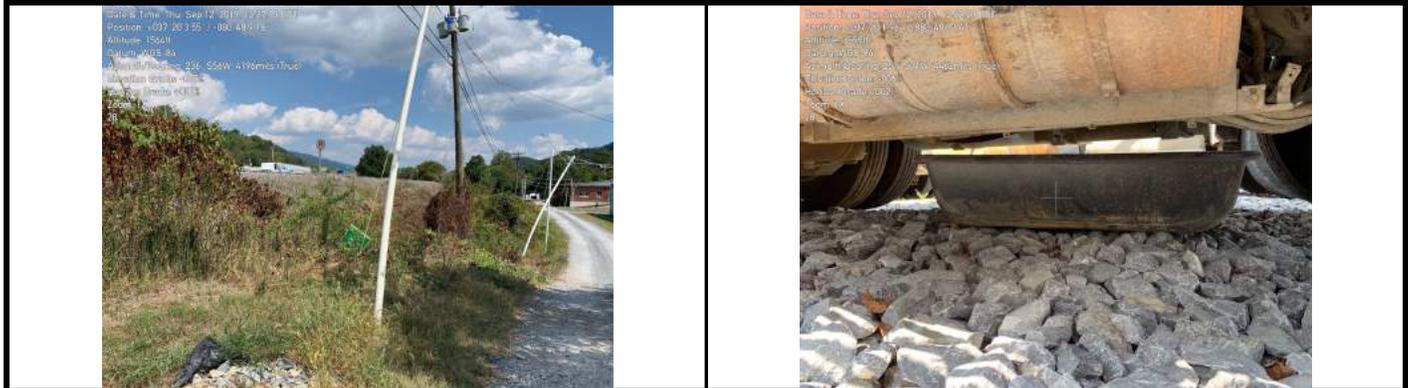
Field Station#	+28	Field Station#	+28
-----------------------	-----	-----------------------	-----

Pic 3 Desc.	ECD's and row conditions @ LDY 28	Pic 4 Desc.	Secondary containment
--------------------	-----------------------------------	--------------------	-----------------------

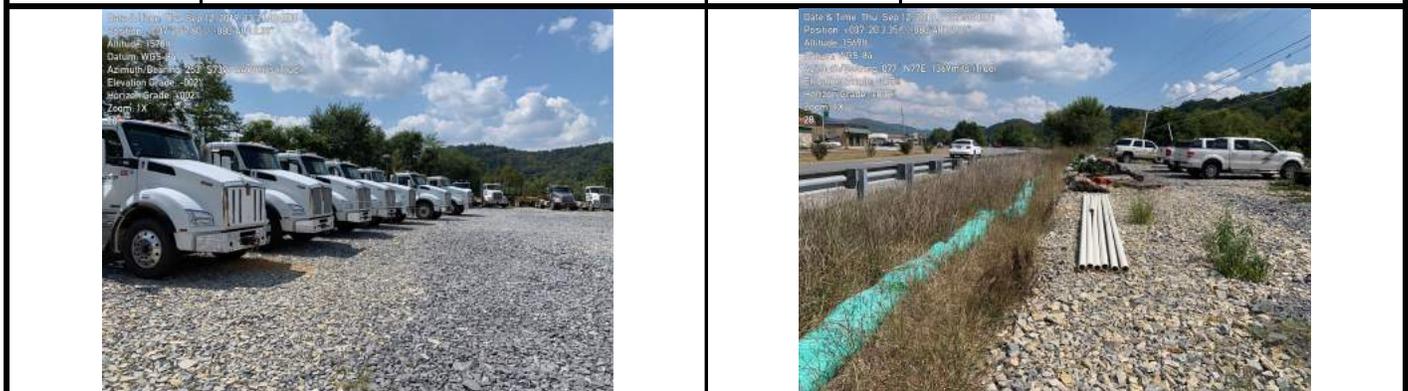
Field Station#	+28	Field Station#	+28
-----------------------	-----	-----------------------	-----

Pic 5 Desc.	ECD's and row conditions @ LDY 28	Pic 6 Desc.	ECD's and row conditions @ LDY 28
--------------------	-----------------------------------	--------------------	-----------------------------------
