Visual Site Inspection Report

Project Name	H-600 Pipeline Spread H	AFE	124300138	Spread	H-600 Pipeline Spread H
Contractor	Precision			Report #	5243
Inspector	Pat Davis			Date/Time	10/28/2019 5:05 PM
Permit #	TBD	Inspection Type	VA SWPP	Station Begin	+0
State	VA	Inspection Area	Partial	Station End	+0
County	Montgomery	Ground	Wet	Temperature (°F)	69.00
Municipality	N/A	Weather	Sunny	Rain Gauge (in)	0.00
				Rain Accumulation Time (days)	0.00

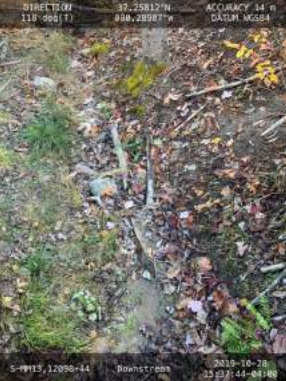
GPS Location	See photo GPS for location		GPS Location	See photo GPS for location	
Field Station#	12098+44		Field Station#	12086+56	
Pic 1 Desc.	No evidence of sediment in stream following yesterday's rain event.		Pic 2 Desc.	Bridge and ECDs in acceptable condition. Stream is dry.

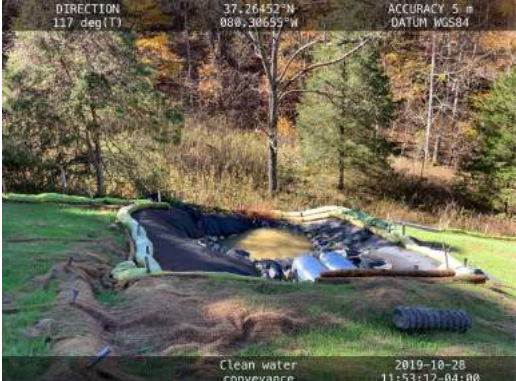
GPS Location	See photo GPS for location		GPS Location	See photo GPS for location	
Field Station#	12040+00		Field Station#	12031+51	
Pic 3 Desc.	Conveyance and plunge pools in acceptable condition.		Pic 4 Desc.	Stream, bridge, and ECDs are in acceptable condition. GAS is starting to vegetate.

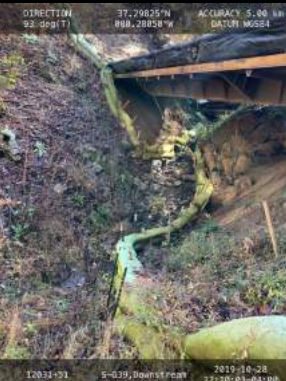
GPS Location	See photo GPS for location		GPS Location	See photo GPS for location	
Field Station#	12031+51		Field Station#	12028+00	
Pic 5 Desc.	Stream has no sediment impact post rain event. ECDs are in acceptable condition.		Pic 6 Desc.	New erosion blanket in place. No water bar slips.

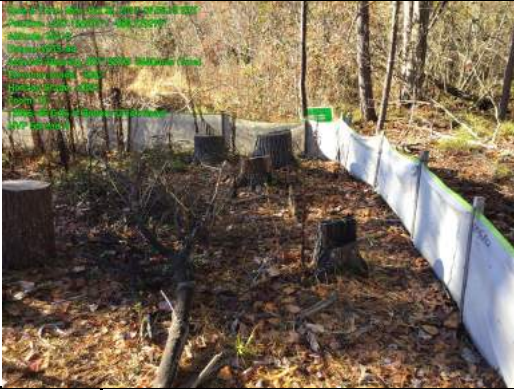
GPS Location	See pic for GPS location		GPS Location	See pic for GPS location	
Field Station#	12866+50		Field Station#	12957+30	
Pic 1 Desc.	Inspected perimeter P1 silt fence for damage and checked area for impacts from project. No issues or impacts were found.		Pic 2 Desc.	No issues or impacts were observed on access road RO-287

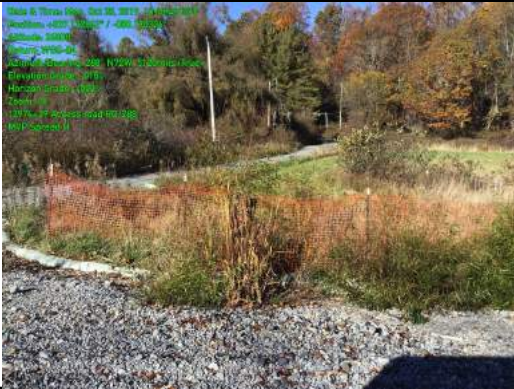
GPS Location	See pic for GPS location		GPS Location	See pic for GPS location	
Field Station#	12974+29		Field Station#	12994+75	
Pic 3 Desc.	No issues or impacts observed at RO-288.		Pic 4 Desc.	Temporary and permanent vegetation is growing in good on the GAS of the US-221 crossing.

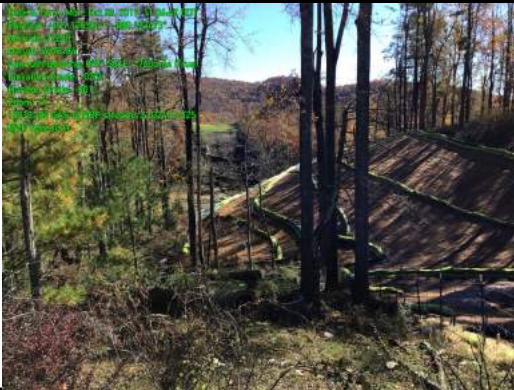
GPS Location	See pic for GPS location		GPS Location	See pic for GPS location	
Field Station#	13018+00		Field Station#	13114+00	
Pic 5 Desc.	Permanent restoration and temporary ECD's remain in good condition. No issues or impacts in the area GAS of the BRP.		Pic 6 Desc.	No erosion or other impacts observed throughout the area from US-221 to FR-292.

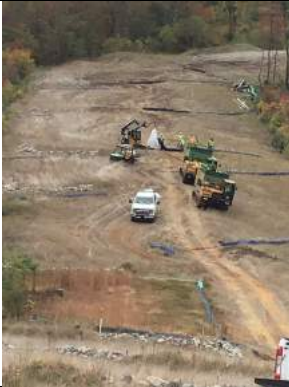
GPS Location	0000	GPS Location	0000		
Field Station#	13450+00	Field Station#	13450+00		
Pic 1 Desc.	Environmental crew installing CFS back across the row after seeding activities were completed		Pic 2 Desc.	Seeding contractor hydro seeding the row in areas needed for winter stabilization

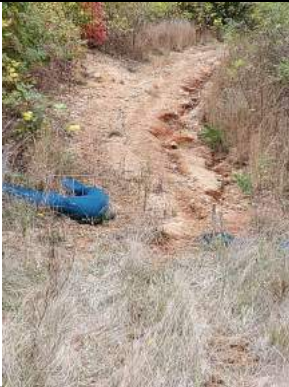
GPS Location	00000	GPS Location	0000		
Field Station#	13443+30	Field Station#	13630+30		
Pic 3 Desc.	Land owner moved boundary CFS to access a ATV trail off row.		Pic 4 Desc.	Seeding contractor hydro seeding the row in areas needed for winter stabilization	
Insert image here			Insert image here		
GPS Location		GPS Location			
Field Station#		Field Station#			
Pic 5 Desc.			Pic 6 Desc.

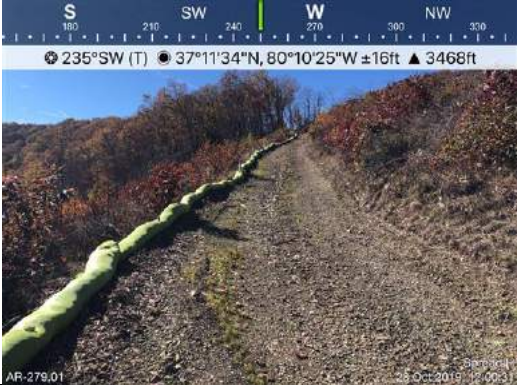
<p>Insert image here</p>			
GPS Location	see photo	GPS Location			
Field Station#	279+01	Field Station#			
Pic 13 Desc.	AR-279.01 controls in place and functioning.	Pic 14 Desc.			
<p>Insert image here</p>		<p>Insert image here</p>			
GPS Location		GPS Location			
Field Station#		Field Station#			
Pic 15 Desc.		Pic 16 Desc.			
<p>Insert image here</p>		<p>Insert image here</p>			
GPS Location		GPS Location			
Field Station#		Field Station#			
Pic 17 Desc.		Pic 18 Desc.

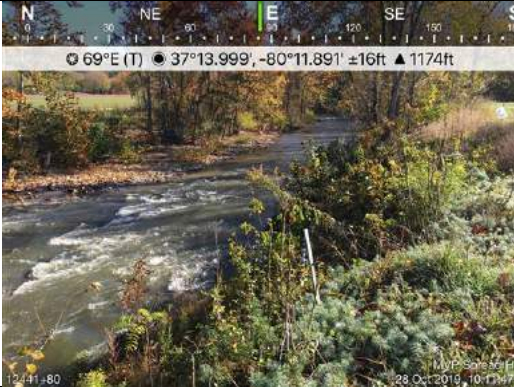
GPS Location	See Picture Watermark		GPS Location	See Picture Watermark	
Field Station#	12441+80		Field Station#	12424+45	
Pic 1 Desc.	Resource buffer zone of Roanoke River in good condition and river remains unimpacted.		Pic 2 Desc.	Construction entrance in good condition and functional.

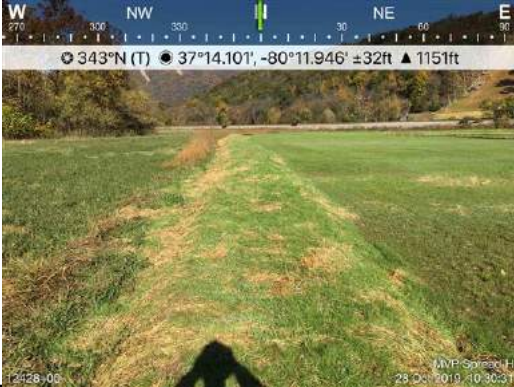
GPS Location	See Picture Watermark		GPS Location	See Picture Watermark	
Field Station#	12428+00		Field Station#	12419+00	
Pic 3 Desc.	Diversion berm stabilized, in good condition, and functional.		Pic 4 Desc.	Waterbar and sump filters functioned during rain storms. Remain in good condition.

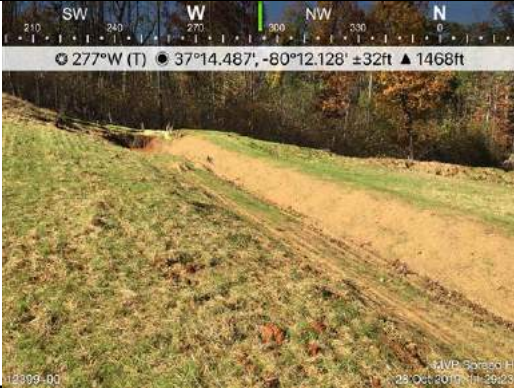
GPS Location	See Picture Watermark		GPS Location	See Picture Watermark	
Field Station#	12399+00		Field Station#	12410+00	
Pic 5 Desc.	Waterbar in good condition, stabilized, and functional.		Pic 6 Desc.	Clean water diversion inlet in good condition and free of sediment.

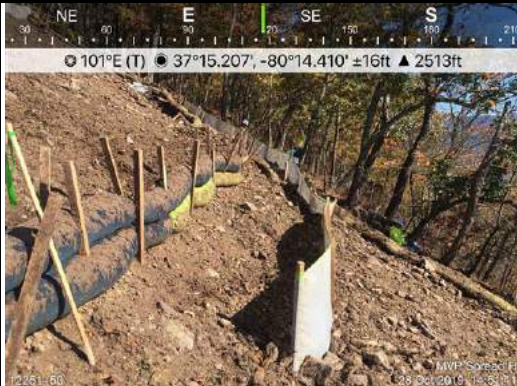
GPS Location	See Picture Watermark		GPS Location	See Picture Watermark	
Field Station#	12251+50		Field Station#	12430+00	
Pic 9 Desc.	P1 silt fence installed as temporary protection measure at punchlist item. ROW currently too wet for equipment travel.		Pic 10 Desc.	Clean water diversion inlet in good condition and appears functional.

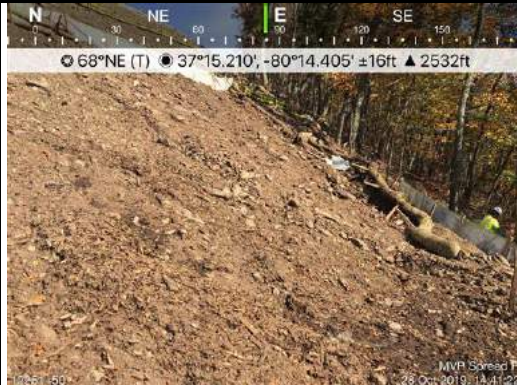
Pic 11 Desc.	Punchlist item for erosion remains to be addressed. ROW currently too wet for equipment to reach this area.		Pic 12 Desc.	CFS energy dissipation installed and appear functional.

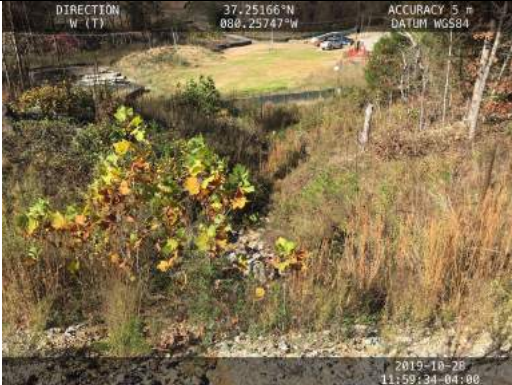
GPS Location	See photo		GPS Location	See photo	
Field Station#	12197+37		Field Station#	12192+50	
Pic 1 Desc.	Stream S-0011, facing west		Pic 2 Desc.	Stream S-C21, Bradshaw Creek, facing south

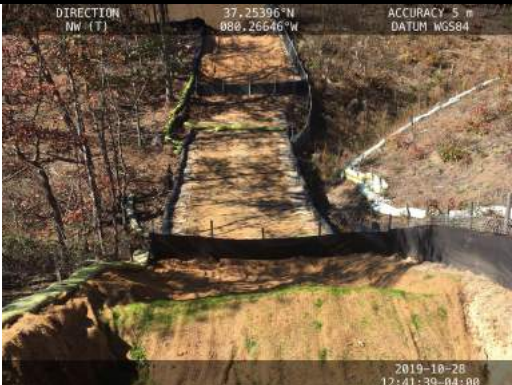
GPS Location	See photo		GPS Location	See photo	
Field Station#	12166+47		Field Station#	12163+05	
Pic 3 Desc.	Stream S-C24, facing northwest		Pic 4 Desc.	Stream S-C25, facing southwest

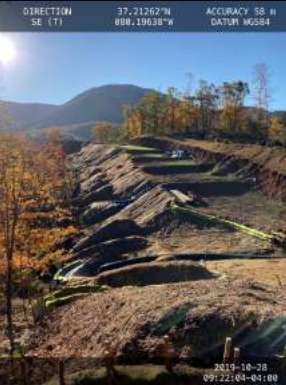
GPS Location	See picture for GPS data		GPS Location	See picture for GPS data	
Field Station#	12543+00		Field Station#	12533+00	
Pic 1 Desc.	Spoil pile erosion, hasn't gotten any bigger since before.		Pic 2 Desc.	Stabilized ROW with fill slope pipes.

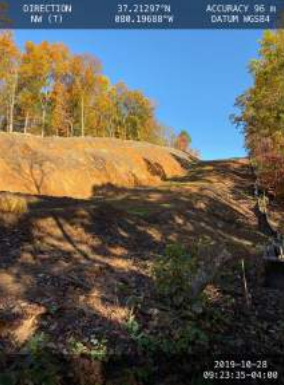
GPS Location	See picture for GPS data		GPS Location	See picture for GPS data	
Field Station#	12528+00		Field Station#	12520+00	
Pic 3 Desc.	Spoil pile.		Pic 4 Desc.	Waterbar with no new erosion in travel lane.

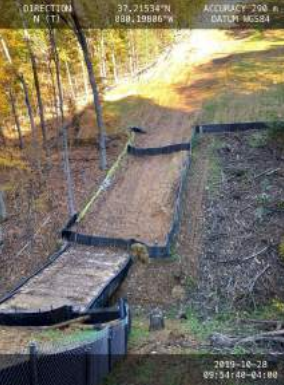
GPS Location	See picture for GPS data		GPS Location	See picture for GPS data	
Field Station#	12519+41		Field Station#	12504+00	
Pic 5 Desc.	Bridge crossing S-EF19		Pic 6 Desc.	Clean water crossing

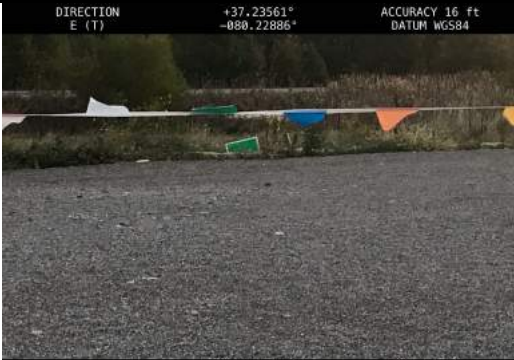
<p>DIRECTION E (T) +37.23561° -080.22886° ACCURACY 16 ft DATUM WGS84</p> <p>MVP-PY-006_110119 Signage & buffer flagging at feature 2019-11-01 07:36:06-04:00</p>

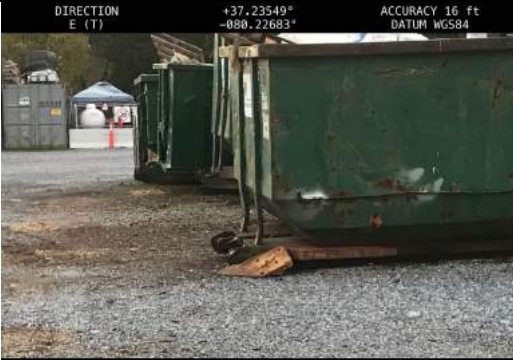
<p>DIRECTION E (T) +37.23549° -080.22683° ACCURACY 16 ft DATUM WGS84</p> <p>MVP-PY-006_110119 No loose trash around dumpsters 2019-11-01 07:38:41-04:00</p>

GPS Location	MVP-PY-006 See photo for gps data		GPS Location	MVP-PY-006 See photo for gps data	
Field Station#	+0		Field Station#	+0	
Pic 3 Desc.	Blue Bulk Fuel tanks no leaky fittings. Looking SW.		Pic 4 Desc.	No loose trash around dumpsters. Looking E.

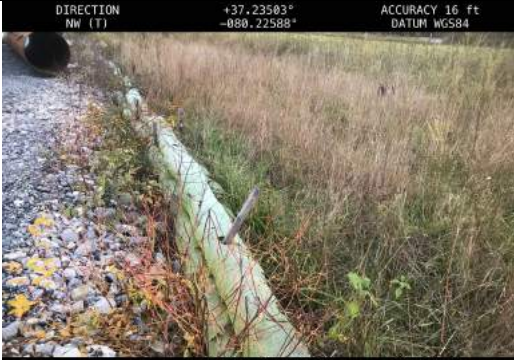
<p>DIRECTION NW (T) +37.23503° -080.22588° ACCURACY 16 ft DATUM WGS84</p> <p>MVP-PY-006_110119 Condition of CFS East LOD 2019-11-01 07:45:28-04:00</p>

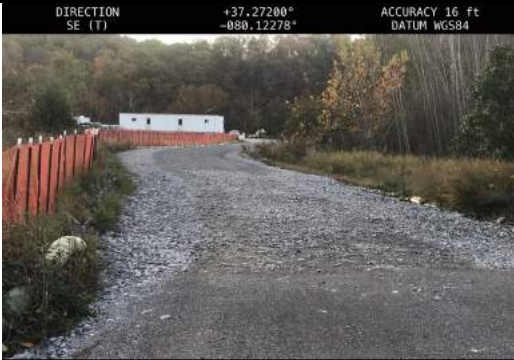
GPS Location	MVP-LY-049 See photo for gps data		GPS Location	MVP-LY-049 See photo for gps data	
Field Station#	+0		Field Station#	+0	
Pic 1 Desc.	Condition of rock entrance on center drive. Looking SE.		Pic 2 Desc.	Condition of containment under light plant. Looking S.

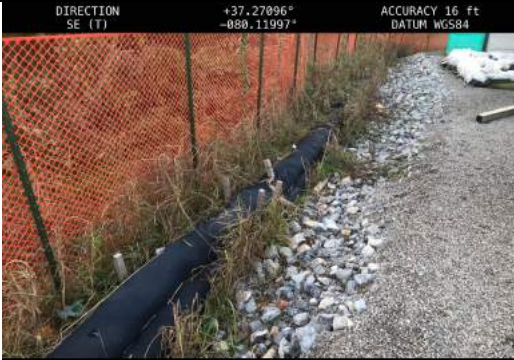
GPS Location	MVP-LY-049 See photo for gps data		GPS Location	MVP-LY-049 See photo for gps data	
Field Station#	+0		Field Station#	+0	
Pic 3 Desc.	Condition of CFS and safety fence on East boundary. Looking SE.		Pic 4 Desc.	No loose trash around FAB Area dumpsters. Looking NW.

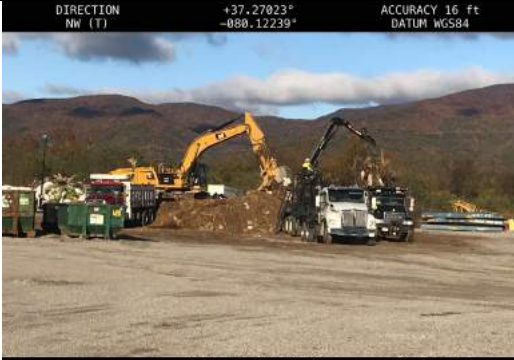
GPS Location	MVP-LY-049 See photo for gps data		GPS Location	MVP-LY-049 See photo for gps data	
Field Station#	+0		Field Station#	+0	
Pic 5 Desc.	Crew loading debris from pile on dump trucks. Looking NW.		Pic 6 Desc.	Landowner parked his equipment next to Compost filter sock and feature. No impact. Looking S.

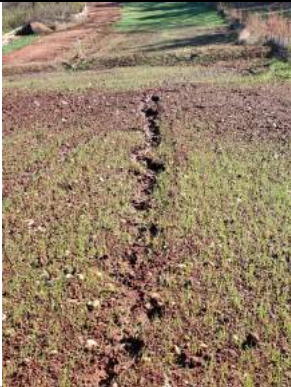
GPS Location	00000	GPS Location	0000		
Field Station#	13655+00	Field Station#	13543+11		
Pic 3 Desc.	Erosion channel , added to the punch list	Pic 4 Desc.	Sediment build up on CFS at stream crossing		
Insert image here			Insert image here		
GPS Location		GPS Location			
Field Station#		Field Station#			
Pic 5 Desc.		Pic 6 Desc.

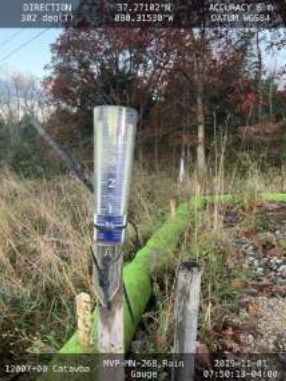
GPS Location	See photo GPS for location		GPS Location	See photo GPS for location	
Field Station#	12007+00		Field Station#	12013+97	
Pic 1 Desc.	Rainfall total for for this event is 1.50".		Pic 2 Desc.	Rising stream flow dislodged ECDs, and will need to be re-installed

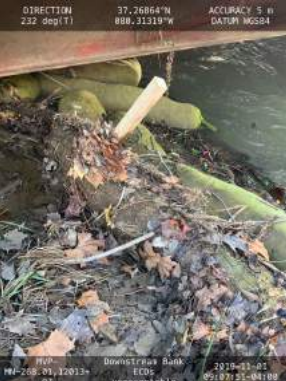
GPS Location	See photo GPS for location		GPS Location	See photo GPS for location	
Field Station#	12013+97		Field Station#	12013+97	
Pic 3 Desc.	Rising stream flow dislodged ECDs, and will need to be re-installed		Pic 4 Desc.	Rising stream flow dislodged ECDs, and will need to be re-installed

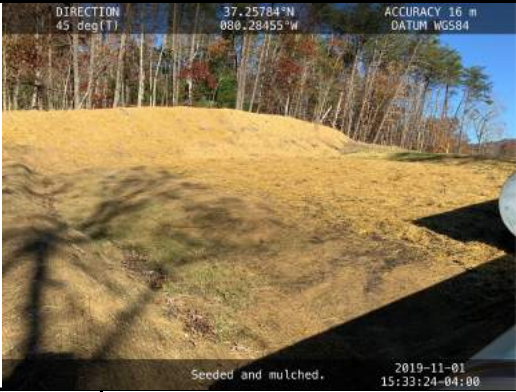
GPS Location	See photo GPS for location		GPS Location	See photo GPS for location	
Field Station#	12113+00		Field Station#	12111+15	
Pic 5 Desc.	Seeding and mulching complete on area that had not germinated since aerial seeding.		Pic 6 Desc.	Seeding and mulching complete on area that had not germinated since aerial seeding.

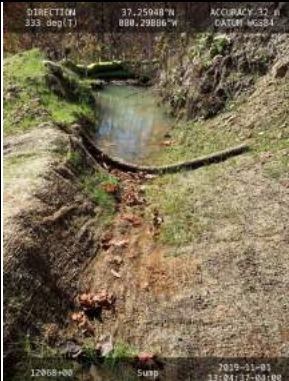
GPS Location	See photo GPS for location		GPS Location	See photo GPS for location	
Field Station#	12068+00		Field Station#	12108+41	
Pic 7 Desc.	Sump functioning properly.		Pic 8 Desc.	Stream now has water running through it. There is no sediment impact from ROW.

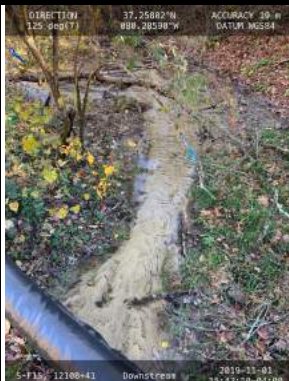
GPS Location	See photo GPS for location		GPS Location	See photo GPS for location	
Field Station#	12108+41		Field Station#	12031+51	
Pic 9 Desc.	Stream now has water running through it. There is no sediment impact from ROW.		Pic 10 Desc.	ECDs are acceptable. Stream has no sediment impact.

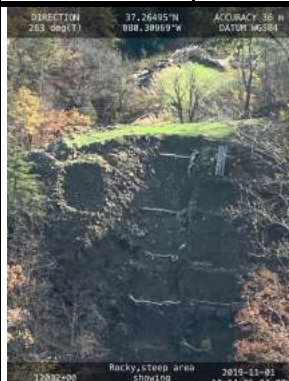
GPS Location	See photo GPS for location		GPS Location	See photo GPS for location	
Field Station#	12032+00		Field Station#	12031+51	
Pic 11 Desc.	Area showing acceptable vegetation growth. Area is stable.		Pic 12 Desc.	ECDs are acceptable. Stream has no sediment impact.

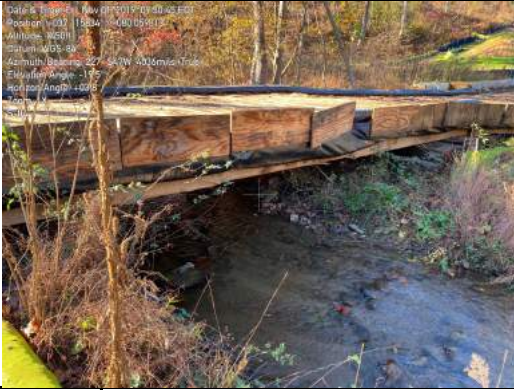
GPS Location	See photo for coordinates.		GPS Location	See photo for coordinates.	
Field Station#	13260+70		Field Station#	13260+70	
Pic 1 Desc.	S-II4, looking upstream of equipment bridge, no sediment releases noted from bridge, ECDs functioning acceptably.		Pic 2 Desc.	CIS of S-II4, permanent stabilization in progress, vegetation establishing across ROW.

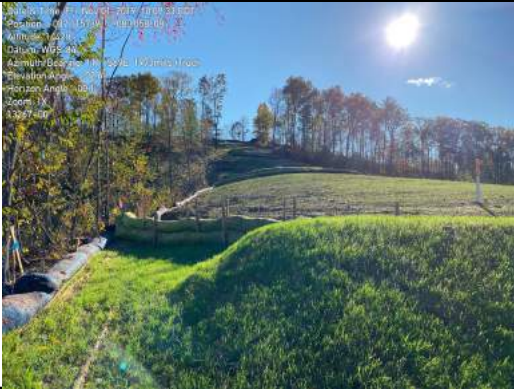
GPS Location	See photo for coordinates.		GPS Location	See photo for coordinates.	
Field Station#	13267+00		Field Station#	13270+75	
Pic 3 Desc.	Permanent vegetation establishing across ROW, germination noted in area where proganix was applied.		Pic 4 Desc.	Germination of seed applied with proganix.

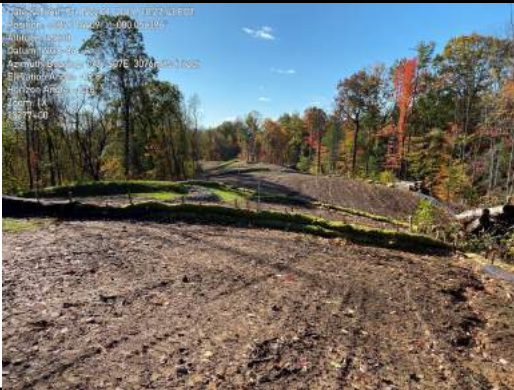
GPS Location	See photo for coordinates.		GPS Location	See photo for coordinates.	
Field Station#	13277+00		Field Station#	13302+00	
Pic 5 Desc.	Permanent waterbars, waterbar extensions, and perimeter controls functioning acceptably.		Pic 6 Desc.	Erosion control upgrades functioning acceptably, reducing erosion.

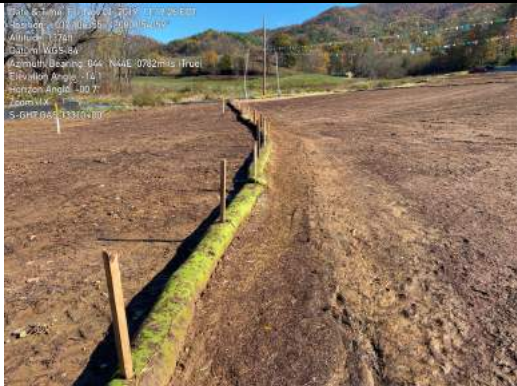
GPS Location	See photo for coordinates.	GPS Location	See photo for coordinates.		
Field Station#	13310+00	Field Station#	13312+00		
Pic 9 Desc.	Straw curlex reduced erosion where vegetation has not yet established.	Pic 10 Desc.	Straw curlex reduced erosion where vegetation has not yet established.		
Insert image here		Insert image here			
GPS Location		GPS Location			
Field Station#		Field Station#			
Pic 11 Desc.		Pic 12 Desc.
