Visual Site Inspection Report

Project Name	H-600 Pipeline Spread H	AFE	124300138	Spread	H-600 Pipeline Spread H
Contractor	Precision			Report #	6078
Inspector	Logan Box			Date/Time	11/25/2019 5:02 PM
Permit #	TBD	Inspection Type	VA SWPP	Station Begin	13415+51
State	VA	Inspection Area	Partial	Station End	13670+00
County	Franklin	Ground	Wet	Temperature (°F)	48.00
Municipality	N/A	Weather	Cloudy	Rain Gauge (in)	0.00
				Rain Accumulation Time (days)	1.00

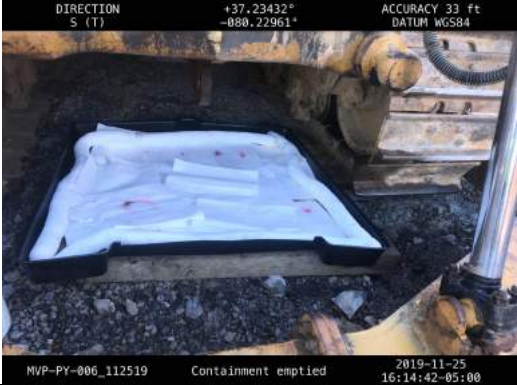
GPS Location	MVP-PY-006 See photo for gps data	GPS Location			
Field Station#	+0	Field Station#			
Pic 7 Desc.	Containment tray in dozer #R009915. Looking S.	Pic 8 Desc.			
Insert image here		Insert image here			
GPS Location		GPS Location			
Field Station#		Field Station#			
Pic 9 Desc.		Pic 10 Desc.			
Insert image here		Insert image here			
GPS Location		GPS Location			
Field Station#		Field Station#			
Pic 11 Desc.		Pic 12 Desc.

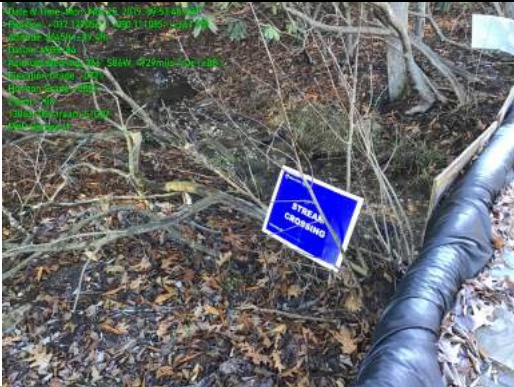
GPS Location	See pic for GPS location	GPS Location	See pic for GPS location
Field Station#	13033+59	Field Station#	13062+00
Pic 1 Desc.	0.6" total precipitation at Callaway Road.	Pic 2 Desc.	No impacts to stream S-G26 observed

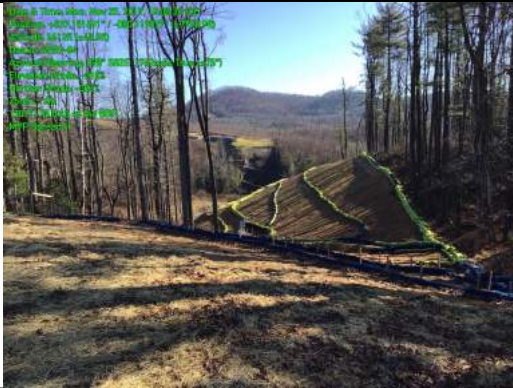
GPS Location	See pic for GPS location	GPS Location	See pic for GPS location
Field Station#	13063+00	Field Station#	13063+00
Pic 3 Desc.	No impacts to stream S-G27 observed	Pic 4 Desc.	GAS of FR-290 remains stabilized and no issues observed.

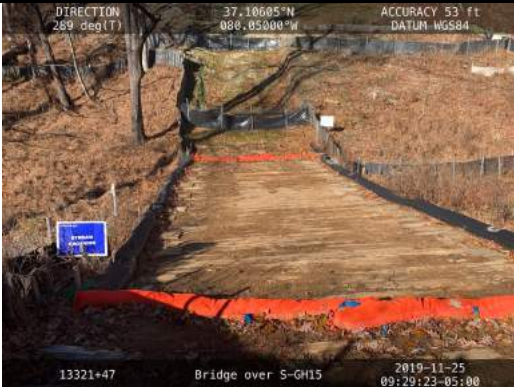
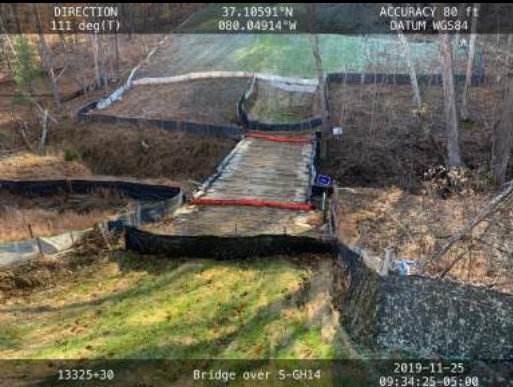
GPS Location	See photo for gps data.		GPS Location	See photo for gps data.	
Field Station#	13321+47		Field Station#	13325+30	
Pic 1 Desc.	Photo shows the bridge over stream S-GH15.		Pic 2 Desc.	Photo shows the bridge over stream S-GH14.

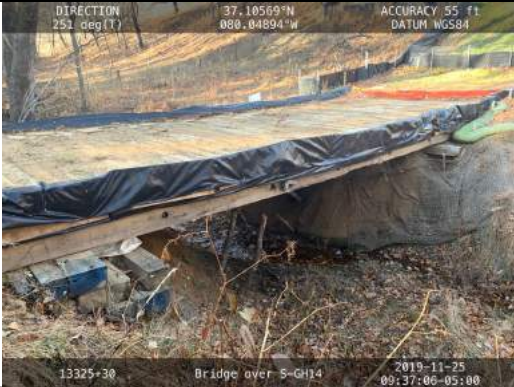
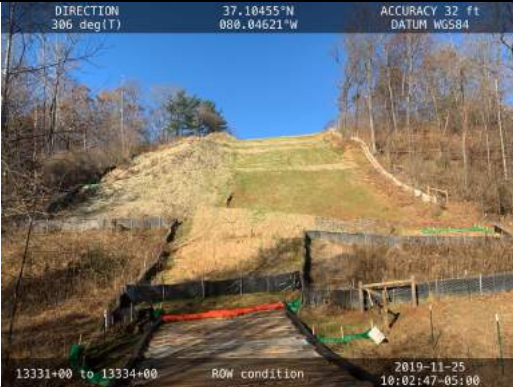
GPS Location	See photo for gps data.		GPS Location	See photo for gps data.	
Field Station#	13325+30		Field Station#	13331+00	
Pic 3 Desc.	Photo shows stream S-GH14.		Pic 4 Desc.	Photo shows the ROW condition from about 13331+00 to 13334+00.

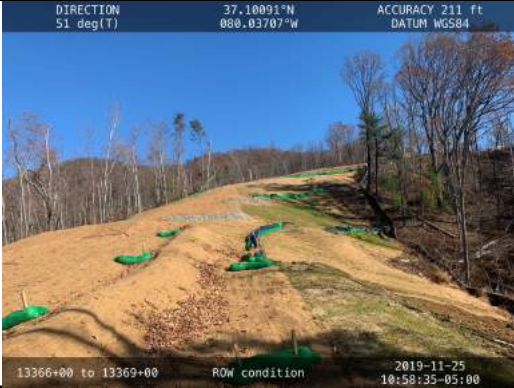
GPS Location	See photo for gps data.		GPS Location	See photo for gps data.	
Field Station#	13366+00		Field Station#	13389+00	
Pic 5 Desc.	Photo shows the ROW condition from about 13366+00 to 13369+00.		Pic 6 Desc.	Photo shows the contractor stabilizing the ROW with straw mulch.

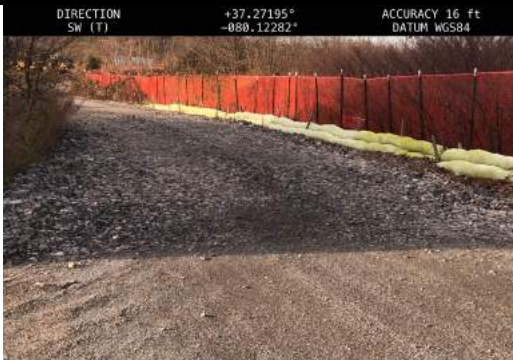
<p>DIRECTION SW (T) +37.27195° -88.12282° ACCURACY 16 ft DATUM WGS84</p> <p>MVP-LY-049_112619 Condition of North rock entrance 2019-11-26 08:32:53-05:00</p>

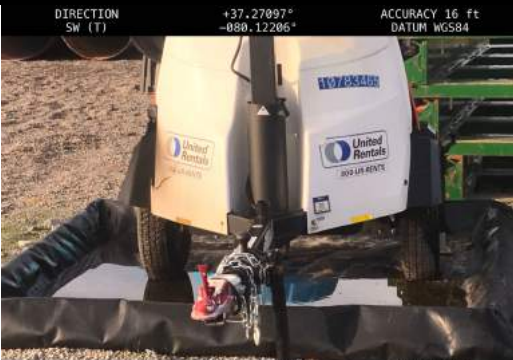
<p>DIRECTION SW (T) +37.27097° -88.12206° ACCURACY 16 ft DATUM WGS84</p> <p>MVP-LY-049_112619 Condition of containment 2019-11-26 08:33:52-05:00</p>			
GPS Location	MVP-LY-049 See photo for gps data		GPS Location	MVP-LY-049 See photo for gps data	
Field Station#	+0		Field Station#	+0	
Pic 1 Desc.	Condition of North rock entrance. Looking SW.		Pic 2 Desc.	Condition of containment under light plant. Looking SW.

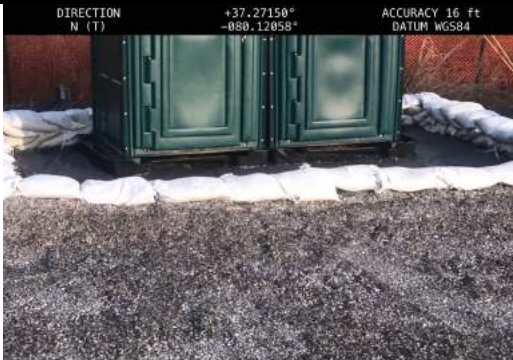
<p>DIRECTION N (T) +37.27150° -88.12058° ACCURACY 16 ft DATUM WGS84</p> <p>MVP-LY-049_112619 Condition of trays and containment 2019-11-26 08:34:56-05:00</p>

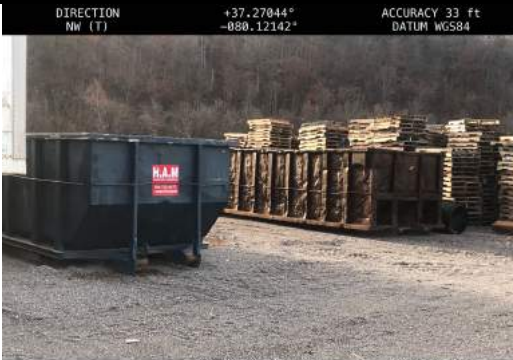
<p>DIRECTION NW (T) +37.27044° -88.12142° ACCURACY 33 ft DATUM WGS84</p> <p>MVP-LY-049_112619 No loose trash at south dumpsters 2019-11-26 08:37:28-05:00</p>

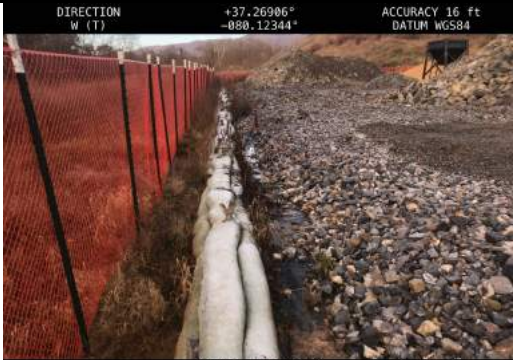
<p>DIRECTION W (T) +37.26906° -88.12344° ACCURACY 16 ft DATUM WGS84</p> <p>MVP-LY-049_112619 Condition of CFS & safety fence south LOD 2019-11-26 08:43:20-05:00</p>

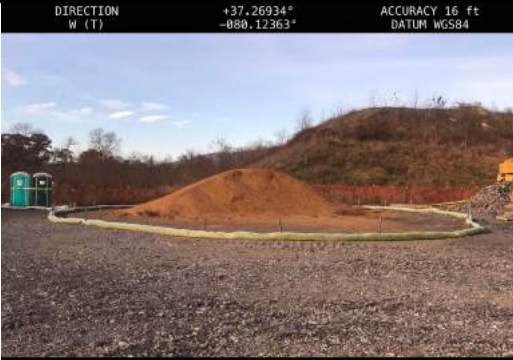
<p>DIRECTION W (T) +37.26934° -88.12363° ACCURACY 16 ft DATUM WGS84</p> <p>MVP-LY-049_112619 Condition of CFS around sand pile 2019-11-26 08:44:15-05:00</p>			
GPS Location	MVP-LY-049 See photo for gps data		GPS Location	MVP-LY-049 See photo for gps data	
Field Station#	+0		Field Station#	+0	
Pic 5 Desc.	Condition of CFS and safety fence along south LOD. Looking W.		Pic 6 Desc.	Condition of CFS around sand pile. Looking W.

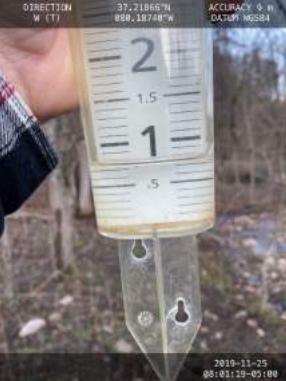
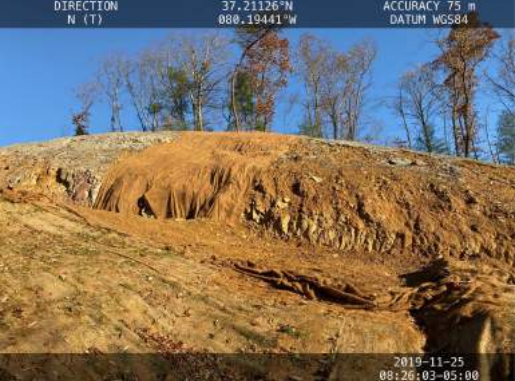
GPS Location	See picture for GPS data		GPS Location	See picture for GPS data	
Field Station#	12543+56		Field Station#	12542+00	
Pic 1 Desc.	Yellow Finch rain gauge (.7")		Pic 2 Desc.	Crew began curlex omg pile until it became too rocky and steep.

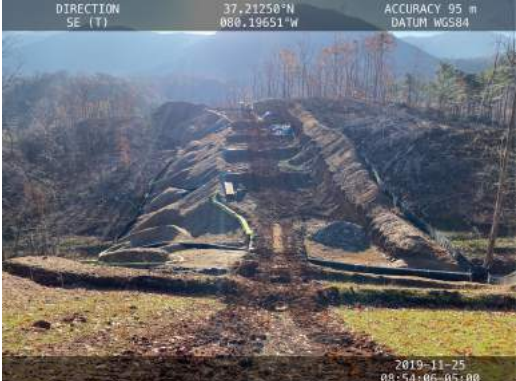
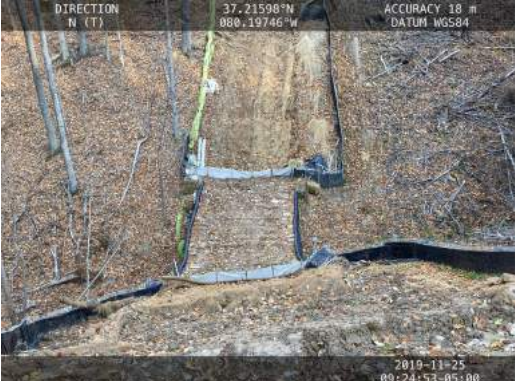
GPS Location	See picture for GPS data		GPS Location	See picture for GPS data	
Field Station#	12538+07		Field Station#	12519+40	
Pic 3 Desc.	Clear water crossing where land owner wants access across ROW.		Pic 4 Desc.	Bridge crossing S-EF19

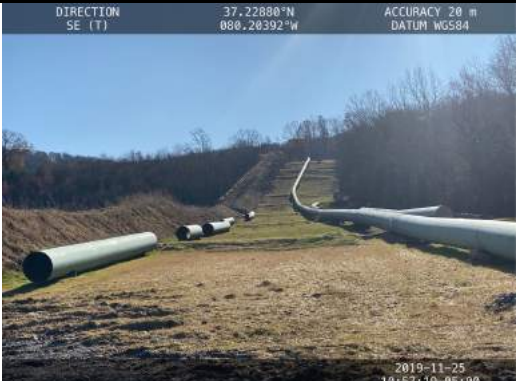
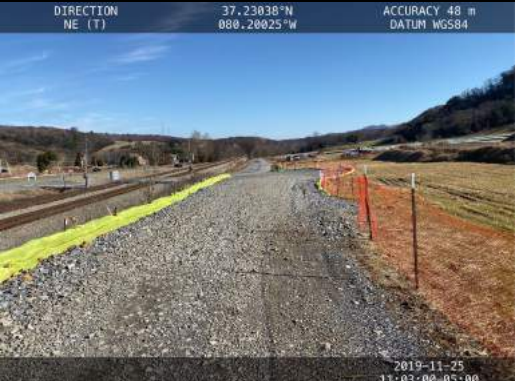
GPS Location	See picture for GPS data		GPS Location	See picture for GPS data	
Field Station#	12469+62		Field Station#	12455+37	
Pic 5 Desc.	Stabilized ROW with good vegetation growing in the temporary stabilization.		Pic 6 Desc.	RCE

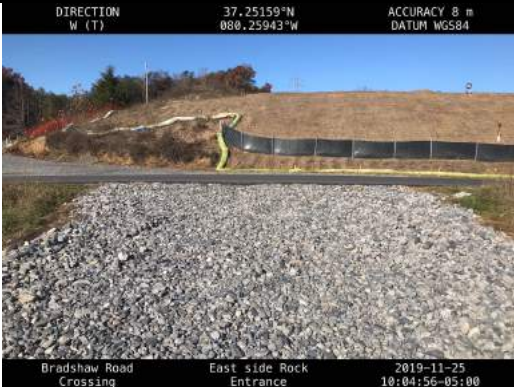
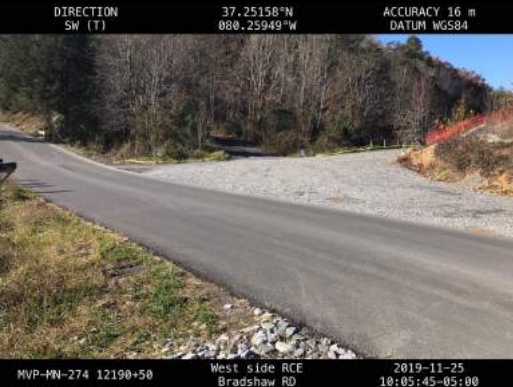
GPS Location	Please see photo for GPS data.		GPS Location	Please see photo for GPS data.	
Field Station#	12191+00		Field Station#	12190+50	
Pic 1 Desc.	Rock construction entrance on the east side of Bradshaw Road found to be in good working order.		Pic 2 Desc.	Rock construction entrance on the west side of Bradshaw Road. MVP-MN-274 entrance.

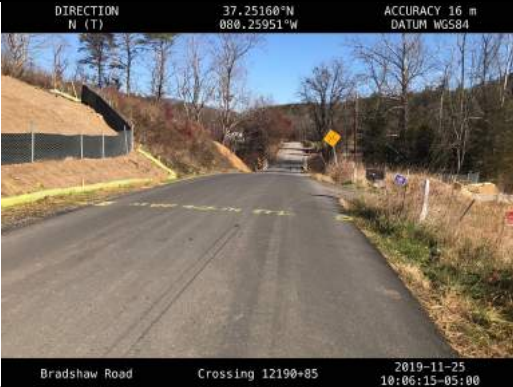
GPS Location	Please see photo for GPS data.		GPS Location	Please see photo for GPS data.	
Field Station#	12191+00		Field Station#	12190+85	
Pic 3 Desc.	East side of Bradshaw Road. Portable toilets tied down and sitting in drip pans.		Pic 4 Desc.	Bradshaw Road, photo facing north.

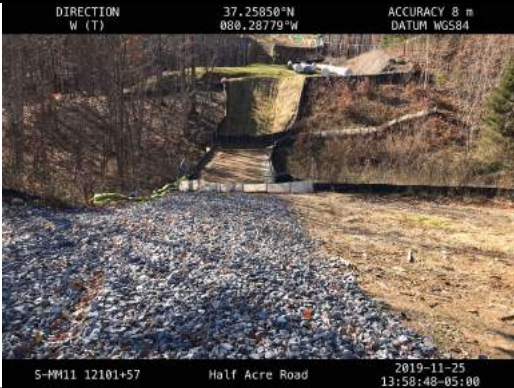
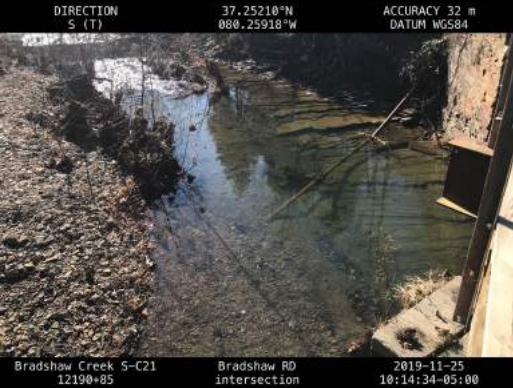
GPS Location	Please see photo for GPS data.		GPS Location	Please see photo for GPS data.	
Field Station#	1210+57		Field Station#	12190+85	
Pic 5 Desc.	Rock construction entrance on the west side of Half Acre Rock Road.		Pic 6 Desc.	Bradshaw creek bridge crossing on Bradshaw Road.

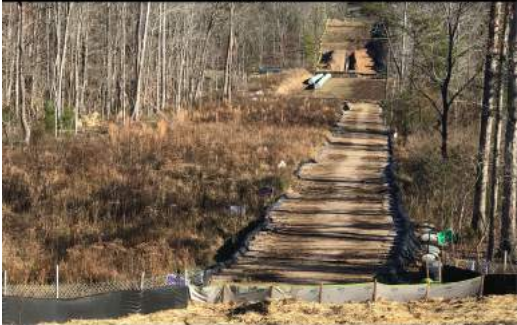
Wetland W-C12 Flatwoods 12121+29 2019-11-25 14:16:47-05:00		DIRECTION SE (T)

MVP-MN-268 12007+00 Access road 2019-11-25 15:03:15-05:00			
GPS Location	Please see photo for GPS data.		GPS Location	Please see photo for GPS data.	
Field Station#	12121+29		Field Station#	12007+00	
Pic 7 Desc.	Wetland W-C12 (Wetland and stream complex to the east of Flatwoods Road.		Pic 8 Desc.	Access road MVP-MN-268 in good shape.	
DIRECTION SE (T)

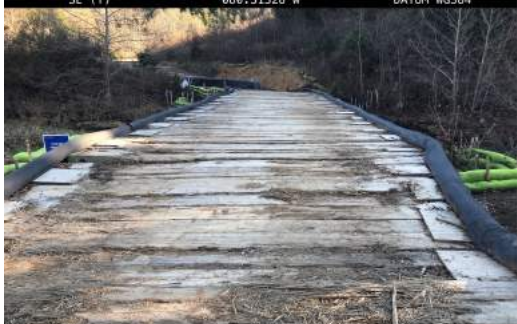
S-G36 12010+00 AR-MVP-MN-268.01 2019-11-25 15:09:55-05:00		DIRECTION E (T)

S-G36 12010+50 Looking south 2019-11-25 15:11:07-05:00			
GPS Location	Please see photo for GPS data.		GPS Location	Please see photo for GPS data.	
Field Station#	12010+00		Field Station#	12010+00	
Pic 9 Desc.	Access road (MVP-MN-268.01)stream crossing of S-G36 in good order and clean.		Pic 10 Desc.	Access road crossing of (MVP-MN-268.01), hunters peeled back super silt fencing Tom access deer stand in the background.

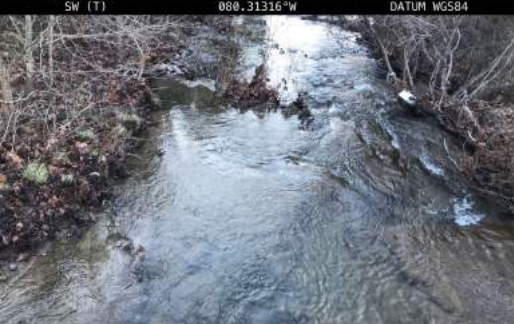
S-G36 downstream 12010+50 MVP-MN-268.01 2019-11-25 15:11:00-05:00			
GPS Location	Please see photo for GPS data.		GPS Location	Please see photo for GPS data.	
Field Station#	12010+00		Field Station#	12010+50	
Pic 11 Desc.	S-G36 ECD's found to be in working order.		Pic 12 Desc.	Stream S-G36, Looking downstream flowing clear.

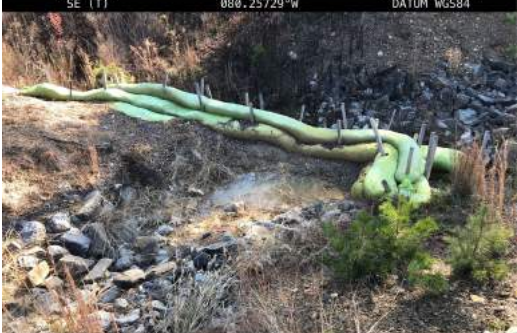
GPS Location	Please see photo for GPS data.		GPS Location	Please see photo for GPS data.	
Field Station#	12101+57		Field Station#	12197+56	
Pic 15 Desc.	Stream S-MM11 bridge in good clean condition.		Pic 16 Desc.	Stream S-oo11 sediment coming through culvert onto the project right of way from disturbed soils on the RR easement.	
DIRECTION SE (T) 37.25171°N 088.25729°W ACCURACY 16 m DATUM WGS84

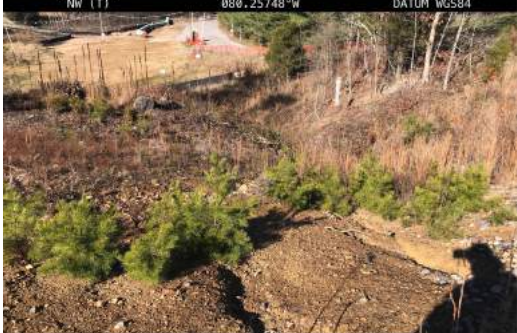
Stream S-0011 12198+64 RR runoff entry point 2019-11-25 10:59:07-05:00		Stream S-0011 12197+35 RR runoff entry point 2019-11-25 10:55:54-05:00			
GPS Location	Please see photo for GPS data.		GPS Location	Please see photo for GPS data.	
Field Station#	12198+64		Field Station#	12197+35	
Pic 17 Desc.	Sediment from the RR easement that is being stopped by ECD's. There is a large disturbed area of the RR easement eroding to the NE.		Pic 18 Desc.	Large area of bare soils eroding into Stream S-oo11 from the bare RR easement.

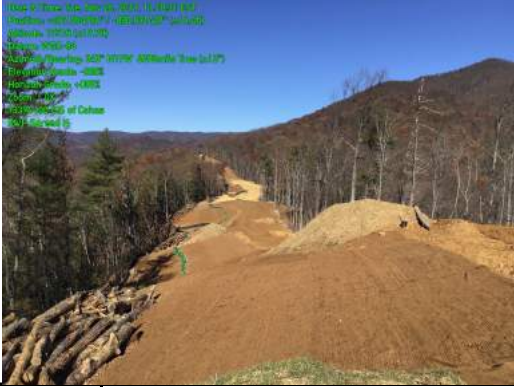
GPS Location	See pic for GPS location		GPS Location	See pic for GPS location	
Field Station#	13398+00		Field Station#	13394+00	
Pic 3 Desc.	Temporary vegetative stabilization on topsoil piles has a good even coverage.		Pic 4 Desc.	Curlex applied on the side slope up to 13394+00.

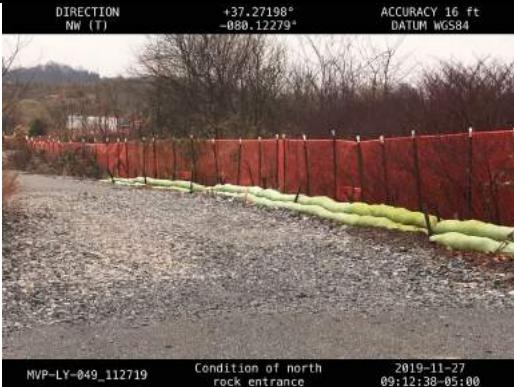
GPS Location	MVP-LY-049 See photo for gps data	GPS Location	MVP-LY-049 See photo for gps data		
Field Station#	+0	Field Station#	+0		
Pic 1 Desc.	Condition of north rock entrance. Looking NW.	Pic 2 Desc.	Condition of CFS and safety fence along center driveway. Looking N.

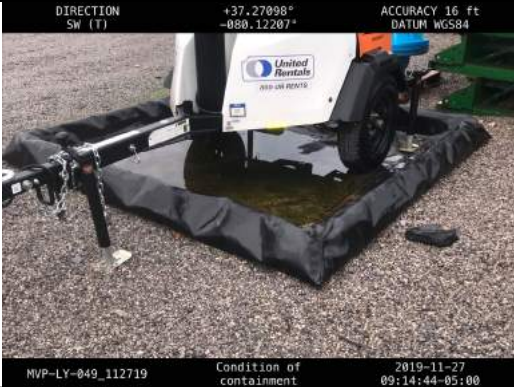
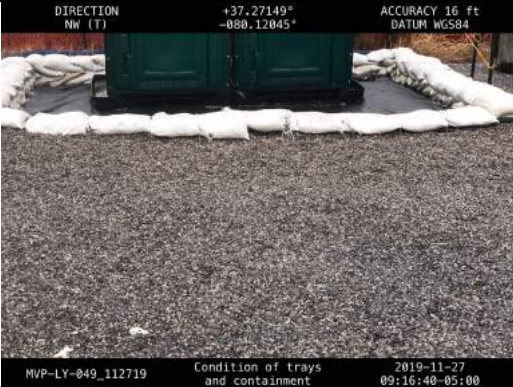
GPS Location	MVP-LY-049 See photo for gps data	GPS Location	MVP-LY-049 See photo for gps data		
Field Station#	+0	Field Station#	+0		
Pic 3 Desc.	Condition of containment under light plant. Looking SW.	Pic 4 Desc.	Condition of containment under toilets. Looking NW.

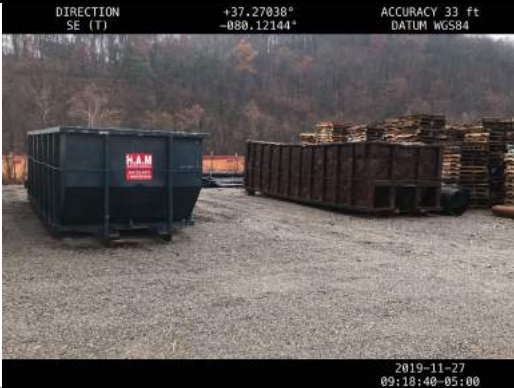
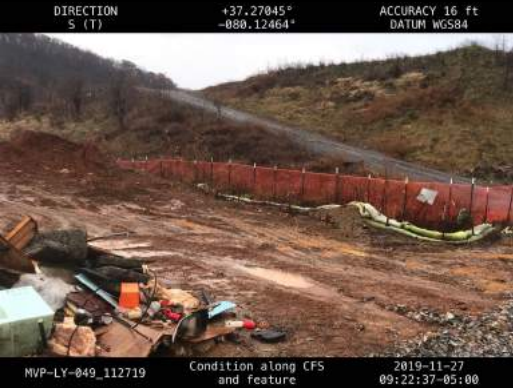
GPS Location	MVP-LY-049 See photo for gps data	GPS Location	MVP-LY-049 See photo for gps data		
Field Station#	+0	Field Station#	+0		
Pic 5 Desc.	No loose trash around south dumpsters. Looking SE.	Pic 6 Desc.	Condition of landowner disturbed area along CFS and feature. No impacts. Looking S.

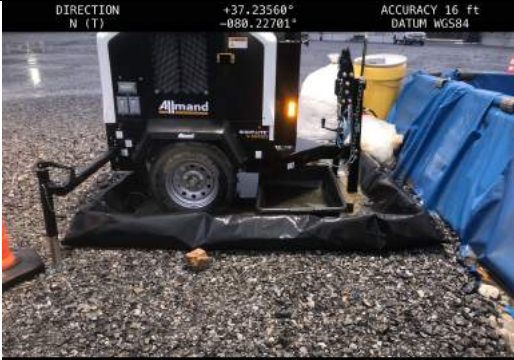
<p>DIRECTION N (T) +37.23560° -880.22701° ACCURACY 16 ft DATUM WGS84</p> <p>MVP-PY-006_112719 Condition of containment 2019-11-27 08:08:46-05:00</p>

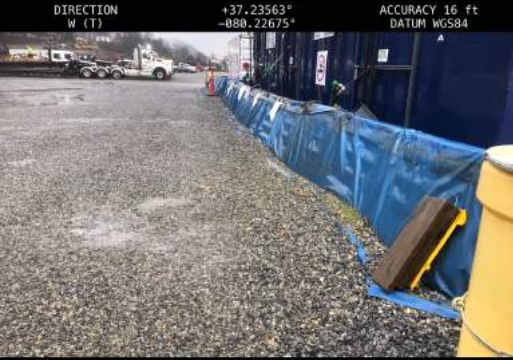
<p>DIRECTION W (T) +37.23563° -880.22675° ACCURACY 16 ft DATUM WGS84</p> <p>MVP-PY-006_112719 No fluid deposits South of bulk tanks 2019-11-27 08:06:13-05:00</p>			
GPS Location	MVP-PY-006 See photo for gps data		GPS Location	MVP-PY-006 See photo for gps data	
Field Station#	+0		Field Station#	+0	
Pic 1 Desc.	Condition of containment under light plant. Looking N.		Pic 2 Desc.	No fluid deposits on the south side of the bulk fuel tanks. Looking W.

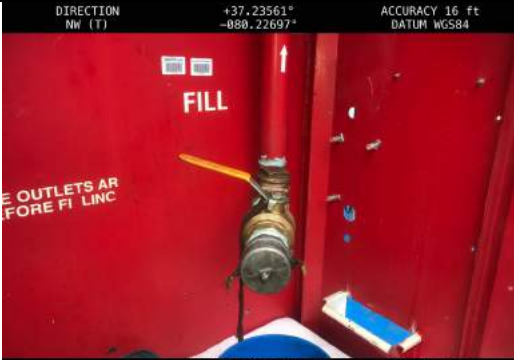
<p>DIRECTION NW (T) +37.23561° -880.22697° ACCURACY 16 ft DATUM WGS84</p> <p>MVP-PY-006_112719 Off Road Fuel unit no leaky internal fitti... 2019-11-27 08:07:23-05:00</p>

GPS Location	MVP-PY-006 See photo for gps data		GPS Location	MVP-PY-006 See photo for gps data	
Field Station#	+0		Field Station#	+0	
Pic 3 Desc.	Off Road Fuel unit no leaky internal fittings. Looking NW.		Pic 4 Desc.	Blue Bulk Fuel tanks no leaky internal fittings. Looking SW.

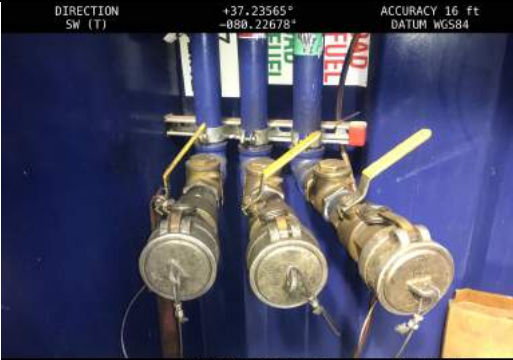
<p>DIRECTION SW (T) +37.23565° -880.22678° ACCURACY 16 ft DATUM WGS84</p> <p>MVP-PY-006_112719 Blue Bulk Fuel tanks no leaky internal fi... 2019-11-27 08:05:44-05:00</p>

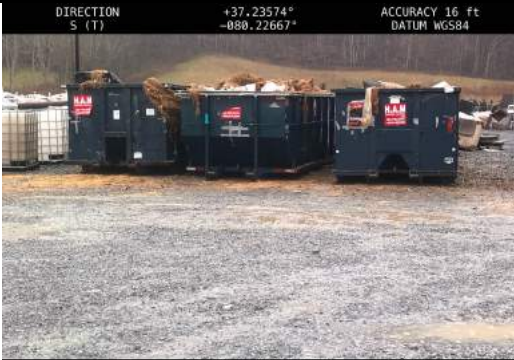
<p>DIRECTION S (T) +37.23574° -880.22667° ACCURACY 16 ft DATUM WGS84</p> <p>MVP-PY-006_112719 No loose trash around dumpsters 2019-11-27 08:04:42-05:00</p>

<p>DIRECTION S (T) +37.23443° -880.22788° ACCURACY 16 ft DATUM WGS84</p> <p>MVP-PY-006_112719 Crew pumping stormwater no sheen 2019-11-27 08:46:45-05:00</p>			
GPS Location	MVP-PY-006 See photo for gps data		GPS Location	MVP-PY-006 See photo for gps data	
Field Station#	+0		Field Station#	+0	
Pic 5 Desc.	No loose trash around dumpsters. Looking S.		Pic 6 Desc.	Crew pumping stormwater from poly lined containments. Looking S.

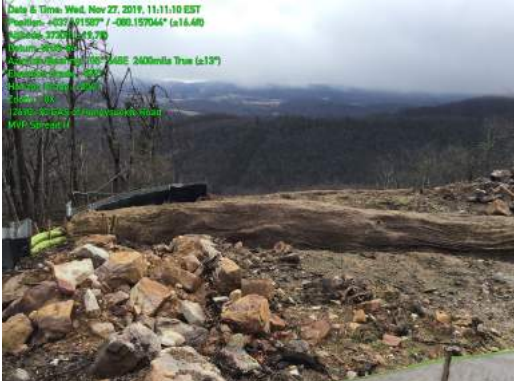
GPS Location	See pic for GPS location		GPS Location	See pic for GPS location	
Field Station#	12690+90		Field Station#	12866+00	
Pic 3 Desc.	ECD's and stabilization in good shape on the GAS of Honeysuckle road.		Pic 4 Desc.	Installed ECD's and stabilization with out issues near Bottom Creek Road.

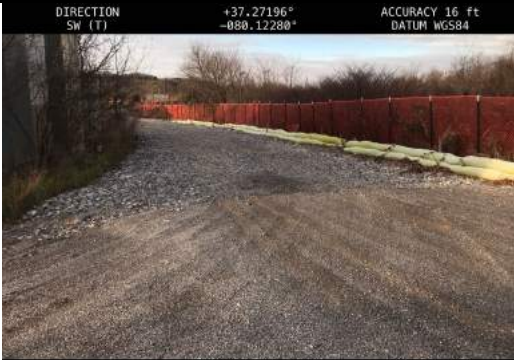
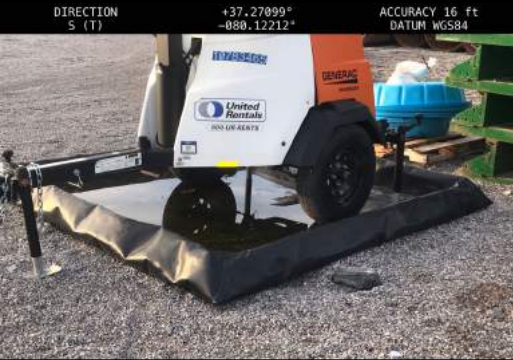
GPS Location	MVP-LY-049 See photo for gps data		GPS Location	MVP-LY-049 See photo for gps data	
Field Station#	+0		Field Station#	+0	
Pic 1 Desc.	Condition of rock entrance on north driveway. Looking SW.		Pic 2 Desc.	Condition of containment under light plant. Looking SW.

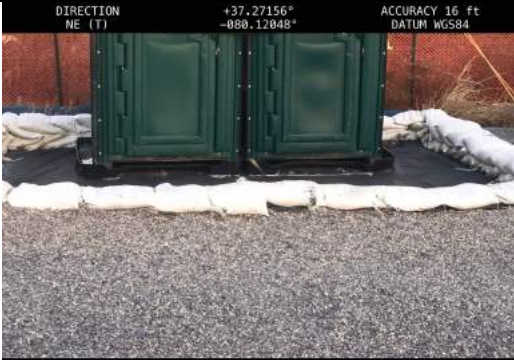
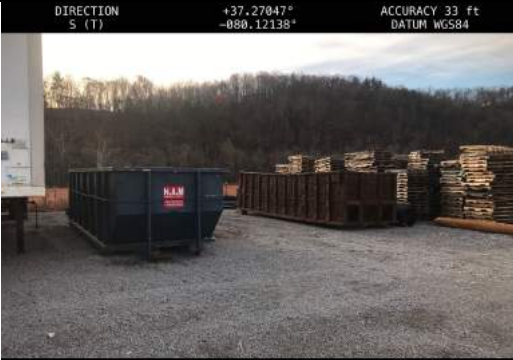
GPS Location	MVP-LY-049 See photo for gps data		GPS Location	MVP-LY-049 See photo for gps data	
Field Station#	+0		Field Station#	+0	
Pic 3 Desc.	Condition of trays and containment under toilets. Looking NE.		Pic 4 Desc.	No loose trash around south dumpsters. Looking S.

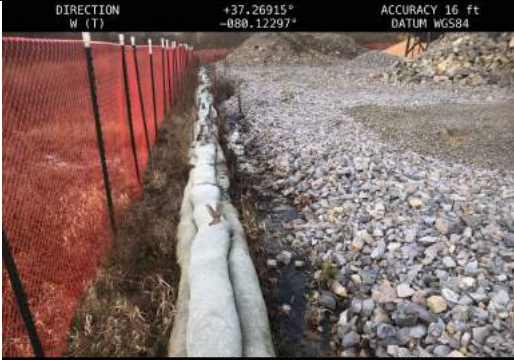
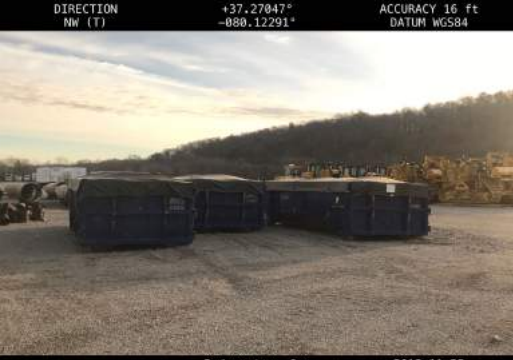
GPS Location	MVP-LY-049 See photo for gps data		GPS Location	MVP-LY-049 See photo for gps data	
Field Station#	+0		Field Station#	+0	
Pic 5 Desc.	Condition of CFS and safety fence along South LOD. Looking W.		Pic 6 Desc.	3 covered dumpsters for contaminated materials. Looking NW.

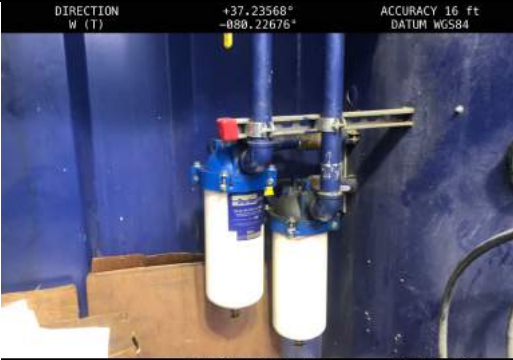
<p>DIRECTION W (T) +37.23568° -880.22676° ACCURACY 16 ft DATUM WGS84</p> <p>MVP-PY-006_112919 Blue Bulk Fuel tanks no leaky internal fittings 2019-11-29 07:33:19-05:00</p>		GPS Location	MVP-PY-006 See photo for gps data

Field Station#	+0	Field Station#	+0	GPS Location	MVP-PY-006 See photo for gps data
Pic 3 Desc.	No loose trash around dumpsters. Looking E.	Pic 4 Desc.	Blue Bulk Fuel tanks no leaky internal fittings. Looking W.	GPS Location	MVP-PY-006 See photo for gps data

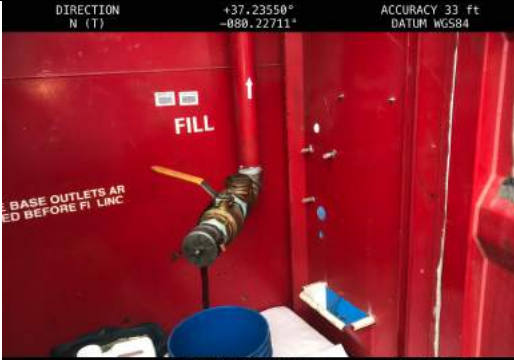
<p>DIRECTION N (T) +37.23550° -880.22711° ACCURACY 33 ft DATUM WGS84</p> <p>MVP-PY-006_112919 Off Road Fuel unit no leaky internal fittings 2019-11-29 07:39:22-05:00</p>

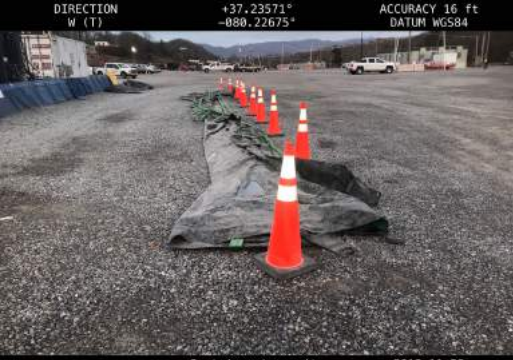
<p>DIRECTION W (T) +37.23571° -880.22675° ACCURACY 16 ft DATUM WGS84</p> <p>MVP-PY-006_112919 Containment on site for tankers offloading 2019-11-29 07:34:10-05:00</p>		GPS Location	MVP-PY-006 See photo for gps data
Field Station#	+0	Field Station#	+0	GPS Location	MVP-PY-006 See photo for gps data
Pic 5 Desc.	Off Road Fuel unit no leaky internal fittings. Looking NW.	Pic 6 Desc.	Condition on site for tankers for off loading fuel. Looking W.	GPS Location	MVP-PY-006 See photo for gps data

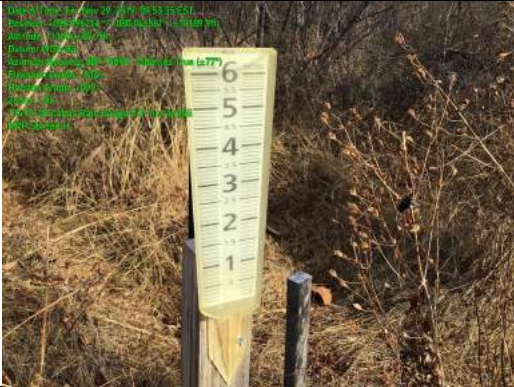
GPS Location	See pic for GPS location		GPS Location	See pic for GPS location	
Field Station#	13415+00		Field Station#	13413+00	
Pic 1 Desc.	No rainfall accumulation to report for today.		Pic 2 Desc.	No impacts observed at any of the stream crossings throughout the area today.

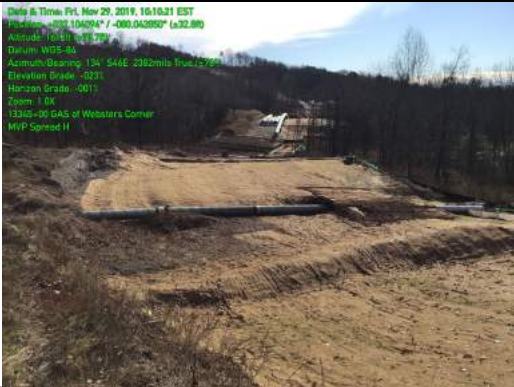
GPS Location	See pic for GPS location		GPS Location	See pic for GPS location	
Field Station#	13345+00		Field Station#	13341+00	
Pic 3 Desc.	Clean water diversion berms, pipes and plunge pools remain in compliance.		Pic 4 Desc.	Area stabilized with aerial applied ProGanics and FlexTera.

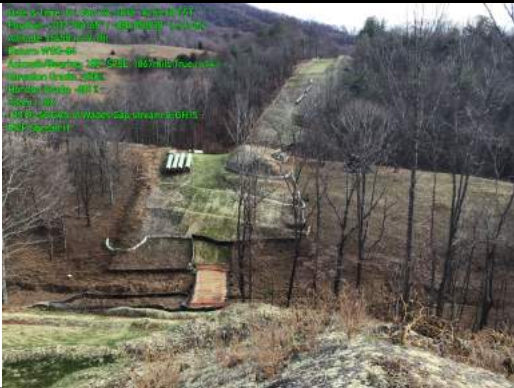
GPS Location	See pic for GPS location		GPS Location	See pic for GPS location	
Field Station#	13319+50		Field Station#	13319+00	
Pic 5 Desc.	No impacts observed at any of the stream crossings or off ROW throughout the area.		Pic 6 Desc.	Good vegetative stabilization growing in throughout the work area.

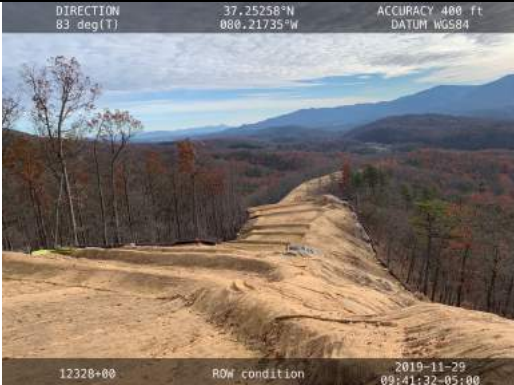
GPS Location	See photo for gps data.		GPS Location	See photo for gps data.	
Field Station#	12328+00		Field Station#	12379+00	
Pic 3 Desc.	Photo shows the ROW condition from about 12328+00 to 12333+00		Pic 4 Desc.	Photo shows the ROW and bridge over stream S-NN19.

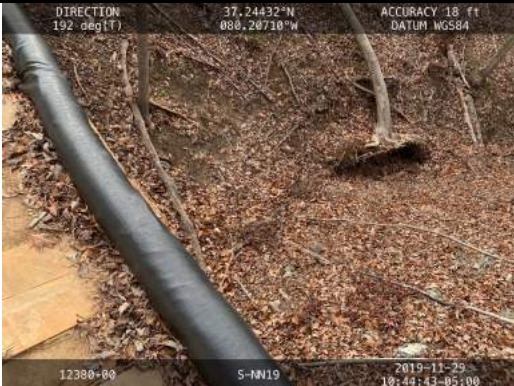
GPS Location	See photo for gps data.		GPS Location	See photo for gps data.	
Field Station#	12380+00		Field Station#	12408+00	
Pic 5 Desc.	Photo shows stream S-NN19.		Pic 6 Desc.	Photo shows the ROW condition from about 12408+00 to 12410+00.

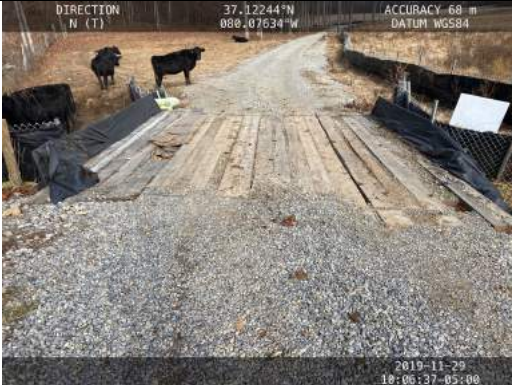
GPS Location	See picture for GPS data		GPS Location	See picture for GPS data	
Field Station#	13196+31		Field Station#	13197+98	
Pic 1 Desc.	Bridge crossing stream s-D10 on access road MVP-MLV-AR-29		Pic 2 Desc.	RCE

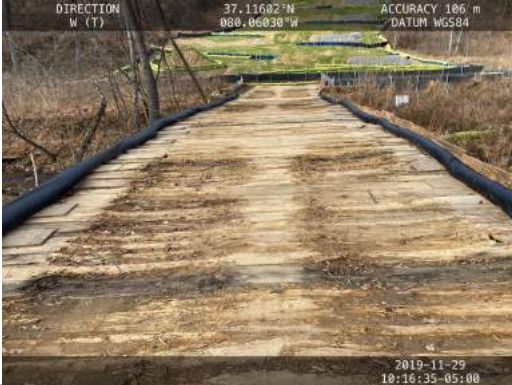
GPS Location	See picture for GPS data		GPS Location	See picture for GPS data	
Field Station#	13260+75		Field Station#	13262+84	
Pic 3 Desc.	Bridge crossing feature S-li4		Pic 4 Desc.	Daylight drain apron

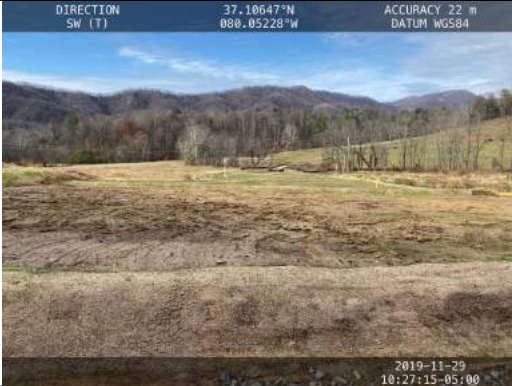
GPS Location	See picture for GPS data		GPS Location	See picture for GPS data	
Field Station#	13310+59		Field Station#	13315+70	
Pic 5 Desc.	Stabilized ROW.		Pic 6 Desc.	Portable toilet location

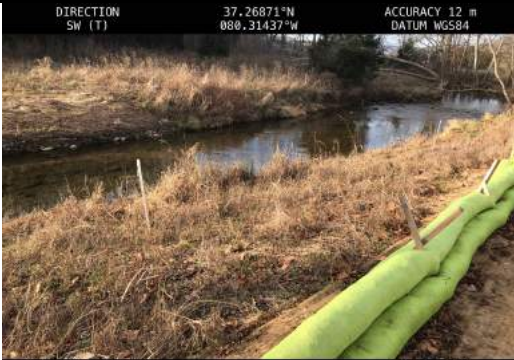
<p>DIRECTION SW (T) 37.26871°N 880.31437°W ACCURACY 12 m DATUM WGS84</p> <p>Northfork Roanoke River S-G36 12008+53 2019-11-29 08:47:43-05:00</p>

<p>DIRECTION N (T) 37.25174°N 880.25945°W ACCURACY 6 m DATUM WGS84</p> <p>Bradshaw RD. Bridge S-C21 12190+85 2019-11-29 13:57:41-05:00</p>			
GPS Location	See photo for GPS data.		GPS Location	See photo for GPS data.	
Field Station#	12008+53		Field Station#	12190+85	
Pic 1 Desc.	Pipeline crossing at Stream S-G36. We'll vegetated and stable.		Pic 2 Desc.	Bradshaw Road, Stream Bridge.

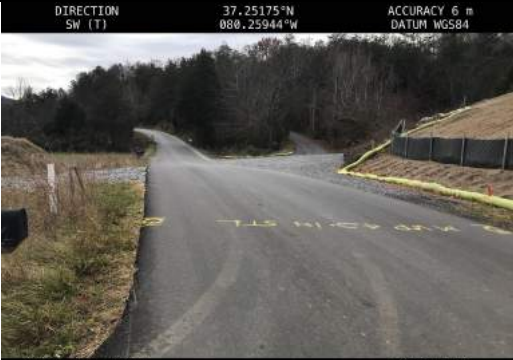
<p>DIRECTION SW (T) 37.25175°N 880.25944°W ACCURACY 6 m DATUM WGS84</p> <p>MVP-WW-274 access clean 12190+85 2019-11-29 13:57:37-05:00</p>			
GPS Location	See photo for GPS data.		GPS Location	See photo for GPS data.

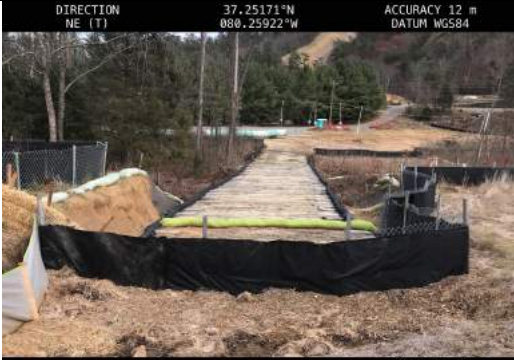
<p>DIRECTION NE (T) 37.25171°N 880.25922°W ACCURACY 12 m DATUM WGS84</p> <p>S-C21 12192+00 Bridge Clean 2019-11-29 13:57:16-05:00</p>

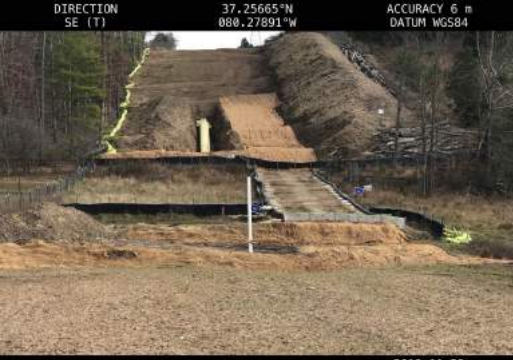
<p>DIRECTION SE (T) 37.25665°N 880.27891°W ACCURACY 6 m DATUM WGS84</p> <p>S-C29 12132+73 2019-11-29 12:26:29-05:00</p>			
GPS Location	See photo for GPS data.		GPS Location	See photo for GPS data.	
Field Station#	12192+00		Field Station#	12132+73	
Pic 5 Desc.	Stream S-C21 facing north.		Pic 6 Desc.	Stream bridge over S-C29 clean and free of spoil.

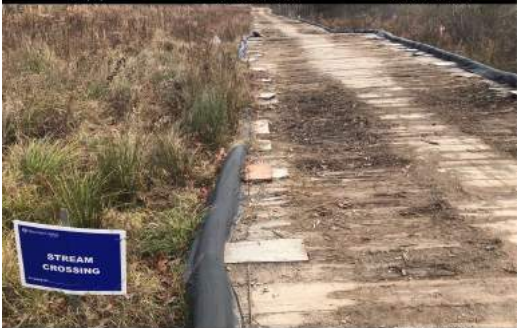
S-MM31 12125+65 2019-11-29 12:16:47-05:00		S-C36 12121+83 2019-11-29 12:11:34-05:00			
GPS Location	See photo for GPS data.		GPS Location	See photo for GPS data.	
Field Station#	12125+65		Field Station#	12121+83	
Pic 9 Desc.	Stream S-MM31 facing south.		Pic 10 Desc.	Stream bridge over S-C36 clean and free of spoil.

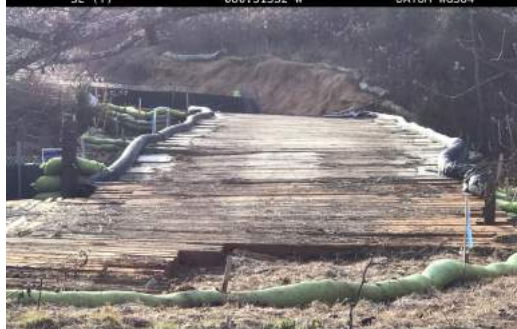
Northfork Roanoke River SSF taken down By hunters 12010+00 2019-11-29 08:54:45-05:00		Northfork Roanoke River ATWS 473 12008+00 2019-11-29 08:51:24-05:00			
GPS Location	See photo for GPS data.		GPS Location	See photo for GPS data.	
Field Station#	12010+00		Field Station#	12008+00	
Pic 11 Desc.	Super silt fence on the south bank of access road MVP-MN-268.01 S-G36 bridge clean.		Pic 12 Desc.	ATWS 473 temporarily stabilized.
