## Visual Site Inspection Report

| <b>Project Name</b> | H-600 Pipeline Spread H | <b>AFE</b> | 124300138 | <b>Spread</b> | H-600 Pipeline Spread |
| <b>Inspector</b> | Logan Box | | | <b>Date/Time</b> | 8/26/2019 5:30 PM |

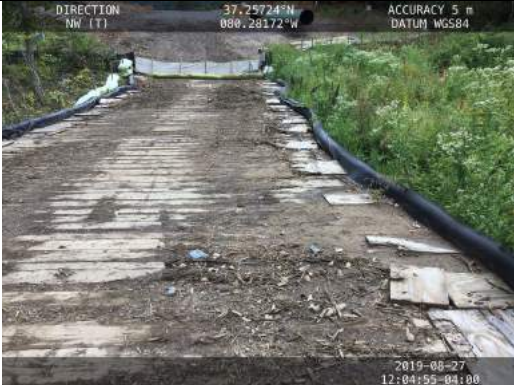
| <b>Field Station#</b> | 12121+33 | | <b>Field Station#</b> | 12121+83 | |

| <b>Pic 1 Desc.</b> | Stream S-C33, facing west. | | <b>Pic 2 Desc.</b> | Stream S-C36, facing east. | |

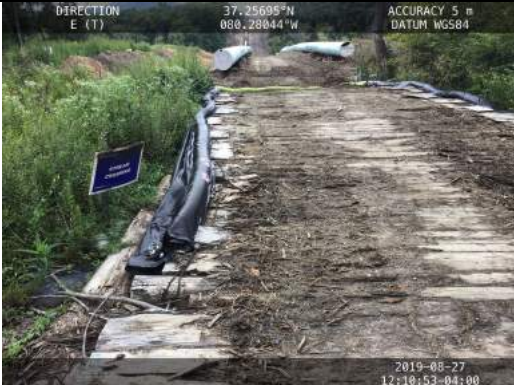
| <b>Field Station#</b> | 12125+65 | | <b>Field Station#</b> | 12132+73 | |

| <b>Pic 3 Desc.</b> | Stream S-MM31, facing east. | | <b>Pic 4 Desc.</b> | Stream S-C29, facing east. | |

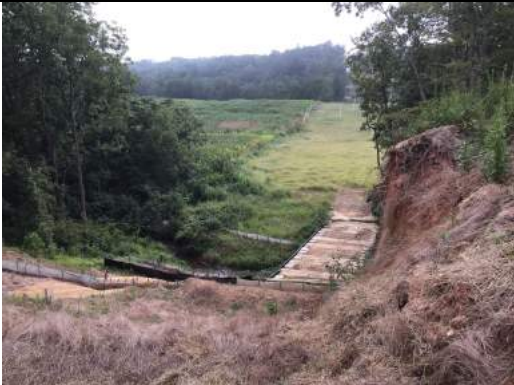
| <b>Field Station#</b> | 13543+11 | <b>Field Station#</b> | 13433+00 | | |

| <b>Pic 3 Desc.</b> | Hill side stabilized, ECDs in place | <b>Pic 4 Desc.</b> | Travel lane worn down during work activities, recommended seeding and adding earth guard to prevent washing | | |
