Visual Site Inspection Report

Project Name H-600 Pipeline Spread I		AFE 124300139	Spread H-600 Pipeline Spread I
Contractor Precision		Report # 5638	
Inspector Logan Box		Date/Time 11/7/2019 11:17 AM	
Permit # TBD	Inspection Type VA SWPP	Station Begin 13670+00	
State VA	Inspection Area Partial	Station End 13898+31	
County Franklin	Ground Damp	Temperature (°F) 61.00	
Municipality N/A	Weather Sunny	Rain Gauge (in) 0.00	
Rain Accumulation Time (days)			0.00

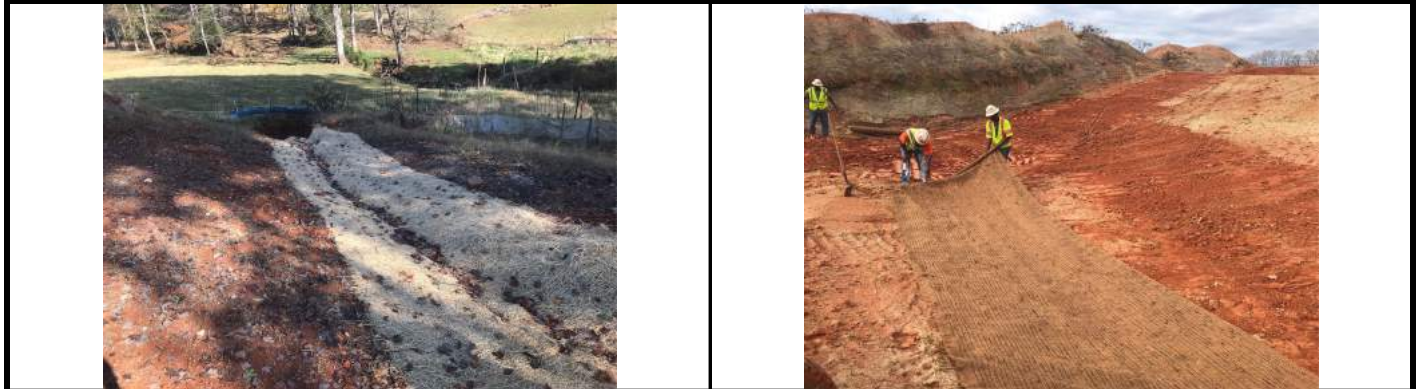
Field Station# 14222+09	Field Station# 14436+00
--------------------------------	--------------------------------

Pic 1 Desc. Approximately 14222+09. Over of stream crossing and equipment bridge at stream S-C20. ROW temporarily stabilized and has winter vegetation growing.	Pic 2 Desc. Approximately 14436+00. Overview of ROW. ROW temporarily seeded and stabilized in this area.
--	---
