# Visual Site Inspection Report

<b>Project Name</b>	H-600 Pipeline Spread I	<b>AFE</b>	124300139	<b>Spread</b>	H-600 Pipeline Spread I
<b>Contractor</b>	Precision			<b>Report #</b>	100154
<b>Inspector</b>	Ben Davenport			<b>Date/Time</b>	9/6/2019 7:36 PM
<b>Permit #</b>	TBD	<b>Inspection Type</b>	VA SWPP	<b>Station Begin</b>	14981+55
<b>State</b>	VA	<b>Inspection Area</b>	Partial	<b>Station End</b>	15496+70
<b>County</b>	Franklin/Pittsylvania	<b>Ground</b>	Dry	<b>Temperature (°F)</b>	81.00
<b>Municipality</b>	Chatham	<b>Weather</b>	Cloudy	<b>Rain Gauge (in)</b>	0.00
				<b>Rain Accumulation Time (days)</b>	0.00

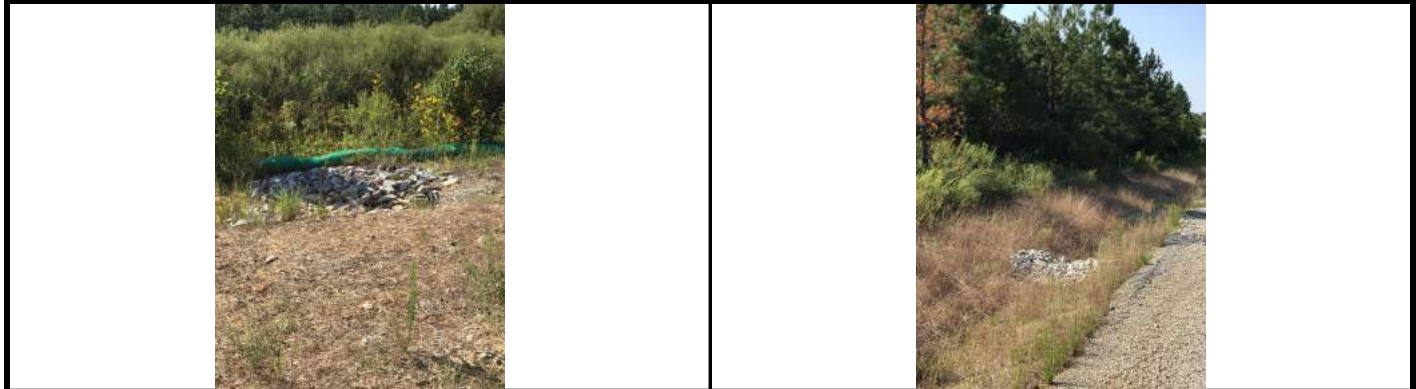
<b>Field Station#</b> 00+00	<b>Field Station#</b> 00+00
-----------------------------	-----------------------------

<b>Pic 3 Desc.</b> Observing outlet and outlet protection.	<b>Pic 4 Desc.</b> Observing rock check dams.
--	---
