Visual Site Inspection Report

Project Name	H-600 Pipeline Spread I	AFE	124300139	Spread	H-600 Pipeline Spread I
Contractor	Precision			Report #	100136
Inspector	Ben Davenport			Date/Time	9/30/2019 8:44 AM
Permit #	TBD	Inspection Type	VA SWPP	Station Begin	14981+55
State	VA	Inspection Area	Partial	Station End	15496+70
County	Franklin/Pittsylvania	Ground	Dry	Temperature (°F)	81.00
Municipality	Chatham	Weather	Cloudy	Rain Gauge (in)	0.00
				Rain Accumulation Time (days)	0.00

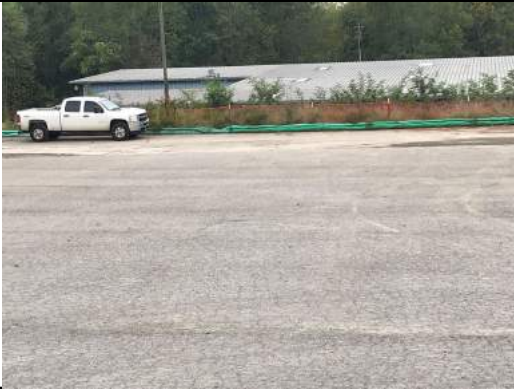
GPS Location	00000000	GPS Location	00000000		
Field Station#	0000+00	Field Station#	0000+00		
Pic 1 Desc.	Inlet protection for parking lot drain on north end of paved yard in good condition.	Pic 2 Desc.	Secondary containment structure for fuel cell in compliance.

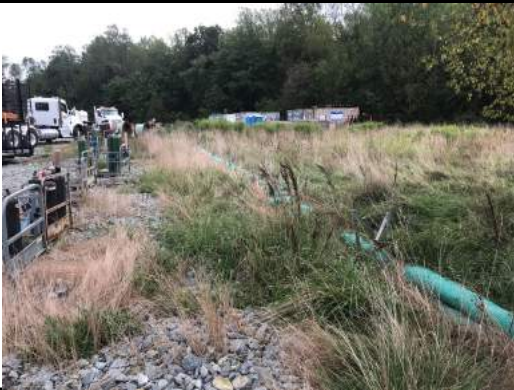
GPS Location	00000000	GPS Location	00000000		
Field Station#	0000+00	Field Station#	0000+00		
Pic 3 Desc.	Perimeter ECD's in good condition on northwest side on paved yard in acceptable condition.	Pic 4 Desc.	Perimeter ECD's is south end of paved yard in good condition.

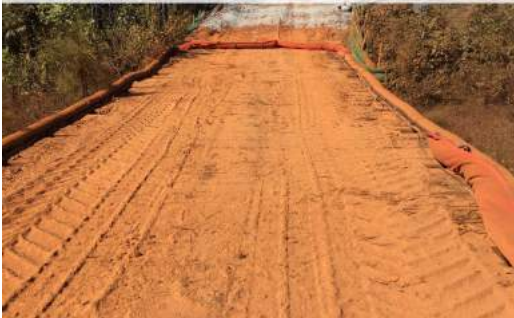
South East Elevation <small>316°NW (T) LAT: 36.979683 LON: -79.679952 ±2897ft ▲ 924ft</small>  	
GPS Location	0		GPS Location	0	
Field Station#	14804+99		Field Station#	14795+00	
Pic 1 Desc.	Equipment bridge full of dirt and needs cleaned off at stream S-H23		Pic 2 Desc.	Temporary stabilization on the GAS of Indian Cave Road	
	South East Elevation <small>329°NW (T) LAT: 36.976761 LON: -79.678181 ±16421ft ▲ 998ft</small>

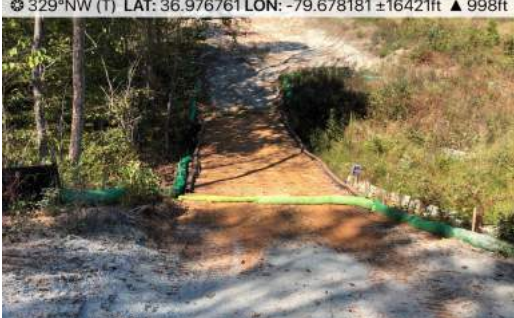
East Elevation <small>285°W (T) LAT: 36.972404 LON: -79.666518 ±98ft ▲ 899ft</small>  	
GPS Location	0		GPS Location	0	
Field Station#	14793+78		Field Station#	14840+00	
Pic 3 Desc.	Equipment bridge clean at stream S-H24		Pic 4 Desc.	Temporary stabilization on the CIS of Listening Hill Road	
	South Elevation <small>355°N (T) LAT: 36.973172 LON: -79.668732 ±32ft ▲ 1038ft</small>  			West Elevation <small>103°E (T) LAT: 36.972212 LON: -79.665329 ±98ft ▲ 936ft</small>
