Visual Site Inspection Report

Project Name	H-600 Pipeline Spread G	AFE	124300137	Spread	H-600 Pipeline Spread G
Contractor	Precision			Report #	7292
Inspector	Garrett Barclay			Date/Time	1/13/2020 7:13 AM
Permit #	TBD	Inspection Type	VA SWPP	Station Begin	11520+00
State	VA	Inspection Area	Partial	Station End	11640+00
County	Craig	Ground	Wet	Temperature (°F)	38.00
Municipality	N/A	Weather	Sunny	Rain Gauge (in)	1.60
				Rain Accumulation Time (days)	1.00

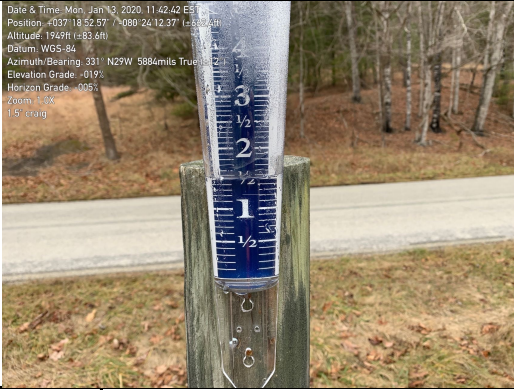
<p>Date & Time: Mon, Jan 13, 2020, 11:42:42 EST Position: +037 12 52.37 N +080 24 12.37 W (+83.6M) Altitude: 1945ft (+593M) Datum: WGS 84 Azimuth/Bearing: 331° N29W 5884mils True (+12.1) Elevation Grade: -019° Horizon Grade: -005° Zoom: 1.0X 11537</p>			
GPS Location	See picture above for GPS coordinates		GPS Location	See picture above for GPS coordinates	
Field Station#	11613+69		Field Station#	11537+00	
Pic 1 Desc.	1.5" of rain recorded @ Craig's Creek		Pic 2 Desc.	ECD's and row conditions

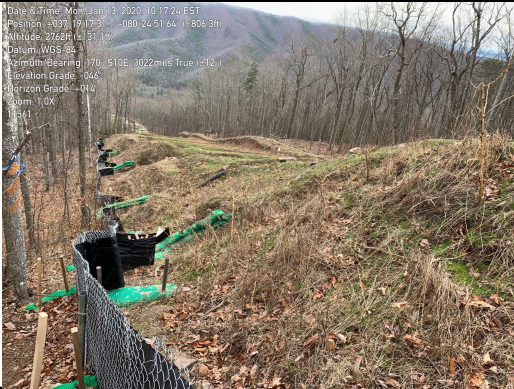
GPS Location	See picture above for GPS coordinates		GPS Location	See picture above for GPS coordinates	
Field Station#	11561+00		Field Station#	11576+00	
Pic 3 Desc.	ECD's and row conditions		Pic 4 Desc.	ECD's and row conditions

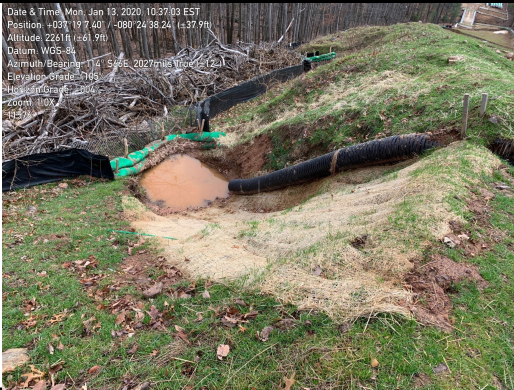
<p>Date & Time: Mon, Jan 13, 2020, 10:37:03 EST Position: +037 12 52.37 N +080 24 12.37 W (+83.6M) Altitude: 2261ft (+689M) Datum: WGS 84 Azimuth/Bearing: 331° N29W 5884mils True (+12.1) Elevation Grade: -019° Horizon Grade: -005° Zoom: 1.0X 11537</p>			
GPS Location	See picture above for GPS coordinates		GPS Location	See picture above for GPS coordinates	
Field Station#	11576+00		Field Station#	11585+00	
Pic 5 Desc.	ECD's and row conditions		Pic 6 Desc.	ECD's and row conditions

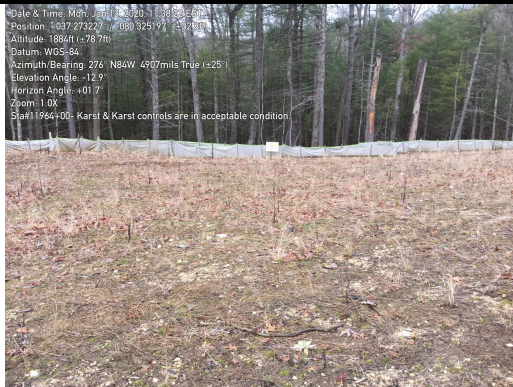
<p>Date & Time: Mon Jan 13, 2020 11:55:45 EST Position: +037.272322 / -080.325192 (+16.4ft) Altitude: 1884ft (+178.7ft) Datum: WGS-84 Azimuth/Bearing: 276° N84W 490mils True (+25°) Elevation Angle: -12.9° Horizon Angle: -01.7° Zoom: 1.0X Karst & Karst controls are in acceptable condition.</p>			
GPS Location	See photo GPS	GPS Location	See photo GPS		
Field Station#	11942+00	Field Station#	11964+00		
Pic 3 Desc.	Karst and Karst ECD's are in acceptable condition	Pic 4 Desc.	Karst and Karst ECD's are in acceptable condition

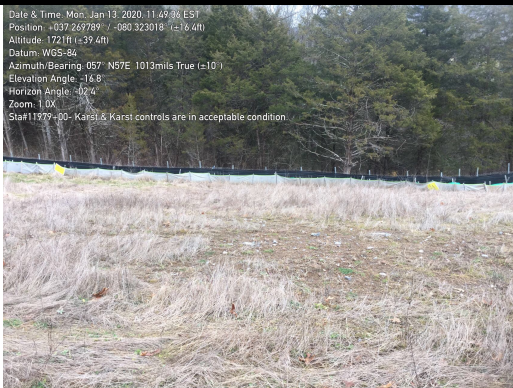
<p>Date & Time: Mon Jan 13, 2020 11:49:30 EST Position: +037.257944 / -080.323018 (+16.4ft) Altitude: 1721ft (+59.4ft) Datum: WGS-84 Azimuth/Bearing: 057° N57E 1013mils True (+10°) Elevation Angle: -16.8° Horizon Angle: -02.4° Zoom: 1.0X Karst & Karst controls are in acceptable condition.</p>

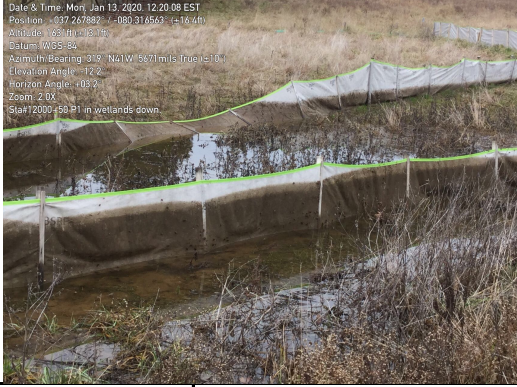
GPS Location	See photo GPS	GPS Location	See photo GPS		
Field Station#	12001+00	Field Station#	12000+00		
Pic 7 Desc.	P1 damaged from heavy rain, contractor notified, will address issue	Pic 8 Desc.	P1 damaged from heavy rain, contractor notified, will address issue.		
Insert image here		Insert image here			
GPS Location		GPS Location			
Field Station#		Field Station#			
Pic 9 Desc.		Pic 10 Desc.			
Insert image here		Insert image here			
GPS Location		GPS Location			
Field Station#		Field Station#			
Pic 11 Desc.		Pic 12 Desc.

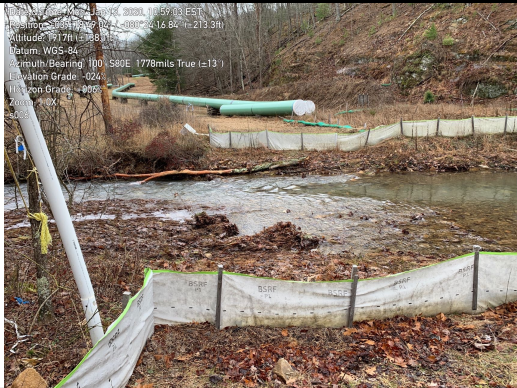
GPS Location	On photo	GPS Location			
Field Station#	11607+81	Field Station#			
Pic 9 Desc.	The S-006 crossing shows no sign of impact		Pic 10 Desc.		
<div style="text-align: center;">Insert image here</div>		<div style="text-align: center;">Insert image here</div>			
GPS Location		GPS Location			
Field Station#		Field Station#			
Pic 11 Desc.		Pic 12 Desc.

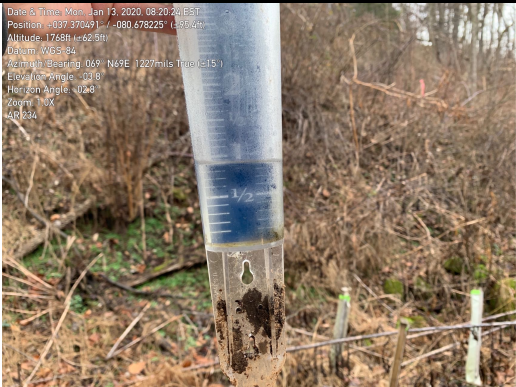
Field Station#	12005+00		Field Station#	10696+00	
Pic 1 Desc.	Rain gauge at AR 234 reads 0.9 inches.		Pic 2 Desc.	Rain gauge at Buffalo Anklets Road reads 0.9 inches.

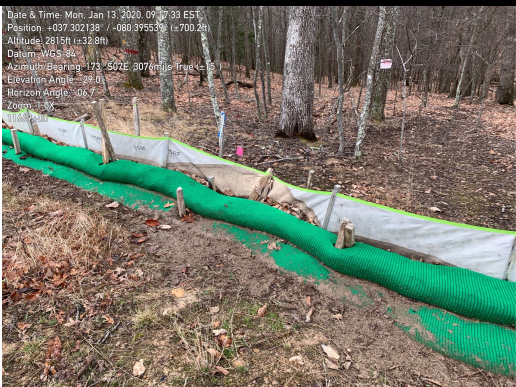
GPS Location	See photo for GPS location.		GPS Location	See photo for GPS location.	
Field Station#	11669+00		Field Station#	11713+00	
Pic 3 Desc.	Priority one silt fence stake broke.		Pic 4 Desc.	Triple stack CFS end treatment undermined.

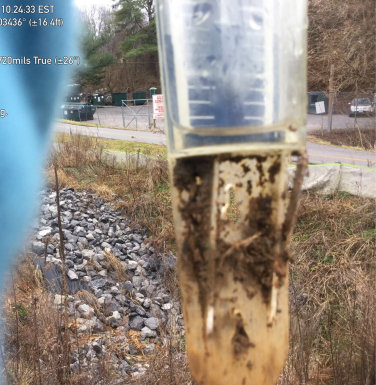
AFE	124300137	Date/Time	1/14/2020 7:21 AM	Report #	
Pictures					
<small> Date & Time: Tue Jan 14, 2020 10:24:20 EST Position: -037.3005137° / -080.503436° (±16.4m) Altitude: 1993ft (±19.7m) Datum: WGS-84 Azimuth/Bearing: 150° 52' 18.82" (mils True) (±2.0°) Elevation Angle: -12.3° Horizon Angle: -05.9° Zoom: 1.0X Winding Way rain gauge reading. </small>

Insert image here	
GPS Location	See photo GPS	GPS Location			
Field Station#	11227+00	Field Station#			
Pic 7 Desc.	Winding Way rain gauge reading- 0.10"	Pic 8 Desc.			
Insert image here		Insert image here			
GPS Location		GPS Location			
Field Station#		Field Station#			
Pic 9 Desc.		Pic 10 Desc.			
Insert image here		Insert image here			
GPS Location		GPS Location			
Field Station#		Field Station#			
Pic 11 Desc.		Pic 12 Desc.

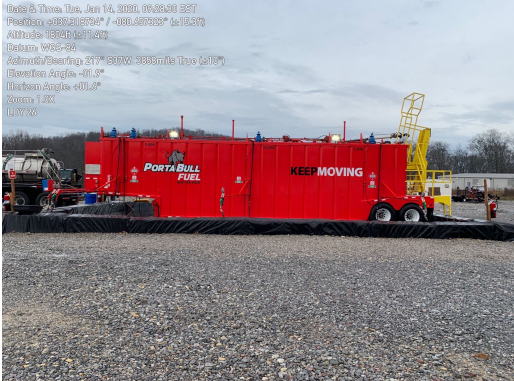
GPS Location	See photo for GPS location.		GPS Location	See photo for GPS location.	
Field Station#	12011+25		Field Station#	11613+00	
Pic 3 Desc.	Secondary containment in place under fuel cell.		Pic 4 Desc.	Rain gauge at Craig Creek Road reads 0.1 inches.

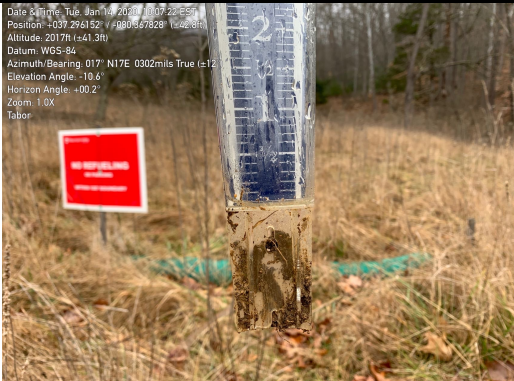
GPS Location	See photo for GPS location.		GPS Location	See photo for GPS location.	
Field Station#	11767+00		Field Station#	11990+00	
Pic 5 Desc.	Rain gauge at Mount Tabor Road has trace amounts.		Pic 6 Desc.	Rain gauge at Catawba Road reads 0.1 inches.

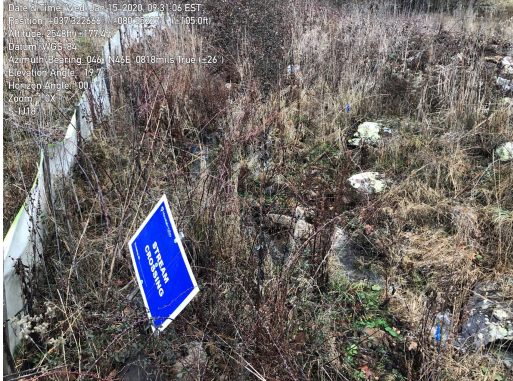
GPS Location				1		GPS Location				2	
Field Station#				11025+50		Field Station#				11034+00	
Pic 1 Desc.				S-IJ18.		Pic 2 Desc.				Vegetation or stabilization sufficient.

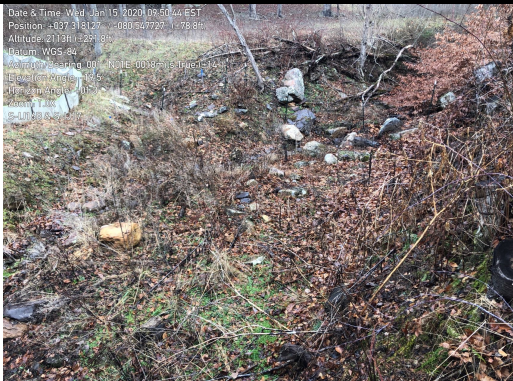
GPS Location				3		GPS Location				4	
Field Station#				11050+10		Field Station#				11055+00	
Pic 3 Desc.				S-IJ16B/S-IJ17.		Pic 4 Desc.				Multiple layers of perimeter controls functional.

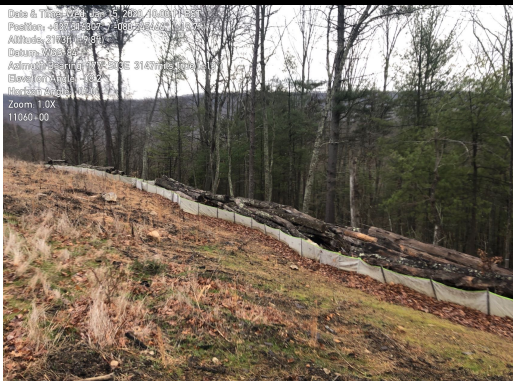
GPS Location				5		GPS Location				6	
Field Station#				11060+00		Field Station#				11064+00	
Pic 5 Desc.				P-1 silt fence perimeter controls functional.		Pic 6 Desc.				Vegetation or stabilization sufficient.

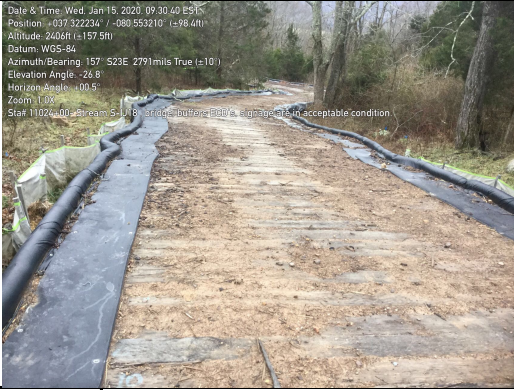
<p>Date & Time: Wed Jan 15, 2020 09:30:40 EST Position: 437.322234 / -80.553210 (-98.4ft) Altitude: 240ft (+157.5ft) Datum: WGS-84 Azimuth/Bearing: 157.523E 2791mils True (+10) Elevation Angle: -26.8 Horizon Angle: +00.5 Zoom: 1.0x Sta# 11024+00: Stream S-IJ18: bridge, buffers, ECD's, signage are in acceptable condition.</p>

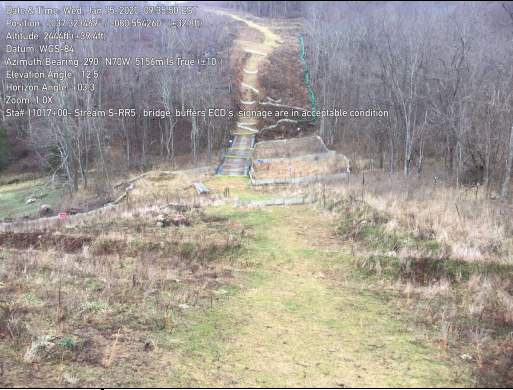
<p>Date & Time: Wed Jan 15, 2020 09:34:00 EST Position: 437.321034 / -80.546261 (-97.4ft) Altitude: 244ft (+152.0ft) Datum: WGS-84 Azimuth/Bearing: 290.120W 518mils True (+10) Elevation Angle: -12.5 Horizon Angle: +00.0 Zoom: 1.0x Sta# 11017+00: Stream S-RR5: bridge, buffers, ECD's, signage are in acceptable condition.</p>			
GPS Location	See photo GPS	GPS Location	See photo GPS		
Field Station#	11024+00	Field Station#	11017+00		
Pic 1 Desc.	Stream S-IJ18 and controls are in acceptable condition.	Pic 2 Desc.	Stream S-RR5 and controls are in acceptable condition.

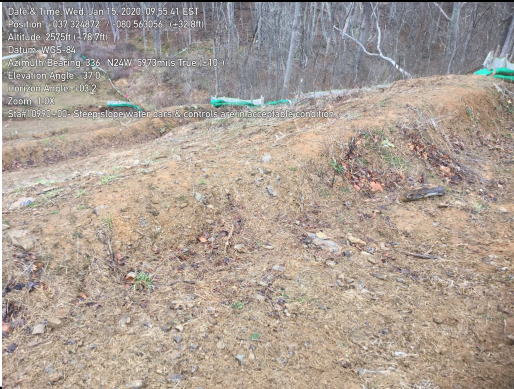
<p>Date & Time: Wed Jan 15, 2020 09:35:21 EST Position: 437.324512 / -80.561054 (-132.0ft) Altitude: 257ft (+178.9ft) Datum: WGS-84 Azimuth/Bearing: 234.124W 577mils True (+10) Elevation Angle: -17.0 Horizon Angle: +00.2 Zoom: 1.0x Sta# 10990+00: Steepslope water bars & controls are in acceptable condition.</p>

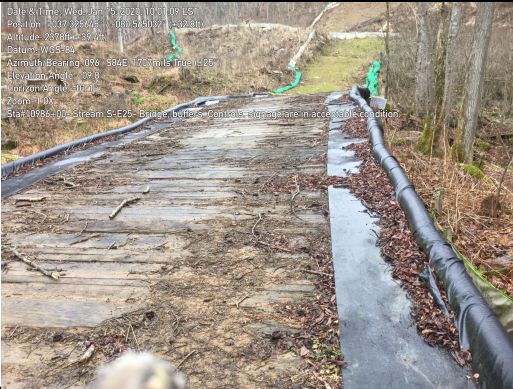
<p>Date & Time: Wed Jan 15, 2020 09:36:05 EST Position: 437.325644 / -80.560021 (-132.0ft) Altitude: 237ft (+137.0ft) Datum: WGS-84 Azimuth/Bearing: 89.634E 1707mils True (+25) Elevation Angle: -29.8 Horizon Angle: +01.1 Zoom: 1.0x Sta# 10986+00: Stream S-E25: Bridge, buffers, signage are in acceptable condition.</p>			
GPS Location	See photo GPS	GPS Location	See photo GPS		
Field Station#	10990+00	Field Station#	10986+00		
Pic 3 Desc.	Water bars & end treatment's are in acceptable condition.	Pic 4 Desc.	Stream S-E25 and environmental controls are in acceptable condition.

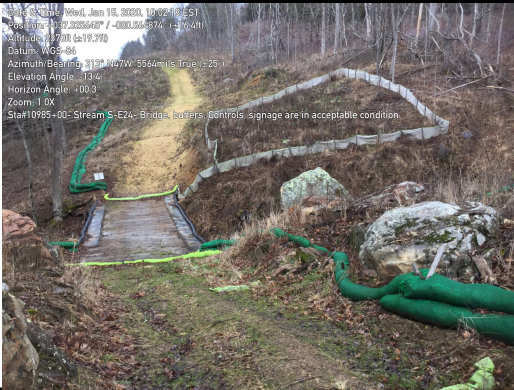
<p>Date & Time: Wed Jan 15, 2020 10:12:12 EST Position: 437.320548 / -80.574370 (-95.4ft) Altitude: 227ft (+126.2ft) Datum: WGS-84 Azimuth/Bearing: 102.102E 0036mils True (+10) Elevation Angle: -13.4 Horizon Angle: +00.3 Zoom: 1.0x Sta# 10985+00: Stream S-E24: Bridge, buffers, controls, signage are in acceptable condition.</p>

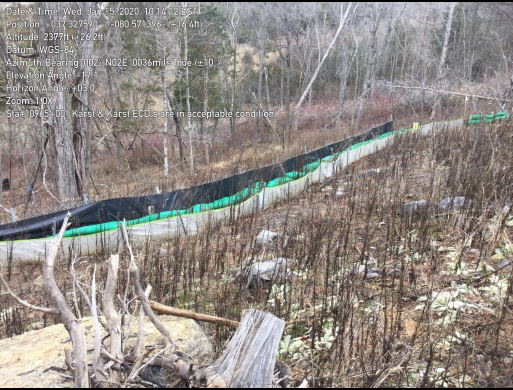
<p>Date & Time: Wed Jan 15, 2020 10:12:12 EST Position: 437.320548 / -80.574370 (-95.4ft) Altitude: 227ft (+126.2ft) Datum: WGS-84 Azimuth/Bearing: 102.102E 0036mils True (+10) Elevation Angle: -13.4 Horizon Angle: +00.3 Zoom: 1.0x Sta# 10985+00: Karst & Karst ECD's are in acceptable condition.</p>			
GPS Location	See photo GPS	GPS Location	See photo GPS		
Field Station#	10985+00	Field Station#	10964+00		
Pic 5 Desc.	Stream S-E24 and environmental controls are in acceptable condition.	Pic 6 Desc.	Karst and Karst ECD's are in acceptable condition.

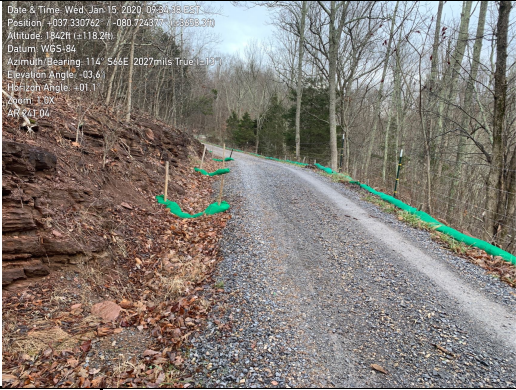
<p>Date & Time: Wed Jan 15 2020 09:34:49 EST Position: +09° 33'07.8" / +80° 52'37.0" (±213.3m) Altitude: 2220ft (±68.1m) Datum: WGS-84 Azimuth/Bearing: 114° S86E 2027mils True (±10°) Elevation Angle: -03.6° Horizon Angle: +01.1° Zoom: 1.0X 10712+00</p>

<p>Date & Time: Wed Jan 15 2020 09:37:47 EST Position: +09° 33'07.8" / +80° 52'37.0" (±213.3m) Altitude: 2220ft (±68.1m) Datum: WGS-84 Azimuth/Bearing: 091° S89E 1618mils True (±16°) Elevation Angle: -04.0° Horizon Angle: +01.9° Zoom: 1.0X 10712+50 S-G33</p>			
GPS Location	See photo for GPS location.		GPS Location	See photo for GPS location.	
Field Station#	10695+00		Field Station#	10712+50	
Pic 1 Desc.	Compost filter sock checks in place in bar ditch along access road 241.04.		Pic 2 Desc.	Sensitive resource buffer in place at stream S-G33.

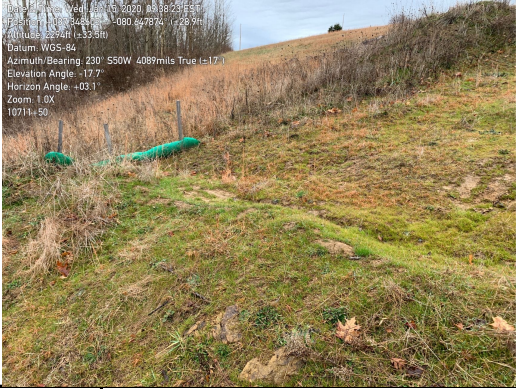
<p>Date & Time: Wed Jan 15 2020 09:40:29 EST Position: +09° 33'10.2" / +80° 52'37.0" (±213.3m) Altitude: 2220ft (±68.1m) Datum: WGS-84 Azimuth/Bearing: 230° S50W 4089mils True (±17.1°) Elevation Angle: -17.7° Horizon Angle: +03.1° Zoom: 1.0X 10711+50</p>

GPS Location	See photo for GPS location.		GPS Location	See photo for GPS location.	
Field Station#	10711+50		Field Station#	10709+00	
Pic 3 Desc.	Waterbar in place across travel lane with compost filter sock end treatment.		Pic 4 Desc.	ROW is stabilized with natural vegetation.

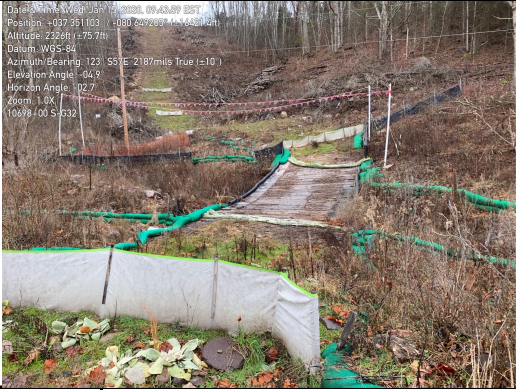
<p>Date & Time: Wed Jan 15 2020 09:43:49 EST Position: +09° 33'10.2" / +80° 52'37.0" (±213.3m) Altitude: 2220ft (±68.1m) Datum: WGS-84 Azimuth/Bearing: 123° S51E 2187mils True (±10°) Elevation Angle: -04.9° Horizon Angle: +02.7° Zoom: 1.0X 10698+00 S-G32</p>

Pic 5 Desc.	Sensitive resource buffer in place at stream S-G32.		Pic 6 Desc.	RCE in place at Buffalo Anklets Road.

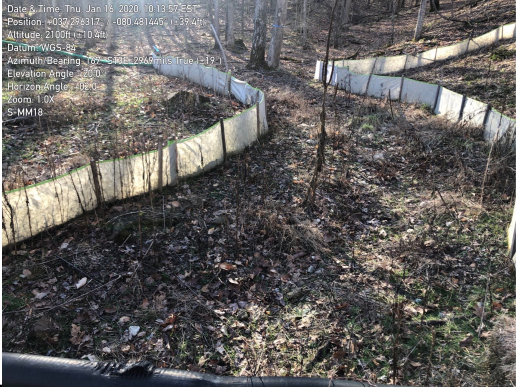
GPS Location	3	GPS Location	4		
Field Station#	11292+80	Field Station#	11314+00		
Pic 3 Desc.	S-MM18.	Pic 4 Desc.	Multiple layers of perimeter control functional on sensitive resource.

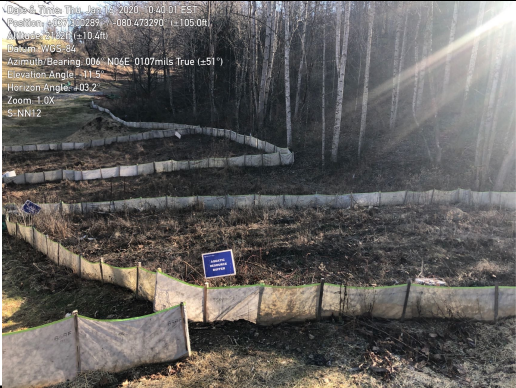
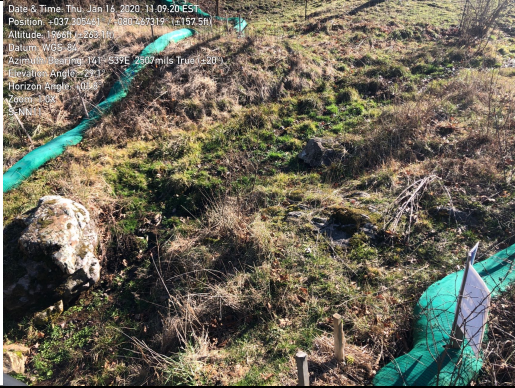
GPS Location	5	GPS Location	6		
Field Station#	11327+85	Field Station#	11352+97		
Pic 5 Desc.	S-NN12 and buffers.	Pic 6 Desc.	S-NN11.

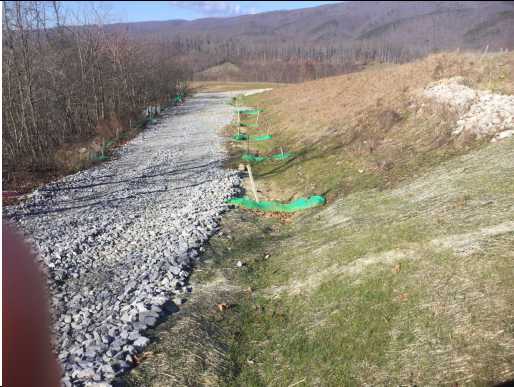
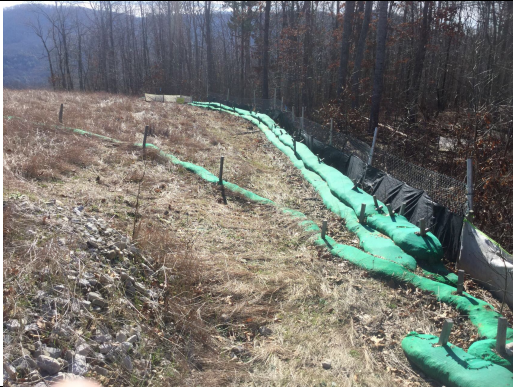
GPS Location	See photo GPS		GPS Location	See photo GPS	
Field Station#	111900+00		Field Station#	1194200-	
Pic 1 Desc.	Controls on AR-266.03		Pic 2 Desc.	Karst and Karst ECD's are in good condition.

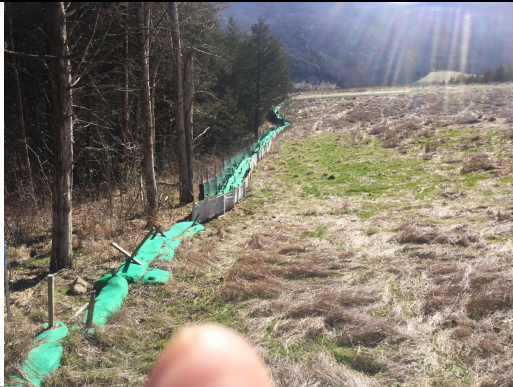
GPS Location	See photo GPS		GPS Location	See photo GPS	
Field Station#	11950+00		Field Station#	11976+50	
Pic 3 Desc.	Subsidence has grown		Pic 4 Desc.	Karst and Karst ECD's are in acceptable condition

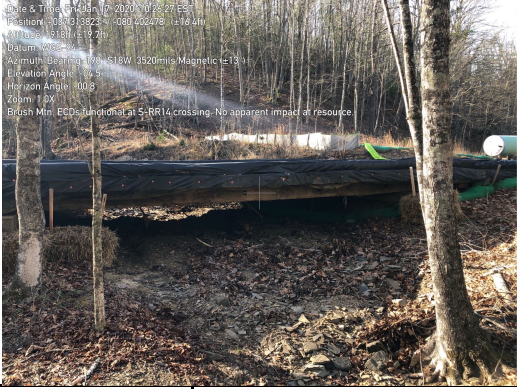
<p><small>Date & Time: Wed Jan 15 2020 10:52:21 EST Position: +087.313739°N, -090.420538°W, 98.41m Altitude: 188ft ±105.0ft Datum: WGS 84 Azimuth: Bearing: 200° SOW, 3950mils Magnetic ±13° Elevation Angle: 123° Horizon Angle: -0.8° Zoom: 1.0X Brush Mtn. CCDs functional at S-RR14/crossing. No apparent impact at resource.</small></p>

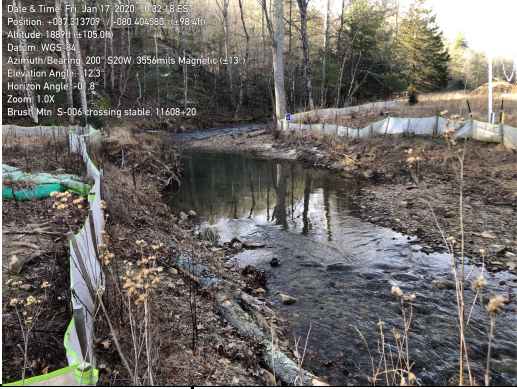
<p><small>Date & Time: Fri Jan 17 2020 11:32:18 EST Position: +087.313739°N, -090.420538°W, 98.41m Altitude: 188ft ±105.0ft Datum: WGS 84 Azimuth: Bearing: 200° SOW, 3950mils Magnetic ±13° Elevation Angle: 123° Horizon Angle: -0.8° Zoom: 1.0X Brush Mtn. S-006 crossing stable. 11608+20.</small></p>		
GPS Location	On photo		GPS Location	On photo	
Field Station#	11614+20		Field Station#	11608+20	
Pic 7 Desc.	Resource crossing S-RR14 is stable with no sign of impact		Pic 8 Desc.	Resource crossing S-006 is stable with no sign of impact
