Visual Site Inspection Report

Project Name	H-600 Pipeline Spread G	AFE	124300137	Spread	H-600 Pipeline Spread G
Contractor	Precision			Report #	7679
Inspector	Garrett Barclay			Date/Time	1/27/2020 7:21 AM
Permit #	TBD	Inspection Type	VA SWPP	Station Begin	10843+00
State	VA	Inspection Area	Partial	Station End	10930+00
County	Giles	Ground	Wet	Temperature (°F)	32.00
Municipality	N/A	Weather	Cloudy	Rain Gauge (in)	1.40
				Rain Accumulation Time (days)	1.00

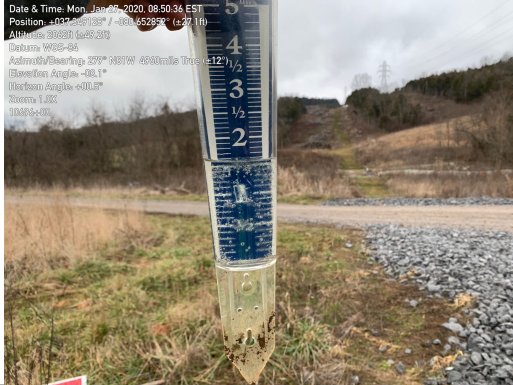
GPS Location		See photo for GPS location.		GPS Location	
Field Station#		11767+00		Field Station#	
Pic 3 Desc.		Rain gauge at Mount Tabor Road reads 1.3 inches.		Pic 4 Desc.

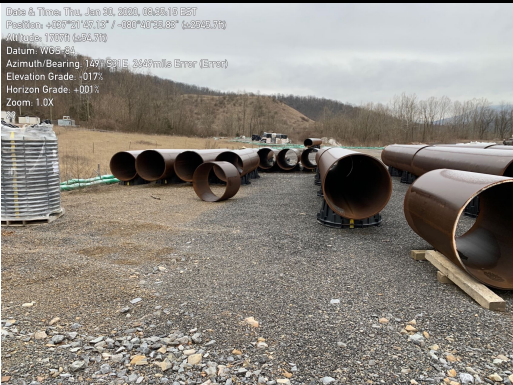
<p>Date & Time: Thu, Jan 30, 2020, 08:08:10 EST Position: +38°21'52.87" N -88°48'29.87" W (+18.30) Altitude: 1799' (+61.40) Datum: WGS-84 Azimuth/Bearing: 149° 5916' 334Ymils Error (Error) Elevation Grade: +017% Horizon Grade: +001% Zoom: 1.0X</p>			
GPS Location	See picture above for GPS coordinates		GPS Location	See picture above for GPS coordinates	
Field Station#	+29		Field Station#	+29	
Pic 1 Desc.	ECD's and row conditions		Pic 2 Desc.	ECD's and row conditions

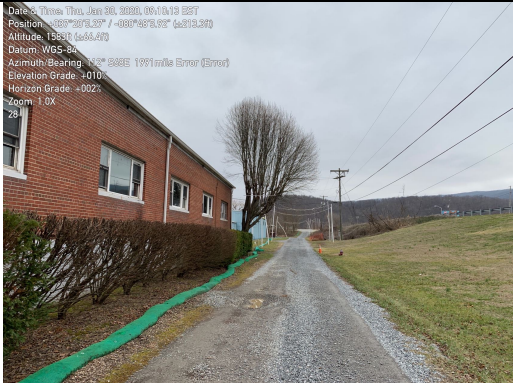
GPS Location	See picture above for GPS coordinates		GPS Location	See picture above for GPS coordinates	
Field Station#	+28		Field Station#	+28	
Pic 3 Desc.	ECD's and row conditions		Pic 4 Desc.	ECD's and row conditions	
  <p>Date & Time: Thu, Jan 30, 2020, 09:15:41 EST Position: +38°20'12.87" N -88°48'29.87" W (+18.30) Altitude: 1843' (+61.30) Datum: WGS-84 Azimuth/Bearing: 070° 1105' 1244' 3241mils Error (Error) Elevation Grade: +00% Horizon Grade: +002% Zoom: 1.0X 28</p>

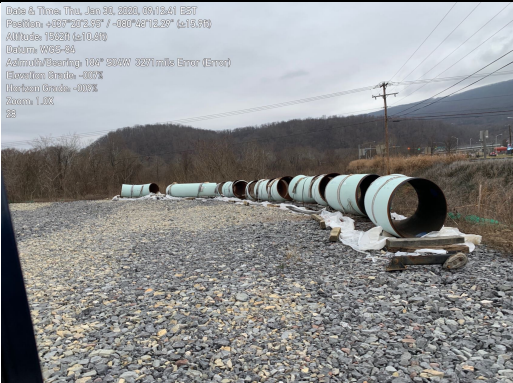
<p>Date & Time: Thu, Jan 30, 2020, 09:15:41 EST Position: +38°20'12.87" N -88°48'29.87" W (+18.30) Altitude: 1843' (+61.30) Datum: WGS-84 Azimuth/Bearing: 106° 3024' 3241mils Error (Error) Elevation Grade: +00% Horizon Grade: +00% Zoom: 1.0X 28</p>			
GPS Location	See picture above for GPS coordinates		GPS Location	See picture above for GPS coordinates wi	
Field Station#	+28		Field Station#	+28	
Pic 5 Desc.	ECD's and row conditions		Pic 6 Desc.	ECD's and row conditions

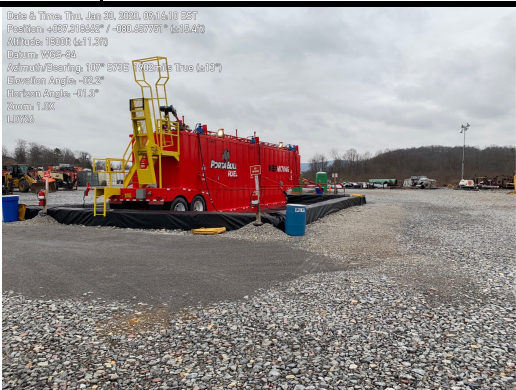
GPS Location	See photo for GPS location.		GPS Location	See photo for GPS location.	
Field Station#	12005+00		Field Station#	12005+00	
Pic 3 Desc.	Checked equipment for leaks. No leaks observed.		Pic 4 Desc.	Leak observed under forklift. Less than one quart of hydraulic fluid released.

7. Identify all remedial measures that have been taken since the previous inspection was conducted.					
Comments (Reference above questions as appropriate.)					
<p>Precision Pipeline employees used loader and hand tools to remove contaminated materials. Once contaminated materials were removed and disposed of, stone was replaced and containment was placed under forklift.</p> <p>Conducted VA SWPPP inspection at lay down yard 26. Checked equipment in yards for leaks. No leaks observed. All perimeter ECDs in place and functional. Secondary containment in place at stationary equipment. No deficiencies located during VA SWPPP inspection.</p>					
Note: It is a condition of National Pollutant Discharge Elimination System and Erosion and Sediment permits that a maintenance program be conducted to provide for the operation and maintenance of all BMPs to be inspected on a weekly basis and after each stormwater event. Please list in the space provided comments to note if repairs or replacement are needed or have been made for BMPs as a result of the inspection. Failure to conduct the required inspection may result in permit suspension or the imposition of civil penalties. If supplemental monitoring is required as part of a permit condition this form may be used to meet those monitoring requirements.

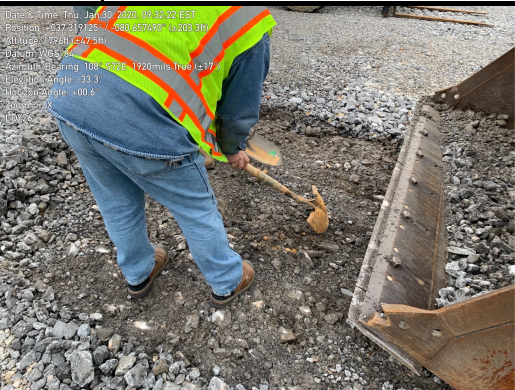
Pic 5 Desc.	Secondary containment in place under fuel cell.		Pic 6 Desc.	Precision Pipeline employees removing contaminated materials from hydraulic fluid leak.

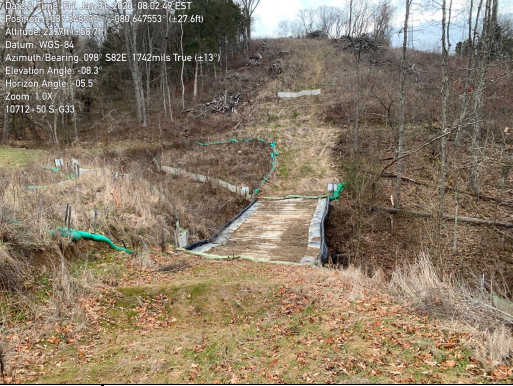
GPS Location	See photo for GPS location.		GPS Location	See photo for GPS location.	
Field Station#	10695+00		Field Station#	10712+50	
Pic 1 Desc.	Compost filter sock checks in place in bar ditch along access road 241.04.		Pic 2 Desc.	Sensitive resource buffer in place at stream S-G33.	
<p>Date & Time: Fri Jan 31, 2020 08:00:00 EST Position: 4327.355425, -8080.652685 (±15.3ft) Altitude: 1875ft (±52.3ft) Datum: WGS-84 Azimuth/Bearing: 222.542W 3947mils True (±13°) Elevation Angle: -20.1° Horizon Angle: -00.7° Zoom: 1.0X 10711+00</p>

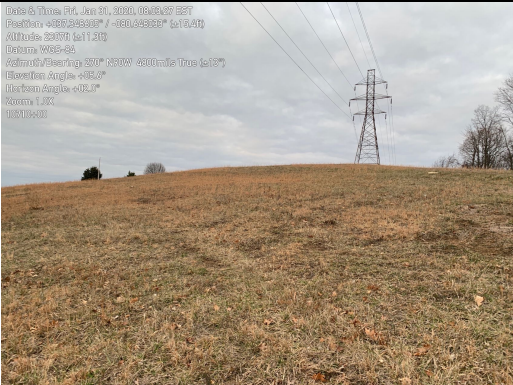
GPS Location	See photo for GPS location.		GPS Location	See photo for GPS location.	
Field Station#	10711+00		Field Station#	10710+00	
Pic 3 Desc.	Waterbar with end treatment in place across travel lane.		Pic 4 Desc.	ROW is stabilized with natural vegetation.	
<p>Date & Time: Fri Jan 31, 2020 08:07:45 EST Position: 4327.355425, -8080.652685 (±15.3ft) Altitude: 1875ft (±52.3ft) Datum: WGS-84 Azimuth/Bearing: 124.554E 2204mils True (±13°) Elevation Angle: -01.3° Horizon Angle: -00.2° Zoom: 1.0X 10698+00</p>
