Visual Site Inspection Report

Project Name	H-600 Pipeline Spread G	AFE	124300137	Spread	H-600 Pipeline Spread G
Contractor	Precision			Report #	6679
Inspector	Len Kruizenga			Date/Time	12/16/2019 7:05 AM
Permit #	TBD	Inspection Type	VA SWPP	Station Begin	11354+00
State	VA	Inspection Area	Full	Station End	11161+00
County	Giles	Ground	Muddy	Temperature (°F)	42.00
Municipality	N/A	Weather	Light Rain	Rain Gauge (in)	0.00
				Rain Accumulation Time (days)	1.00

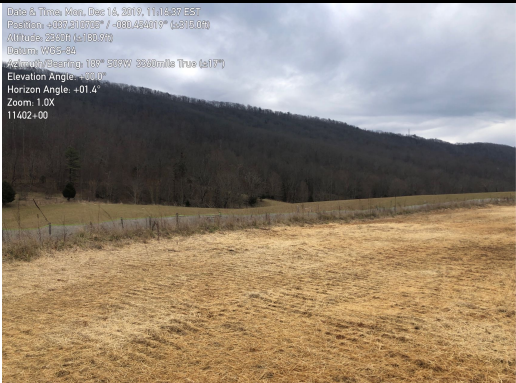
GPS Location	3	GPS Location	4		
Field Station#	11459+00	Field Station#	11451+18		
Pic 3 Desc.	P-1 silt fence perimeter controls functional.	Pic 4 Desc.	S-0013.

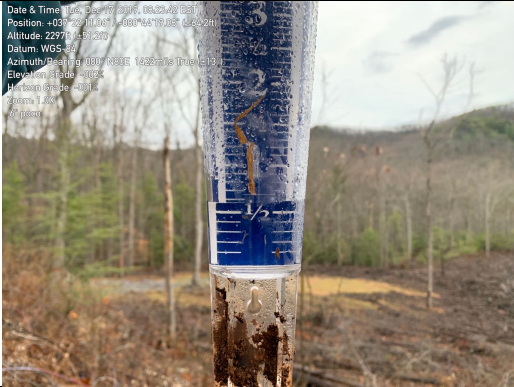
GPS Location	See picture above for GPS coordinates		GPS Location	See picture above for GPS coordinates	
Field Station#	+1		Field Station#	+1	
Pic 1 Desc.	.6" of rain recorded @ Pocahontas AR		Pic 2 Desc.	1" of rain recorded @ Steel Acres AR

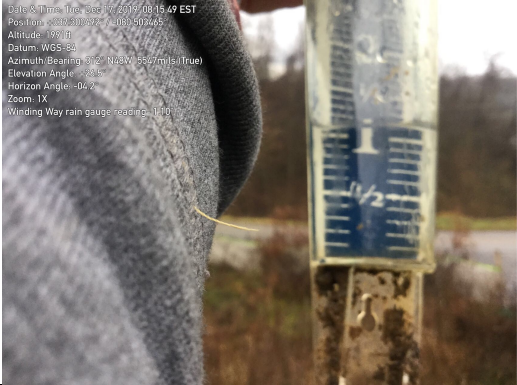
Insert image here			
GPS Location	See photo GPS	GPS Location			
Field Station#	11227+00	Field Station#			
Pic 7 Desc.	Winding Way rain gauge reading- 1.10"	Pic 8 Desc.			
Insert image here		Insert image here			
GPS Location		GPS Location			
Field Station#		Field Station#			
Pic 9 Desc.		Pic 10 Desc.			
Insert image here		Insert image here			
GPS Location		GPS Location			
Field Station#		Field Station#			
Pic 11 Desc.		Pic 12 Desc.

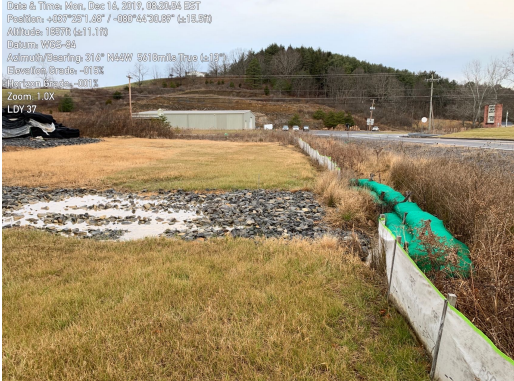
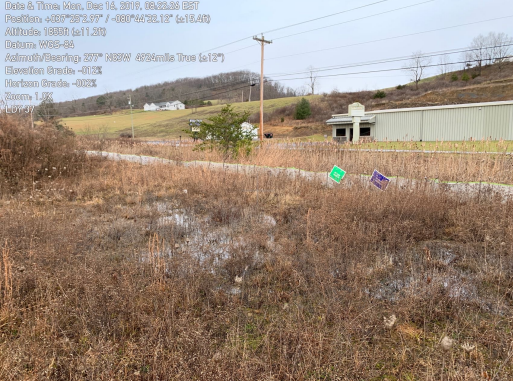
<p>Date & Time Mon, Dec 16, 2019, 06:23:03 EST Position: +38°57'51.88" / -88°44'30.87" (+18.89) Altitude: 1833ft (+11.1ft) Datum: WGS-84 Azimuth/Heading: 327° 0427' 4210mils True (+13°) Elevation Grade: -012% Horizon Grade: -001% Zoom: 1.0X LDY: 37</p>			
GPS Location	See picture above for GPS coordinates		GPS Location	See picture above for GPS coordinates	
Field Station#	+37		Field Station#	+37	
Pic 1 Desc.	ECD's and row conditions		Pic 2 Desc.	ECD's and row conditions

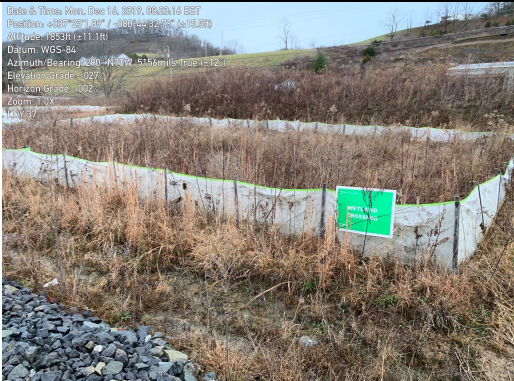
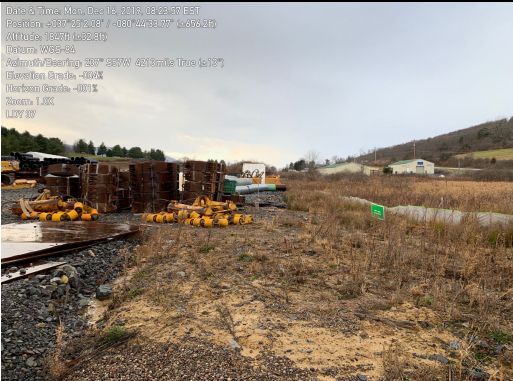
GPS Location	See picture above for GPS coordinates		GPS Location	See picture above for GPS coordinates	
Field Station#	+37		Field Station#	+37	
Pic 3 Desc.	ECD's and row conditions		Pic 4 Desc.	ECD's and row conditions

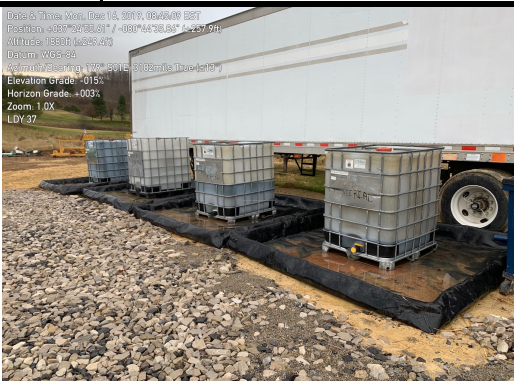
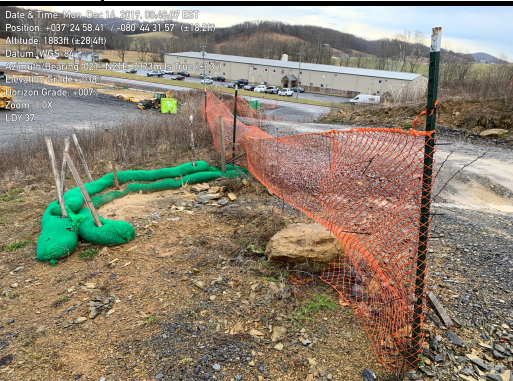
<p>Date & Time Mon, Dec 16, 2019, 06:23:27 EST Position: +38°57'51.88" / -88°44'30.87" (+18.89) Altitude: 1833ft (+11.1ft) Datum: WGS-84 Azimuth/Heading: 327° 0427' 4210mils True (+13°) Elevation Grade: -013% Horizon Grade: -007% Zoom: 1.0X LDY: 37</p>			
GPS Location	See picture above for GPS coordinates		GPS Location	See picture above for GPS coordinates	
Field Station#	+37		Field Station#	+37	
Pic 5 Desc.	ECD's and row conditions		Pic 6 Desc.	ECD's and row conditions

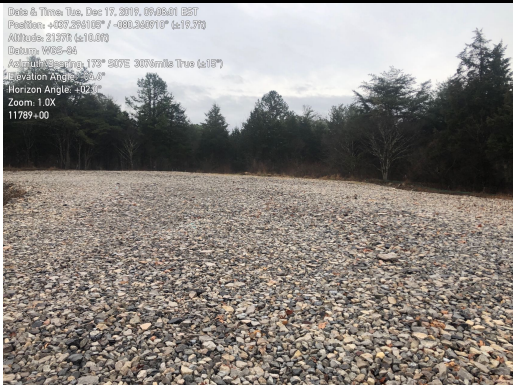
</div></div></div>			
GPS Location	1	GPS Location	2		
Field Station#	11789+00	Field Station#	11804+00		
Pic 1 Desc.	RCE South of Mt Tabor rd.	Pic 2 Desc.	Restored RoW.		
<div><div><div>Date & Time Tue, Dec 17, 2019, 05:45:11 (EST) Position: +407.260461° / +406.349894° ±19.010 Altitude: 21340 ±10.00 Datum: WGS-84 Azimuth/Bearing: 130° 52'50" 300mils True (±10°) Elevation Angle: -40.6° Horizon Angle: +03.0° Zoom: 1.0X 11830+00</div><div>

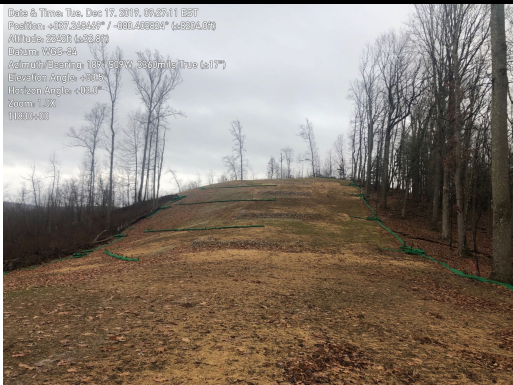
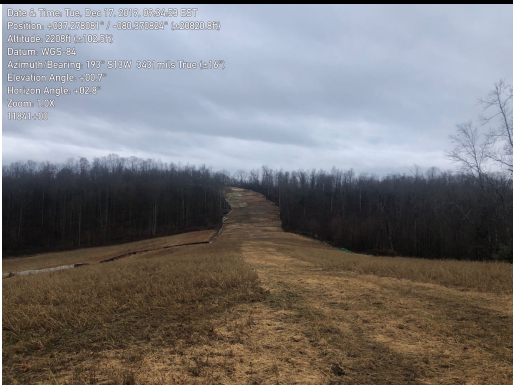
GPS Location	3	GPS Location	4		
Field Station#	11830+00	Field Station#	11841+00		
Pic 3 Desc.	Restored RoW.	Pic 4 Desc.	Restored RoW.		
<div><div><div>Date & Time Tue, Dec 17, 2019, 05:46:01 (EST) Position: +407.267777° / +406.350094° ±19.010 Altitude: 21360 ±10.00 Datum: WGS-84 Azimuth/Bearing: 016° N16E 0284mils True (±16°) Elevation Angle: -15.4° Horizon Angle: +03.9° Zoom: 1.0X P-KL2 11843+65</div><div> </div></div></div>		<div><div><div>Date & Time Tue, Dec 17, 2019, 05:46:46 (EST) Position: +407.270777° / +406.350094° ±19.010 Altitude: 21360 ±10.00 Datum: WGS-84 Azimuth/Bearing: 016° N16E 0284mils True (±16°) Elevation Angle: -15.4° Horizon Angle: +03.9° Zoom: 1.0X P-KL2 11874+50</div><div> </div></div></div>			
GPS Location	5	GPS Location	6		
Field Station#	11863+65	Field Station#	11874+50		
Pic 5 Desc.	P-KL2.	Pic 6 Desc.	P-1 silt fence perimeter controls functional.

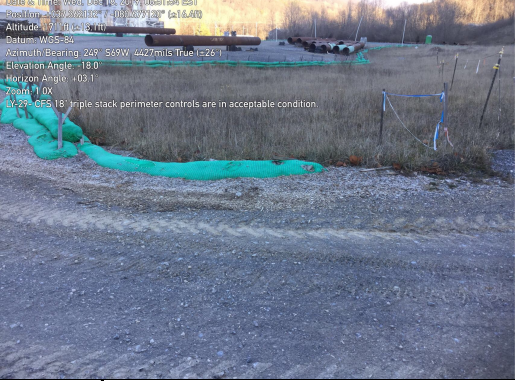
<p>Date & Time: Wed, Dec 18, 2019, 08:51:54 EST Position: +429.362199° / -089.67286° (+16.4ft) Altitude: 1717ft (+19.7ft) Datum: WGS-84 Azimuth/Bearing: 249° S69W 4427mils True (+26°) Elevation Angle: -18.0° Horizon Angle: +03.1° Zoom: 1.0X LY-29- CFS 18" Triple stack perimeter controls are in acceptable condition.</p>

GPS Location	See photo GPS	GPS Location	See photo GPS		
Field Station#	12005+00	Field Station#	12005+00		
Pic 1 Desc.	LY-29- Arnold's materials storage.	Pic 2 Desc.	LY- 29- CFS 18" Triple stack perimeter controls are in acceptable condition.

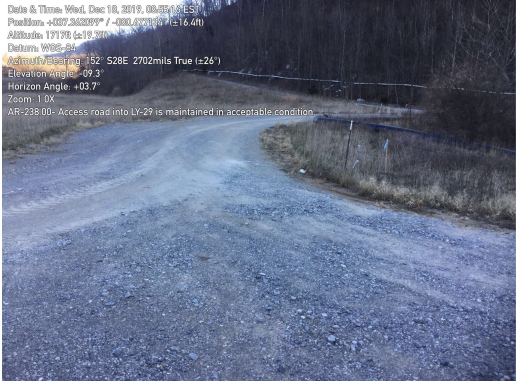
<p>Date & Time: Wed, Dec 18, 2019, 08:59:44 EST Position: +429.362199° / -089.67286° (+16.4ft) Altitude: 1717ft (+19.7ft) Datum: WGS-84 Azimuth/Bearing: 152° S28E 2702mils True (+26°) Elevation Angle: -69.3° Horizon Angle: +03.7° Zoom: 1.0X AR-238.00- Access road into LY-29 is maintained in acceptable condition.</p>

GPS Location	See photo GPS	GPS Location	See photo GPS		
Field Station#	12005+00	Field Station#	12005+00		
Pic 3 Desc.	AR-238.00+ Road leading into LY-29 is maintained in acceptable condition.	Pic 4 Desc.	LY-29- PPL Materials storage.		
<p>Date & Time: Wed, Dec 18, 2019, 09:05:35 EST Position: +429.362199° / -089.67286° (+16.4ft) Altitude: 1717ft (+19.7ft) Datum: WGS-84 Azimuth/Bearing: 161° S39E 2657mils True (+15°) Elevation Angle: -16.9° Horizon Angle: +00.0° Zoom: 1.0X LY-29 - Rock surface of the yard is maintained in acceptable condition.</p>

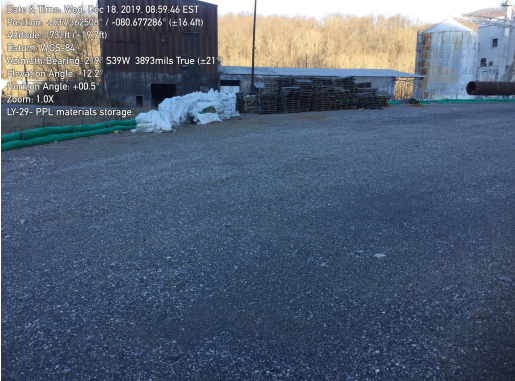
<p>Date & Time: Wed, Dec 18, 2019, 08:59:44 EST Position: +429.362199° / -089.67286° (+16.4ft) Altitude: 1717ft (+19.7ft) Datum: WGS-84 Azimuth/Bearing: 110° S39W 3893mils True (+21°) Elevation Angle: -17.2° Horizon Angle: +00.5° Zoom: 1.0X LY-29- PPL materials storage.</p>

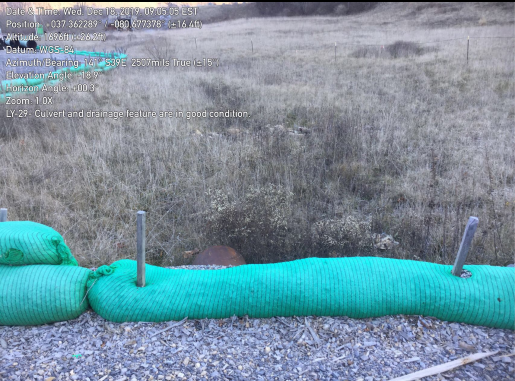
<p>Date & Time: Wed, Dec 18, 2019, 09:05:35 EST Position: +429.362199° / -089.67286° (+16.4ft) Altitude: 1717ft (+19.7ft) Datum: WGS-84 Azimuth/Bearing: 161° S39E 2657mils True (+15°) Elevation Angle: -16.9° Horizon Angle: +00.0° Zoom: 1.0X LY-29- Culvert and drainage feature are in good condition.</p>

GPS Location	See photo GPS	GPS Location	See photo GPS		
Field Station#	12005+00	Field Station#	12005+00		
Pic 5 Desc.	LY-29- The rock surface of the yard is maintained in acceptable condition.	Pic 6 Desc.	LY-29- Culvert and drainage feature are in good condition.

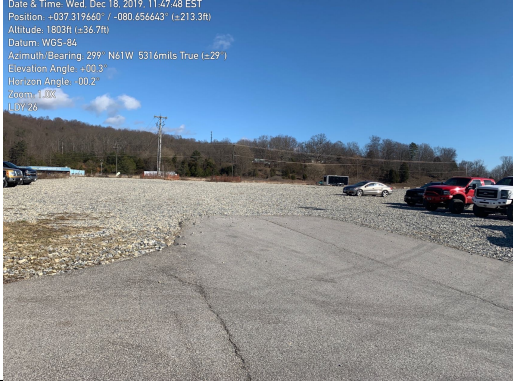
GPS Location		See photo for GPS location.				GPS Location		See photo for GPS location.			
Field Station#		12005+00				Field Station#		12005+00			
Pic 1 Desc.		RCE in place employee entrance.				Pic 2 Desc.		Secondary containment in place under fuel cell.			
<p>Date & Time: Wed Dec 18 2019 11:49:02 EST Position: +037 318866 / -080 658432 (+15.3ft) Altitude: 1792ft (+36.4ft) Datum: WGS-84 Azimuth/Bearing: 206 S26W 3662mils True (+30.4) Elevation Angle: +01.5 Horizon Angle: +02.3 Zoom: 1.0X LDY 26</p>

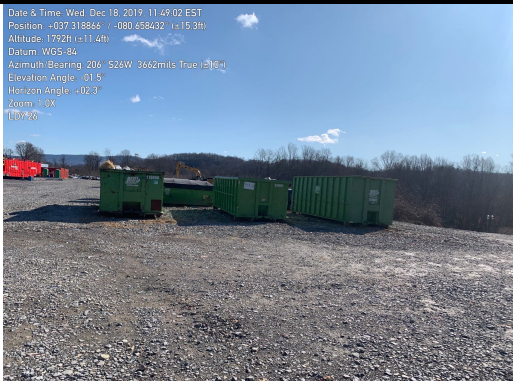
GPS Location		See photo for GPS location.				GPS Location		See photo for GPS location.			
Field Station#		12005+00				Field Station#		12005+00			
Pic 3 Desc.		Dumpsters in place for waste management.				Pic 4 Desc.		Triple stack 12 inch compost filter sock in place.			
<p>Date & Time: Wed Dec 18 2019 11:49:48 EST Position: +037 319667 / -080 658737 (+13.4ft) Altitude: 1790ft (+36.2ft) Datum: WGS-84 Azimuth/Bearing: 207 S26W 3698mils True (+10.1) Elevation Angle: +02.5 Horizon Angle: +01.2 Zoom: 2.0X LDY 26</p>

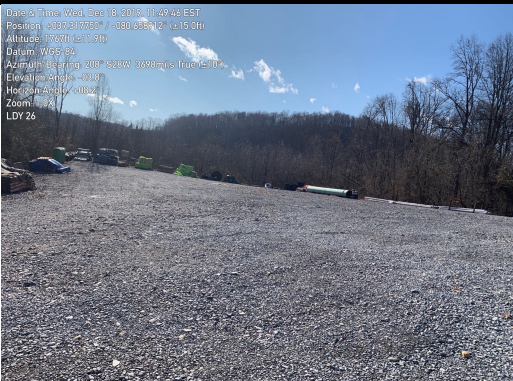
Pic 5 Desc.		No leaks observed under staged equipment.				Pic 6 Desc.		Yard covered with stone with geotextile fabric in place over top soil.

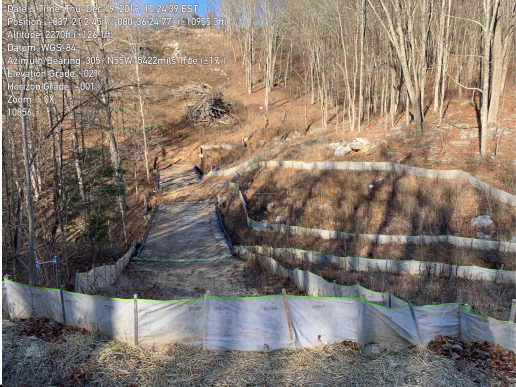
GPS Location	See picture above for GPS coordinates		GPS Location	See picture above for GPS coordinates	
Field Station#	2+35		Field Station#	2+34	
Pic 1 Desc.	ECD's and row conditions		Pic 2 Desc.	ECD's and row conditions

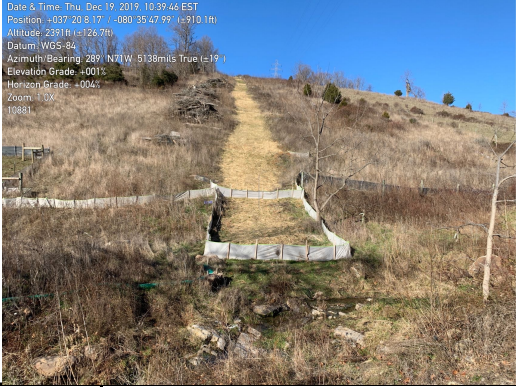
GPS Location	See picture above for GPS coordinates		GPS Location	See picture above for GPS coordinates	
Field Station#	10856+00		Field Station#	10865+00	
Pic 3 Desc.	ECD's and row conditions		Pic 4 Desc.	ECD's and row conditions

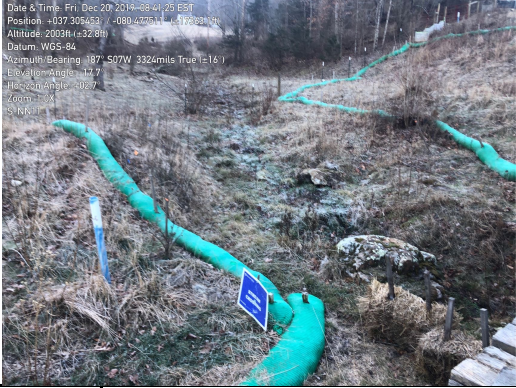
<p>Date & Time: Fri, Dec 20, 2019, 08:41:25 EST Position: +037 305493 / -080 467541 (+19.7m) Altitude: 2023ft (+10.6ft) Datum: WGS-84 Azimuth/Bearing: 187.507W 3324mils True (+16.1) Elevation Angle: -12.7 Horizon Angle: -00.7 Zoom: 1.0X S-NN11</p>

<p>Date & Time: Fri, Dec 20, 2019, 08:42:03 EST Position: +037 305493 / -080 467524 (+19.7m) Altitude: 2023ft (+10.6ft) Datum: WGS-84 Azimuth/Bearing: 240.560W 4267mils True (+16.1) Elevation Angle: -16.6 Horizon Angle: -00.4 Zoom: 1.0X 11351+50</p>		GPS Location	1
Field Station#		11352+97	GPS Location	2	
Pic 1 Desc.		S-NN11.	Field Station#	11351+50	
Pic 2 Desc.			Vegetation/stabilization sufficient.

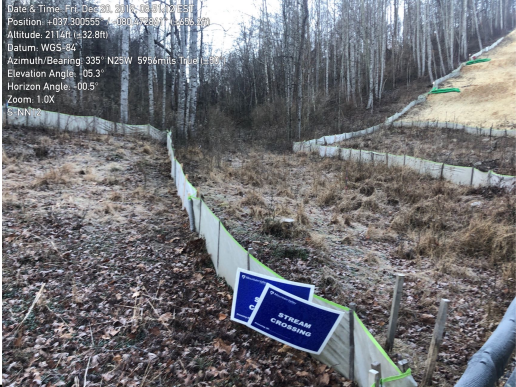
<p>Date & Time: Fri, Dec 20, 2019, 08:52:55 EST Position: +037 305550 / -080 471668 (+105.0ft) Altitude: 2114ft (+32.8ft) Datum: WGS-84 Azimuth/Bearing: 335.925W 5961mils True (+18.8) Elevation Angle: -105.3 Horizon Angle: -00.5 Zoom: 1.0X S-NN12</p>

Field Station#		11327+85	GPS Location	4	
Pic 3 Desc.		S-NN12.	Field Station#	11331+25	
Pic 4 Desc.			Vegetation/stabilization sufficient.

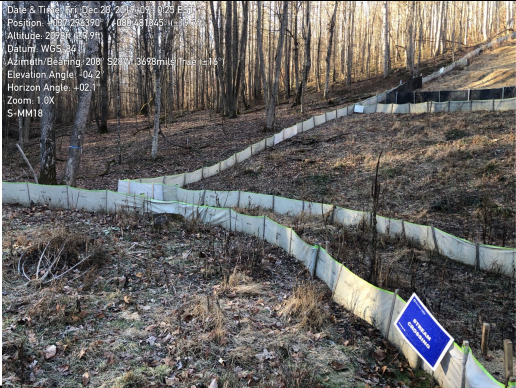
<p>Date & Time: Fri, Dec 20, 2019, 09:14:25 EST Position: +037 305592 / -080 471668 (+105.0ft) Altitude: 2095ft (+33.3ft) Datum: WGS-84 Azimuth/Bearing: 208.503W 3638mils True (+16.1) Elevation Angle: -104.2 Horizon Angle: -02.1 Zoom: 1.0X S-MM18</p>

<p>Date & Time: Fri, Dec 20, 2019, 09:14:07 EST Position: +037 305592 / -080 471668 (+105.0ft) Altitude: 2153ft (+10.4ft) Datum: WGS-84 Azimuth/Bearing: 066.946E 1173mils True (+18.8) Elevation Angle: -09.3 Horizon Angle: -02.2 Zoom: 1.0X 11299+50</p>		GPS Location	5
Field Station#		11292+80	GPS Location	6	
Pic 5 Desc.		S-MM18.	Field Station#	11299+50	
Pic 6 Desc.			Vegetation/stabilization sufficient on topsoil pile.

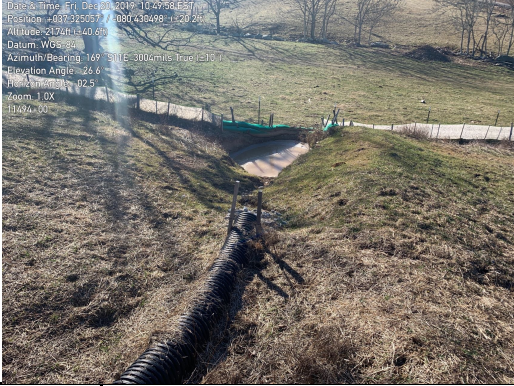
GPS Location		See photo for GPS location.		GPS Location	
Field Station#		11494+00		Field Station#	
Pic 1 Desc.		Slope drain, water bar, sump pit, waterbar end treatment, and rock outlet in place.		Pic 2 Desc.

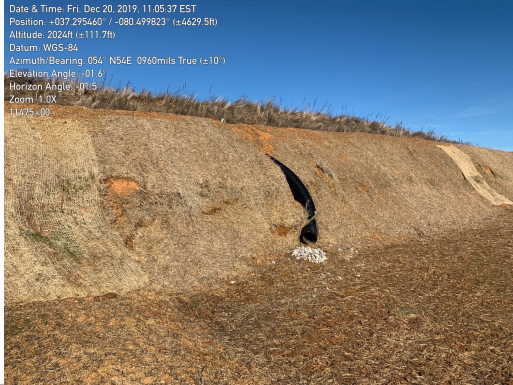
GPS Location		See photo for GPS location.		GPS Location	
Field Station#		11485+00		Field Station#	
Pic 3 Desc.		Plunge pool and clean water drainage pipe in place.		Pic 4 Desc.

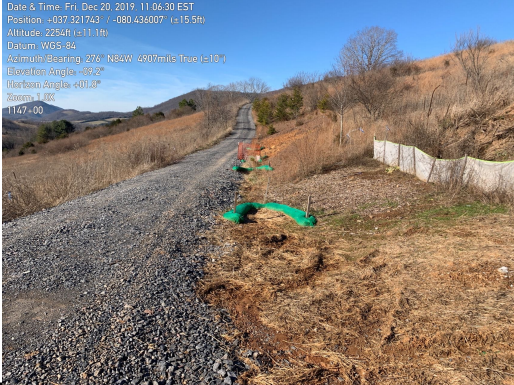
GPS Location		See photo for GPS location.		GPS Location	
Field Station#		11471+00		Field Station#	
Pic 5 Desc.		Compost filter sock checks in place along access road.		Pic 6 Desc.
