# Visual Site Inspection Report

<b>Project Name</b>	H-600 Pipeline Spread G	<b>AFE</b>	124300137	<b>Spread</b>	H-600 Pipeline Spread G
<b>Contractor</b>	Precision			<b>Report #</b>	6258
<b>Inspector</b>	Garrett Barclay			<b>Date/Time</b>	12/2/2019 7:59 AM
<b>Permit #</b>	TBD	<b>Inspection Type</b>	VA SWPP	<b>Station Begin</b>	11520+00
<b>State</b>	VA	<b>Inspection Area</b>	Partial	<b>Station End</b>	11620+00
<b>County</b>	Giles	<b>Ground</b>	Wet	<b>Temperature (°F)</b>	28.00
<b>Municipality</b>	N/A	<b>Weather</b>	Sunny	<b>Rain Gauge (in)</b>	1.60
				<b>Rain Accumulation Time (days)</b>	1.00

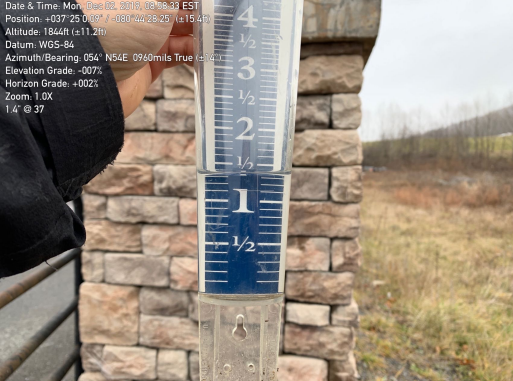
<p>Date &amp; Time: Mon, Dec 02, 2019, 08:12:43 EST Position: +37°25'1.91" / -83°44'28.25" (419.41) Altitude: 1844ft (+11.21) Datum: WGS-84 Azimuth/Bearing: 054° N 54E 0760mils True (51°) Elevation Grade: -007% Horizon Grade: +002% Zoom: 1.0X 1.4" @ 37</p>			
<b>GPS Location</b>	See picture above for GPS coordinates	<b>GPS Location</b>	See picture above for GPS coordinates		
<b>Field Station#</b>	+37	<b>Field Station#</b>	+37		
<b>Pic 1 Desc.</b>	ECD's and row conditions	<b>Pic 2 Desc.</b>	1.4" of rain recorded

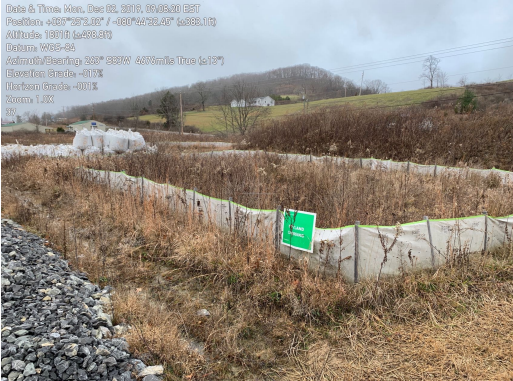
<b>GPS Location</b>	See picture above for GPS coordinates	<b>GPS Location</b>	See picture above for GPS coordinates		
<b>Field Station#</b>	+37	<b>Field Station#</b>	+37		
<b>Pic 3 Desc.</b>	ECD's and row conditions	<b>Pic 4 Desc.</b>	ECD's and row conditions

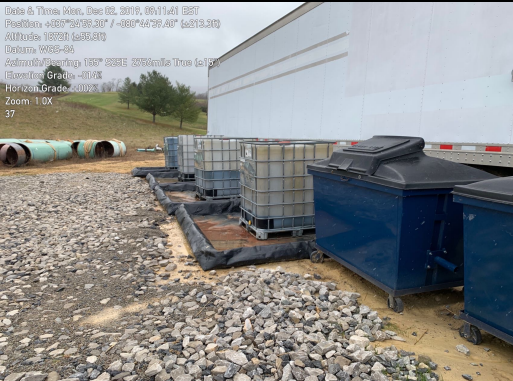
<b>Pic 5 Desc.</b>	ECD's and row conditions	<b>Pic 6 Desc.</b>	ECD's and row conditions secondary containment

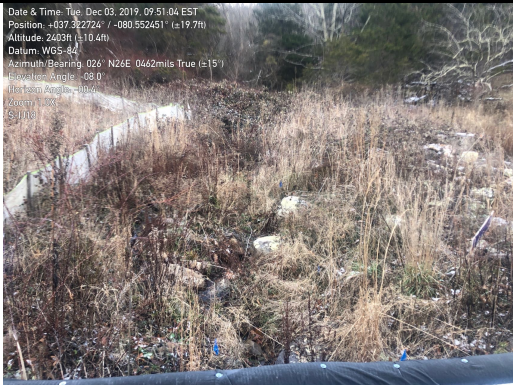
<p>Date &amp; Time: Tue Dec 03 2019 09:54:31 EST Position: +037.321650 / -080.551197 (+19.7ft) Altitude: 2378ft (+10.4ft) Datum: WGS-84 Azimuth/Bearing: 298° N22W 038mils True (±18°) Elevation Angle: -15.8° Horizon Angle: -03.7° Zoom: 1.0x 11032+00</p>			
GPS Location	1	GPS Location	2		
Field Station#	11026+00	Field Station#	11032+00		
Pic 1 Desc.	S-IJ18.	Pic 2 Desc.	Downed tree from off RoW that damaged the barbed wire fence on the edge of the RoW LoD.

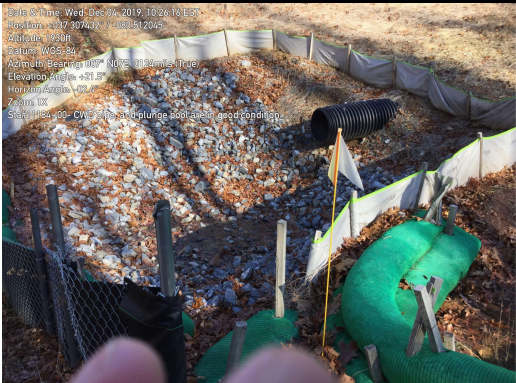
<b>Pic 5 Desc.</b>	CWD pipe and plunge pool are in good condition.		<b>Pic 6 Desc.</b>	AR-249.02 is maintained in acceptable condition

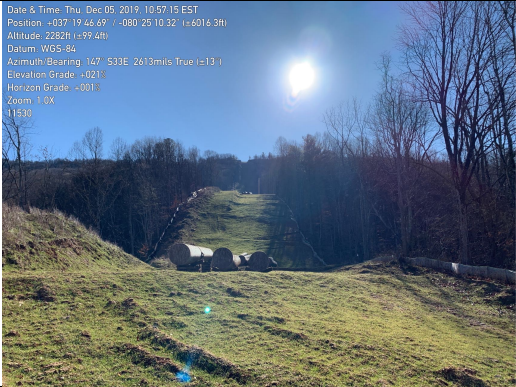
<b>GPS Location</b>	See picture above for GPS coordinates		<b>GPS Location</b>	See picture above for GPS coordinates	
<b>Field Station#</b>	11530+00		<b>Field Station#</b>	11534+00	
<b>Pic 1 Desc.</b>	ECD's and row conditions		<b>Pic 2 Desc.</b>	ECD's and row conditions	
<p>Date &amp; Time: Thu Dec 05 2019 11:03:11 EST  Position: +037 19 44.69 - -080 25 10.32 116016.3ft  Altitude: 2279ft 116016.3ft  Datum: WGS 84  Azimuth/Bearing: 147.533E 2613mils True 113.1  Elevation Grade: +001  Horizon Grade: +001  Zoom: 1.0X  11570</p>

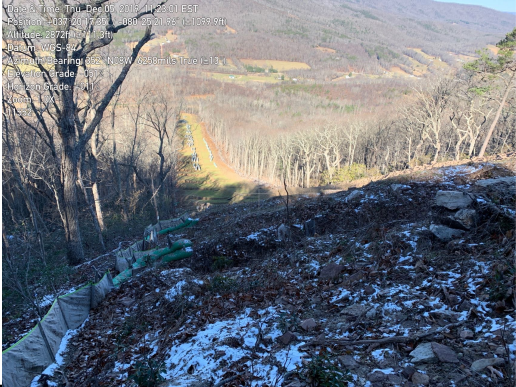
<b>GPS Location</b>	See picture above for GPS coordinates		<b>GPS Location</b>	See picture above for GPS coordinates	
<b>Field Station#</b>	11552+00		<b>Field Station#</b>	11570+00	
<b>Pic 3 Desc.</b>	ECD's and row conditions		<b>Pic 4 Desc.</b>	ECD's and row conditions	
<p>Date &amp; Time: Thu Dec 05 2019 12:12:28 EST  Position: +037 19 44.69 - -080 25 11.66 116016.3ft  Altitude: 2250ft 116016.3ft  Datum: WGS 84  Azimuth/Bearing: 107.540E 1112mils True 113.1  Elevation Grade: +019  Horizon Grade: +001  Zoom: 2.0X  11570</p>

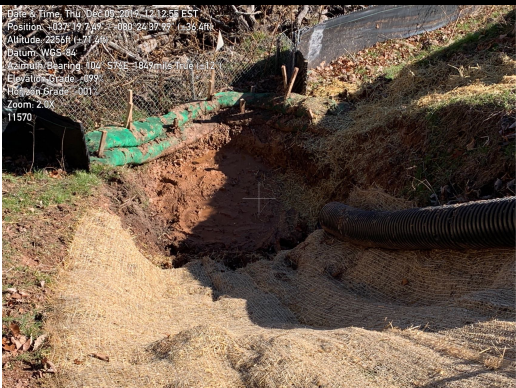
<b>Field Station#</b>	11570+00		<b>Field Station#</b>	11570+00	
<b>Pic 5 Desc.</b>	ECD's and row conditions		<b>Pic 6 Desc.</b>	ECD's and row conditions

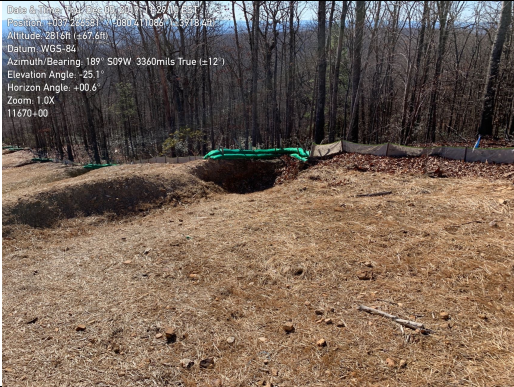
<p>Date &amp; Time: Thu, Dec 05, 2019 11:35:55 Position: +037.299628° / -080.391291° (+23.4m) Altitude: 2072ft (+32.6m) Datum: WGS-84 Azimuth/Bearing: 189° S09W 3360mils True (±12°) Elevation Angle: -25.1° Horizon Angle: +00.6° Zoom: 1.0X 11670+00</p>			
<b>GPS Location</b>	See photo for GPS location.		<b>GPS Location</b>	See photo for GPS location.	
<b>Field Station#</b>	11670+00		<b>Field Station#</b>	11681+00	
<b>Pic 1 Desc.</b>	Waterbar, sump pit, and end treatment in place.		<b>Pic 2 Desc.</b>	ROW has been stabilized with seed and mulch. Minor vegetation growth present.

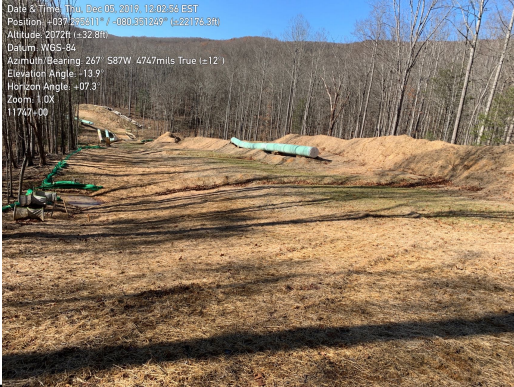
<p>Date &amp; Time: Thu, Dec 05, 2019 11:35:17 EST Position: +037.299628° / -080.391291° (+23.4m) Altitude: 2449ft (+52.4m) Datum: WGS-84 Azimuth/Bearing: 168° S12E 2987mils True (±13°) Elevation Angle: -16.7° Horizon Angle: +02.1° Zoom: 1.0X 11687+40 S-MN21</p>			
<b>GPS Location</b>	See photo for GPS location.		<b>GPS Location</b>	See photo for GPS location.	
<b>Field Station#</b>	11747+00		<b>Field Station#</b>	11687+40	
<b>Pic 3 Desc.</b>	ROW has been stabilized with seed and mulch. Minor vegetation growth present. Waterbar, sump pit, and end treatment in place.		<b>Pic 4 Desc.</b>	Sensitive resource buffer in place at stream S-MN21.

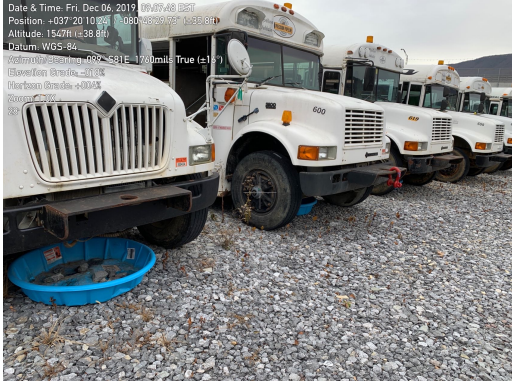
<p>Date &amp; Time: Fri, Dec 06, 2019, 09:08:25 EST Position: +37°23.10'N / -80°45'39.25" W (19.87) Altitude: 1547ft (478.6m) Datum: WGS-84 Azimuth Bearing: 000° 00'00" Azimuth True (±1°) Elevation Grade: -00% Horizon Grade: +00% Zoom: 1.0x 28</p>			
GPS Location	See picture above for GPS coordinates		GPS Location	See picture above for GPS coordinates	
Field Station#	+28		Field Station#	+28	
Pic 1 Desc.	ECD's and row conditions		Pic 2 Desc.	ECD's and row conditions

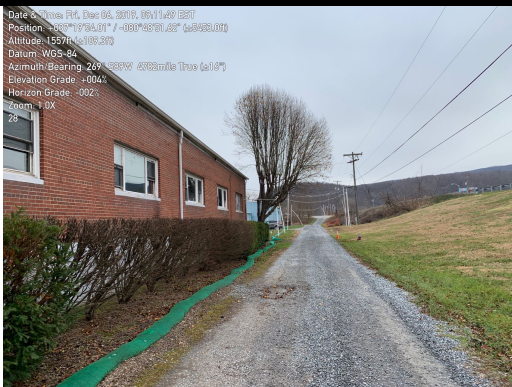
GPS Location	See picture above for GPS coordinates		GPS Location	See picture above for GPS coordinates	
Field Station#	+28		Field Station#	+28	
Pic 3 Desc.	ECD's and row conditions		Pic 4 Desc.	ECD's and row conditions

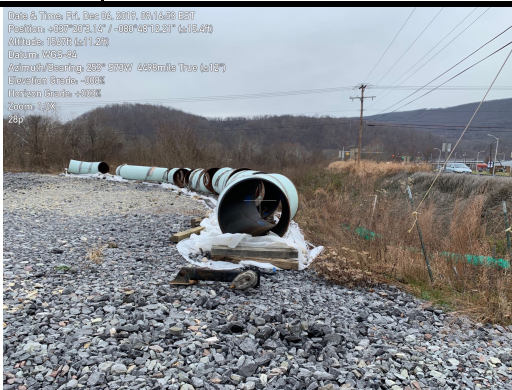
<p>Date &amp; Time: Fri, Dec 06, 2019, 09:17:15 EST Position: +37°20'2.42" N / -80°45'11.44" W (19.93) Altitude: 1570ft (478.6m) Datum: WGS-84 Azimuth Bearing: 000° 00'00" Azimuth True (±1°) Elevation Grade: -00% Horizon Grade: +00% Zoom: 1.0x 28</p>			
GPS Location	See picture above for GPS coordinates		GPS Location	See picture above for GPS coordinates	
Field Station#	+28		Field Station#	+28	
Pic 5 Desc.	ECD's and row conditions		Pic 6 Desc.	ECD's and row conditions
