# Visual Site Inspection Report

<b>Project Name</b>	H-600 Pipeline Spread G	<b>AFE</b>	124300137	<b>Spread</b>	H-600 Pipeline Spread G
<b>Contractor</b>	Precision			<b>Report #</b>	6958
<b>Inspector</b>	Brian Shields			<b>Date/Time</b>	12/30/2019 8:37 AM
<b>Permit #</b>	TBD	<b>Inspection Type</b>	VA SWPP	<b>Station Begin</b>	11254+88
<b>State</b>	VA	<b>Inspection Area</b>	Partial	<b>Station End</b>	11158+12
<b>County</b>	Giles	<b>Ground</b>	Wet	<b>Temperature (°F)</b>	55.00
<b>Municipality</b>	N/A	<b>Weather</b>	Cloudy	<b>Rain Gauge (in)</b>	0.10
				<b>Rain Accumulation Time (days)</b>	1.00

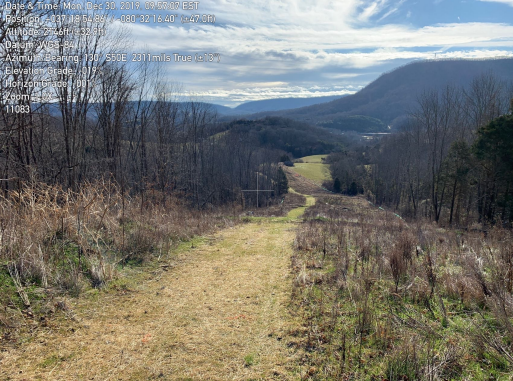
<b>GPS Location</b>		See picture above for GPS coordinates		<b>GPS Location</b>	
<b>Field Station#</b>		11067+00		<b>Field Station#</b>	
<b>Pic 1 Desc.</b>		ECD's and row conditions		<b>Pic 2 Desc.</b>

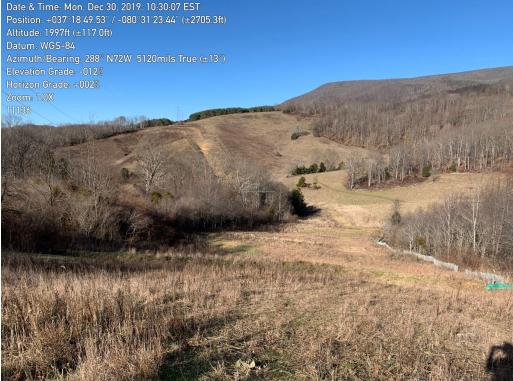
<b>GPS Location</b>		See picture above for GPS coordinates		<b>GPS Location</b>	
<b>Field Station#</b>		11104+00		<b>Field Station#</b>	
<b>Pic 3 Desc.</b>		ECD's and row conditions		<b>Pic 4 Desc.</b>

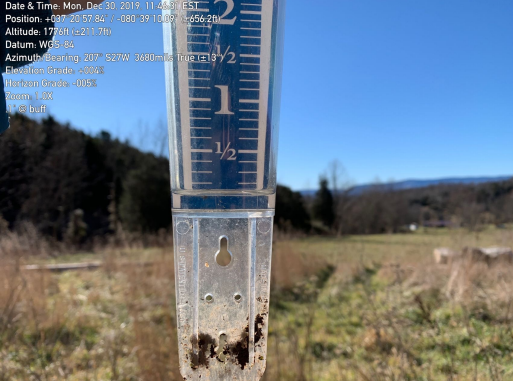
<b>GPS Location</b>		See picture above for GPS coordinates		<b>GPS Location</b>	
<b>Field Station#</b>		11133+00		<b>Field Station#</b>	
<b>Pic 5 Desc.</b>		ECD's and row conditions		<b>Pic 6 Desc.</b>	
				.1" @ Buffalo Anklets

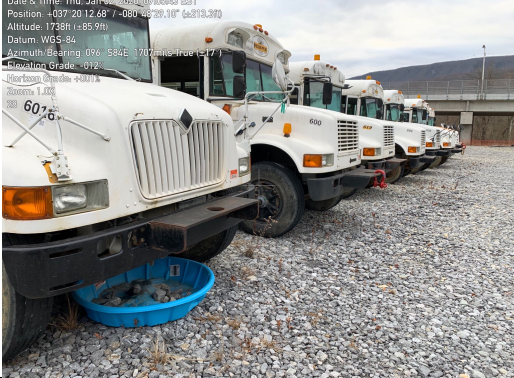
<p>Date &amp; Time: Thu Jan 02, 2020 09:45:43 EST Position: +43°20'12.68" N -080°43'39.10" W (4319.370) Altitude: 1735ft (529m) Datum: WGS-84 Azimuth/Bearing: 32° N34W 4022mils True (416°) Elevation Grade: +01% Horizon Grade: +0.01% Zoom: 1.0X 28</p>		<b>GPS Location</b> See picture above for GPS coordinates <b>Field Station#</b> +28 <b>Pic 1 Desc.</b> ECD's and row conditions

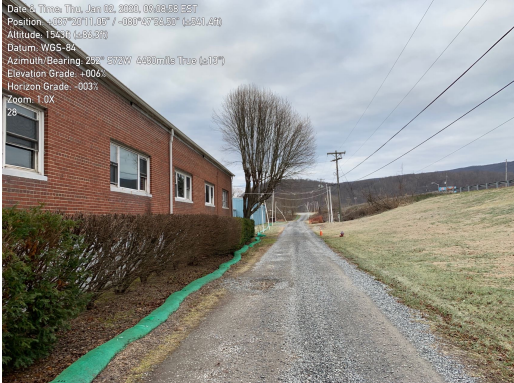
<p>Date &amp; Time: Thu Jan 02, 2020 09:45:43 EST Position: +43°20'12.68" N -080°43'39.10" W (4319.370) Altitude: 1735ft (529m) Datum: WGS-84 Azimuth/Bearing: 34° N34W 4022mils True (416°) Elevation Grade: +01% Horizon Grade: +0.01% Zoom: 1.0X 28</p>		<b>GPS Location</b> See picture above for GPS coordinates <b>Field Station#</b> +28 <b>Pic 3 Desc.</b> ECD's and row conditions

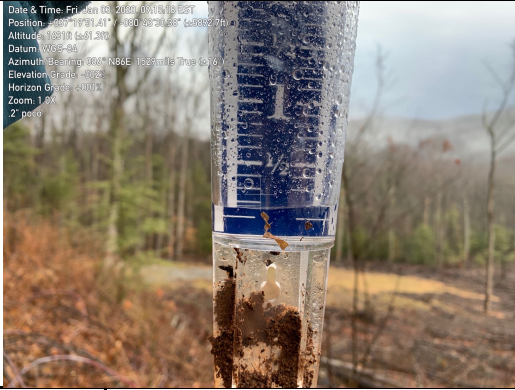
<p>Date &amp; Time: Fri Jan 03 2020 09:16:19 EST Position: +037 20 15 28 / -060 34 19 71 (±39.3m) Altitude: 2215ft (±68.9m) Datum: WGS-84 Azimuth/Bearing: 236° N66W 5227mils True (±10°) Elevation Grade: +025% Horizon Grade: -001% Zoom: 1.0X 2' post</p>		<b>GPS Location</b> See picture above for GPS coordinates	
<b>Field Station#</b> +1		<b>Field Station#</b> +1		<b>Pic 1 Desc.</b> .3" @ Kow Camp

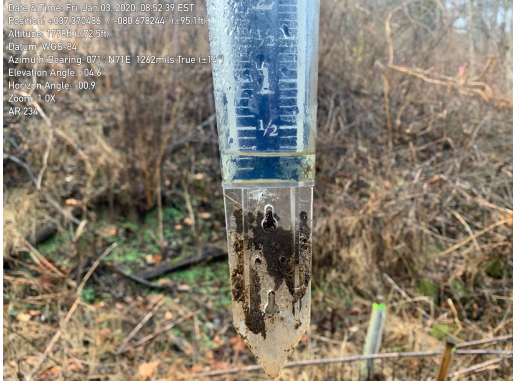
<p>Date &amp; Time: Fri, Jan 03, 2020, 08:55:59 EST Position: +037.349200° / -080.508600° (±19.2m) Altitude: 2065ft (±37.7m) Datum: WGS-84 Azimuth/Bearing: 07° N70W 1262mils True (±14°) Elevation Angle: -04.6° Horizon Angle: -03.6° Zoom: 2.0X 10670+00</p>			
GPS Location	See photo for GPS location.		GPS Location	See photo for GPS location.	
Field Station#	12005+00		Field Station#	10670+00	
Pic 1 Desc.	Rain gauge at access road 234 reads. 0.3 inches.		Pic 2 Desc.	Reinforced super silt fence in place along LOD.

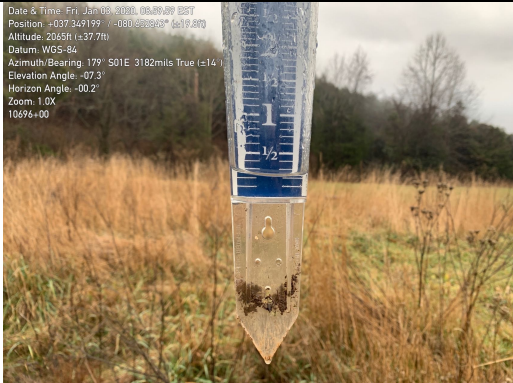
GPS Location	See photo for GPS location.		GPS Location	See photo for GPS location.	
Field Station#	10696+00		Field Station#	10696+00	
Pic 3 Desc.	Rain gauge at Buffalo Anklets Road reads 0.3 inches.		Pic 4 Desc.	RCE in place at Buffalo Anklets Road.

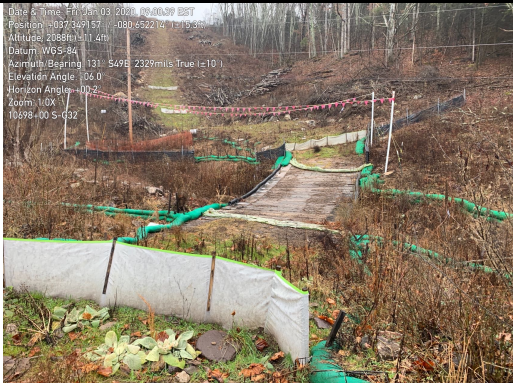
Pic 5 Desc.	Sensitive resource buffer in place at stream S-G32.		Pic 6 Desc.	12 inch compost filter sock replaced due to fire.
