Visual Site Inspection Report

Project Name	H-600 Pipeline Spread G	AFE	124300137	Spread	H-600 Pipeline Spread G
Contractor	Precision			Report #	6475
Inspector	Chris Burns			Date/Time	12/9/2019 7:15 AM
Permit #	TBD	Inspection Type	VA SWPP	Station Begin	11024+00
State	VA	Inspection Area	Partial	Station End	11065+00
County	Giles	Ground	Wet	Temperature (°F)	50.00
Municipality	N/A	Weather	Light Rain	Rain Gauge (in)	0.30
				Rain Accumulation Time (days)	3.00

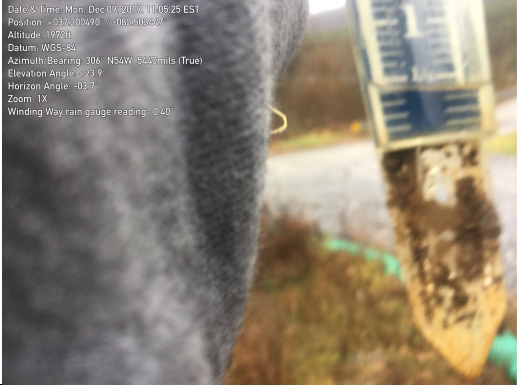
AFE	124300137	Date/Time	12/9/2019 7:51 AM	Report #	
Pictures					
<small> Date & Time: Mon, Dec 9, 2019 11:05:25 EST Position: -031.0310470, -108.1510320 Altitude: 1972 ft Datum: WGS-84 Azimuth/Bearing: 306, NSAW: 502 miles (True) Elevation Angle: -23.9 Horizon Angle: -03.2 Zoom: 1X Winding Way rain gauge reading: 0.40" </small>

Insert image here			
GPS Location	See photo GPS	GPS Location			
Field Station#	11024+00	Field Station#			
Pic 7 Desc.	Winding Way rain gauge reading- 0.40"	Pic 8 Desc.			
Insert image here		Insert image here			
GPS Location		GPS Location			
Field Station#		Field Station#			
Pic 9 Desc.		Pic 10 Desc.			
Insert image here		Insert image here			
GPS Location		GPS Location			
Field Station#		Field Station#			
Pic 11 Desc.		Pic 12 Desc.

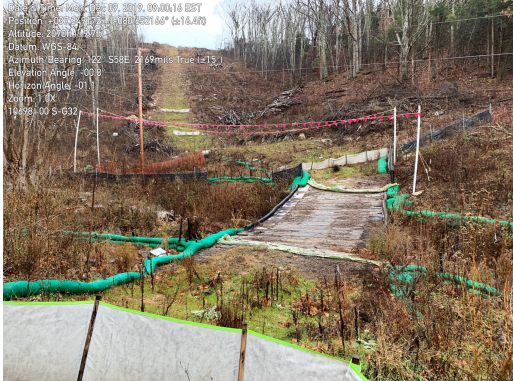
<p>Date & Time: Mon, Dec 09, 2019, 09:40:14 EST Position: +487.34922° / +480.8277° (+16.40) Altitude: 2000' (+6.80) Datum: WGS-84 Azimuth Bearing: 102.558° 0.60mils True (+13.1) Elevation Angle: -00.0 Horizon Angle: -01.1 Zoom: 1.0X 10698+00 S-G32</p>

<p>Date & Time: Mon, Dec 09, 2019, 09:41:10 EST Position: +487.34922° / +480.8277° (+16.40) Altitude: 2000' (+6.80) Datum: WGS-84 Azimuth Bearing: 31.2° 337'N 332mils True (+6.8) Elevation Angle: -03.2 Horizon Angle: -01.2 Zoom: 1.0X 10696+00 0.3</p>			
GPS Location	See photo for GPS location.		GPS Location	See photo for GPS location.	
Field Station#	10698+00		Field Station#	10696+00	
Pic 1 Desc.	Sensitive resource buffer in place at stream S-G32.		Pic 2 Desc.	Rain gauge at Buffalo Anklets Road reads 0.3 inches.

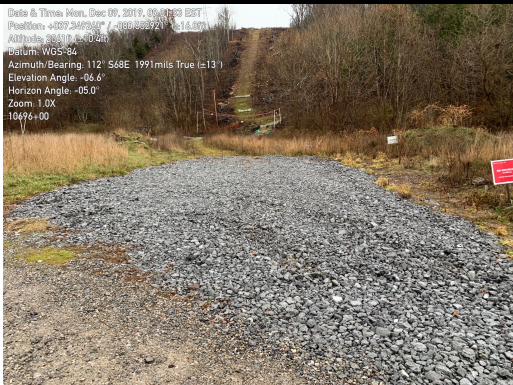
<p>Date & Time: Mon, Dec 09, 2019, 09:41:10 EST Position: +487.34922° / +480.8277° (+16.40) Altitude: 2000' (+6.80) Datum: WGS-84 Azimuth Bearing: 112.568° 199mils True (+13.1) Elevation Angle: -06.6 Horizon Angle: -05.0 Zoom: 1.0X 10696+00</p>

GPS Location	See photo for GPS location.		GPS Location	See photo for GPS location.	
Field Station#	10696+00		Field Station#	11767+00	
Pic 3 Desc.	RCE in place at buffalo Buffalo Anklets Road.		Pic 4 Desc.	Rain gauge at Mount Tabor Road reads 0.3 inches.

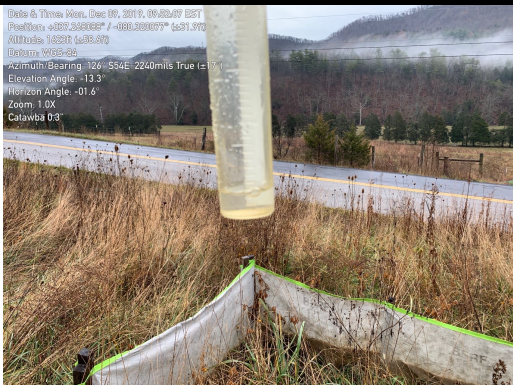
<p>Date & Time: Mon, Dec 09, 2019, 09:42:47 EST Position: +487.34922° / +480.8277° (+16.40) Altitude: 1920' (+38.40) Datum: WGS-84 Azimuth Bearing: 124.554° 2240mils True (+13.1) Elevation Angle: -13.3 Horizon Angle: -01.6 Zoom: 1.0X Catawba 0.3</p>

Pic 5 Desc.	Rain gauge at Catawba Road reads 0.3 inches.		Pic 6 Desc.	Rain gauge at Craig Creek Road reads 0.3 inches.

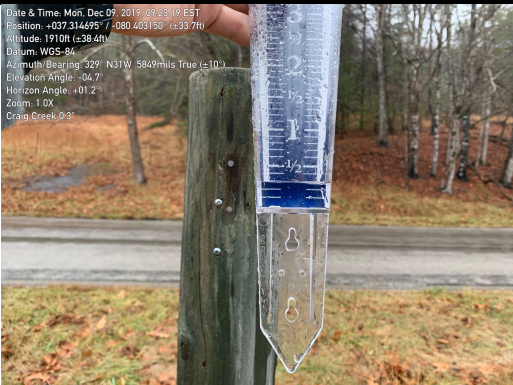
<p>Date & Time: Mon, Dec 09, 2019, 09:43:19 EST Position: +487.314695° / +480.403150° (+13.70) Altitude: 1910' (+38.40) Datum: WGS-84 Azimuth Bearing: 329° N31W 5849mils True (+10.1) Elevation Angle: -04.7 Horizon Angle: -01.2 Zoom: 1.0X Craig Creek 0.3</p>			
GPS Location	See photo for GPS location.		GPS Location	See photo for GPS location.	
Field Station#	11990+00		Field Station#	11613+00

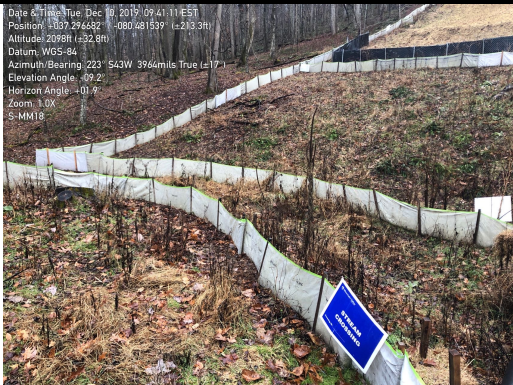
GPS Location	3	GPS Location	4		
Field Station#	11292+80	Field Station#	11310+00		
Pic 3 Desc.	S-MM18.	Pic 4 Desc.	Temporary stabilization.

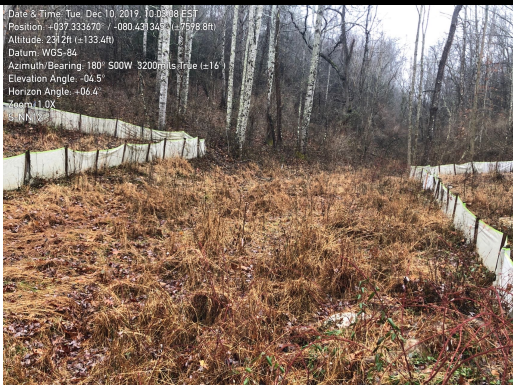
GPS Location	5	GPS Location	6		
Field Station#	11327+85	Field Station#	11352+97		
Pic 5 Desc.	S-NN12.	Pic 6 Desc.	S-NN11.

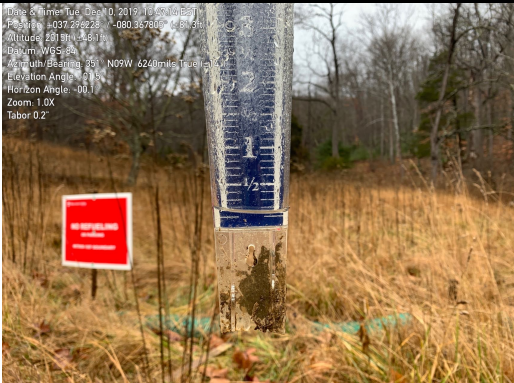
<p>Date & Time: Tue, Dec 10, 2019, 10:00:08 EST Position: +037.22217° / -080.35765° (±69.5M) Altitude: 1919ft (±53.3M) Datum: WGS-84 Azimuth/Bearing: 95° N09W 6240mils True (±13°) Elevation Angle: -01.5° Horizon Angle: -00.1° Zoom: 1.0X Catawba 0.2"</p>

Pic 5 Desc.	Rain gauge at Mount Tabor Road reads 0.2 inches.	Pic 6 Desc.	Rain gauge at Catawba Road reads 0.2 inches.	GPS Location	See photo for GPS location.

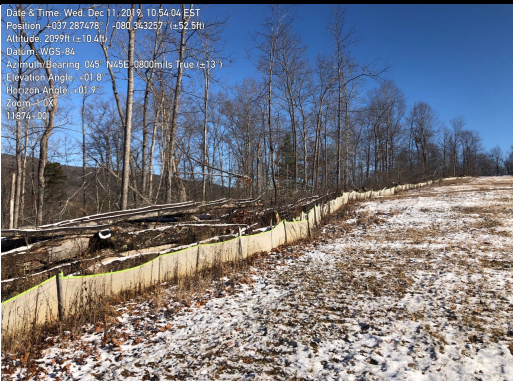
</div></div></div>		
GPS Location	5	GPS Location	6		
Field Station#	11863+65	Field Station#	11874+00		
Pic 5 Desc.	P-KL2.	Pic 6 Desc.	P-1 silt fence perimeter control in good condition.

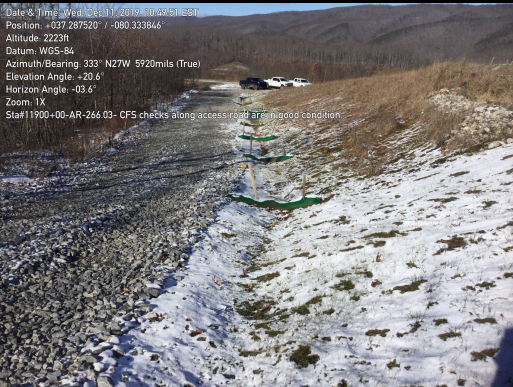
GPS Location	See photo GPS		GPS Location	See photo GPS	
Field Station#	11989+00		Field Station#	11900+00	
Pic 1 Desc.	Catawba rain gauge reading- 0.30"		Pic 2 Desc.	AR-266.03- Access road and environmental controls are maintained in acceptable condition.	
<p>Date & Time: Wed, Dec 11, 2019, 10:59:32 EST Position: +037.283560° / -080.331003° Altitude: 2264ft Datum: WGS-84 Azimuth/Bearing: 332° N48W 5671mils (True) Elevation Angle: +18.0° Horizon Angle: -03.6° Zoom: 1X Sta#11921+00-Water bar level spreaders in good condition.</p>

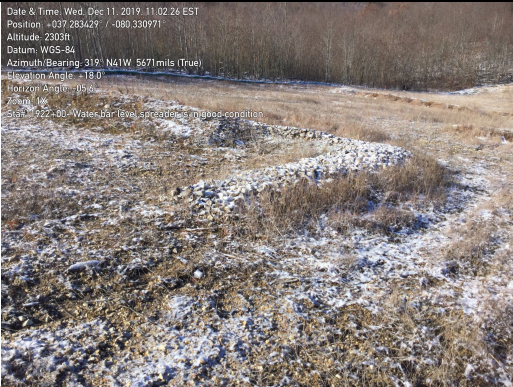
GPS Location	See photo GPS		GPS Location	See photo GPS	
Field Station#	11921+00		Field Station#	11922+00	
Pic 3 Desc.	Water bar outlet protection is in acceptable condition.		Pic 4 Desc.	Water bar level spreaders are in good condition.	
<p>Date & Time: Wed, Dec 11, 2019, 11:13:54 EST Position: +037.278936° / -080.327614° Altitude: 2108ft Datum: WGS-84 Azimuth/Bearing: 336° N24W 5973mils (True) Elevation Angle: +19.7° Horizon Angle: -02.7° Zoom: 1X Sta#11942+00- Karst & Karst ECD's are in acceptable condition.</p>

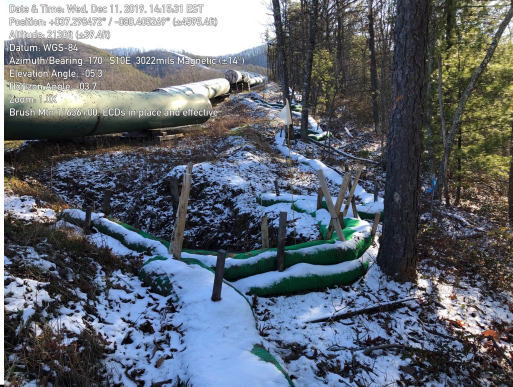
<p>Date & Time: Wed, Dec 11, 2019, 14:15:51 EST Position: +037.296472° / -080.408269° (+489.6ft) Altitude: 2410ft (+39.4ft) Datum: WGS-84 Azimuth/Bearing: 170° S10E 3022mils Magnetic (+14°) Elevation Angle: -05.3 Horizon Angle: -03.7 Zoom: 1.0X Brush Min: 11636+00 ECDs in place and effective</p>

GPS Location	On photo	GPS Location	On photo		
Field Station#	11655+00	Field Station#	11636+00		
Pic 3 Desc.	Slope breakers functioning properly	Pic 4 Desc.	ECDs in place		
<p>Date & Time: Wed, Dec 11, 2019, 14:21:17 EST Position: +037.302916° / -080.477708° (+894.7ft) Altitude: 2015ft (+5.1ft) Datum: WGS-84 Azimuth/Bearing: 327° N03W 5913mils Magnetic (+13°) Elevation Angle: -22.4 Horizon Angle: -01.2 Zoom: 1.0X Brush Min: 11629+00 Slope breakers effective</p>

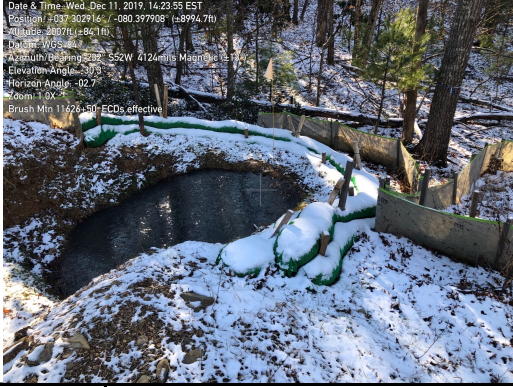
<p>Date & Time: Wed, Dec 11, 2019, 14:23:55 EST Position: +037.302916° / -080.377708° (+894.7ft) Altitude: 2017ft (+5.1ft) Datum: WGS-84 Azimuth/Bearing: 327° S52W 4124mils Magnetic (+13°) Elevation Angle: -30.3 Horizon Angle: -02.7 Zoom: 1.0X Brush Min: 11626+50 ECDs effective</p>

GPS Location	On photo	GPS Location	On photo		
Field Station#	11629+00	Field Station#	11626+50		
Pic 5 Desc.	Slope breakers working as designed	Pic 6 Desc.	ECD effective

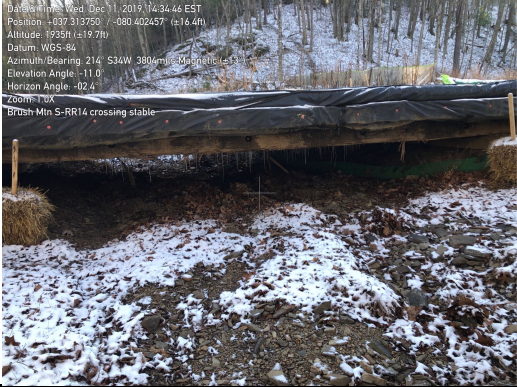
<p><small>Date & Time: Wed, Dec 11, 2019 16:34:46 EST Position: -037.313720 / -080.402457 / 14644ft Altitude: 1935ft (+19.7ft) Datum: WGS-84 Azimuth/Bearing: 214° S34W 380ft Magnetic (+13°) Elevation Angle: -11.0 Horizon Angle: -02.4 Zoom: 1.0x Brush Min 5-RR14 crossing stable</small></p>			
GPS Location	On photo	GPS Location	On photo		
Field Station#	11626+04	Field Station#	11614+20		
Pic 7 Desc.	S-HH18 crossing stable	Pic 8 Desc.	S-RR14 crossing stable

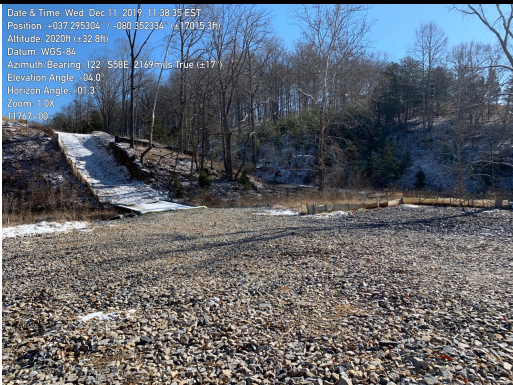
<p>Date & Time: Wed, Dec 11, 2019, 11:38:35 EST Position: +037.295304 / -080.352334 (±17.019m) Altitude: 2020ft (±32.8ft) Datum: WGS-84 Azimuth/Bearing: 122° S58E 2149mils True (±17°) Elevation Angle: -04.0° Horizon Angle: -01.3° Zoom: 1.0X 11767+00</p>

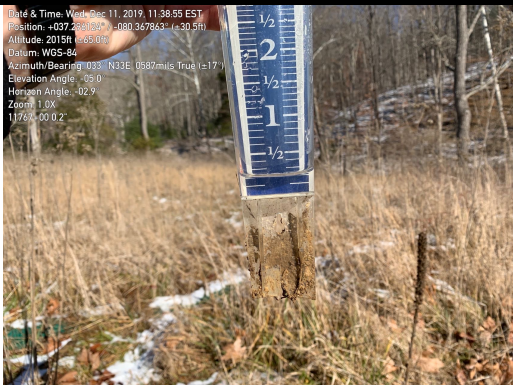
<p>Date & Time: Wed, Dec 11, 2019, 11:38:55 EST Position: +037.295304 / -080.352334 (±17.019m) Altitude: 2015ft (±10.9ft) Datum: WGS-84 Azimuth/Bearing: 033° N33E 0587mils True (±17°) Elevation Angle: -05.0° Horizon Angle: -02.9° Zoom: 1.0X 11767+00 0.2</p>		  <p>Date & Time: Wed, Dec 11, 2019, 11:46:51 EST Position: +037.293244 / -080.353294 (±16.84m) Altitude: 2093ft (±10.9ft) Datum: WGS-84 Azimuth/Bearing: 176° S04E 3129mils True (±17°) Elevation Angle: -22.4° Horizon Angle: +09.1° Zoom: 1.0X 11778+00</p>			
GPS Location	See photo for GPS location.		GPS Location	See photo for GPS location.	
Field Station#	11767+00		Field Station#	11778+00	
Pic 5 Desc.	Rain gauge at Mount Tabor Road reads 0.2 inches.		Pic 6 Desc.	Clean water diversion pipe and plunge pool in place.

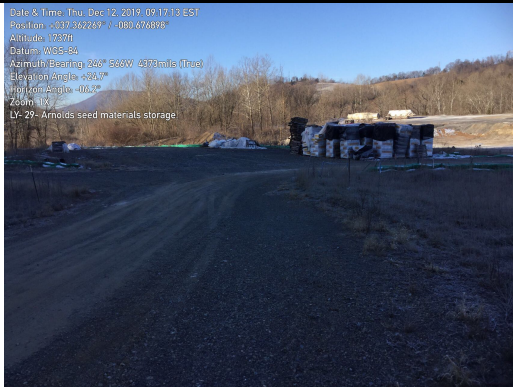
<p>Date & Time: Thu, Dec 12, 2019 09:17:13 EST Position: +011.132729° / -080.676898° Altitude: 1232ft Datum: WGS-84 Azimuth/Bearing: 260° S60W 4123mils (True) Elevation Angle: +34.1° Horizon Angle: -06.5° Zoom: 1X LY-29- Arnold's seed materials storage.</p>			
GPS Location	See photo GPS		GPS Location	See photo GPS	
Field Station#	12005+00		Field Station#	12005+00	
Pic 1 Desc.	AR-238.00- LY-29- The access road is maintained in acceptable condition.		Pic 2 Desc.	LY-29- Arnold's materials storage.

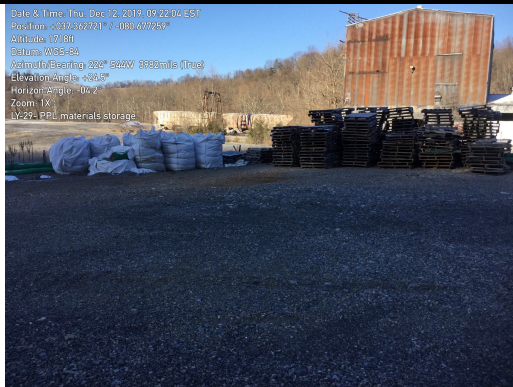
<p>Date & Time: Thu, Dec 12, 2019 09:24:05 EST Position: +012.162182° / -080.677059° Altitude: 1703ft Datum: WGS-84 Azimuth/Bearing: 285° S60W 3906mils (True) Elevation Angle: +33.5° Horizon Angle: -06.2° Zoom: 1X LY-29- PPL materials storage.</p>

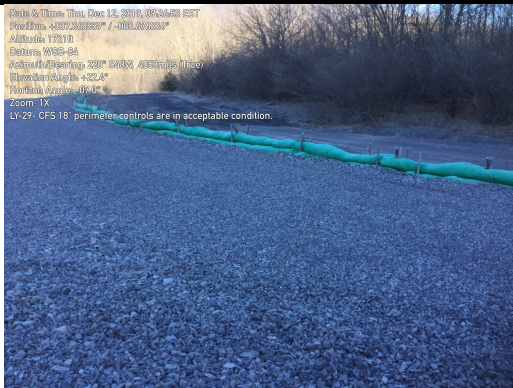
<p>Date & Time: Thu, Dec 12, 2019 09:26:20 EST Position: +010.283907° / -080.683337° Altitude: 1392ft Datum: WGS-84 Azimuth/Bearing: 214° S66W 3906mils (True) Elevation Angle: +27.8° Horizon Angle: -06.6° Zoom: 1X LY-29- CFS 18" perimeter controls are in acceptable condition.</p>			
GPS Location	See photo GPS		GPS Location	See photo GPS	
Field Station#	12005+00		Field Station#	12005+00

Pic 5 Desc.	LY-29- The rock surface of the yard is maintained in acceptable condition.		Pic 6 Desc.	LY-29- The CFS 18" Triple stack perimeter controls are in acceptable condition.

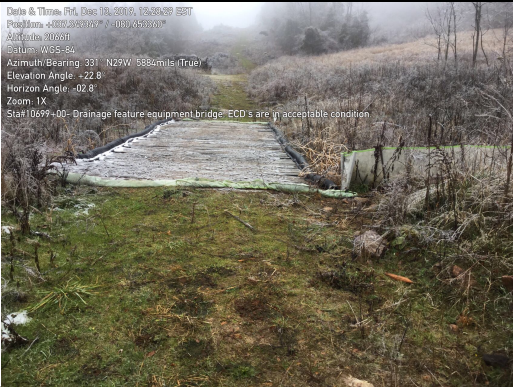
<p>Date & Time: Fri, Dec 13, 2019, 12:46:00 EST Position: +10694.000000 / +080.659174 Altitude: 2063ft Datum: WGS-84 Azimuth Bearing: 331° N29W 588mils (True) Elevation Angle: +22.8 Horizon Angle: -02.8 Zoom: 1X Start 10694+00- Drainage feature equipment bridge, ECD's are in acceptable condition.</p>

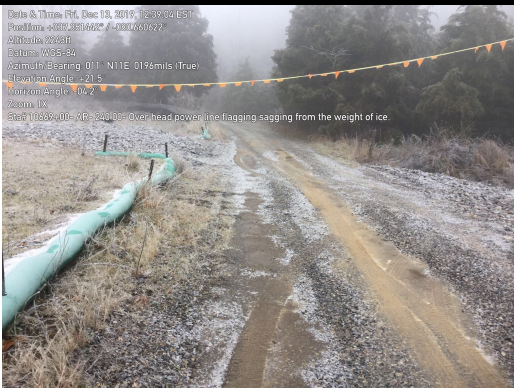
GPS Location	See photo GPS		GPS Location	See photo GPS	
Field Station#	10698+00		Field Station#	10694+00	
Pic 3 Desc.	Stream S-G32- Equipment bridge, ECD's, buffers, sensitive resource signage are in acceptable condition.		Pic 4 Desc.	Drainage feature equipment bridge and ECD's are in acceptable condition.	
<p>Date & Time: Fri, Dec 13, 2019, 12:39:04 EST Position: +10669.000000 / +080.659174 Altitude: 1836ft Datum: WGS-84 Azimuth Bearing: 011° N11E 019mils (True) Elevation Angle: +21.5 Horizon Angle: -05.2 Zoom: 1X Start 110669+00- AR-240.00- Overhead power line flagging sagging from the weight of ice.</p>

Field Station#	10669+00		Field Station#	12005+00	
Pic 5 Desc.	AR-240.00- Overhead power line flagging is sagging from the weight of ice.		Pic 6 Desc.	AR-234.00 rain gauge reading- 0.40"

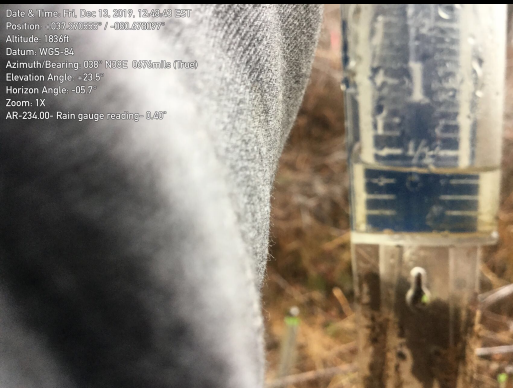
<p>Date & Time: Fri, Dec 13, 2019, 12:46:31 EST Position: +12005.000000 / +080.670000 Altitude: 1836ft Datum: WGS-84 Azimuth Bearing: 038° N38E 047mils (True) Elevation Angle: +23.5 Horizon Angle: -05.7 Zoom: 1X AR-234.00- Rain gauge reading- 0.40"</p>

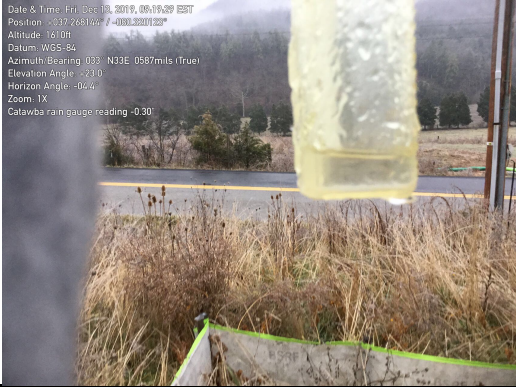
AFE	124300137	Date/Time	12/13/2019 10:16 AM	Report #	
Pictures					
<small> Date & Time: Fri, Dec 13, 2019, 09:19:29 EST Position: -037.268129, 7-000.320122° Altitude: 1610ft Datum: WGS-84 Azimuth Bearing: 030° N33E 0587mils (True) Elevation Angle: -21.0 Horizon Angle: -02.4 Zoom: 1X Catawba rain gauge reading -0.30" </small>

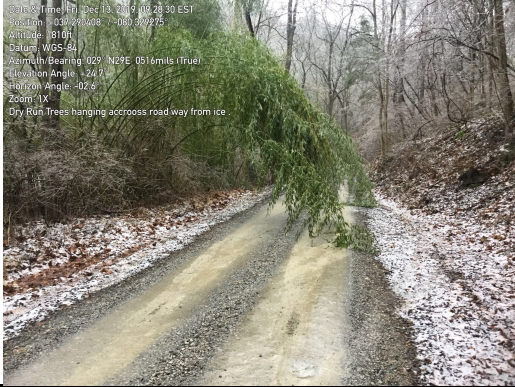
<small> Date & Time: Fri, Dec 13, 2019, 09:28:30 EST Position: -037.268129, 7-000.320122° Altitude: 1610ft Datum: WGS-84 Azimuth Bearing: 029° N24E 0516mils (True) Elevation Angle: -24.13 Horizon Angle: -02.4 Zoom: 1X Dry Run Trees hanging accross road way from ice. </small>

GPS Location	See photo GPS	GPS Location	See photo GPS		
Field Station#	11989+00	Field Station#	11900+00		
Pic 7 Desc.	Catawba rain gauge reading-0.30"	Pic 8 Desc.	Dry Run road near AR-266.03- Ice on trees.		
Insert image here		Insert image here			
GPS Location		GPS Location			
Field Station#		Field Station#

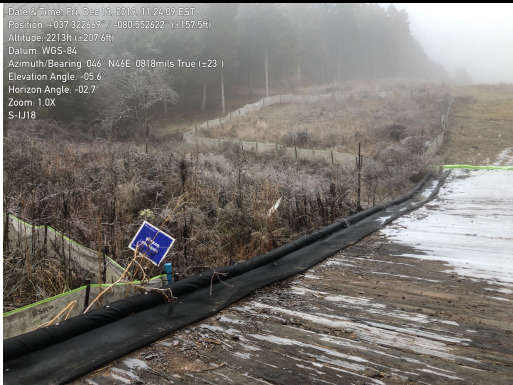
GPS Location	1		GPS Location	2	
Field Station#	11025+50		Field Station#	11028+00	
Pic 1 Desc.	S-IJ18.		Pic 2 Desc.	Reinforced silt fence perimeter control in good condition.

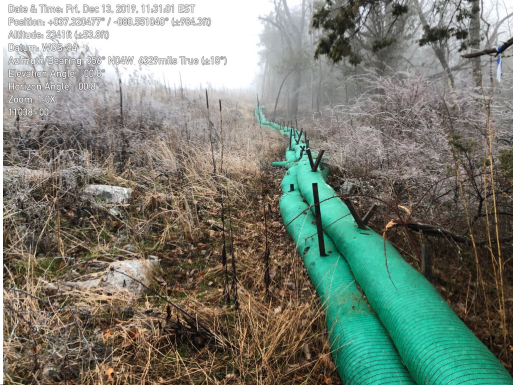
GPS Location	3		GPS Location	4	
Field Station#	11038+00		Field Station#	11055+00	
Pic 3 Desc.	CFS perimeter control in good condition.		Pic 4 Desc.	Multi layer perimeter control in good condition.

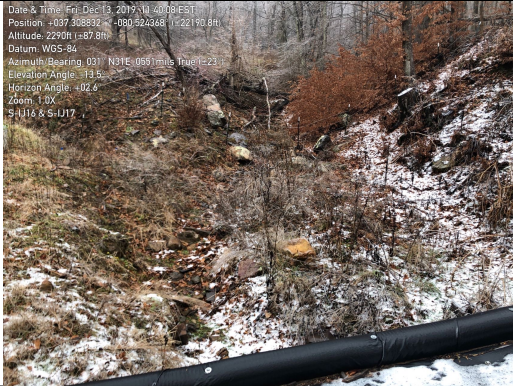
GPS Location	5		GPS Location	6	
Field Station#	11050+10		Field Station#	11065+00	
Pic 5 Desc.	S-IJ16 & S-IJ17.		Pic 6 Desc.	Vegetation and stabilization adequate.
