# Visual Site Inspection Report

<b>Project Name</b>	H-600 Pipeline Spread G	<b>AFE</b>	124300137	<b>Spread</b>	H-600 Pipeline Spread G
<b>Contractor</b>	Precision			<b>Report #</b>	9192
<b>Inspector</b>	Garrett Barclay			<b>Date/Time</b>	3/16/2020 7:38 AM
<b>Permit #</b>	TBD	<b>Inspection Type</b>	VA SWPP	<b>Station Begin</b>	12005+00
<b>State</b>	VA	<b>Inspection Area</b>	Partial	<b>Station End</b>	12005+00
<b>County</b>	Giles	<b>Ground</b>	Wet	<b>Temperature (°F)</b>	38.00
<b>Municipality</b>	N/A	<b>Weather</b>	Sunny	<b>Rain Gauge (in)</b>	0.70
				<b>Rain Accumulation Time (days)</b>	1.00

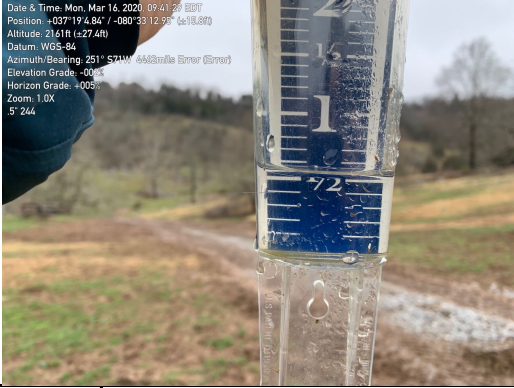
<p>Date &amp; Time: Mon, Mar 16, 2020, 09:41:29 EDT Position: +037°19'4.84" / -080°35'12.07" (+18.88) Altitude: 2161ft (+27.4ft) Datum: WGS-84 Azimuth/Bearing: 251° 53W 3787m (+300m Error Error) Elevation Grade: -001% Horizon Grade: +005% Zoom: 1.0X 5' 244</p>

<p>Date &amp; Time: Mon, Mar 16, 2020, 09:28:03 EDT Position: +037°20'5.79" / -080°35'48.35" (+18.88) Altitude: 2093ft (+189.9ft) Datum: WGS-84 Azimuth/Bearing: 213° 53W 3787m (+300m Error Error) Elevation Grade: -001% Horizon Grade: +007% Zoom: 1.0X 7' kow</p>			
<b>GPS Location</b>	See picture above for GPS coordinates		<b>GPS Location</b>	See picture above for GPS coordinates	
<b>Field Station#</b>	+1		<b>Field Station#</b>	+1	
<b>Pic 1 Desc.</b>	.5" of rain recorded @ AR 244		<b>Pic 2 Desc.</b>	.7" of rain recorded @ Kow

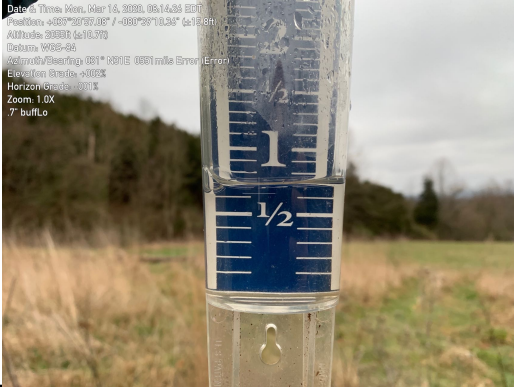
<p>Date &amp; Time: Mon, Mar 16, 2020, 09:14:08 EDT Position: +037°20'57.08" / -080°35'18.33" (+18.88) Altitude: 2093ft (+189.9ft) Datum: WGS-84 Azimuth/Bearing: 251° 53W 3787m (+300m Error Error) Elevation Grade: -002% Horizon Grade: +003% Zoom: 1.0X 7' buffalo</p>

<b>GPS Location</b>	See picture above for GPS coordinates		<b>GPS Location</b>	See picture above for GPS coordinates	
<b>Field Station#</b>	+1		<b>Field Station#</b>	12005+00	
<b>Pic 3 Desc.</b>	.7" of rain recorded @ Buffalo Anklets		<b>Pic 4 Desc.</b>	ECD's and row conditions

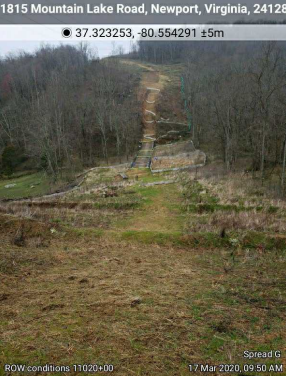
<b>GPS Location</b>	see photo		<b>GPS Location</b>	see photo	
<b>Field Station#</b>	11020+00		<b>Field Station#</b>	11015+80	
<b>Pic 1 Desc.</b>	Stabilized ROW conditions		<b>Pic 2 Desc.</b>	stream s-RR5

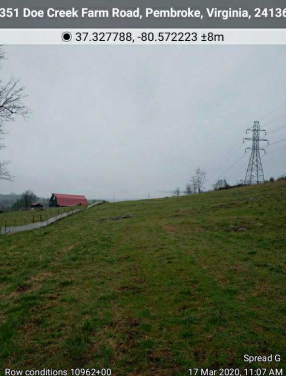
<b>GPS Location</b>	see photo		<b>GPS Location</b>	see photo	
<b>Field Station#</b>	10962+00		<b>Field Station#</b>	10952+00	
<b>Pic 5 Desc.</b>	stabilized ROW conditions.		<b>Pic 6 Desc.</b>	ROW conditions

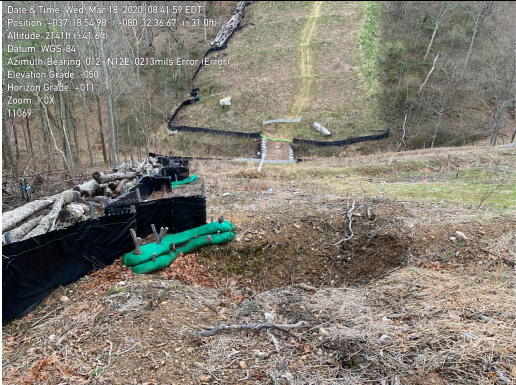
<b>GPS Location</b>	See picture above for GPS coordinates		<b>GPS Location</b>	See picture above for GPS coordinates	
<b>Field Station#</b>	11069+00		<b>Field Station#</b>	11082+00	
<b>Pic 1 Desc.</b>	ECD's and row conditions		<b>Pic 2 Desc.</b>	ECD's and row conditions

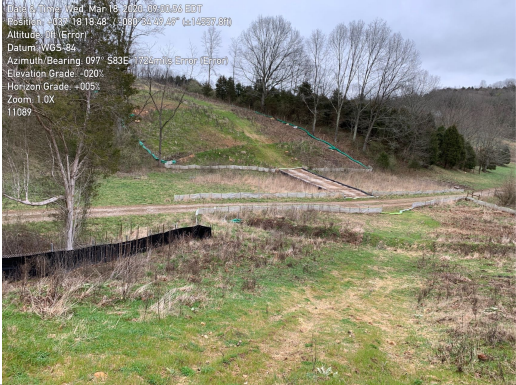
<b>GPS Location</b>	See picture above for GPS coordinates		<b>GPS Location</b>	See picture above for GPS coordinates	
<b>Field Station#</b>	11089+00		<b>Field Station#</b>	11119+00	
<b>Pic 3 Desc.</b>	ECD's and row conditions		<b>Pic 4 Desc.</b>	ECD's and row conditions

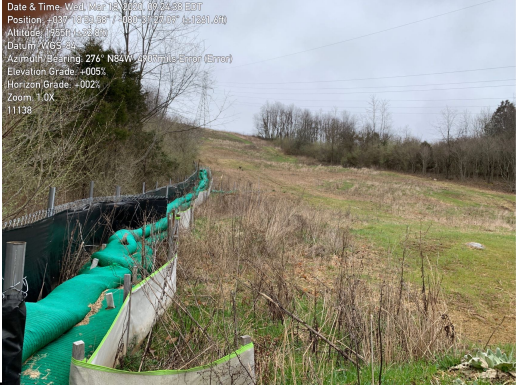
<b>GPS Location</b>	See picture above for GPS coordinates		<b>GPS Location</b>	See picture above for GPS coordinates	
<b>Field Station#</b>	11138+00		<b>Field Station#</b>	11138+00	
<b>Pic 5 Desc.</b>	ECD's and row conditions		<b>Pic 6 Desc.</b>	ECD's and row conditions

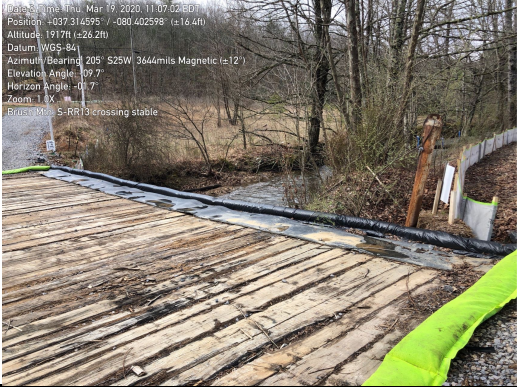
<p>Date &amp; Time: Thu, Mar 19, 2020 11:07:45 EDT  Position: +037 314595 / -080 402598 (+16.4ft)  Altitude: 1917ft (+26.2ft)  Datum: WGS-84  Azimuth/Bearing: 205° S25W 3644mils Magnetic (+12°)  Elevation Angle: -07.7°  Horizon Angle: -04.7°  Zoom: 1.0X  Brush Min. S-RR13 crossing stable</p>		  <p>Date &amp; Time: Thu, Mar 19, 2020 11:15:58 EDT  Position: +037 313140 / -080 402598 (+16.4ft)  Altitude: 1857ft (+420.0ft)  Datum: WGS-84  Azimuth/Bearing: 238° S58W 4231mils Magnetic (+12°)  Elevation Angle: -11.3°  Horizon Angle: -04.2°  Zoom: 1.0X  Brush Min. 11601 + 00 controls in place</p>			
<b>GPS Location</b>	On photo	<b>GPS Location</b>	On photo		
<b>Field Station#</b>	11613+69	<b>Field Station#</b>	11601+00		
<b>Pic 7 Desc.</b>	The S-RR13 access MN-258.04 crossing is stable	<b>Pic 8 Desc.</b>	Perimeter controls effective. Surface stable.

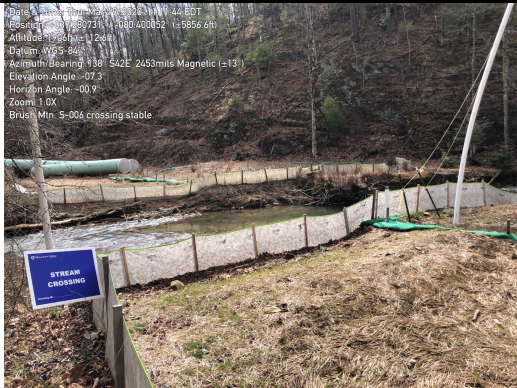
<p>Date &amp; Time: Thu, Mar 19, 2020 11:17:45 EDT  Position: +037 313140 / -080 402598 (+16.4ft)  Altitude: 1857ft (+420.0ft)  Datum: WGS-84  Azimuth/Bearing: 138° S42E 2453mils Magnetic (+13°)  Elevation Angle: -07.3°  Horizon Angle: -00.7°  Zoom: 1.0X  Brush Min. S-006 crossing stable</p>				Insert image here	
<b>GPS Location</b>	On photo	<b>GPS Location</b>			
<b>Field Station#</b>	11607+81	<b>Field Station#</b>			
<b>Pic 9 Desc.</b>	The S-006 crossing is stable.	<b>Pic 10 Desc.</b>			
Insert image here		Insert image here			
<b>GPS Location</b>		<b>GPS Location</b>			
<b>Field Station#</b>		<b>Field Station#</b>			
<b>Pic 11 Desc.</b>		<b>Pic 12 Desc.</b>
